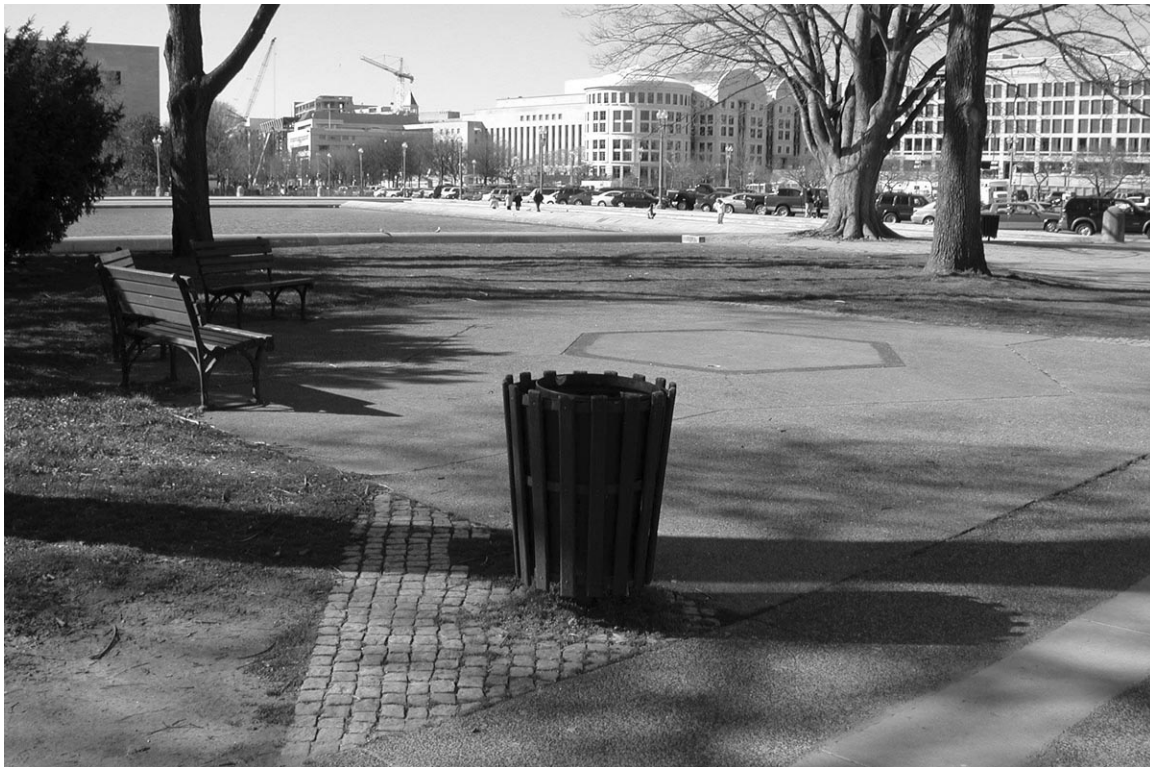
At Union Square, such amenities as benches and trash receptacles are located only along 1st Street. This small paved area off the 1st St. sidewalk probably once featured a kiosk for visitor services. (CLP file "GM, paved recess in sidewalk along 1st, 2" Feb. 24 2006)

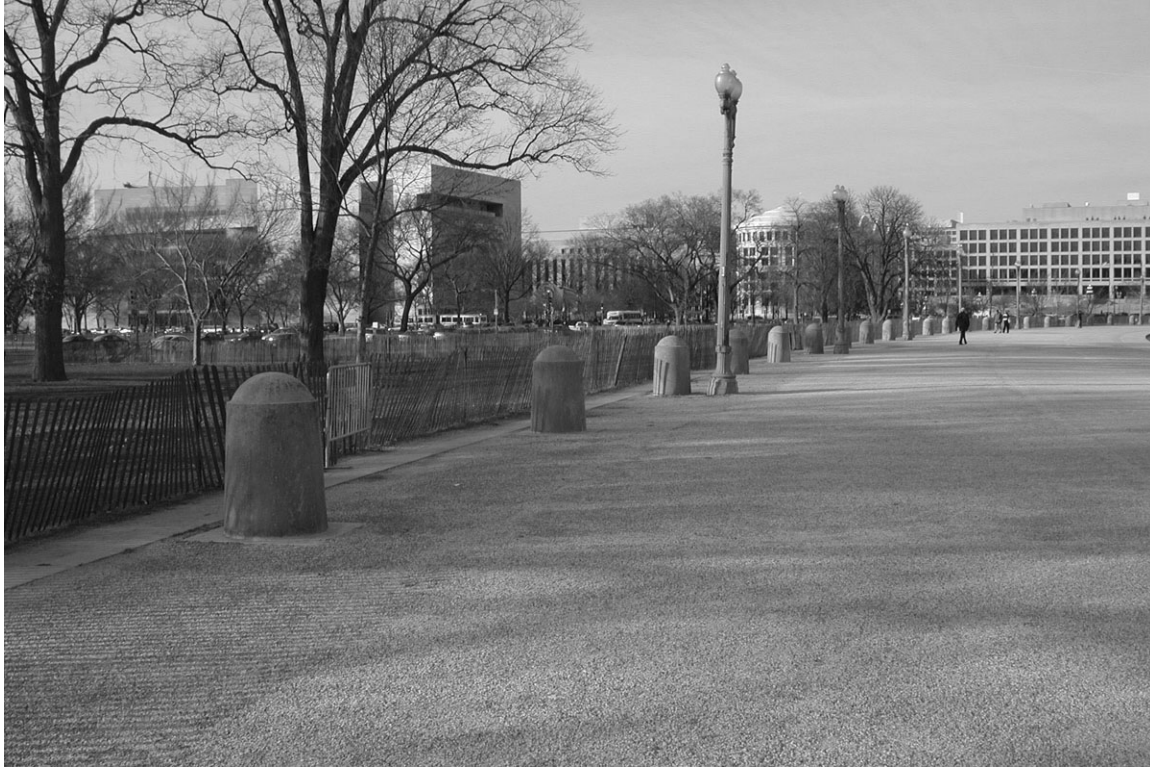
A row of concrete bollards lines the west end of the broad plaza that extends west of the reflecting pool. Bacon Twin-Twenty light standards stand to the inside of every third bollard. Single bollards are located at the northeast and southeast corners of the pool at the top of the steps. Measuring about three-and-a-half feet high, the bollards are cylindrical, with sides that slope slightly inward. The sides are cut back to form a rim, then rise into a rounded, domical top. Each stands on a square concrete platform. Except for some staining of the concrete, the bollards are in good condition.

Bollards and Bacon Twin-Twenty lights line the west side of the large concrete plaza west of the pool. (CLP file "bollards" Feb. 10 2006)

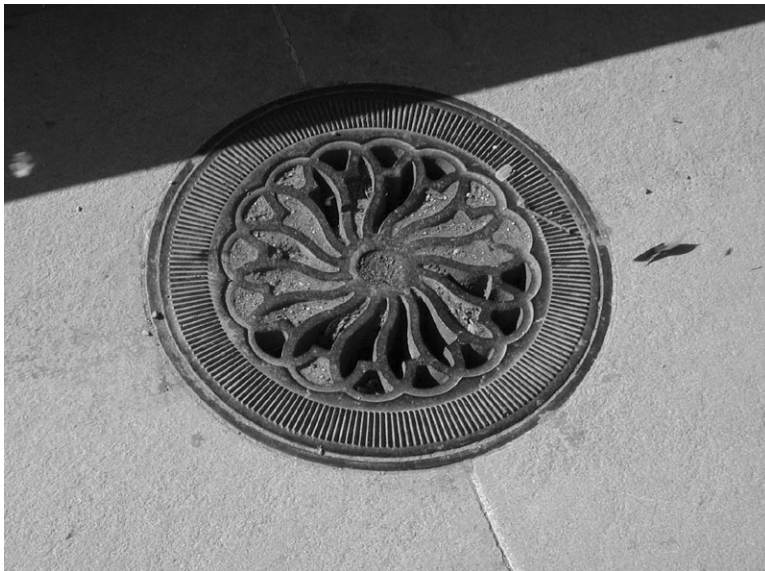
Round metal (probably cast iron) drainage grates are set in the paving in front of the pool's coping. Each grate is embossed with a stylized flower head.

The ornamental flourish of the drainage grates set around the reflecting pool contrast with the stark simplicity of the rest of the SOM design. (CLP file "decorative grate" Feb. 24 2006)

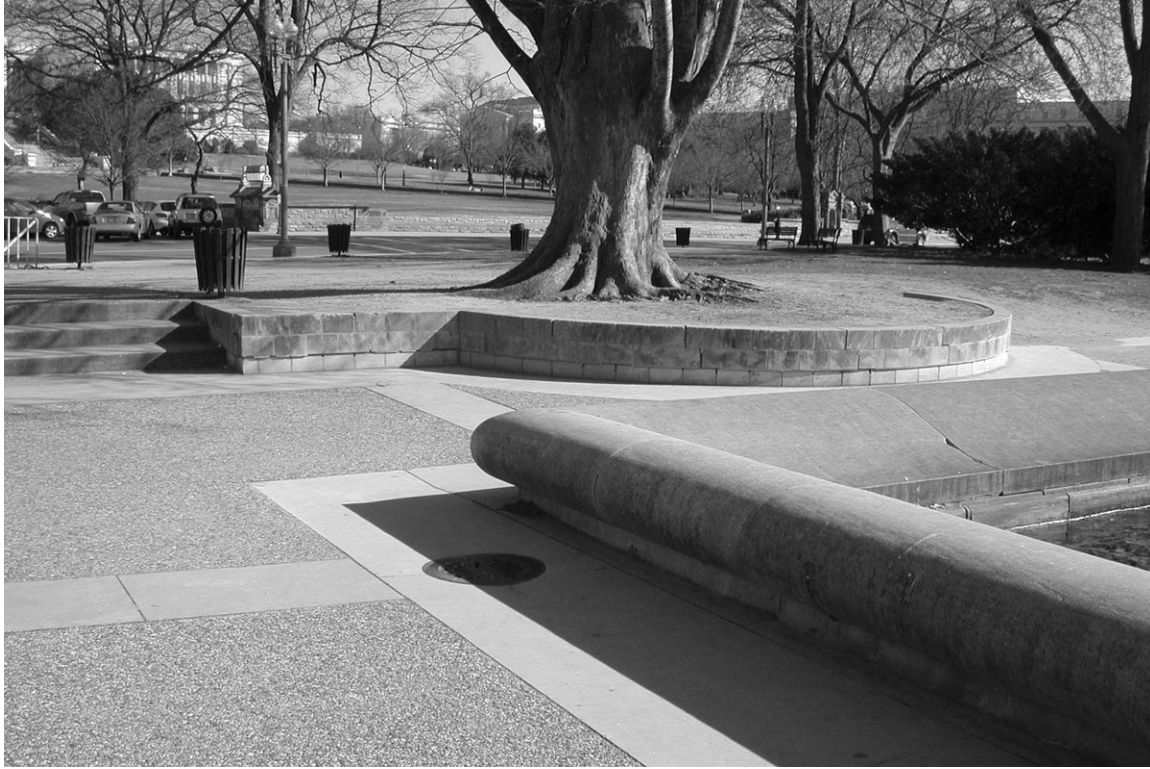
Two low semicircular retaining walls are located northwest and southwest of the Grant Memorial, where the low rise in the ground is cut back for the walk along the east side of the pool. The walls curve from the steps on one side into the sloping ground on the other. They were probably built as part of the SOM design for the pool and its surroundings. The walls, about a foot high, are constructed of three courses of limestone blocks. The top two courses are darker and larger than the base course, and extend out slightly farther. A few blocks have shifted, and many are stained; some mortar is missing, and weeds grow from the mortar in places. Overall, the walls are in fair condition.

This retaining wall partially surrounds a *Zelkova serrata*, remaining from the historic Botanic Garden, located in the square's northeast corner. (CLP file "GM NE tree well and corner of pool" Feb. 24 2006)
