National Mall and Memorial Parks Tour Bus Study

Final Report Summary

Site Specific Recommendations Overview

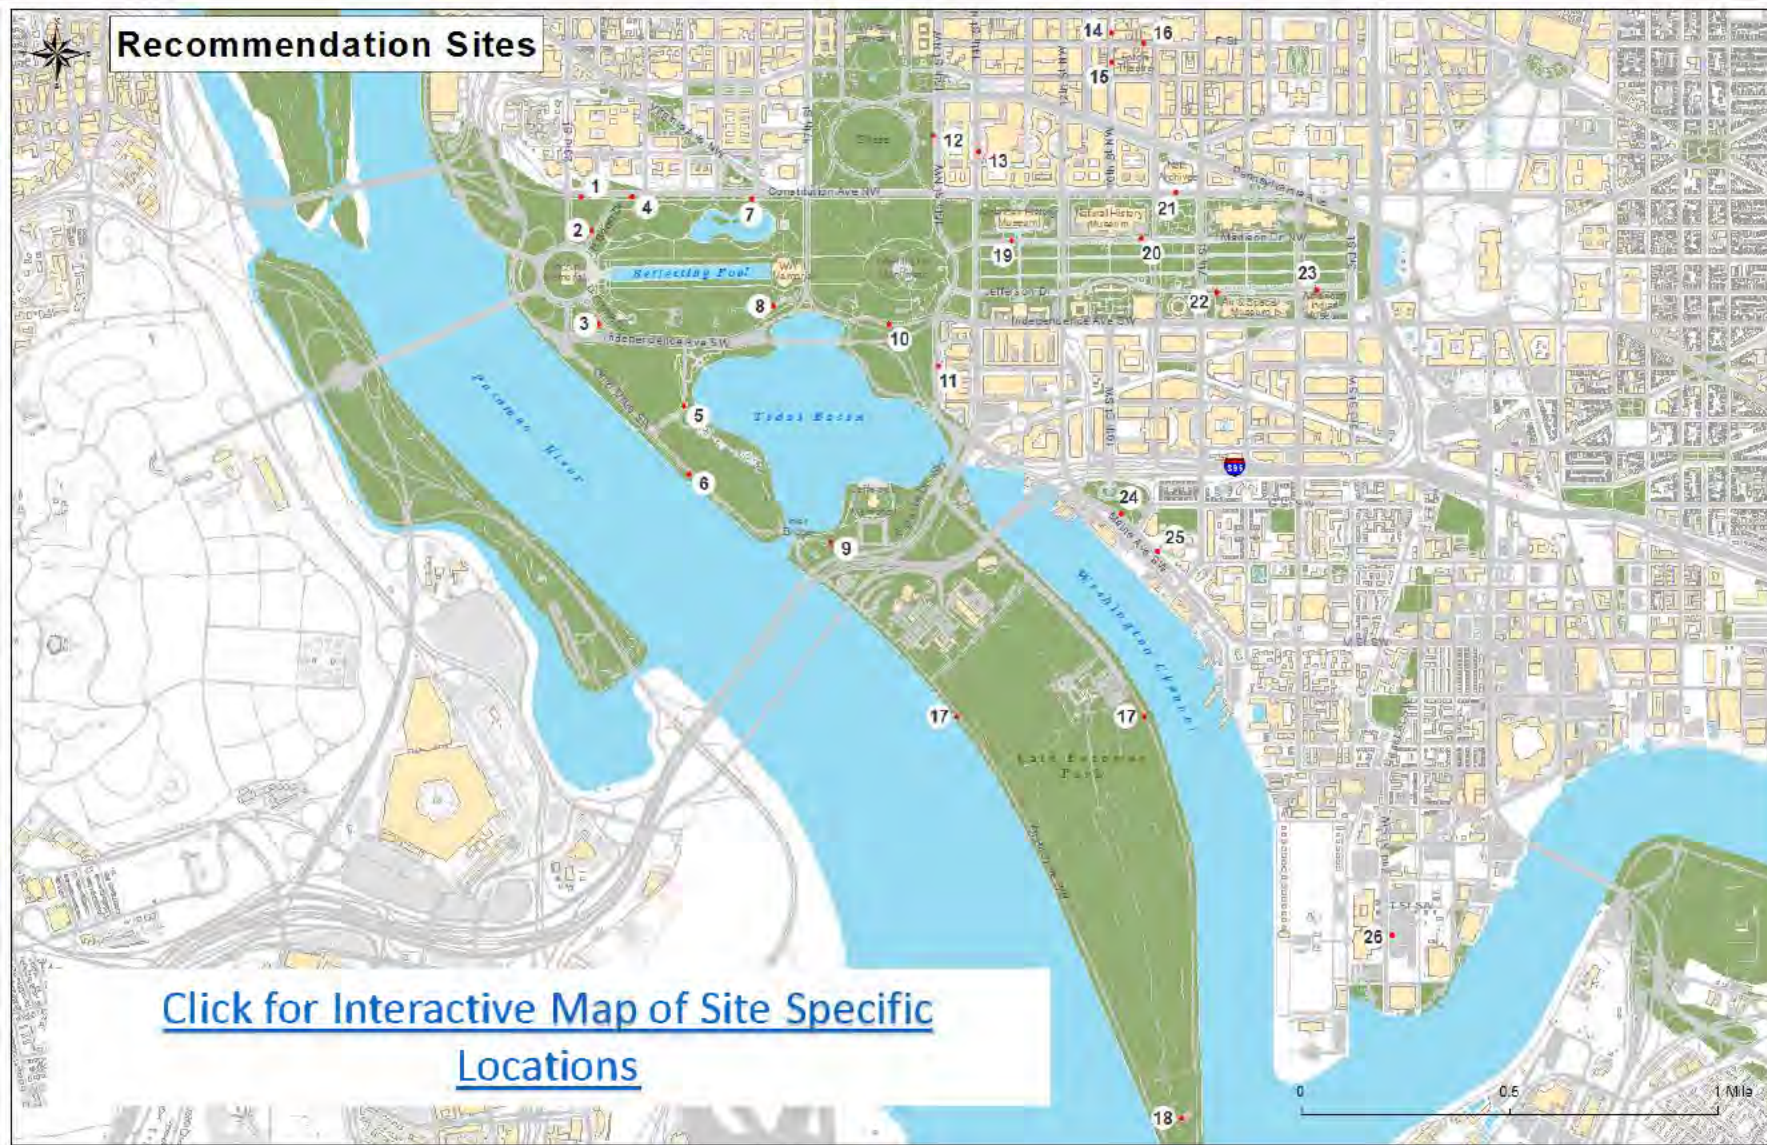
- Study Area, approx. 684 acres
- 21-25 million visitors annually
- 1200+ buses per day
- Study conducted March 2012 thru June 2014
- 26 site specific recommendations, numbered on map 1-26
- 8 Additional Global Recommendations, letters A-H on map (shown slide 39)

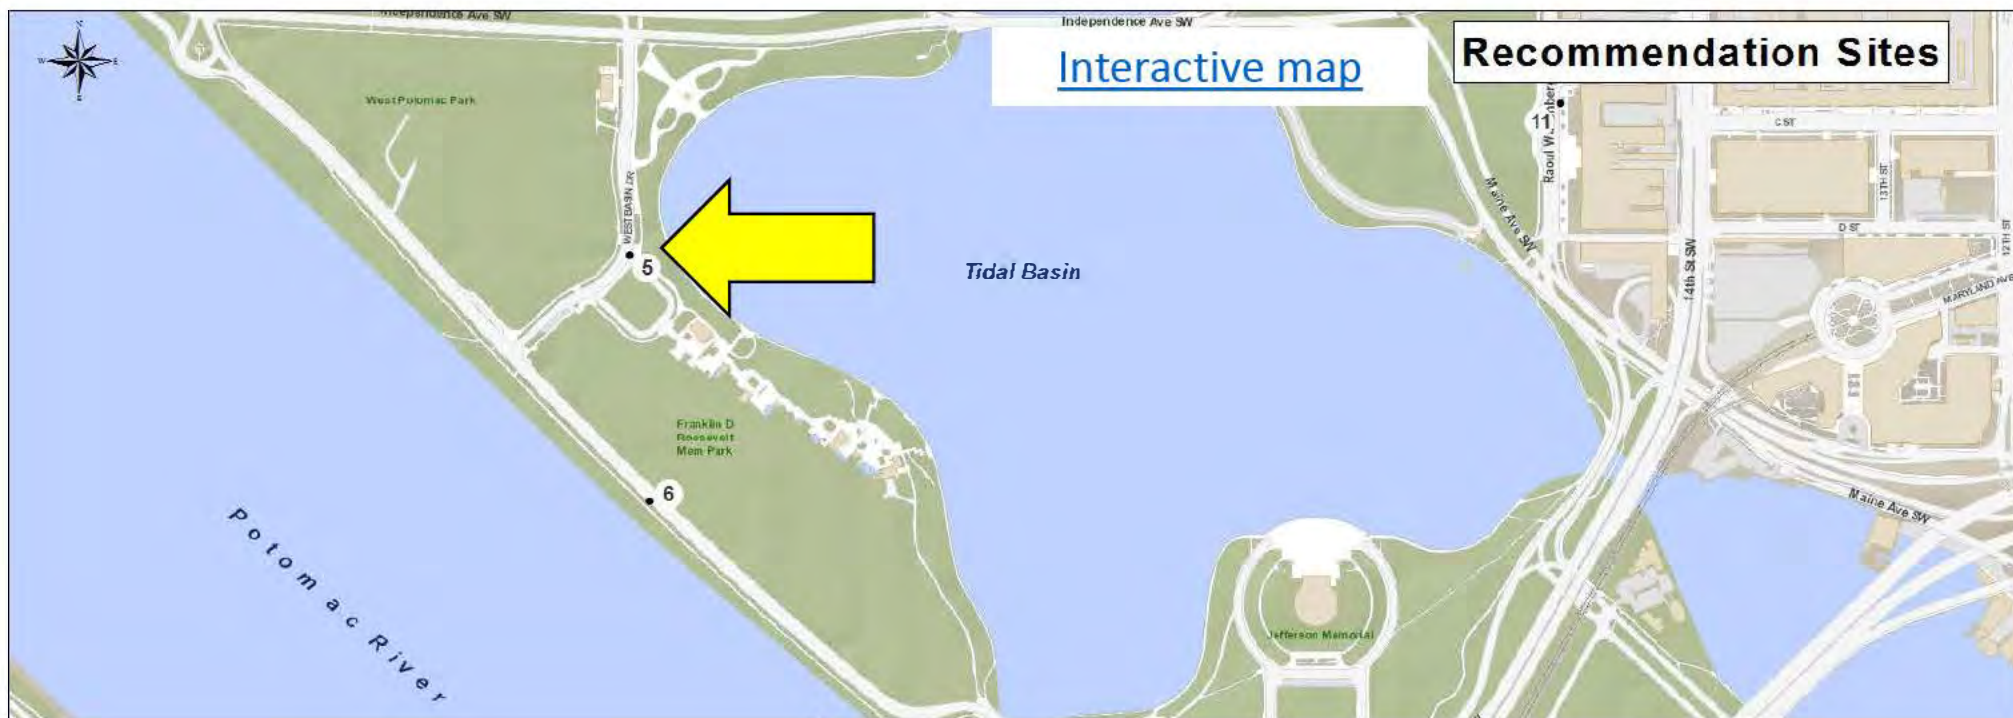
Site 5 of 26

FDR/MLK Memorial, West Basin Drive

Current Function	Summary of Documented Issues	Recommendations
5 spaces for tour bus loading/unloading	Over-utilized, particularly during peak season; stopping in zone beyond time needed to load/unload; illegal loading/unloading in non-designated areas; minimal/ inconsistent enforcement	Reallocate and accommodate tour bus loading/unloading, tour bus parking, private vehicle parking, parking for individuals with disabilities, NPS visitor transit, permit parking and local sightseeing buses to be responsive to seasonal modal surges; explore best uses for FDR one-way circle road; develop and install standard regulatory signs; standardize and coordinate enforcement.

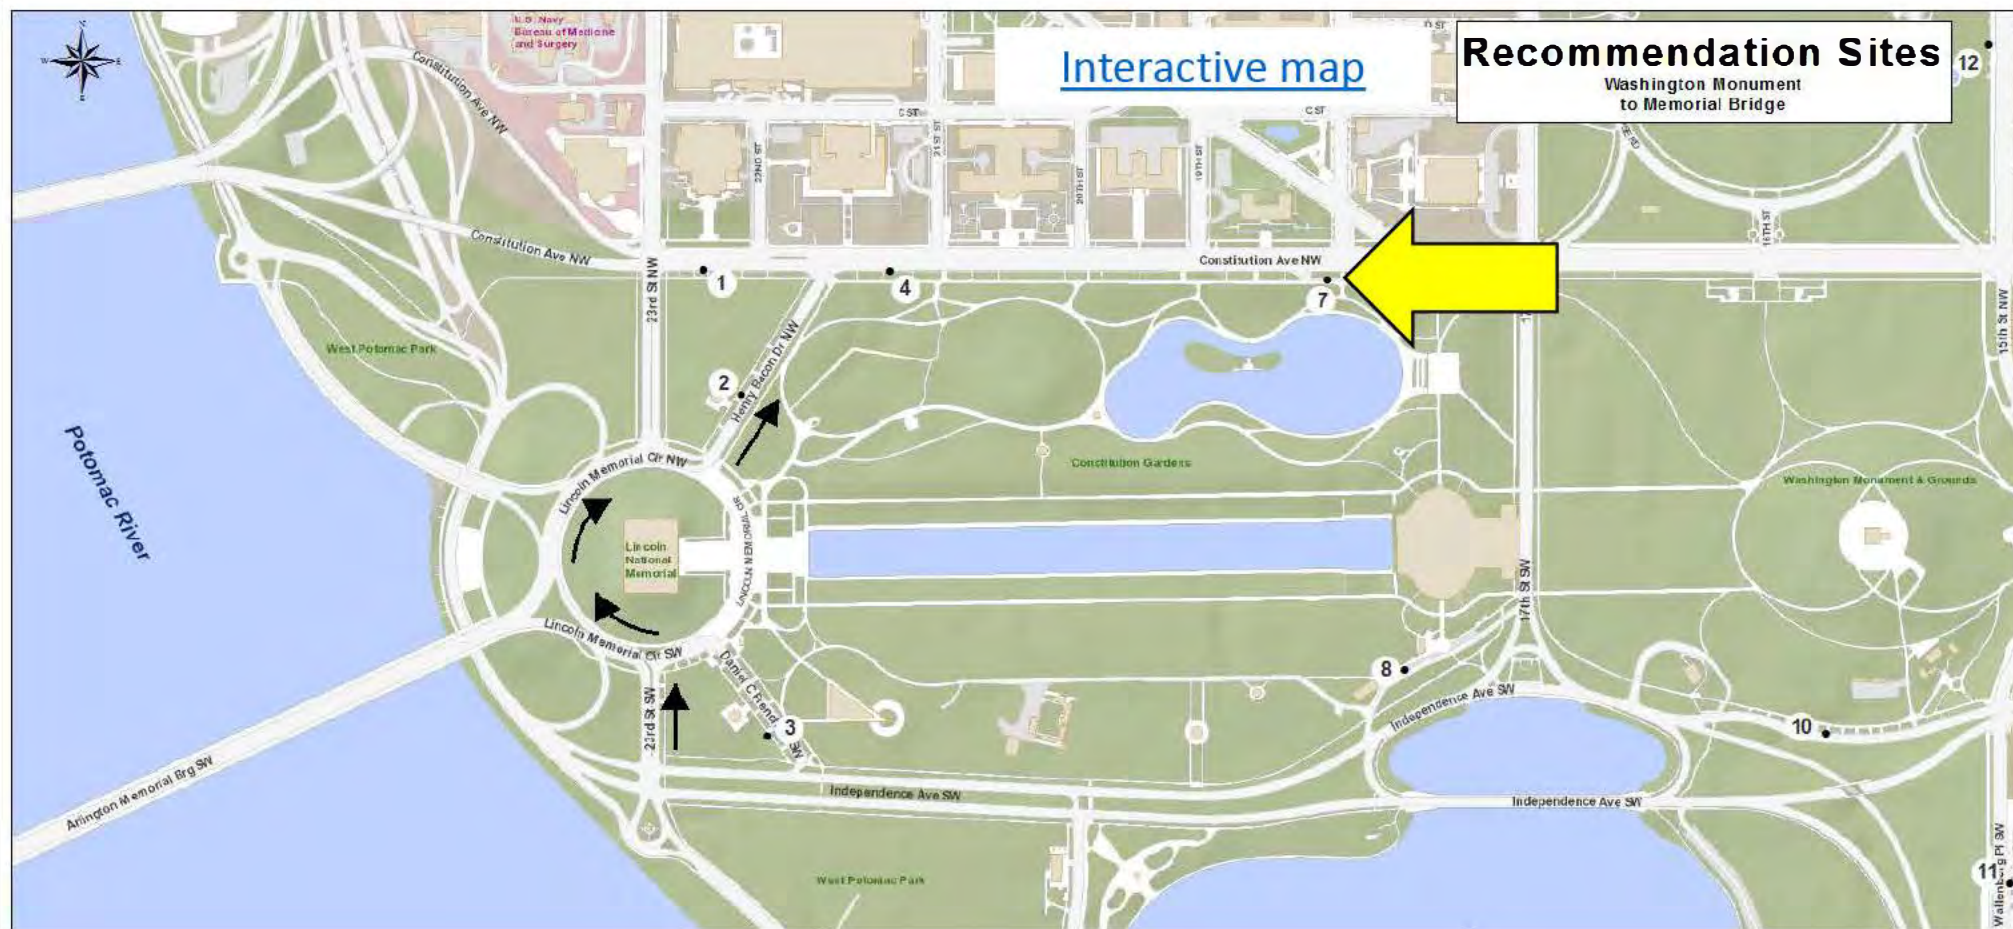
Site 7 of 26

Constitution Avenue, east-bound between 19th and 18th

5 spaces for tour bus loading/ unloading during non-rush hour periods

Underutilized; illegal use as parking area; minimal/ inconsistent enforcement

Convert to 3-hour tour bus parking during peak season, non-rush hour times; install 3-hour parking meters; develop and install standard regulatory signs; standardize and coordinate enforcement.

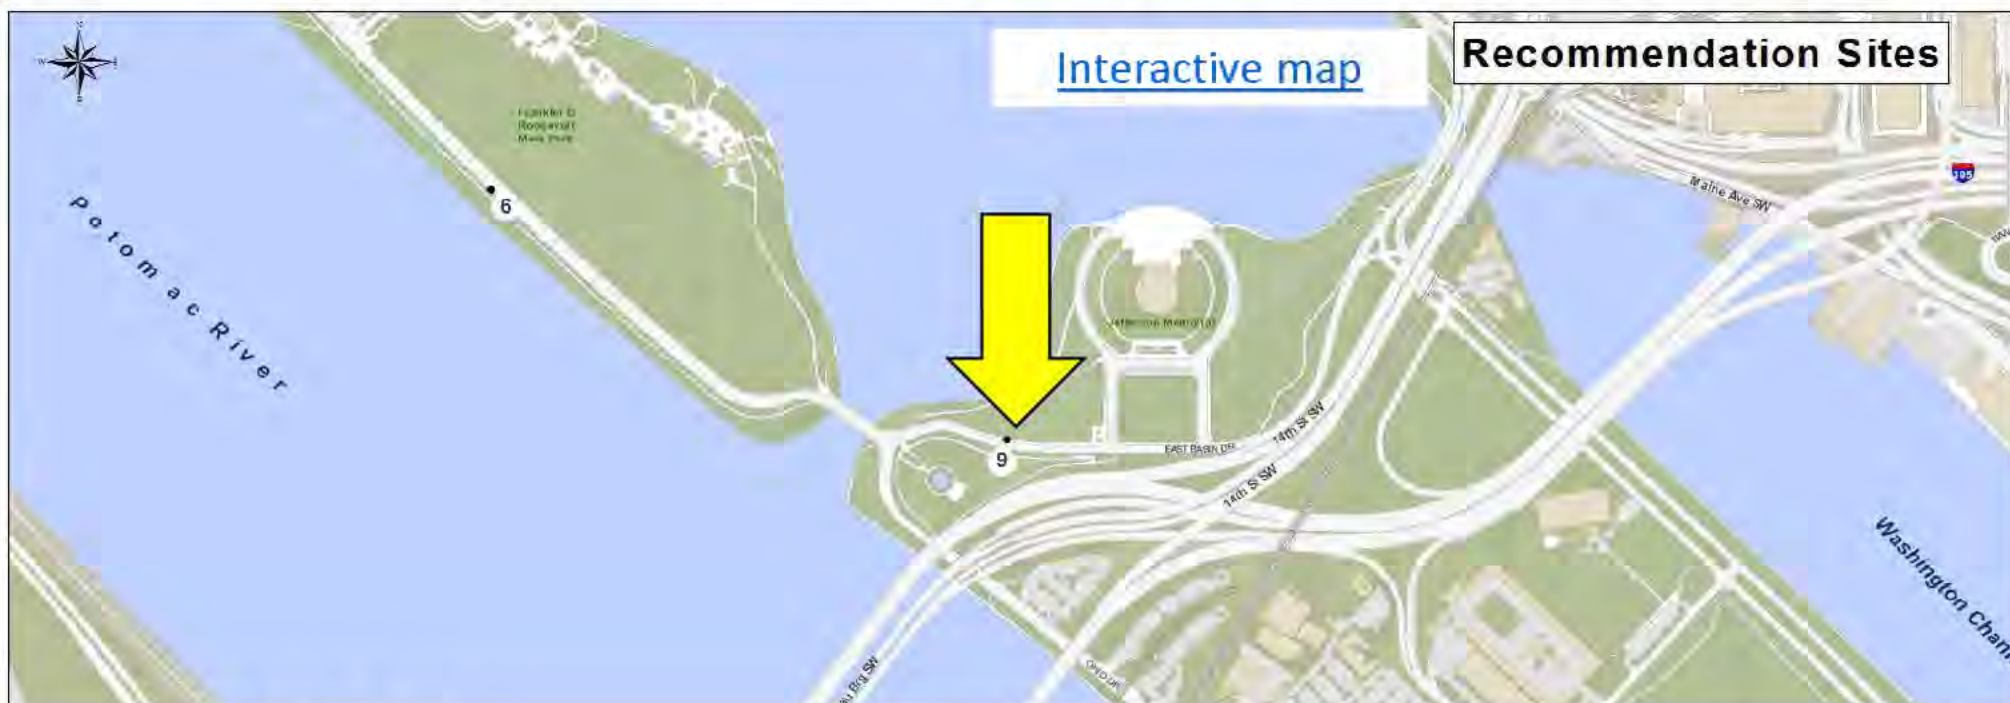
Site 9 of 26

Thomas Jefferson Memorial, East Basin Dr

7 spaces for tour bus loading/unloading

Over-utilized during peak season; dangerous thoroughfare along East Basin Dr.; pulling dangerously into traffic; stopping in zone beyond time needed to load/unload; illegal loading/unloading in non-designated areas; idling beyond legal limits; minimal/inconsistent enforcement

Assess the feasibility of using a portion of NPS National Capital Regional Office parking lot as a parking area (for after drop-off) as a weekend seasonal pilot; install parking meters; develop and install standard regulatory signs; standardize and coordinate enforcement.

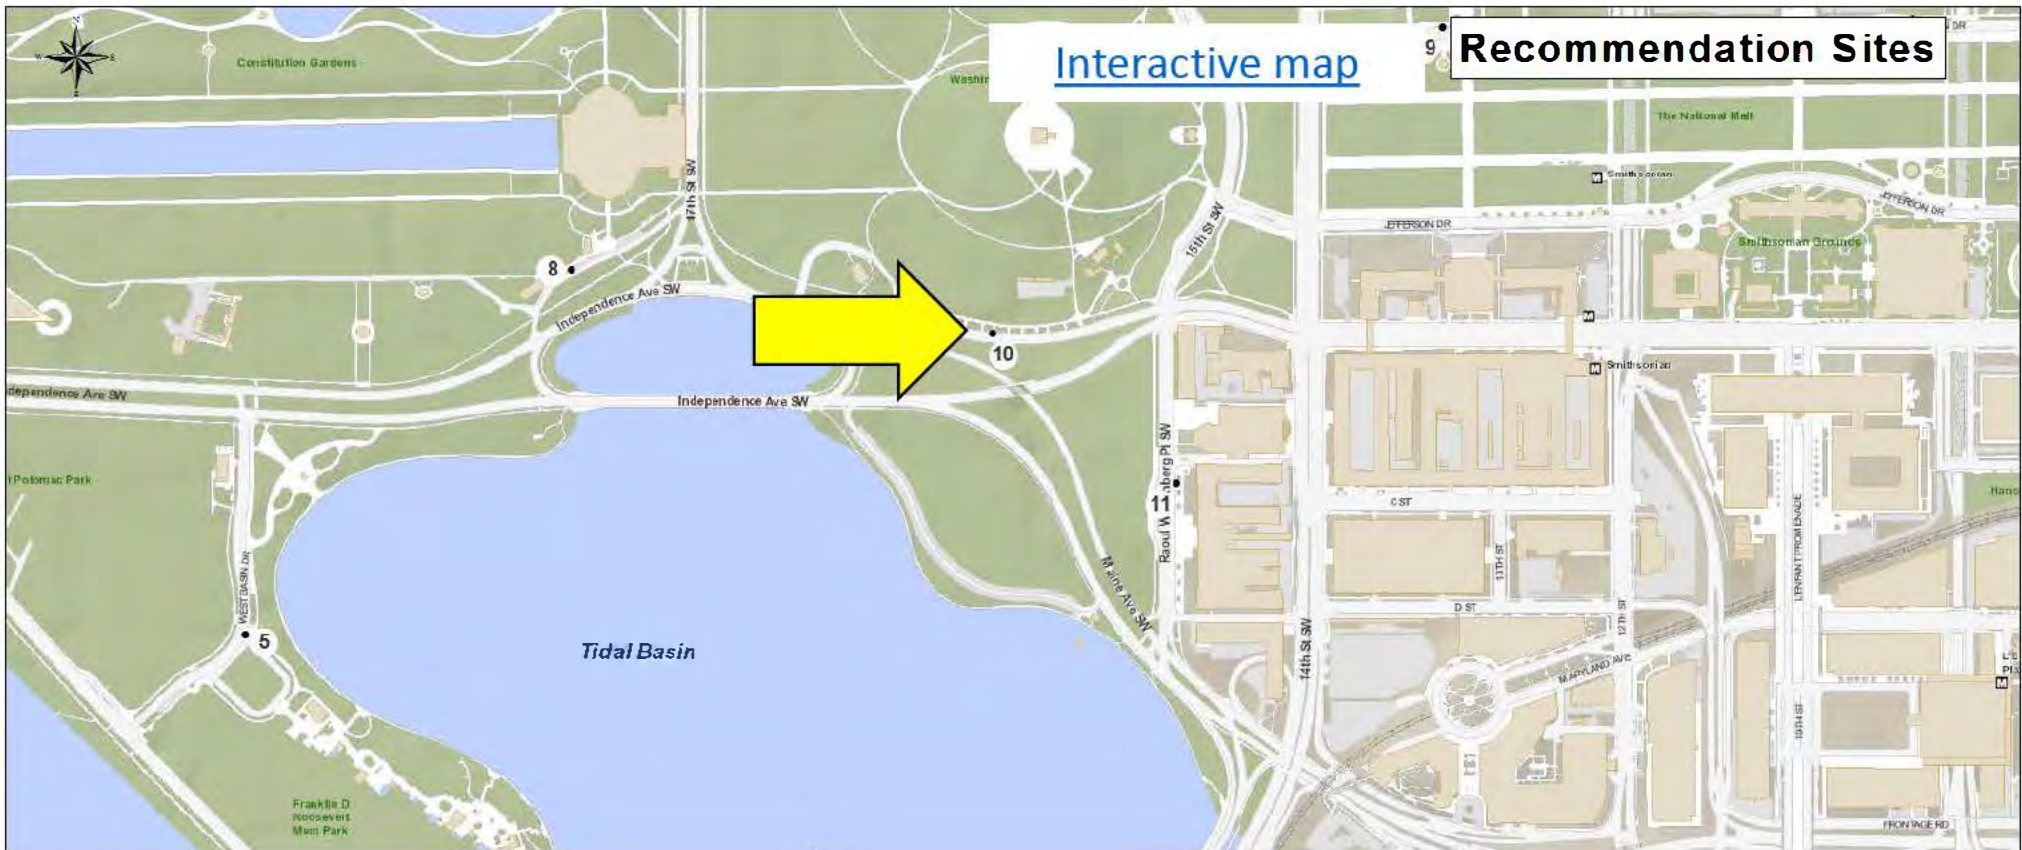
Site 10 of 26

1500 Block, Independence Ave., NW

Current Function	Summary of Documented Issues	Recommendations
8 curbside spaces for tour bus parking	Frequently at or beyond capacity; access difficulties due to Independence Ave. thoroughfare, parking beyond designated area; blocking turn lane at 15th street; minimal/inconsistent enforcement	Demarcate tour bus parking from through lane; reconfigure parking to protect north-south viewshed of Great Cross Axis; install parking meters; develop and install standard regulatory signs; standardize and coordinate enforcement.

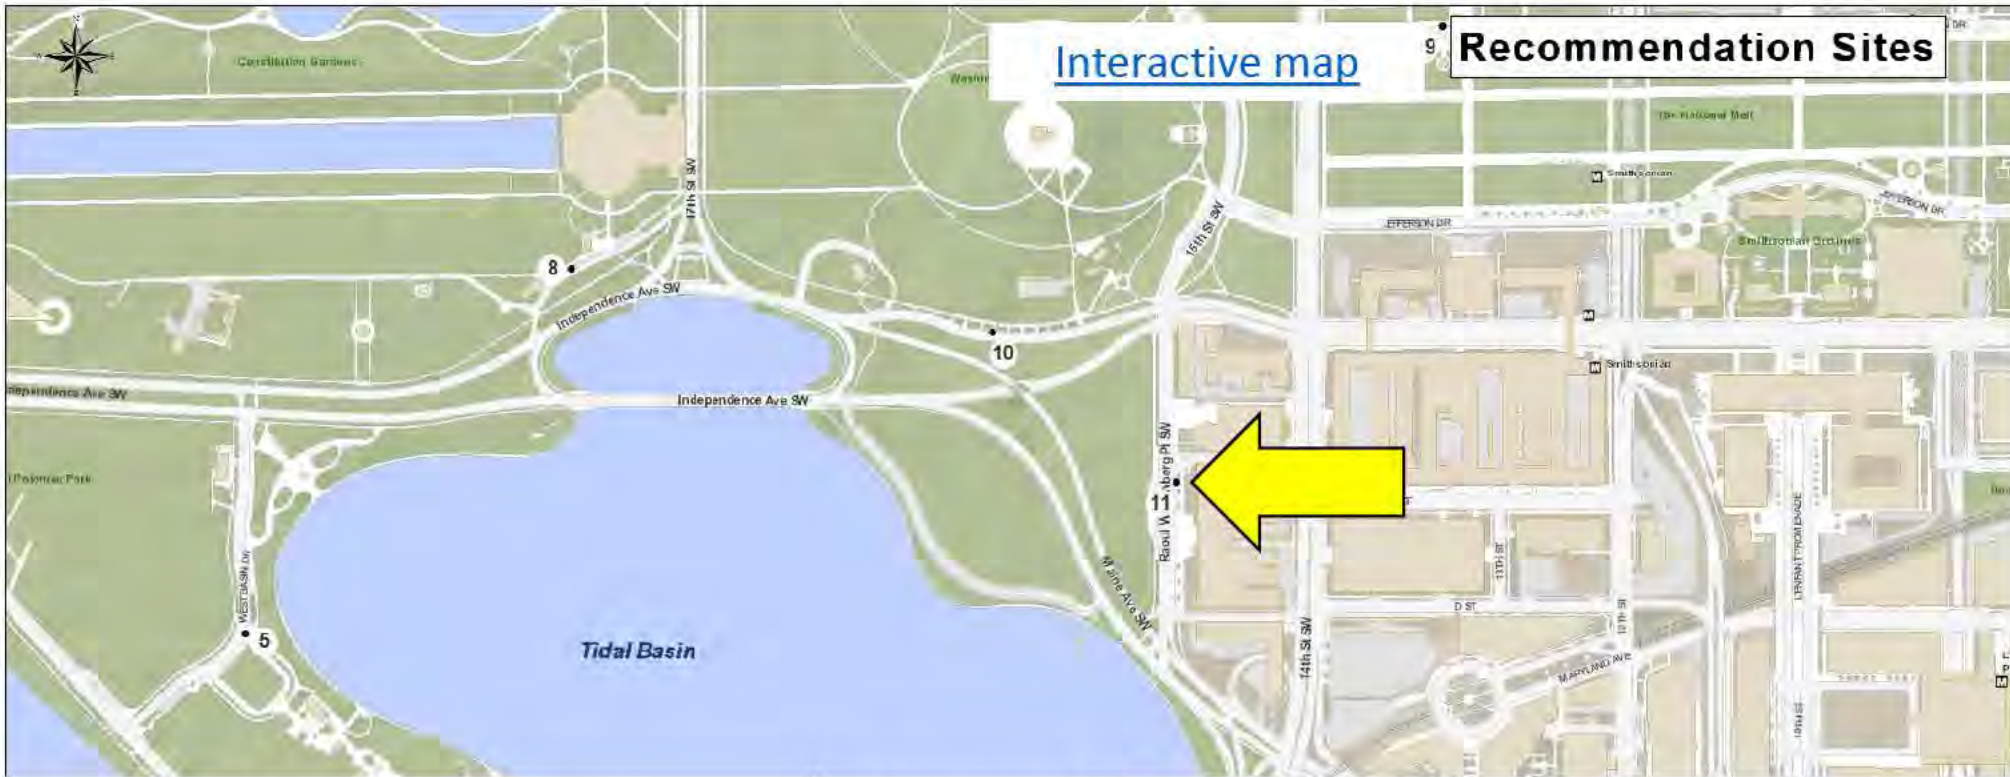
Site 11 of 26

U.S. Holocaust Memorial Museum, 100 Raoul Wallenberg Place

Current Function	Summary of Documented Issues	Recommendations
2 spaces for tour bus loading/unloading	Stopping in zone beyond time needed to load/unload; illegal loading/unloading in non-designated areas	Review designated areas (i.e., government vehicle, no standing zone, bus loading/unloading, commuter vehicles) to increase tour bus loading/unloading spaces during peak season; develop and install standard regulatory signs; standardize and coordinate enforcement.

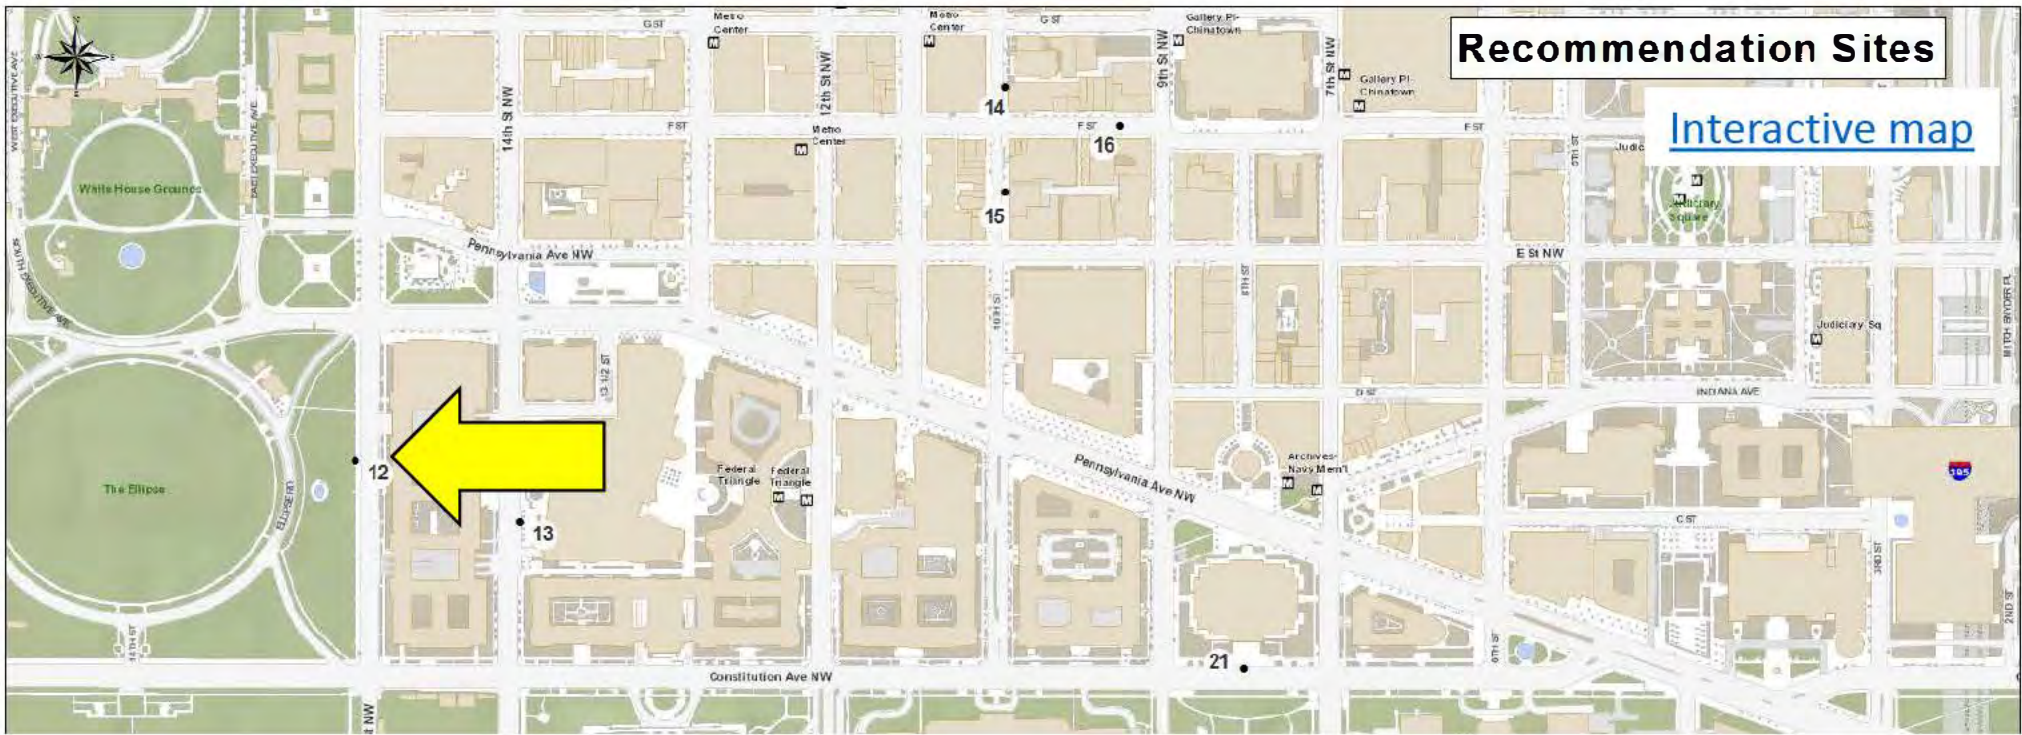
Site 12 of 26

15th Street, NW between Pennsylvania Avenue and Constitution Avenue near the Ellipse

Current Function	Summary of Documented Issues	Recommendations
5 spaces for tour bus parking; also used for loading/ unloading	Consistently at or beyond capacity; mixed use confusion; congestion; use/encroachment by private vehicles and permitted food/retail vendors; illegal double parking; blocking traffic; pulling dangerously into traffic; stopping in zone beyond time needed to load/unload; illegal loading/unloading in non-designated areas; minimal/inconsistent enforcement	Reallocate space for distinct uses (tour bus parking, tour bus loading/ unloading, vendors, bike route) and clearly separate, with input from NPS and DC to collaboratively determine appropriate percentage allocation of space for each use; install parking meters; develop and install standard regulatory signs; standardize and coordinate enforcement.

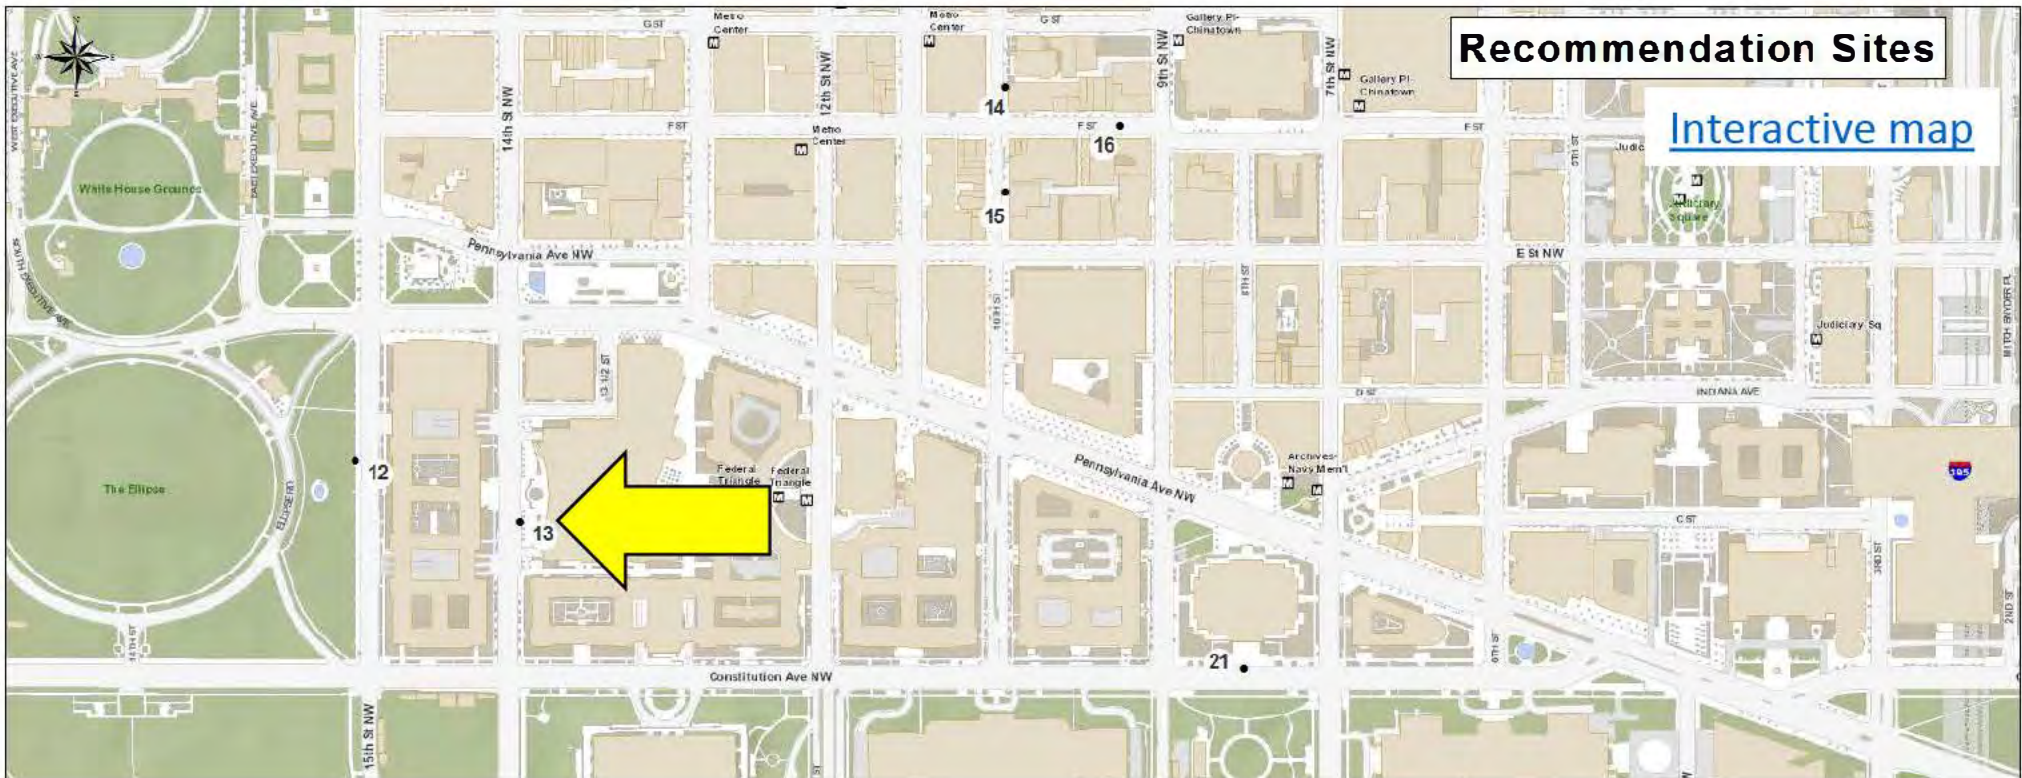
Site 13 of 26

14th Street, west side of Ronald Reagan Building northbound pull-off

Current Function	Summary of Documented Issues	Recommendations
Not designated for tour bus loading/unloading	Undesignated use; blocking traffic; stopping in zone beyond time needed to load/ unload; illegal loading/ unloading in non-designated areas; idling beyond legal limits; minimal/inconsistent enforcement	Designate a minimum of two spaces for tour bus loading/unloading during peak season during non-rush hour times; assess off-peak seasonal use; develop and install standard regulatory signs; standardize and coordinate enforcement

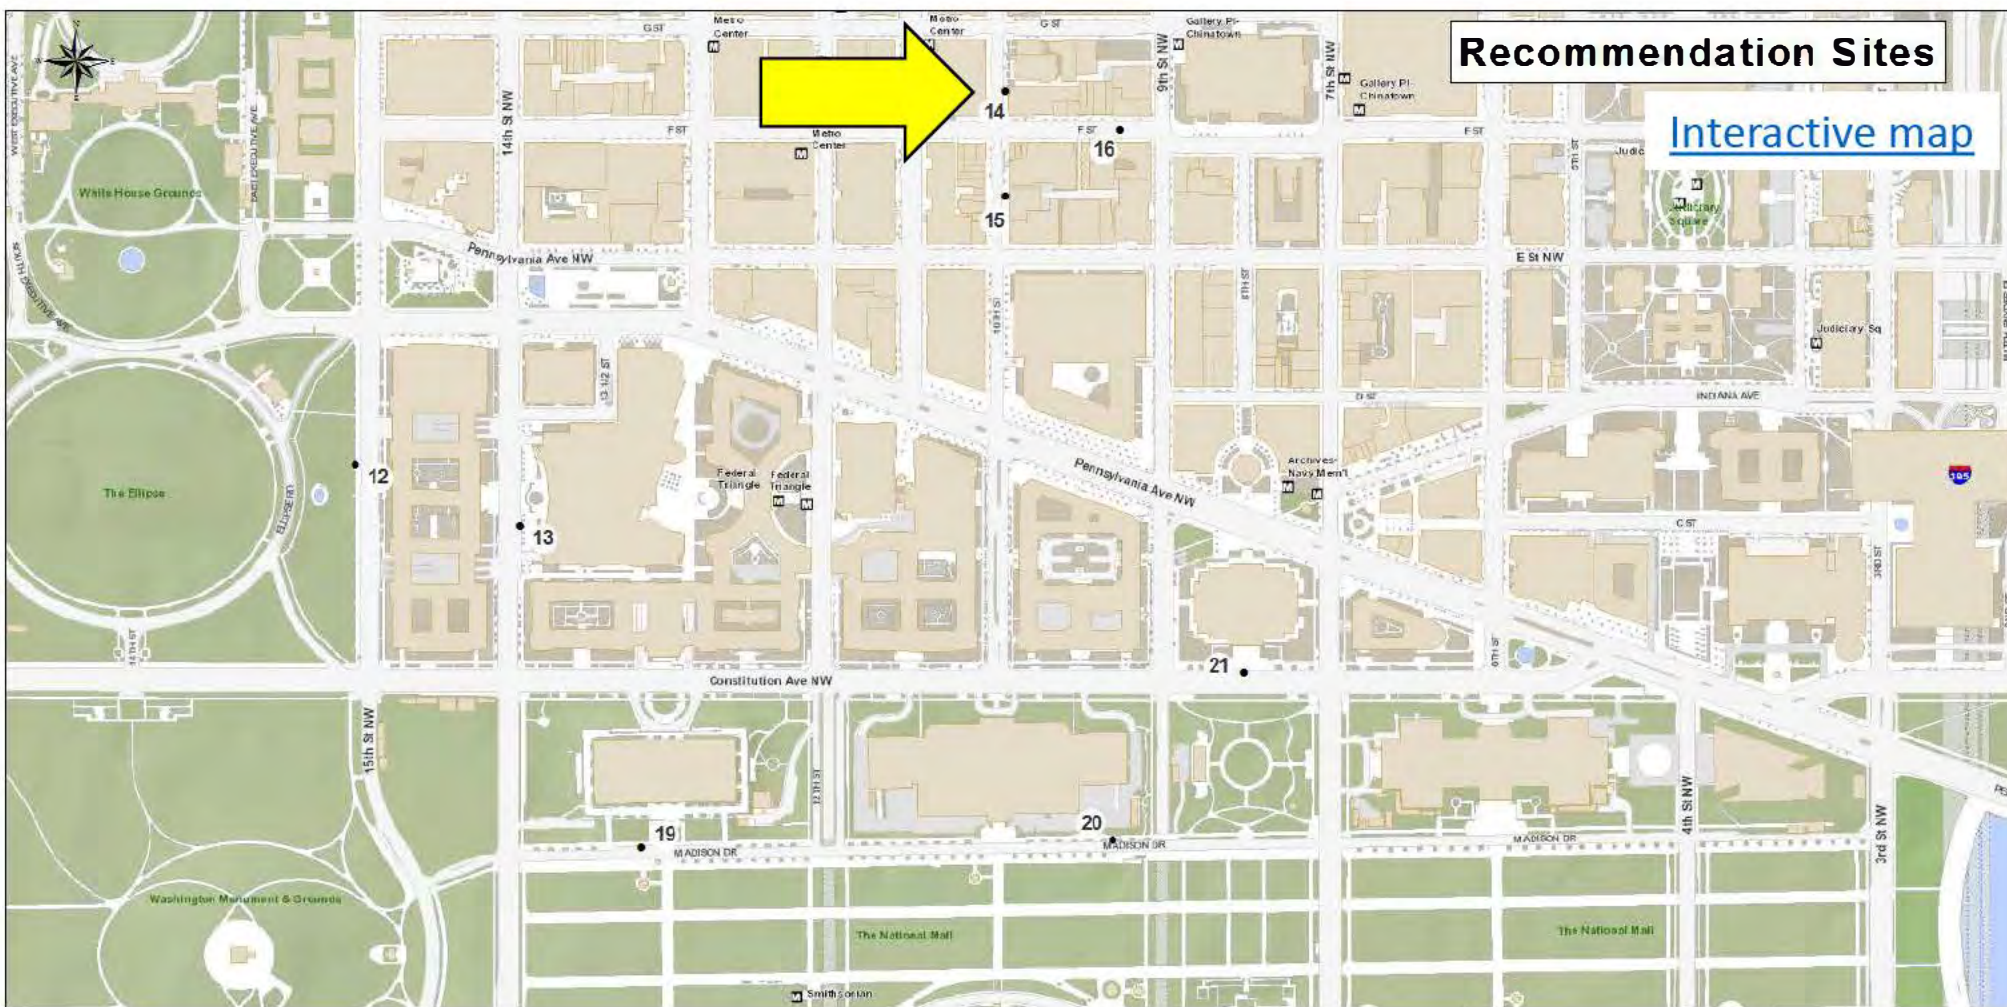
Site 14 of 26

Ford's Theatre, 600 Block 10th Street

Current Function	Summary of Documented Issues	Recommendations
1 space for tour bus loading/unloading	Underutilized; illegal use as parking area; minimal/inconsistent enforcement	Convert to metered parking; develop and install standard regulatory signs; standardize and coordinate enforcement

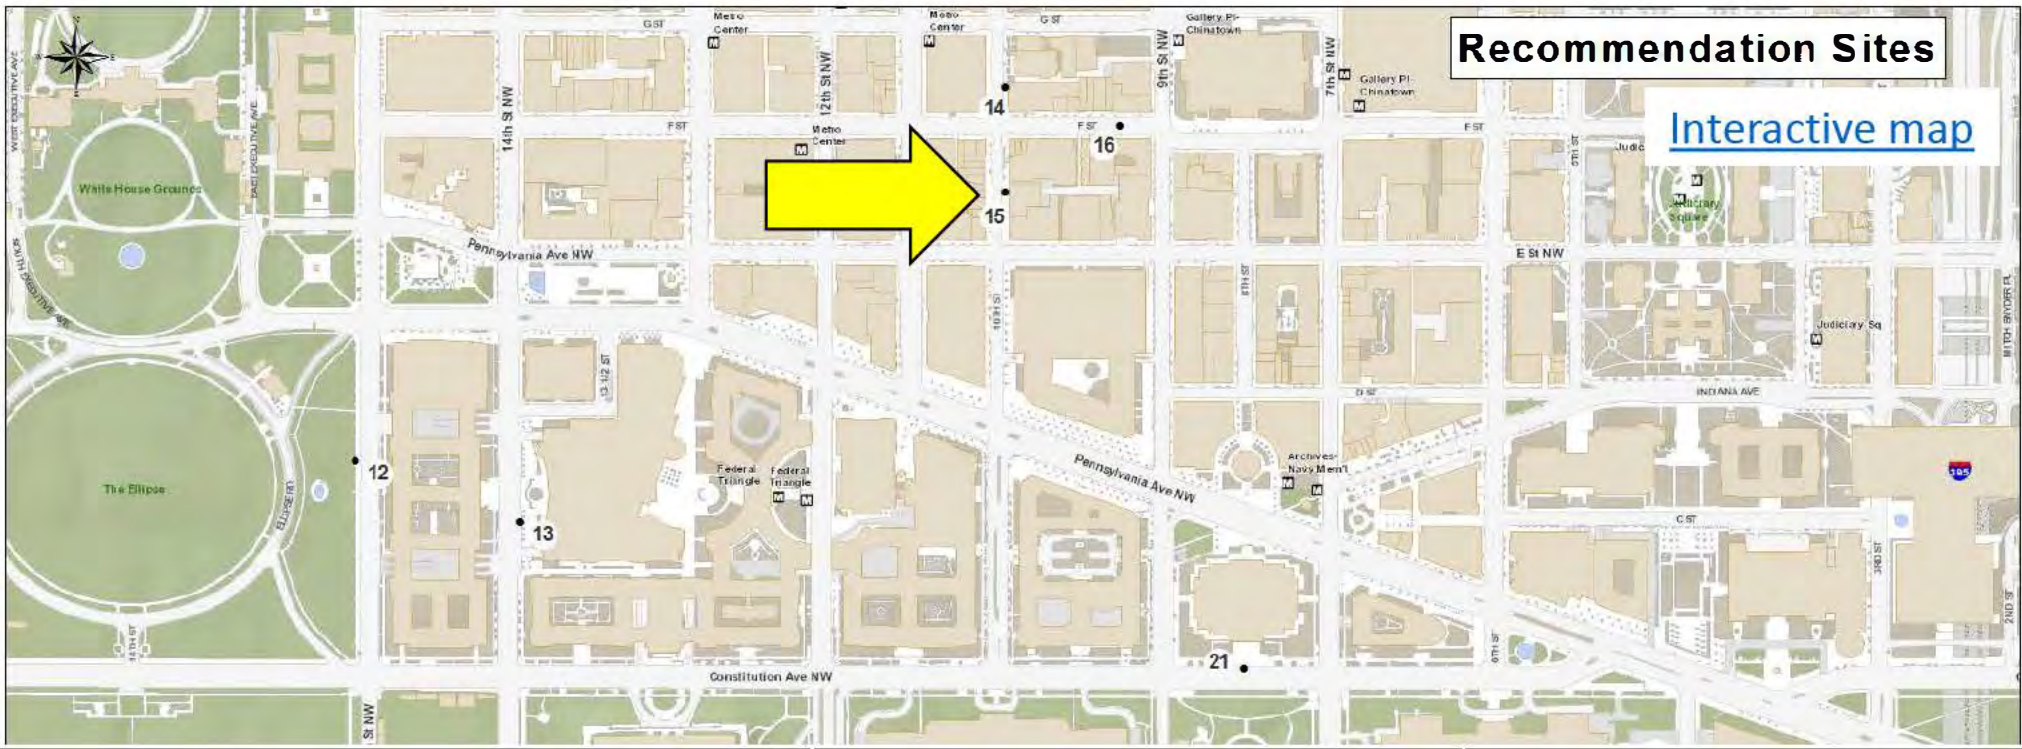
Site 15 of 26

Ford's Theatre, 500 block 10th Street

Current Function	Summary of Documented Issues	Recommendations
<p>One-way southbound; 2 spaces for tour bus loading/unloading</p>	<p>Over-utilized and highly congested during peak season; stopping on the wrong side of the road; illegal double parking; pulling into traffic in a dangerous way; stopping in zone beyond time needed to load/unload; illegal loading/ unloading in non-designated areas; idling beyond legal limits; minimal/ inconsistent enforcement</p>	<p>Convert public through-traffic on 10th Street to buses only and those going to parking garages; use signage and pavement changes to indicate gateway to an area that can be named Ford's Theatre District; consider use of crossing guard or traffic control personnel during peak season; develop and install standard regulatory signs; standardize and coordinate enforcement.</p>

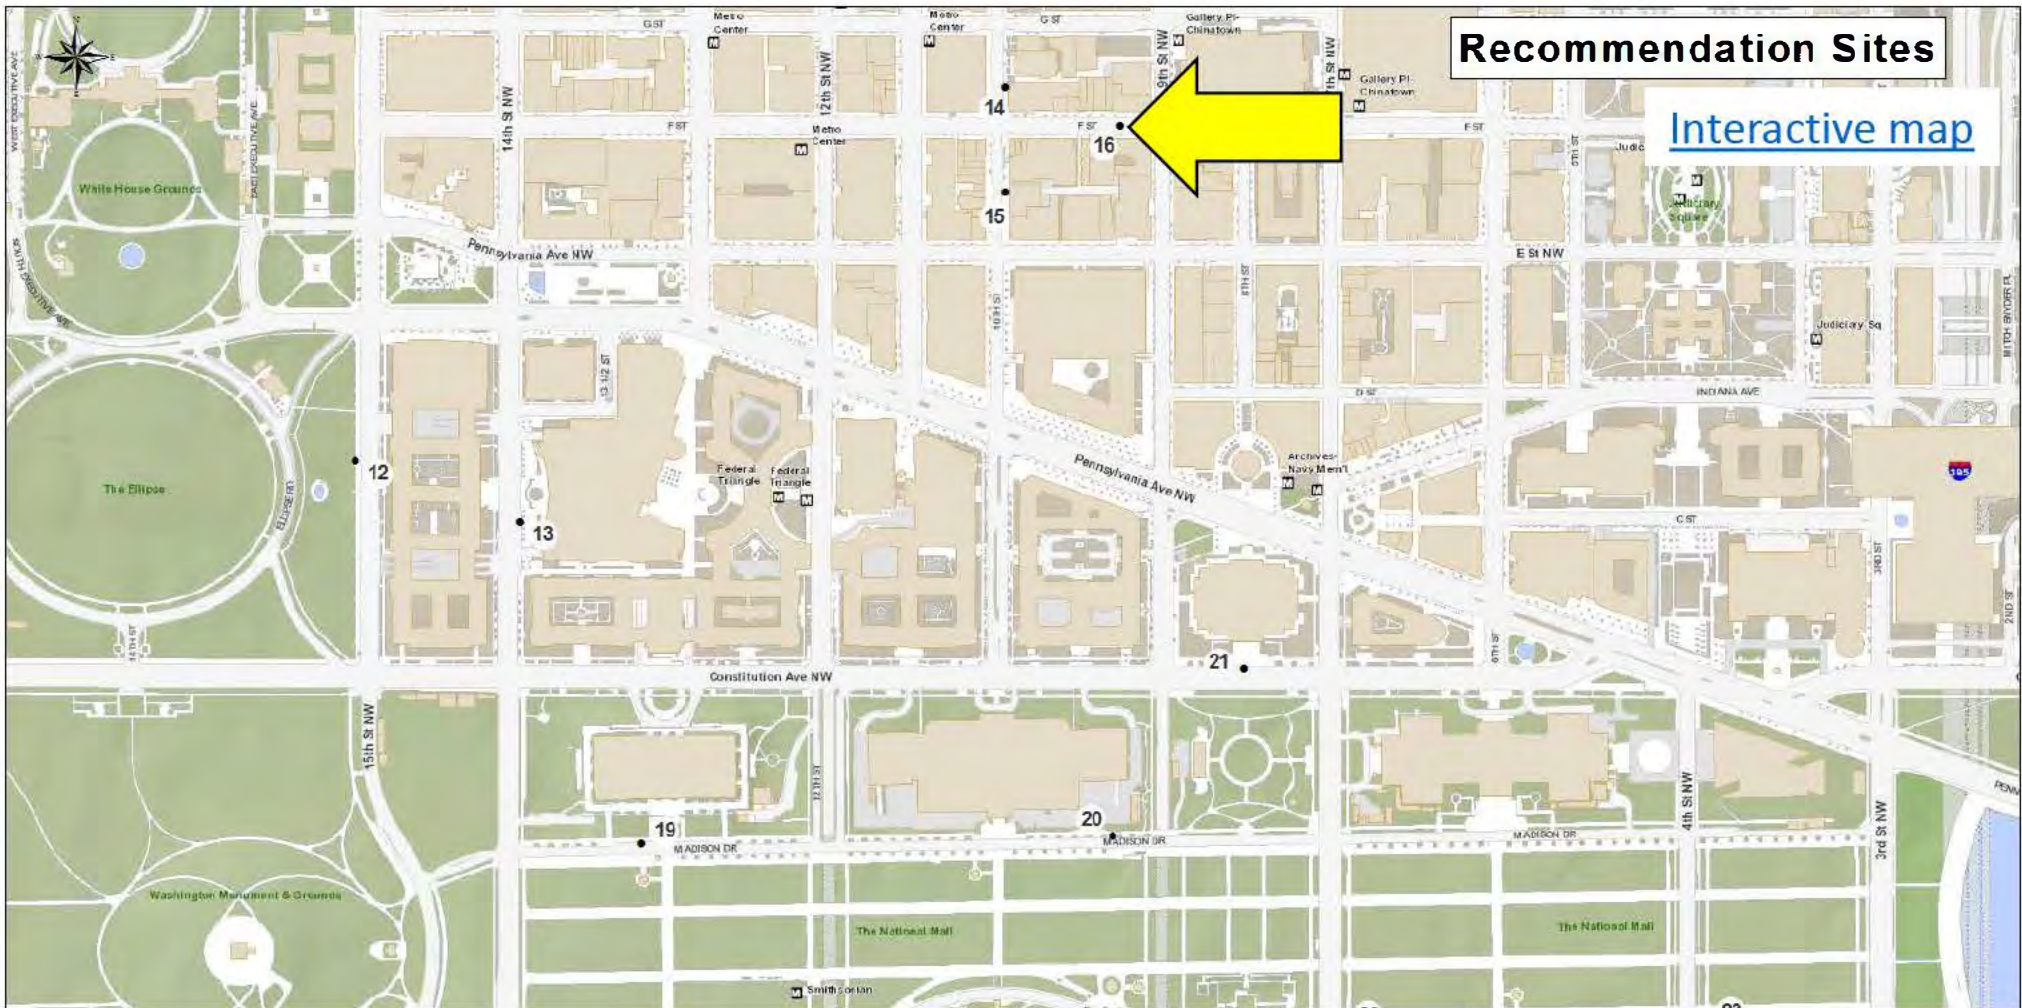
Site 16 of 26

Ford's Theatre, 1000 Block F Street

Current Function	Summary of Documented Issues	Recommendations
1 space for tour bus loading/unloading	Underutilized; illegal use as parking area; minimal/inconsistent enforcement	Convert to metered parking; develop and install standard regulatory signs; standardize and coordinate enforcement.

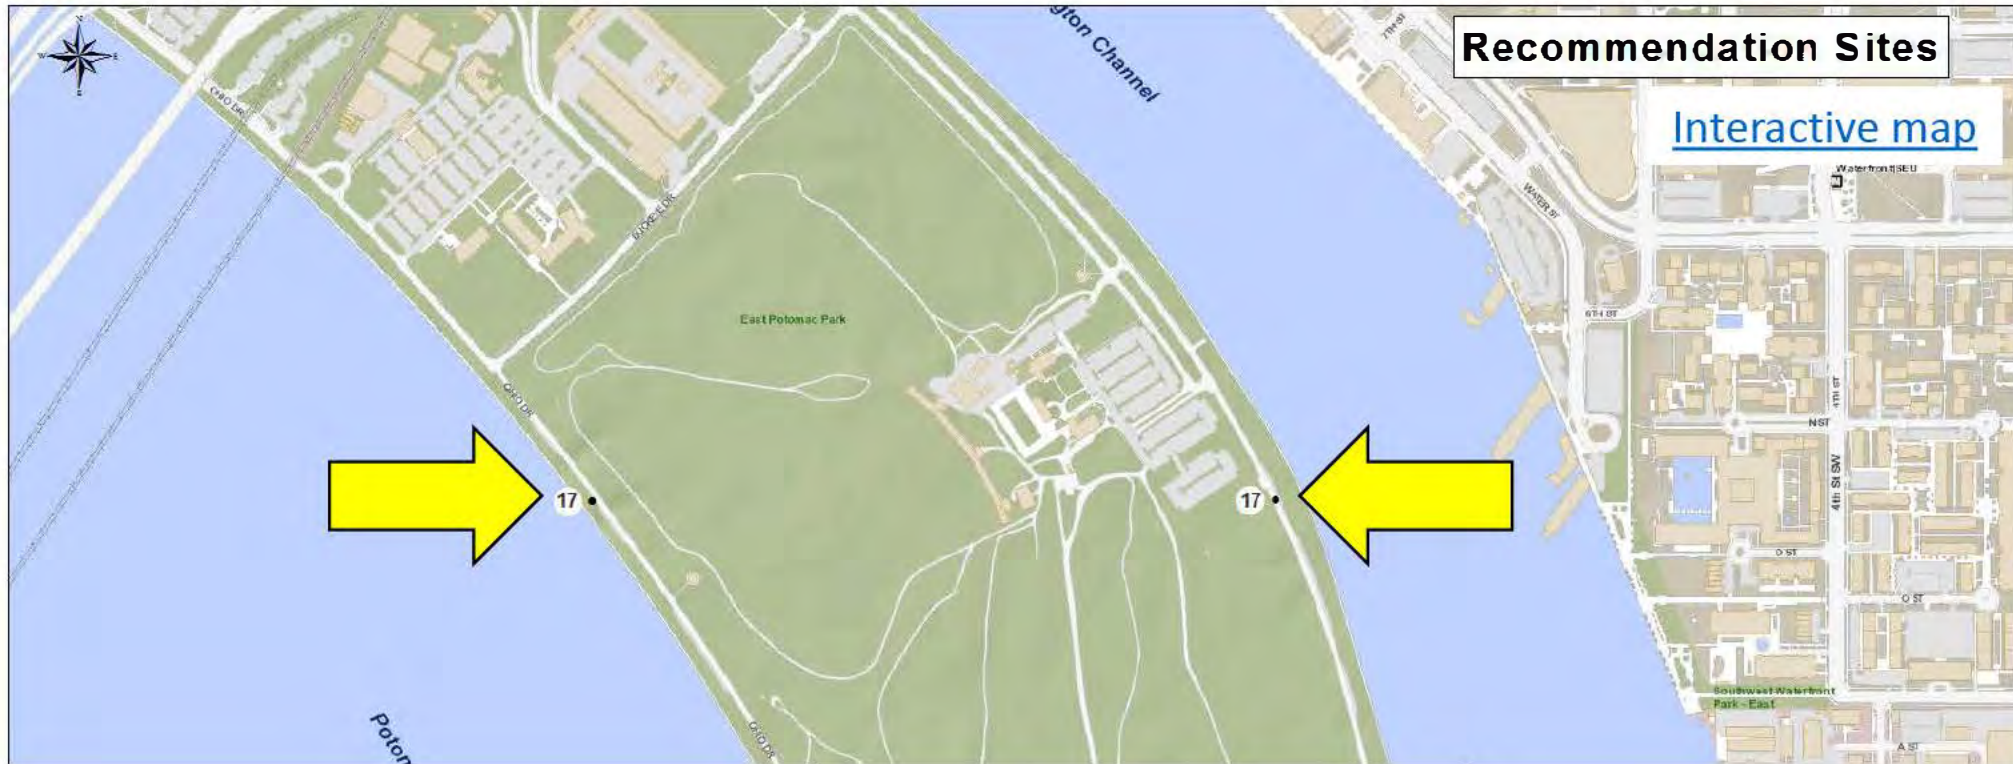
Site 17 of 26

Ohio Drive, south of East Potomac Park Golf Course entry

Current Function	Summary of Documented Issues	Recommendations
0 curbside spaces	Removal of curbside spaces for safety and access reasons; consistent requests from tour bus drivers and owners for reinstatement of tour bus parking spaces; common area for cruising	Reinstate and reallocate pull-off areas for tour bus parking located south of U.S. Park Police District One Station and East Potomac Park Golf Course during peak season as a pilot; ensure that tour bus presence will not block law enforcement access; install parking meters; develop and install standard regulatory signs; standardize and coordinate enforcement.
