National Mall and Memorial Parks Tour Bus Study

Final Report Summary

Site Specific Recommendations Overview

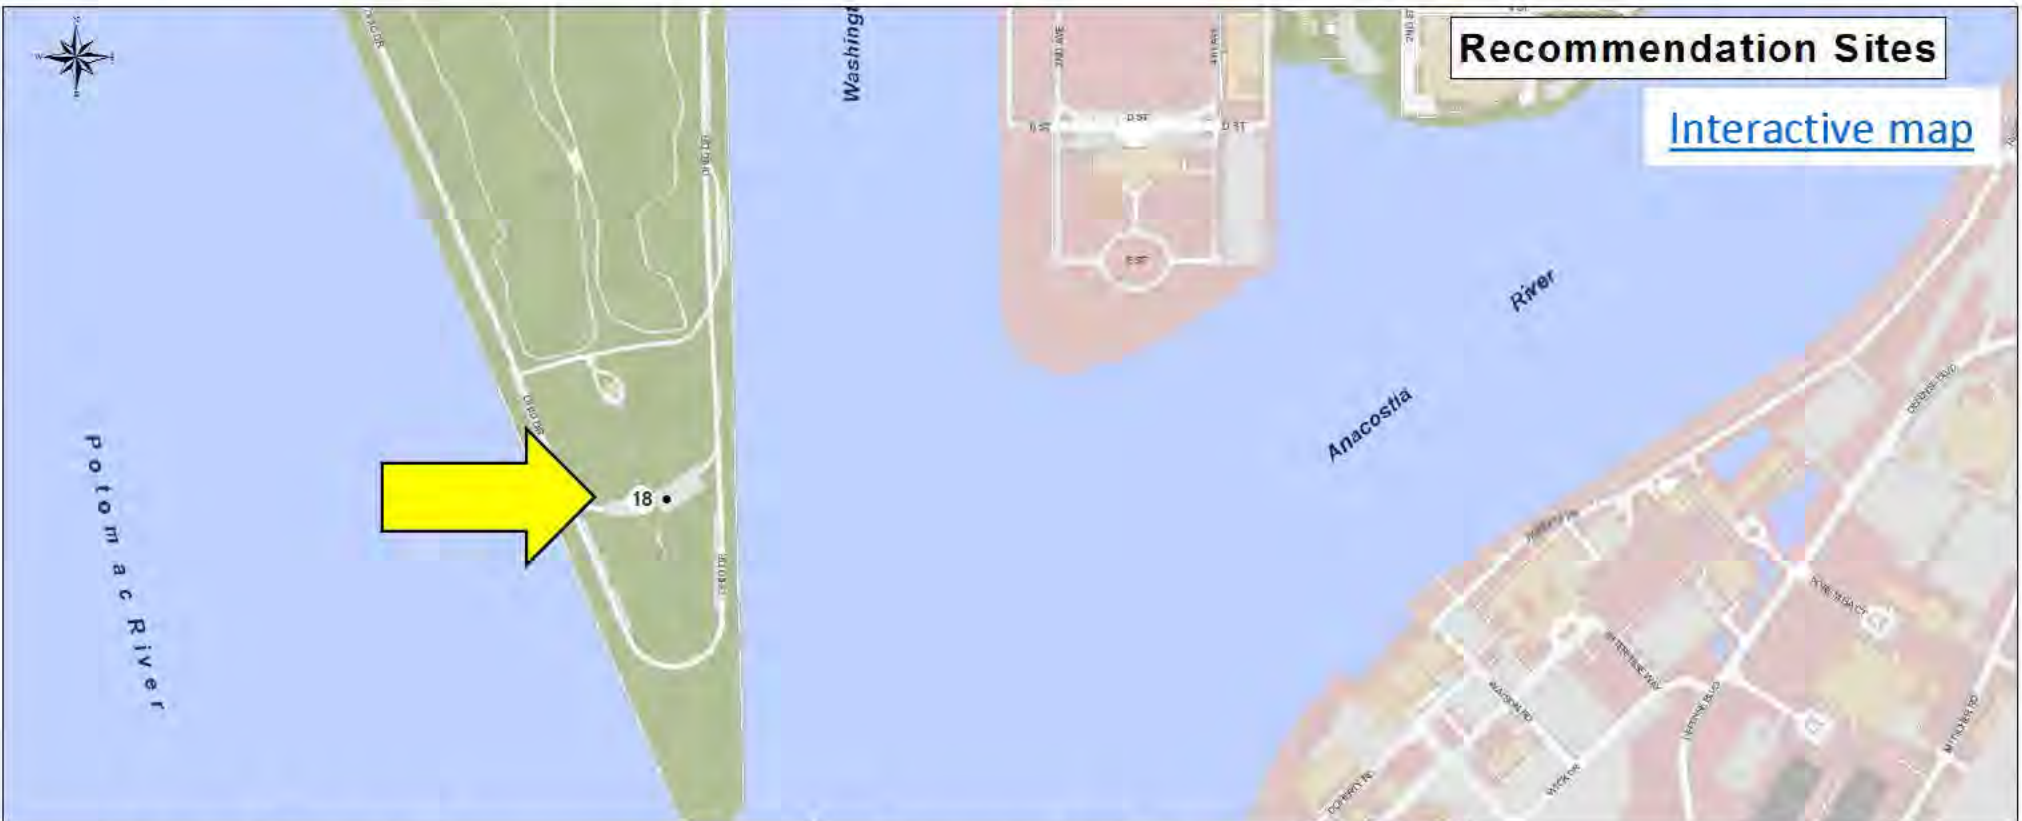
Site 18 of 26

Hains Point, East Potomac Park

Current Function	Summary of Documented Issues	Recommendations
11-space area for tour bus parking	Mixed use area; illegal double parking; access hindered by buses encroaching on spaces for private vehicles; common area for cruising	Reallocate and separate usage areas; increase number of tour bus parking spaces by allowing tour bus parking within the private vehicle area during peak season; clearly demarcate tour bus parking; install parking meters; develop and install standard regulatory signs; standardize and coordinate enforcement.

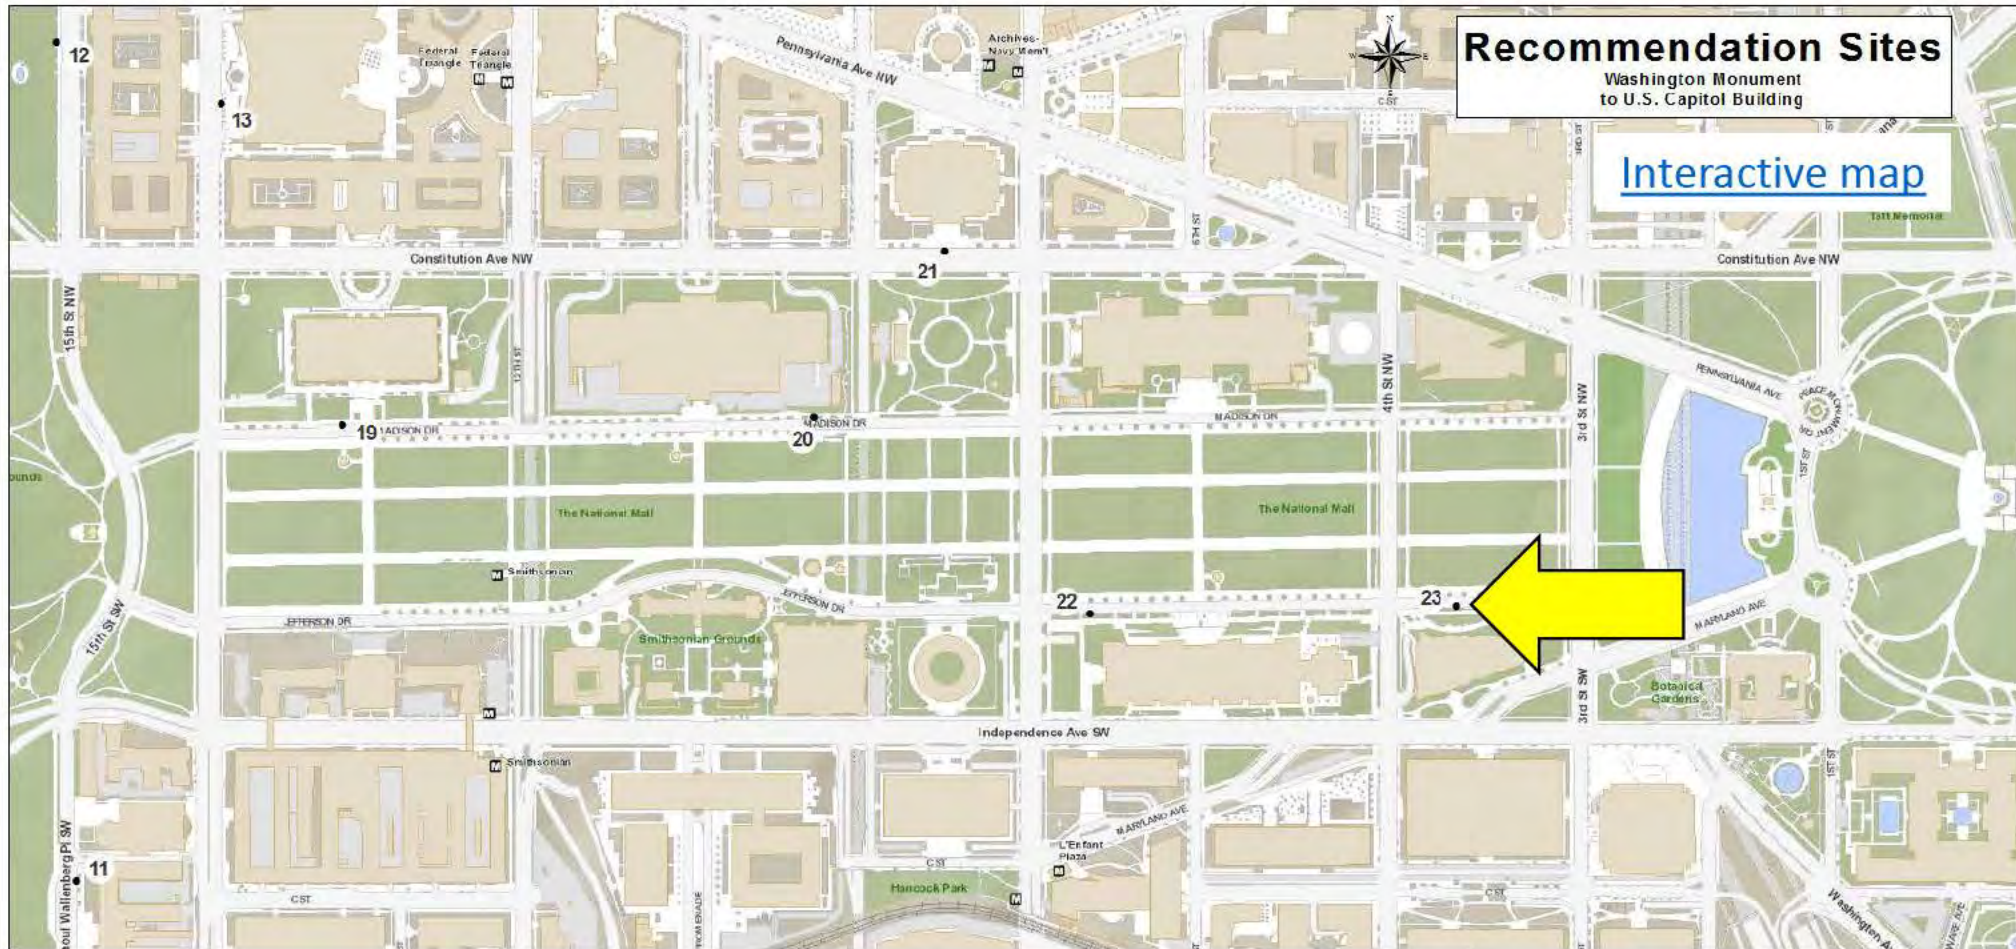
Site 23 of 26

National Museum of the American Indian, Jefferson Dr. between 3rd and 4th St.

Current Function	Summary of Documented Issues	Recommendations
9 spaces for tour bus loading/unloading	Underutilized; illegal use as parking area; minimal/inconsistent enforcement	Convert to 3-hour tour bus parking area; install parking meters; develop and install standard regulatory signs; standardize and coordinate enforcement.

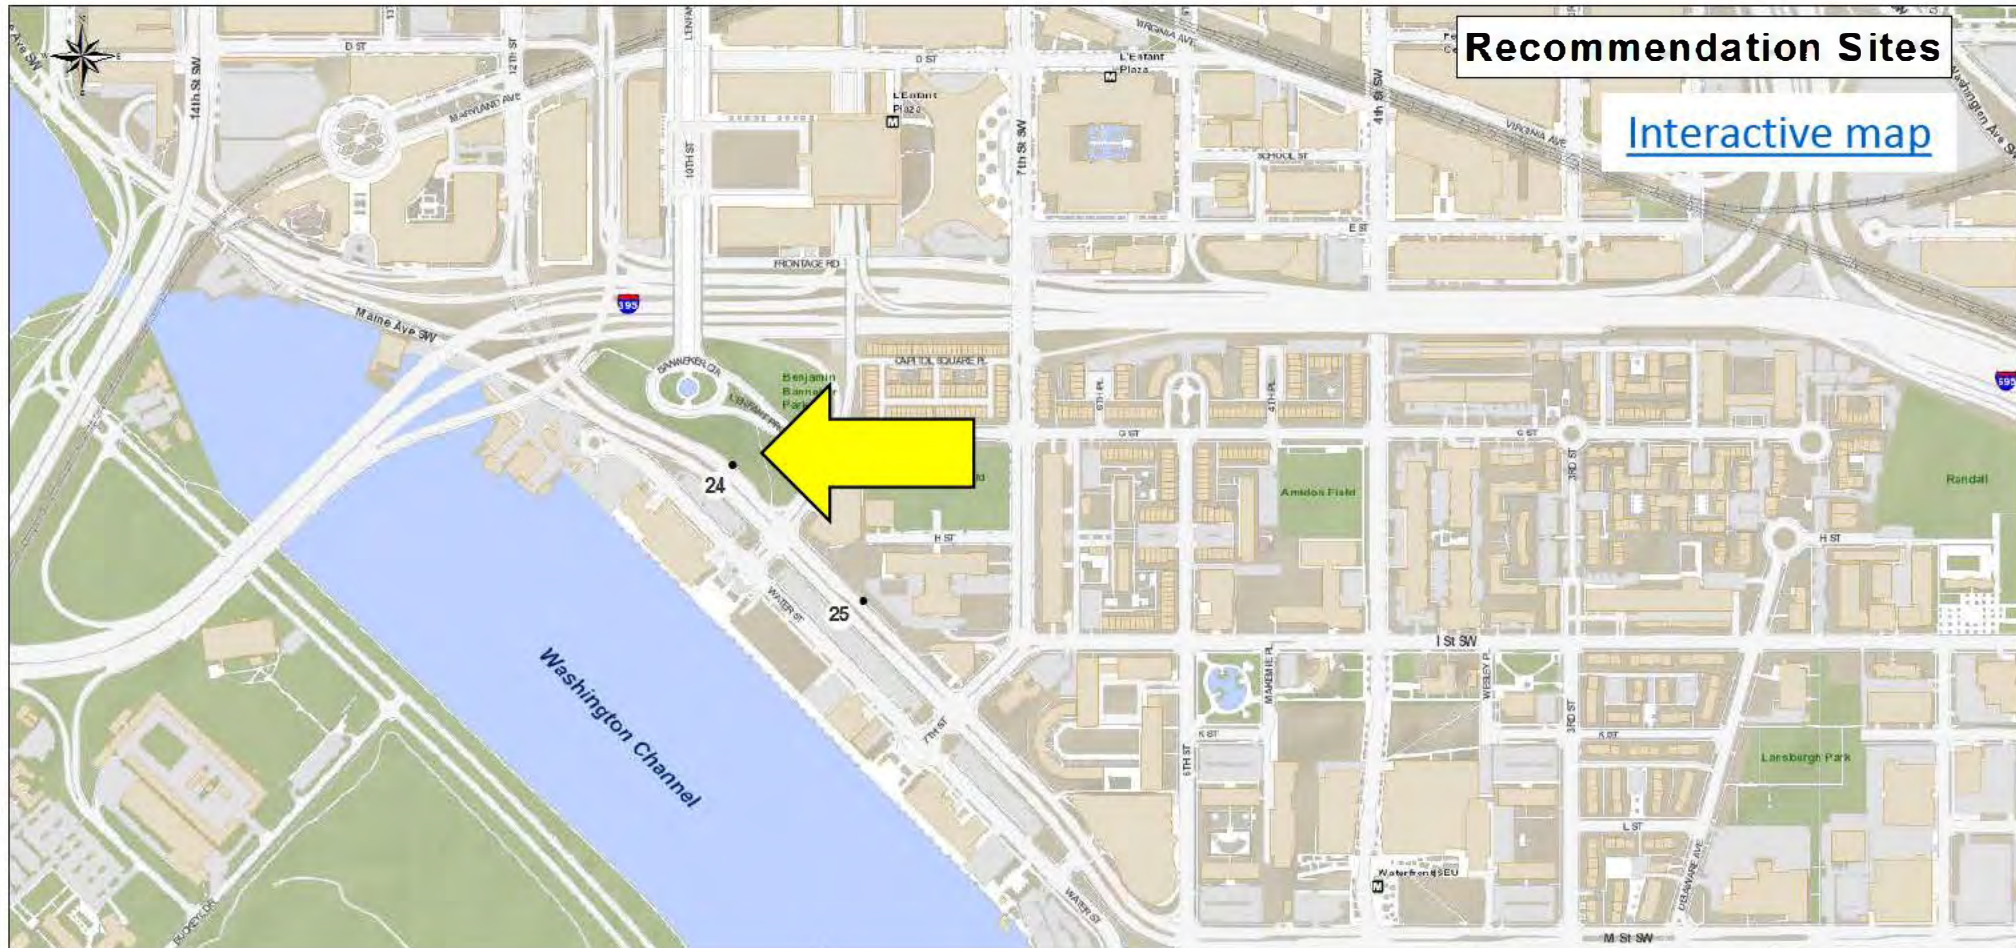
Site 24 of 26

900-1200 Block, Maine Avenue, SW

Current Function	Summary of Documented Issues	Recommendations
4 curbside spaces for tour bus parking	Consistently at or beyond capacity; cruising by area	Increase number of tour bus parking spaces; install parking meters; develop and install standard regulatory signs; standardize and coordinate enforcement.

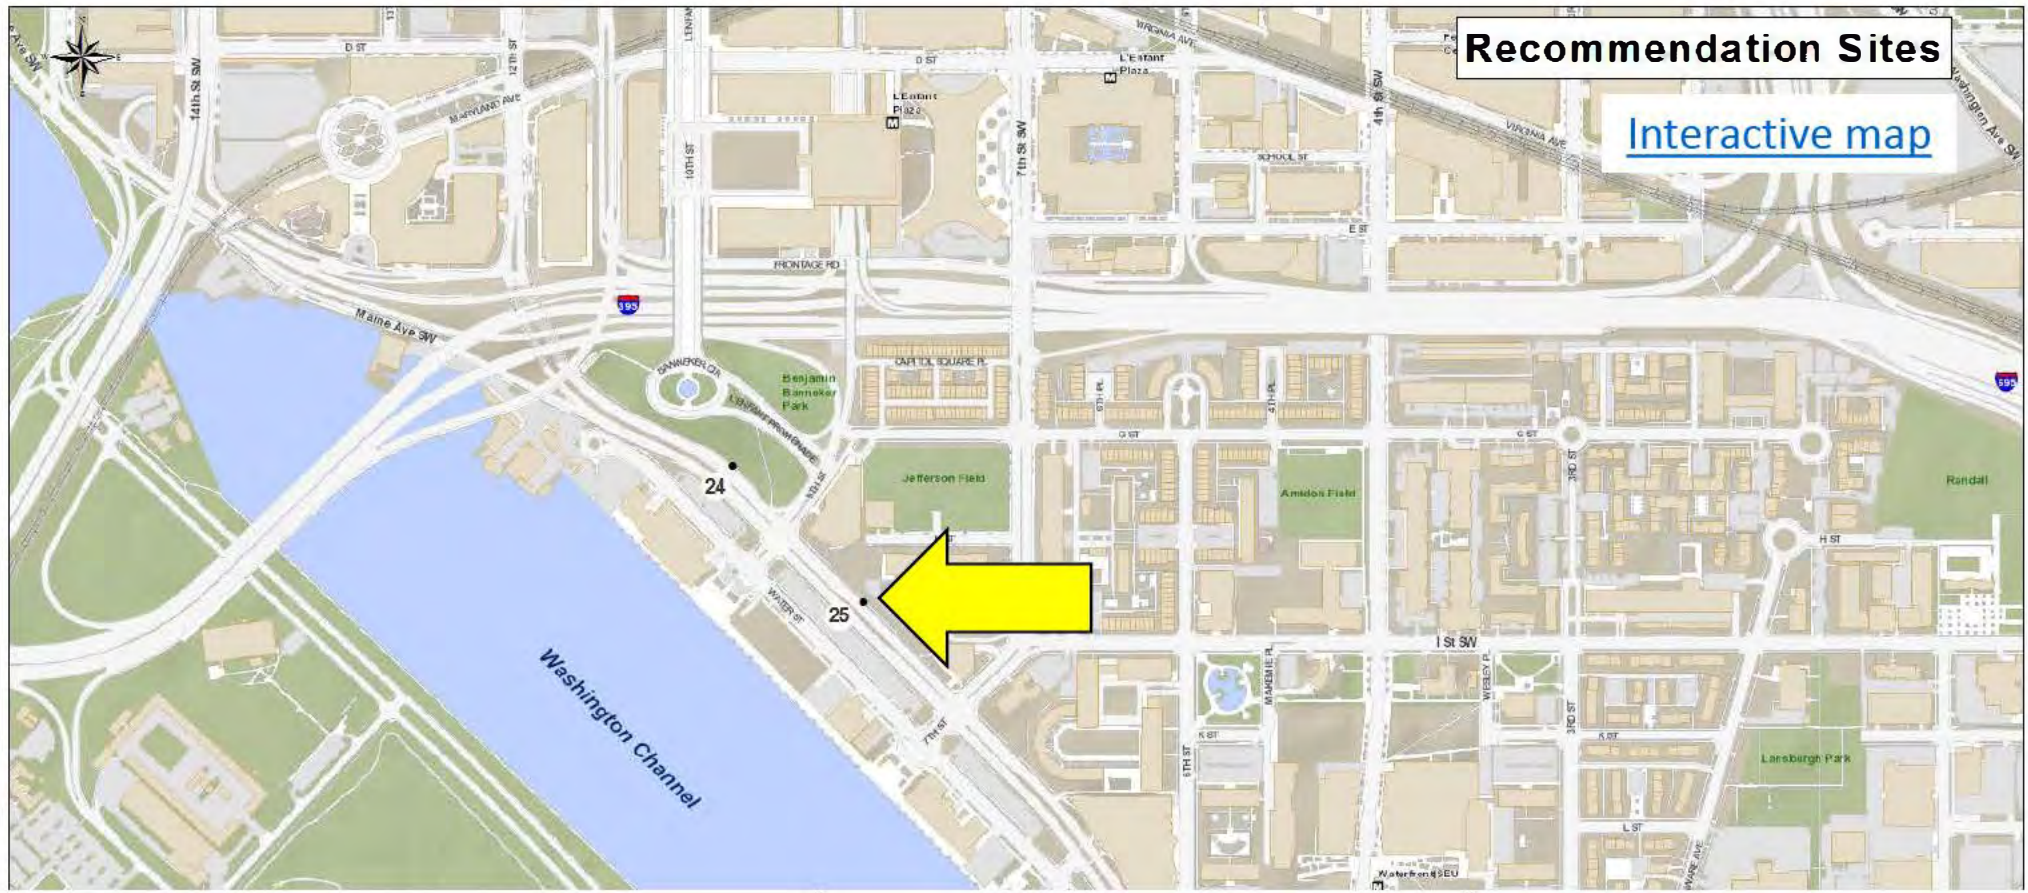
Site 25 of 26

700–900 Block, Maine Avenue, SW

Current Function	Summary of Documented Issues	Recommendations
6 curbside spaces for tour bus parking	Consistently at or beyond capacity; cruising by area; idling beyond legal limits; minimal/inconsistent enforcement	Increase number of tour bus parking spaces; install parking meters; develop and install standard regulatory signs; standardize and coordinate enforcement.

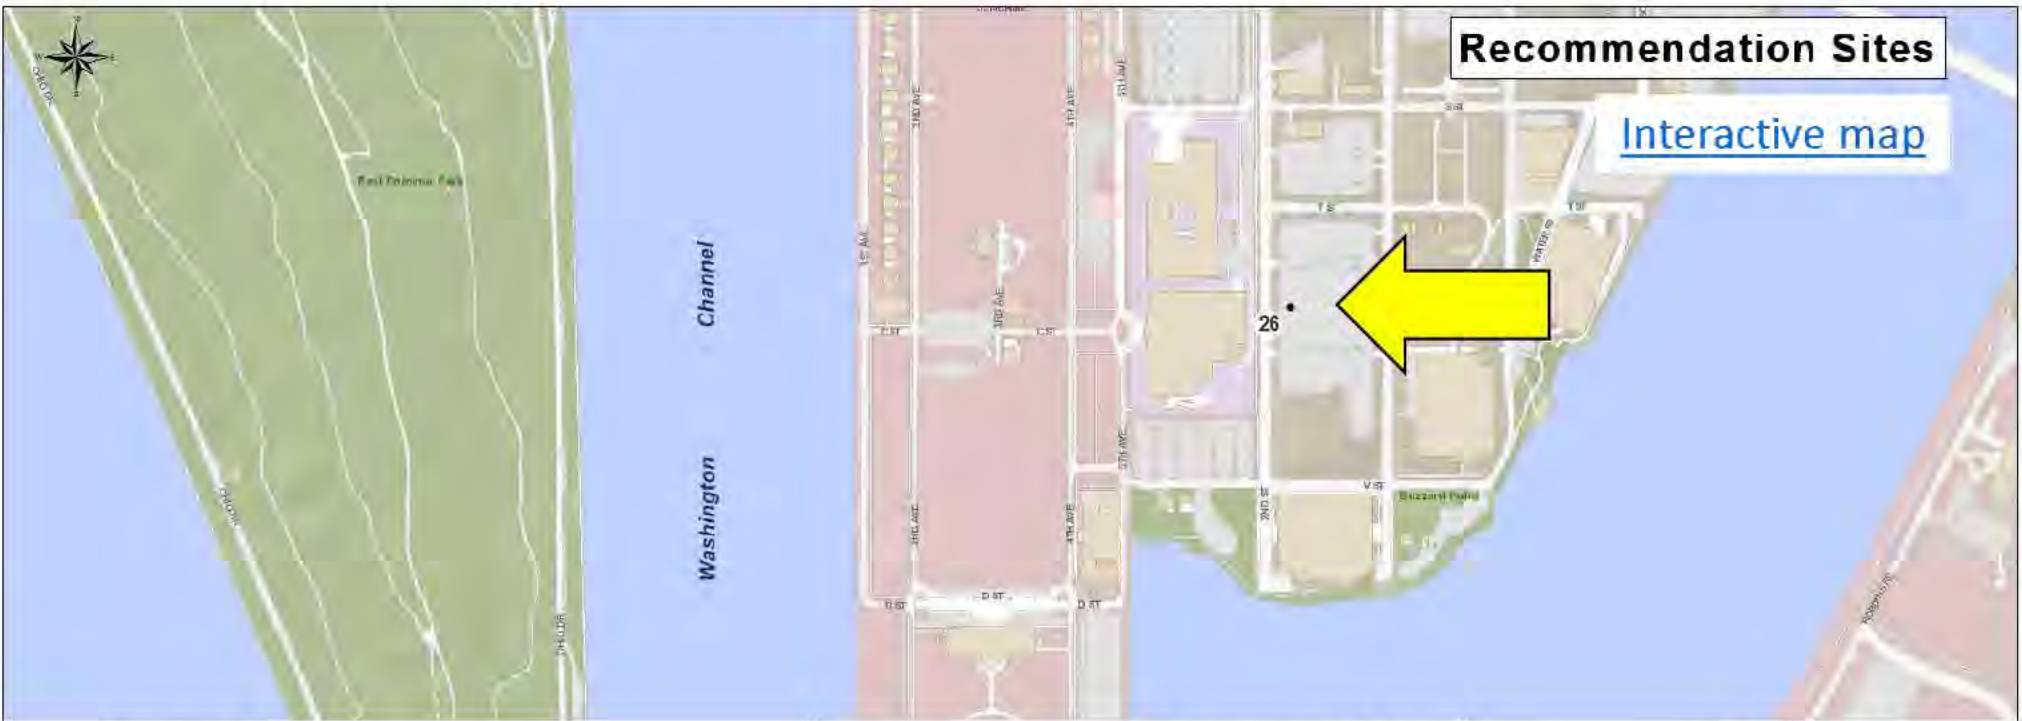
Site 26 of 26

Buzzard Point, 1880 2nd Street, SW

80-space mixed use parking lot

Few tour bus spaces available during weekdays due to monthly parking privileges of private vehicles; 3-hour fee of \$20 does not allow for in-and-out privileges; \$50 daily fee that allows for in and out privileges is perceived as cost prohibitive; weekend access not regularly offered

Negotiate with MarcParc leadership team to establish weekend tour bus parking with in-and-out privileges during peak season; negotiate with MarcParc leadership team to set aside 10 weekday tour bus parking spaces that require advance registration; educate drivers regarding this optional parking area.

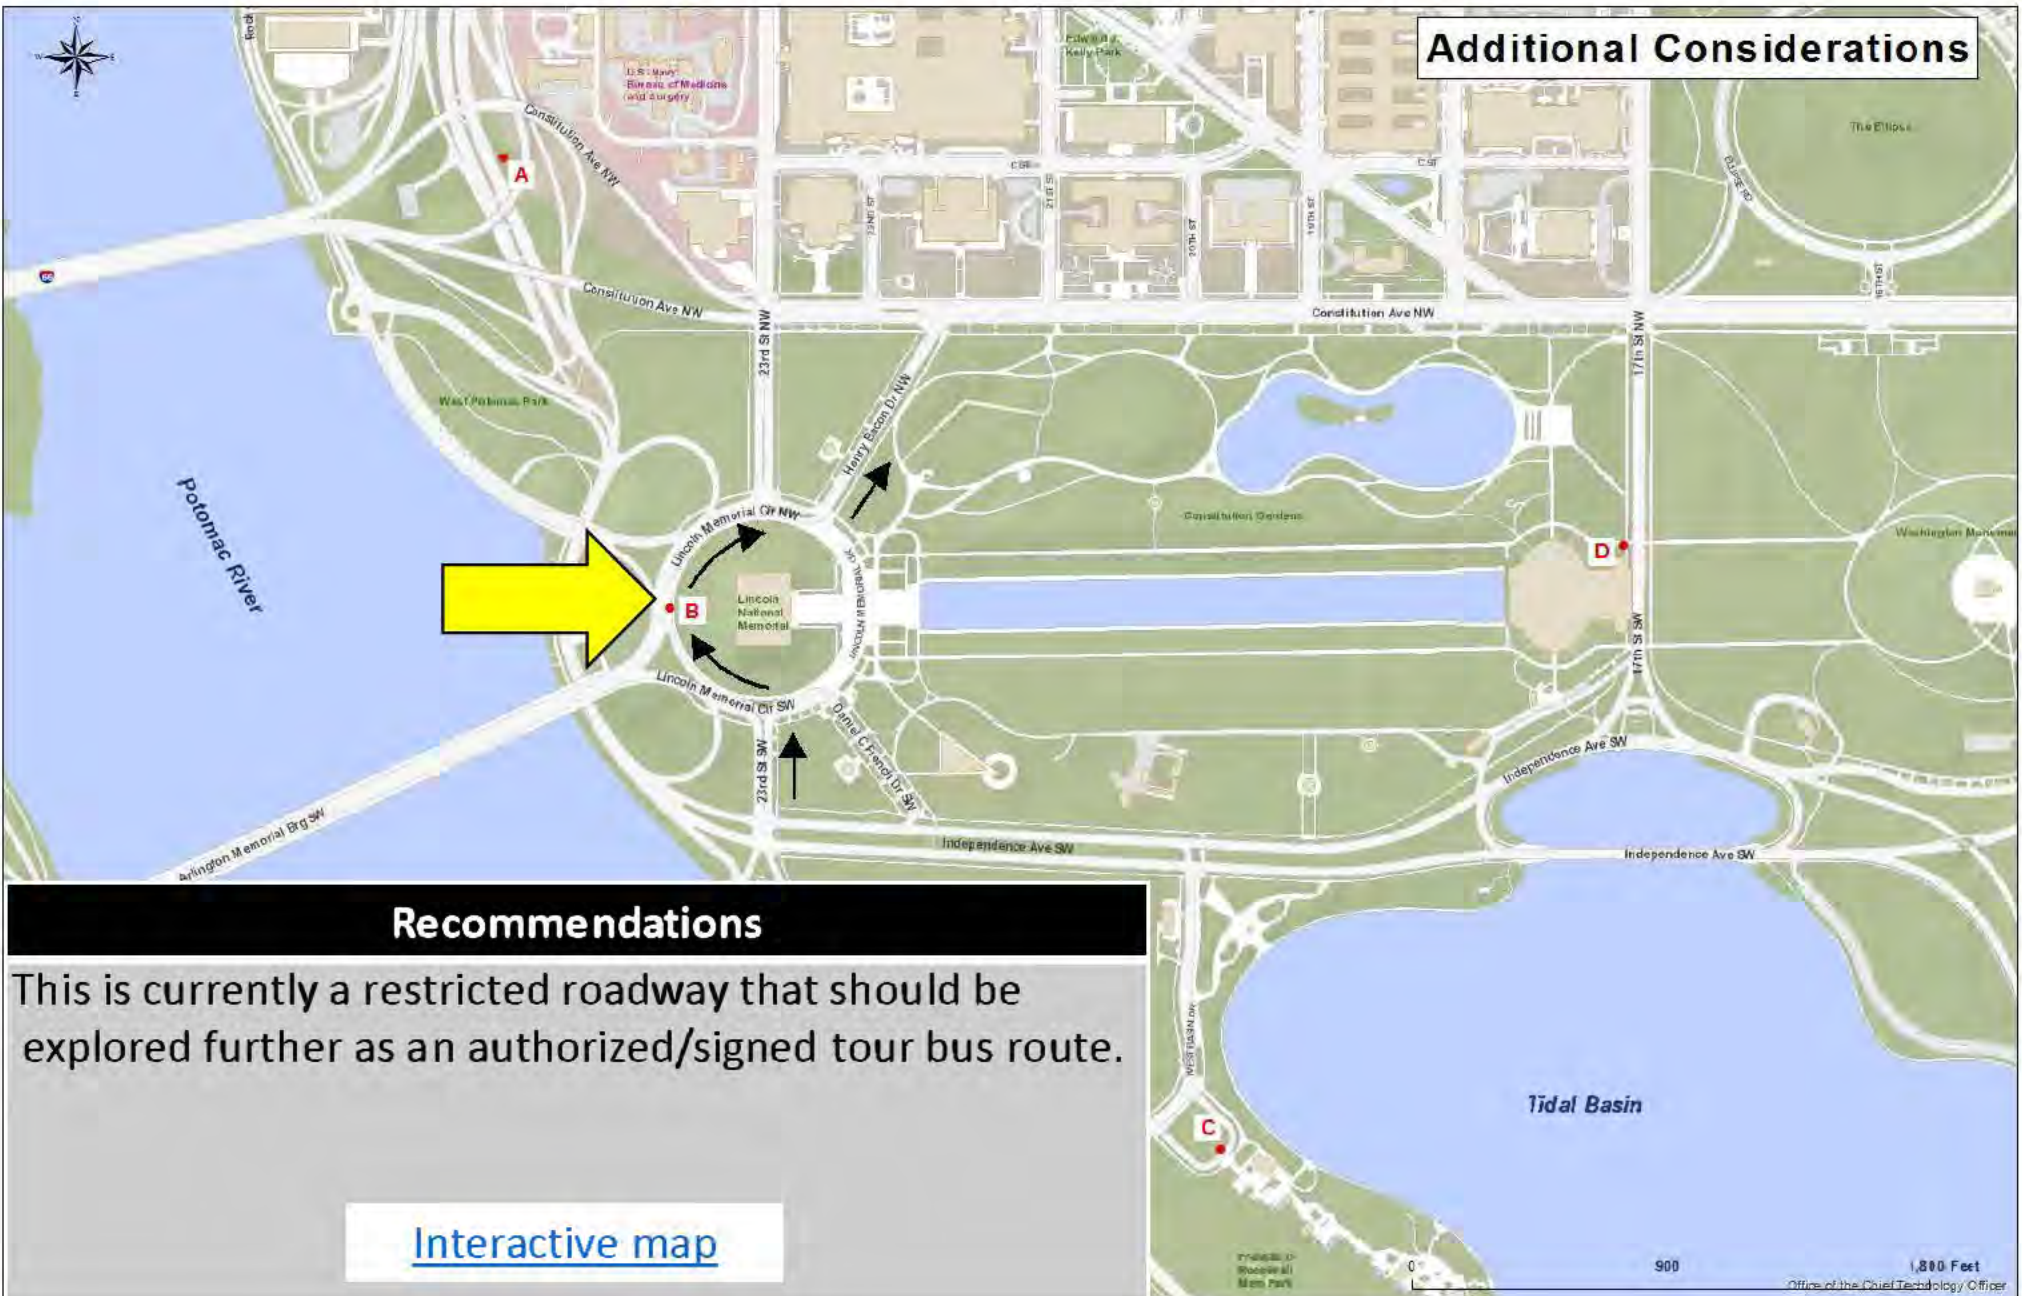
Site B

Lincoln Circle

This is currently a restricted roadway that should be explored further as an authorized/signed tour bus route.
