NATIONAL MALL AND MEMORIAL PARKS TOUR BUS STUDY

FINAL REPORT

June 2015

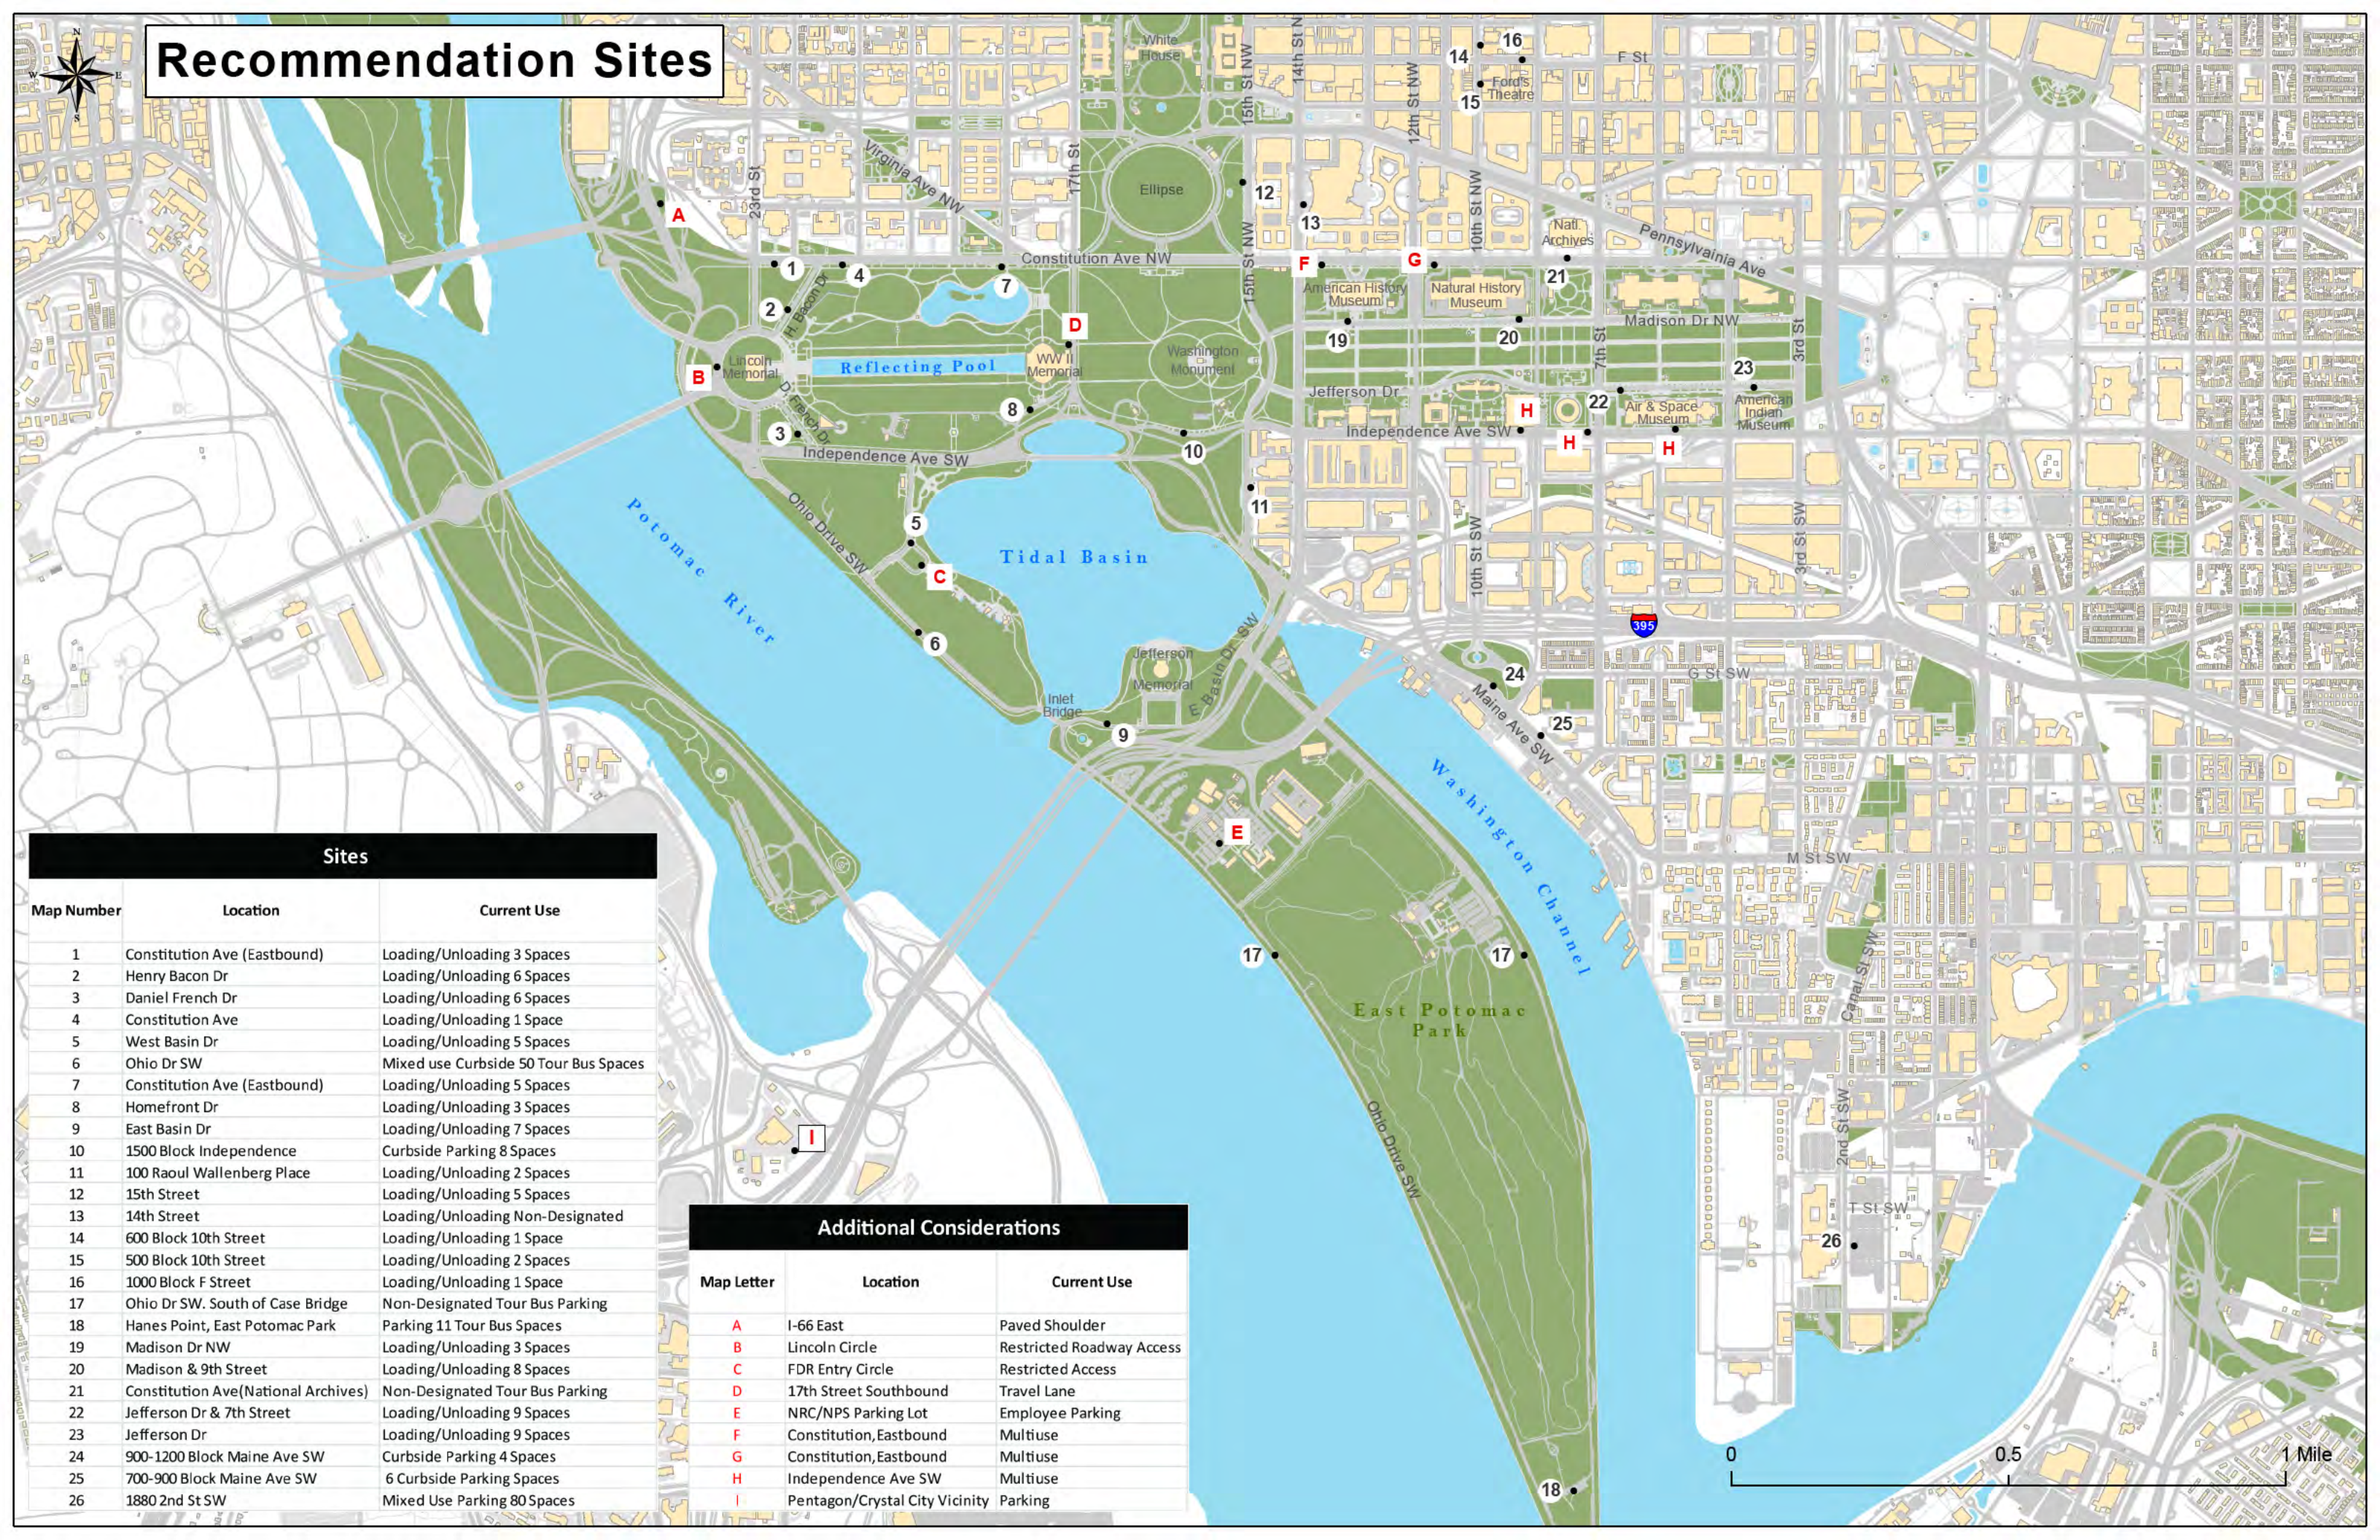
Recommendation Sites

As loading/unloading and parking present a cumulative circulation impact, recommendations are not listed in priority order; instead, they are grouped in areas to coincide with the accompanying map (Figure A) and the associated inset maps (Figures B and C). On Figures A, B and C, numbered locations represent precise study areas while spaces designated by letters represent additional locations that are salient to the recommendations.
