AN ANALYSIS OF TOUR BUS OPERATIONS WITHIN THE NATIONAL MALL AND MEMORIAL PARKS

Phase IV: Off-Bus Data Collection at Parking Areas

March 2014

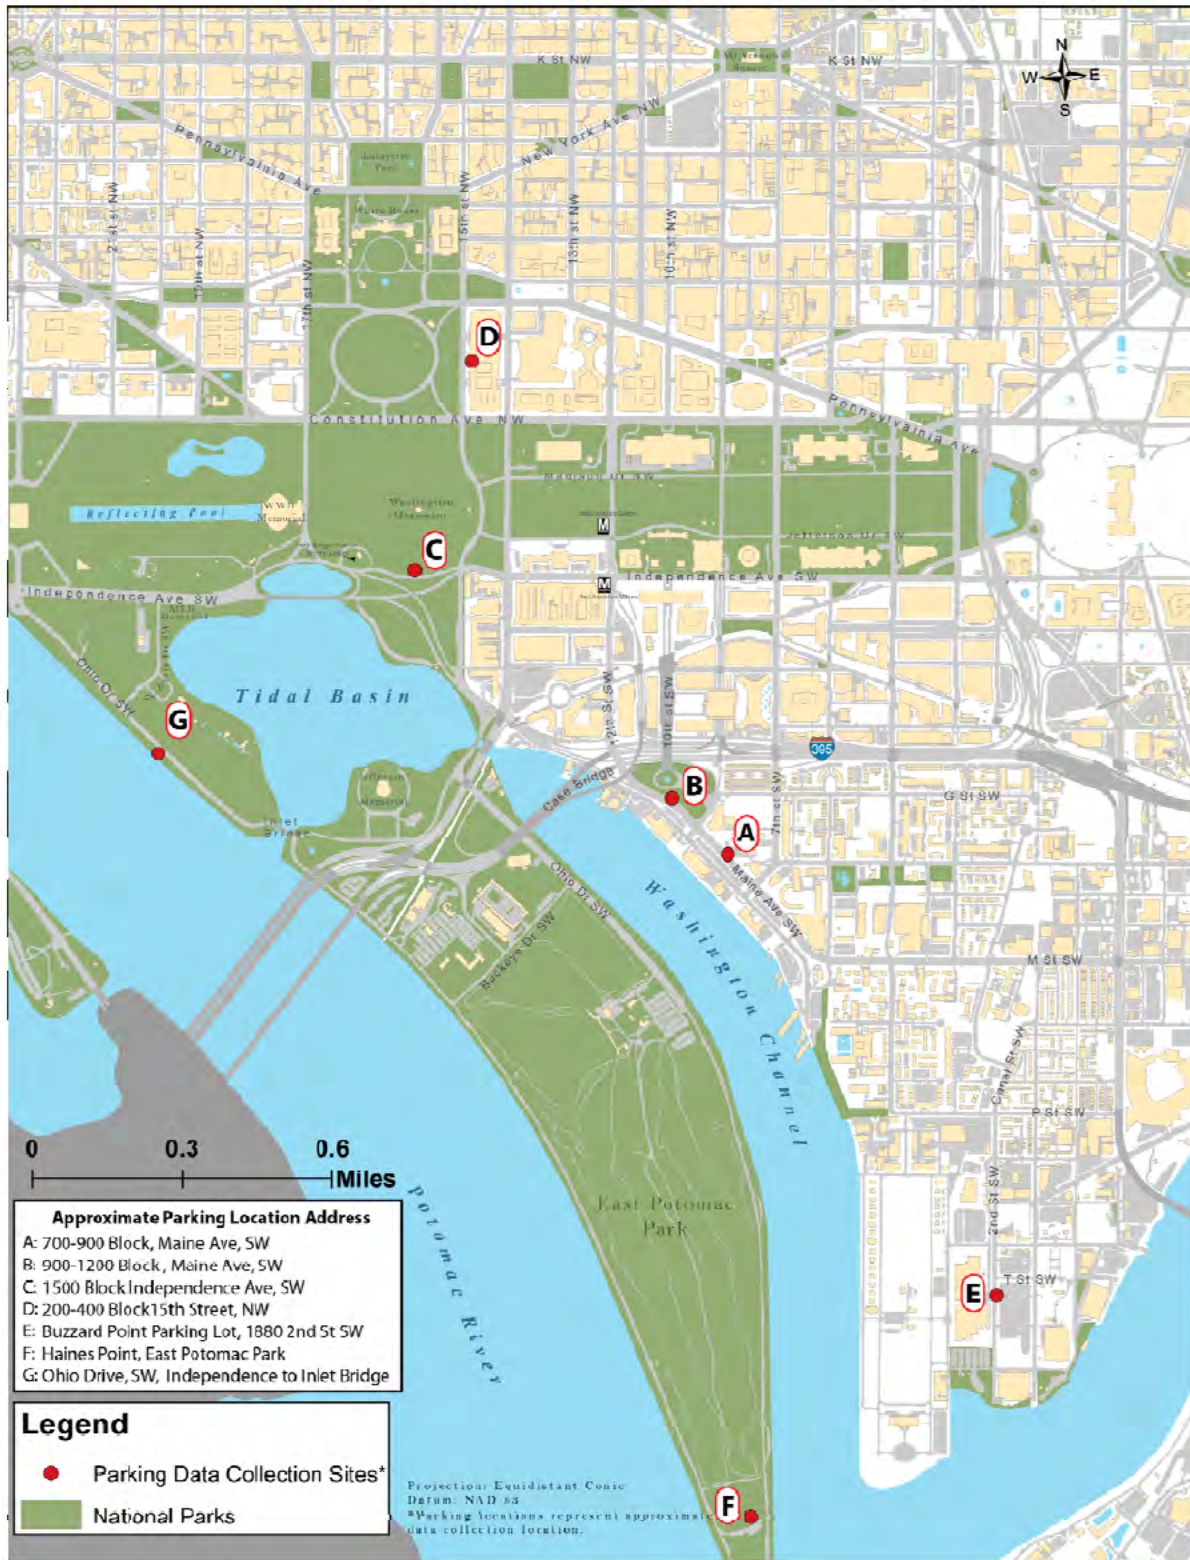
FIGURE 2.1: PARKING ZONES

Seven zones were identified by the NPS for inclusion in the parking analysis. Table 2.1 lists the zones and the data collection dates and times for each, while Figure 2.1 offers a visual representation of the zones. Due to typical tour bus schedules, Wednesdays were over-sampled to capture maximum usage. While the sum of spaces suggests that up to 173 curbside spaces and 91 parking lot spaces are available for use, these totals are misleading in that curbside parking along Ohio Drive and the Buzzard Point parking lot are also utilized by personal vehicles (cars, SUVs, vans, etc.), greatly diminishing the parking availability for tour buses.

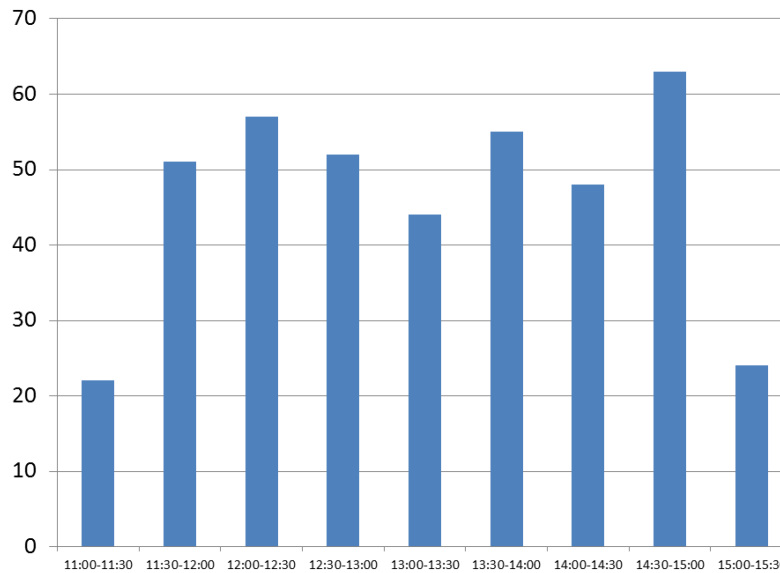
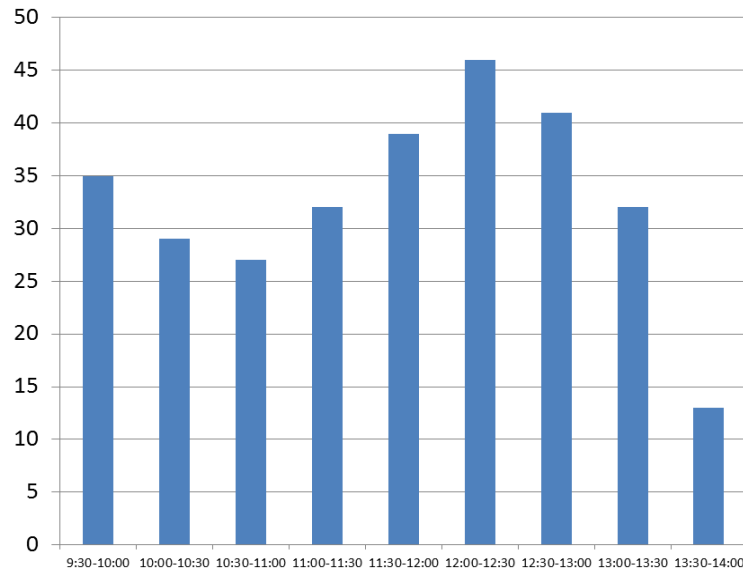
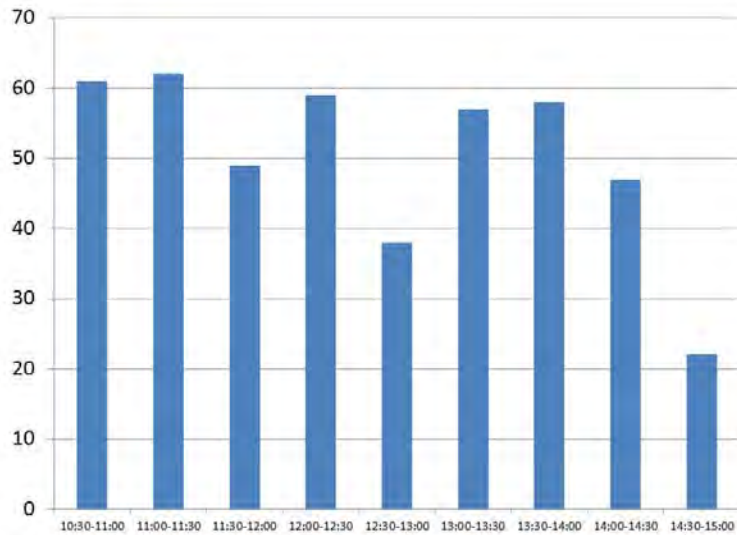
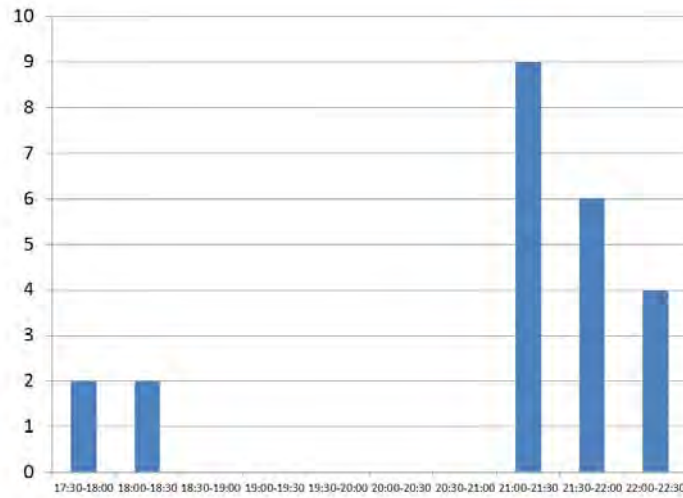
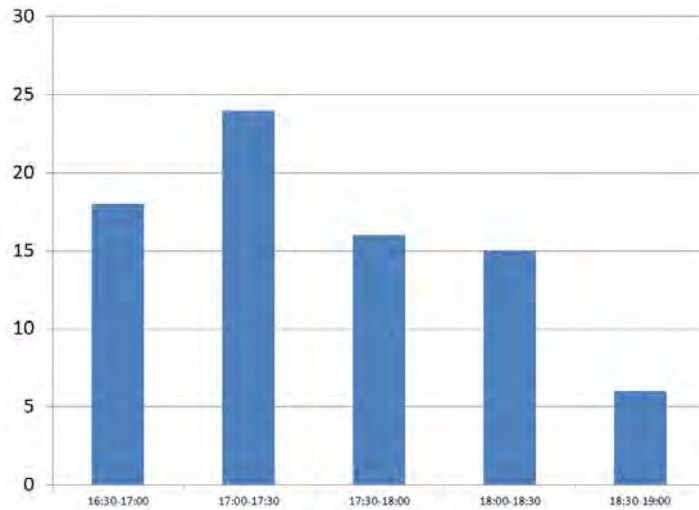
Figure 3.1 through Figure 3.5 illustrate the approximate number of buses observed when considering all zones, using 30-minute intervals, on each of the five days of data collection. These figures indicate unique observations only, meaning that if the same bus was documented more than once in a 30-minute interval, only the first data point was included. The temporal distribution findings suggest the utility of a flipped itinerary where tour planners consider an early/late lunch and early/late dinner in order to benefit from improved circulation and parking access, as parking demand drops during typical meal periods.

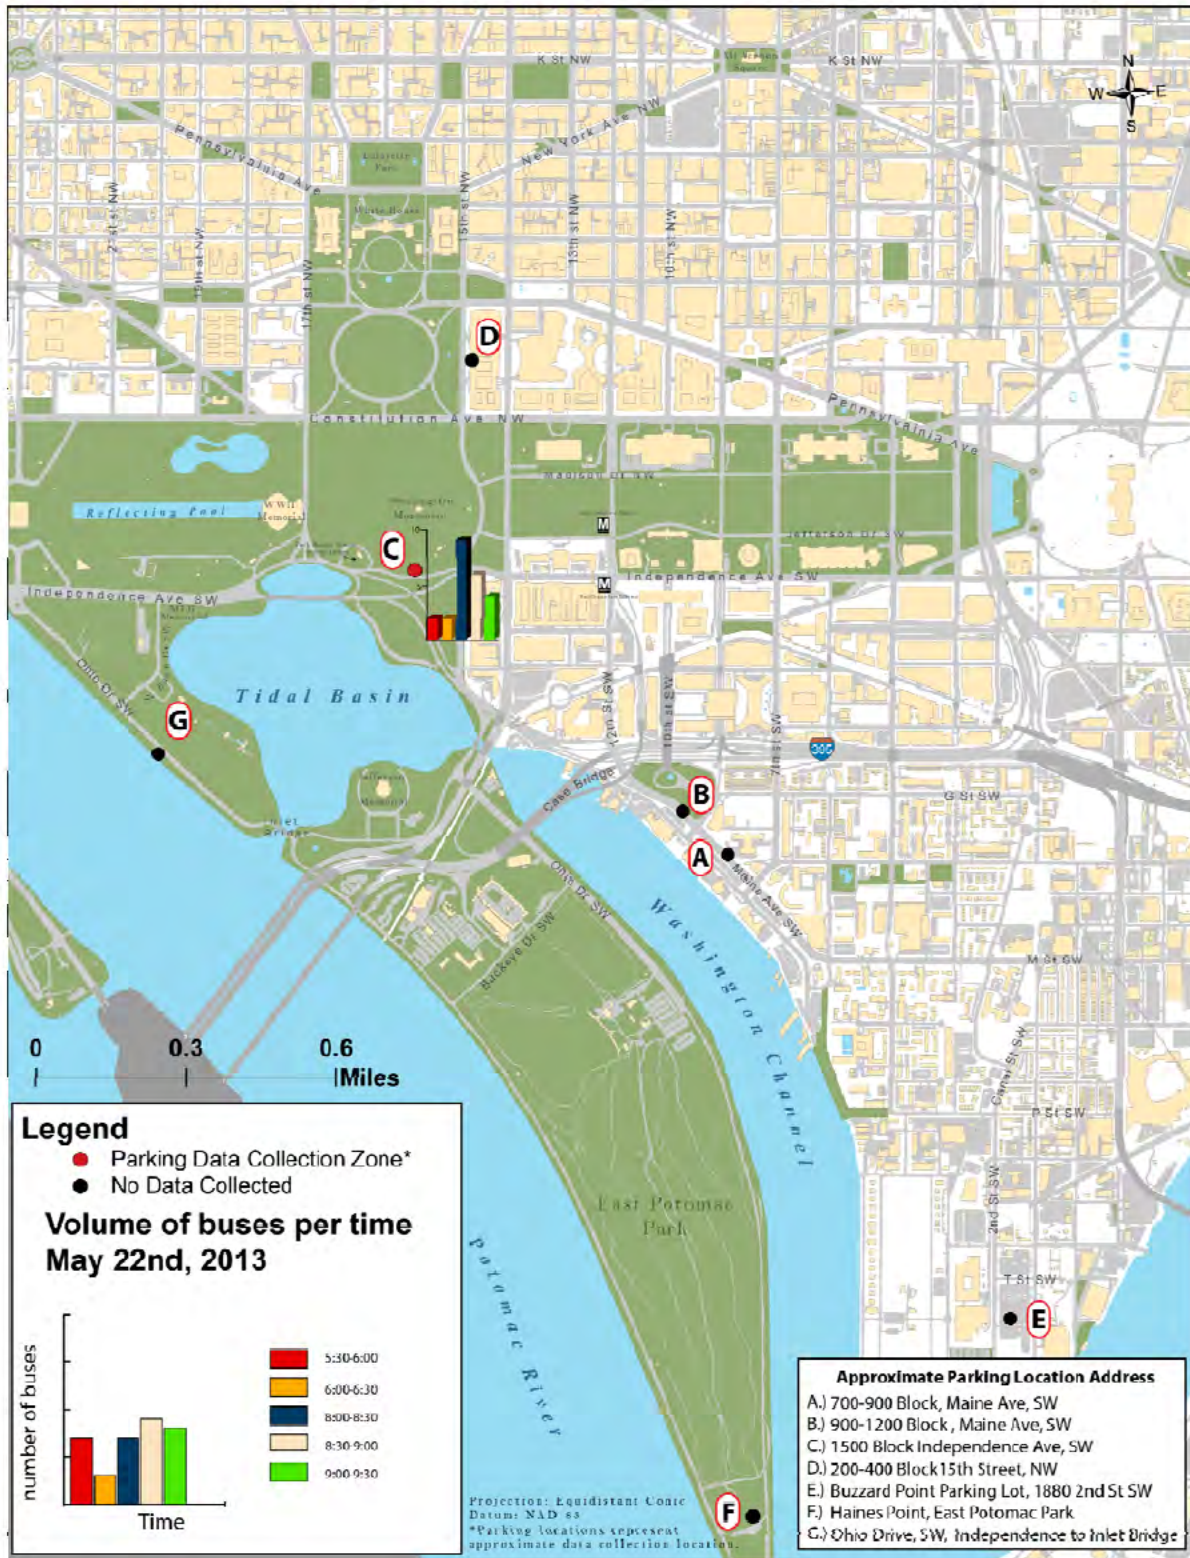
Figure 3.6 through Figure 3.10 illustrate the approximate number of buses observed when considering all zones individually, using 30-minute intervals, on each of the five days of data collection. These figures indicate unique observations only, meaning that if the same bus was documented more than once in a 30-minute interval, only the first data point was included. As noted with the combined zones, the temporal distribution findings suggest the utility of a flipped itinerary where tour planners consider an early/late lunch and early/late dinner in order to benefit from improved circulation and parking access, as parking demand drops during typical meal periods.

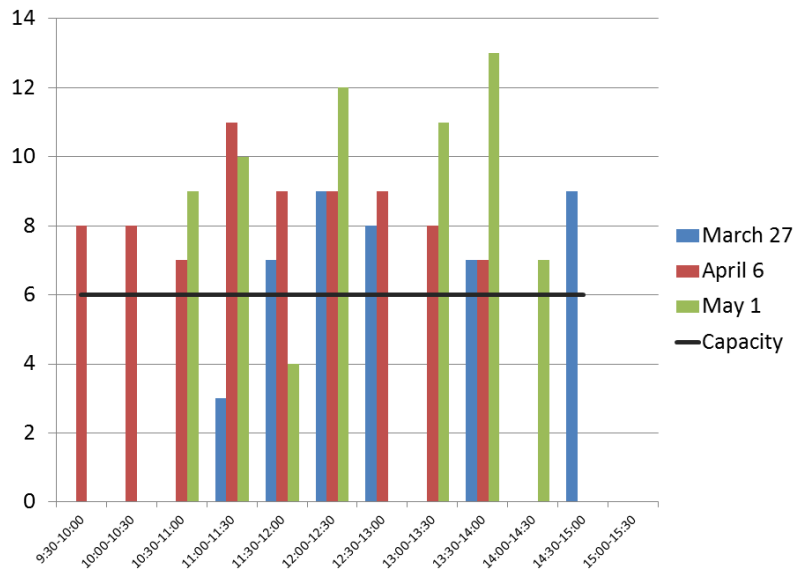
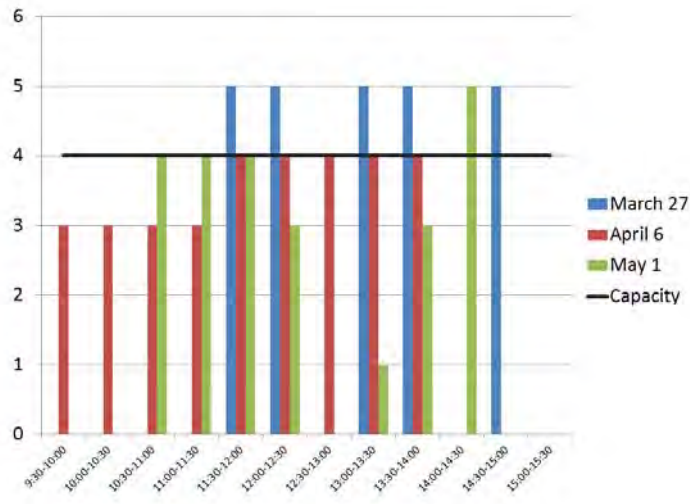
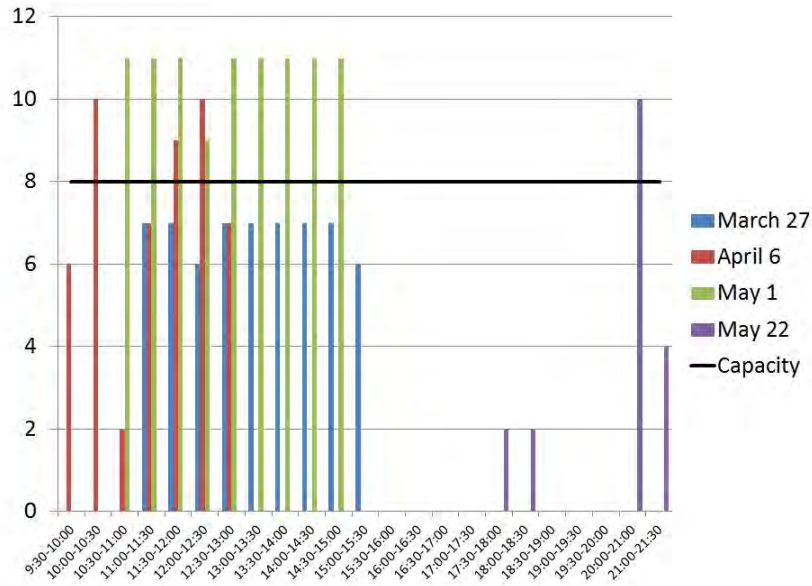
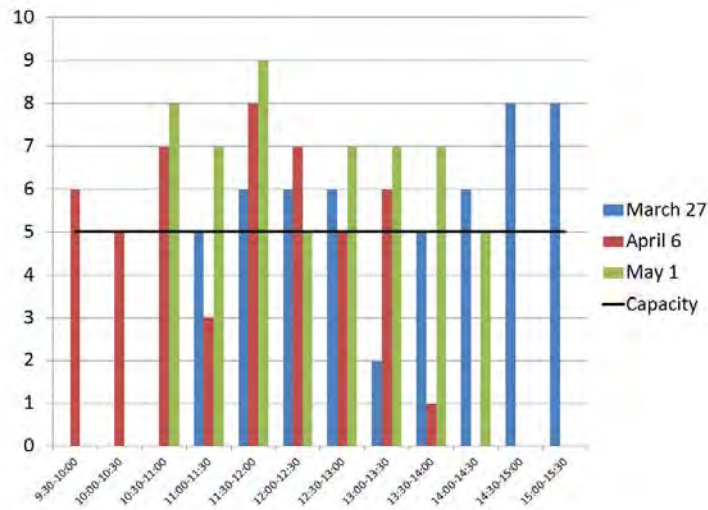
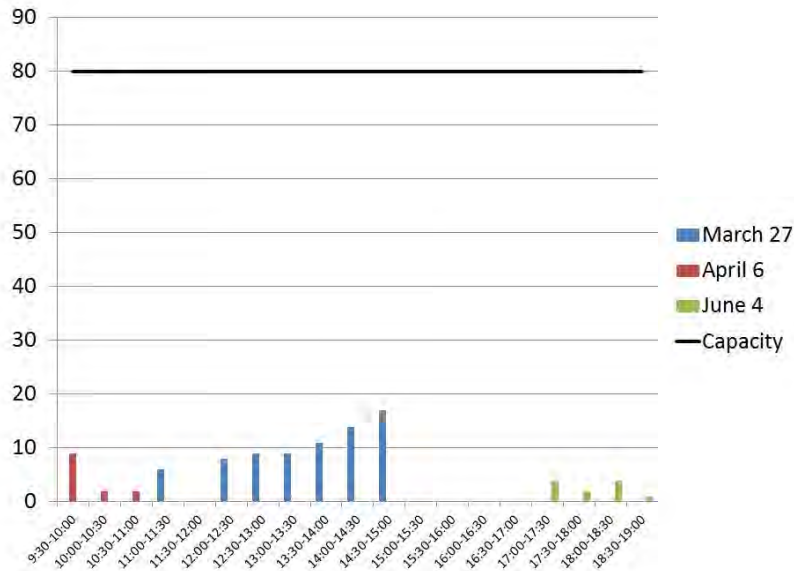
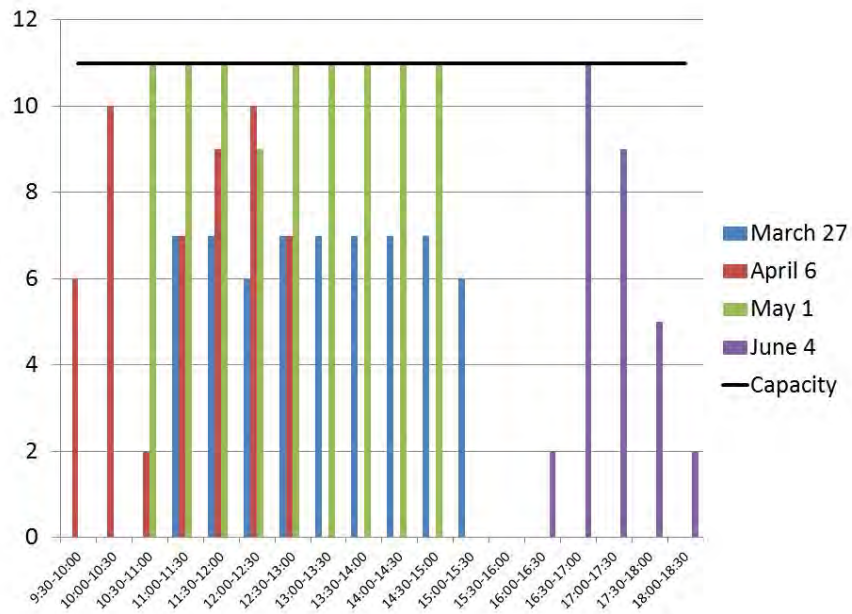
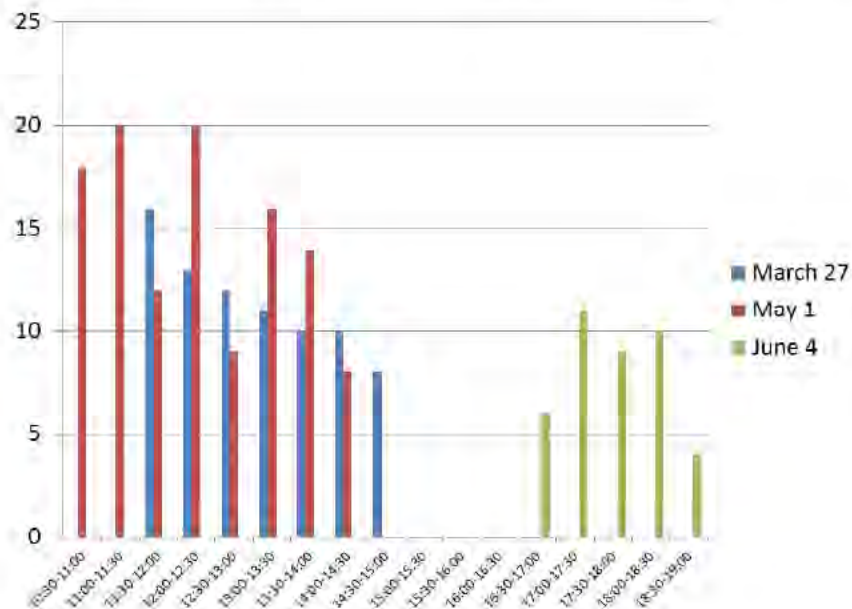
Figure 3.11 through Figure 3.17 illustrate the temporal distribution of parking demand with respect to the parking capacity of the zone. Zones were frequently above capacity, evidenced by movement within the zone during 30-minute increments and parking beyond the boundaries of the zone. Table 3.1 indicates the percentage of time that each zone was at capacity.
