Water Quality Monitoring Program 2001- 2003 New River Gorge National River Bluestone National Scenic River Gauley River National Recreation Area

July 2006

United States Department of the Interior
National Park Service
Glen Jean, West Virginia

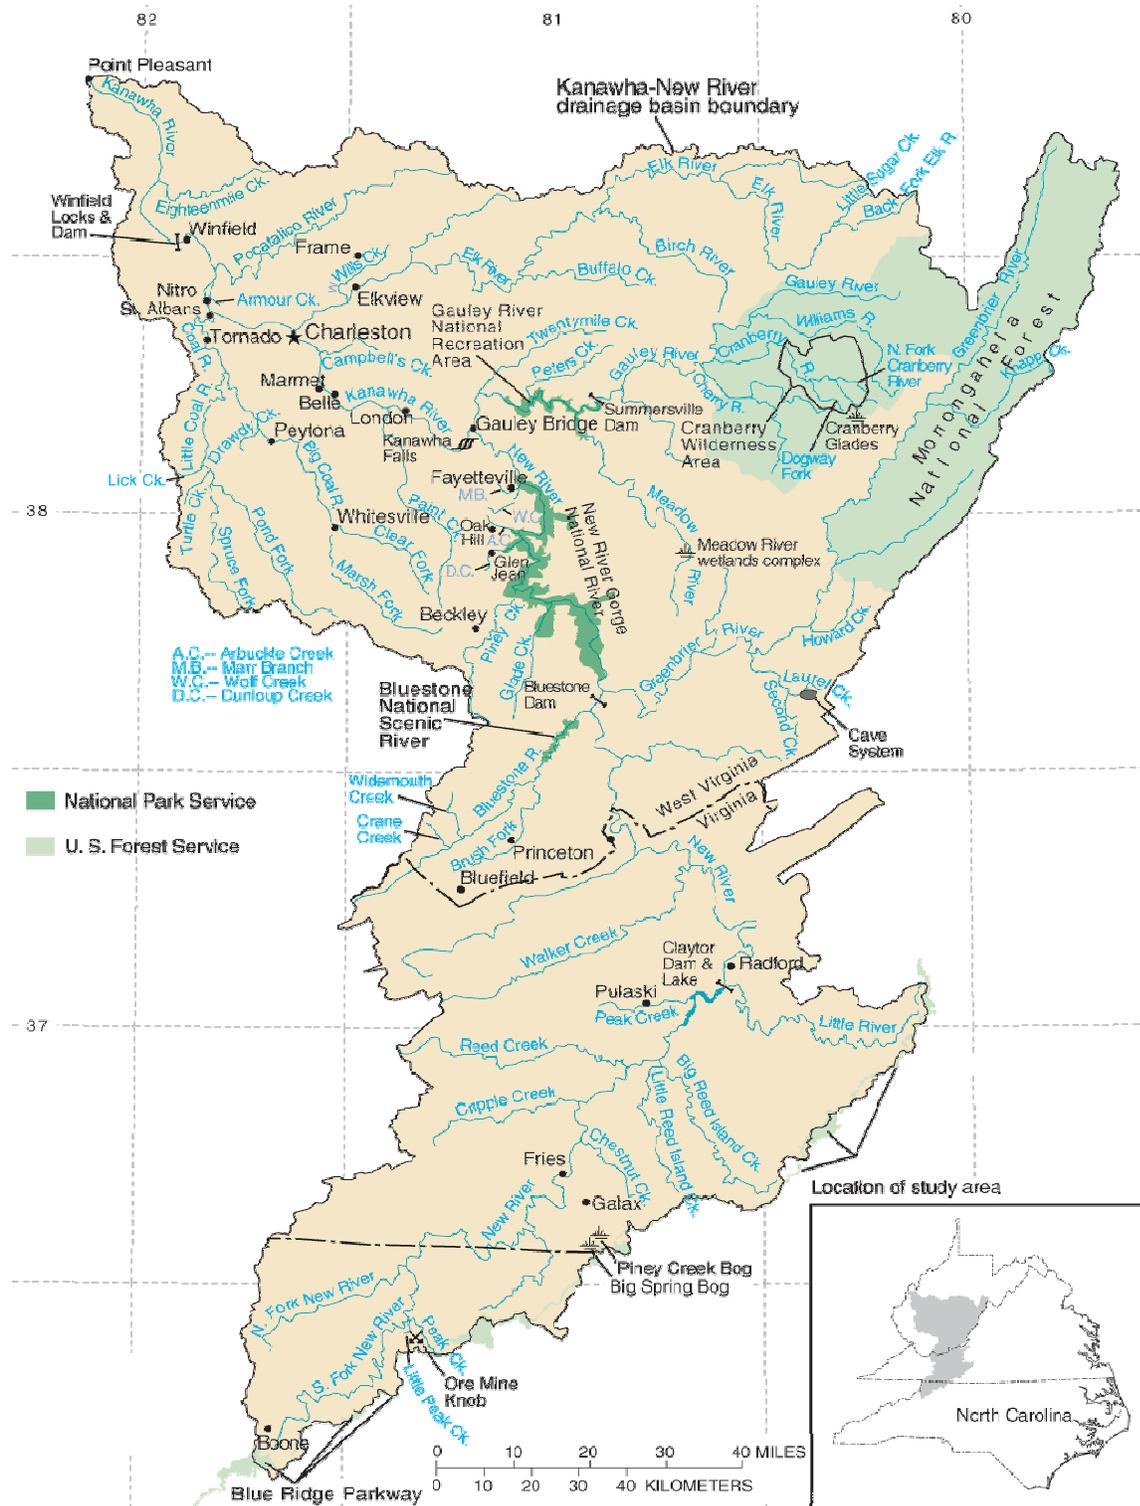
Base from U.S. Geological Survey digital data, 1:2,000,000, 1992 and National Park Service digital data, 1:24,000, 1996

Figure 1. Kanawha - New River watershed, showing the locations of Bluestone National Scenic River, New River Gorge National River, and Gauley River National Recreation Area.

All three parks lie within the Kanawha- New River watershed (Fig. 1). The New River begins in the Blue Ridge Mountains near Blowing Rock, North Carolina. The river flows generally northward 250 miles, through Virginia and West Virginia. The two major tributaries to the New River (West Virginia Department of Natural Resources 1983b), the Bluestone River and the Greenbrier River (West Virginia Department of Natural Resources 1983a), both enter within a few miles of each other near Hinton, West Virginia. The Bluestone River enters the New River in Bluestone Lake from river left about 3 miles upstream of Bluestone Dam, and about 4 miles upstream of the confluence of the Greenbrier River. The New River then flows north and northwest to its confluence with the Gauley River at Gauley Bridge, West Virginia. Confluence of the New and Gauley Rivers forms the Kanawha River. The Kanawha River flows northwest 97 miles to its mouth on the Ohio River, a tributary of the Mississippi River, at Point Pleasant, West Virginia. The New River watershed includes 5,274 square miles: 756 square miles in North Carolina, 3,044 square miles in Virginia, and 1,474 square miles in West Virginia. The entire Kanawha- New River watershed includes 12,233 square miles.
