**ITS**  
NUMBER 17

**Interpreting**  
**The Secretary of the Interior's Standards for Rehabilitation**

**Subject: Adding Parking to the Interior of Historic Buildings**

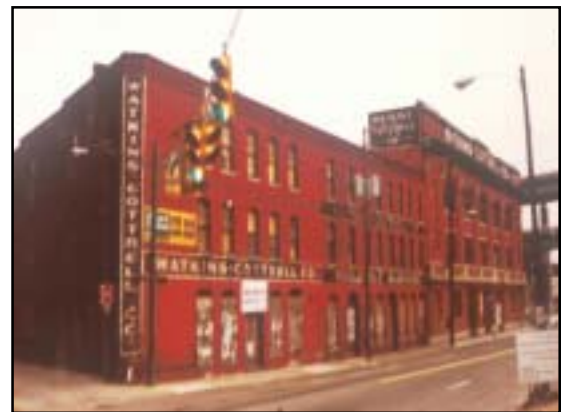
*This brick warehouse complex built between 1865 and 1905 was converted to commercial and retail uses. A concealed rear structure worked well for interior parking.*

When this late-nineteenth/early-twentieth century brick warehouse complex was converted to office and retail use, the local jurisdiction required the owner to provide a large amount of parking. Although the space designated for parking was not originally intended for this purpose, its utilitarian character lent itself well for this function and its warehouse quality, complete with its heavy-timber trusses, was left exposed. The entrance to the parking area was located along an alley, where existing openings were combined for vehicular use.

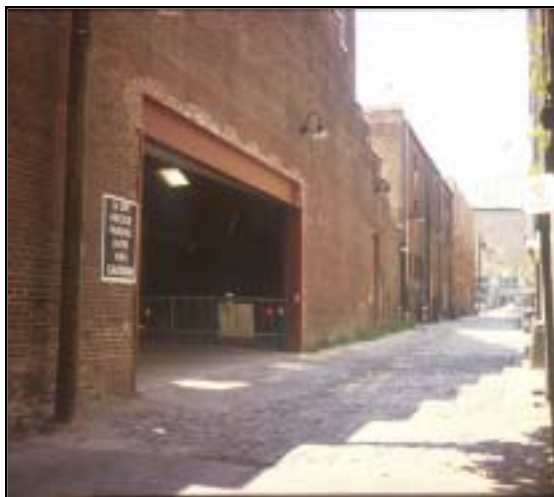
*The new parking entrance is appropriately located along an alley where two smaller openings were enlarged to accommodate vehicular traffic.*

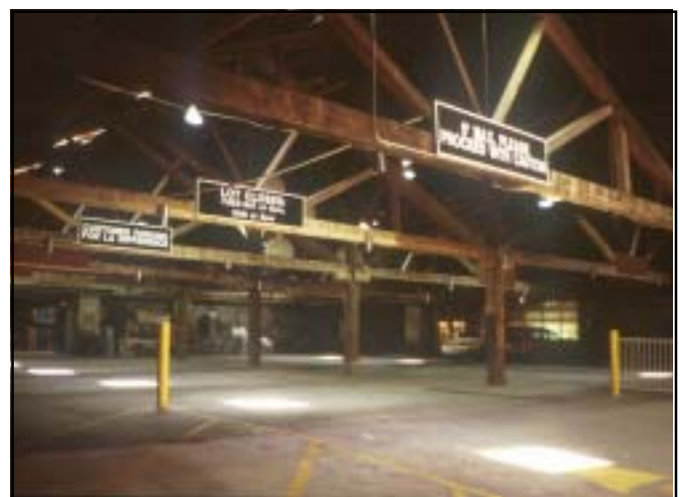
*The historic heavy-timber trusses were left exposed in the parking area.*

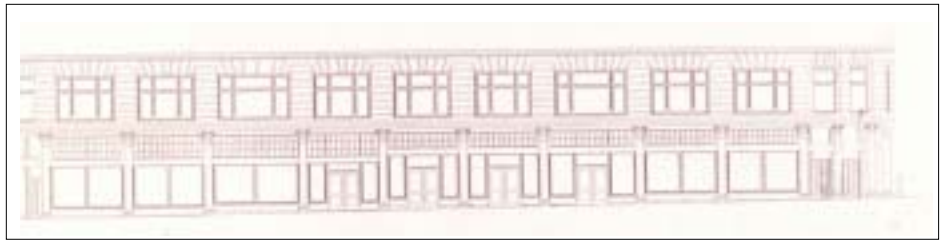
*The transom of this compatible replacement storefront contains both spandrel glass and screening. The screened portion is used for ventilation.*

In this example, it was difficult to ventilate to the roof, so other alternatives were investigated. The solution was to direct the exhaust out through and above the retail space. A modest transom detail was developed as part of the new compatible replacement storefront, which alternated spandrel glass with a dark screening material. This screening provided the necessary ventilation, without being too visually intrusive.

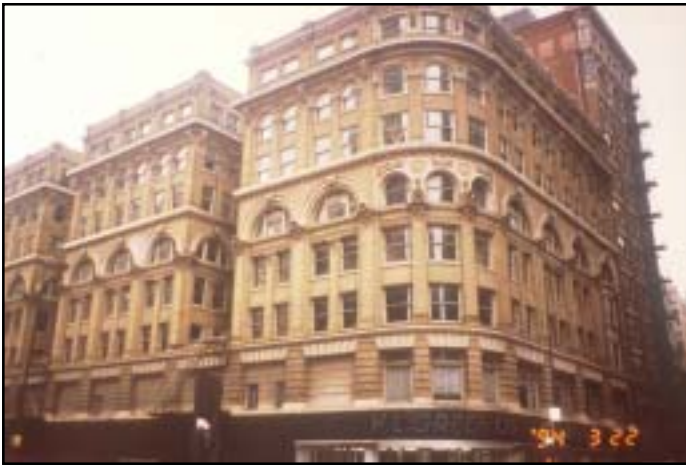
*The parking area in this early-twentieth century structure is not visible to the public.*

This early-twentieth century commercial structure in a major downtown area was converted into retail and residential use. Parking was introduced at the rear of the first floor, which had little historic fabric remaining, and in the basement, which was service-oriented in nature. The new parking entrances were added to secondary facades and were not visible from the primary elevations.

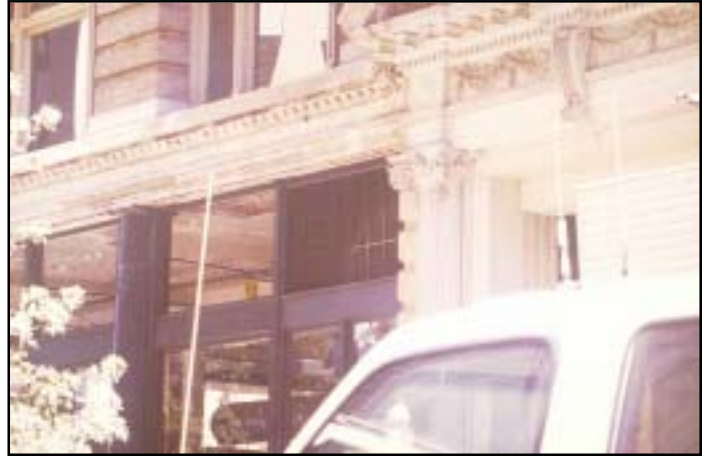
*Detail of transom (under construction).*

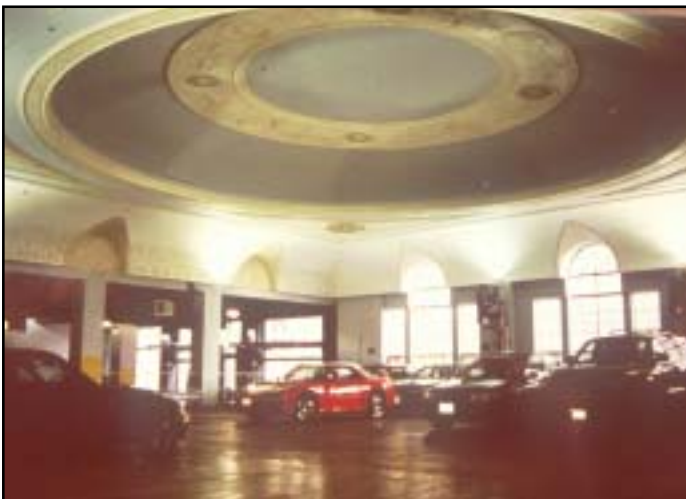
*Parking cars in this highly-finished space is not a compatible treatment.*

**Application 3** (*Incompatible treatment*): Parking cars is never appropriate in historically finished interiors, as demonstrated by the following example:
