Interpreting The Secretary of the Interior's Standards for Rehabilitation

Subject: Industrial Bridges in Mill Complexes

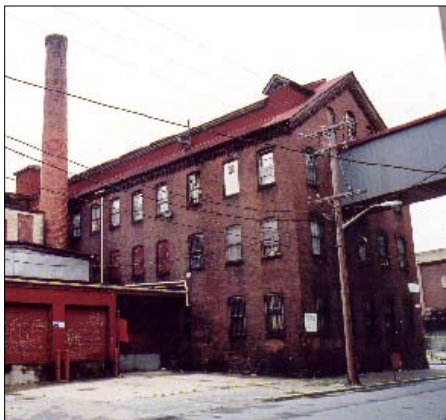
Industrial building and bridge before rehabilitation.

Application 3 (Compatible treatment): This mill complex, which was constructed between 1849 and 1951, consists of six buildings. The property includes an industrial bridge that links the third floors of the two buildings. Investigation of the bridge revealed that it was an early wood-frame feature of the complex originally clapboarded, but now covered with a steel membrane. The proposal for converting the property into
