# Preservation Briefs: 9

## The Repair of Historic Wooden Windows

John H. Myers

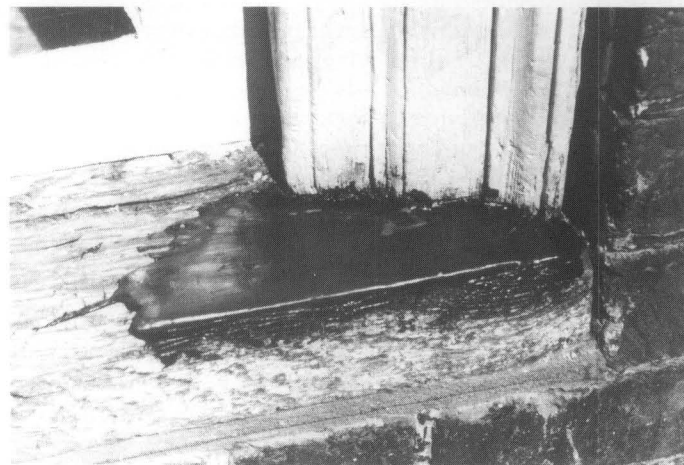
Figure 5. This illustrates a two-part epoxy patching compound used to fill the surface of a weathered sill and rebuild the missing edge. When the epoxy cures, it can be sanded smooth and painted to achieve a durable and waterproof repair. Photo: John H. Myers

Wood may also be strengthened and stabilized by consolidation, using semi-rigid epoxies which saturate the porous decayed wood and then harden. The surface of the consolidated wood can then be filled with a semi-rigid epoxy patching compound, sanded and painted (see figure 5). Epoxy patching compounds can be used to build up
