# 33 PRESERVATION BRIEFS

## The Preservation and Repair of Historic Stained and Leaded Glass

Neal A. Vogel and Rolf Achilles

National Park Service  
U.S. Department of the Interior

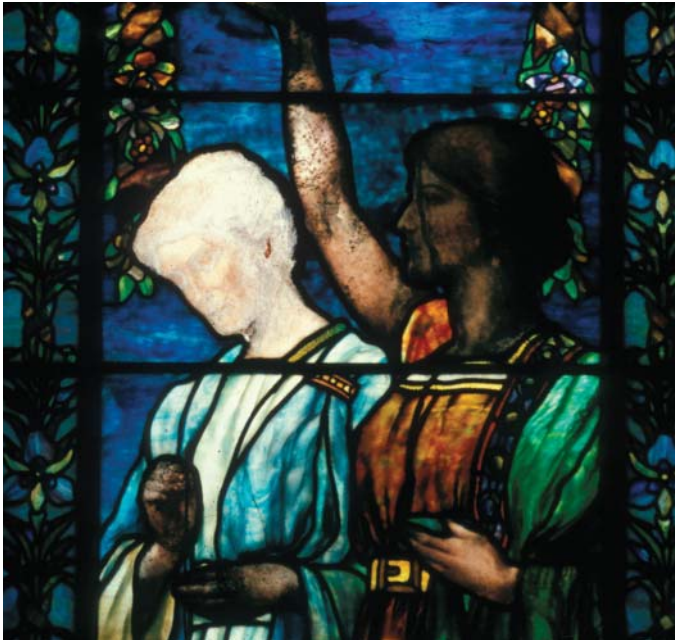
Figure 11. The face paint has failed substantially in the figure at the left. Ghost images of the feature are barely visible. Window (1903) by Edwin P. Sperry, glass by Tiffany Studios; “Old Main,” (1891-1893) Illinois Institute of Technology, Chicago. Photo: Rolf Achilles.

Painted glass, typically associated with pictorial scenes and figures found in church windows, often presents serious preservation challenges. If fired improperly, or if poor quality mixtures were used, painted glass is especially vulnerable to weathering and condensation. Some studios were notorious for poorly fired paints (particularly those working with opalescent glass), while others had outstanding reputations for durable painted glass. Paints can be applied cold on the glass or fused in a kiln. Since they are produced from ground glass, enamels do not “fade,” as often suggested, but rather flake off in particles. Several steps in the painting process can produce fragile paint that is susceptible to flaking. If applied too thick, the paint may not fuse properly to the glass, leaving small bubbles on the surface. This condition, sometimes called “frying,” can also result from poor paint mixtures or retouching. Paint failure is more commonly caused by under firing (i.e., baking the glass either at too low a temperature or for too little time). Unfortunately, in American stained glass, the enamels used to simulate flesh tones were typically generated from several layers that were fired at too low a temperature. This means the most difficult features to replicate—faces, hands and feet—are often the first to flake away (Fig. 11).
