# 41 PRESERVATION BRIEFS

## The Seismic Rehabilitation of Historic Buildings

National Park Service  
U.S. Department of the Interior  
Technical Preservation Services

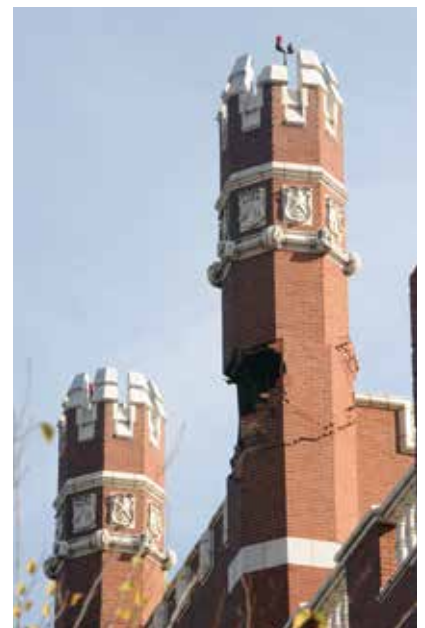
Figure 1. In 2011, a 5.6 magnitude earthquake substantially damaged all four turrets atop St. Gregory's University Benedictine Hall in Shawnee, Oklahoma. Photo: St. Gregory University.

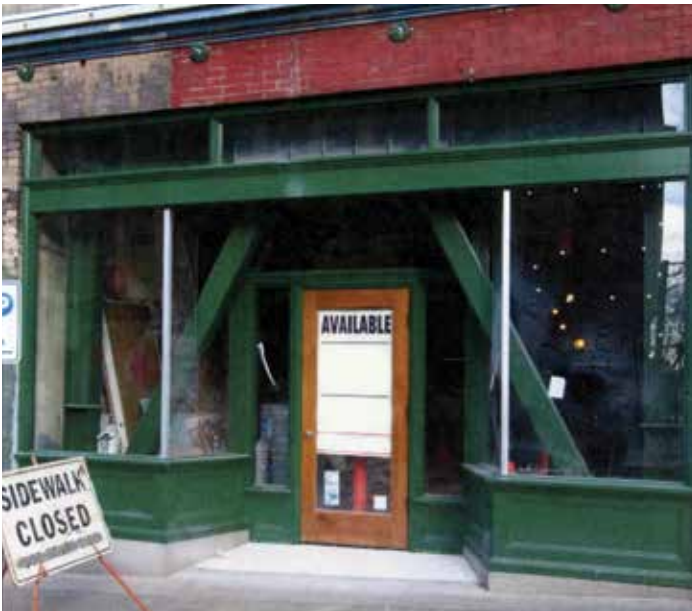
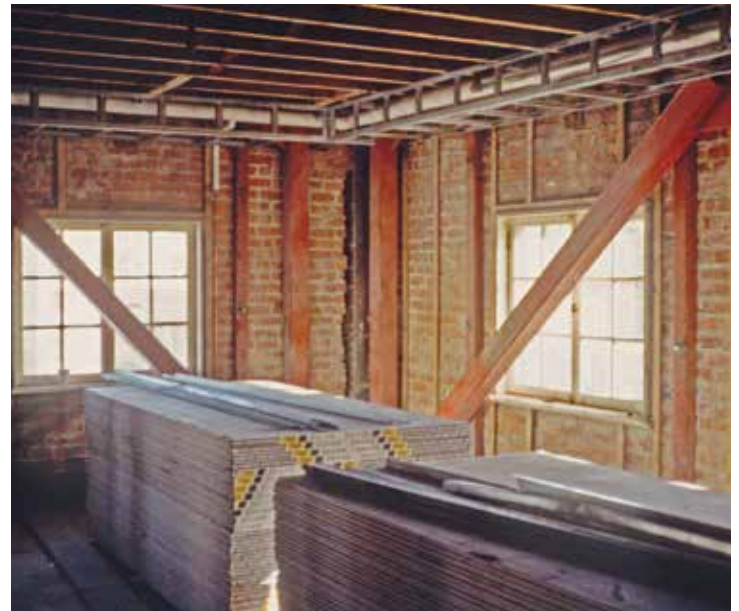
Figures 2-3. Standard approaches to seismic rehabilitation, such as adding diagonal bracing to reinforce window and storefront openings as seen in these photos, can be visually intrusive. Figure 2 (left). Figure 3 (right). Photo: Steade Craig.

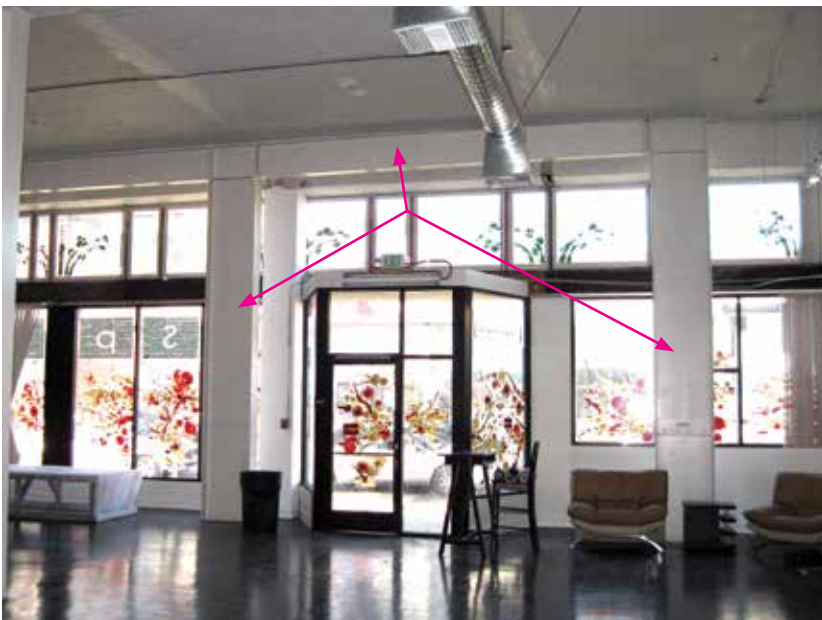
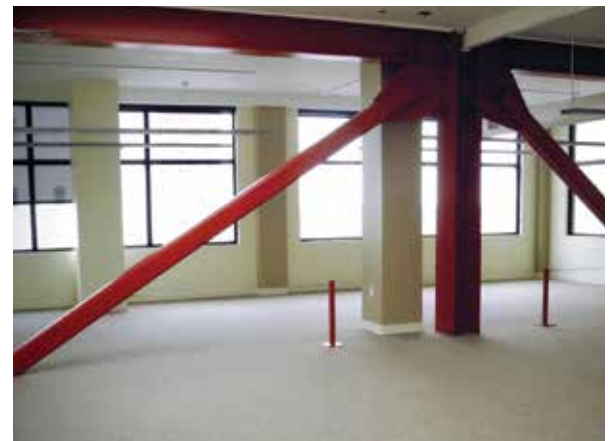
Figures 4-5. Using moment frames (horizontal and vertical steel members identified by the arrows) set back behind storefront openings as seen in Figure 4 (left), or placing brace frames (in red) away from the windows as illustrated in Figure 5 (right) are solutions that meet historic preservation goals. Figure 4. Photo: Elizabeth Hilton.

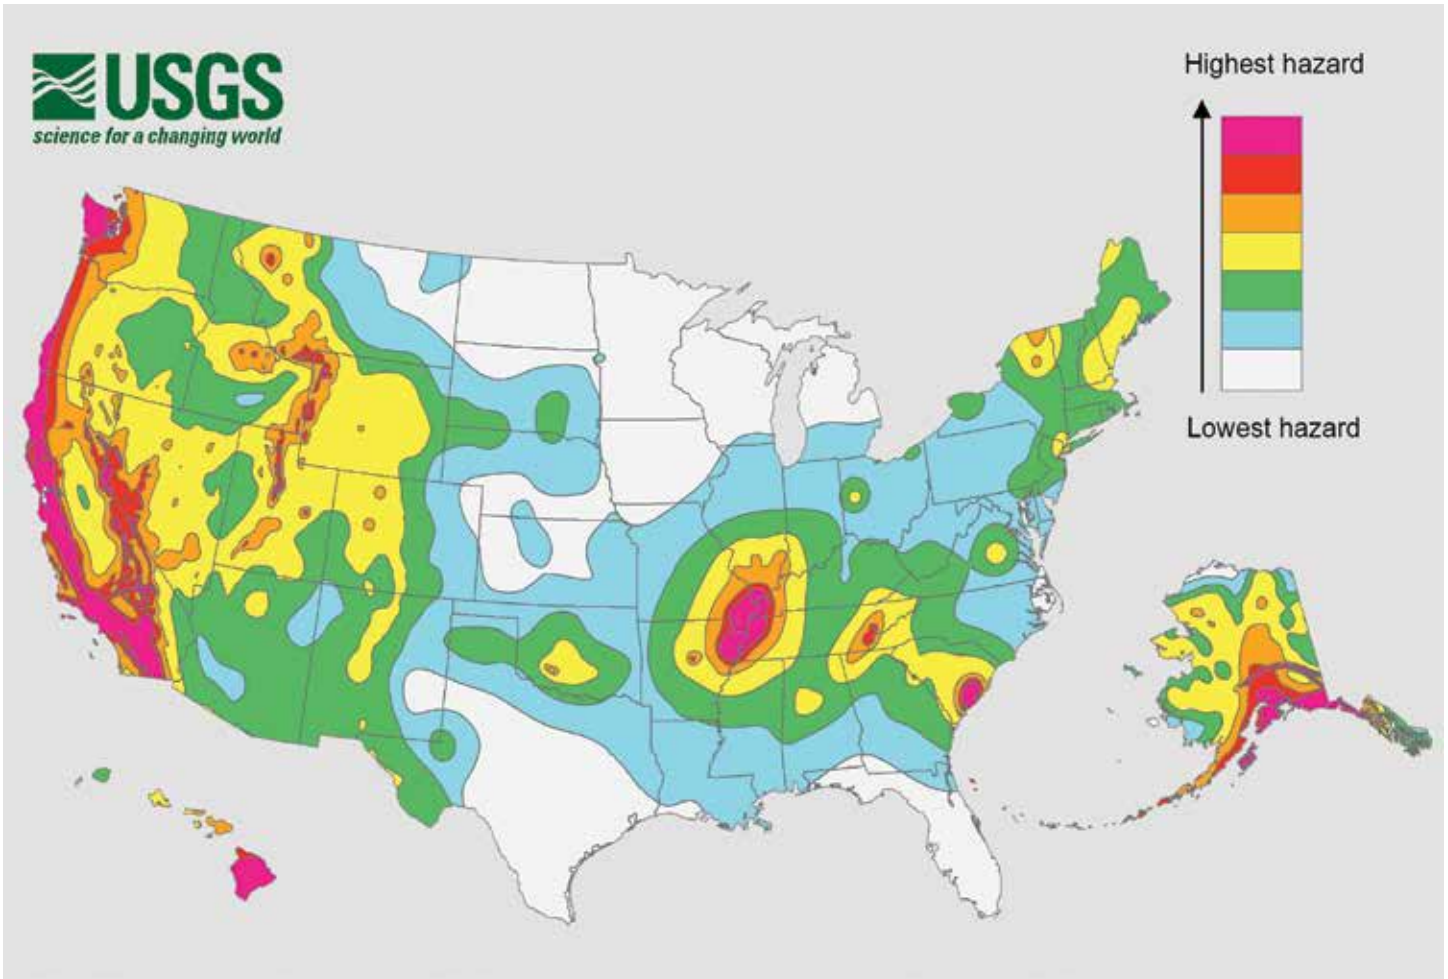
Figure 7. A simplified 2014 United States Geological Survey (USGS) seismic hazard map. Owners of certain classes of high-risk buildings in regions of high seismic activity are advised, and often required by local ordinances, to take immediate action in undertaking a comprehensive vulnerability assessment and make any necessary seismic rehabilitation measures. Owners of buildings in moderate seismic zones are advised to do further investigation of their building's exposure to earthquake risk, identify seismic rehabilitation needs, and consider mitigation of risks primarily due to nonstructural hazards. Owners of buildings in low seismic areas are advised to consider low-cost rehabilitation measures that protect against casualties and property loss, if such measures are found to be necessary, even though the potential occurrence of an earthquake might be low.

Other important nonstructural hazards to consider are the possibility that gas and water lines may rupture during an earthquake, which can cause fire and water damage. Many of these vulnerabilities can be mitigated by understanding how the forces unleashed in an earthquake affect a building, and then planning and implementing appropriate remedial treatments (Figure 7).

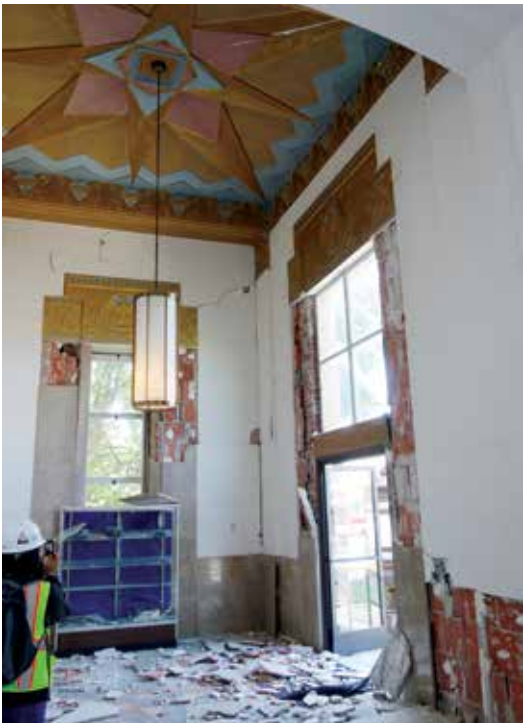
Figure 6. Failing nonstructural elements such as the stone-veneer window and door surrounds shown in this image can become a life-safety hazard when they block or impede an exit path. Photo: Wiss, Janney, Elstner and Associates, Inc.

Nonstructural failures generally account for the majority of earthquake damage repair costs during earthquakes. Thus, it is critical to consider the risk and consequences of potential nonstructural failures. This is particularly important for historic buildings located in areas of low or moderate earthquake hazard, where the danger of collapse may be relatively small, but nonstructural elements such as unanchored stone veneers, cornices, parapets, chimneys, and gable ends may dislodge and fall to the ground during a moderate earthquake and pose severe life-safety hazards (Figure 6).

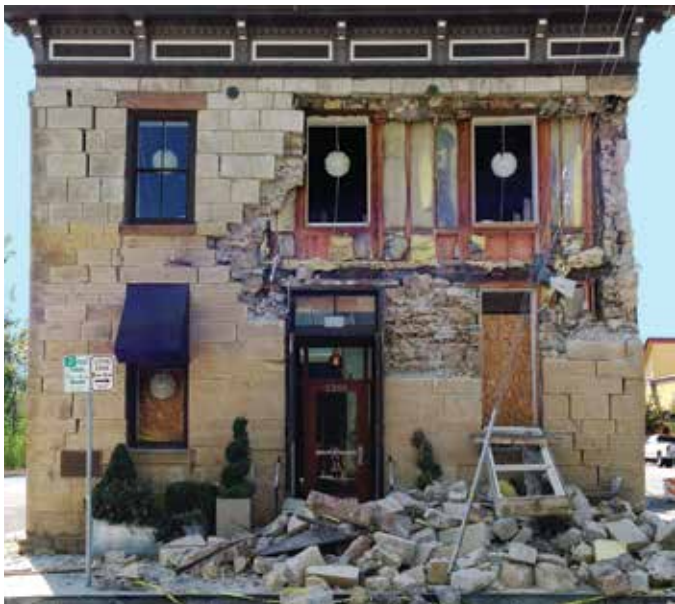
Figure 8. Unreinforced masonry buildings, such as this 1875 stone building damaged during the 2014 South Napa, California earthquake, can be particularly vulnerable to earthquake damage. Photo: Architectural Resources Group.

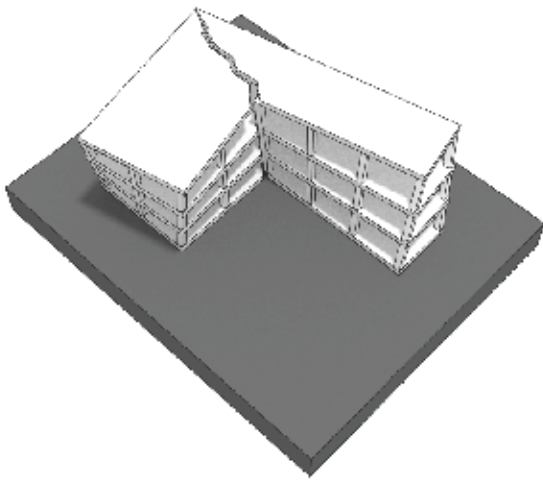
Figure 9. This image shows structural deformation due to stress concentration in structures with re-entrant corners, the inside corner where the two perpendicular exterior walls meet.

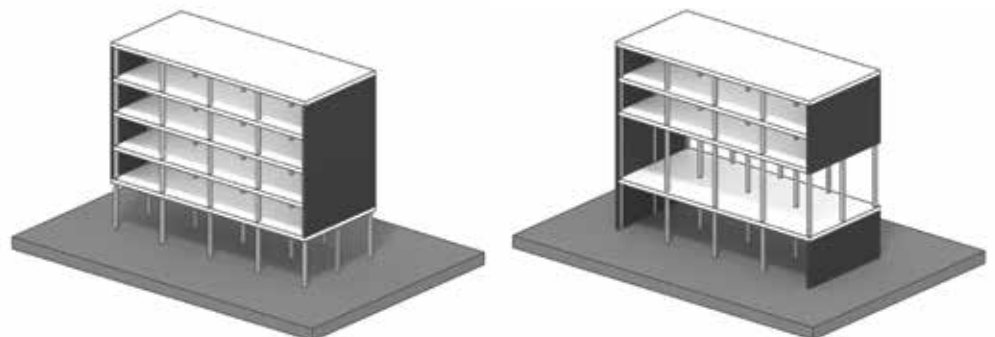
Figure 10. (left) Open first floor. Figure 11. (right) Double height second floor. These renderings show examples of "weak" or "soft" story irregularities.

Similarly, the more complex and irregular buildings are in elevation, the more susceptible they are to damage, especially tall structures. Other building features such as large ground-level storefront or garage openings, or floors with columns and walls running in only one direction, are commonly known as "soft" or "weak" stories, which increase the seismic vulnerability of historic buildings (Figures 10 and 11).

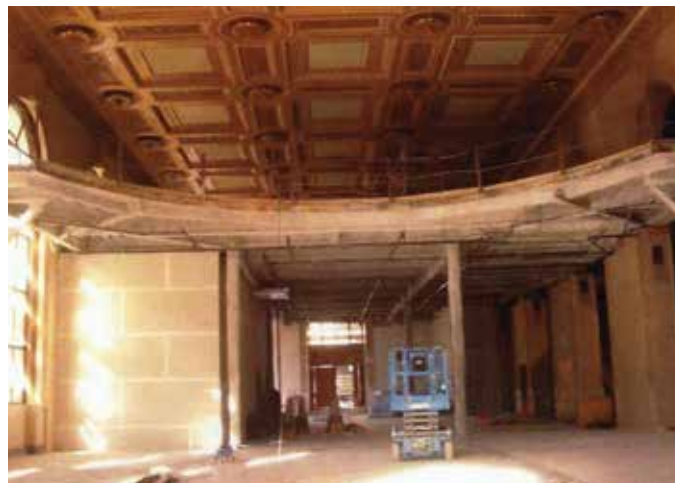
Figure 12. A mezzanine was added to the original banking hall of this 1921 former bank building as a seismic strengthening measure. Subdividing such an important character-defining space can result in a severe loss to a building's historic integrity.

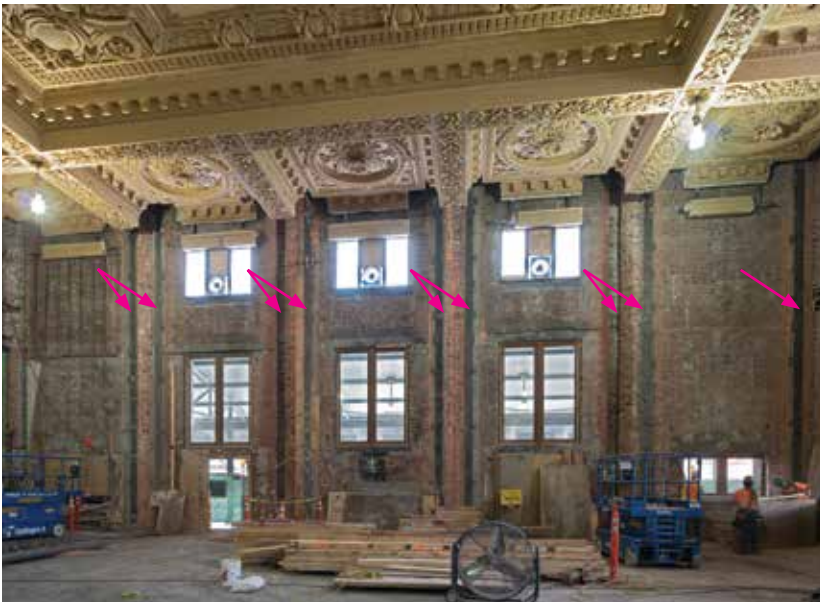
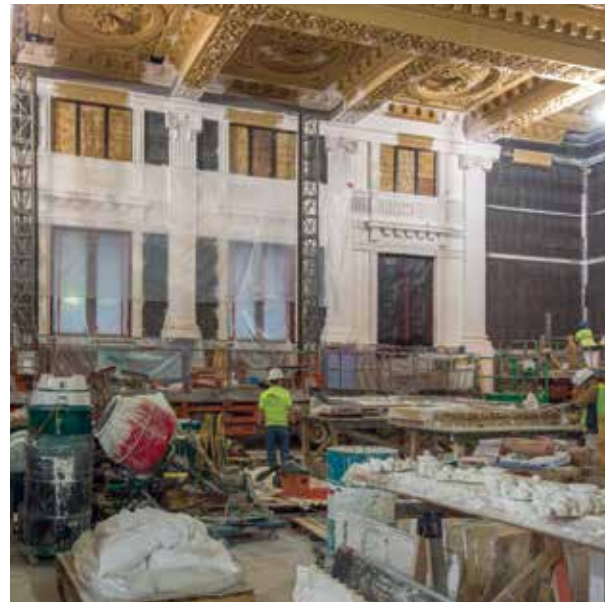
Figures 13-14. Vertical steel reinforcement members were inserted and grouted into the walls of the main waiting room in Seattle's historic 1906 King Street Railroad Station to strengthen them (top left). To replace the original plaster ornamentation, molds were made to cast new replacement plaster elements as shown on this work-in-progress photo (top right). Photos: John Stamets.

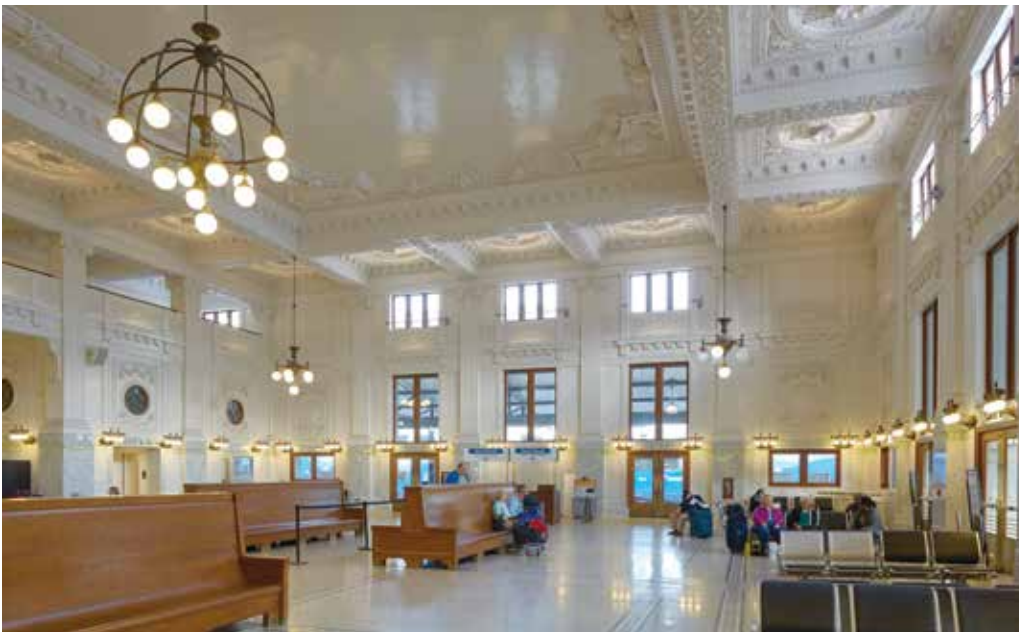
Figure 15. After completion of the seismic reinforcement, the replicated plaster ornamentation was installed and the decorative painted finishes restored, returning the waiting room of King Street Station to its historic appearance. Photo: Doug Scott.

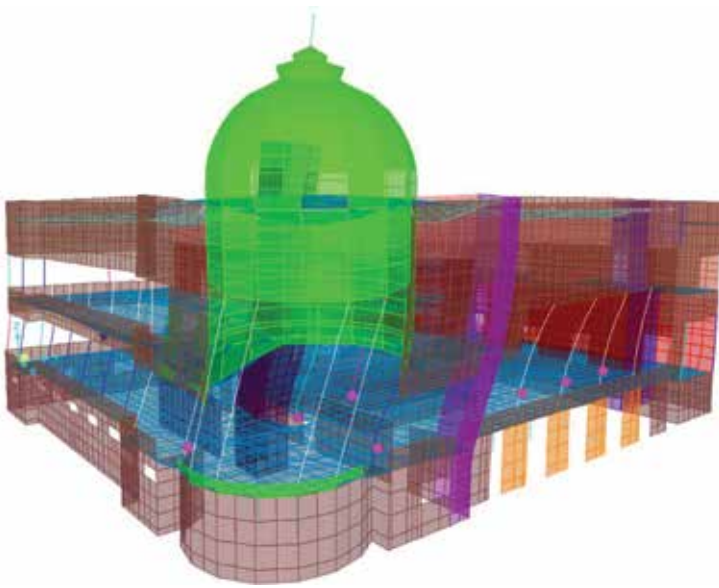
Figure 16. Computer modelling is a useful analytic tool that helps assess the strengths and weaknesses of a building and evaluate different seismic strengthening options. Three-dimensional dynamic analysis is required for a number of different structures located in certain seismic zones.

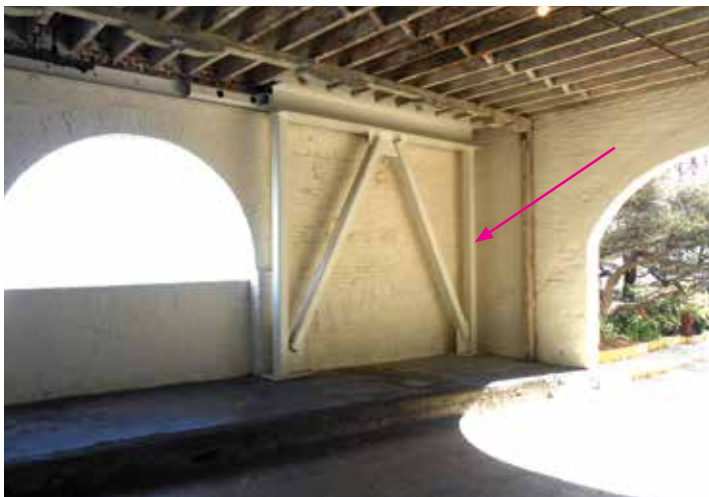
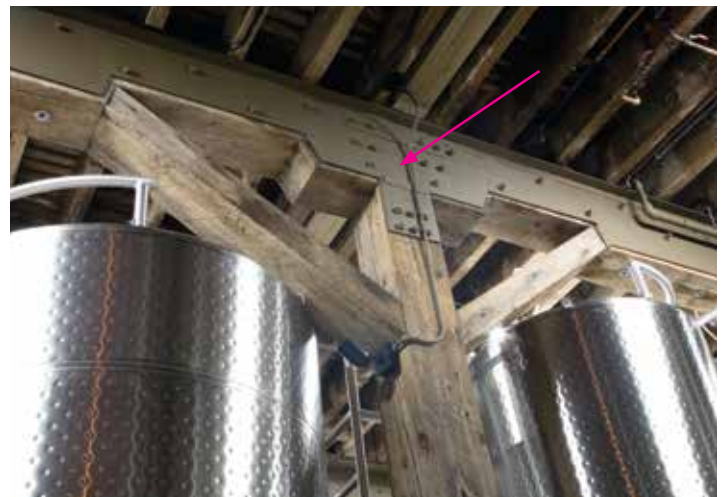
Figures 17 and 18. Careful placement of the new structural reinforcement, painted to match the surrounding building elements, if left exposed, minimizes its visual impact. New added structural elements may be left exposed when their visibility does not impair the historic character of the building. Figure 17 (left). Photo: Jason Hagin. Figure 18 (right). Photo: Architectural Resources Group.

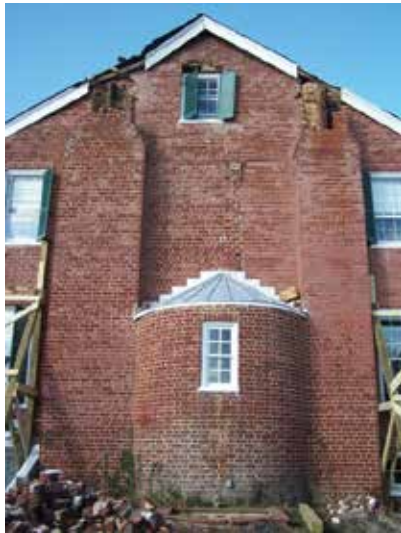
Figure 19. Chimneys are common nonstructural features susceptible to earthquake damage, even in zones of low-to medium-seismic activity as shown on this building

2011 earthquake.  
Photo: Suzanne Tripp.

Nonstructural components are all those elements other than the columns, bearing walls, floors, beams or trusses, bracing elements, foundation, and other elements that make up a building's structure (Figures 19-20). In the past, seismic rehabilitation of existing buildings has focused on mitigating structural deficiencies. However, nonstructural components represent a substantial portion of a building's initial capital investment; and, based on post-earthquake surveys, losses from nonstructural components also represent a high percentage of losses during an earthquake (see FEMA E-74: *Reducing the Risk of Nonstructural Earthquake Damage—A Practical Guide*).

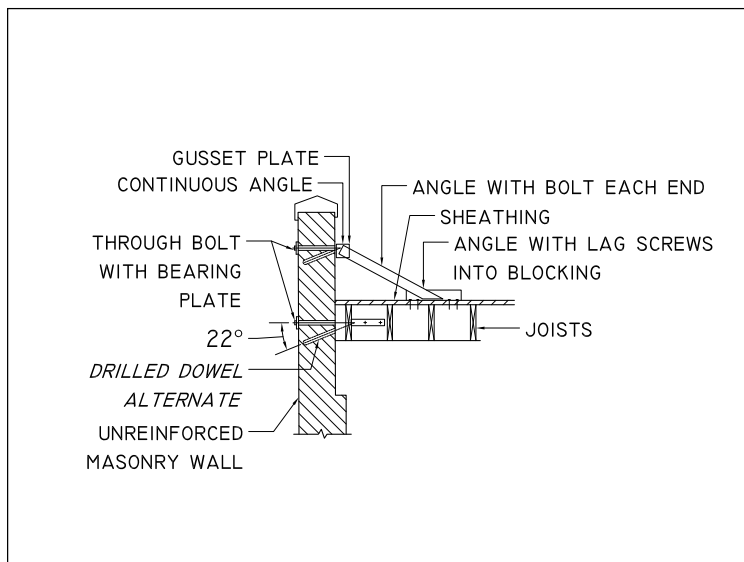
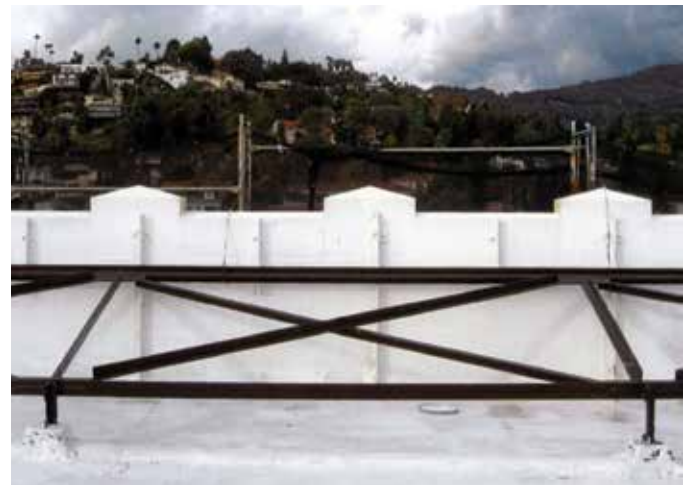
Figure 20. Bracing parapet walls, as illustrated in the typical detail drawing on the left, and as installed in the image on the right, helps avoid hazards from falling debris.

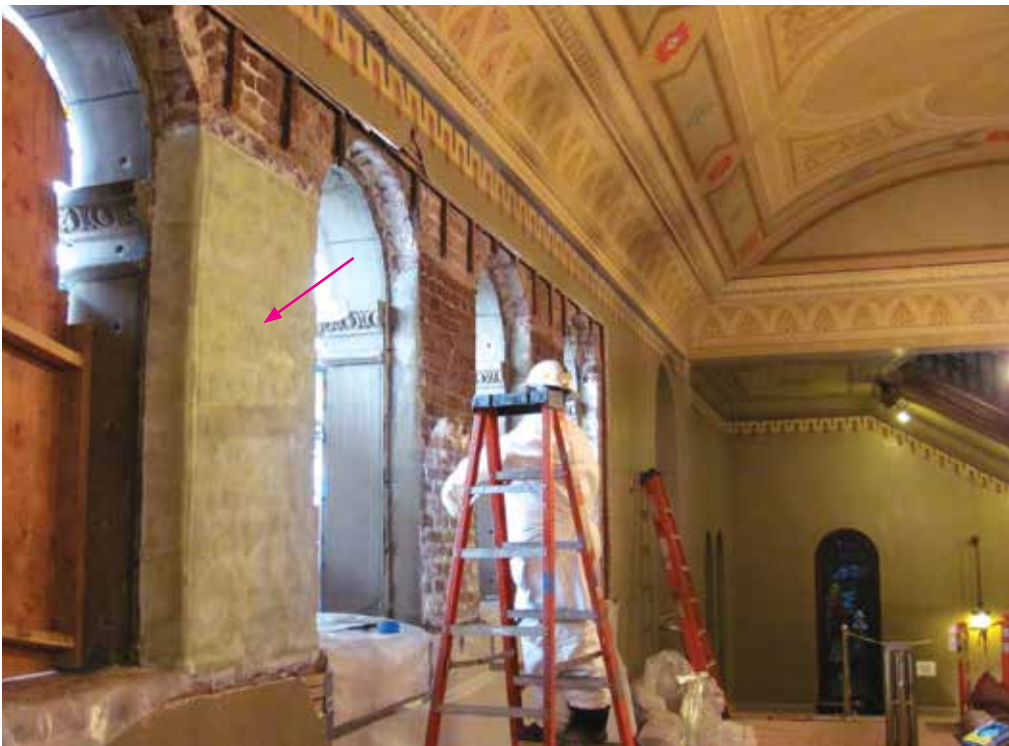
Figure 21. Epoxy-embedded fiberglass mesh is being bonded to the back of the brick pilasters of this 1906 unreinforced masonry building. New finishes matching the appearance and detailing of the original finishes will be applied over the mesh. Photo: Wiss, Janney, Elstner and Associates, Inc.

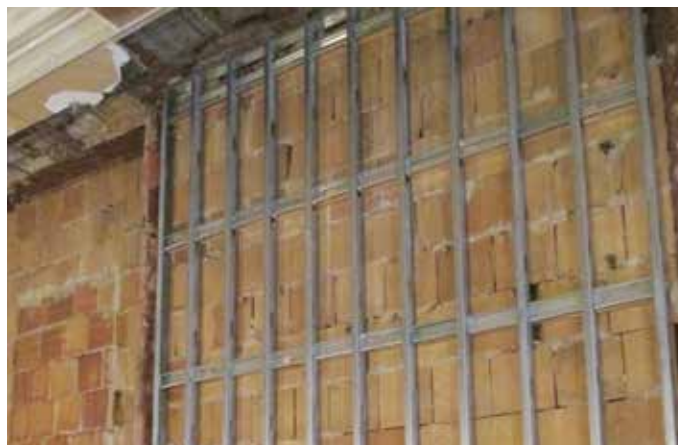
Figure 22. A new steel stud wall is being added to one side of this interior hollow-clay tile wall. The side with the least amount of historic finishes was chosen as the least disruptive location for the added reinforcement. The wall will be returned to its original appearance by installing new finishes matching the historic finishes. Photo: Wiss, Janney, Elstner and Associates, Inc.

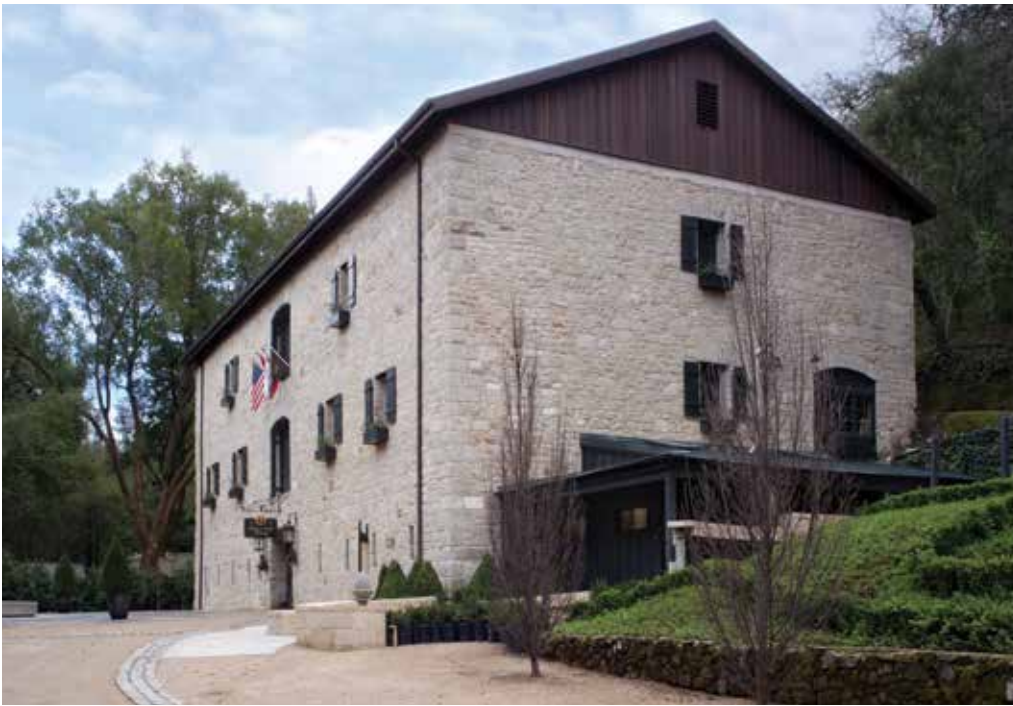
Figure 23. Historic wine cellar building in Napa, California.

The seismic rehabilitation of this historic wine cellar building shown in Figure 23 included center coring of the exterior stone walls to add steel reinforcement, as illustrated in Figures 24 and 25. The floors were tied to the steel reinforcement in the walls using eye bolts, as seen in Figures 26 and 27, eliminating the need for exterior washers or plates. Figure 23 Photo: Architectural Resources Group. Figures 24-27 Photos: MKM & Associates.

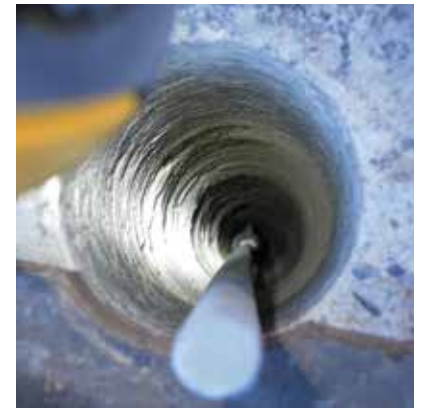
Figure 25. View of one of the center cores drilled down through the wall.

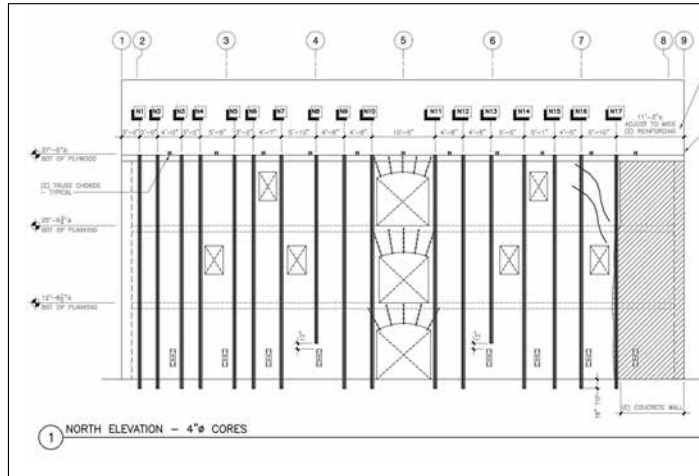
Figure 24. Drawing of the wine cellar's front wall showing the locations of the center cores for continuous steel reinforcement rods to be inserted and grouted in place.

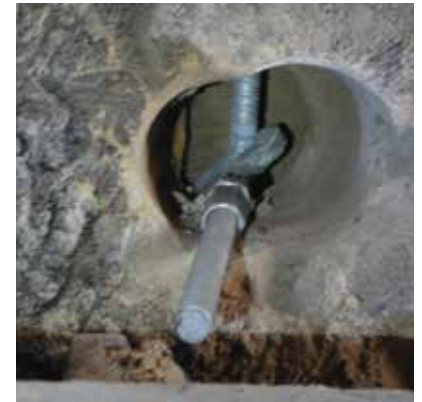
Figure 26. Eye bolts used to anchor the floor to the wall.

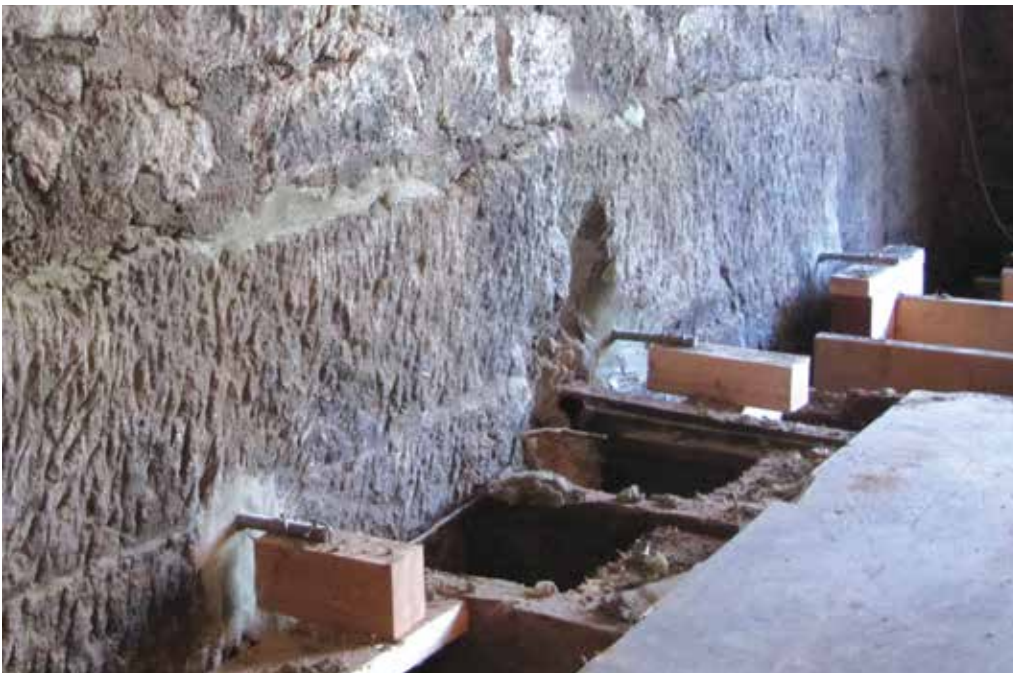
Figure 27. Location of the eye bolts after grouting

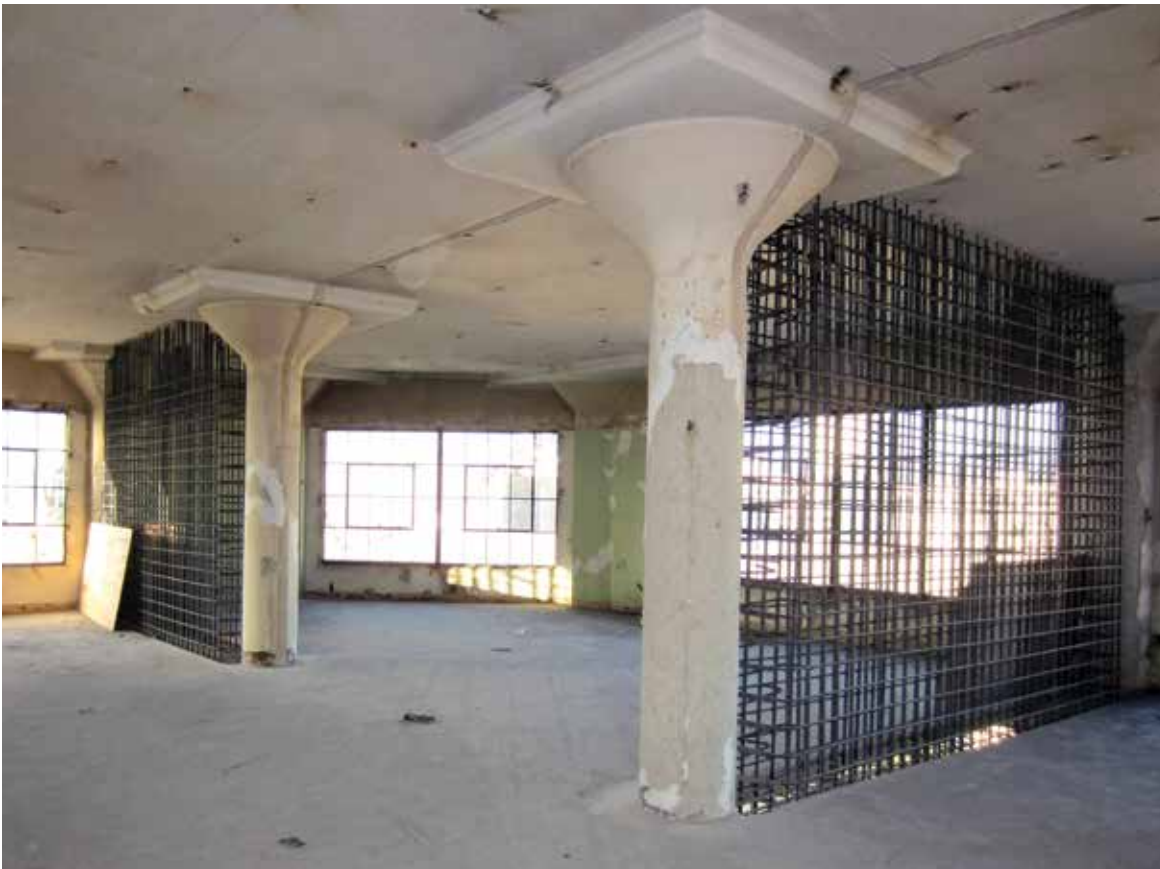
*Figure 28. Steel reinforcement for the new shear walls, perpendicular to the windows, is being installed in this concrete-frame building.  
Photo: Robert Chattel.*

systems of various types (flat slabs, two-way slabs, and beam-and-slab). Exterior and interior walls are often unreinforced masonry, commonly called infill, and are typically nonstructural, presenting the deficiencies described previously. The most important structural vulnerability of this construction type is the lack of ductility. Prior to 1960, building codes may not have required concrete-frame buildings to be designed and detailed for ductile performance (i.e., not fail when loaded beyond capacity) to resist lateral forces, depending on the region. Concrete-frame buildings were required to be “ductile” in the 1976 Uniform Building Code. In many historic concrete-frame buildings, because the connection between the columns and beams is not strong enough to resist the lateral loads during an earthquake, the buildings are in danger of collapsing. Particularly vulnerable buildings of this type are those with relatively few concrete walls and columns that are weaker than the beams or slabs. Mitigating this condition is typically accomplished by adding a new system, such as shear walls (Figure 28).

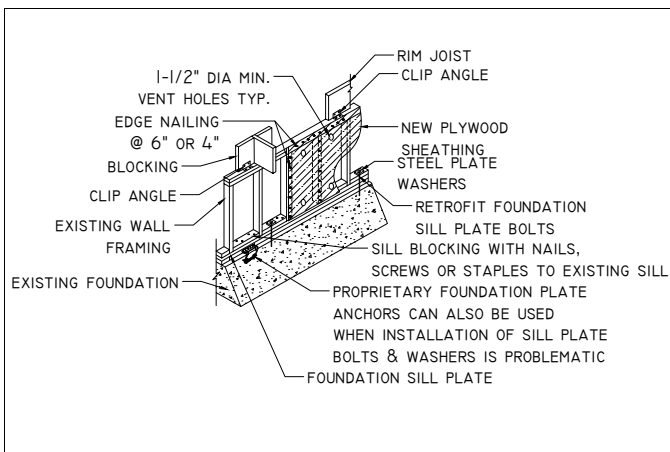
Figure 29. Cripple-wall reinforcement. Simple approaches such as nailing plywood between crawlspace studs, bolting sill plates to the foundation, and strapping the cripple wall to the floor above can make a dramatic difference in protecting a building from seismic damage.

Unbraced cripple walls and poor foundation anchorage are common vulnerabilities in many one-and two-family detached dwellings of one or more stories. In these buildings, interior walls usually provide sufficient bracing to resist lateral loads during a seismic event, but the crawlspace often only has perimeter framing which may become highly stressed and collapse during an earthquake. Adequate anchorage to the foundation in wood-frame dwellings prevents them from sliding off their foundation. Mitigating the lack of adequate bracing of cripple walls and proper foundation anchoring are high priority seismic rehabilitation measures in light wood-frame buildings (Figure 29).

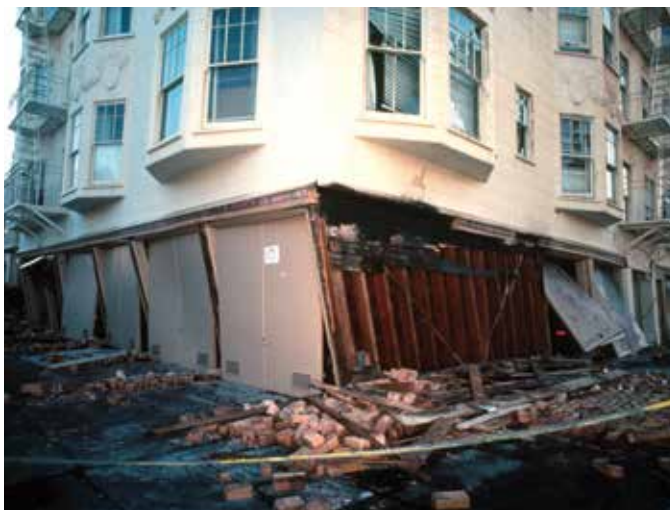
Figure 30. Large perimeter openings and a limited number of interior partitions on the ground floor can create a “weak story” condition that makes buildings particularly vulnerable to earthquake damage. Photo: USGS.

type that is also very susceptible to damage during earthquakes. The upper floors of these buildings typically have a repetitive interior layout which gives them uniform strength and stiffness. The lower floors however, because they typically have larger exterior openings and may have more varied interior configurations and large open spaces, often create a “weak story” condition (Figure 30).
