TRUMAN HOME HARRY S TRUMAN NATIONAL HISTORIC SITE Independence, Missouri

PRESERVATION Tech Notes

EXTERIOR WOODWORK

Paint Removal from Wood Siding

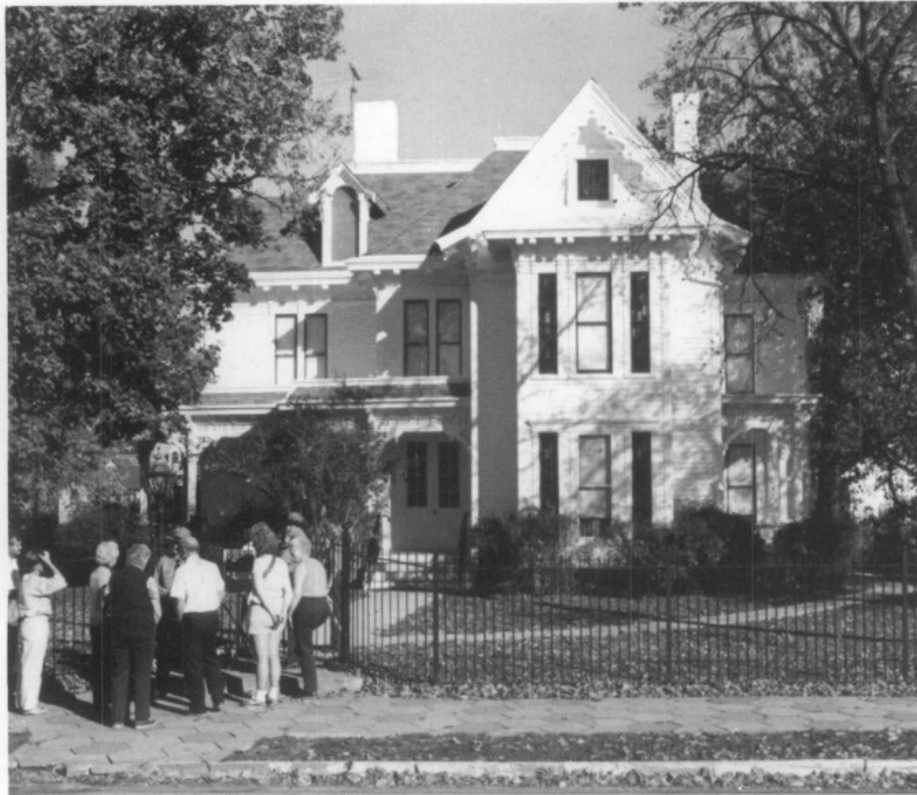
Harry S Truman National Historic Site anchors one end of a local historic residential district in the city of Independence, located just east of Kansas City, Missouri. The Truman home was constructed in three major phases. The initial pre-Civil War construction is believed to have consisted of a simple two-story rectangular structure. Major additions in 1867 and 1884 enlarged the building to 15 rooms, totaling approximately 4000 square feet. Characteristic of the early Queen Anne style, the wood-sided exterior of the 2½ story frame home was embellished with over 200 wooden brackets, decorative jig-sawn porch frieze boards, and layered cornice mouldings.

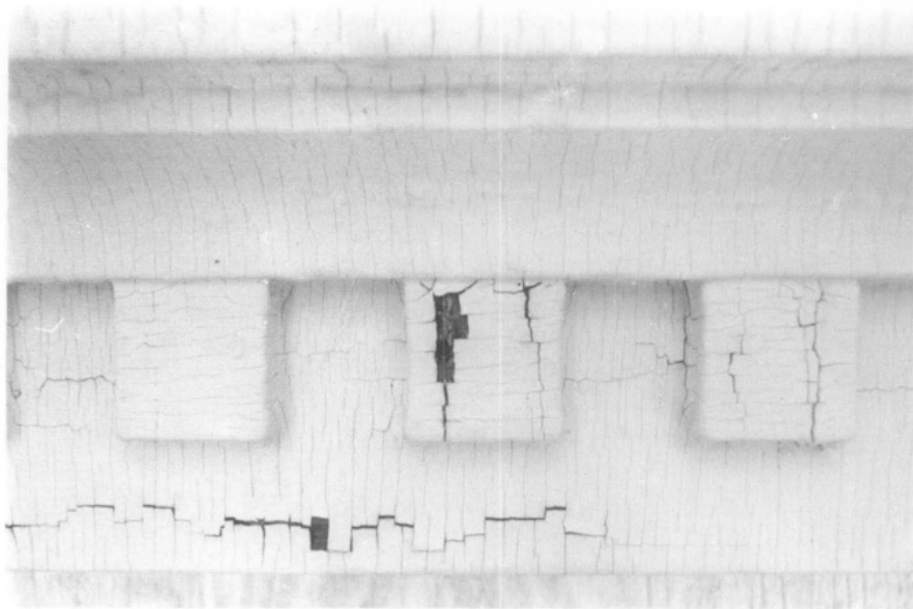
Examination of the exterior paint finishes in areas directly exposed to the elements revealed severe paint film failure, including cross-grain cracking, alligatoring, and peeling (see figure 1). Even in places shielded by porches and cornices, moderate paint film failure had occurred. A number of exposed areas, including soffits, fasciae, and siding, experienced near total paint failure due to recurrent moisture penetration from deteriorated roofs and built-in gutters. Windows were also in very poor condition; many exhibited loose glazing, broken glass and rotted sash. More than 20 coats of paint concealed deteriorated woodwork and cladding from direct examination. On much of the projecting mill work, the final layers of paint had been applied so heavily that stalactites in excess of one-quarter inch were apparent due to paint dripping.

Figure 1. Detail of a cornice dentil shows the severe cracking and failure of paint finish. Photo: Alan O'Bright

bathroom causing the paint to peel off in hand-size sheets. It was clear the exterior finishes had lost most, if not all, of their elastic integrity. In order to achieve a sound surface for painting, the decision was made to remove a majority of the exterior paint finishes to bare wood in preparation for a three-coat paint application.

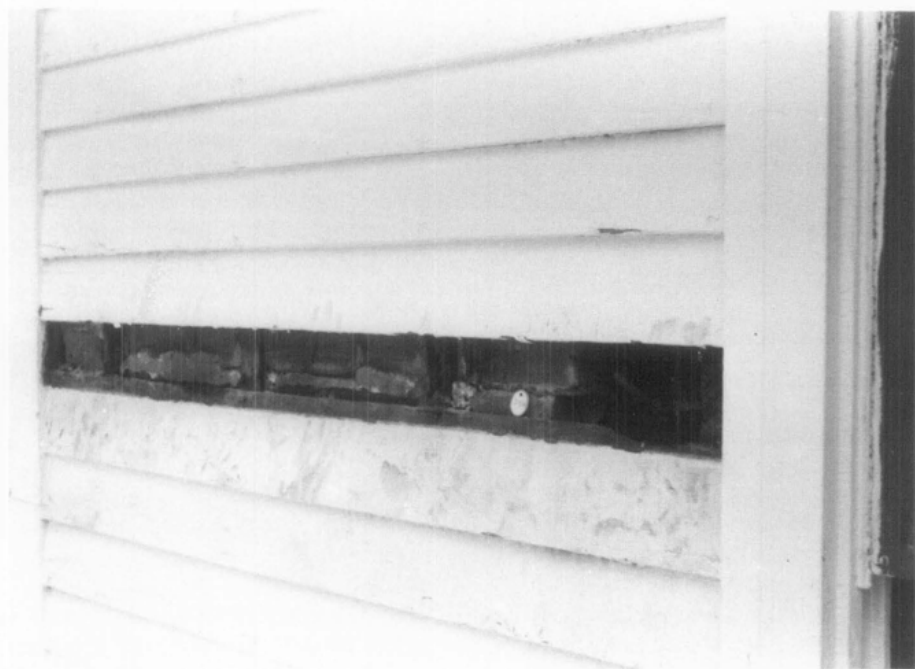
As part of the planning required before the selection of the paint removal method, a physical investigation was conducted of the exterior structure to determine the method of construction and condition (see figure 2). This is particularly critical whenever paint removal is planned. Decisions as to which paint removal methods will be used—especially methods involving heat—are in part guided by the potential flammability of the wall material and debris in the wall cavity and cornices. Sections of lapped siding were carefully removed and the underlying board sheathing cut with a hole saw to reveal the wall cavities. Fortunately, the bulk of the balloon-framed structure was found to be in good condition and the project team believed that potential fire risks could be minimized. With the exception of the 1884 addition, all wall cavities had been filled from foundation sill to soffit with soft brick and mortar.

Figure 2. In assessing the safety of using thermal heat to remove paint from the siding, an investigation was performed to determine wall construction and condition. In this portion of the structure, there was no sheathing backing the siding but brick nogging extended from the foundation to the soffit. Photo: Alan O'Bright

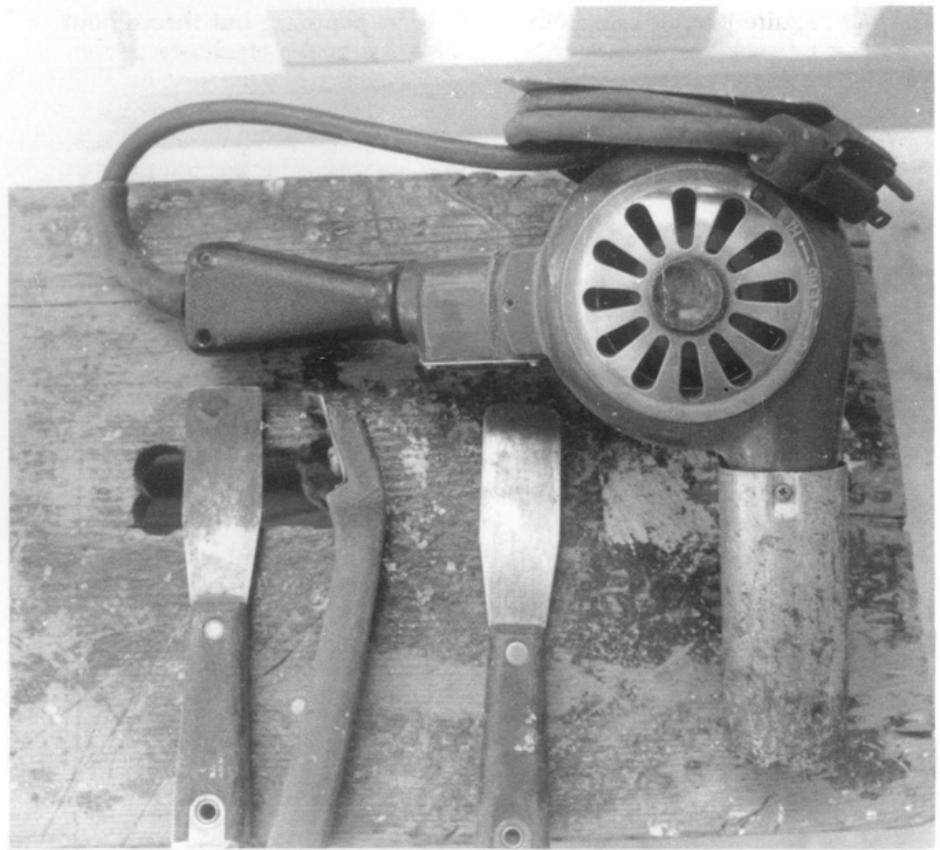
A heavy-duty heat gun was approved for the contractor's use (see figure 3). The metal encased unit featured variable heat control (500-750° F) through adjustable side vents, and a cool down switch, which extends the life of the replaceable heating elements. Since these elements can have a working life as short as 60 to 80 hours, extra elements were purchased and were available at the site for immediate replacement of those in the five heat guns used in the project.

Figure 3. Heat guns, putty knives with corners rounded, and paint scrapers were used in paint removal. Photo: Michael Lee

During paint removal the scraped paint tended to adhere to the putty knife, slowing the paint removal process. The workers tried several putty knives and scrapers, but none was successful in shedding the paint residue from the blade. Therefore, the knives had to be periodically cleaned of gummed paint with another putty knife. For siding, a 2 to 2½ inch-wide rigid putty knife worked best. Narrower blades were used for millwork and tight spots. To reduce chances of the workers gouging the wood with the putty knives, the edges of the blades were rounded using a grinder.

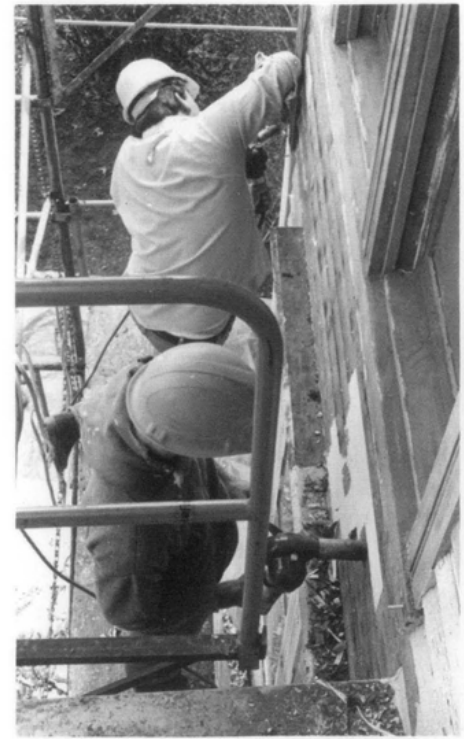
Figure 5. Using scaffolding, workers remove the paint with heat guns. Cracked or deteriorated siding was repaired or replaced. Photo: Alan O'Bright

The siding was inspected for rot and cracks, and suspect sections were marked for repair or replacement. The marked sections were passed over in the paint removal process.

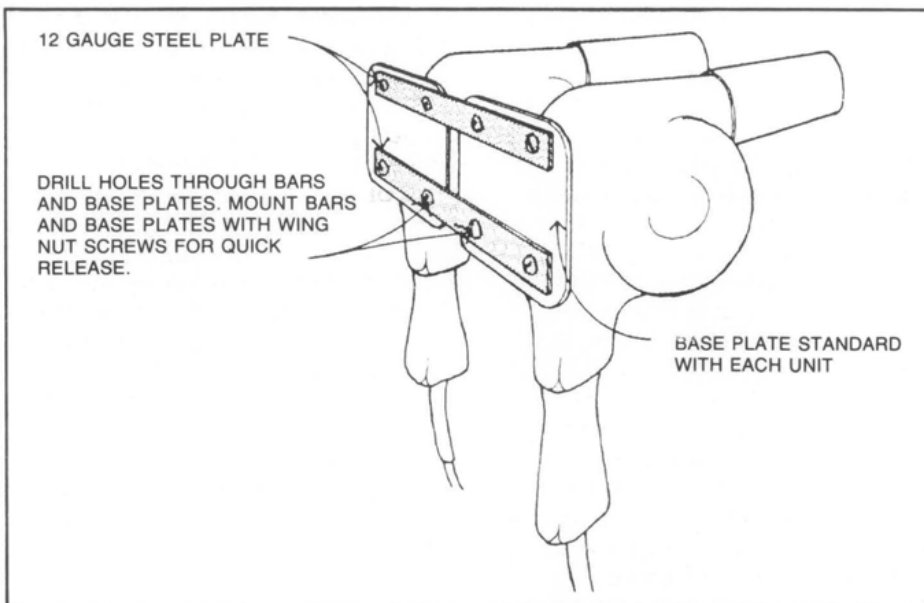
worker alternately heated and scraped the surface. Time was lost in this method because the heat gun had to be set down periodically in order for the worker to clean his putty knife. The second technique, developed by the contractor's site supervisor, was to fasten two heat guns together side by side using metal bars bolted to each gun base (see figure 4). In this way one worker heated the surface while another scraped in a continuous process. This method worked very well for expansive areas of siding and attained an average rate of 8 to 10 square feet per crew hour. On siding in tight areas where one worker operated a single heat gun, paint was removed at a rate of approximately 4 square feet per crew hour (see figure 5).

Figure 4. Method used to join two heat guns for simultaneous use. Drawing: Alan O'Bright

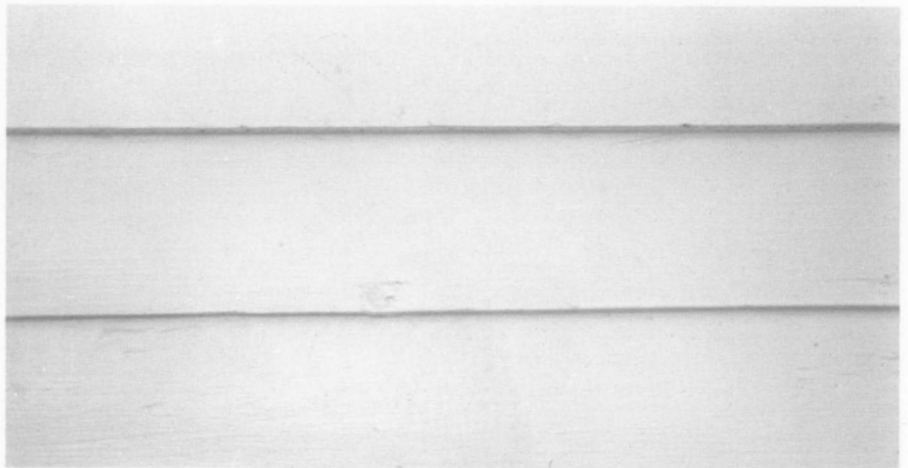
Areas on the Truman home where paint was removed with the heat guns and then lightly sanded provided an excellent painting surface (see figure 6). By using workers experienced with thermal removal of paint, very few scraper tool marks were left that were noticeable. The new paint bonded well to the wood

Figure 6. A typical section of the finish painted siding shows that little damage was done in removing the paint. Photo: Michael Lee
