# Tech Notes

## MUSEUM COLLECTION STORAGE

### FORT PULASKI NATIONAL MONUMENT

### Museum Collection Storage in an Historic Building Using a Prefabricated Structure

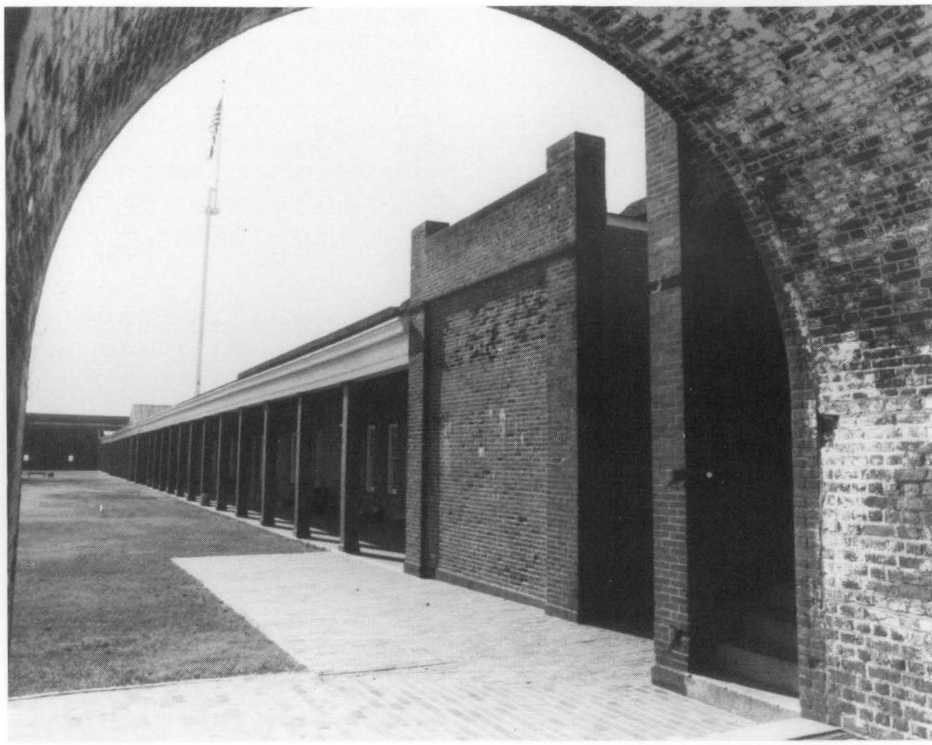
**Figure 2.** View from one of the open casemates, looking across a portion of the parade ground. The piazza provides a covered access to the enclosed casemates which flank the sally port. It was one of these enclosed casemates (each has a door and one or two windows) that was selected to house the museum object storage facility.

The park staff decided to install within a casemate a free-standing structure that could maintain the appropriate environmental conditions necessary to preserve the collection (see figures 1 and 2). They considered both retrofitting a casemate using conventional construction methods and assembling a prefabricated structure within a casemate. A prefabricated thermally efficient structure was selected because of easy assembly, lower cost, minimal physical and visual impact on the structure, high insulation characteristics, and ease of future removal. With the assistance of the author and the staff curator of the National Park Service, Southeast Regional Office, the park staff assembled a museum storage facility within an historic casemate utilizing a commercially available prefab building system (see figure 3).
