**DELINEATION OF POTENTIAL JURISDICTIONAL WETLANDS  
AND “OTHER WATERS”**

**GIACOMINI WETLAND RESTORATION PROJECT**

**MARIN COUNTY, CALIFORNIA**

**January 28, 2005**

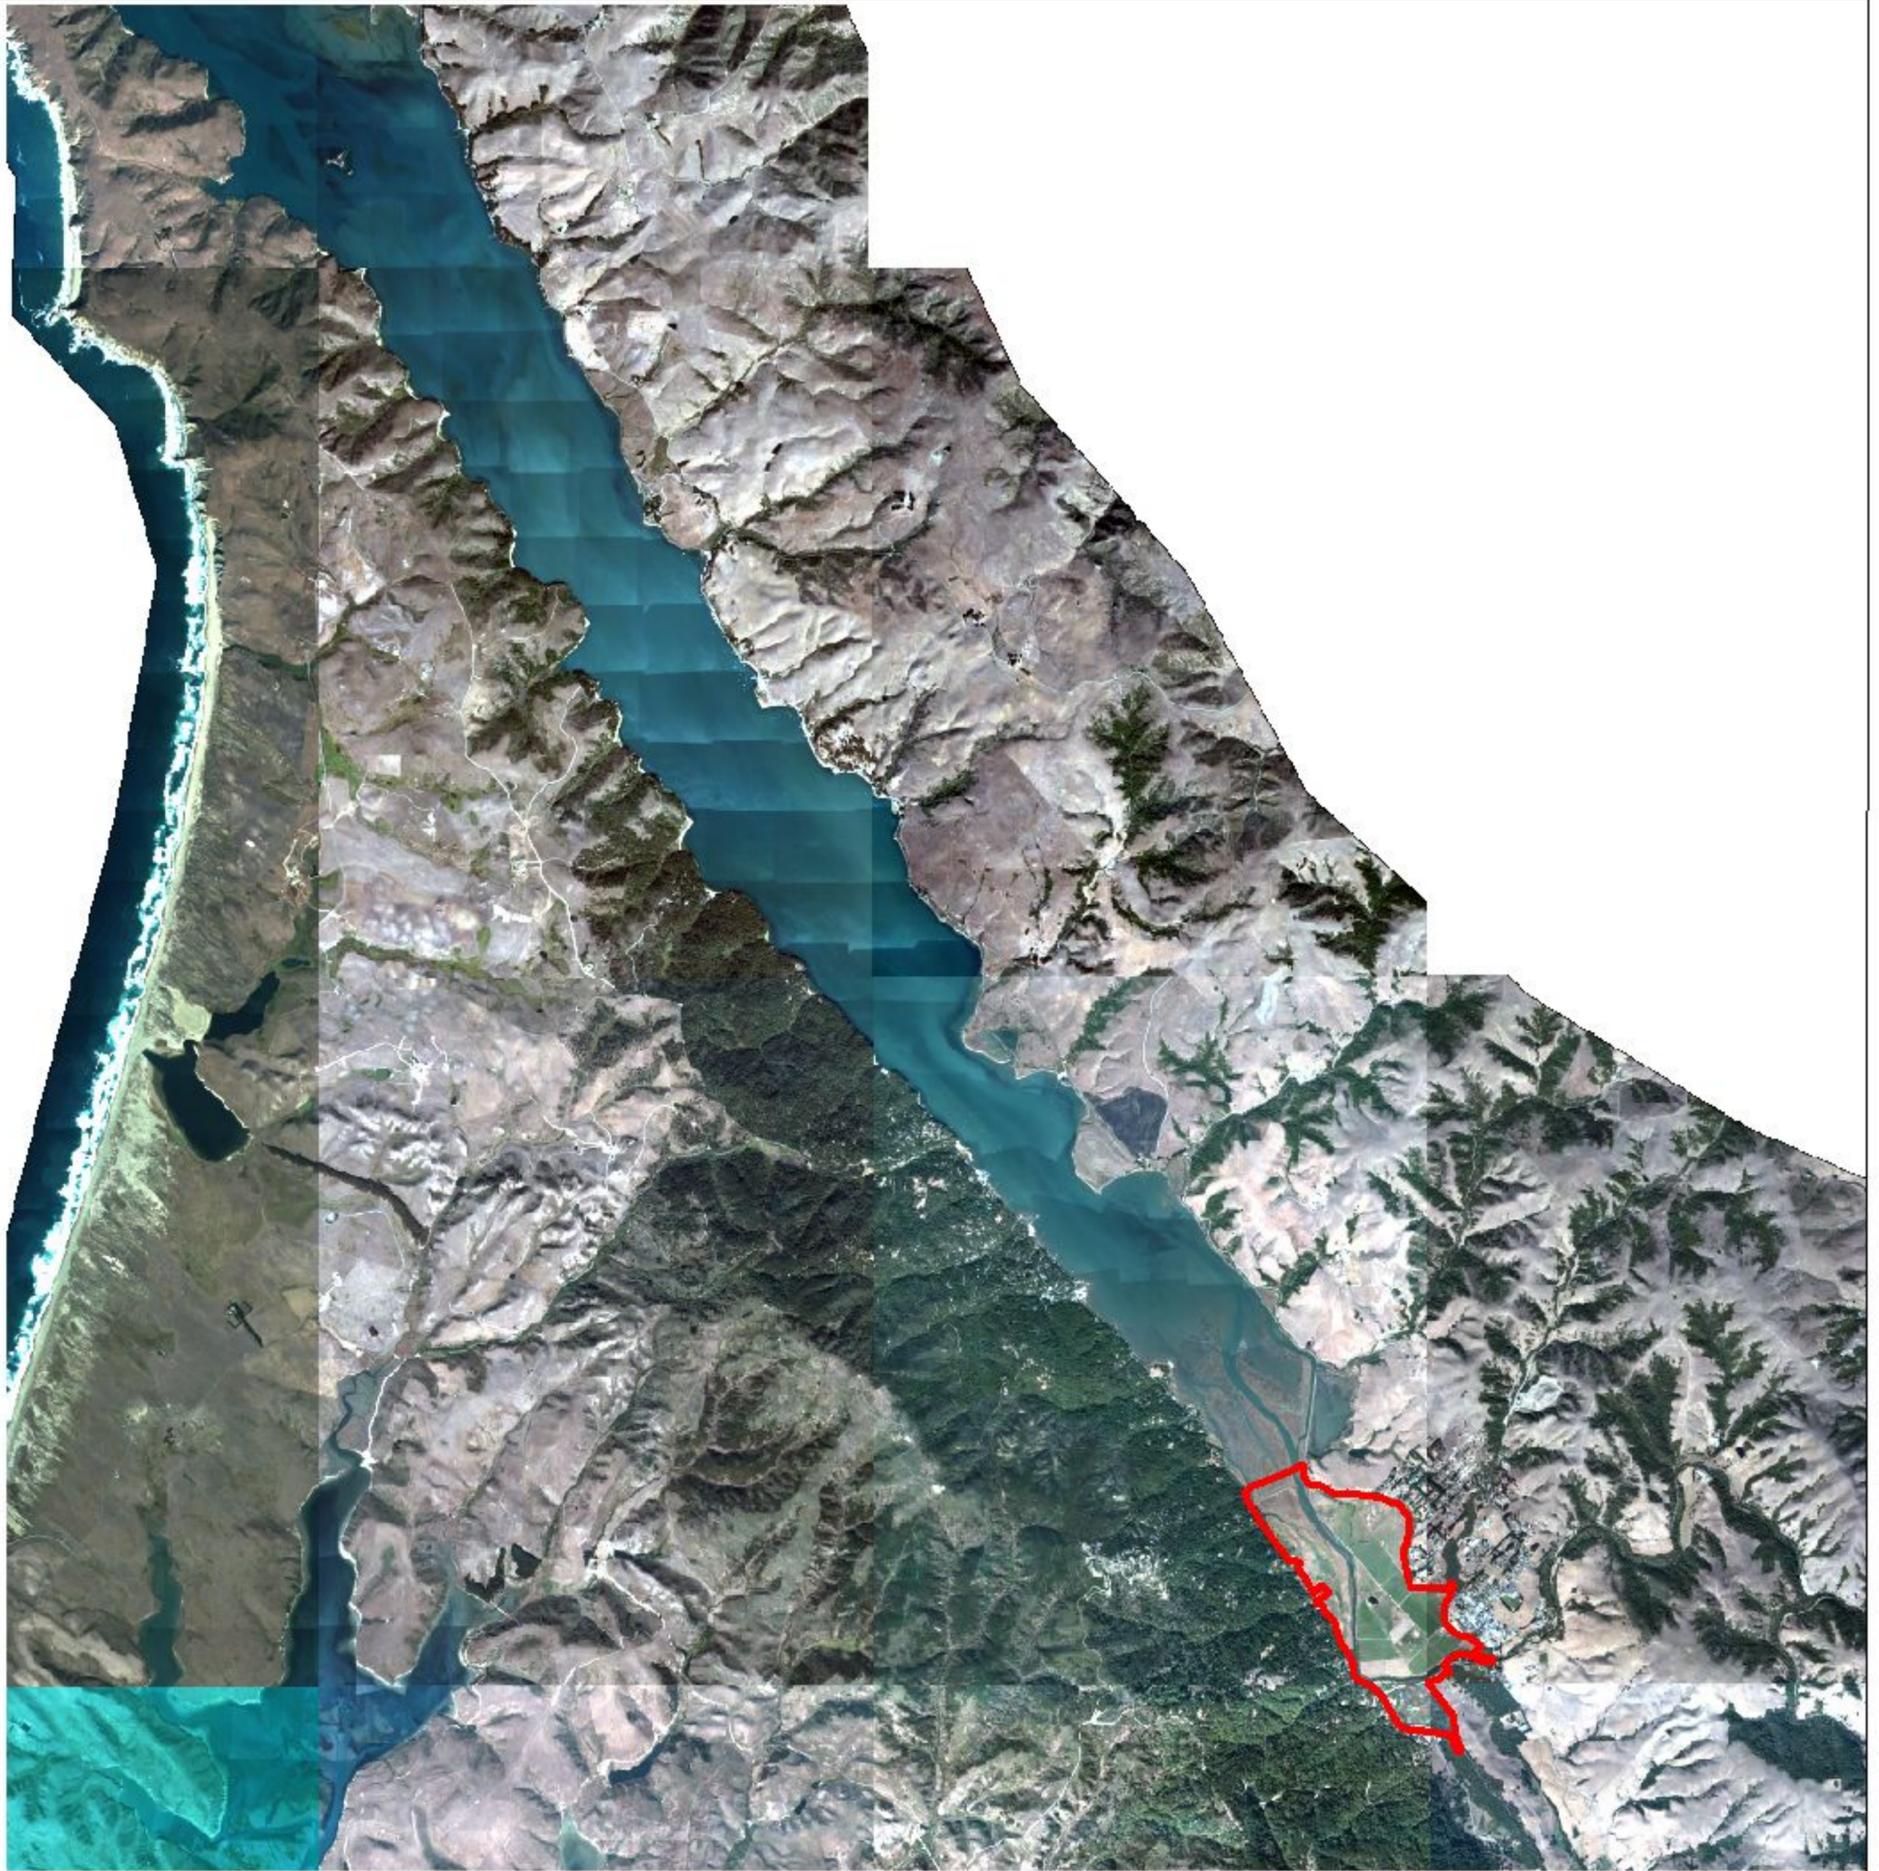
Figure 1. Location of Giacomini Wetland Restoration Project in southern Tomales Bay.

The Project Area is located in the southern portion of the Tomales Bay watershed in the county of Marin west of the town of Point Reyes Station and east of the town of Inverness Park (Figure 1). It incorporates the Giacomini Ranch proper, Olema Marsh, portions of Levee and Bear Valley Road, and undiked marsh areas directly adjacent to the Giacomini Ranch. The Delineation Study Area expands the Project Area by including areas directly adjacent that might be impacted by restoration activities (Figures 1 and 2). The goal of this study was to map and describe areas within the Delineation Study Area under federal jurisdiction pursuant to Section 404 of the federal Clean Water Act and Section 10 of the Rivers and Harbors Act.

The Park Service is proposing a 563-acre wetland restoration project at the Giacomini Ranch and Olema Marsh in the southern end of Tomales Bay in Marin County, California (Figure 1). The Park Service acquired the 563-acre Giacomini Ranch in February 2000 through a combination of Congressional appropriations and funding from the California Department of Transportation (CalTrans). The Giacomini Ranch is located in the north district of the Golden Gate National Recreation Area (GGNRA), which is administered by the Seashore. The Giacominis have been operating a dairy ranch on this property since the 1940s when they constructed levees on Lagunitas Creek and, later in the 1960s, Tomasini Creek. Prior to that, the mouth of the Tomales Bay watershed was largely a combination of subtidal and intertidal habitat, with the latter increasing substantially after the 1860s due to increased sedimentation caused by watershed disturbances such as logging, agriculture, etc. As part of the purchase agreement with the Giacominis, the Giacomini family was granted a reservation of use agreement until 2007 on

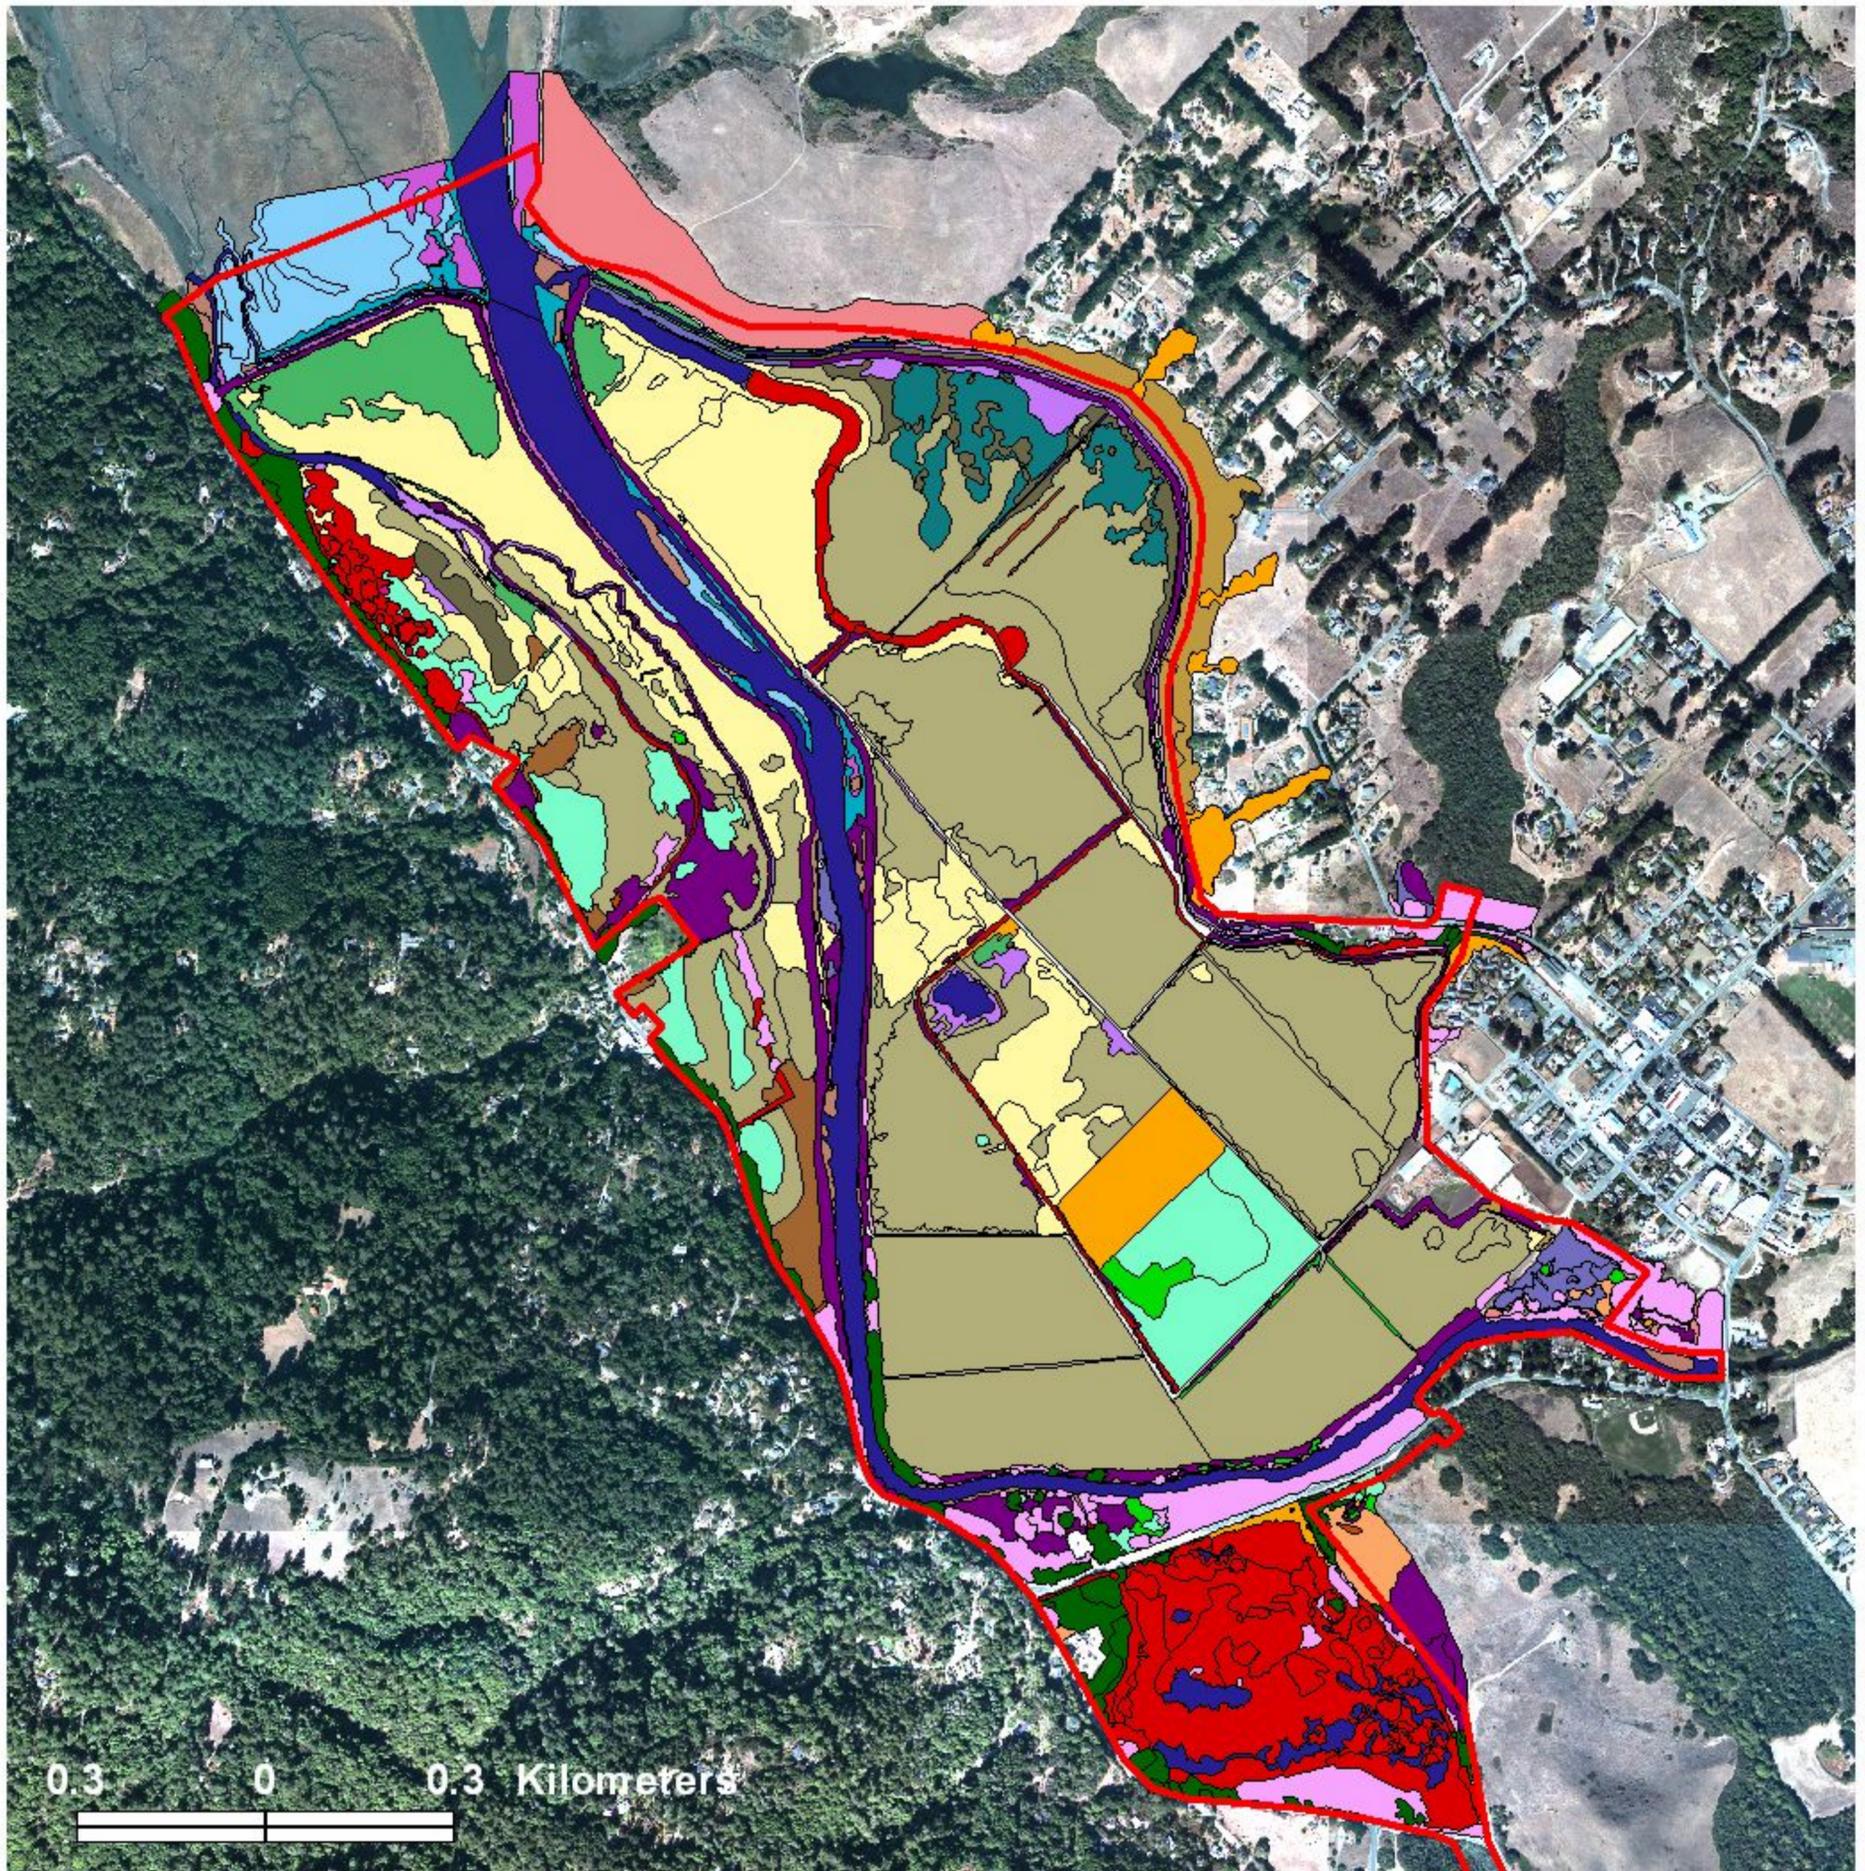
Figure 5. Vegetation sub-alliances or habitat types within the Giacomini Wetland Restoration Project Delineation Study Area.

the halophytic grass, saltgrass (*Distichlis spicata*) and other halophytic herbs such as alkali heath (*Frankenia salina*), as well as pastoral grasses such as creeping bent grass (*Agrostis stolonifera*) and rough blue grass (*Poa trivialis*; Figure 5). Scrub-shrub and Forested Riparian communities primarily occur along the western boundary of the West Pasture, the southern portion of Lagunitas Creek; Wildlife Conservation Board lands near White House Pool and the Green Bridge; the western and southern edges of Olema Marsh; and along limited portions of Tomasini and Fish Hatchery Creeks and other small drainages (Figure 5). Grazing has eliminated riparian habitat along most of the drainages within the pastures themselves. Outboard of the Lagunitas Creek levee and downstream of the Giacomini Ranch, the predominant vegetation communities are Tidal Salt Marsh, Tidal Brackish Marsh, and, to a lesser extent, Moist Grassland (Figure 5). Olema Marsh supports extensive patches of Freshwater Marsh comprised principally of cattails (*Typha angustifolia*) and tules (*Scirpus californicus* and *acutus*) and was at least once considered the most extensive freshwater marsh in Marin County (Shuford and Timossi 1989; Figure 5).

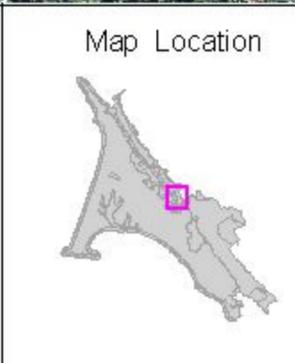
Vegetation Sub-Alliances

Coyote Brush Coastal Scrub	Riparian
Diked Brackish Marsh	Salt Marsh Pasture
Diked Salt Marsh-High	Scrub-Scrub Riparian
Diked Salt Marsh-Mid	Seasonal Wetland
Diked Salt Marsh-Midflat/Pan	Tidal Brackish Marsh
Distributed	Tidal Salt Marsh-High
Dry Grassland	Tidal Salt Marsh-High/Upland
Dry Pasture	Tidal Salt Marsh-Low
Forested Riparian	Tidal Salt Marsh-Mid
Freshwater Marsh	Unvegetated
Marine Coastal Scrub	Vertical Marsh
Moist Grassland	Wet Meadow
Moist Meadow	Wet Pasture
Open Water

This hydrologic complexity undoubtedly accounts for the wide variety of wetland habitats present in the Delineation Study Area, including freshwater marsh, vernal marsh, seasonal wetland, wet meadow, tidal/diked salt marsh, tidal/diked brackish marsh, moist grassland, scrub-shrub riparian, and forested riparian (Parsons and Allen 2004; Figure 5). Even some of the limited coastal scrub habitat present incorporates a mesic component, with perennial or seasonal seep flow on the Point Reyes Mesa creating a unique vegetation community dominated by both arroyo willow (*Salix lasiolepis*) and coyote brush (*Baccharis pilularis*). Approximately 50 percent of the Giacomini Ranch has been mapped as Wet Pasture (Figure 5). Wet Pasture is managed grassland dominated by grasses and herbs that are predominantly facultative or obligate hydrophytes or wetland species. Lower elevation portions of the West Pasture and a smaller portion of the East Pasture also incorporate another vegetation community, Salt Marsh Pasture, that supports

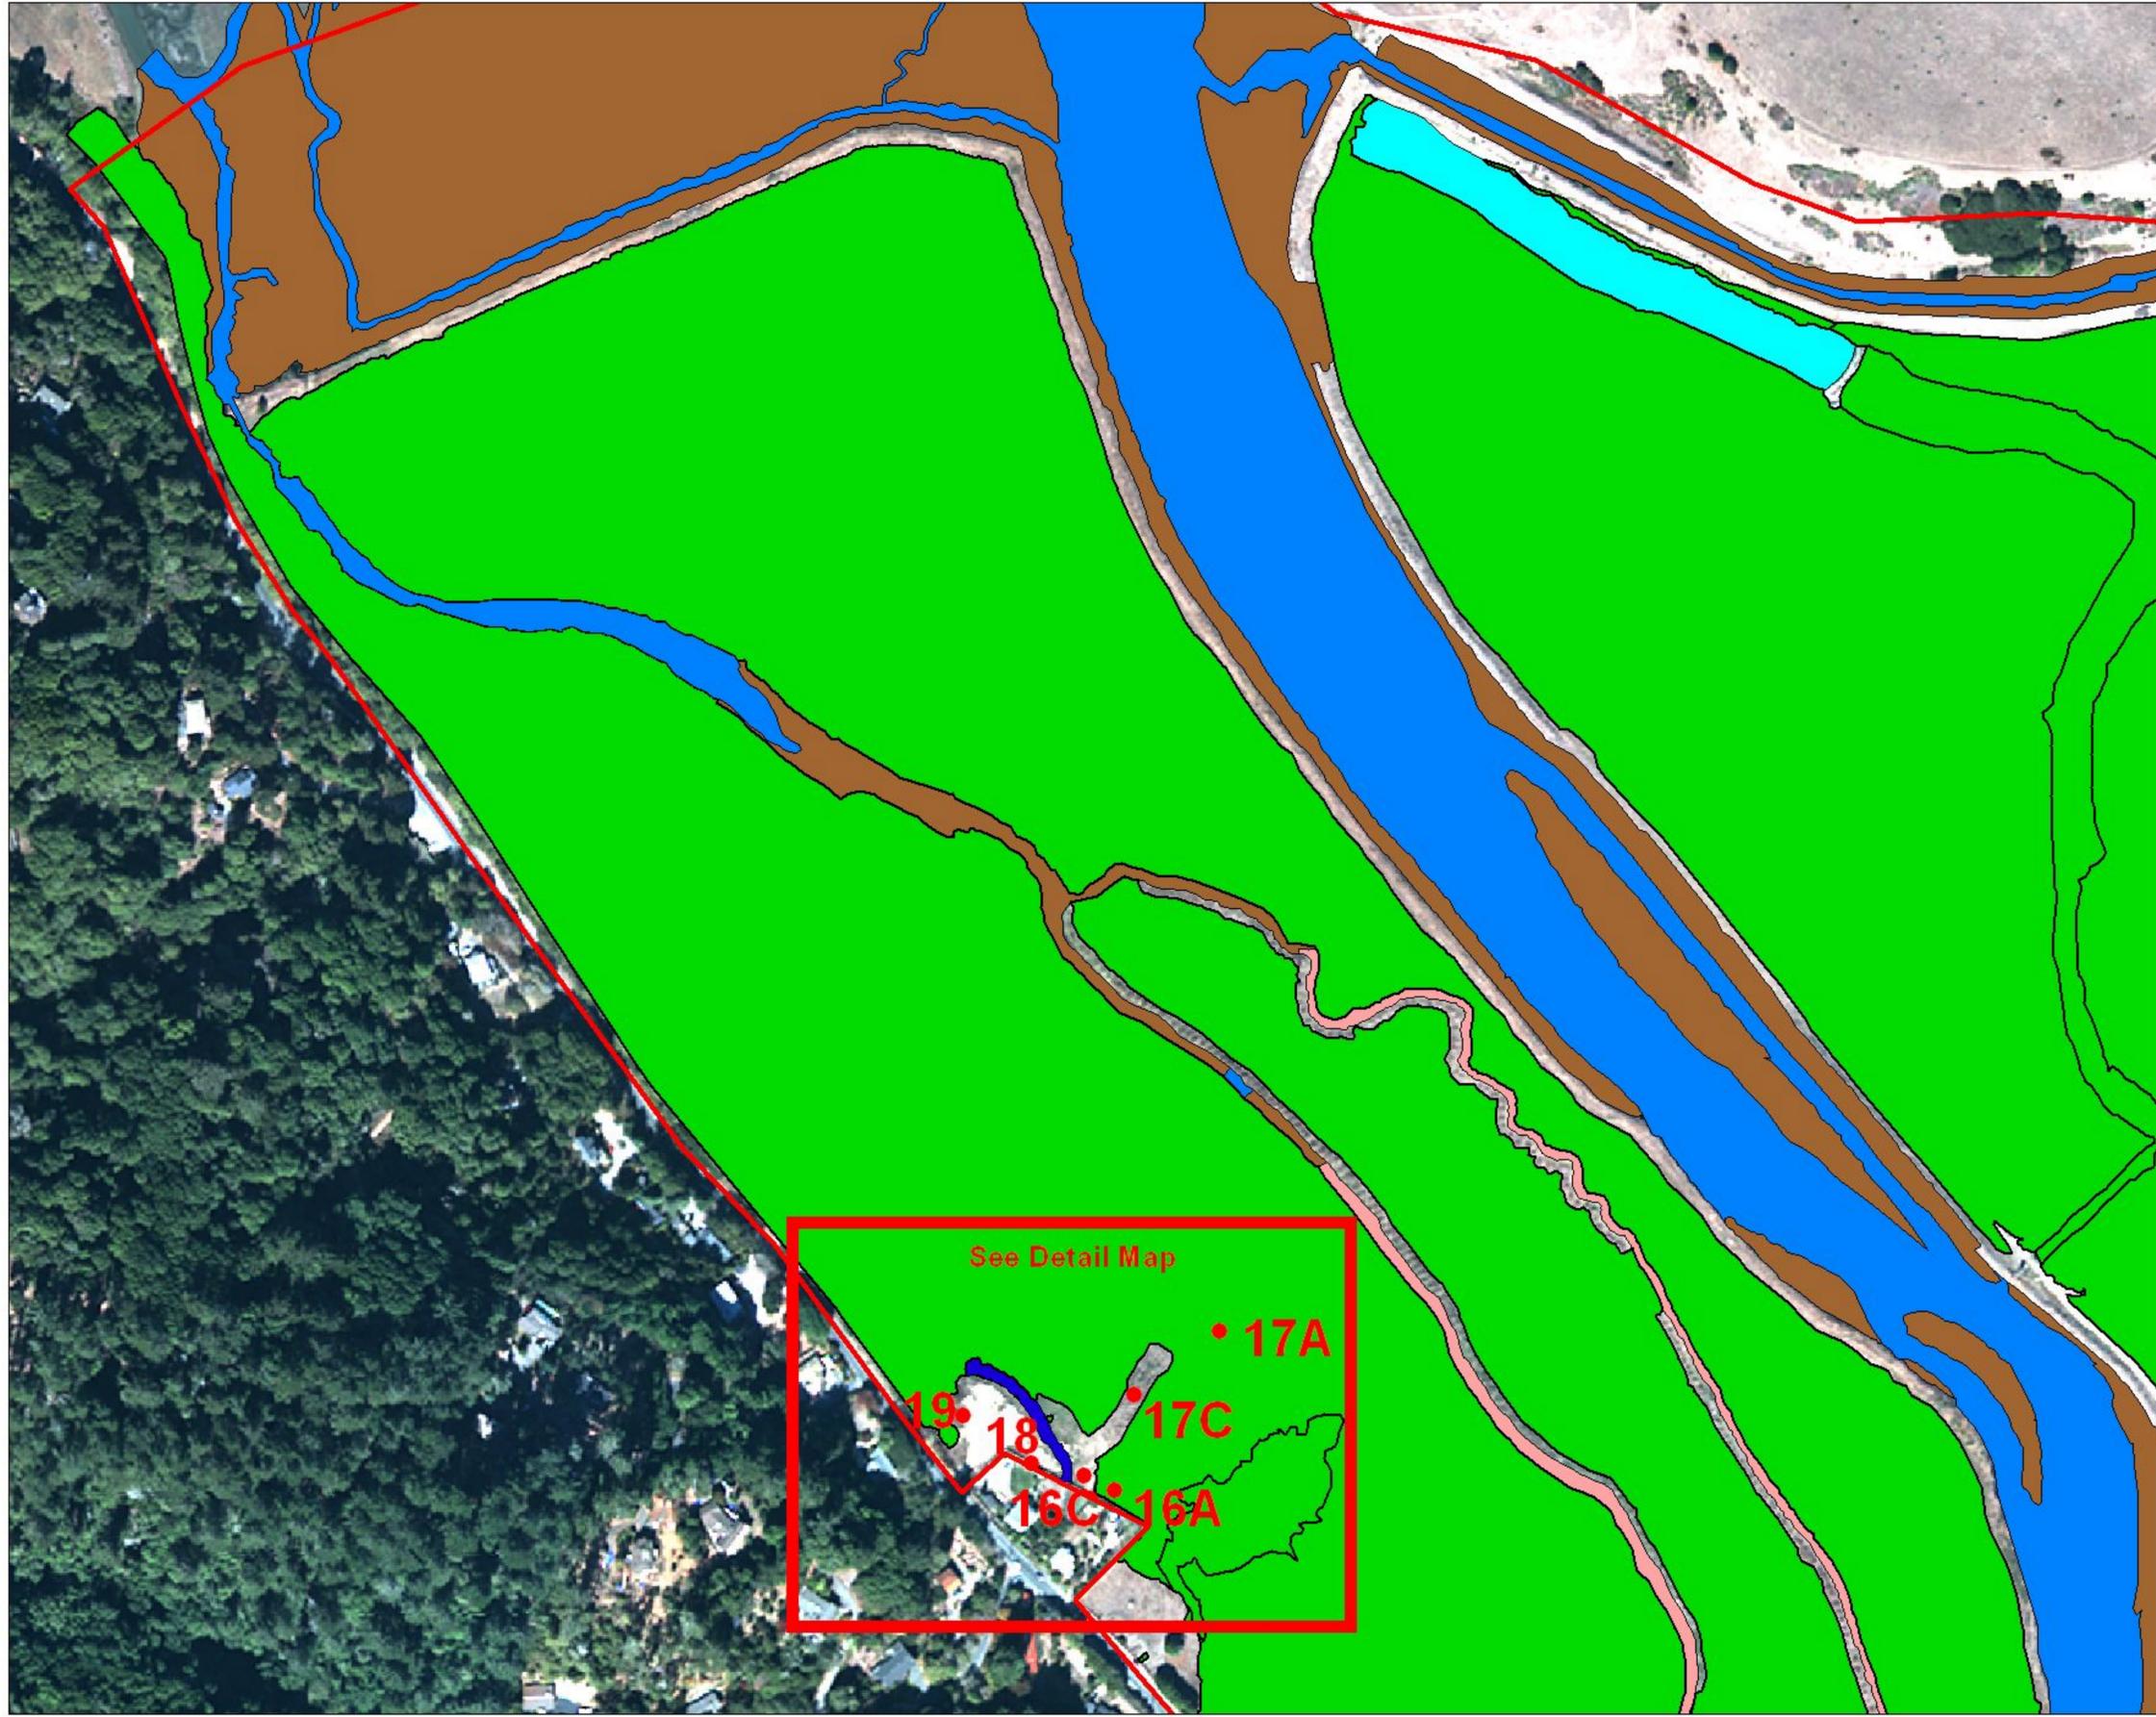
Figure 9. Potential jurisdictional Section 404 wetlands and "other waters" in the northwest portion of the Giacomini Ranch's West Pasture - Giacomini Wetland Restoration Project Delineation Study Area.

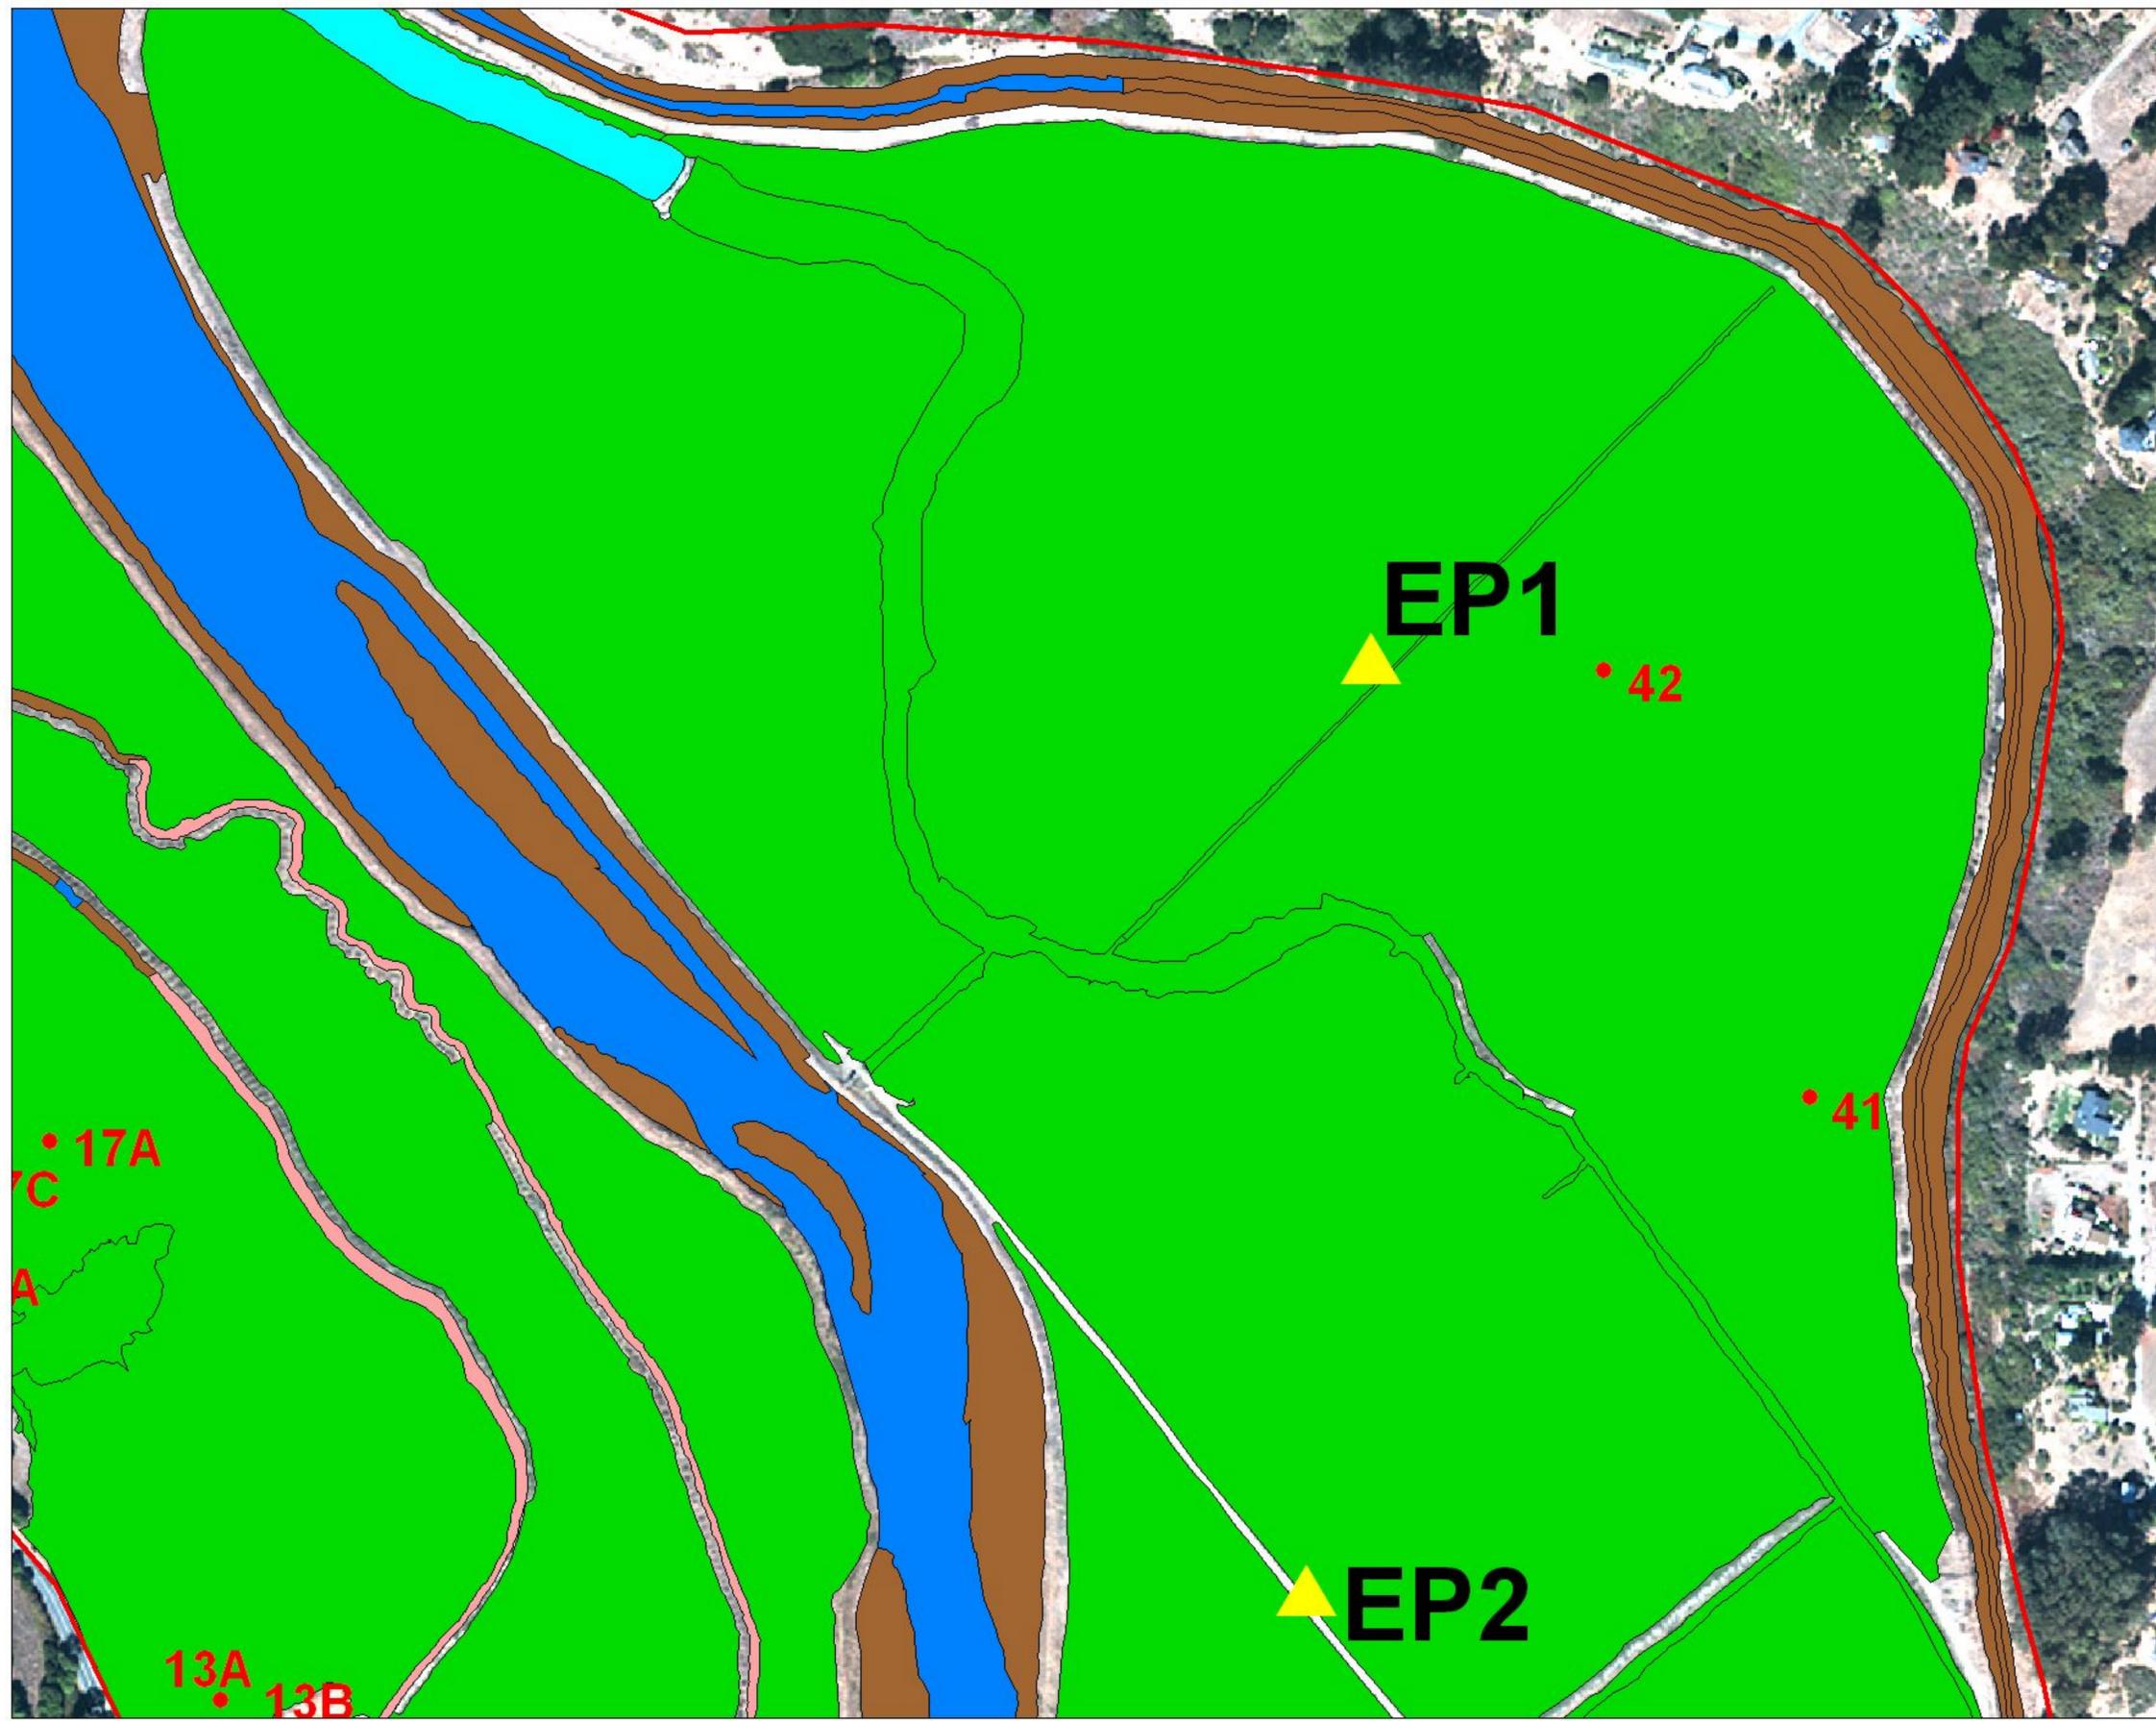
Figure 11. Potential jurisdictional Section 404 wetlands and "other waters" in the northeast portion of the Giacomini Ranch's East Pasture - Giacomini Wetland Restoration Project Delineation Study Area.

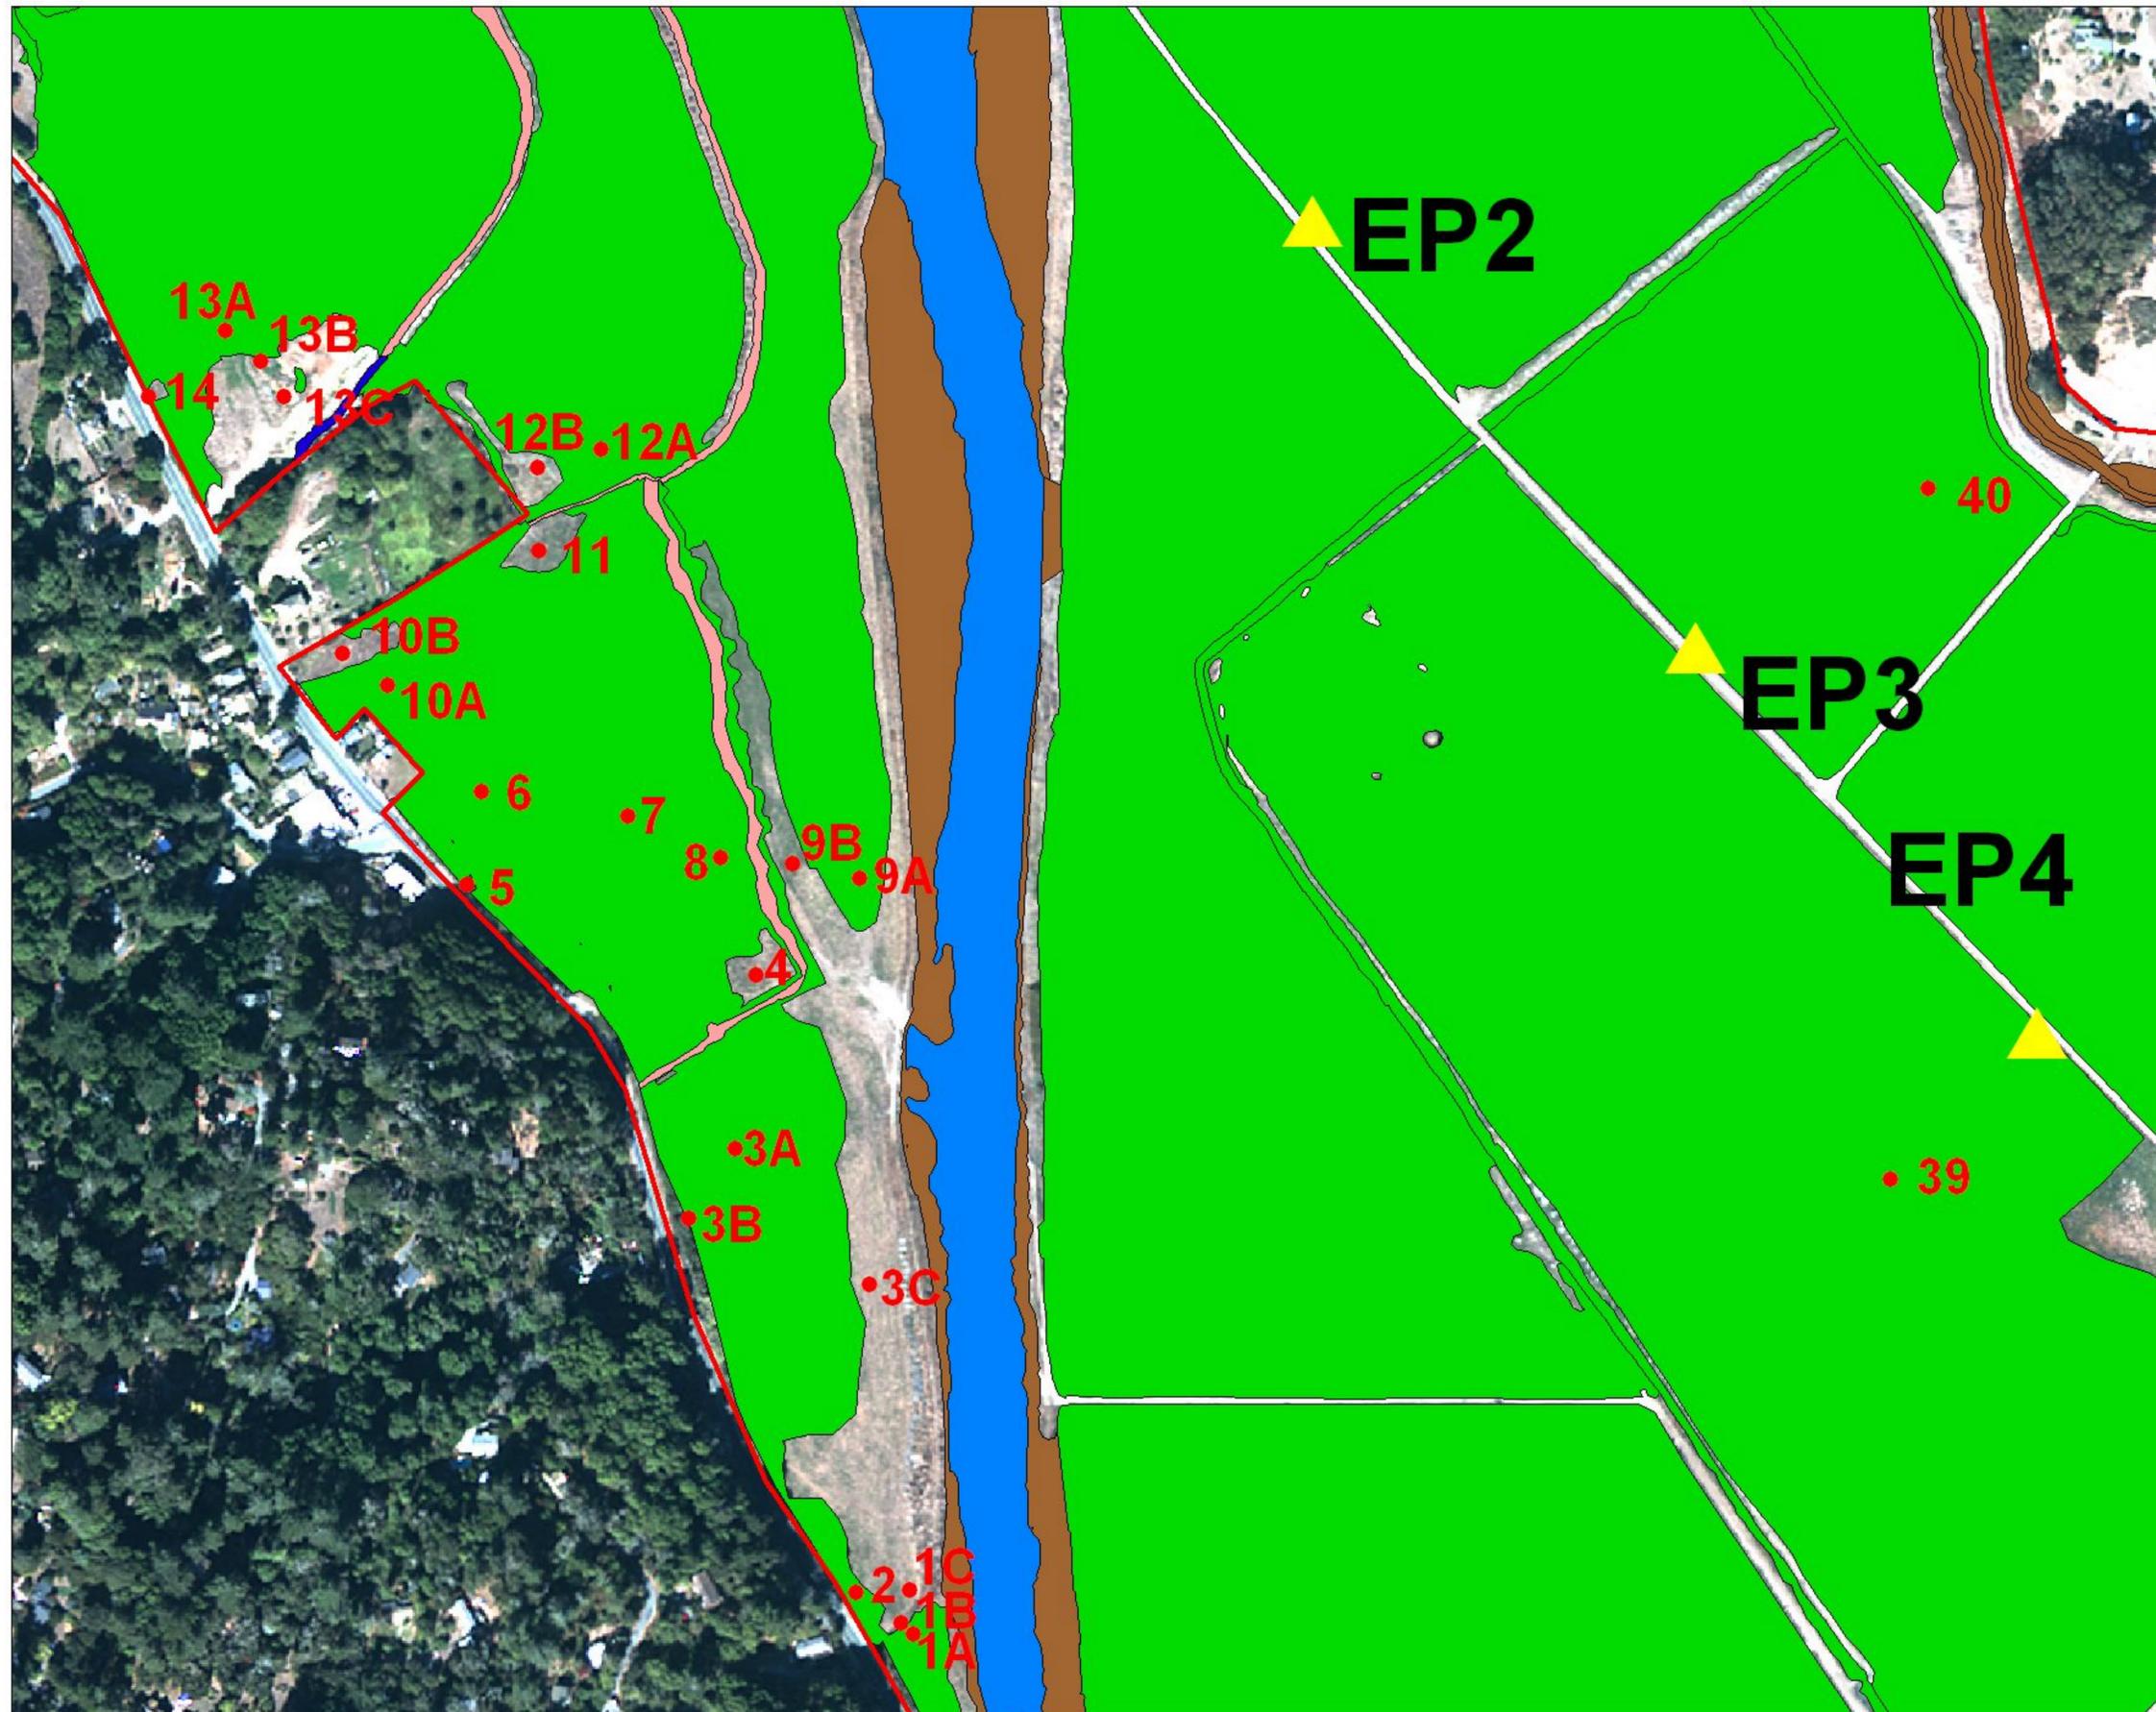
Figure 12. Potential jurisdictional Section 404 wetlands and "other waters" in the central portion of the Giacomini Ranch's West Pasture - Giacomini Wetland Restoration Project Delineation Study Area.
