**DELINEATION OF POTENTIAL JURISDICTIONAL WETLANDS  
AND “OTHER WATERS”**

**GIACOMINI WETLAND RESTORATION PROJECT**

**MARIN COUNTY, CALIFORNIA**

**January 28, 2005**

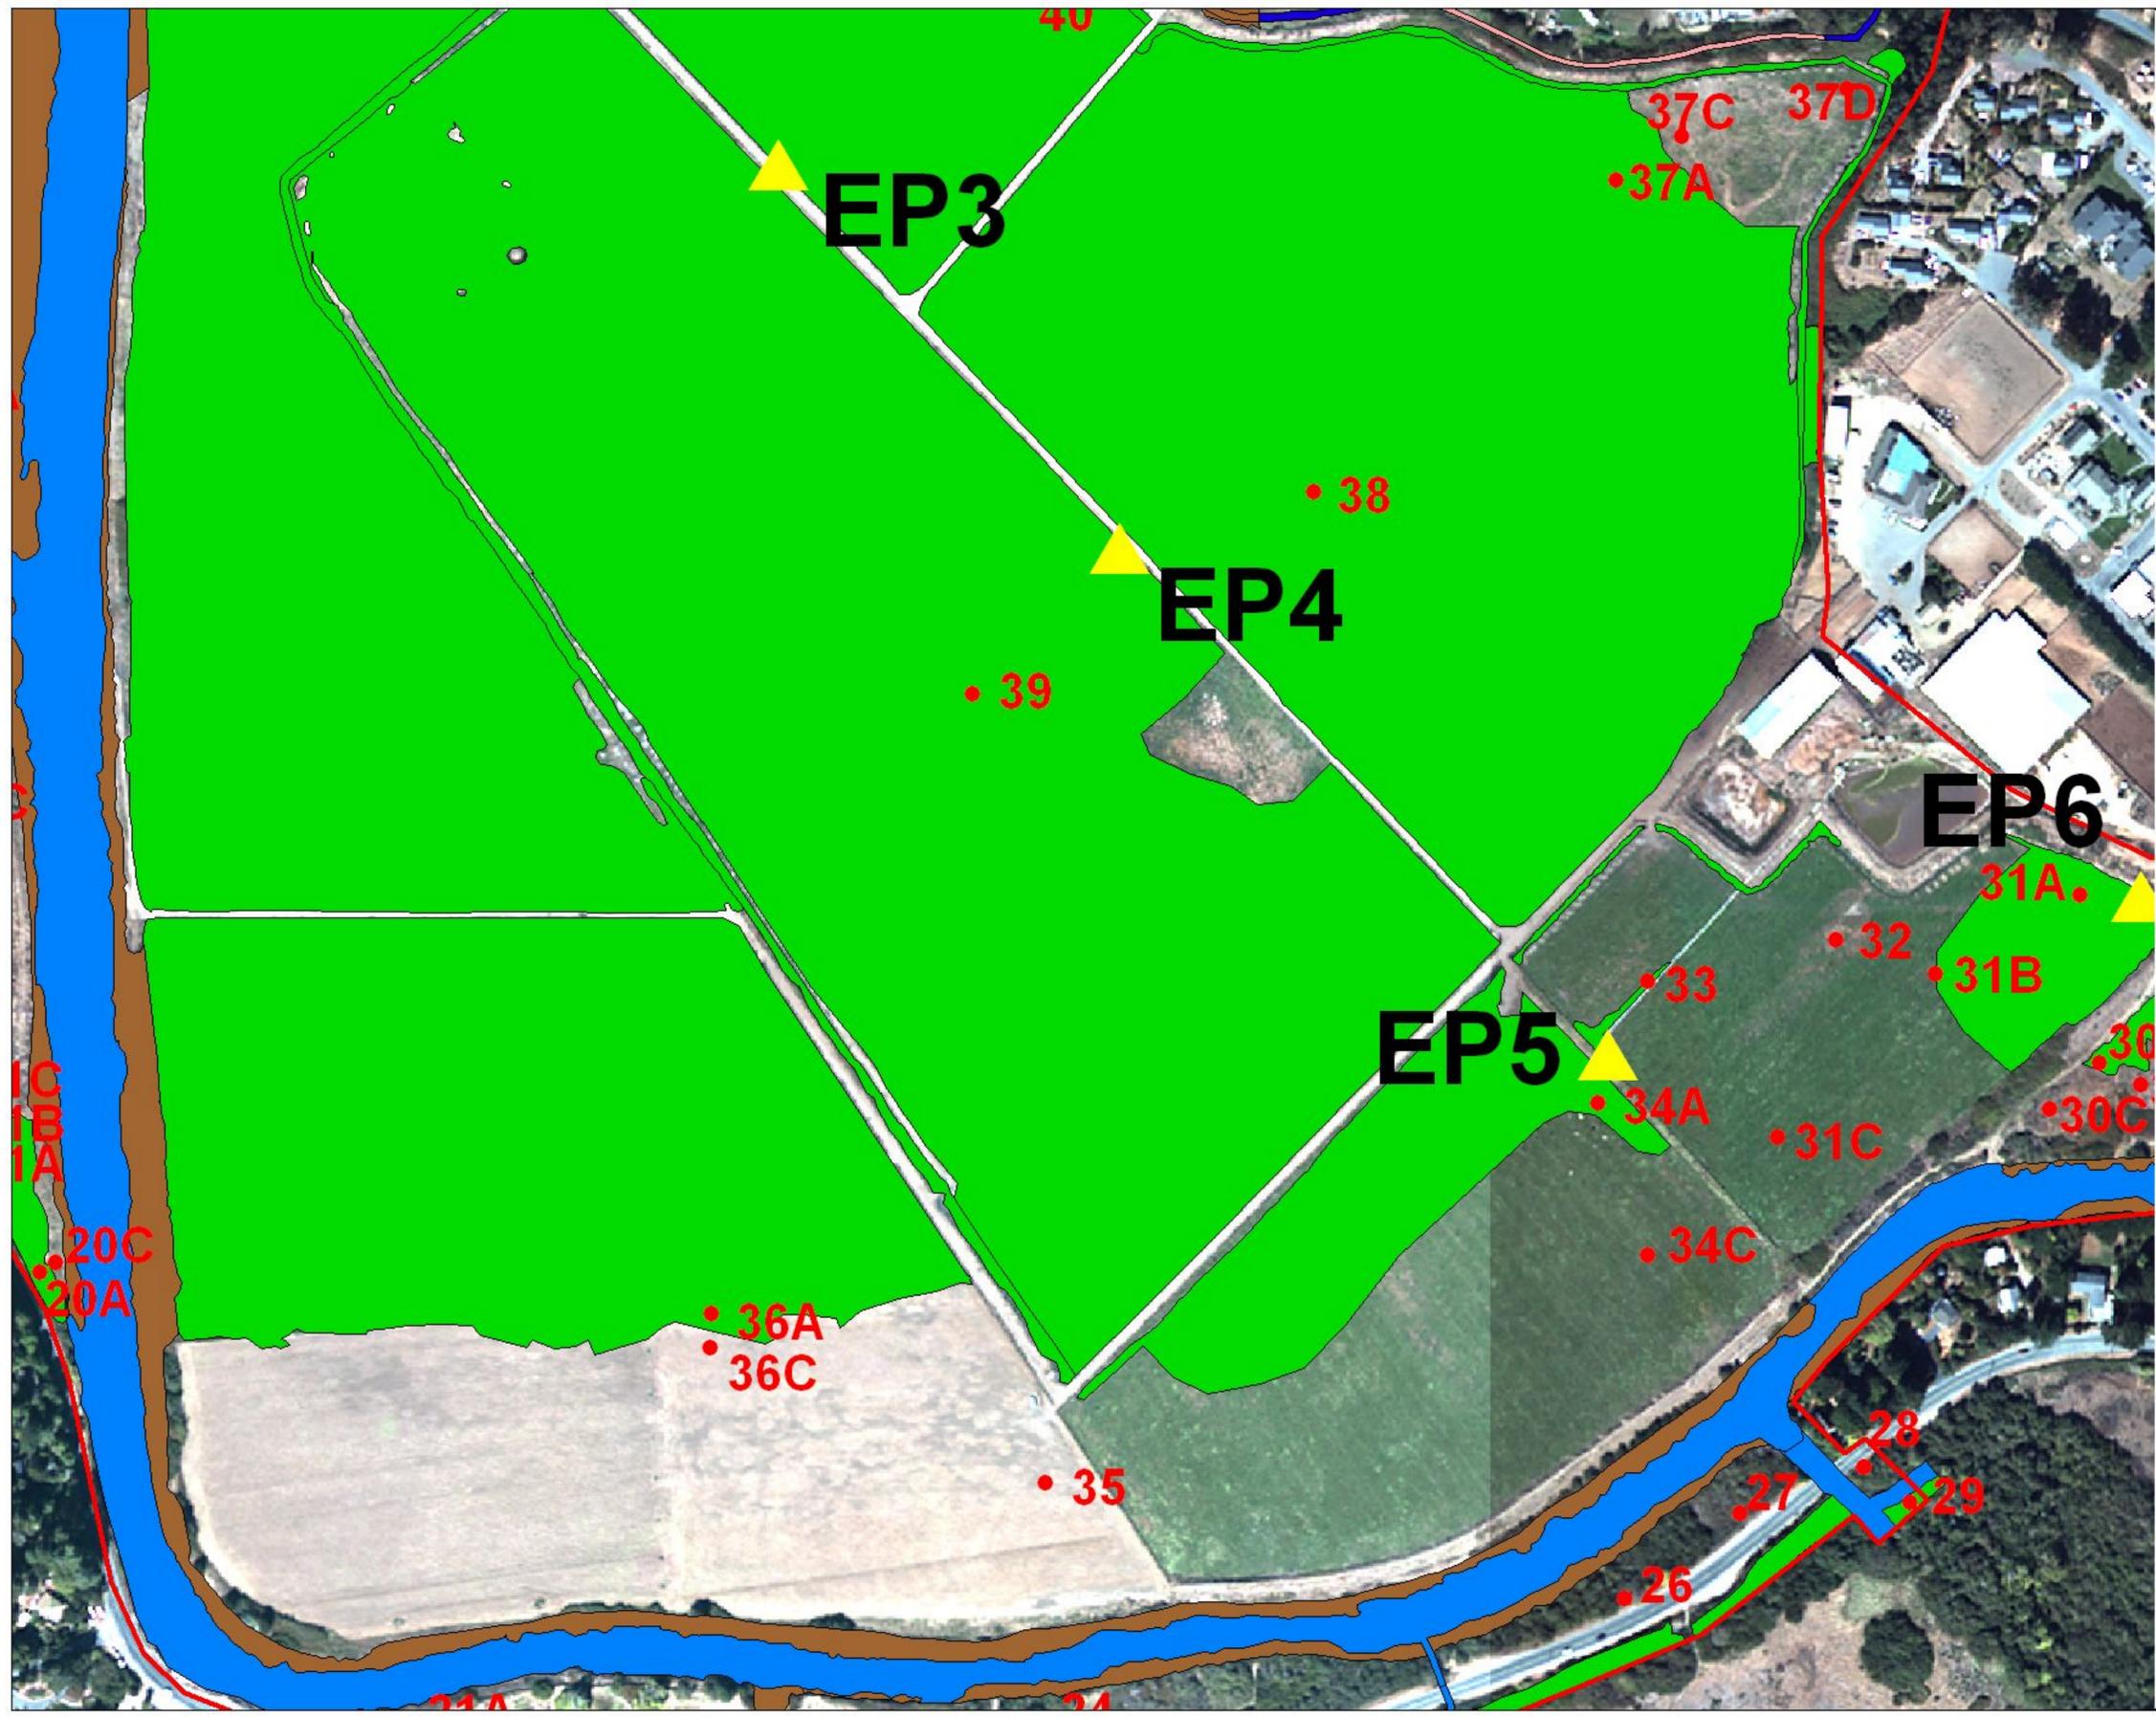
Figure 13. Potential jurisdictional Section 404 wetlands and "other waters" in the central portion of the Giacomini Ranch's East Pasture - Giacomini Wetland Restoration Project Delineation Study Area.

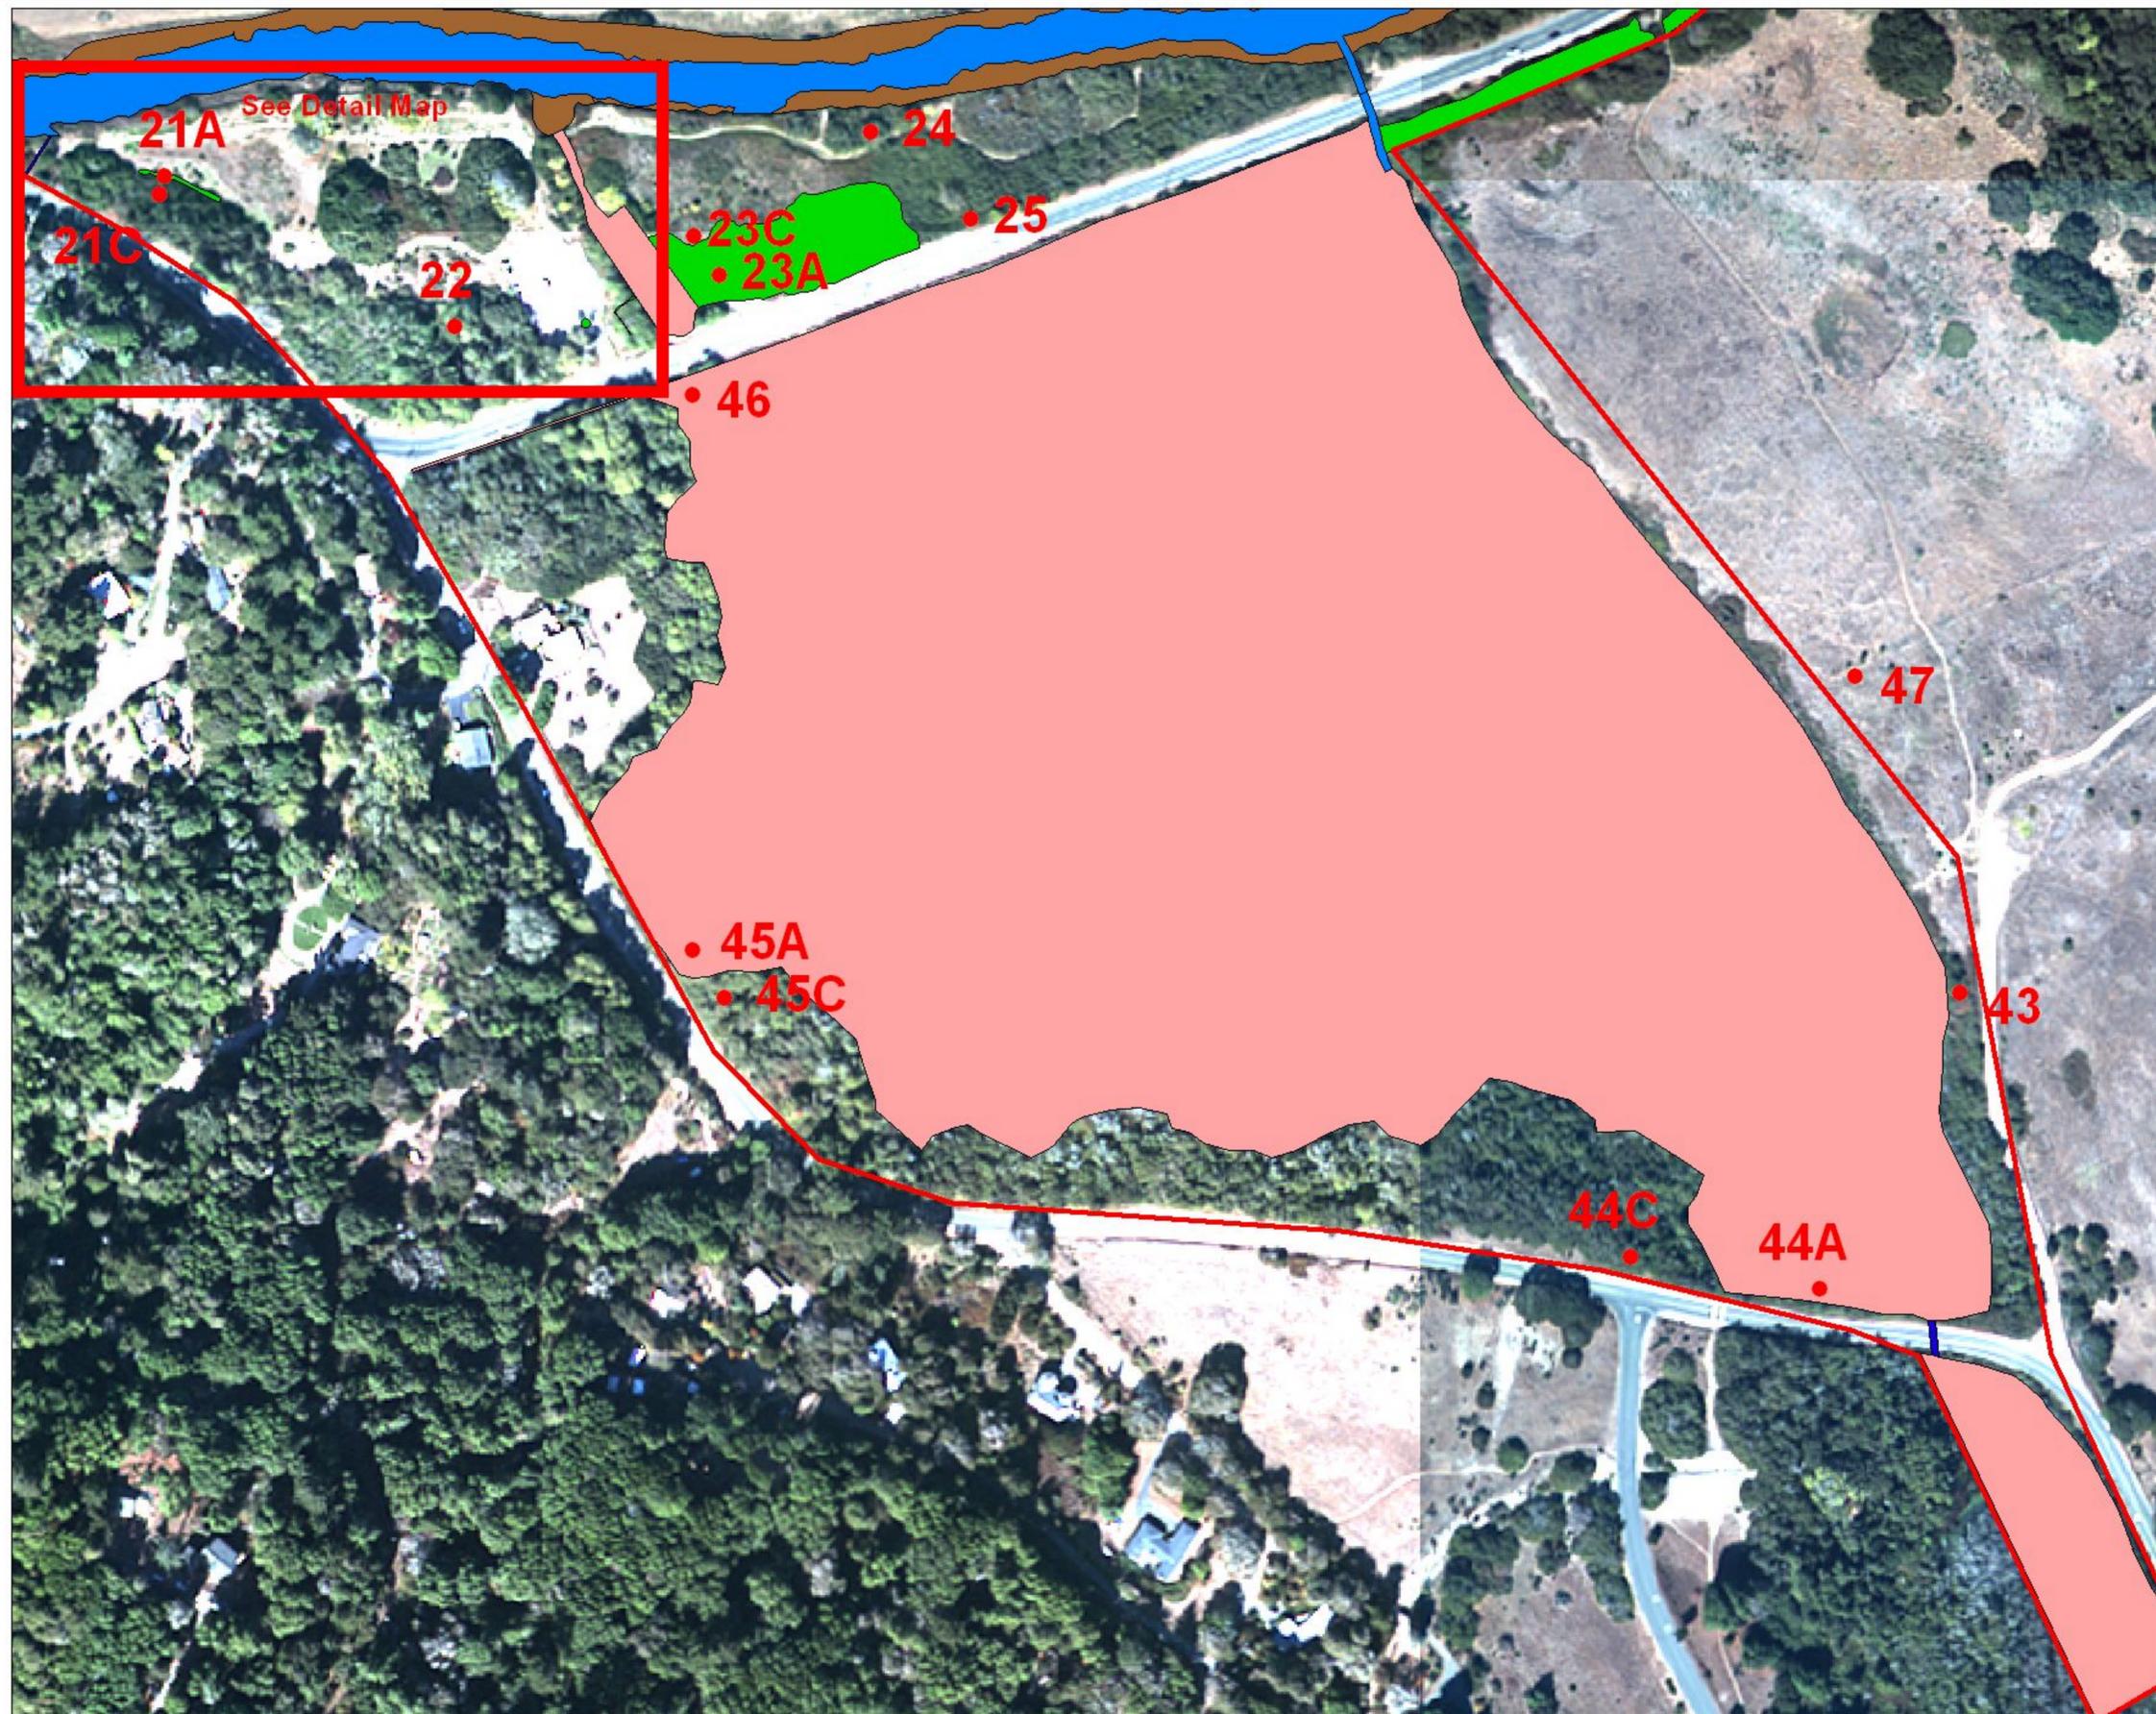
Figure 14. Potential jurisdictional Section 404 wetlands and "other waters" in the White House Pool County Park, Olema Marsh, and Bear Valley Creek areas- Giacomini Wetland Restoration Project Delineation Study Area.

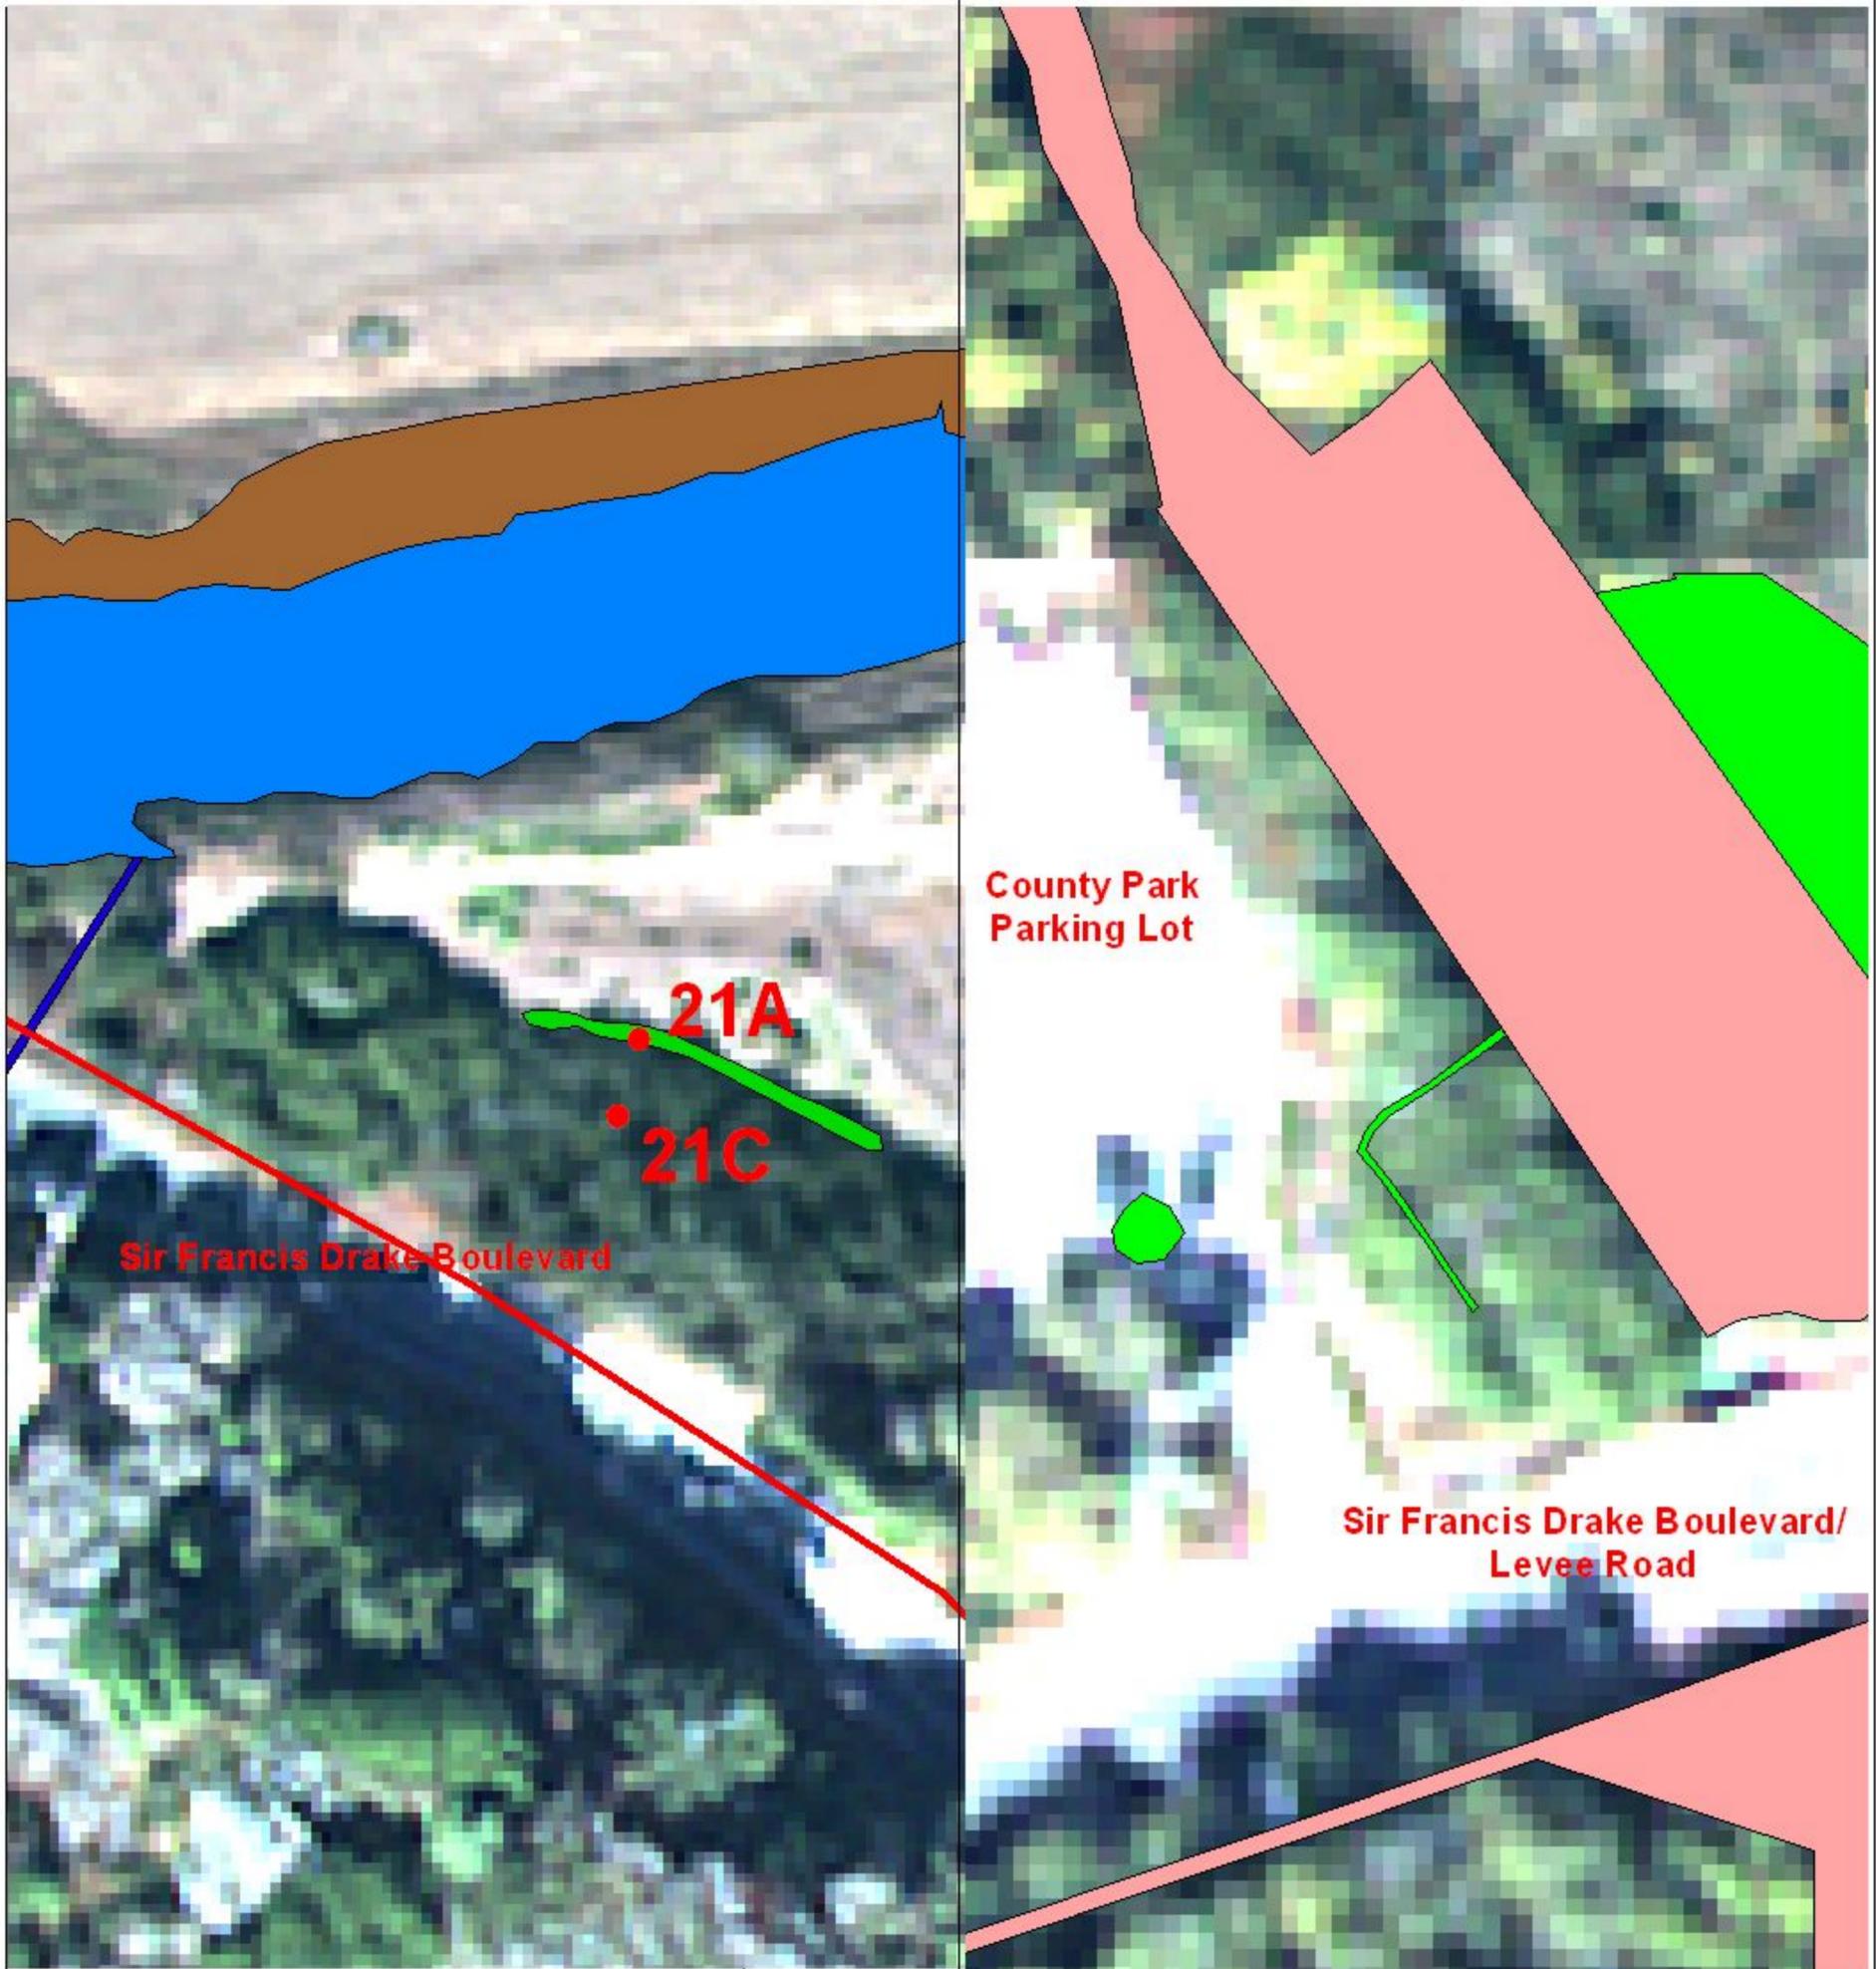
Potential Jurisdictional Section 404 Wetlands and "Other Waters" - White House Pool

Potential Jurisdictional Wetlands and "Other Waters"

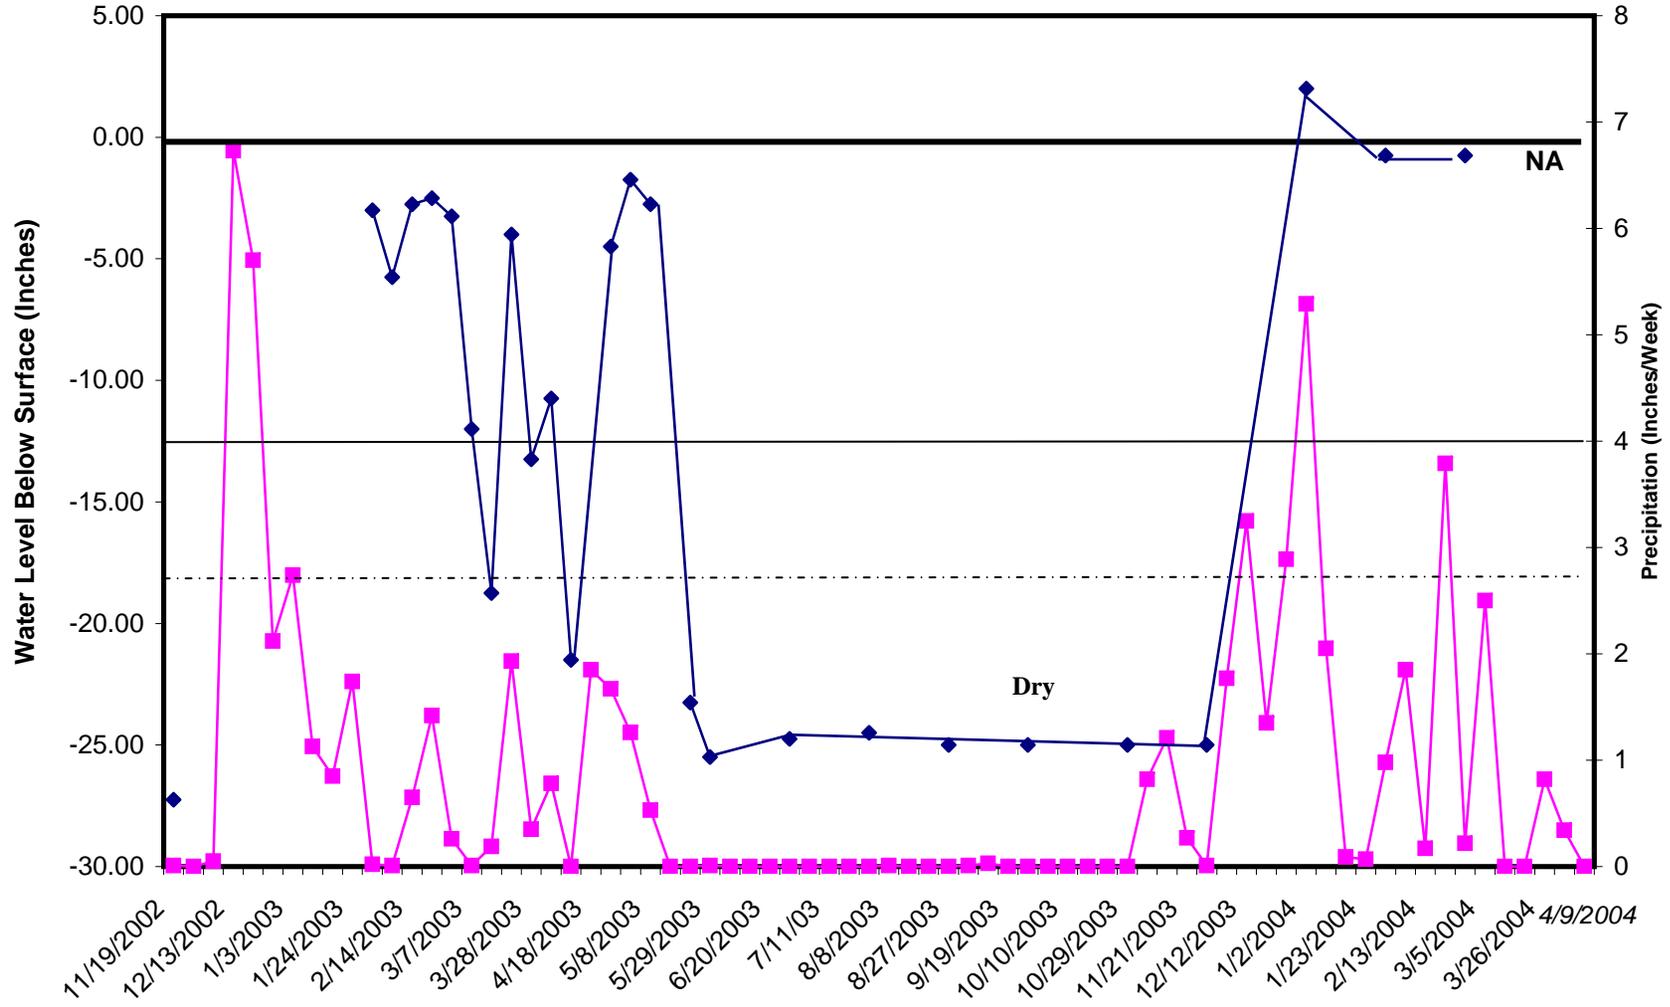
**Giacomini Wetland Restoration Project  
Shallow Monitoring Wells  
November 2002 - April 2004  
East Pasture Well 3**

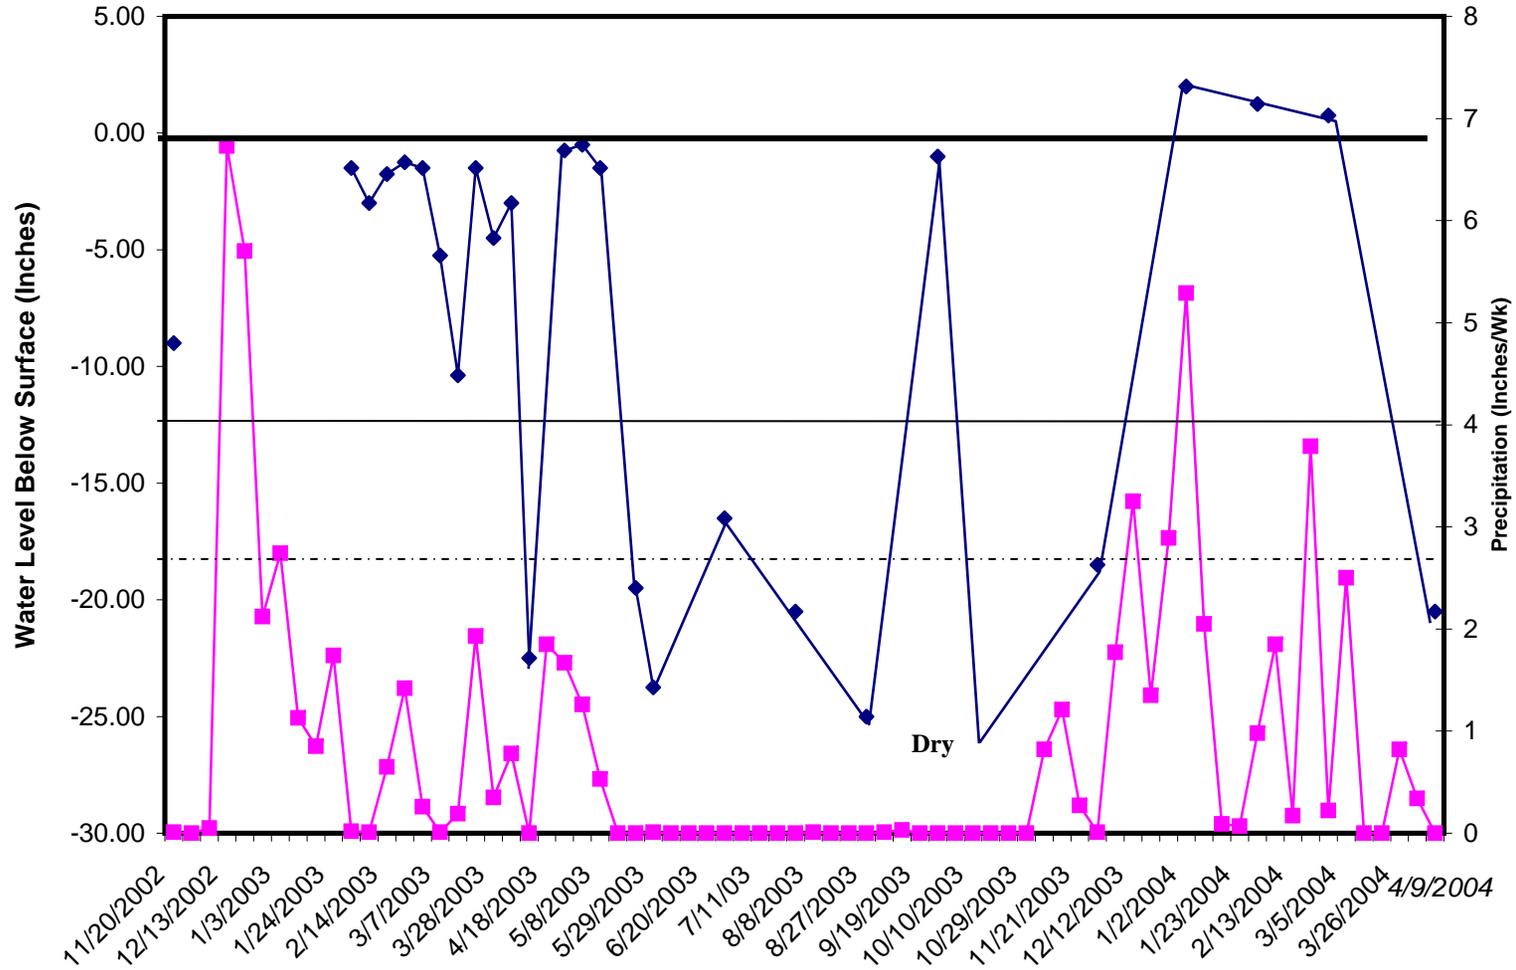
**Giacomini Wetland Restoration Project  
Shallow Monitoring Wells  
November 2002 - April 2004  
East Pasture Well 4**

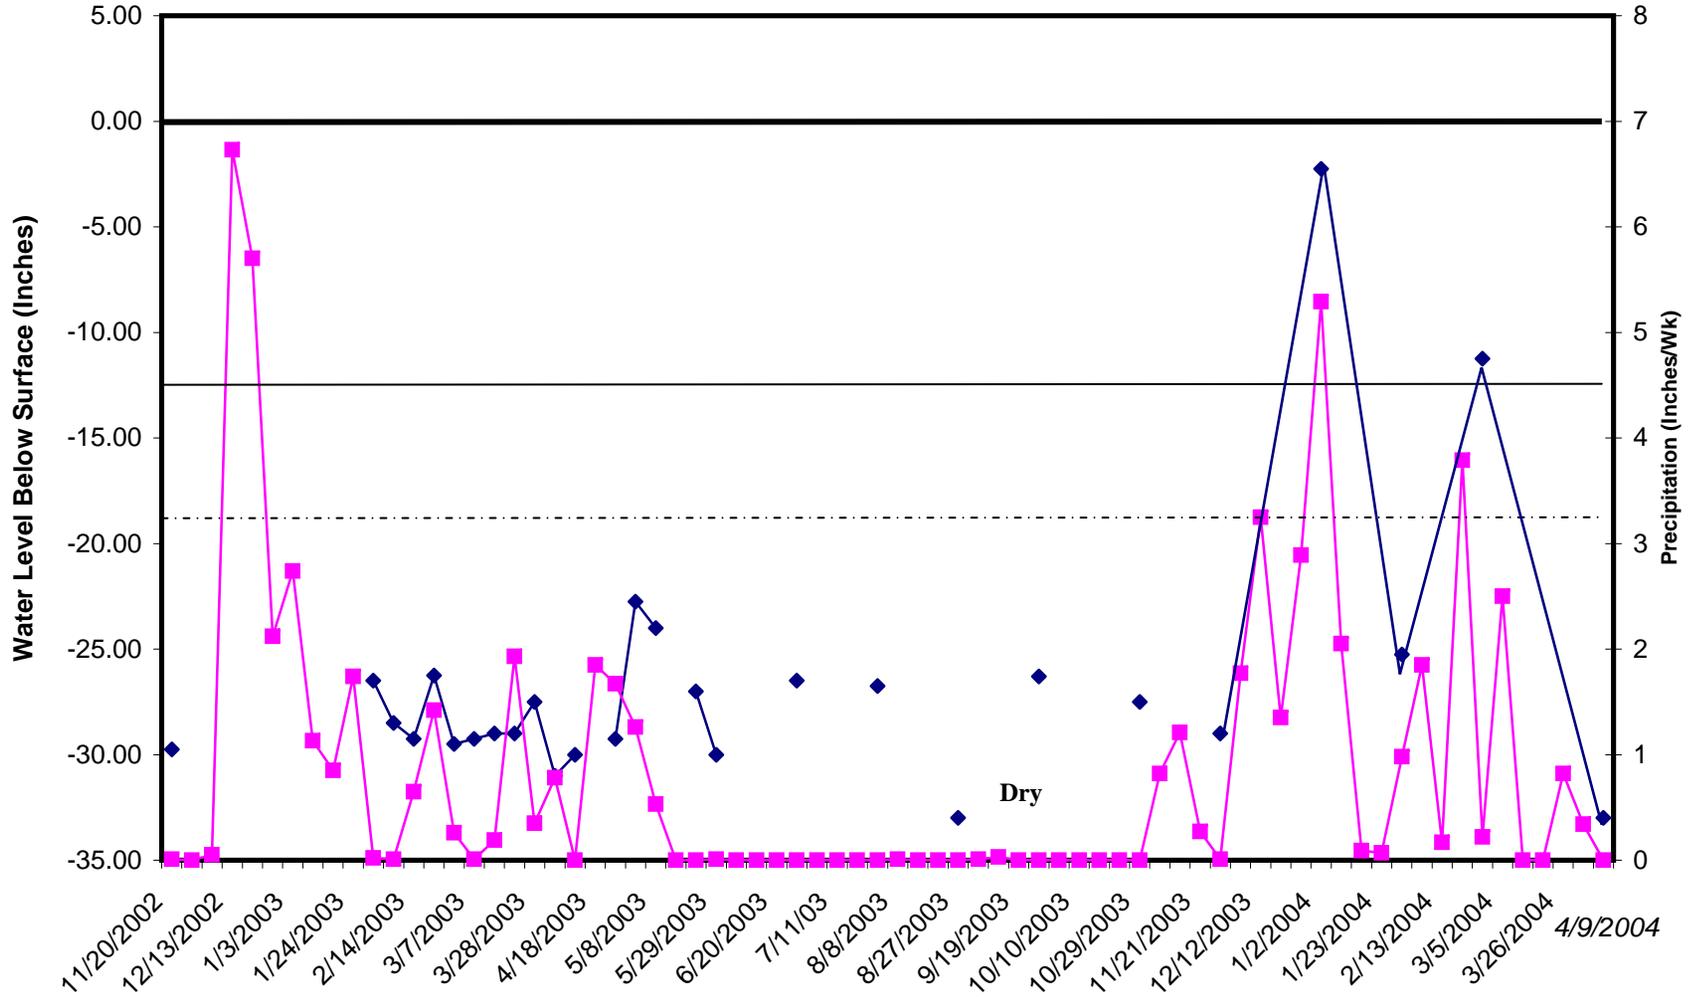
**Giacomini Wetland Restoration Project  
Shallow Monitoring Wells  
November 2002 - March 2003  
East Pasture Well 5**

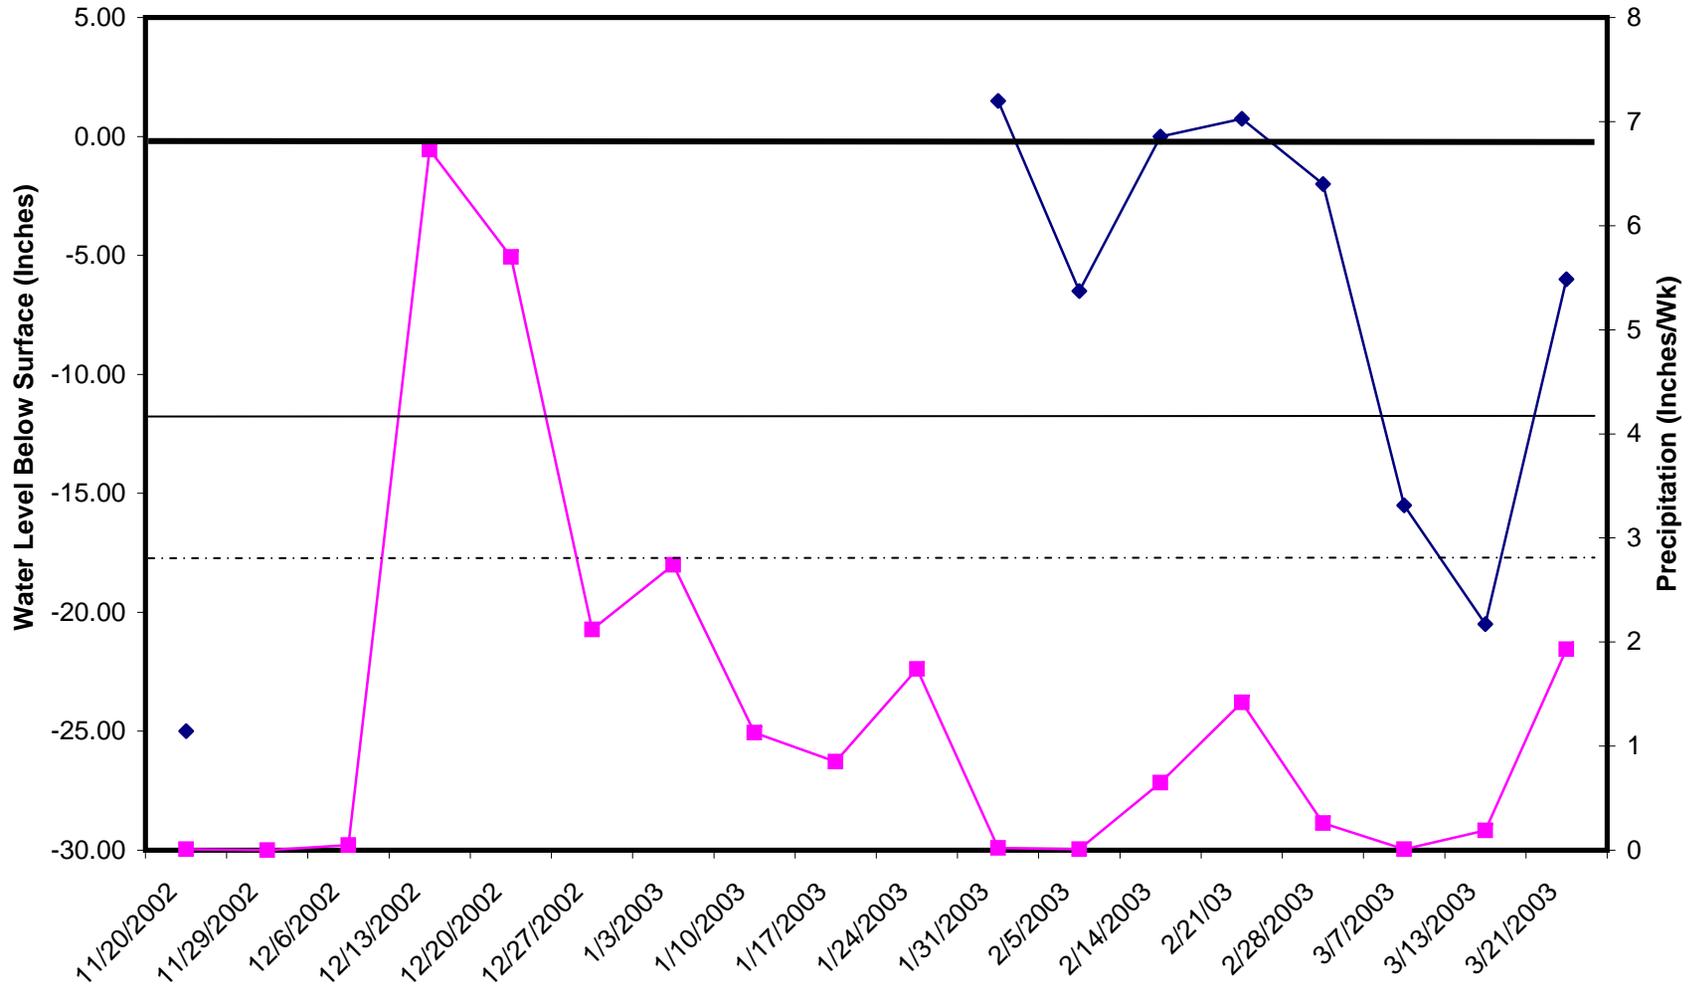
**Giacomini Wetland Restoration Project  
Shallow Monitoring Wells  
November 2002 - April 2004  
East Pasture Well 6**
