Best Practices

in Stone Building Preservation Management

Presented to San Antonio Missions National Historical Park
by The University of Texas at San Antonio Center for Cultural Sustainability

December 2021

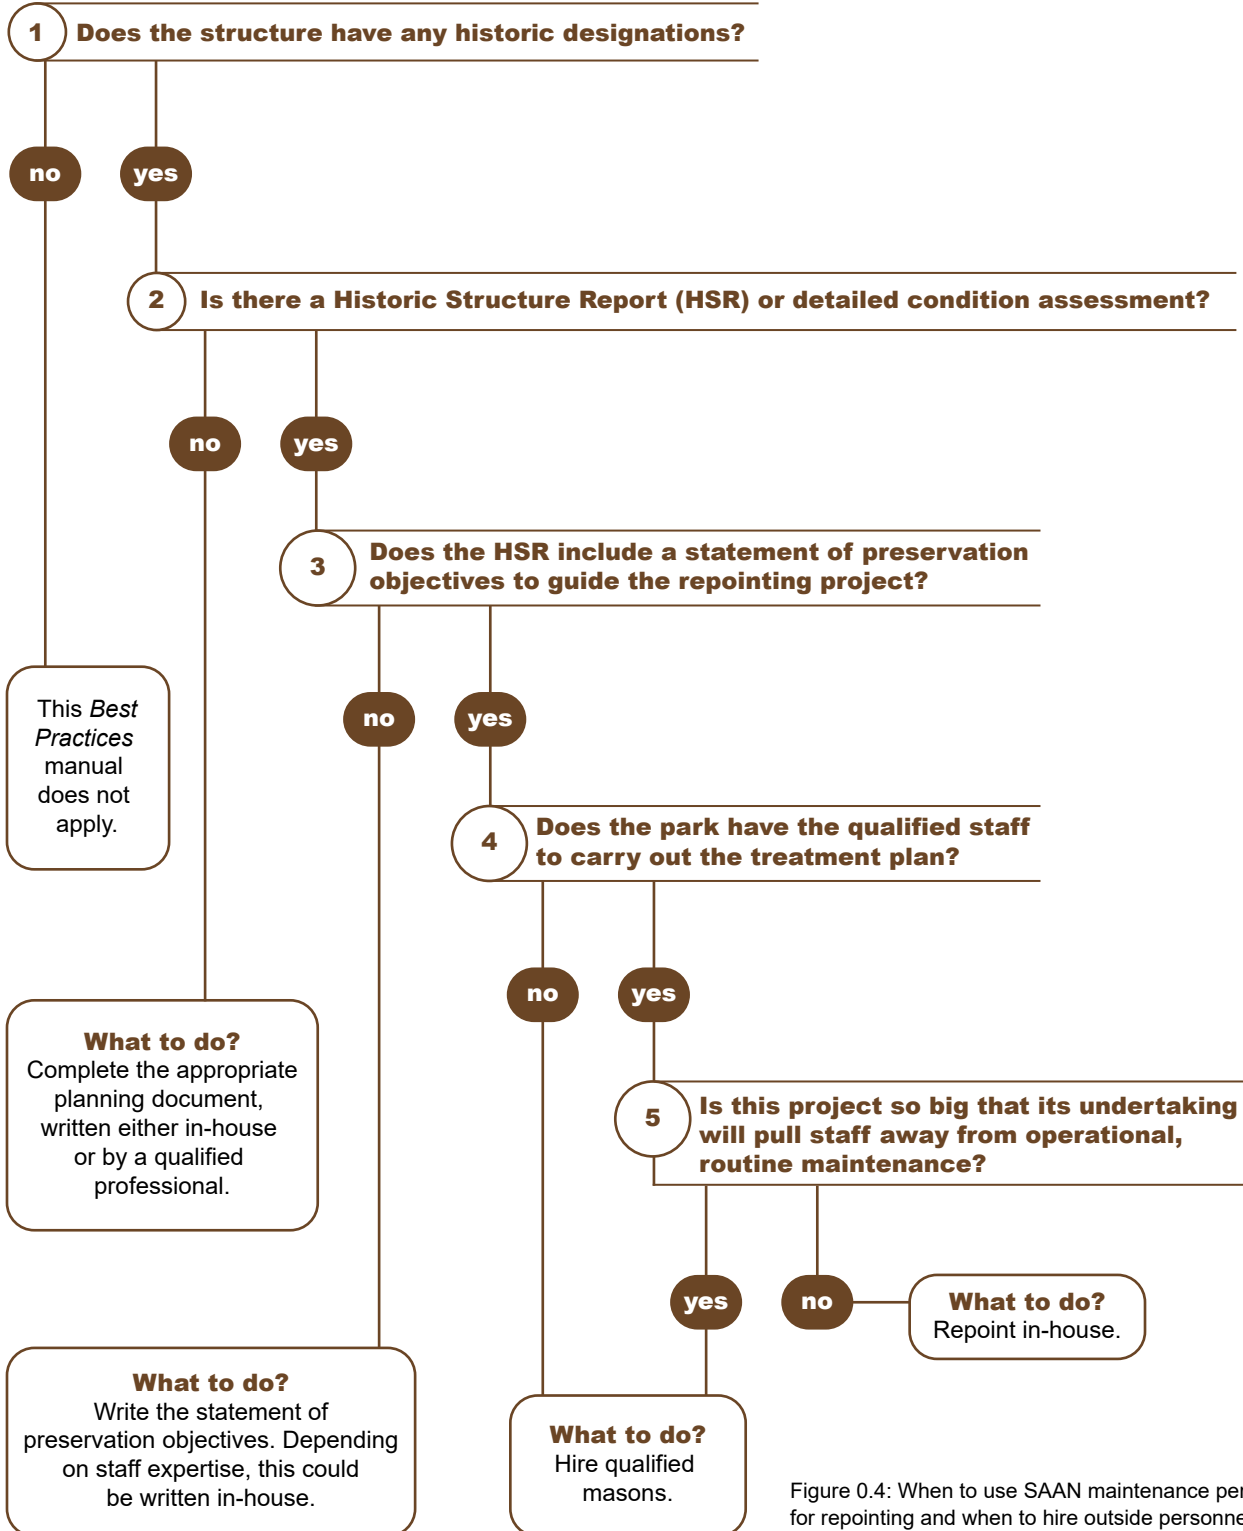
Figure 0.4: When to use SAAN maintenance personnel for repointing and when to hire outside personnel.

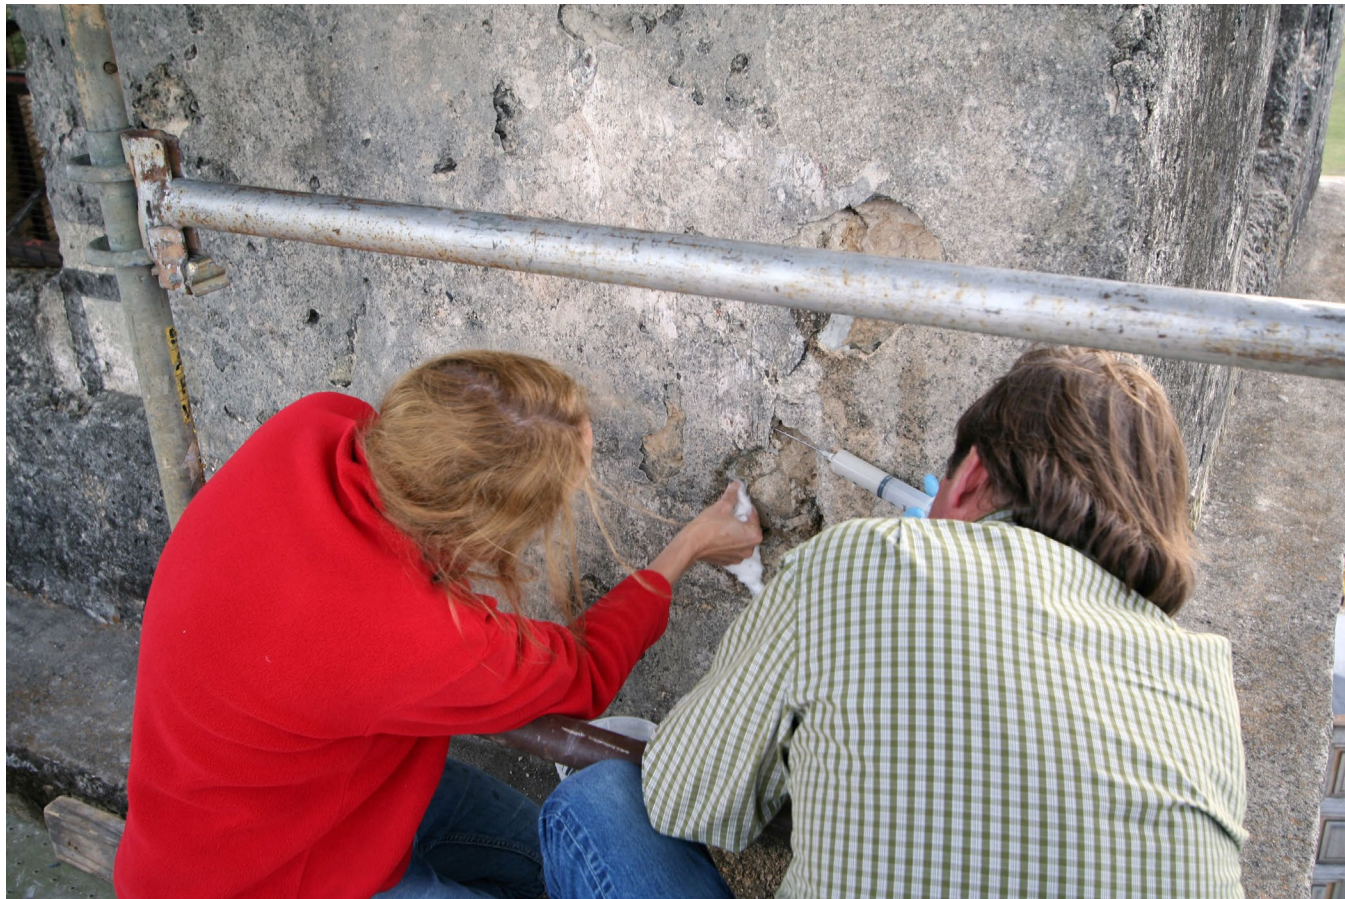
Figure 0.6: Angelyn Bass and Douglas Porter at Mission Concepción reattaching and stabilizing delaminated plaster by grout injection.

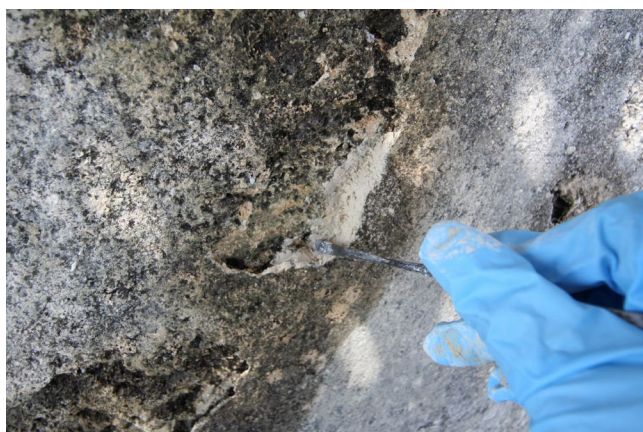
Figure 0.7: Detail of edging mortar applied to the border of fragile plaster remnant as a remedial conservation treatment.

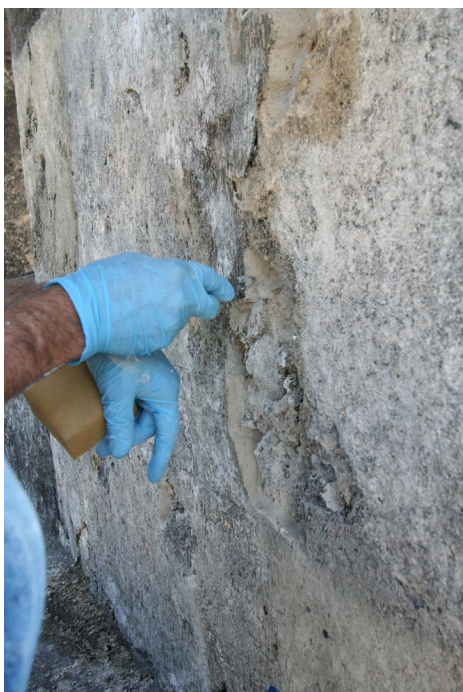
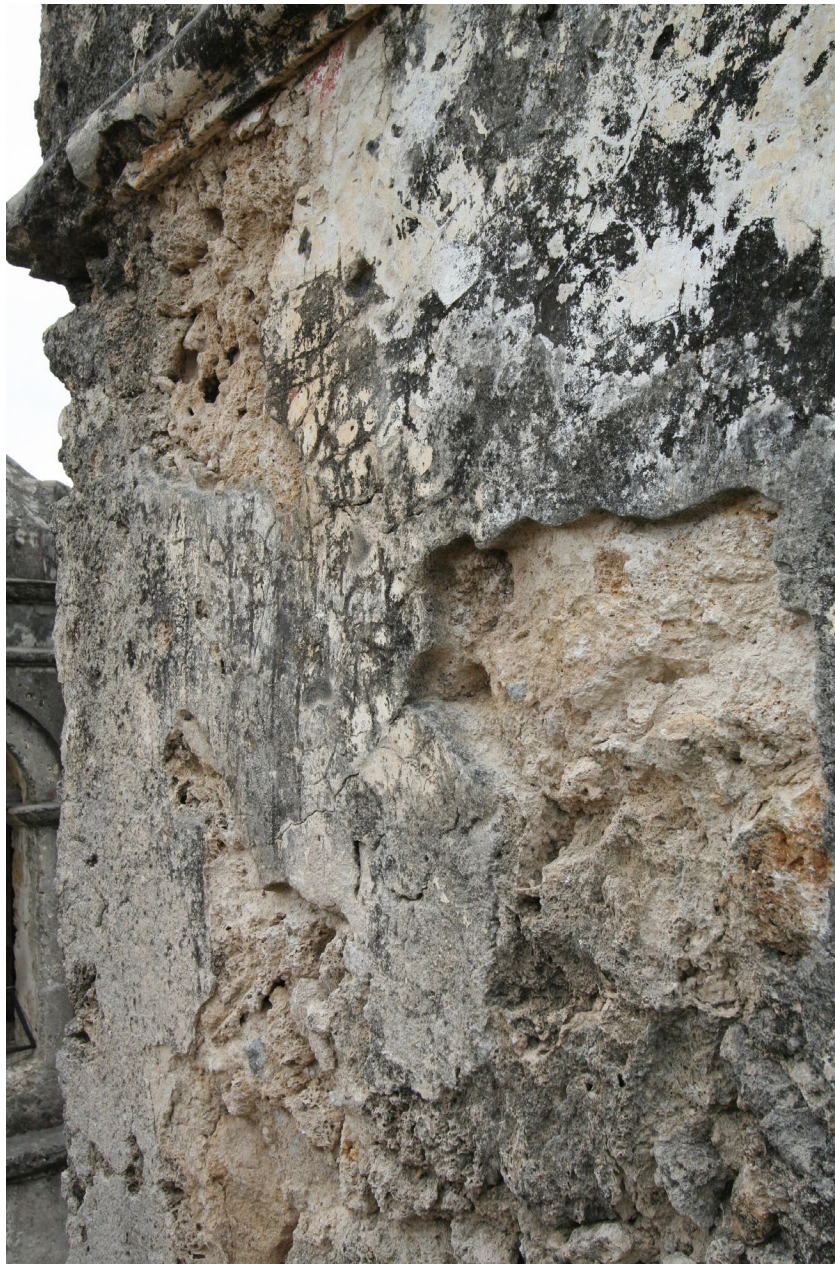
Figure 0.9 (below): Loss compensation and application of edging mortar at plaster fragments is done to support the edges and fill voids for the benefit of surviving plaster and its masonry substrate (see Bass & Porter White Paper No. 8).

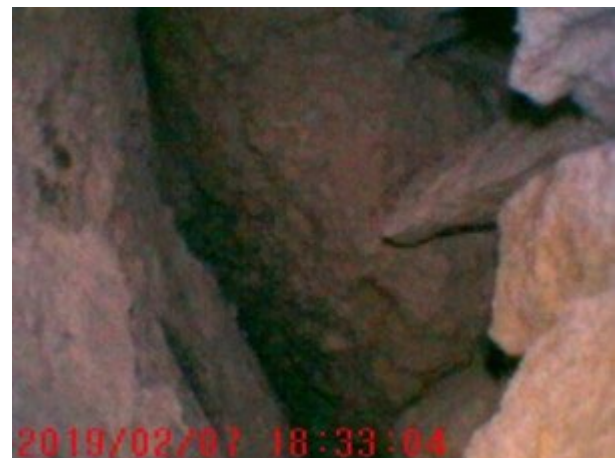
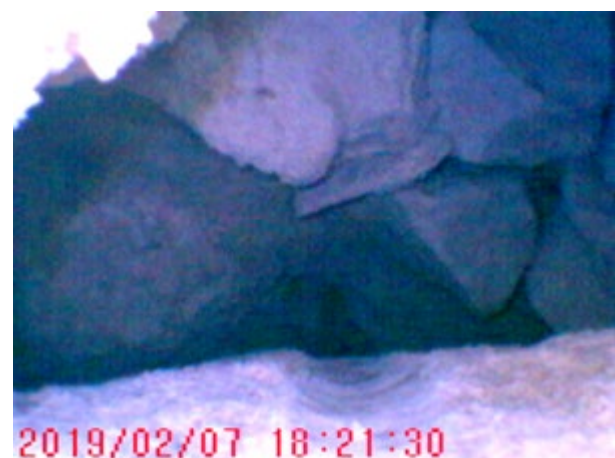
Figures 1.1a and b: Examples of borescope imagery from a historic stone masonry wall showing void areas. (Author 2019)

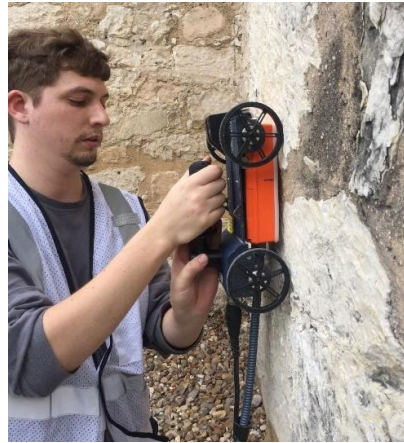
Figure 1.2a and b) Radar scanning on the interior of a historic stone masonry wall using a GSSI SIR-3000 radar unit with 1600 MHz antenna. Laser levels were used to guide the movement of the antenna on an accurate path and provide a consistent starting elevation for the vertical scans. (Author 2019)

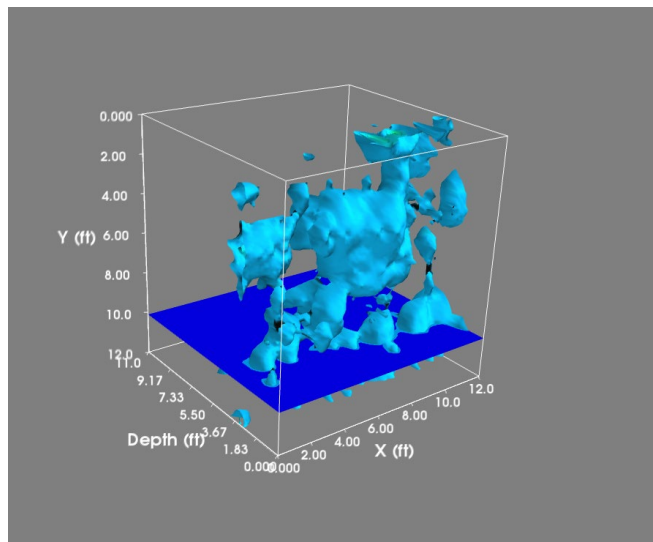
Figure 1.3: View of void information collected using SPR displayed in a 3-dimensional graph. (Author 2019)

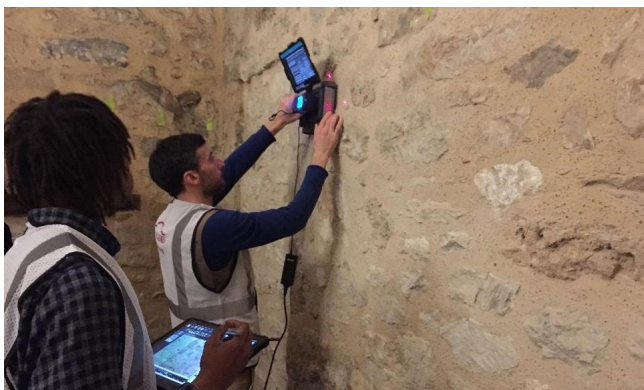
Figure 1.4: View of engineer measuring an individual stone thickness using the Proceq GPR Live unit. (Author 2019)

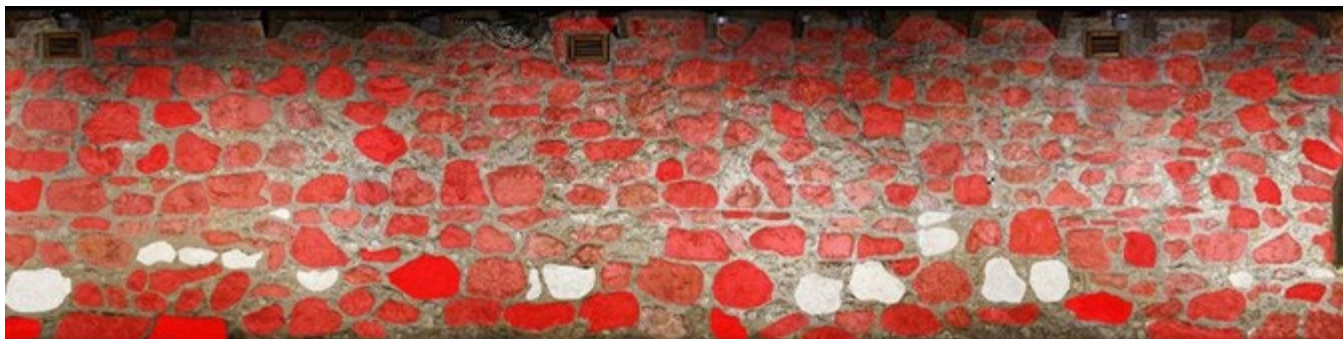
Figure 1.5: Elevation photo with stone thicknesses indicated by different intensities of red. (Author 2019)

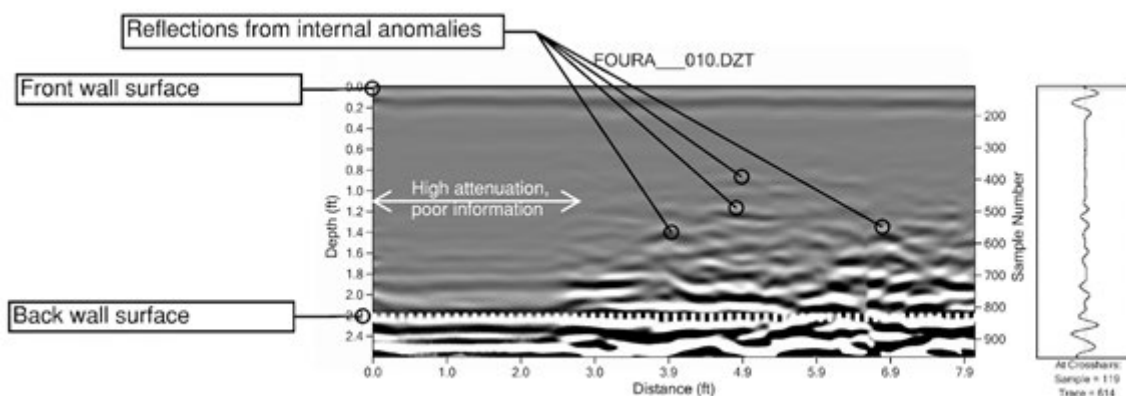
Figure 1.6: Example of vertical radar trace from bottom of wall to top, showing moisture- and salt-related attenuation and the presence of radar "noise" evident in first 3 feet. (Author 2019)

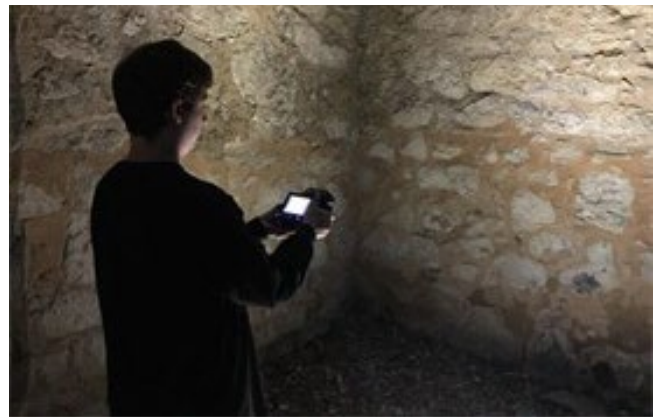
Figure 1.8 Recording a thermogram with an infrared camera. (Author 2019)

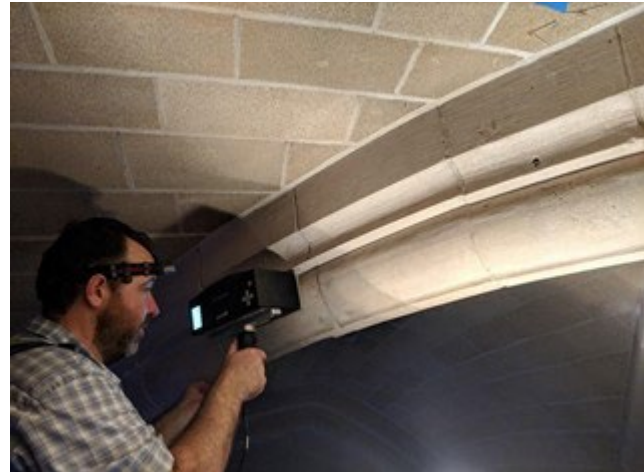
Figure 1.9: View of engineer holding UPE array against the surface of a stone rib at a church structure. (Author 2018)

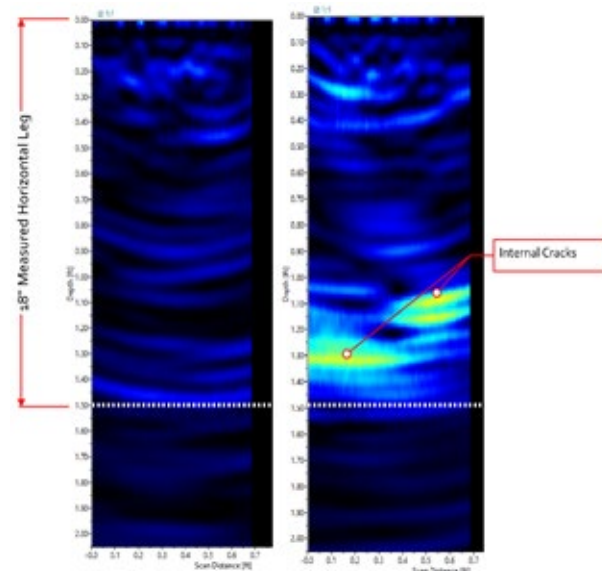
Figure 1.11: Output from UPE device showing a solid stone unit on the left and a unit with cracking below the surface on the right.

UPE is well-suited for detecting cracks and discontinuities in solid substrates such as stone, and it is relatively quick to perform spot measurements. However, **the**

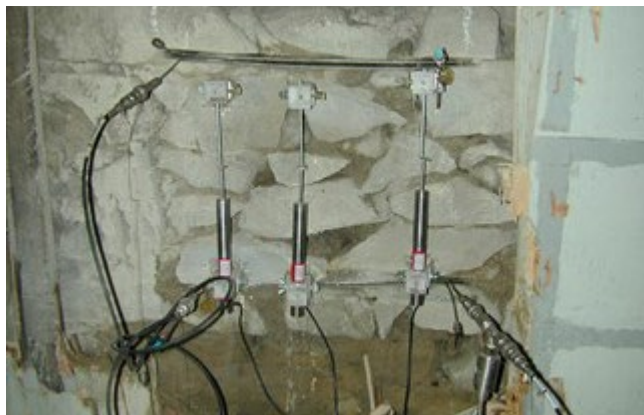
Figure 1.12: In situ compression testing of stone masonry using flatjacks in accordance with ASTM C1197. (Author 2007)

Masonry compressive strength and modulus of elasticity can be evaluated using flatjack testing in accordance with ASTM C1197, In Situ Measurement of Masonry Deformability Properties Using the Flatjack Method (see Figure 1.12). The deformability test method involves cutting horizontal slots for insertion of two parallel hydraulic bladders (flatjacks), one located above the other. As the flatjacks are pressurized, the corresponding deformations of the masonry between the jacks are measured using a set of surface-mounted linear variable differential transformers (LVDTs). Test results are in the form of stress-strain response, with the compression modulus calculated and masonry compressive strength, f'_m , either directly measured or estimated from the test data based on the compression modulus (see Figure 1.13).

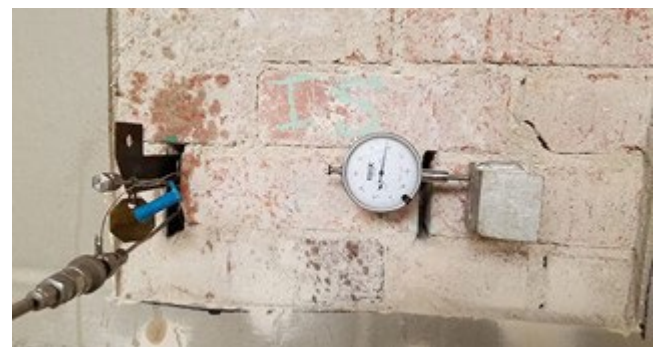
Figure 1.14: In situ shear index testing at a clay brick masonry wall in accordance with ASTM C1531. (Author 2018)

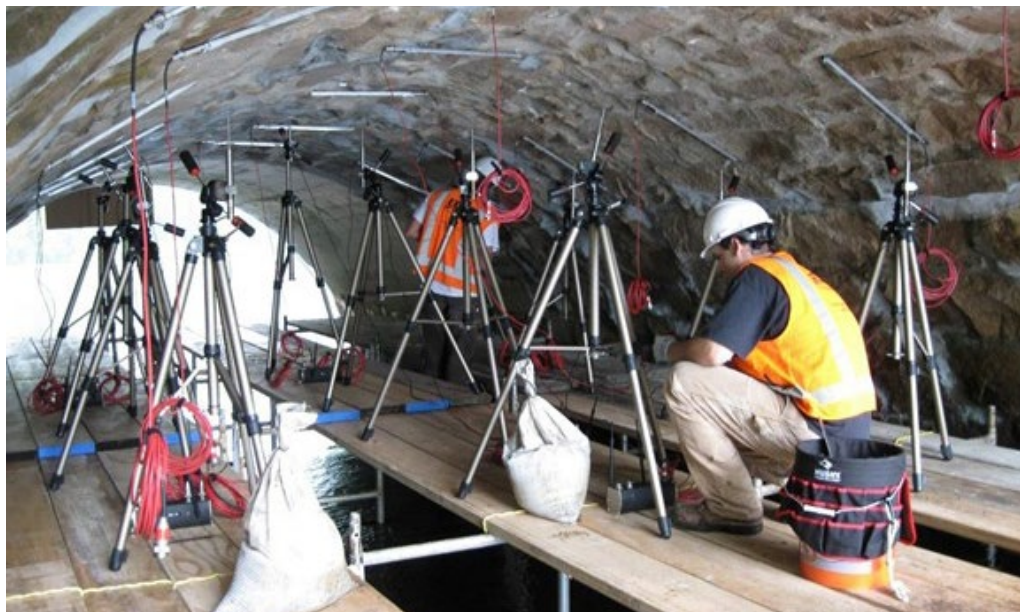
Figure 1.15: Structural monitoring system installation at stone arch bridge prior to load testing. (Author 2008)

Additionally, **they require someone with knowledge of the system to pay attention to the results for months or years, and it can be tedious to weed out false alarms.** The first three sections below (Crack Monitoring, Tilt Monitoring, and Vibration Monitoring) describe some common types of sensors used for historic masonry structures as part of a structural monitoring system (Figure 1.15). The fourth

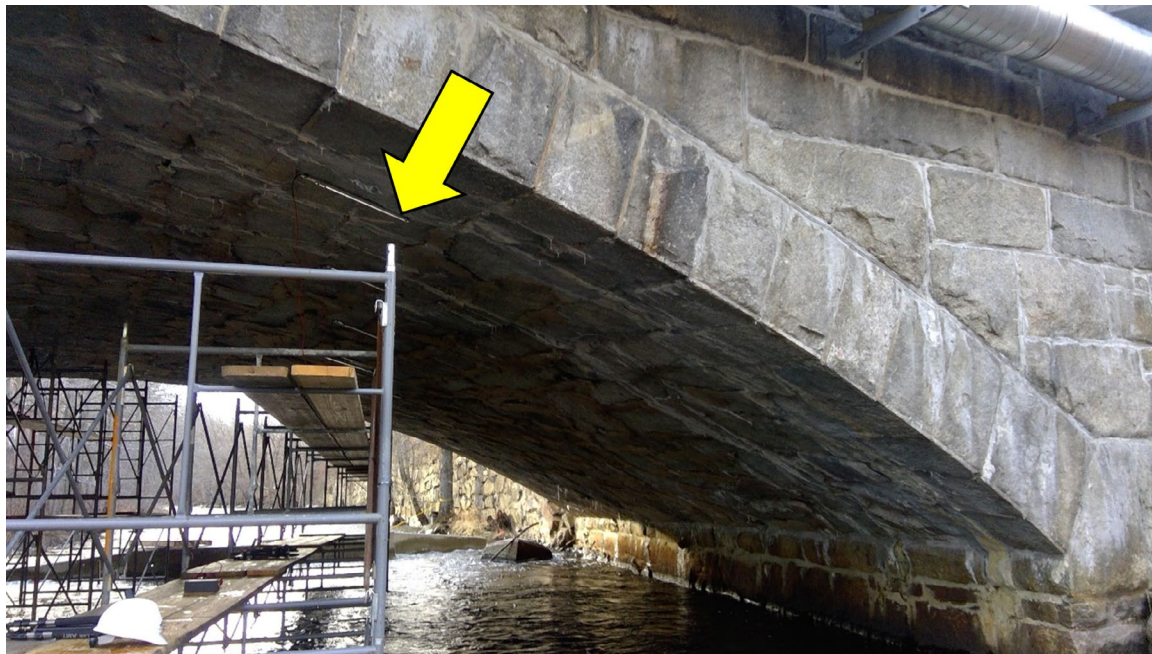
Figure 1.16: View of a stone arch bridge instrumented with a vibrating wire strain gage (indicated with an arrow) to measure strains during a load test. (Author 2018)

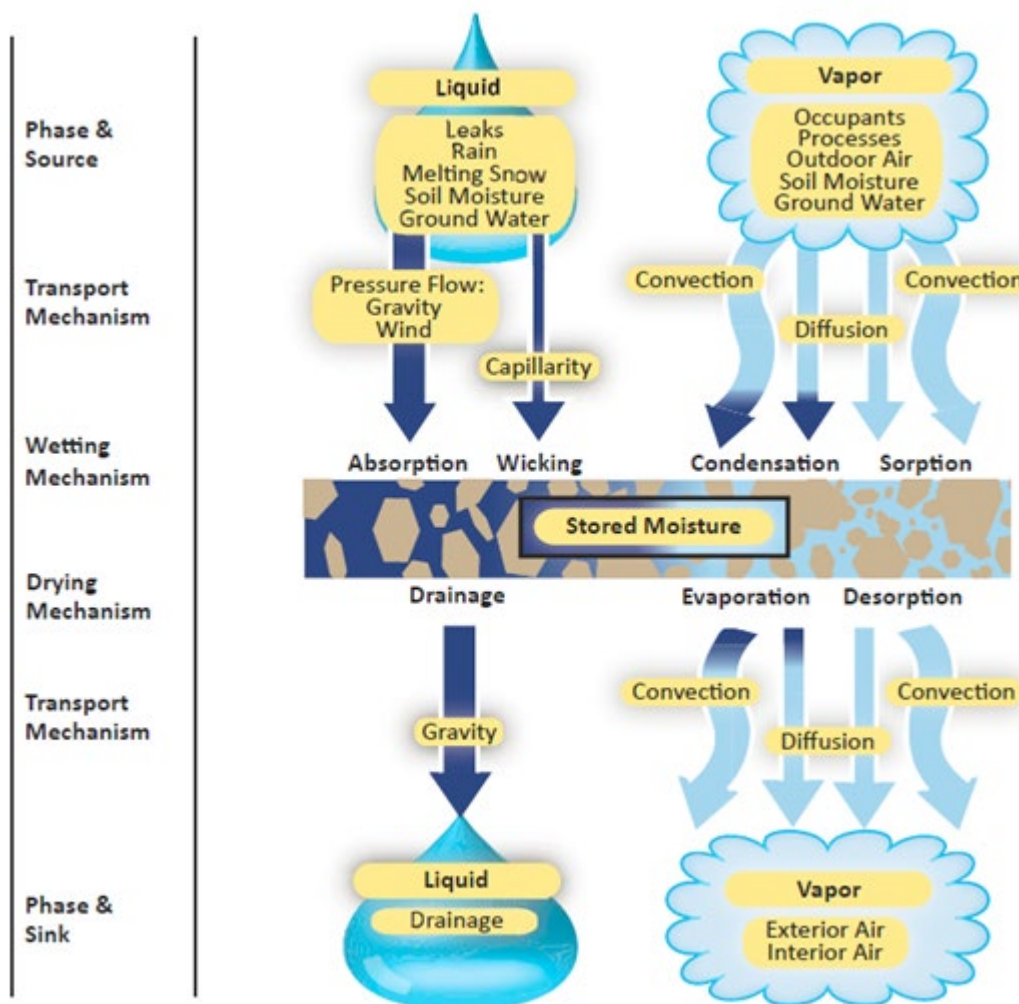
Figure 2.1: Moisture as a system in buildings. Credit: Reformat of (Straube 2002) by Christine Beckman and Michael C. Henry (Maekawa 2015)

The application of Figure 2.1 to the San Antonio Missions is discussed below.

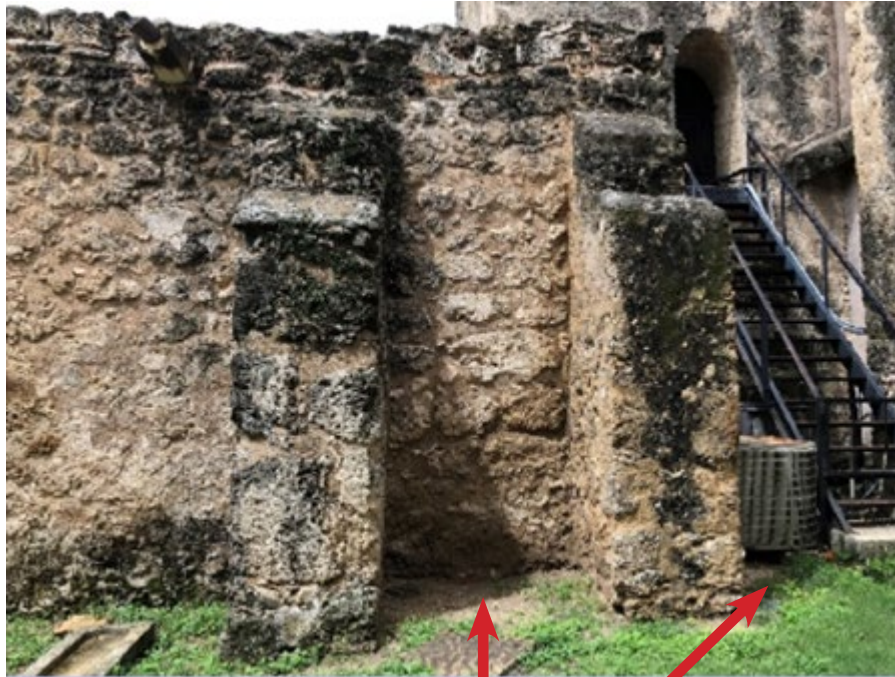
Figure 3.1: Poor site drainage, resulting in ponding water near the walls. At some sites, the slope of the ground directs water toward the historic structures, or changes in grade over time result in the present-day exterior ground level being above the level of the interior floor.

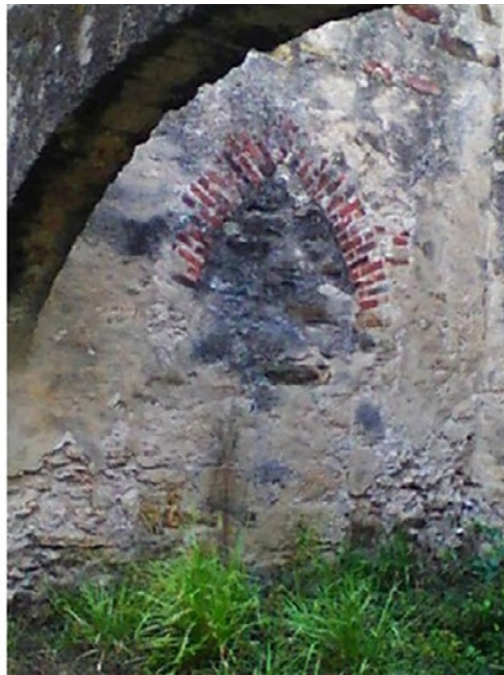
Figure 3.2: Rising damp, in which subgrade moisture rises via capillary action through the porous masonry walls. Rising damp results in deterioration, staining, biological growth, and efflorescence on the walls. Rising damp is especially likely to affect stone units installed with the bedding planes oriented vertically.

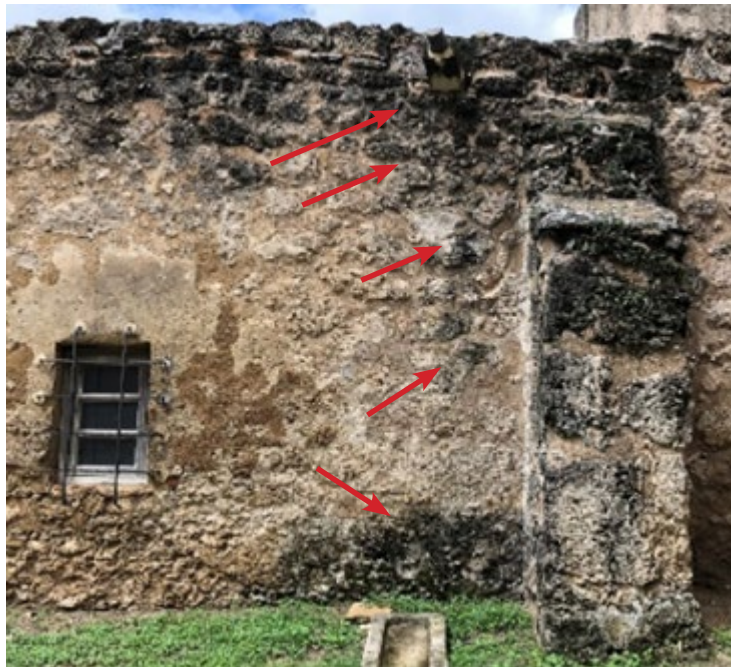
Figure 3.3: Evidence of roof drainage discharging close to the building and/or directly onto the masonry walls.

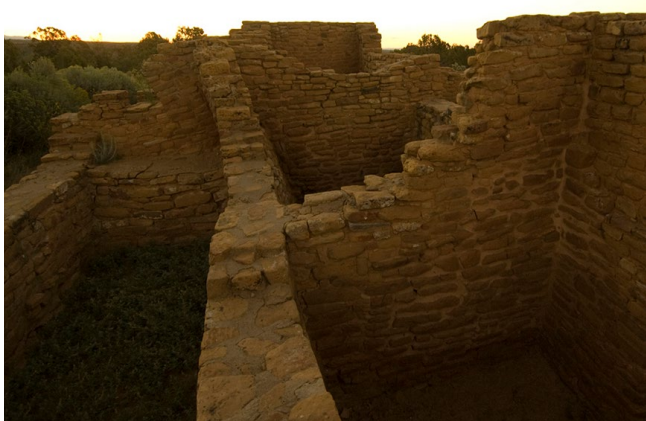
Figure 4.1: Typical hard capped masonry ruin walls in the American West. (Photo by Author)

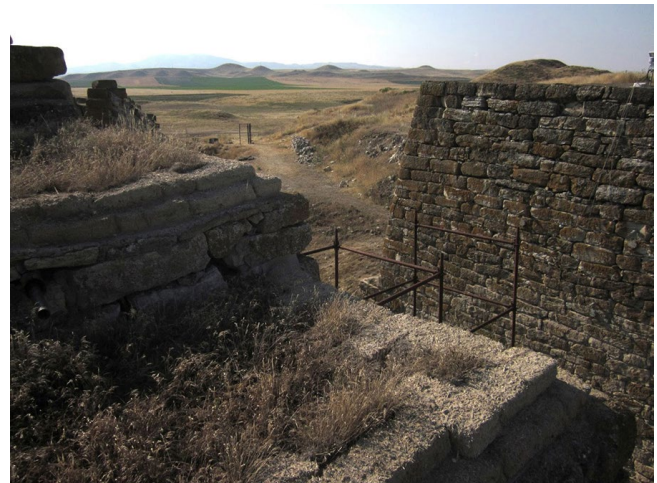
Figure 4.2: Soft capped ruin in Gordion, Turkey, blends well with its landscape of royal tumuli and open field. (Photo by Author)

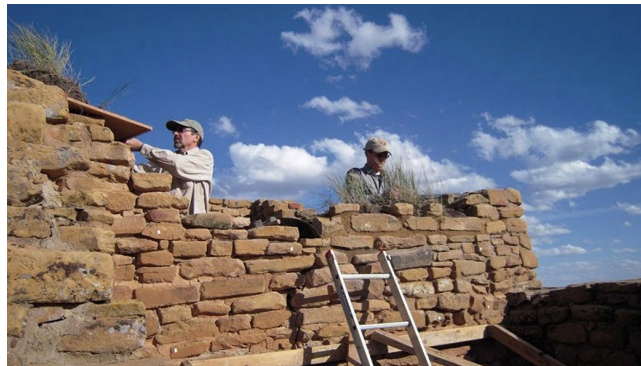
Figure 4.3: In Mesa Verde National Park, the Park botanist and natural resource specialists advised on the selection and harvest of locally available grass. (Photo by Julie Bell)

- **Minimal Soil Volume:** Soil is the key component of moisture management. The cap will not work if there is not enough soil.
- **Vegetation:** Candidate plants should survive the extreme conditions of wall tops. Go for perennials instead of annuals for the ease of maintenance. Encourage a colony of plants instead of a single plant type to discourage weeds. Sods minimize plant death and seed balls are useful in introducing desired vegetation after cap establishment. Consult botanists for information on regional vegetation types, harvest locations, root depth and type, drought resistance, dormancy, among others. (see Figure 4.3)

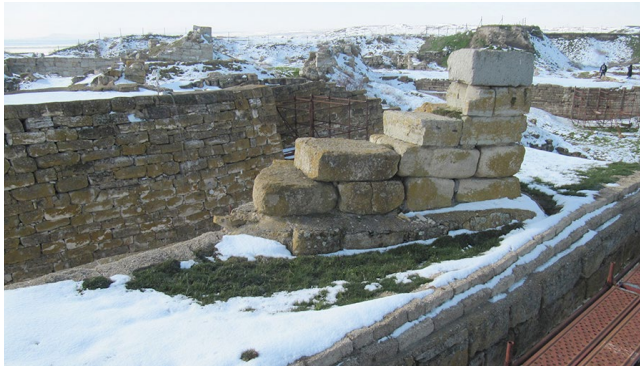
Figure 4.4: In Gordion, Turkey, adobes edged the soil cap which became part of the soil cover. (Photo by Author)

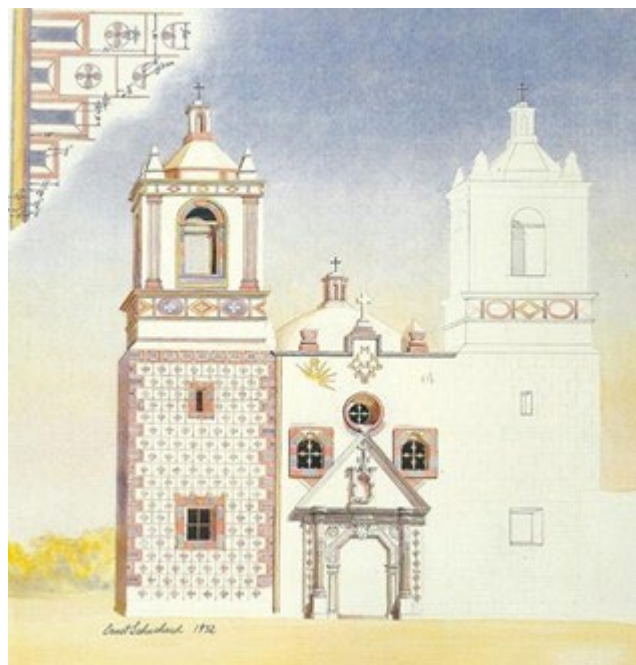
Figure 8.2: In the 1930s Ernst Schuchard made watercolor paintings and annotated black and white photographs documenting the incised patterns and paintings at Mission Concepción (pictured here) and San José. He attributes most of the decorative plaster to the ca. 1770s. Only fragments of the decorative scheme Schuchard documented in the 1920s–30s survive today. (Ernst F. Schuchard Papers, Collection 926, The Daughters of the Republic of Texas Library)

painted (see Figure 8.2). Colonial-era plasters are typically composed of lime and (mostly) carbonate aggregates in mixes that vary with position in the finishes stratigraphy. Extruded bedding mortars and base-coat plasters have gravel-sized aggregates, while finish layers have a larger proportion of lime combined with fine to medium sands (Conservation Associates, 2012). On the main block of the Concepción church, there appear to be three distinct exterior plaster layers: a base-coat and up to two finish layers over a bedding mortar extruded from the joints and struck off to level defects in the ashlar blocks. On the bell towers, there are typically two plaster layers consisting of a base-coat and a finish (see Figure 8.3).

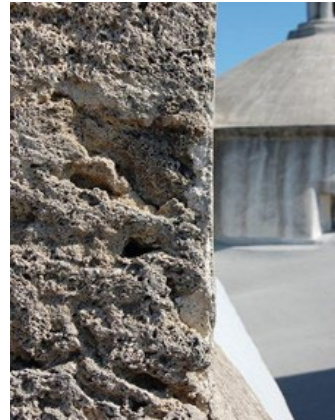
Figure 8.3: This loss at the southwest corner of the north tower reveals a plaster stratigraphy consisting of an extruded mortar that fills joints, a base-coat plaster that levels larger voids, covered with a thin finish coat forming a beautifully executed corner. On the bell towers, there are typically two distinct plaster layers; on the main block, there are two to three. (Conservation Associates, 2012)

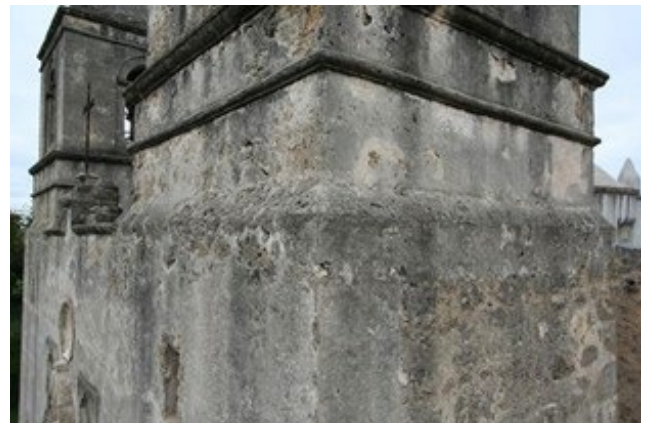
Figure 8.4: Weathering of the plaster on the south facade of the south tower at Mission Concepción church is severe on north-facing exposures, less so on the south. The south facade plaster on the south tower, seen here, is approximately 77% intact, including several surviving fragments on the chamfered tower pedestal, while there are large losses in the same zone on the west facade. Note the large losses in the frieze, many of them located below gaps in the moldings and other horizontal elements, resulting in water infiltration, detachment and loss of the plaster, and concentrations of biological growth along these paths.

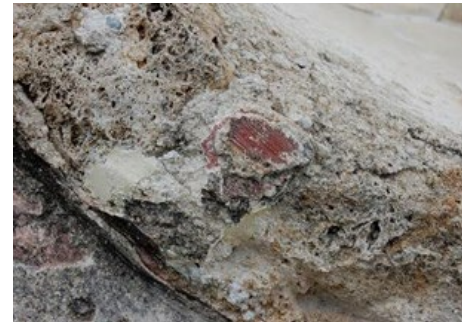
Plaster deterioration conditions captured in this photo are typical of those found on the west façade: partial loss of finish layers, erosion of base-coat plaster, and exposure of tufa masonry units; separation of finish layers from each other and/or the substrate; friable base-coat plaster with large round caliche aggregate (just above the painted fragments); and biological growth on the surface. Previous repairs (center left and upper right) overlap the colonial plasters and have a noticeably different color and texture. (Conservation Associates, 2012)

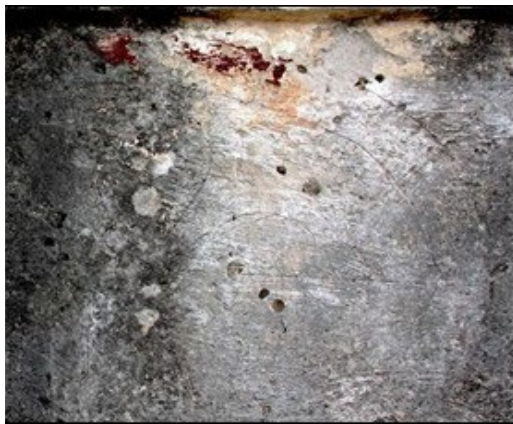
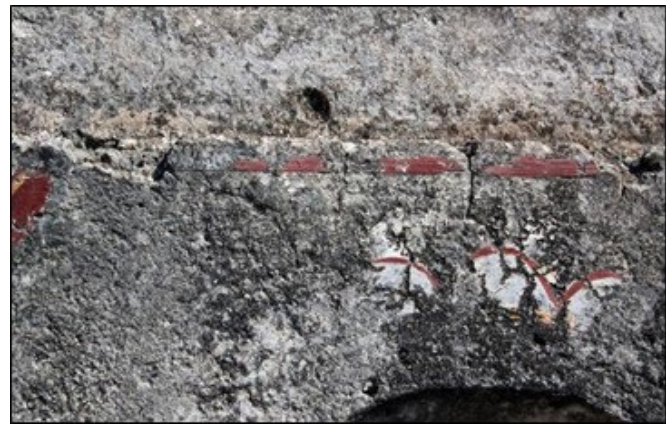
Figure 8.6: Details of the incised and painted decorative elements on the Mission Concepción church. Incised lines served as a preparatory drawing of sorts, and paint was applied to the dry plaster (*fresco secco*). Analysis of paint samples taken from the primary façade and bell towers indicate the paints are essentially oil-based, and the pigments include red and yellow ochres, charcoal black, and calcium carbonate. The incised and painted diamonds and oval patterns in tower friezes (left) are still visible on the south façade of the south tower, although the paint has largely been lost. There is a similarly decorated band above the belfry windows and on the north interior wall of the convento at Mission San José. On the right is a detail of the incised and painted floral designs on the primary facade of Concepción. (Conservation Associates, 2012)

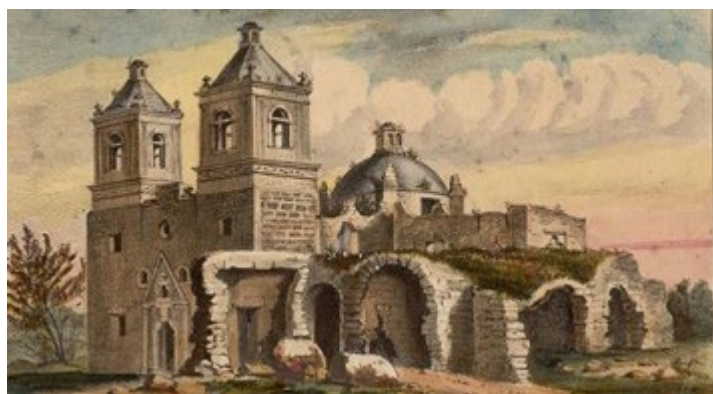
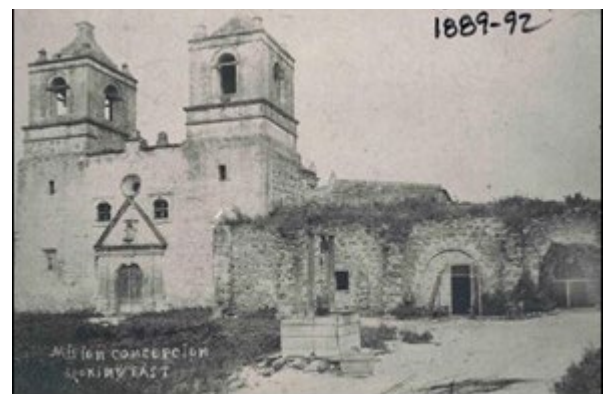
Figure 8.7: In a lithograph based on a c.1847 drawing by Edward Everett of Mission Concepción, there is painted decoration in both panels of the tower bases, the painted pilasters are visible on belfry façades, and the floral decoration of the central pedestal on the west façade can just be seen, though not in detail. Archival documents like this one are useful for determining the location and extent of decorative plaster, and evaluating change in condition and integrity over time. (Texas A&M University, Cushing Memorial Library, Edward Everett Collection)

On the right, many of the existing deterioration patterns are already apparent in this c.1890 image, including plaster losses along the tower chamfer and pedestals, extensive losses on the west façade near grade, the distinctive erosion patterns around the oculus and below the north tower window, and discoloration of the limestone portal to the bottom of the faceted door arch. Note the painted decoration below the central pedestal of the parapet wall and the missing north finial. (8B: NPS 7-81; Catholic Archives, Austin, TX)

treatment reports (see Figure 8.7). Also needed are means of documenting the location and distribution of the surviving plasters and surface features, and the type(s) and extent of deterioration. Methods we have used with good results include: high-resolution rectified photography, repeat photography, infrared thermography (IRT), and reflectance transformation imaging (RTI). Architectural drawings, high-resolution photographs, and images from LiDAR scans can serve as templates for mapping condition information. At Mission Concepción, a field team annotated high-resolution images, working in a grid of 4 square-meter units (see Figures 8.1, 8.8 and 8.9).

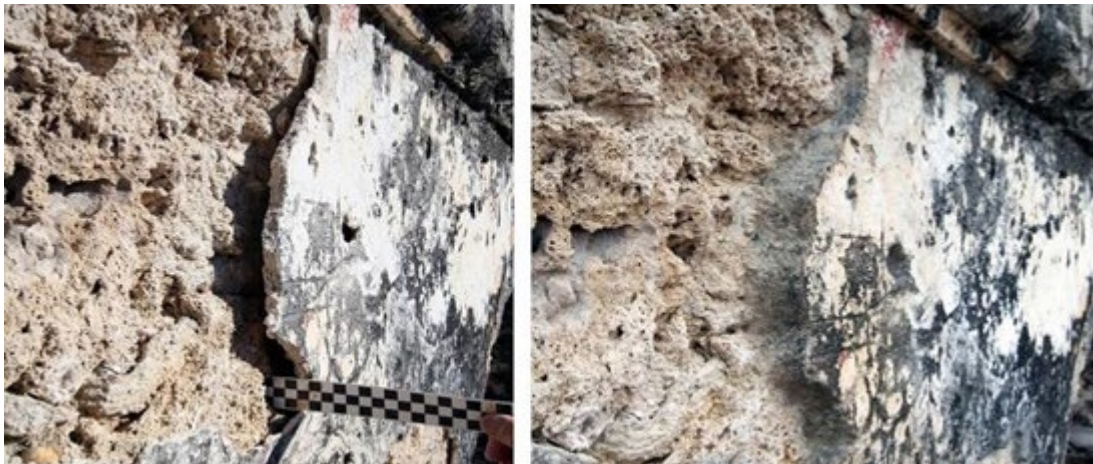
Figure 8.10: Before (left) and after emergency stabilization (reattachment by grouting and edging of the fragment) of the south tower belfry arch, west elevation. The plaster was buckling and detached, with a void over 25 centimeters deep. The fragment was secured in place by injection grouting; the applied edging mortar supports the edges of the fragment and was toned to blend with the patina of the existing plaster. In a later phase of treatment, a compensating plaster will be applied over the exposed masonry. (Conservation Associates, 2012)

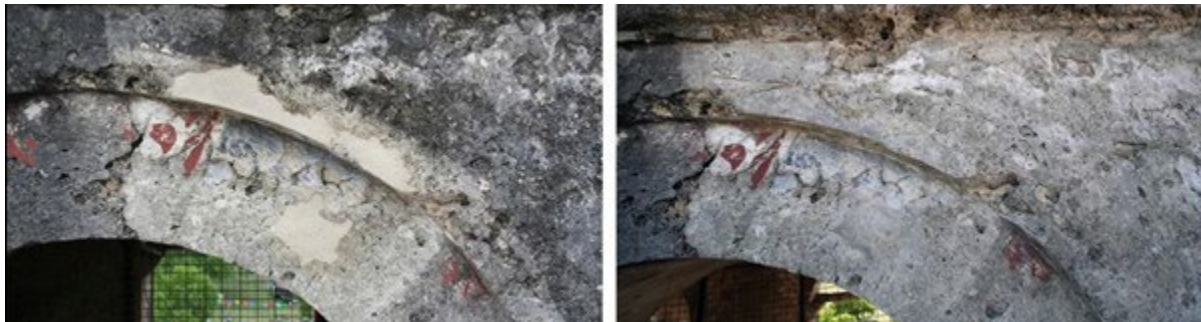
Figure 8.11: At left, loss compensation using a hydraulic lime-based repair mortar on the belfry arch, south tower, east elevation. The filled loss at the belfry window arch reestablishes the shape of that element; this fill is ready for toning. At right, the fill was toned while still wet to match the color of the surrounding plaster. As part of this pilot treatment, a portion of the historic plaster was cleaned; over a period of five years or so, cleaned surfaces were re-colonized by surface biota (Conservation Associates, 2013)
