Riparian Condition Assessment for Big Sandy Creek *Sand Creek Massacre National Historic Site, Colorado*

Natural Resource Technical Report NPS/WRD/NRR—2014/788

March 2014

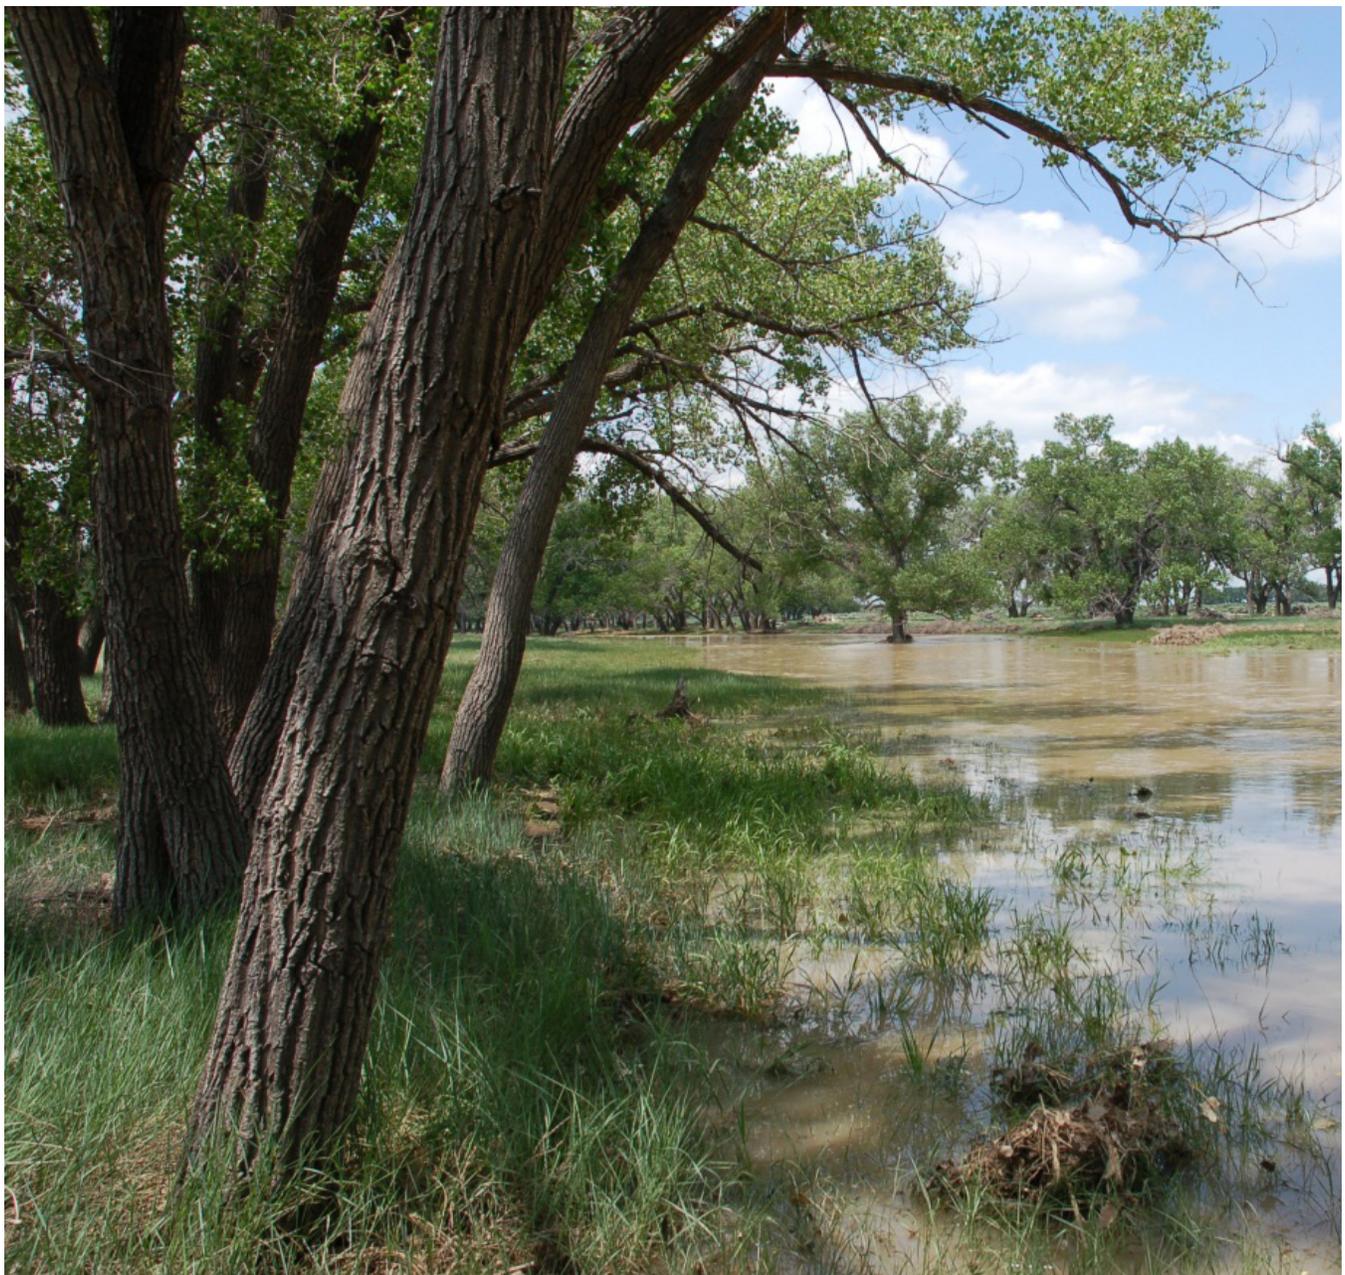
ON THE COVER:

Big Sandy Creek at flood stage, May 2007.

floodplain is inundated at its potential frequency (see cover photo).

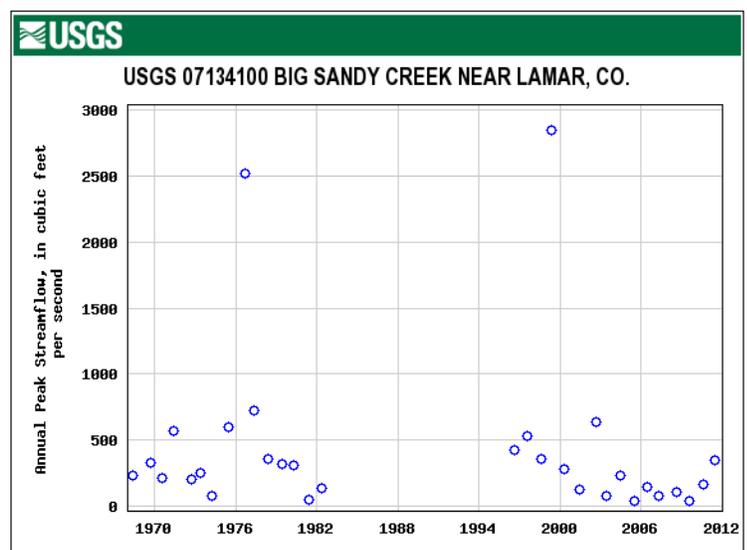
About 30 miles downstream of the park at Lamar, Colorado, the USGS has operated a gage on a perennial reach of Big Sandy Creek for about 30 years (gage #07134100, Figure 2). The record starts in 1968 and continues to the present, with a number of missing years from 1983 - 1995. The range of annual peak flows recorded by this gage is typically about 100 - 500 cubic feet per second (cfs), with an occasional peak around 500 - 700 cfs. For comparison, regional flood frequency equations developed for Eastern Colorado suggest that an “average” watershed of this size should have an annual peak of about 1700 cfs (Ries and Crouse, 2002). Consequently, Big Sandy Creek appears to be much less active hydrologically than other streams in this region. Only twice in the 30-year record did peak flow at the gage exceed the modest discharge value of 700 cfs, once in 1976 and again in 1999. Both of these flow events were large, exceeding 2500 cfs.

Figure 2 – Graphical representation of measured peak flows at the USGS gage located just upstream from the confluence with the Arkansas River near Lamar, CO.

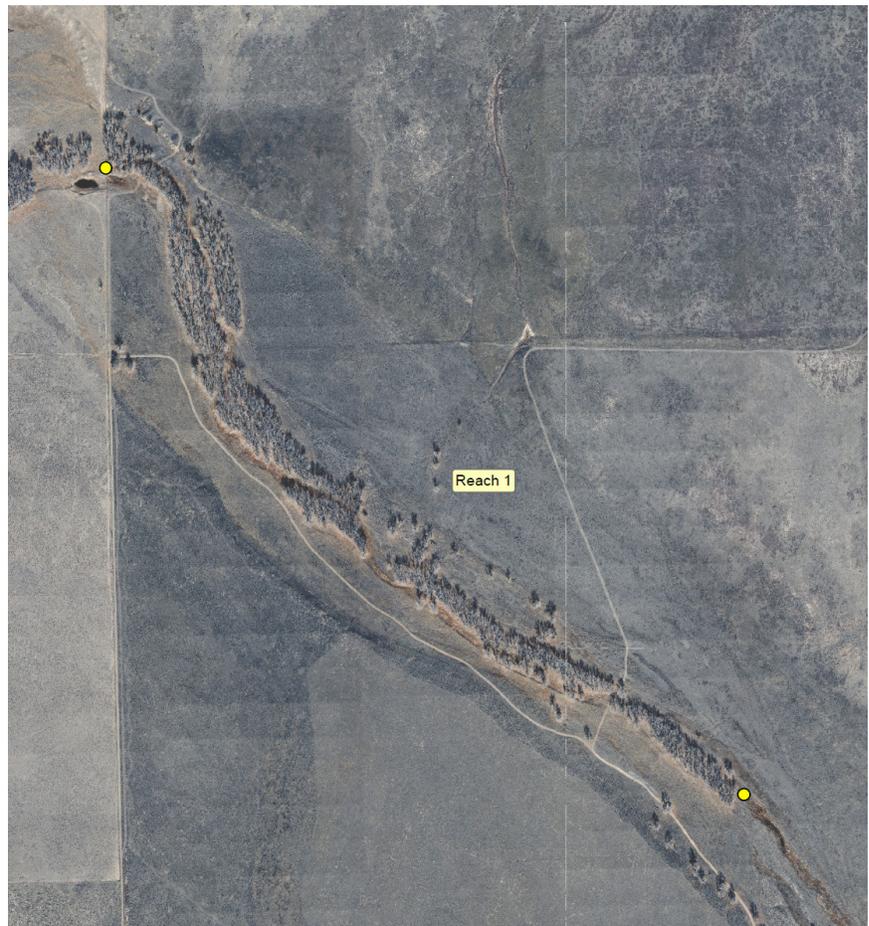
Figure 3 – Orthophoto of Reach 1. Yellow dots mark the upstream (upper left) and downstream (lower right) boundaries of the reach. Note the extensive stand of cottonwood trees and the evidence of some channel development.

The PFC Checklist results for Reach 1 and the comments supporting our responses to the 17 riparian assessment elements are found in Appendix 1. The Checklist shows that almost all applicable items received “yes” responses, which is usually indicative of a properly functioning stream reach. The only “no” response was item #6, which asks if there is an adequately diverse age-class distribution of riparian vegetation for maintaining a healthy system into the future. We answered “no” because there has been no cottonwood recruitment here since the 1950’s, and therefore no young trees exist to replace the older trees that will eventually die. But, given the nature of this site (cottonwood establishment events are on the order of several to many decades), this was not a reason to rate the site as anything lower than “Proper Functioning Condition.”

Checklist Item #7 asks if there is a diverse composition of riparian-wetland vegetation on this stream reach. With the exception of one willow tree (likely peach-leaf willow, *Salix amygdaloides*), plains cottonwood is the only woody riparian species in this reach. Although coyote willow is known to exist several miles upstream, there are no records for this species in the park. Despite the lack of woody species diversity, the team felt that the diverse, native herbaceous plant community in the channel and on the banks/floodplains is likely to maintain channel stability during all but extreme floods. For this reason we answered “yes” for item #7.

Two highly invasive, non-native species, prickly Russian thistle (*Salsola tragus*) and burning bush (*Kochia scoparia*), were observed in the channel in this reach, but neither is dominant except in small patches. These annual weeds do not have the soil-binding characteristics of the native herbaceous species discussed above, and they are difficult to eradicate once well-established. We encourage park staff to continue

to control these species in the riparian zone before they spread further and displace beneficial native species.

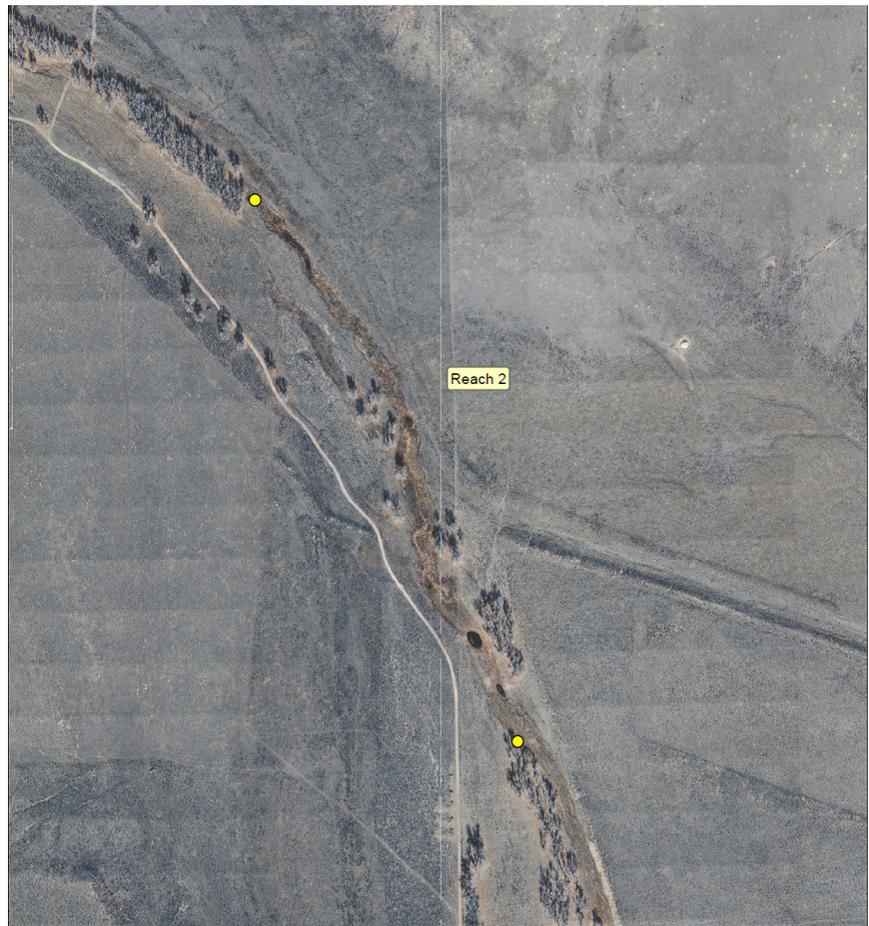
Figure 4 – Orthophoto of Reach 2. Note the relatively sparse cottonwood stands and the trace of the Chivington Canal in the right center of the image.

Reach 2 begins at the downstream end of the riparian forest in Reach 1 and continues downstream for about 2100 feet (Figure 4). We considered this reach distinct from adjacent stream segments due to a somewhat greater degree of channel development and relatively few cottonwood trees. The channelization is not great, with only about 2-3 feet of depth relative to more common channel depths of less than 1.5 feet in other reaches. This reach also includes the site of the former diversion dam and the intake to the Chivington Canal. It is unclear whether these channel alterations caused the slight channel incision seen in parts of this reach, but even if so, the geomorphic effects are not great. There are also several small excavated ponds along the reach

that are part of the cultural landscape at SAND. We did not consider these ponds to be a threat to the stability or detrimental to the functional condition of this reach.

Within the slightly incised channel, sinuosity associated with channel meandering is establishing with formation of point bars and cutbanks, indicating vertical stability. Additionally, the formation of these fluvial features results in a widening riparian-wetland zone at this lower elevation. In spite of the slightly greater degree of channelization along this reach, there is substantial evidence of flood debris on the adjacent floodplain, indicating that flood flows are still able to spread onto the overbank areas.

The PFC Checklist results for Reach 2 and our supporting remarks are found in Appendix 2. As with Reach 1, the assessment team rated Item #6 as a “no” due to the lack of a recruitment age class of cottonwoods. Cottonwood was again the only woody riparian species, and stands in this reach were relatively sparse. A diverse, vigorous, soil-binding herbaceous plant community in the channel and on the streambanks and floodplain is likely to maintain channel stability in frequent to moderately large floods. The small ponds

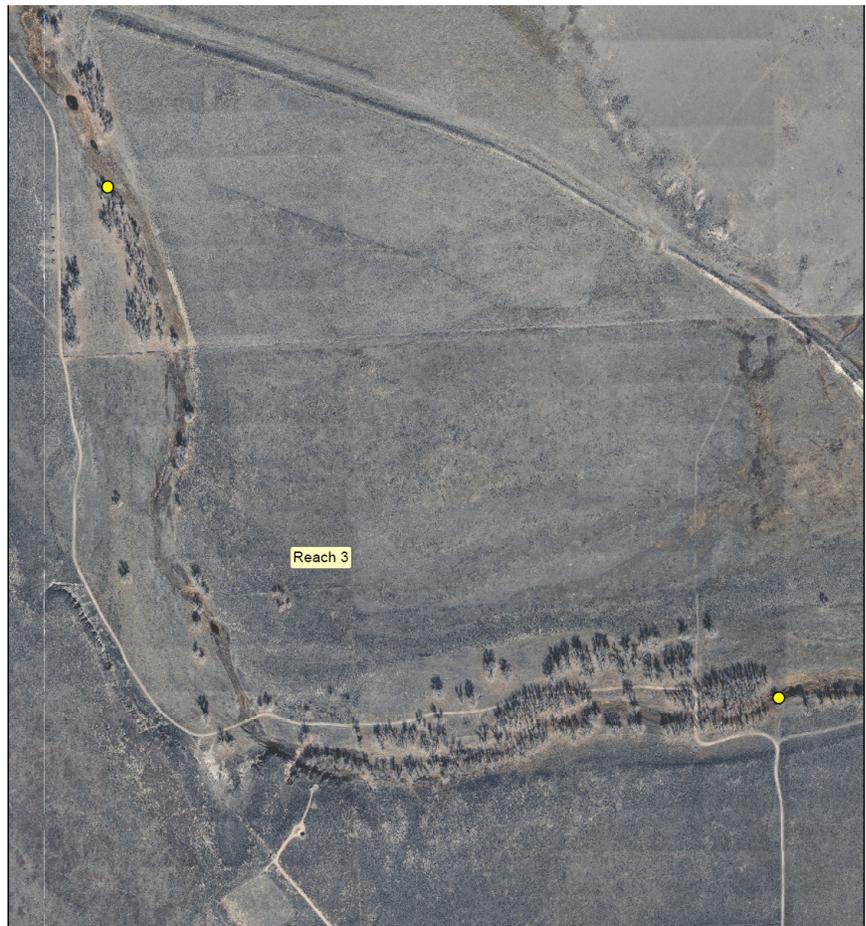
Figure 5 – Orthophoto of Reach 3. Note the presence of cottonwoods both as thick stands and individuals. The reaches immediately upstream and downstream have much less woody vegetation.

The PFC Checklist results for Reach 3 and our supporting remarks are found in Appendix 3. As with Reaches 1 and 2, the lack of a recruitment age class for cottonwoods was the basis for a “no” response for Checklist Item #6 (our only “no” response for this reach). However, also as with Reaches 1 and 2, a diverse, native herbaceous riparian plant community in the channel and on the banks and floodplain provides superior soil stabilization. This is likely to maintain channel stability in frequent to moderately large floods. Buffalograss (*Buchloe dactyloides*) covers 70-100% of the channel bottom in a few small areas. This species does not have deep or massive roots capable of withstanding flood flows, but it is only a small component of the cover in this reach and it is not considered a threat to overall channel stability.

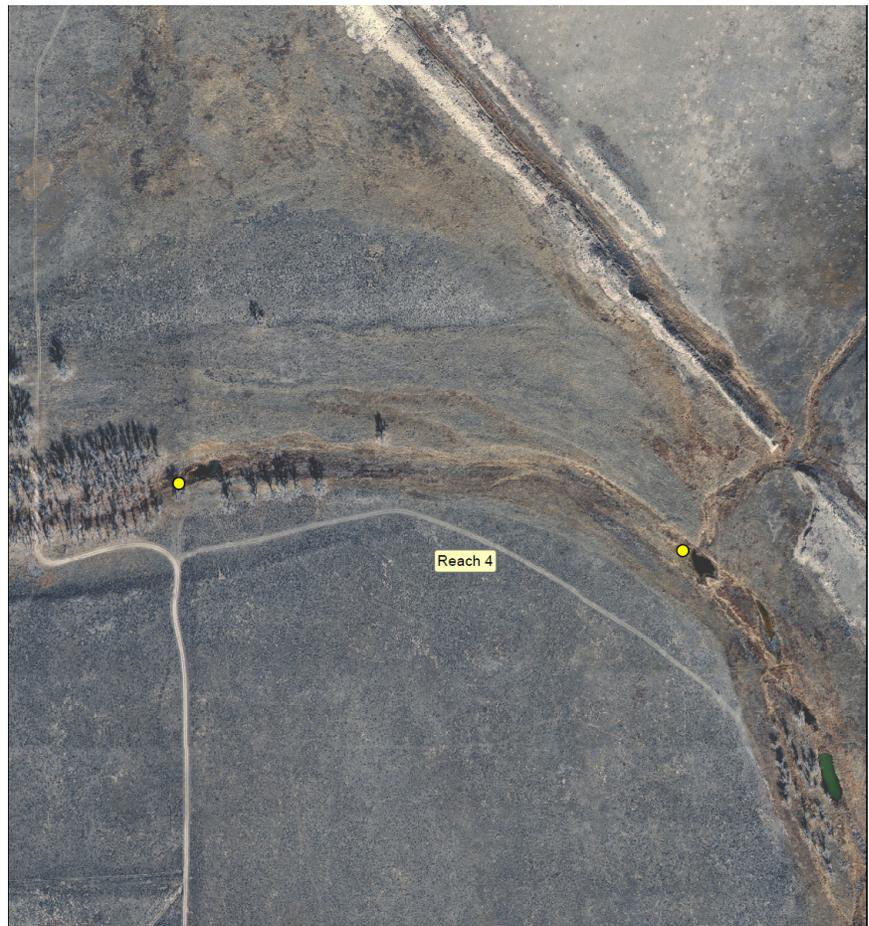
Figure 6 – Orthophoto of Reach 4.

Reach 4 of Big Sandy Creek differed from adjacent reaches due to the almost complete absence of cottonwoods and a general lack of distinct channel development (Figure 6). The PFC Checklist results for this reach and our supporting remarks are found in Appendix 4. The channel in this reach is mostly “on grade” and is more of a wide, variable elevation, vegetated swale than a distinct channel/floodplain configuration. The floodplain is generally less than 1.5 feet above the top of the swale banks, and relatively recent flood debris above the banks indicates that the
