CULTURAL LANDSCAPE REPORT FOR ARMORY SQUARE

SPRINGFIELD ARMORY NATIONAL HISTORIC SITE

Olmsted Center for Landscape Preservation
National Park Service, Boston, Massachusetts, 2010

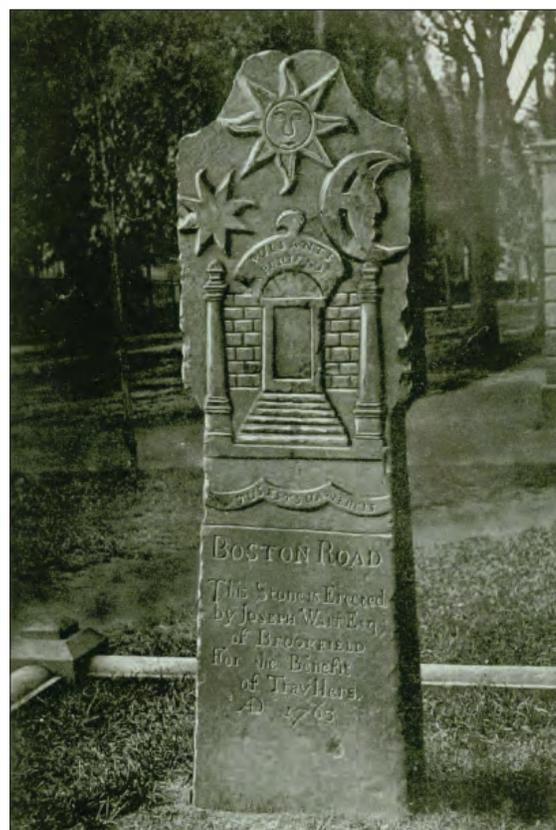
Figure 1.4. Captain Joseph Wait installed this road marker in 1763 to clarify the direction of Boston Road. Carved out of East Longmeadow redstone, the marker was originally placed facing south at the southeast corner of Armory Square. When the ornamental fence was installed in the mid-1800s, the marker was moved further east across Federal Street. A replica is now being constructed to be installed in the original location. SPAR Museum Archives, Box 012, Folder 01, NEG 674-SA.

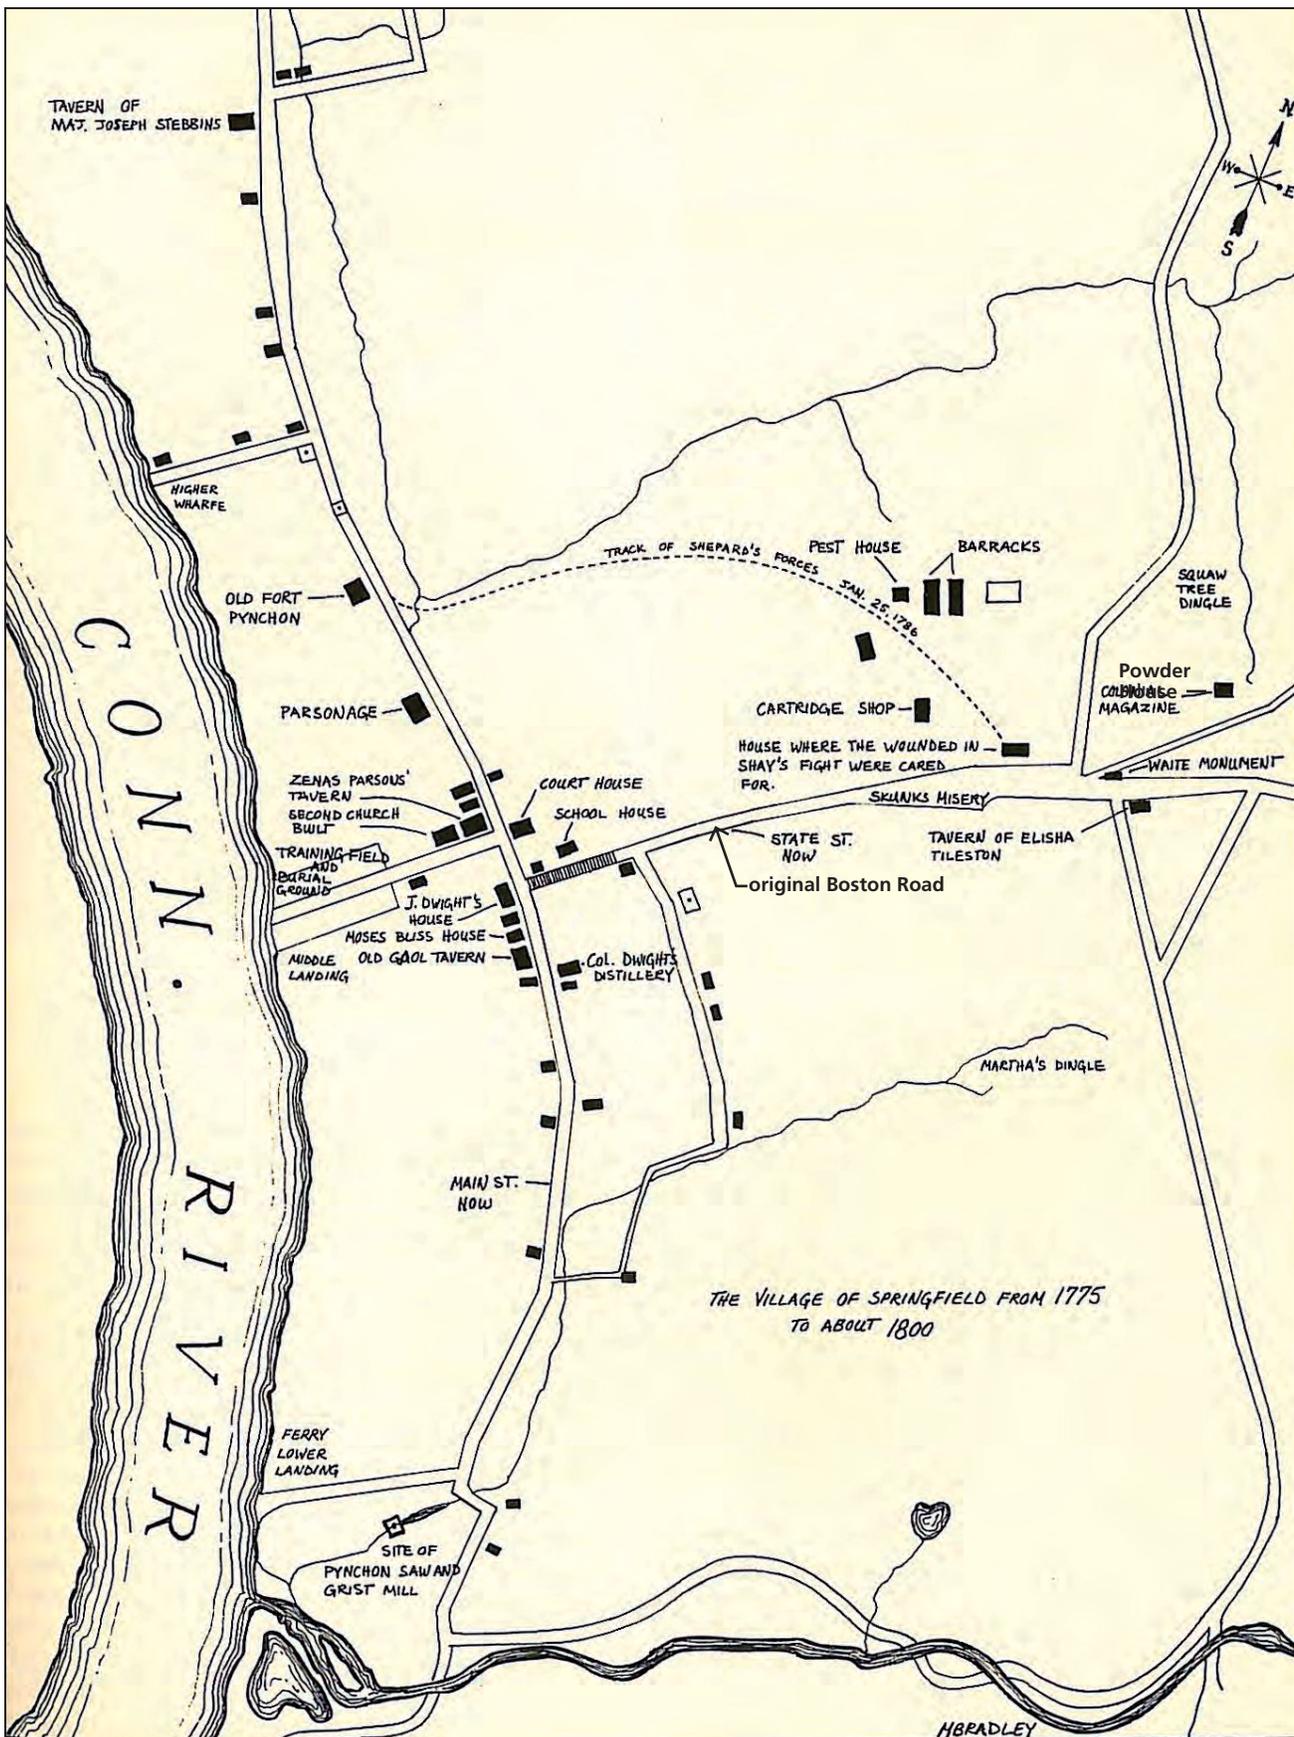
Figure 1.5. "The Village of Springfield from 1775 to about 1800." This map illustrates the layout of the earliest structures associated with Springfield Armory and it also depicts the route taken by Colonel Shepard's troops to thwart the attempted raid by Shays and his men. Illustration from *At the Crossroads, Springfield, Massachusetts, 1636 - 1975*, Frank Bauer.

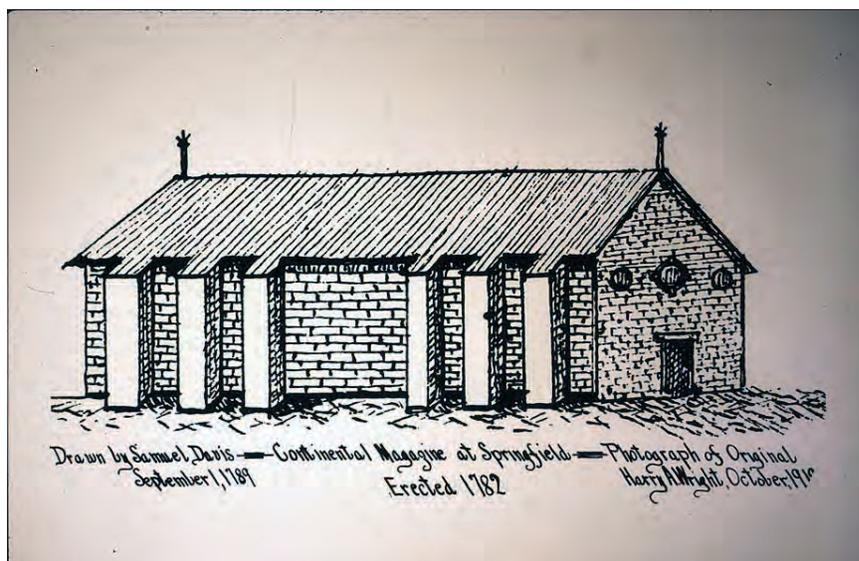
Figure 1.6. Sketch of the magazine built in 1782 on the former training field outside of Springfield. Powder was stored here for sixty years until it was taken down because of encroaching residences and public buildings. SPAR Museum Archives, Box 011, Folder 06, NEG 4514-SA.

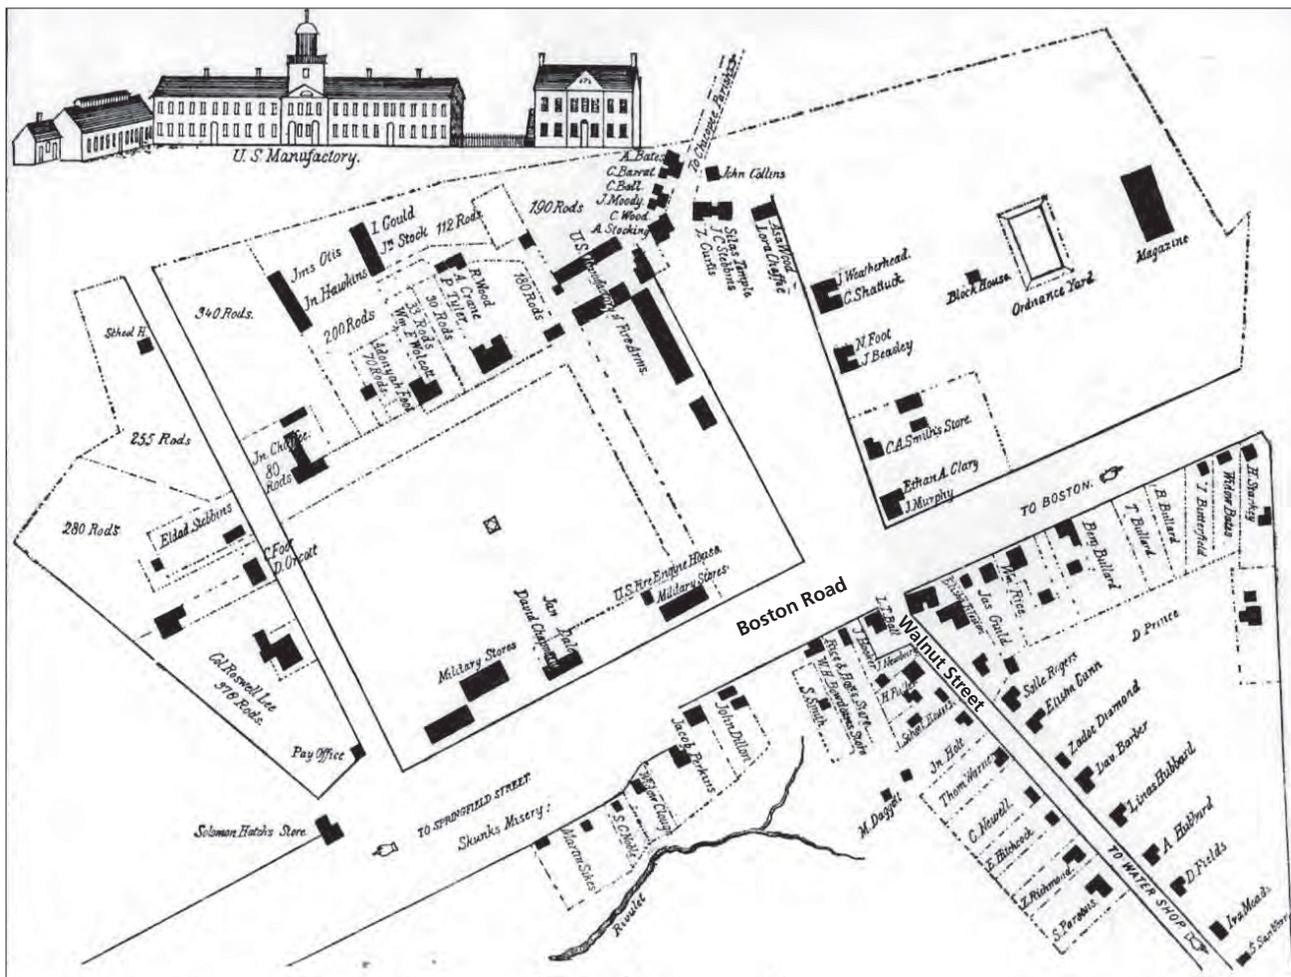
Figure 1.7. Plan of Army Square, referred to as Army Hill, circa 1810. The arrangement of buildings began to define what would become the Green. SPAR Museum Archives, Box 020, Folder 02, NEG 6570-SA.

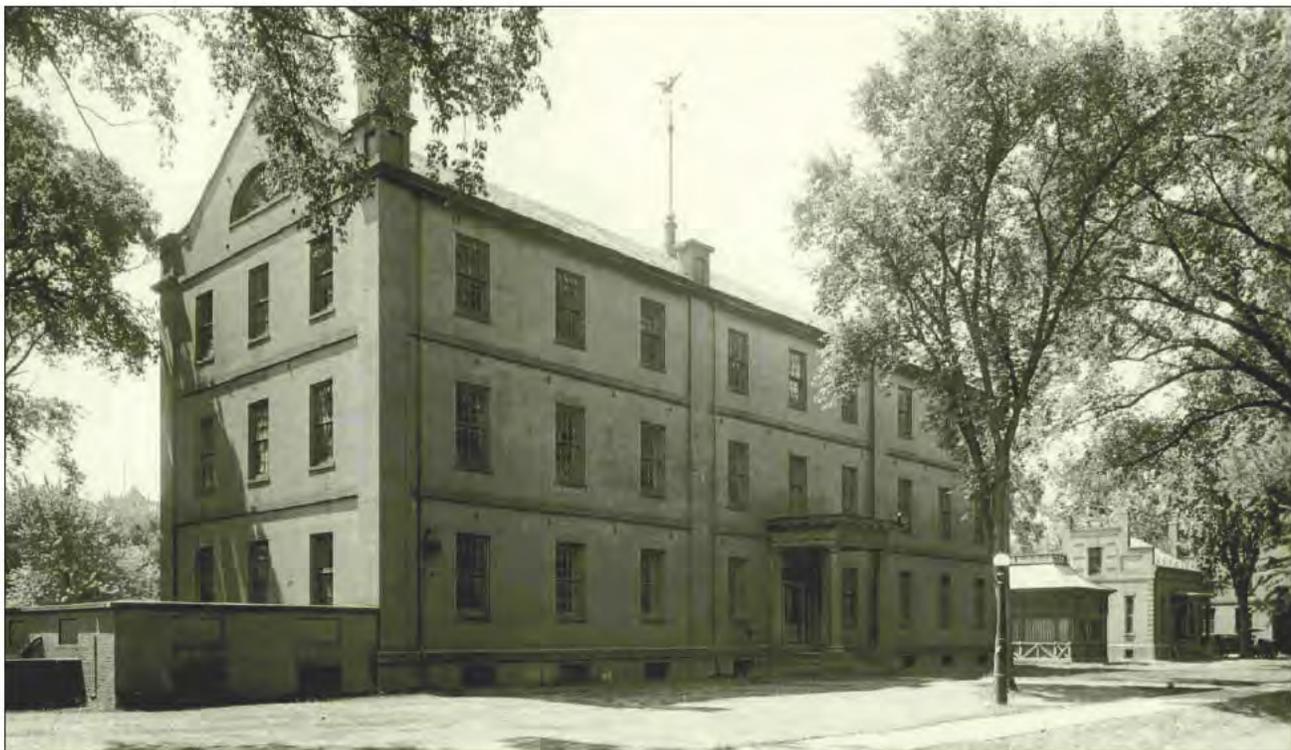
Figure 1.13. Middle Arsenal, completed by Superintendent Roswell Lee in 1830 and photographed here in 1925. Visitors, including Henry Wadsworth Longfellow, were able to view the stored stacks of guns in this Georgian style building. SPAR Museum Archives, Box 004, Folder 05, NEG X1319.

In 1830, Lee completed construction of the Middle Arsenal at the southern edge of the Green (Figure 1.13). This storehouse was the first three-story structure on the site with an elaborate main doorway with a columned Georgian portico on the side away from Boston Road, as the buildings about the square were originally planned to face the center.⁵⁰ Georgian designs were noted for incorporating classical orders of architecture in simple and balanced proportions, using brick or stone materials. It was most likely at the Middle Arsenal where Henry Wadsworth Longfellow and his new wife visited the vast display of gun racks inspiring his poem "The Arsenal at Springfield." Lee had also initiated the construction of the Paymaster's and Master Armorer's residences, but did not live long enough to see their completion.

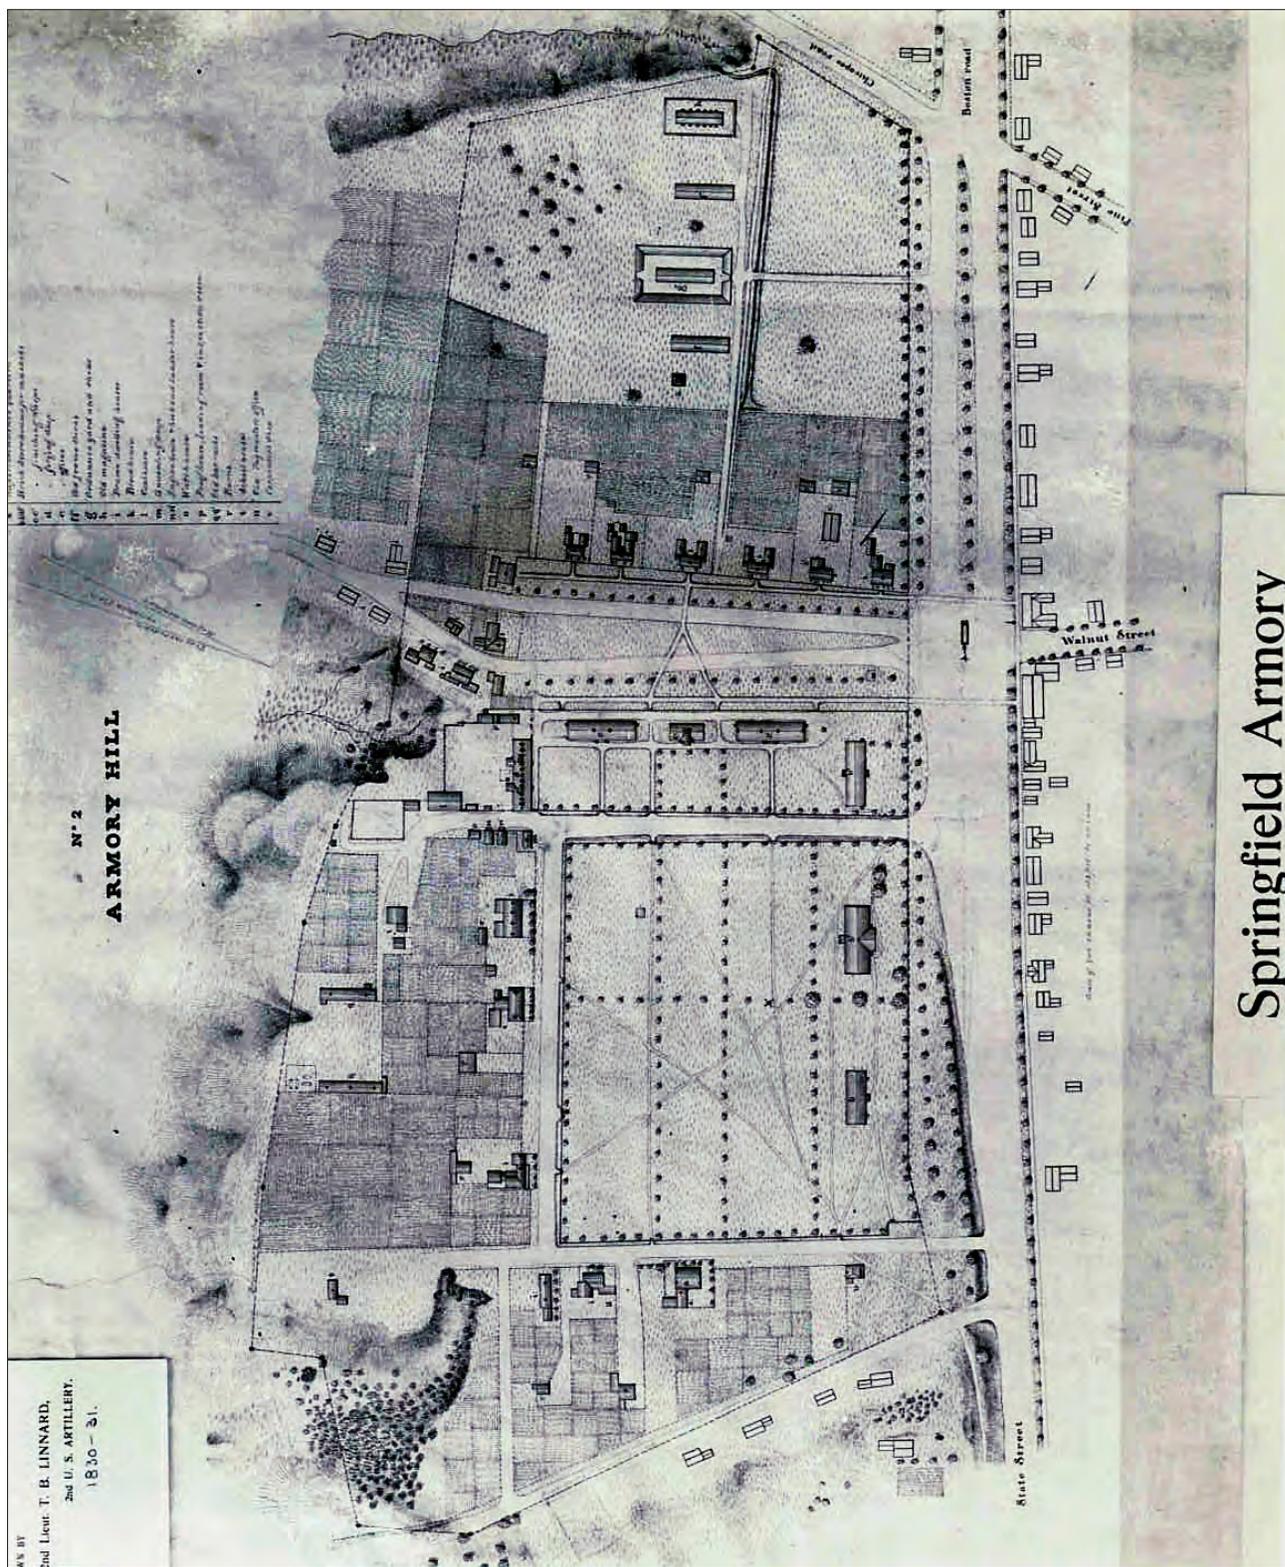
Figure 1.14. Plan of Armory Hill from 1830 illustrating the linear planting of trees on the Green as well as street trees and a planted median on State Street. Note the main road has two names, State Street and Boston Road. Walnut Street provided access to the Workshops. SPAR Museum Archives, Box 020, Folder 03, NEG X1464-SA.

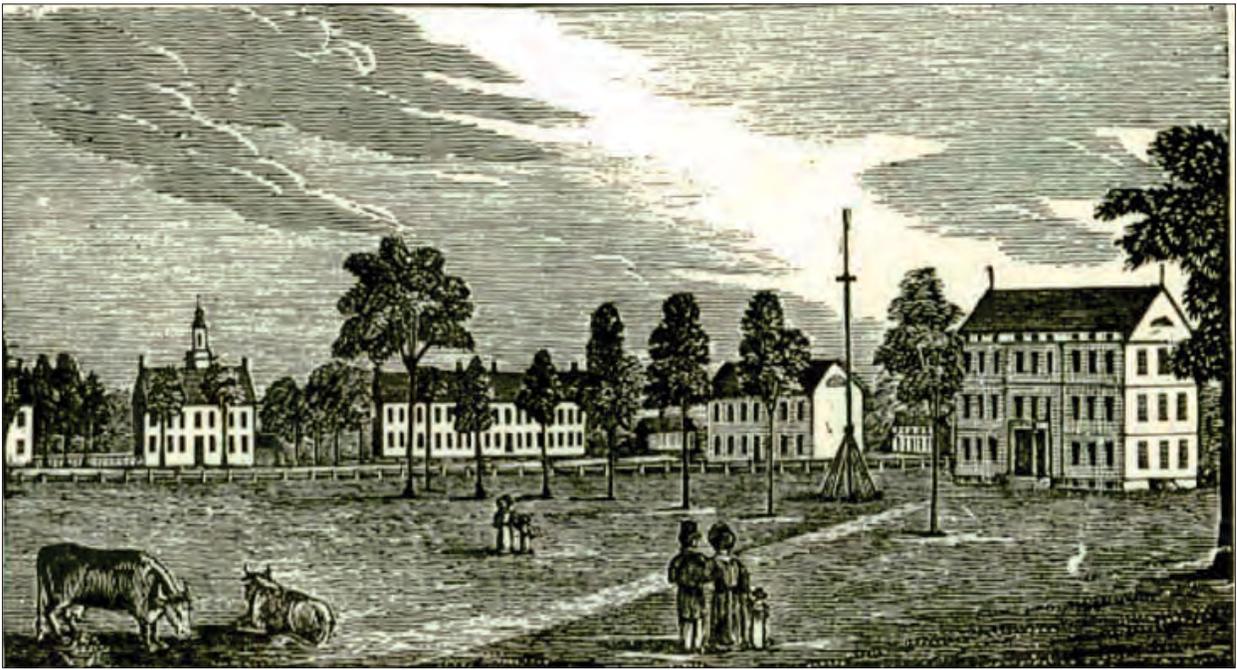
Figure 1.15. Wood engraving of the Armory in 1839, showing, from left to right, a portion of the North Shops, office and chapel, the South Shops, the East Arsenal and the Middle Arsenal. The Green is fenced in with cattle grazing to the left. A liberty pole also appears on the Green to the right. SPAR Museum Archives, Box 011, Folder 05, NEG.

Lee integrated the landscape with the overall layout of the Armory through extensive grading and planting. He oversaw the first large-scale attempt to drain the area around the bluff, especially along the top and bottom, where it stayed wet all year long and gullies tended to form. He also directed a major program of tree planting in straight, regular lines, enhancing the sense of formality in the Armory's layout. Within Armory Square, four parallel rows of trees on an east-west axis intersected with a row of trees on a north-south axis. Regularly spaced rows of trees also lined State Street. Lee's arrangement of structures and trees defined the Green as a permanent central open space and organizing feature of the Armory (Figure 1.14). A woodcut from the 1830s highlights the Green as a public amenity where people strolled, cows grazed and a liberty pole was placed in the center (Figure 1.15).

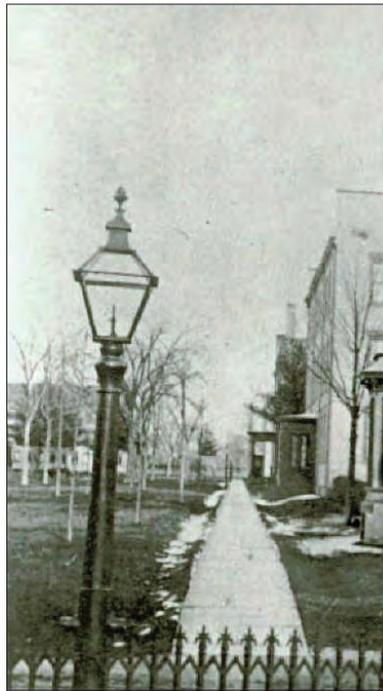
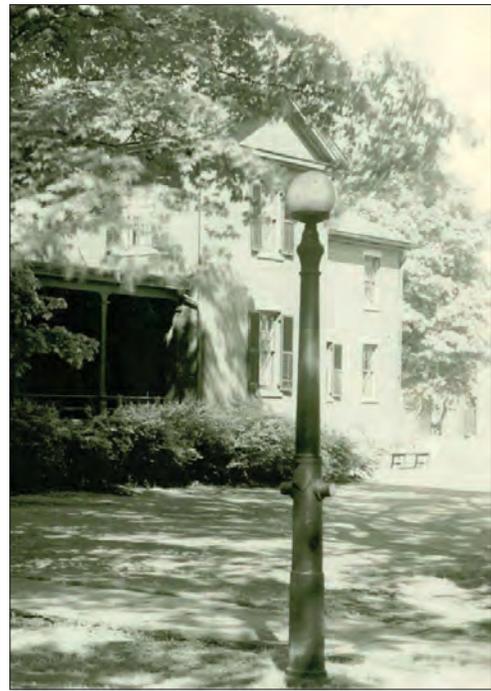
Figures 1.17, 1.18. Recalling cannon tubes, custom made iron lamp posts were installed in the mid 1840s under Ripley's administration. The image to the left appears to show the original glass urn-shaped lantern. The photograph to the right shows the replacement globe fixtures that were installed in the late nineteenth or early twentieth century. SPAR Museum Archives, Box 002, Folder 05, NEG and Box 002, Folder 07, NEG. 699-SA.

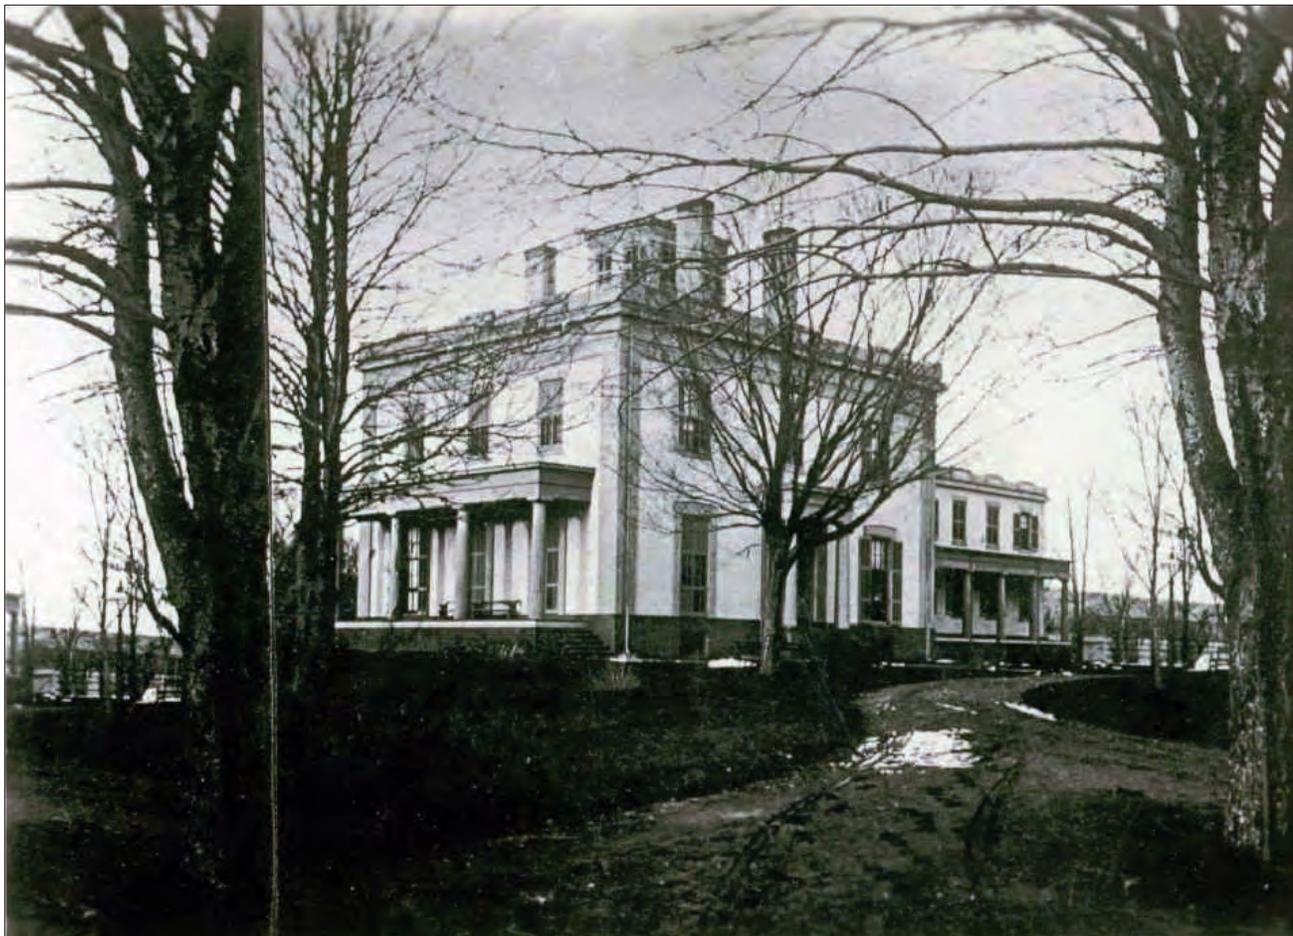
Figure 1.19. View of the Commanding Officer's Quarters in 1871. The building site took advantage of views out to Springfield and the Berkshire mountains beyond (to the left). Note the original Doric columned porches that were later replaced with iron porches. Also note the unpaved circular drive and the number of deciduous trees around the house and drive. SPAR Museum Archives, Box 001, Folder 06, NEG 700-SA.

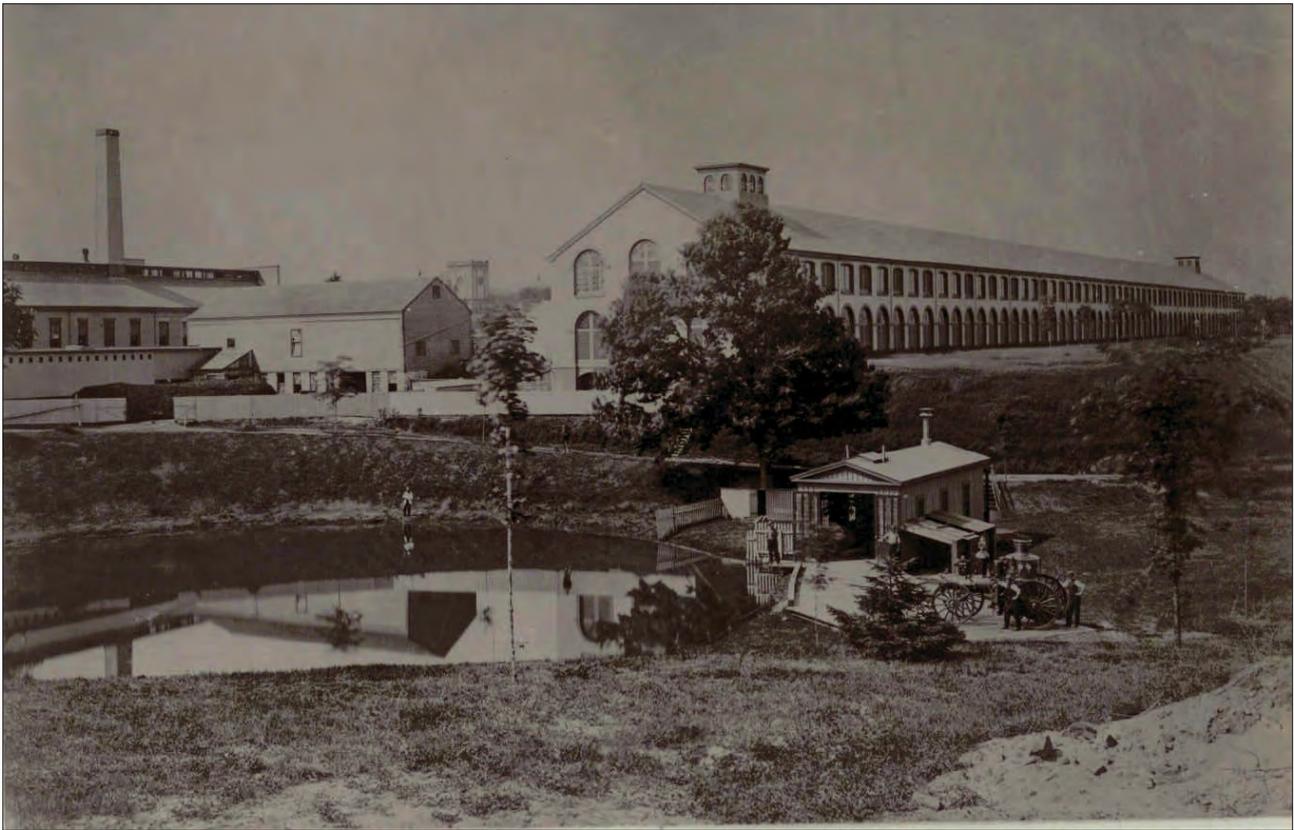
Figure 1.21. View of the Long Storehouse, completed in 1850. The fire house and reservoir in the foreground were constructed later in the 1870s. New trees were planted along the Long Storehouse and around the reservoir. The Main Arsenal tower is barely visible in the background. SPAR Museum Archives, Box 005, Folder 05, NEG 4856-SA.

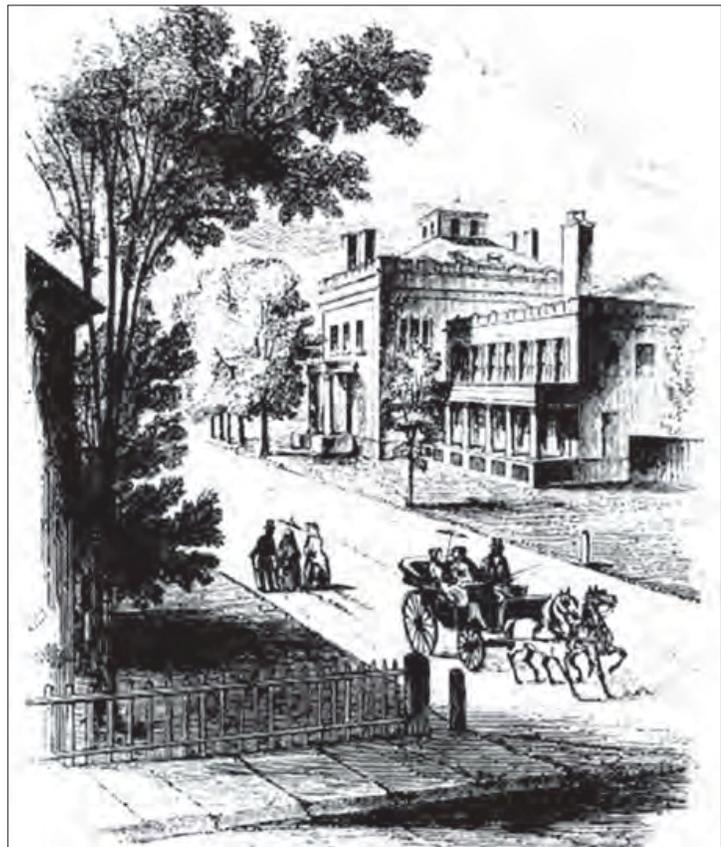
Figure 1.26. Rendering from 1852 of the Commanding Officer's Quarters. The Doric columns were later removed in 1870. Note the wooden picket fence and the sidewalk paved with flagstones. SPAR Museum Archives, Box 05, NEG 6570-SA.

In 1852, an article in *Harper's New Monthly Magazine* described the bucolic charm of the Armory grounds (Figures 1.25 and 1.26).

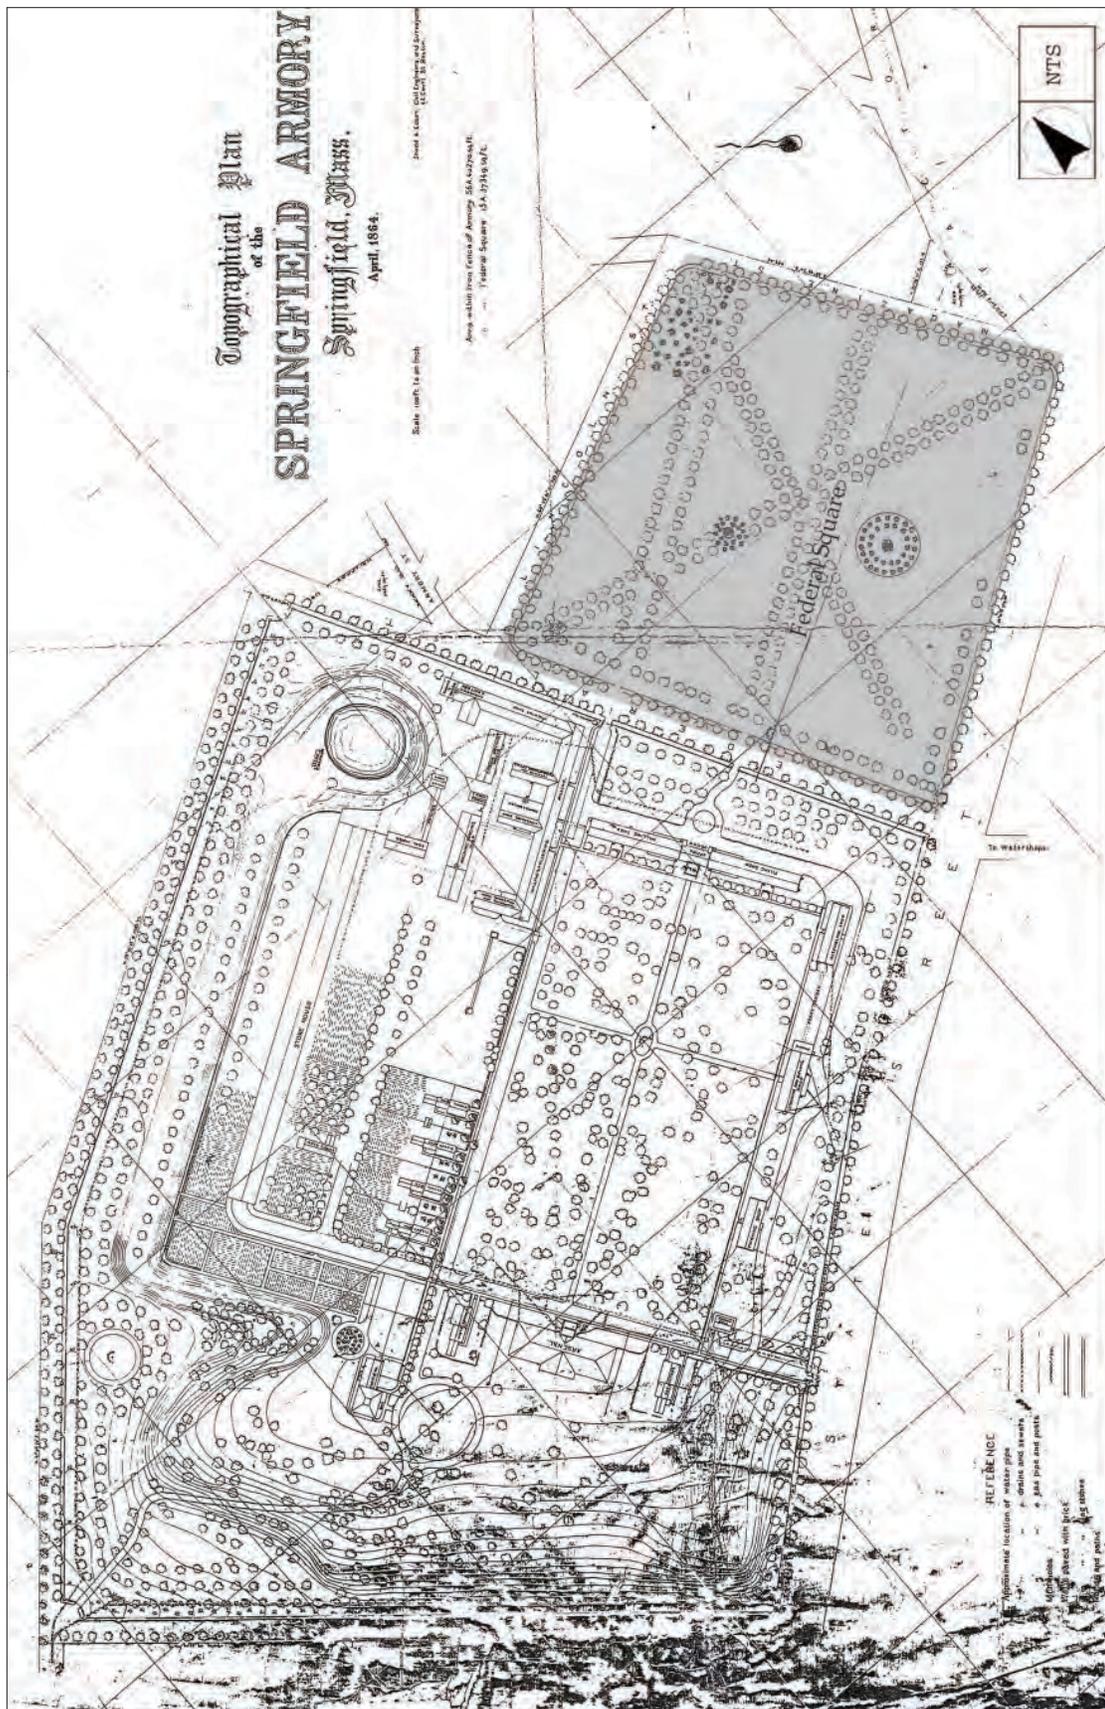
Figure 1.27. Topographic map of Armory Square from 1864, by Shedd & Edson, showing drainage layout including pipes, drain lines and manholes. Evenly spaced contour lines at the northern edge of the campus by Pearl Street illustrate ongoing grading efforts. SPAR Museum Archives, 11086-SA.

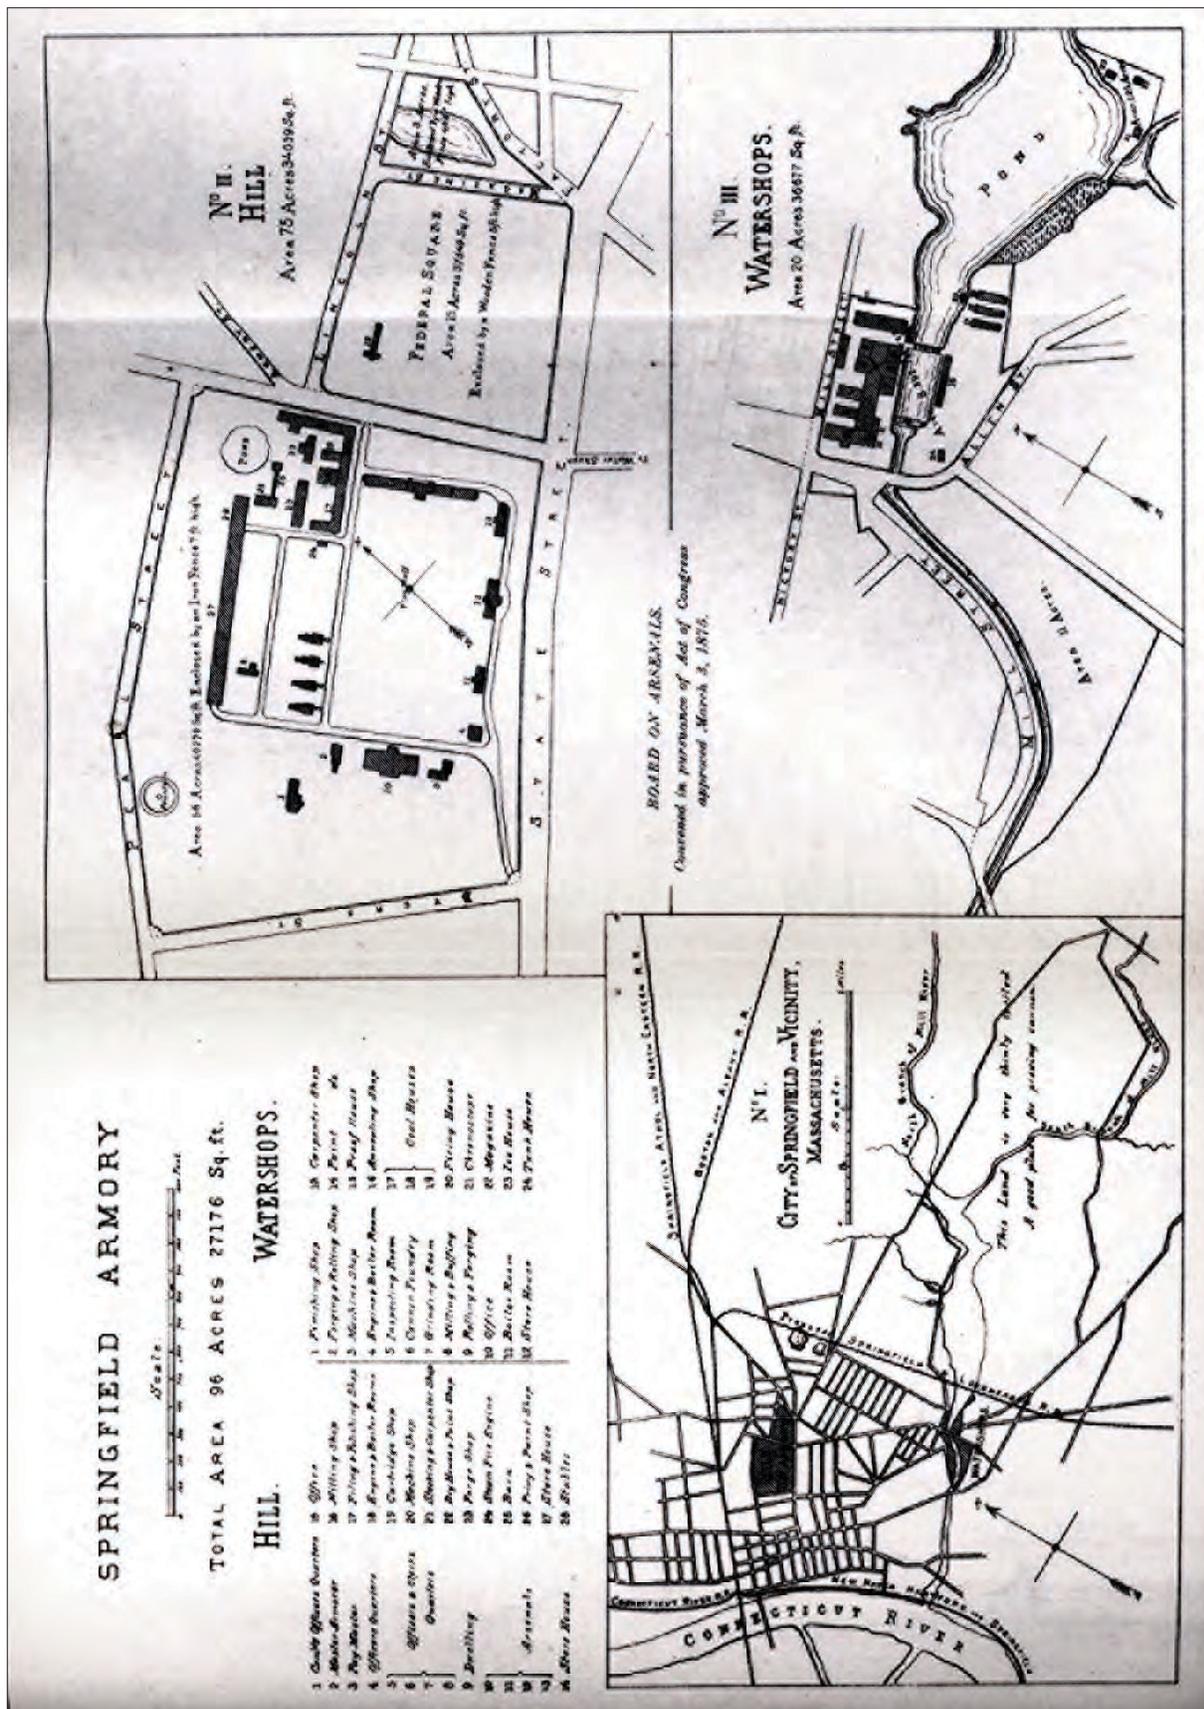
Figure 1.30. Maps of Armory Hill and Watershops from 1875. The map to the left shows the location of the Watershops in relation to Armory Hill. The Hill at this time comprised seventy-five acres. SPAR Museum Archives, United States Congress, "Report of the Chief of Ordnance," 1876, 37.

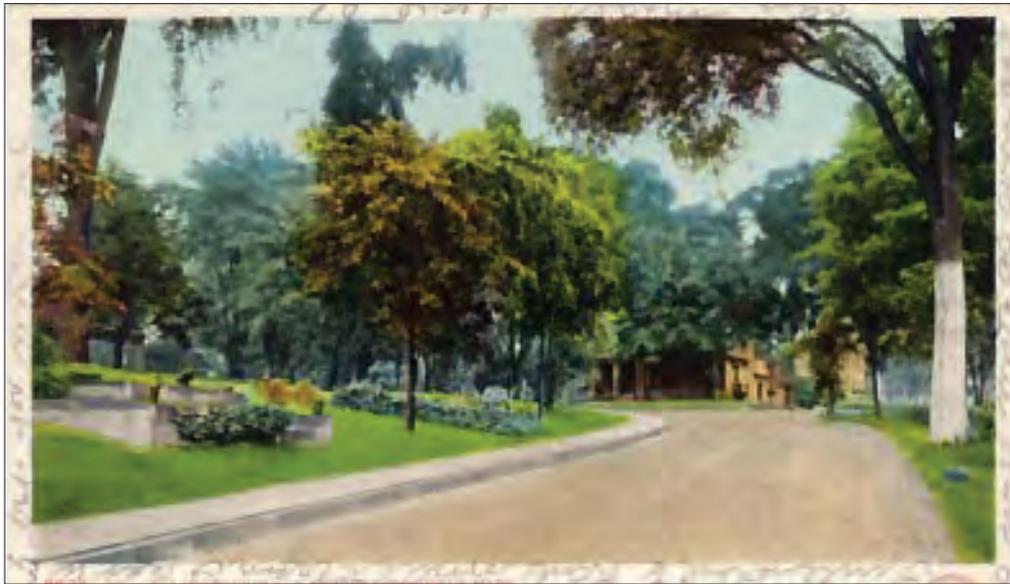
Figure 1.33. Early 1900s postcard of the entrance road from Byers and State Streets gate. A memorial, installed in 1876, is located on the left side of the road and framed by mature elms and young trees and shrubs. SPAR Museum Archives.

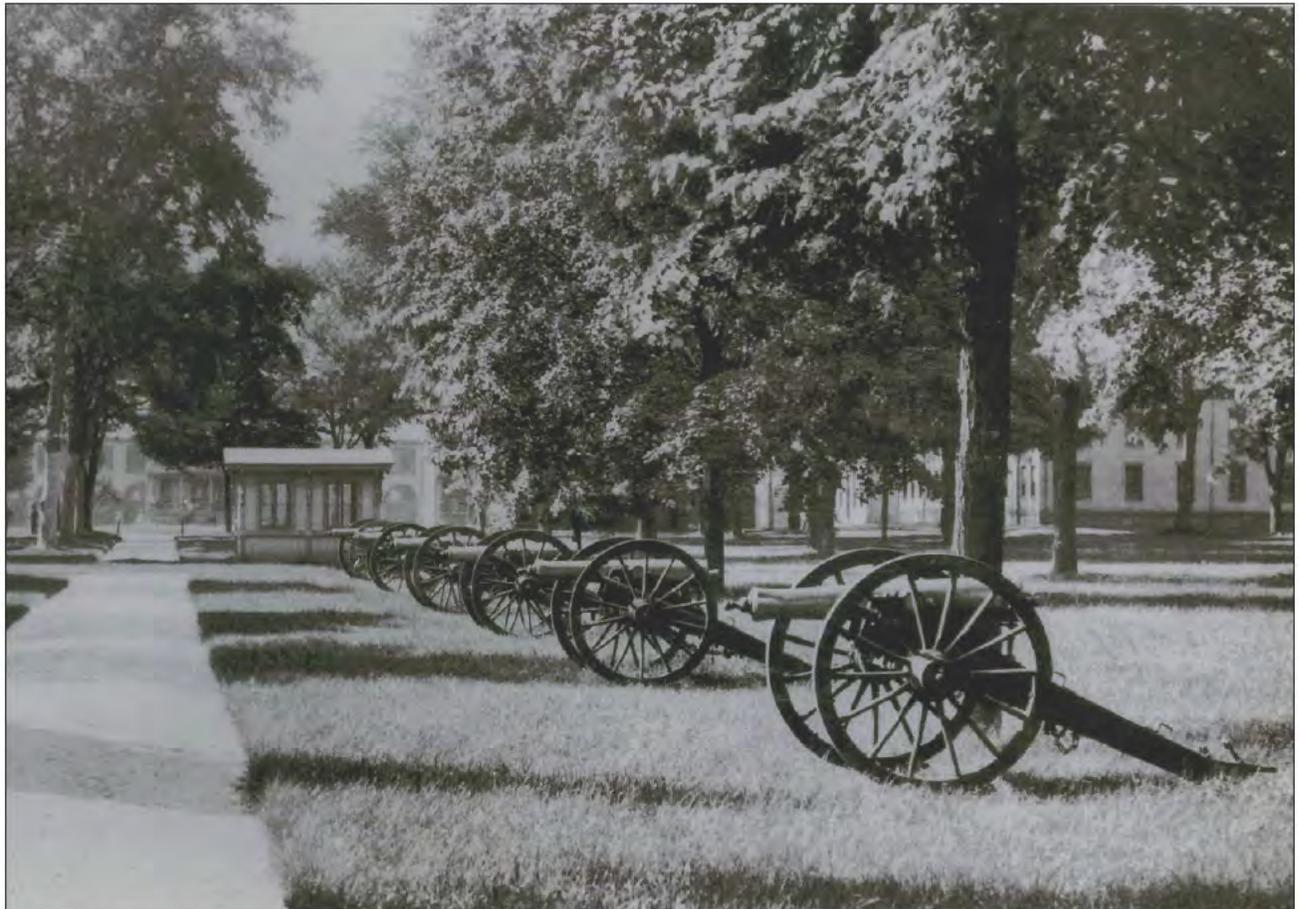
Figure 1.36. View of the Green in 1900 with line of cannons along the central walkway. A small structure appears beyond the line of cannon. The structure was referred to as a "Hose House" in 1910 and later as "Ammunition House" from 1918 until its removal in 1936. SPAR Museum Archives, Box 013, Folder 08.

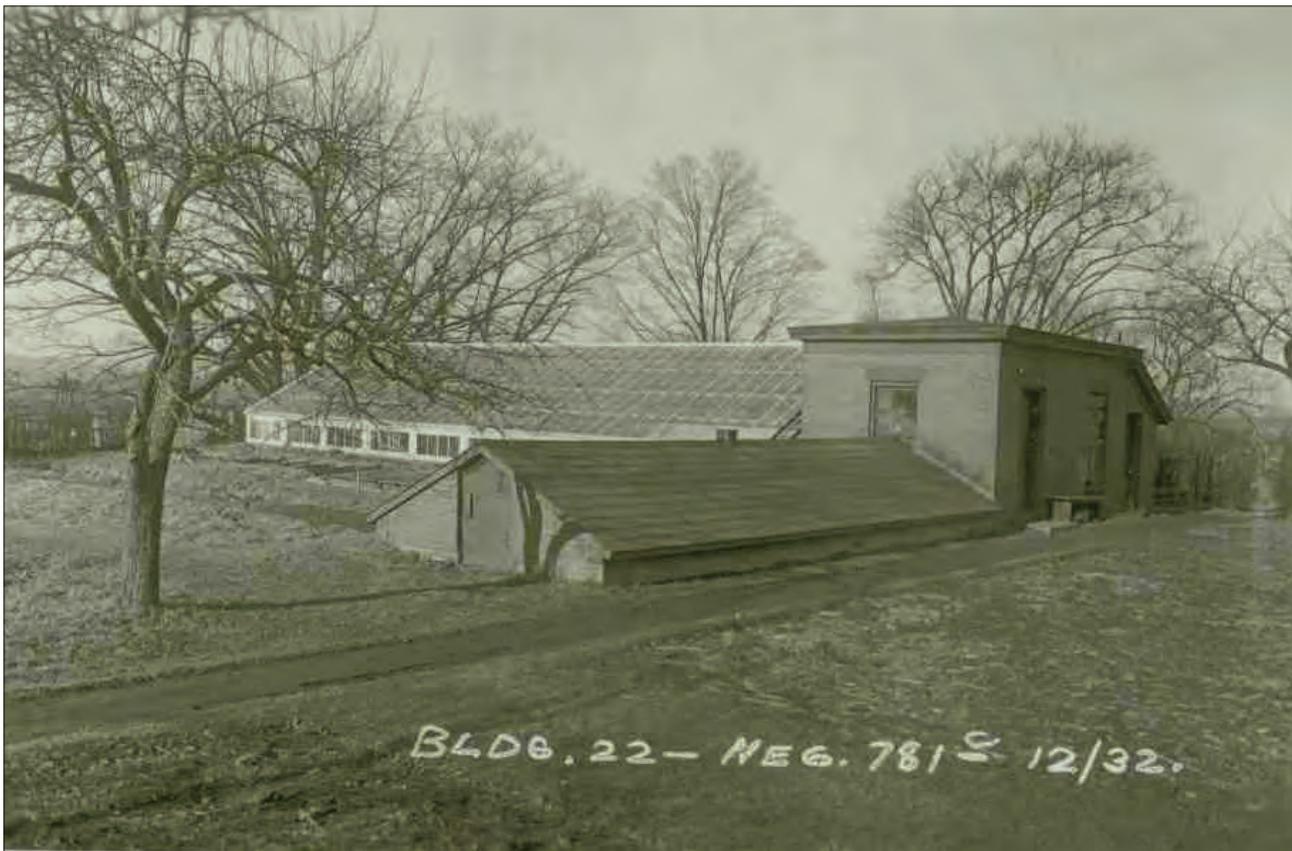
Figure 1.37. View of greenhouse and vegetable cellar northeast of the Commanding Officer's Quarters, 1932. Note the mature trees beyond the greenhouse. SPAR Museum Archives, Box 006, Folder 01, NEG 781-SA.

the Long Storehouse, providing plants for the gardens around the Officers' Quarters and the Commanding Officer's Quarters (Figure 1.37). Sometime between 1877 and 1882, the Master Armorer's Quarters were moved northeast of its original location, near the Long Storehouse.

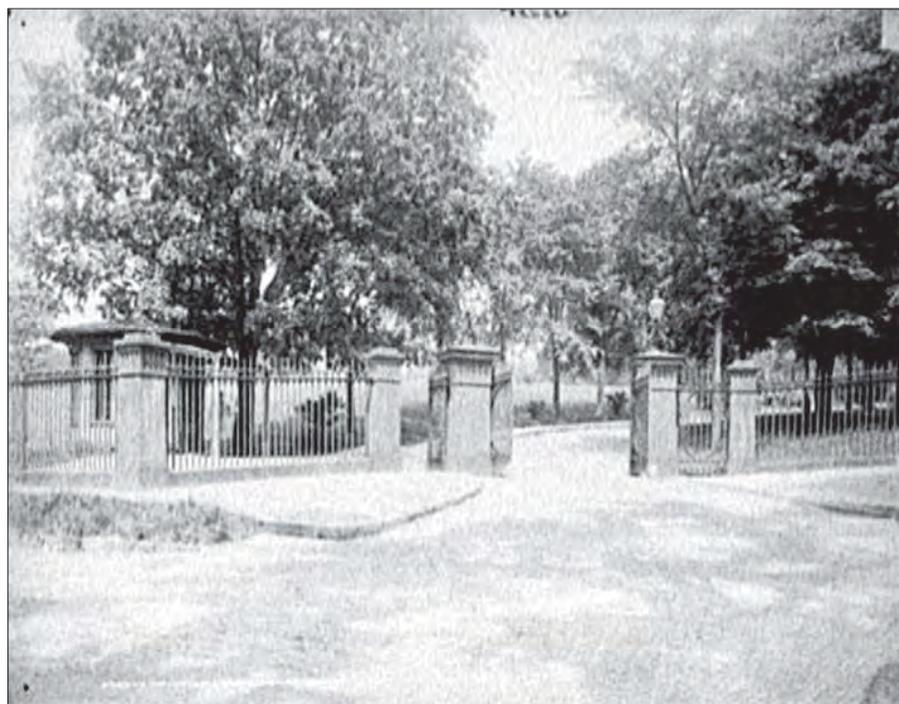
Figure 1.38. View taken in 1907 of gated entrance at the corner of Byers and State streets. Note the walkway along the left side of the drive and the light fixtures on top of the entrance gate piers. SPAR Museum Archives.

During the 1880s, Buffington also oversaw improvements to vehicular and pedestrian circulation. A new drive was built to curve around the south and west sides of the Main Arsenal and connect the road along the western side of the Green and east of the Main Arsenal to the circular drive in front of the Commanding Officer's Quarters. Around the same time, Buffington built a flagstone sidewalk from the Byers and State Streets gatehouse, along the north side of the entrance road to the Green (Figure 1.38).

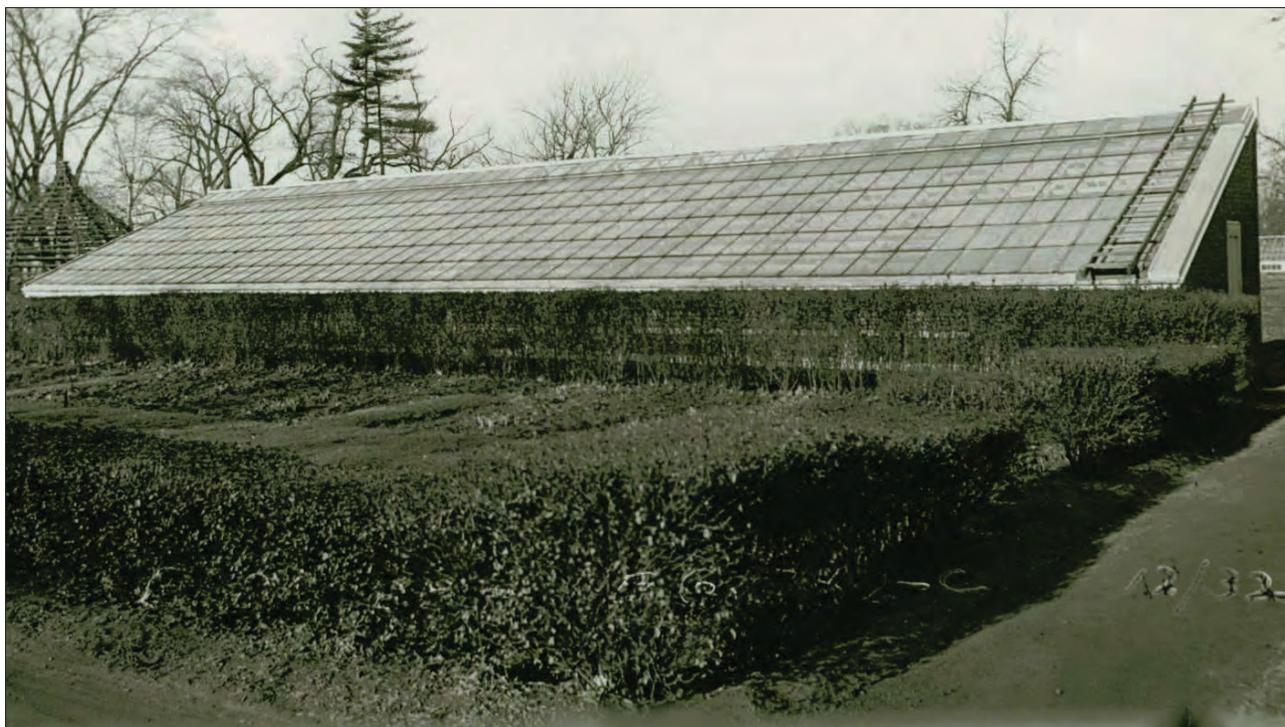
Figure 1.39. View of second greenhouse constructed in 1905 south of the existing greenhouse. The plot of land between the greenhouses was cultivated, including fruit trees. Note the privet hedge-enclosed garden in the foreground and the wooden trellis structure to the left. SPAR Museum Archives, Box 006, Folder 01.

Gardens at the Armory continued to expand in 1900 when a vegetable cellar was built behind the northwest corner of the Long Storehouse. In 1905, a second greenhouse, 750 square feet in size, was built south of the existing greenhouse (Figure 1.39). Both greenhouses were referred to as “root and propagating houses.”⁹⁵ Adjacent to the new greenhouse was a wooden trellis or arbor structure. Its specific use is not known, but it most likely had flowering vines growing on it. One of the most prominent garden features at Armory Square was a large, cross-shaped rose arbor in the service driveway circle at the Commanding Officer’s Quarters, positioned perpendicular to the house. An image from 1900 shows the wooden arbor structure and an extensive collection of climbing roses (Figure 1.40). Rose gardens were a popular landscape feature in the late nineteenth century as a wide variety of new rose hybrids proliferated in the United States and Europe. Rose arbors were usually designed to provide some shade and allow one to walk under the climbing plants. The cross shape was likely utilized to provide multiple approaches from around the perimeter of the circular drive. Wooden rose arbor structures also appeared in a garden in Forest Park, a popular woodland park four miles south of the Armory, around the same time.⁹⁶ Lieutenant Colonel Phipps was succeeded by Colonel Stanhope E. Blunt in 1907. New structures at the Armory included a new brick gatehouse in 1908 that replaced the original octagonal structure at the Byers and State streets entrance, and another vegetable cellar located near the site of the old gardener’s quarters.⁹⁷
