CULTURAL LANDSCAPE REPORT FOR ARMORY SQUARE

SPRINGFIELD ARMORY NATIONAL HISTORIC SITE

Olmsted Center for Landscape Preservation
National Park Service, Boston, Massachusetts, 2010

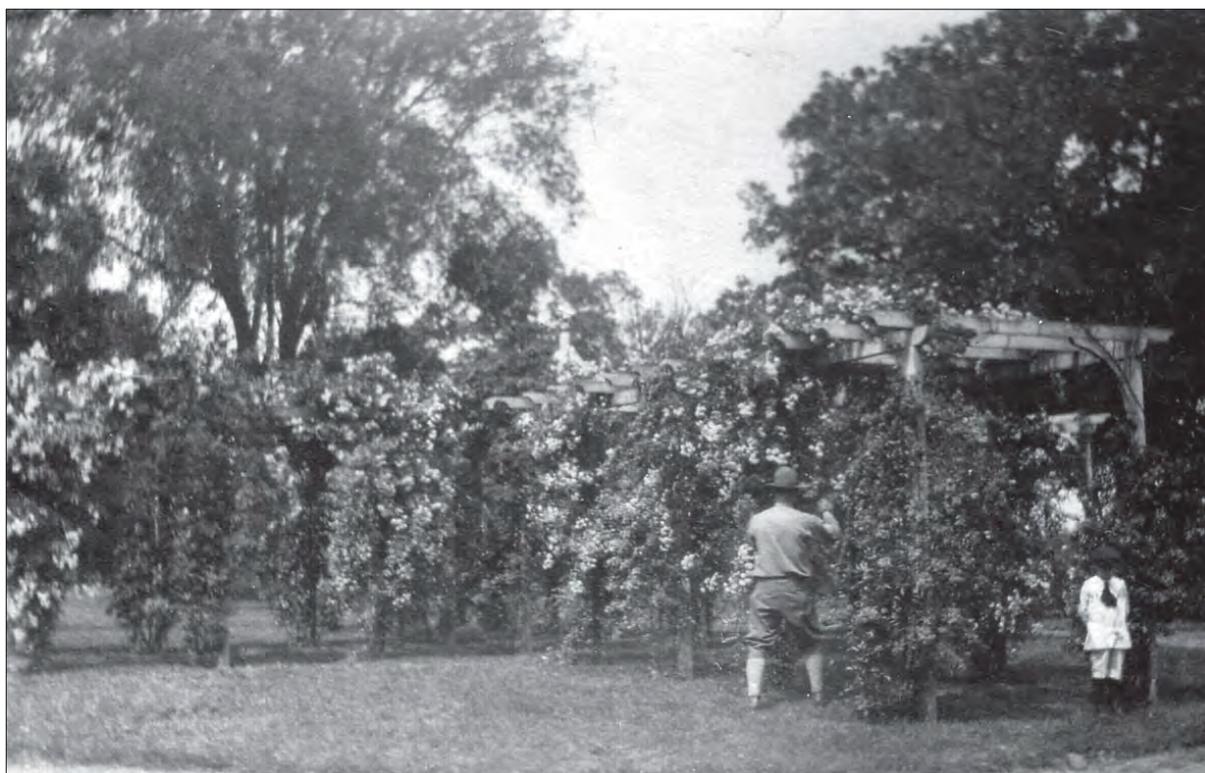
Figure 1.40. Located within the driveway circle north of the Commanding Officer's Quarters, this view from 1900 indicates a well tended, cross-shaped rose arbor and a lawn with mature shade trees in the background. SPAR Museum Archives, Box 001, Folder 10.

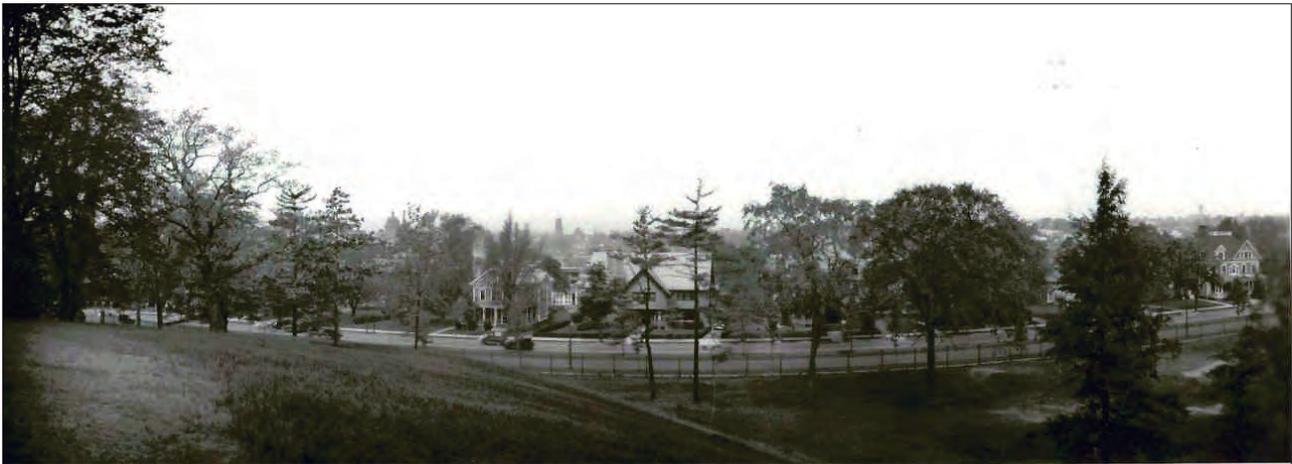
Figure 1.44. Panoramic view from 1932 looking north of the Commanding Officer's Quarters to Pearl Street. Note how views are maintained with trees spaced apart and the fence free of climbing plants. SPAR Museum Archives, Box 013, Folder 01.

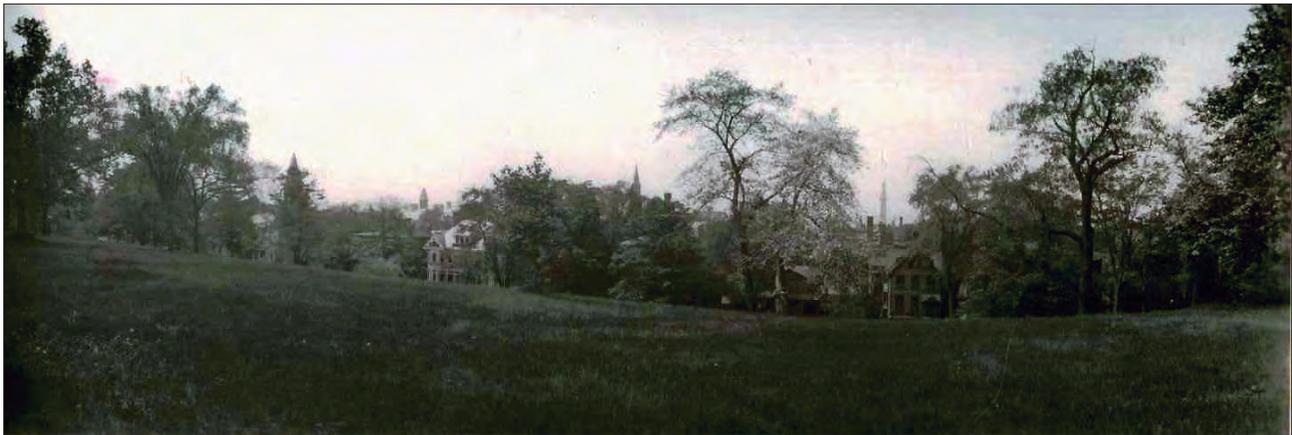
Figure 1.45. Panoramic view in 1932 from the rear of the Commanding Officer's Quarters to the open field. Openings between trees allow for views to the buildings along Byers Street and beyond. SPAR Museum Archives, Box 013, Folder 01.

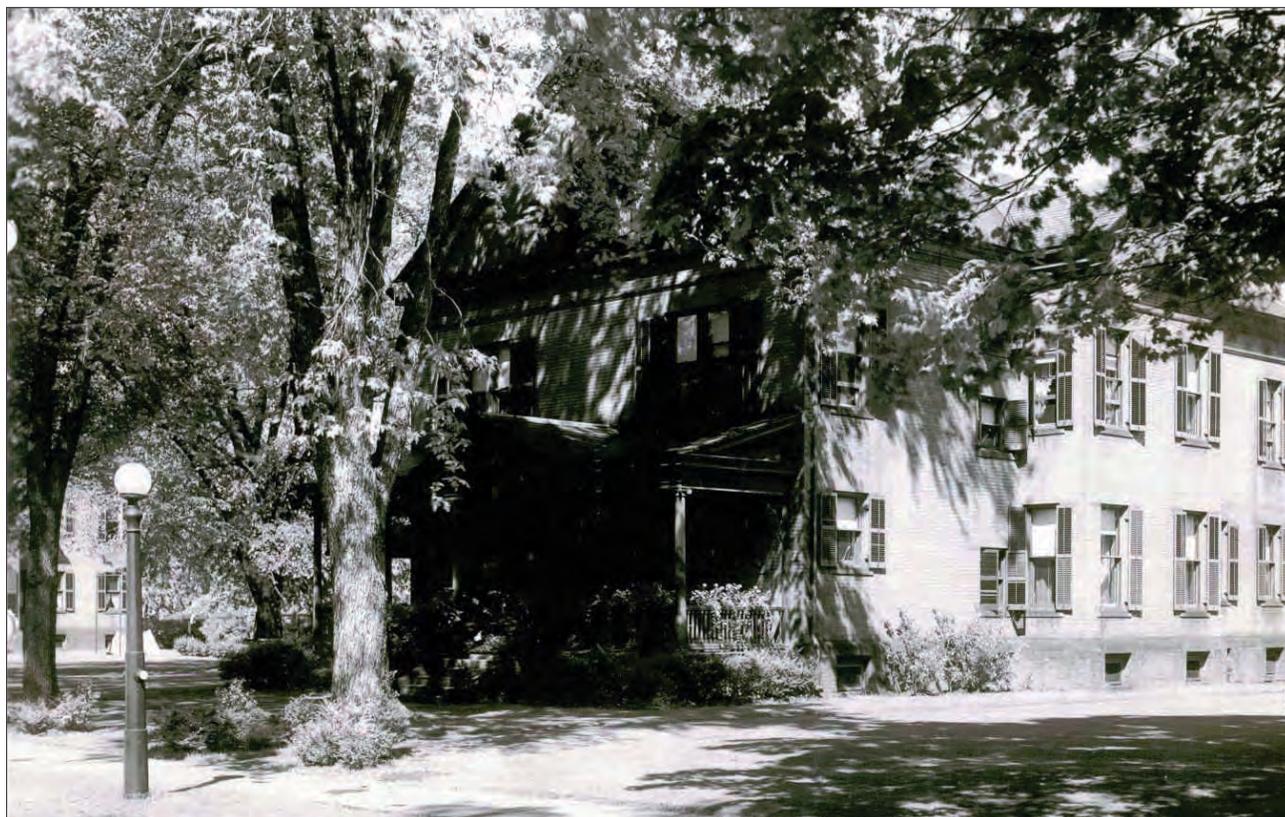
Figure 1.49. View from 1931 of Officer's Quarters 3, built in 1898. Note the foundation plantings and flower boxes, along with the typical cannon tube style lamp post to the left. SPAR Museum Archives, Box 002, Folder 03, NEG 406-SA.

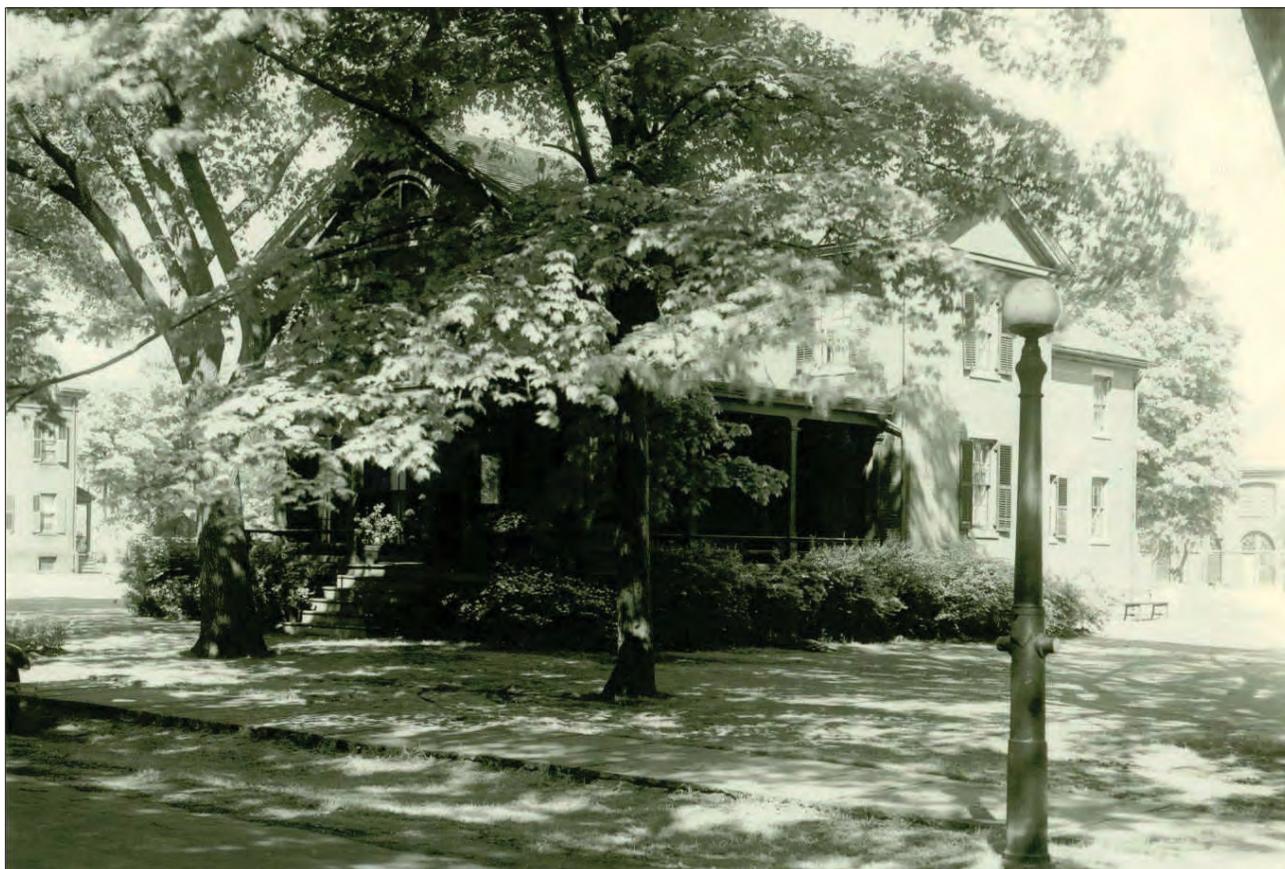
Figure 1.50. View of Officer's Quarters 4 in 1931. The Quarters were built in 1836. Note the foundation plantings and potted plant on the top of the front steps. SPAR Museum Archives, Box 002, Folder 05, NEG 407-SA.

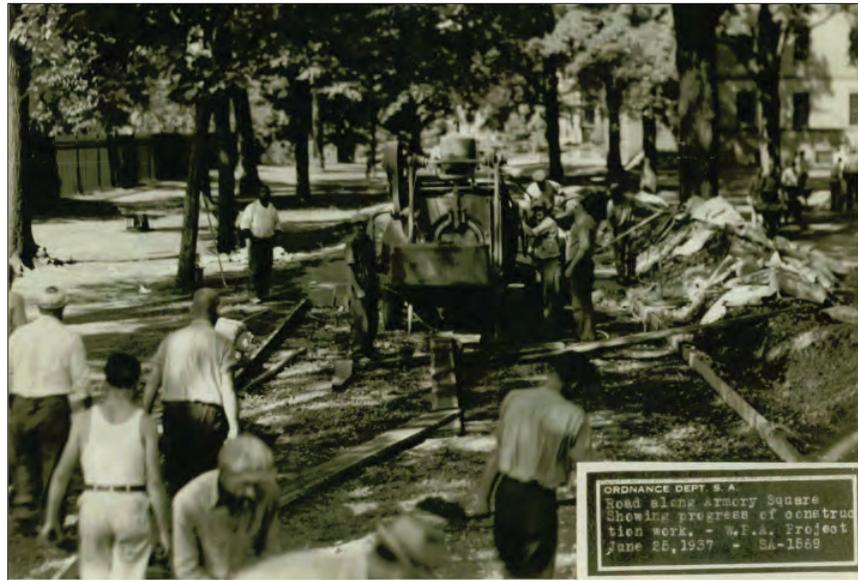
Figure 1.51. New road construction in 1937 at the Armory as part of the Works Progress Administration (W.P.A.) projects. SPAR Museum Archives, Box 013, Folder 05, NEG 1569-SA.

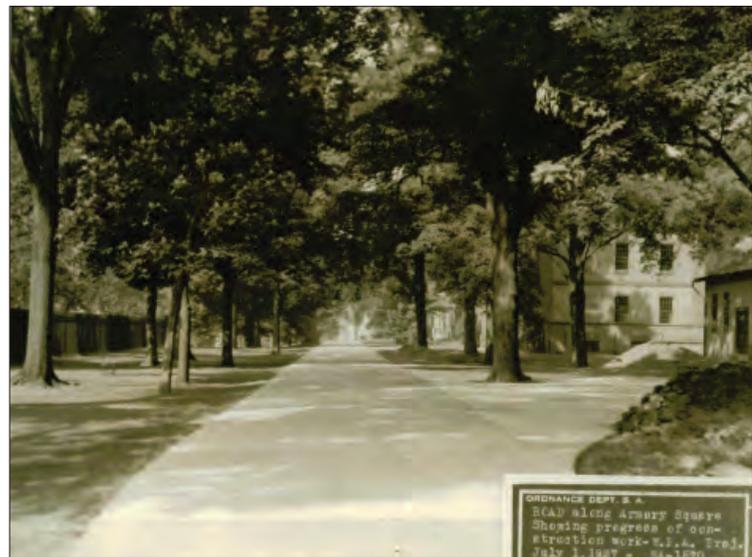
Figure 1.52. Completed W.P.A. road construction from 1937 on the State Street side of the Armory Square campus. SPAR Museum Archives, Box 013, Folder 05, NEG 1570-SA.

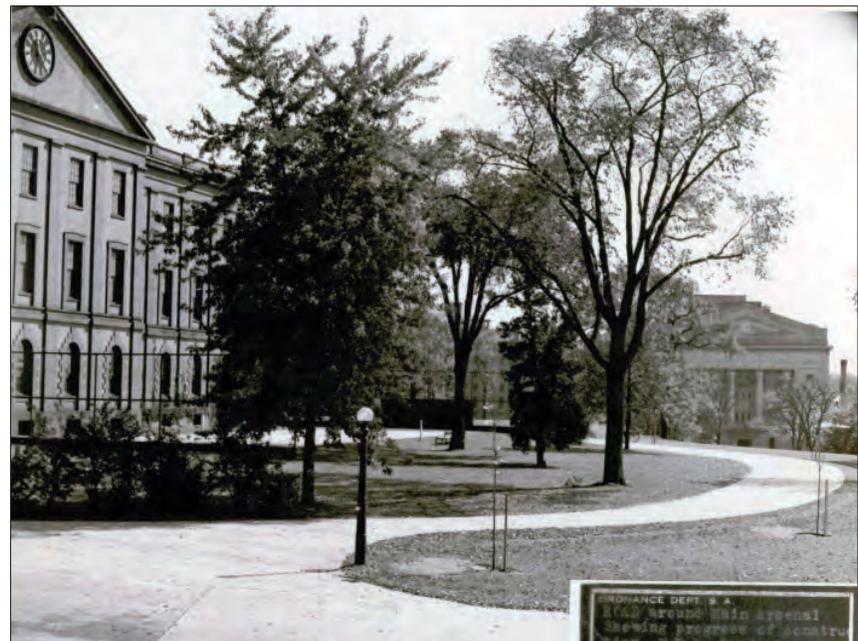
Figure 1.53. W.P.A. road construction, 1937, west of the Main Arsenal. The adjacent tennis court is also considered to be a W.P.A. project. New trees were planted to the right of the new road. The Masonic Temple on State Street is in the background. SPAR Museum Archives, Box 013, Folder 05, NEG 1625-SA.

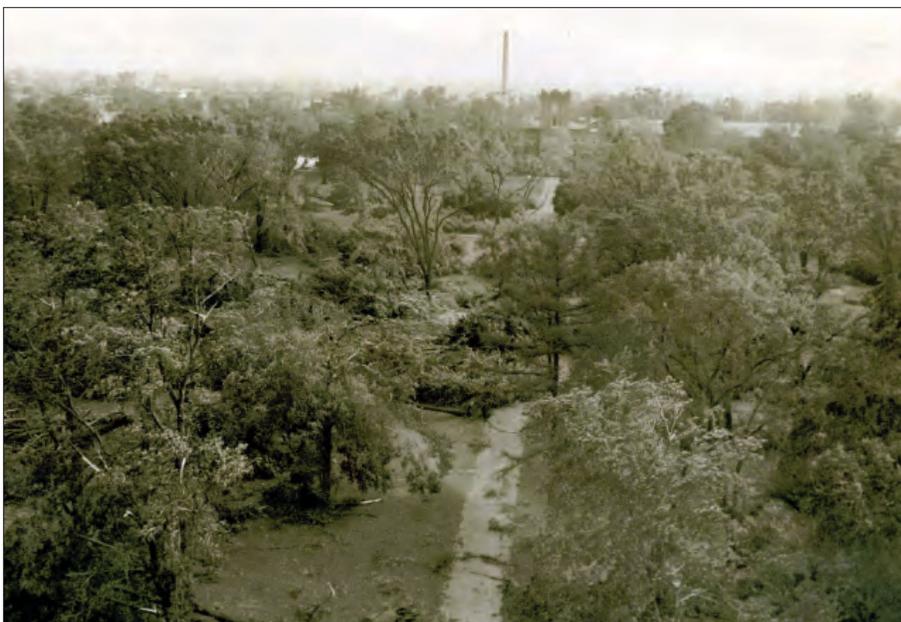
Figure 1.55. View of hurricane damage on the Green, taken from the Administration Building in September 1938. SPAR Museum Archives, Box 066, Folder 03, NEG TEMP 1041.

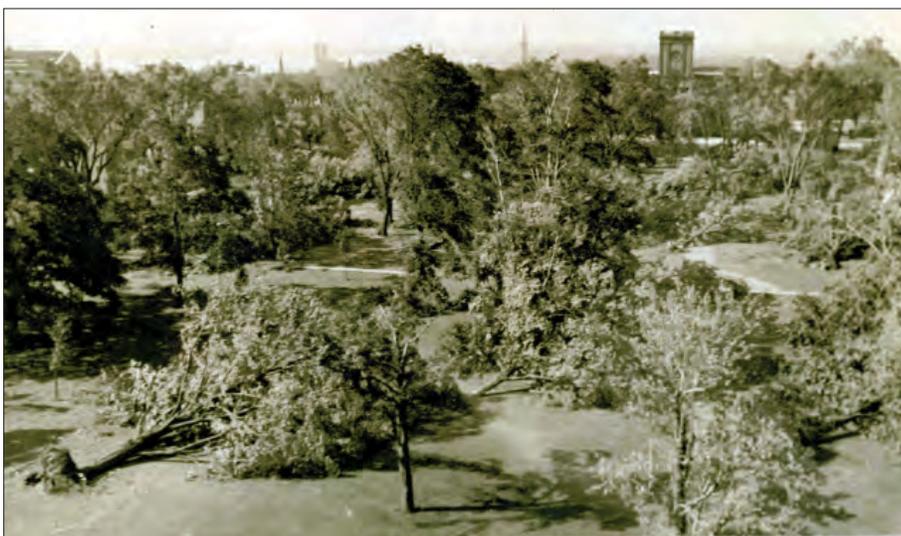
Figure 1.56. View of perimeter sidewalks around Armory Square that were also damaged by uprooted trees from the hurricane of 1938. SPAR Museum Archives, Box 066, Folder 03, NEG 1905-SA.

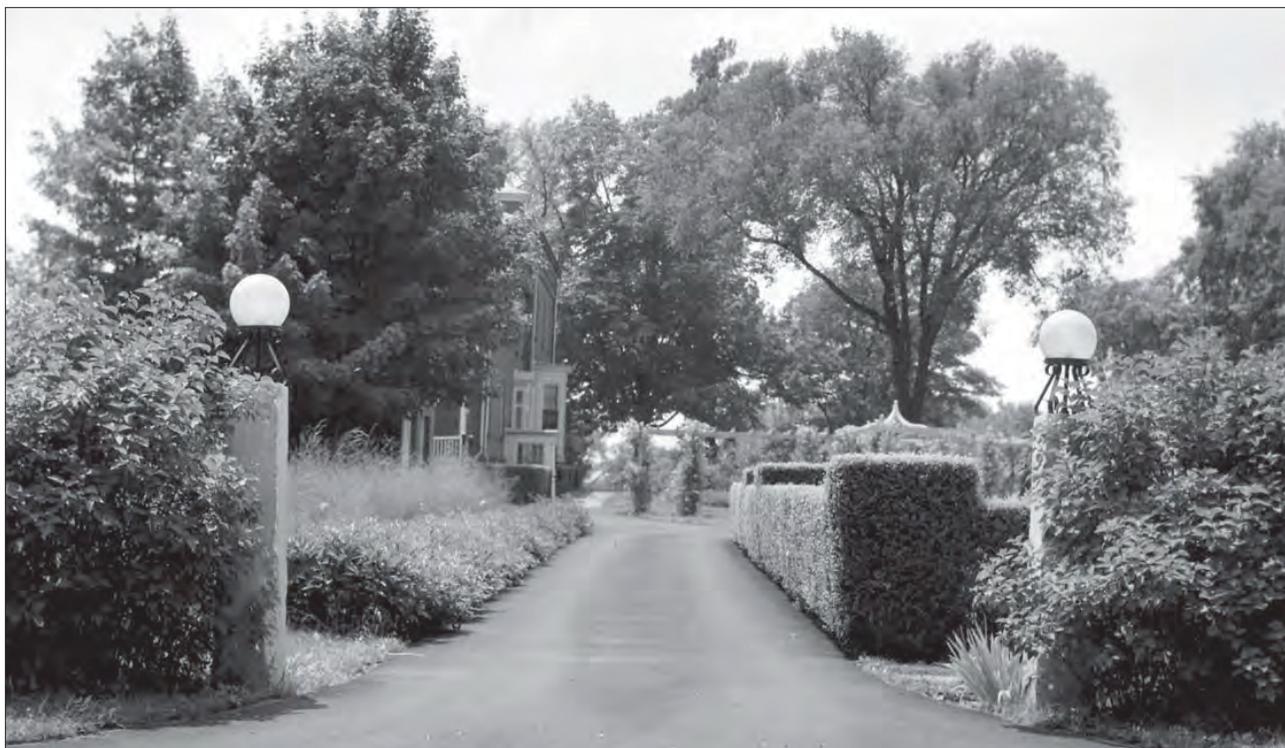
Figure 1.67. Driveway to Commanding Officer's Quarters and garage, circa late 1940s to early 1950s. Two stone piers with lights marked the entrance. The asphalt drive was lined with a privet hedge to the right and linear plantings on the left. Directly ahead was the rose arbor. SPAR Museum Archives, Box 001, Folder 07, NEG 9897-SA.

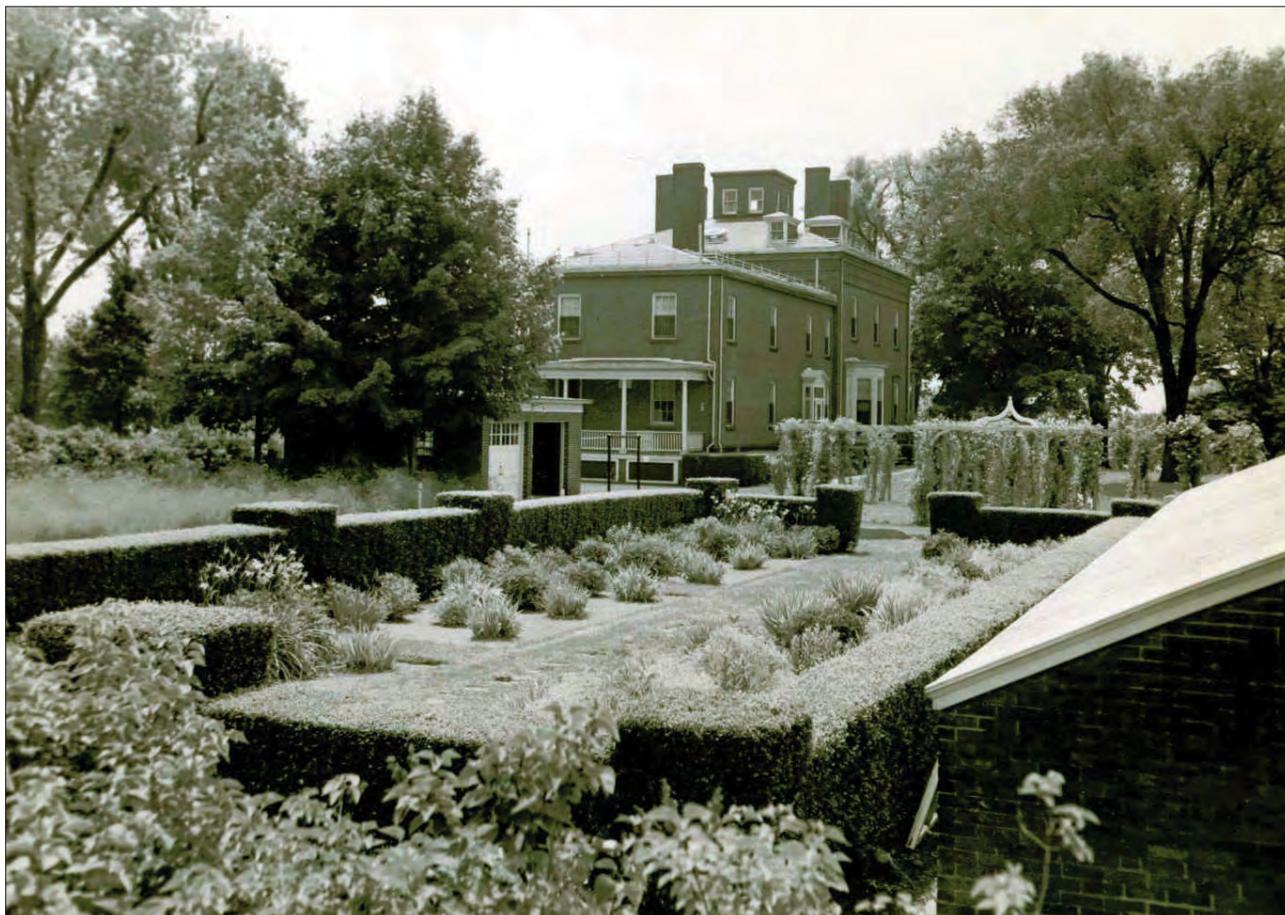
Figure 1.68. View of garden northeast of Commanding Officer's Quarters, circa late 1940s to early 1950s. Note the sheared privet hedge enclosing plantings of daylilies and irises and the greenhouse to the right. SPAR Museum Archives, Box 001, Folder 07, NEG.

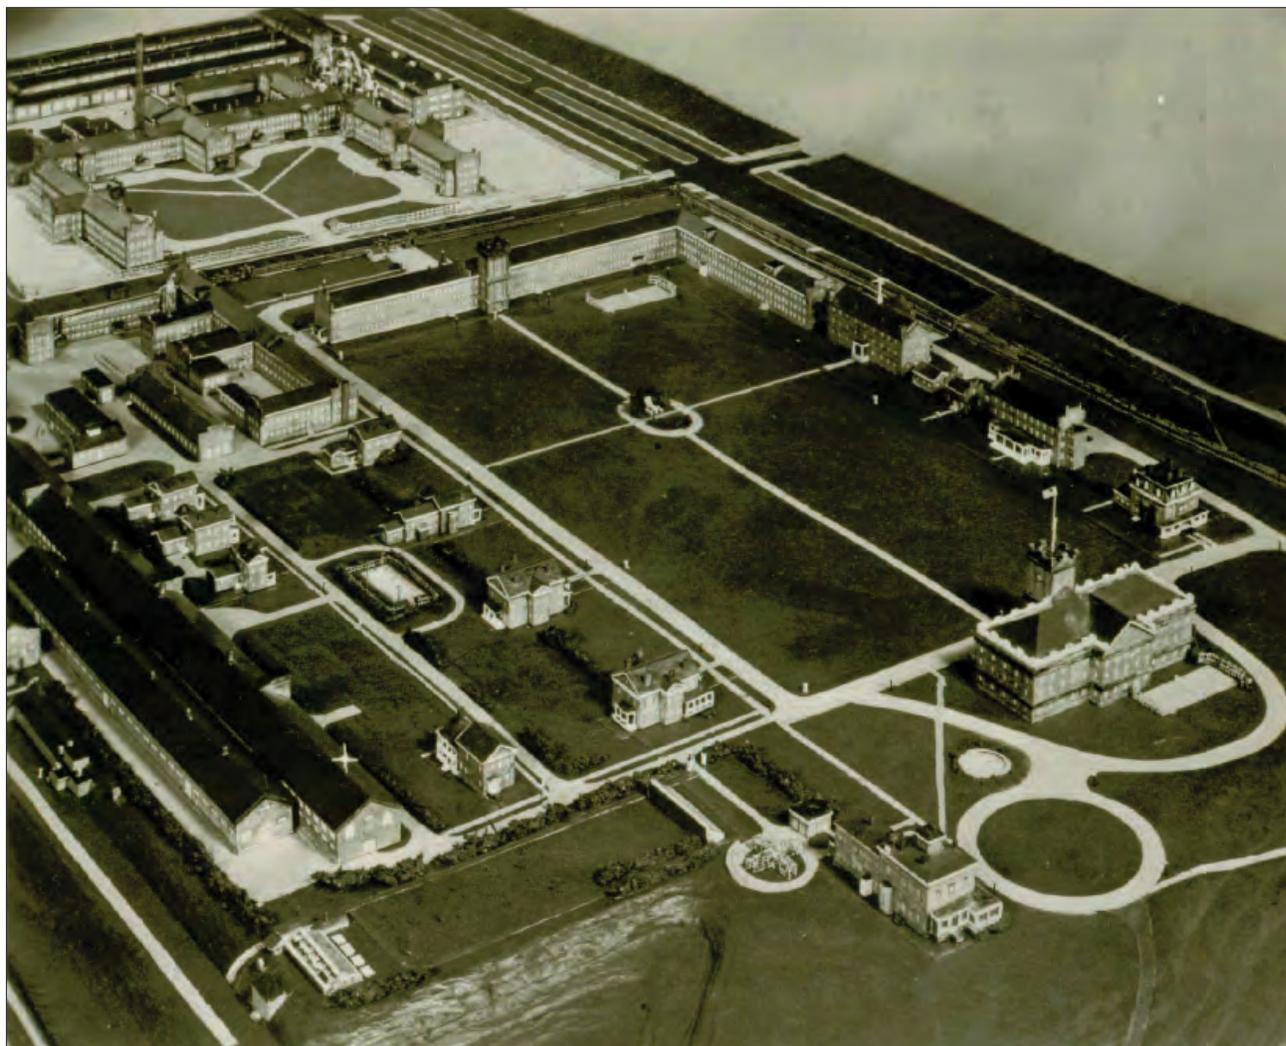
Figure 1.70. Circa 1950 model by Edward H. Rivard, of Armory Square showing landscape features, including the fountain, the cross-shaped rose arbor, and greenhouses. Note the trees in the middle of the Green surrounding what is believed to be a stone barbecue structure, most likely used for public holiday events. The model also shows how the Federal Square buildings were arranged on axis with the Main Arsenal and the Administration Building. SPAR Museum Archives, Box 080, Folder 04, NEG 7004-SA.

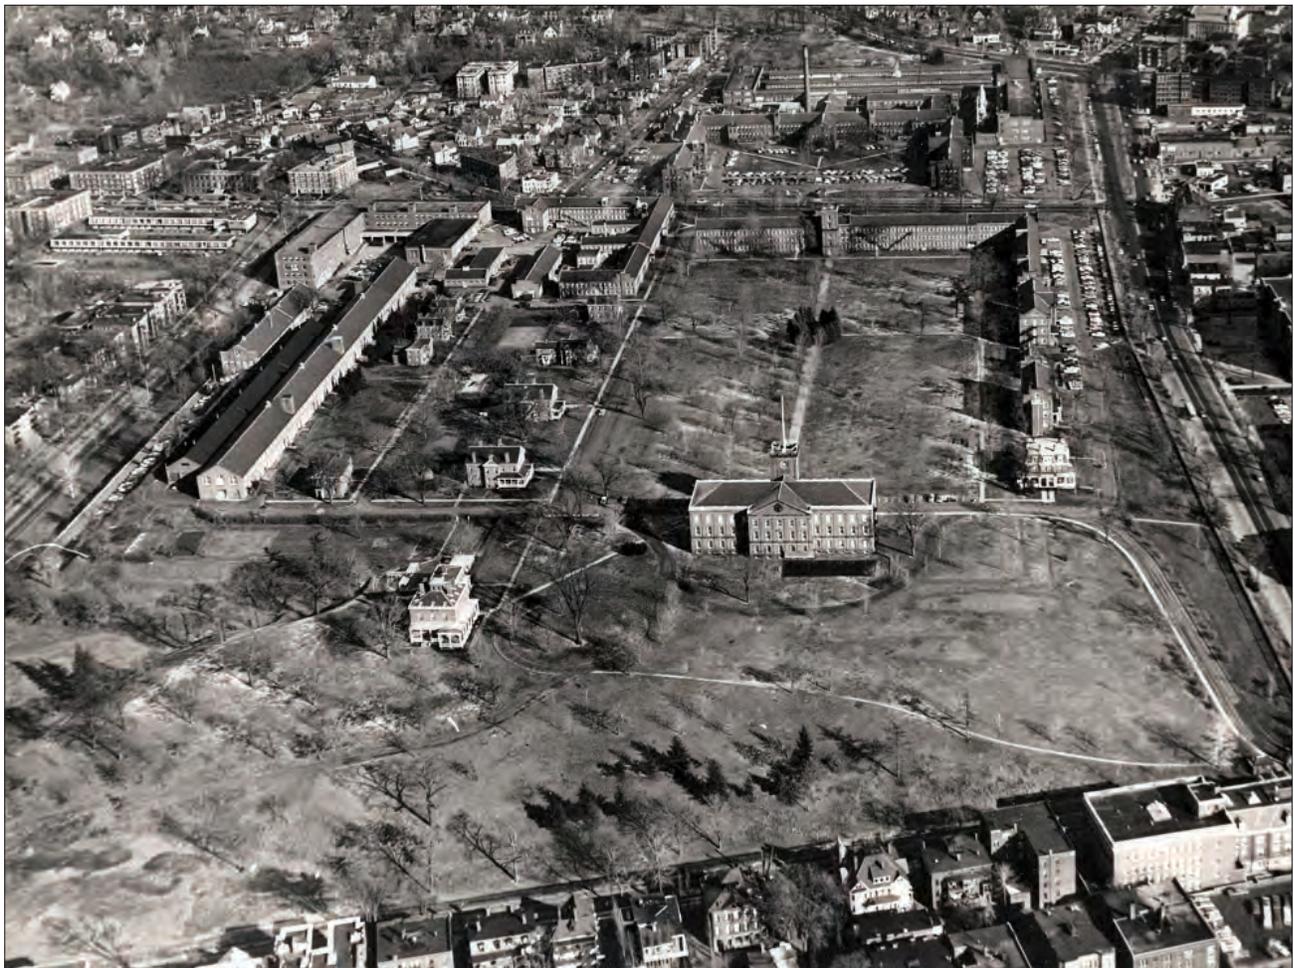
Figure 1.78. Aerial view of Armory Square in 1965. To the left, the greenhouses and other landscape features had been removed. Note the ring of evergreens on the central crosswalk on the Green. SPAR Museum Archives, Box 016, Folder 01.

greenhouses were demolished, along with the adjacent privet hedges and the gardens between the two structures (Figure 1.78). Foundation shrub plantings continued to grow around the Officers' Quarters. But the open lawn and trees in other areas of the site were not maintained, resulting in the growth of self-sown trees and shrubs, obscuring views into and out of the former Armory.

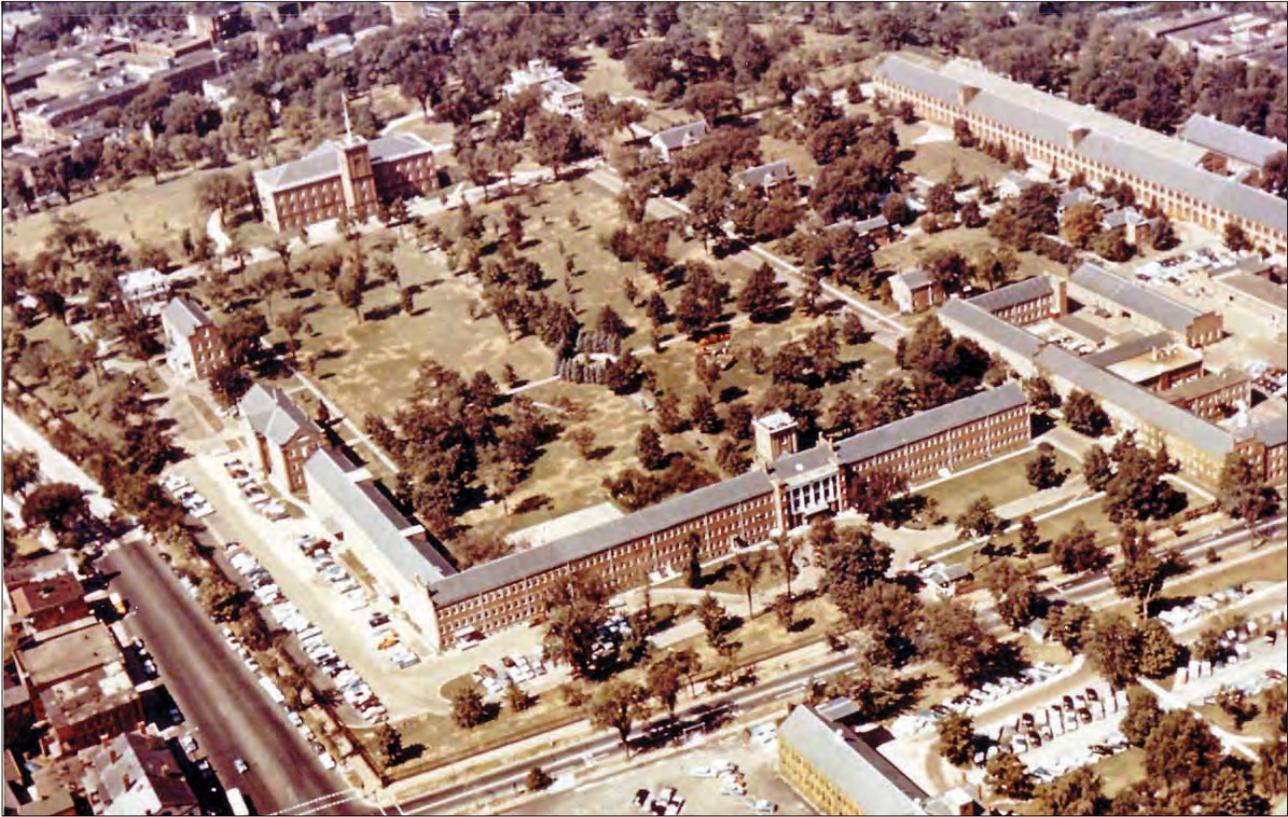
Figure 1.79. Aerial view of Armory Square photographed from the east in 1966. On the Green, note the ring of evergreen trees in the center as well as the tennis court in the southeast corner, adjacent to the Administration Building. SPAR Museum Archives, Box 002, Folder 05, NEG 957-59.

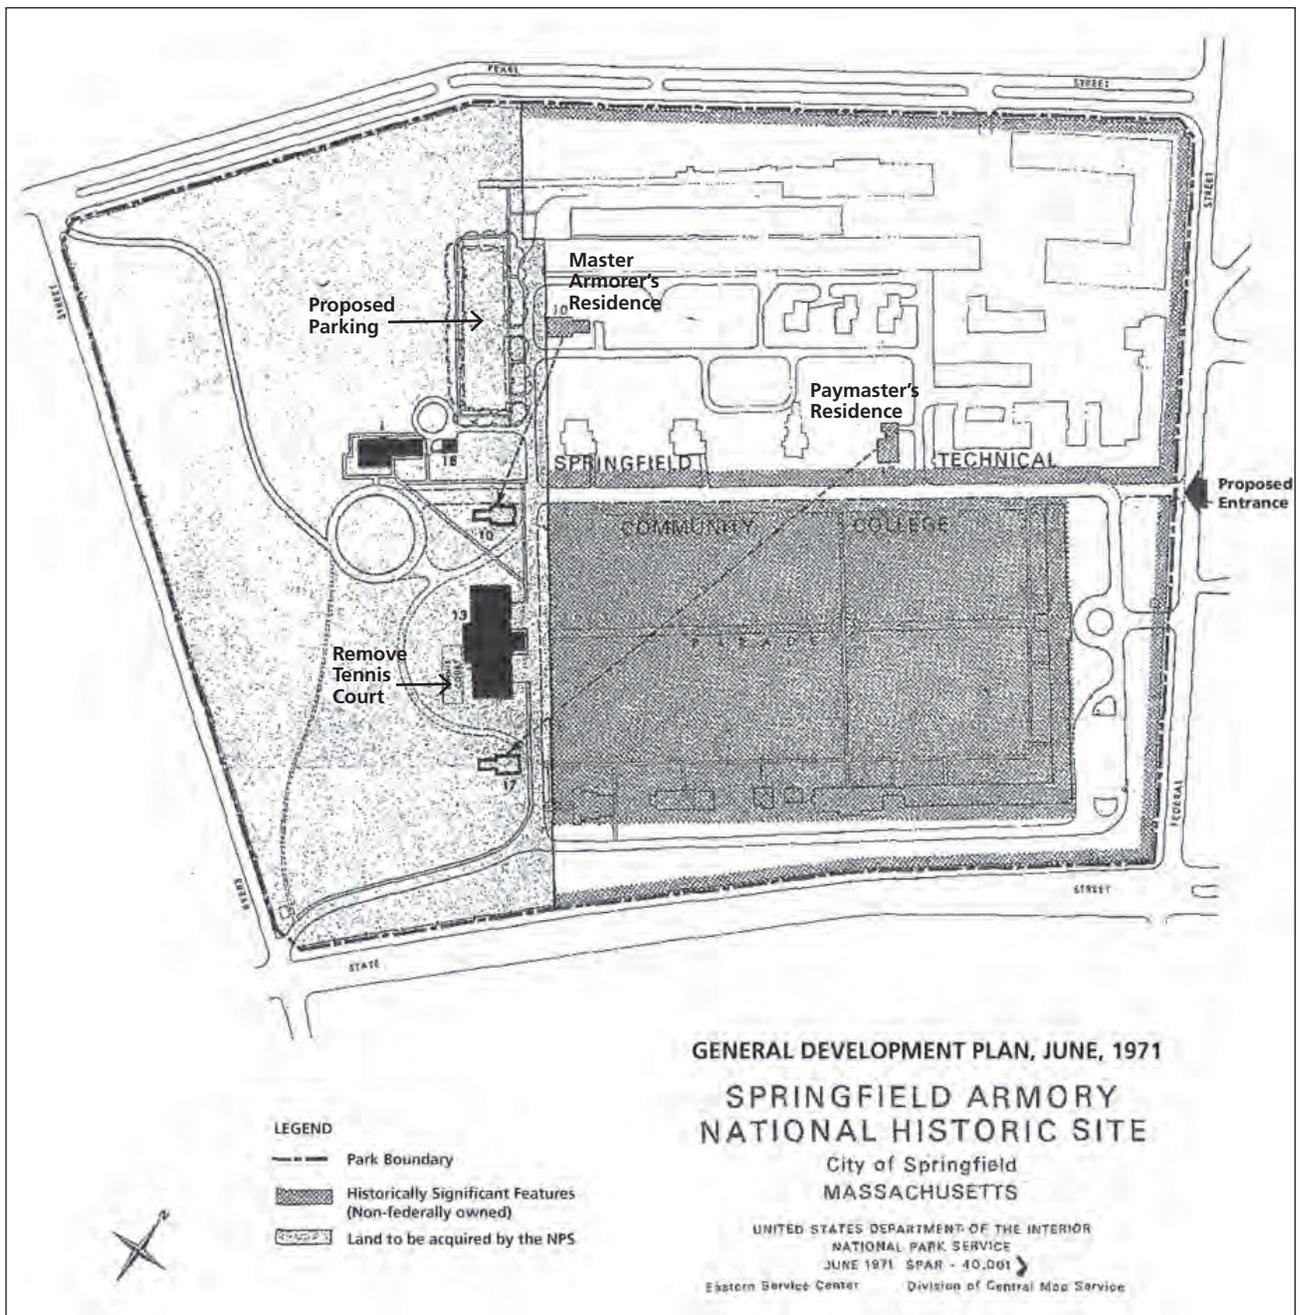
Figure 1.80. A Draft Master Plan was prepared for Armory Square in 1971. The plan, as seen above in the General Development Plan, proposed locating the Master Armorer's and Paymaster's residences to their original sites flanking the Main Arsenal. It also designated specific non-federally owned land as historically significant, including the perimeter fence, the Green, the building exteriors along the south and east sides of the Green and the edge just north of the Green. The plan also proposed to acquire the western portion of Armory Square for restoration and preservation by the National Park Service.

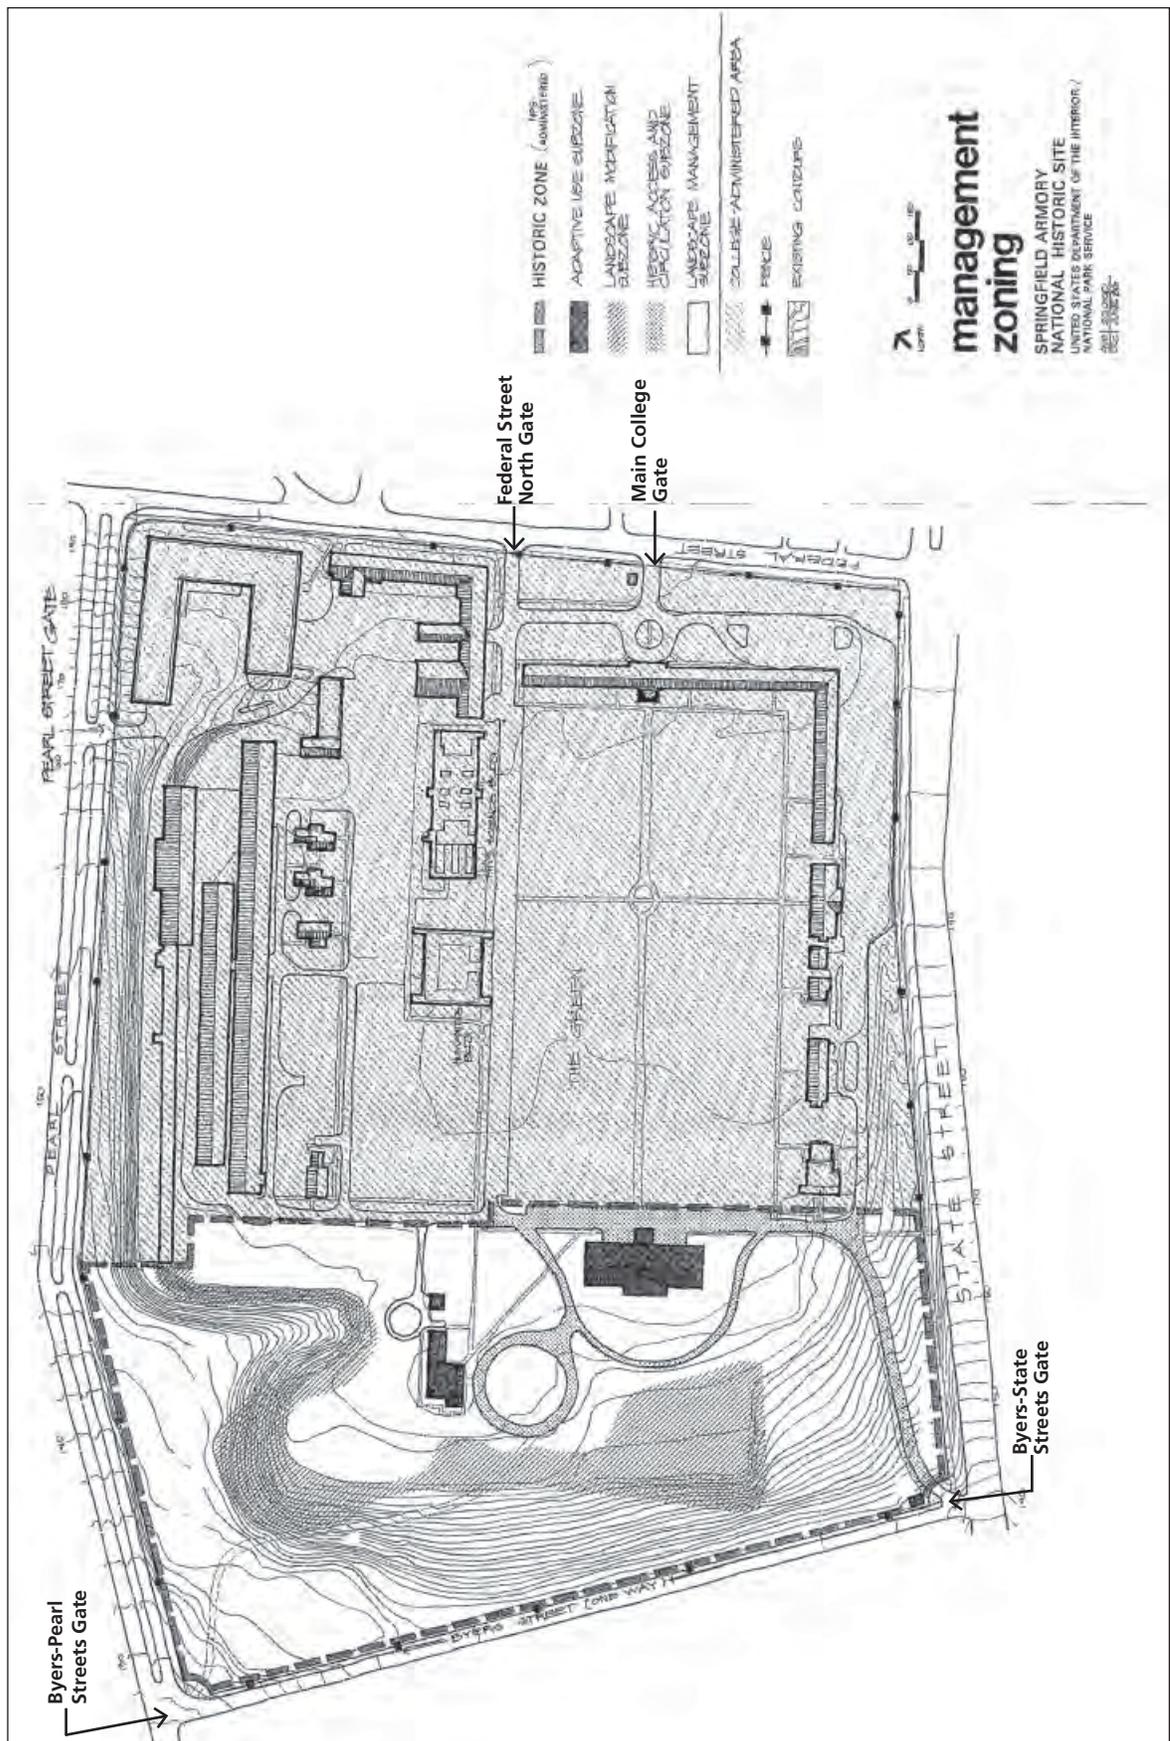
Figure 1.83. This Management Zoning Plan from 1986 addressed the National Historic Site and its two essential uses - a national park and an institution. The National Park Service site was designated as a historic zone with four subzones, including adaptive use, landscape modification, historic access and circulation, and landscape management.

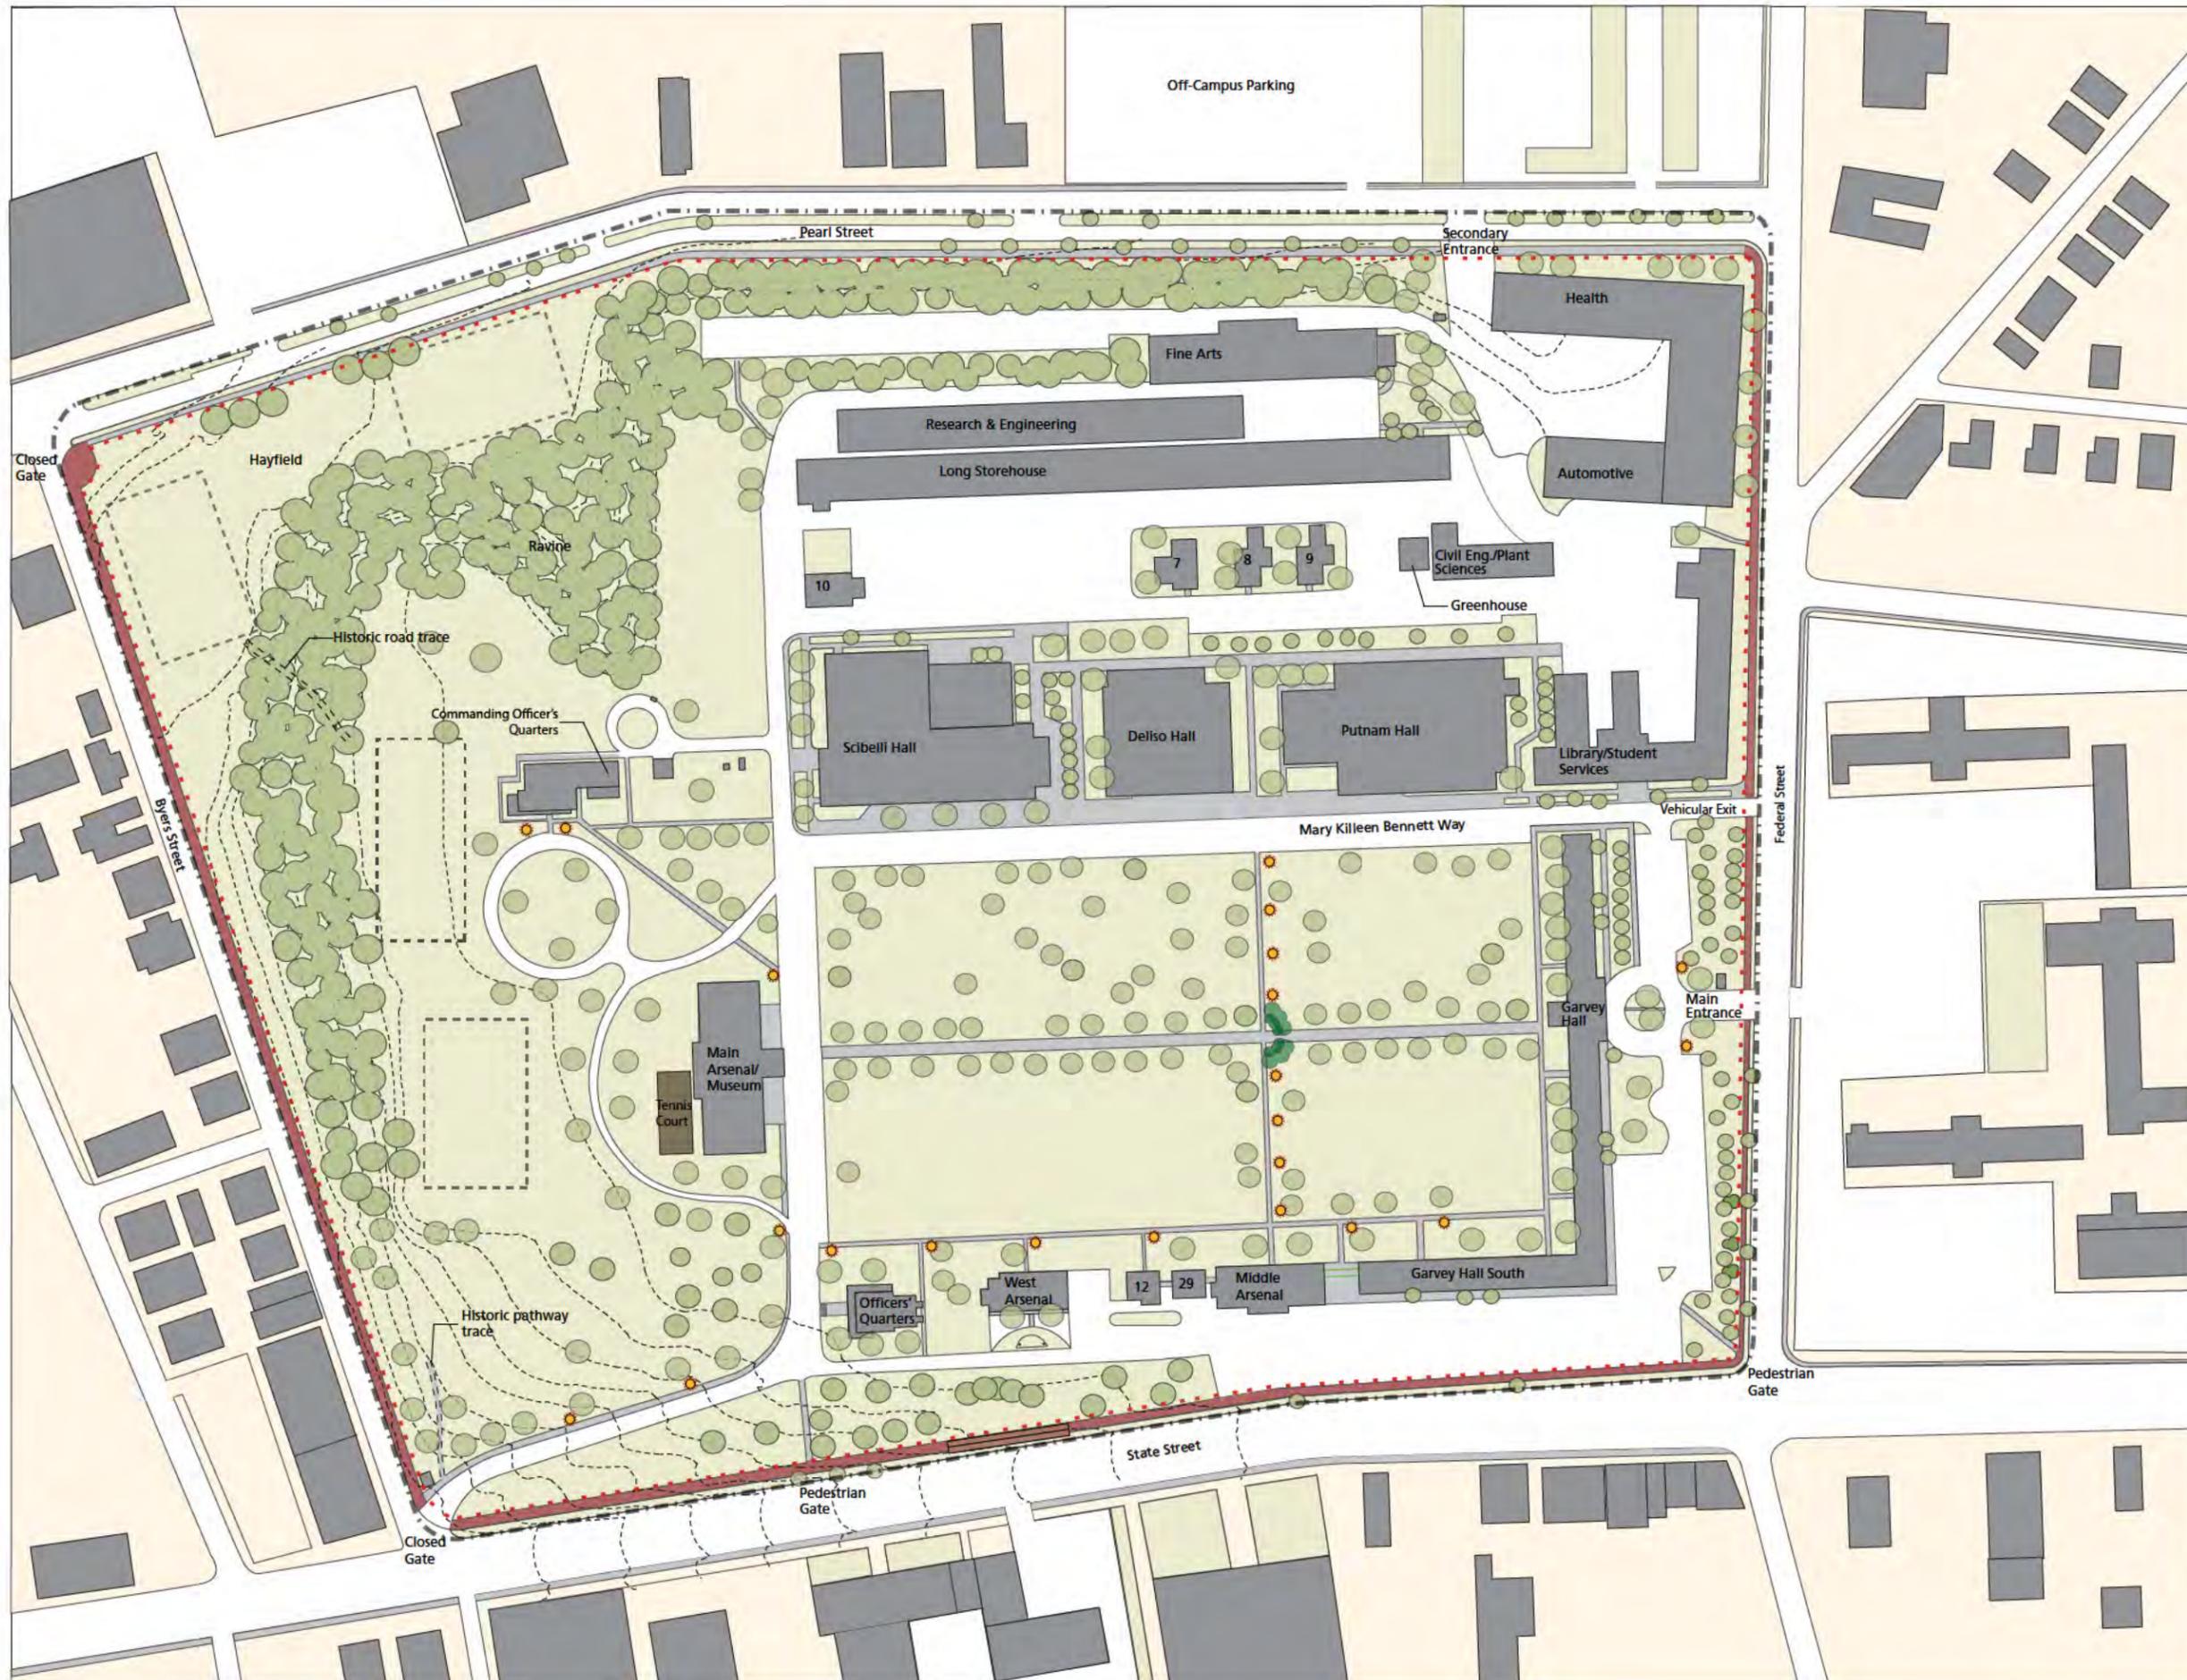
Drawing 6

EXISTING CONDITIONS
