CULTURAL LANDSCAPE REPORT FOR ARMORY SQUARE

SPRINGFIELD ARMORY NATIONAL HISTORIC SITE

Olmsted Center for Landscape Preservation
National Park Service, Boston, Massachusetts, 2010

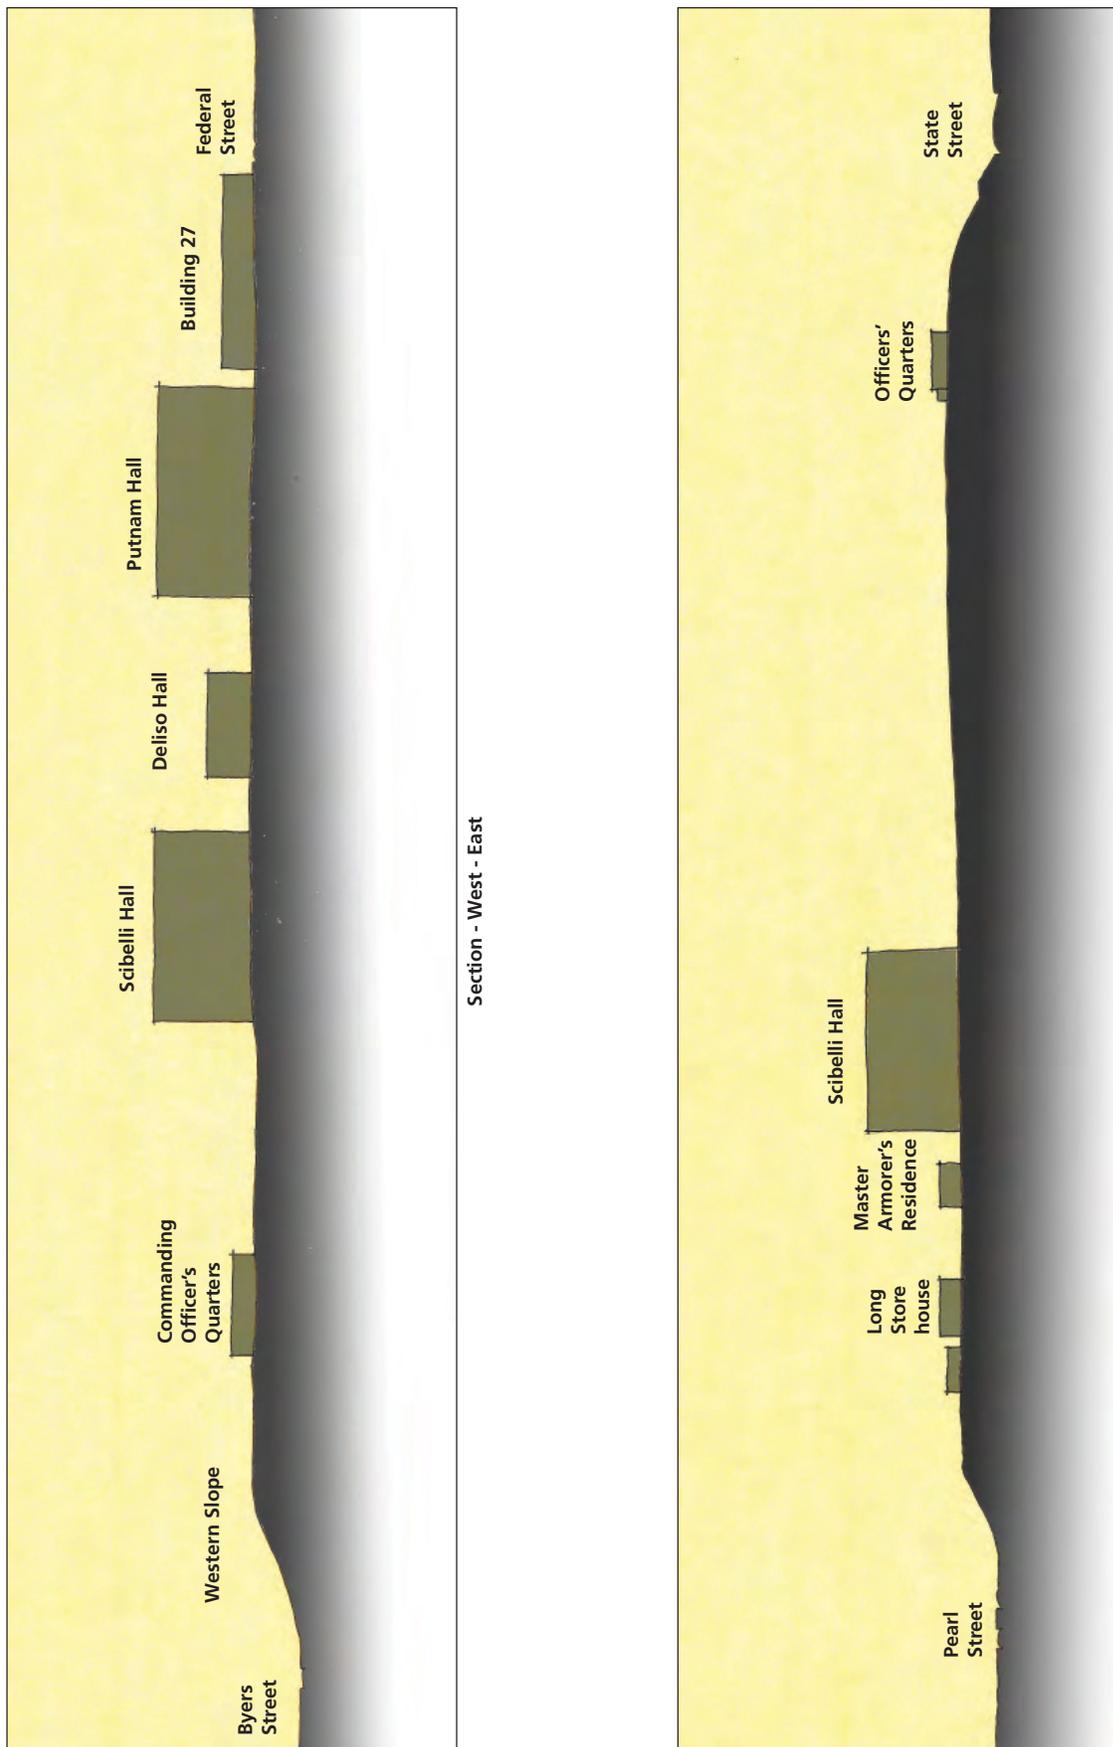
Figure 2.1. Topographic diagrams depicting Armory Square's location on a hill plateau. The left diagram is a cross section along the west-east orientation and the diagram to the right shows the north-south orientation.

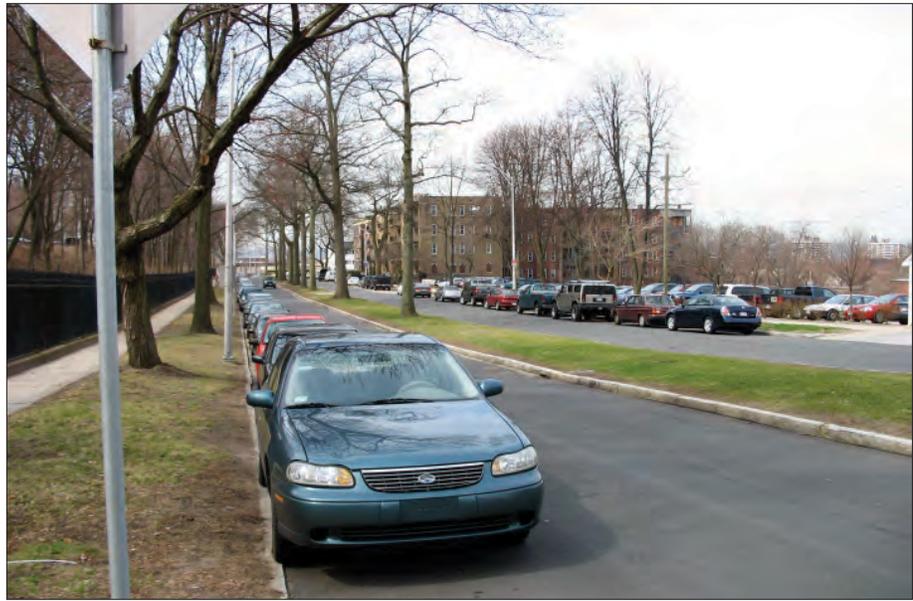
Figure 2.2. View of Pearl Street north of Armory Square. Note the historic fence on the left and concrete sidewalk. The street is divided by a median planted with deciduous shade trees and grass, and public parking is allowed on both sides. OCLP, 2008.

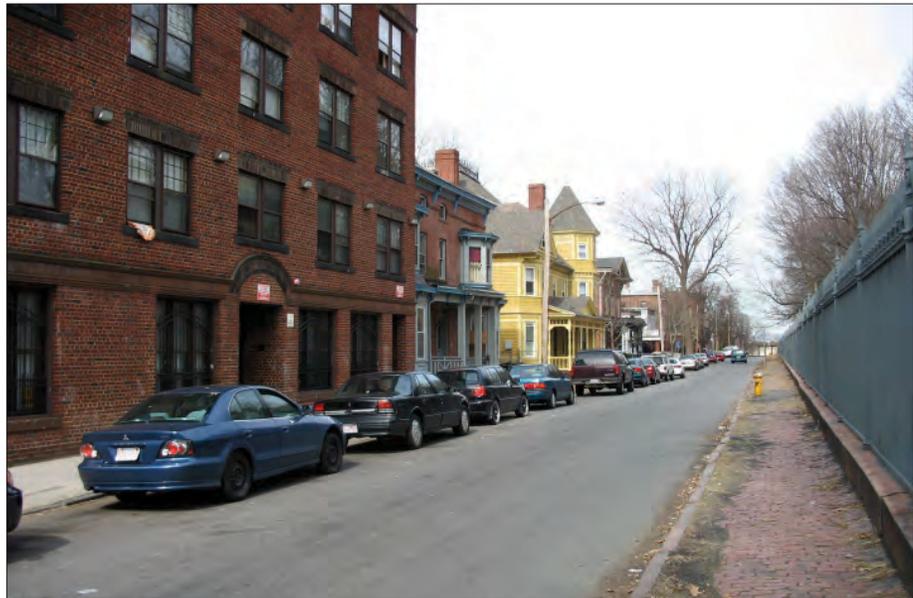
Figure 2.3. View of Byers Street along the western edge of the site. Note the historic brick sidewalk along the edge of the Armory on the right. Apartment buildings and single family homes line the other side of the street facing the armory. OCLP, 2008.

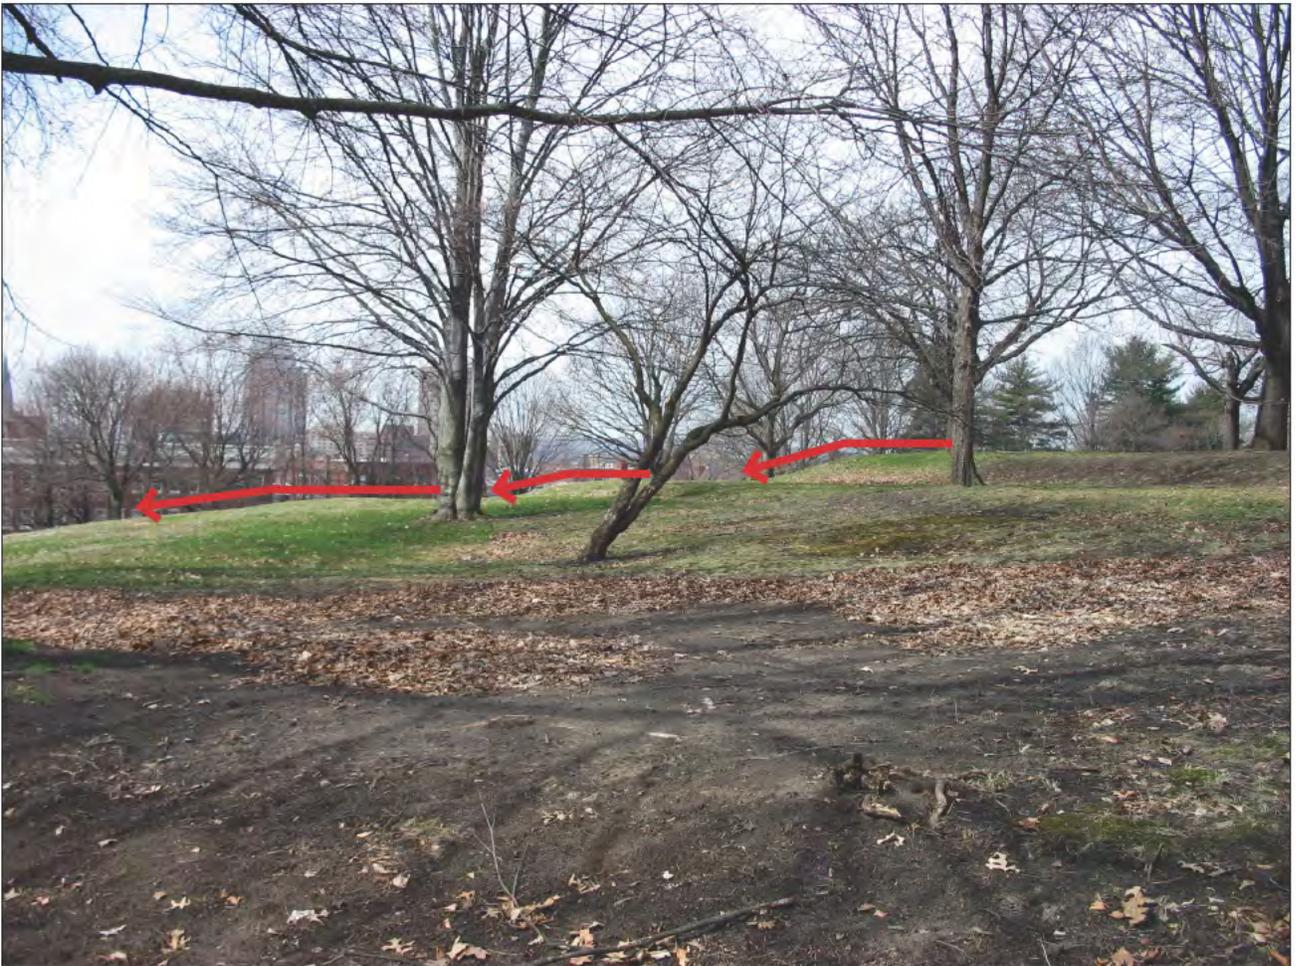
Figure 2.5. View from the top of the Western Slope to the northwest reveals how the land has been terraced over the years. OCLP, 2008.

ongoing effort to overcome erosion problems originating from natural springs on the site (Figure 2.5). These underground springs are another primary feature as they continually influenced the manipulation of the land form. The ravine at the northwest corner of the site is another topographic feature of the site that impacted land use (Figure 2.6).

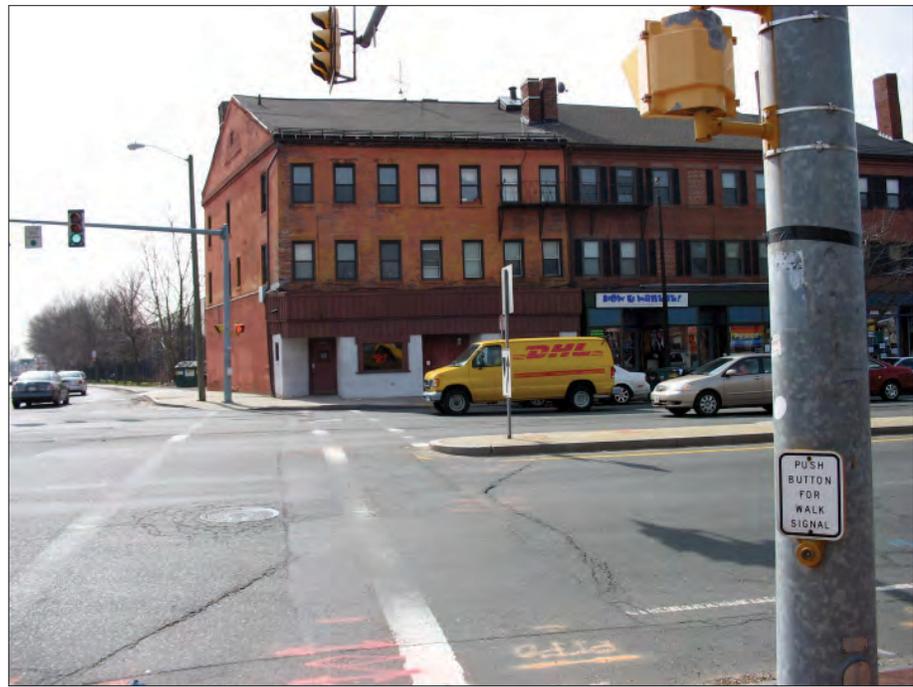
Figure 2.7. View of the corner of Federal and State Streets where the site is at grade with the street. OCLP, 2008.

The elevation rises from a point 130 feet above mean sea level, at the Byers and Pearl Streets gate, to 196 feet above mean sea level on the Green, the highest level on Armory Square. The grade change on the National Park Service property is 130 to 194 feet above mean sea level. Walking around Armory Square, the varying topography becomes clear. The site transitions from street grade at the Federal and State Streets corner, to ten to twelve feet above the street heading west on State Street (Figures 2.7, 2.8).

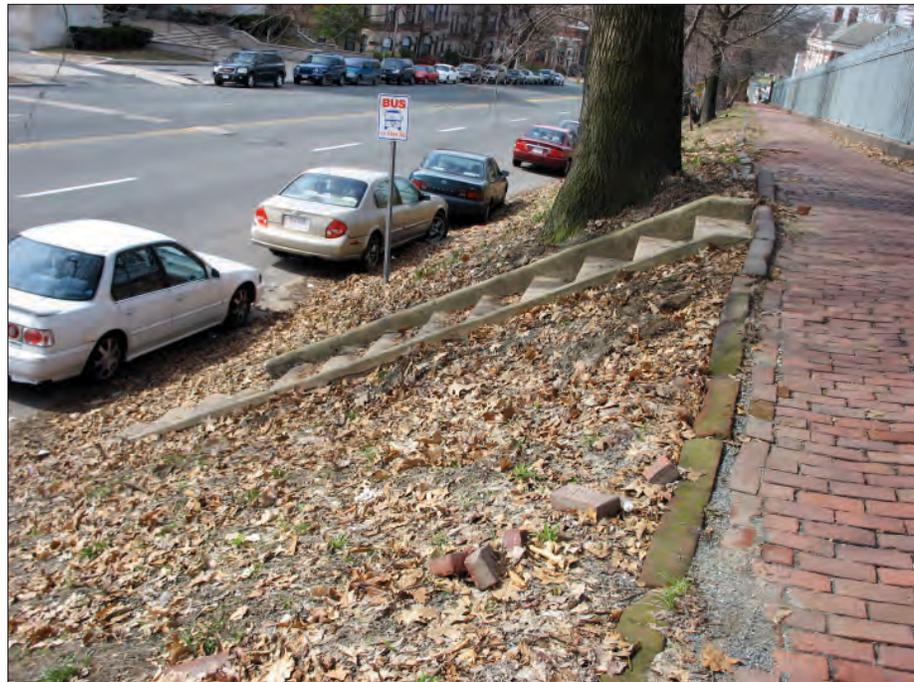
Figure 2.8. Heading west on State Street, the grade of the armory site rises ten to twelve feet above the street level. Note the historic brick paved sidewalk and concrete steps leading from the street to a pedestrian entrance to the site. OCLP, 2008.

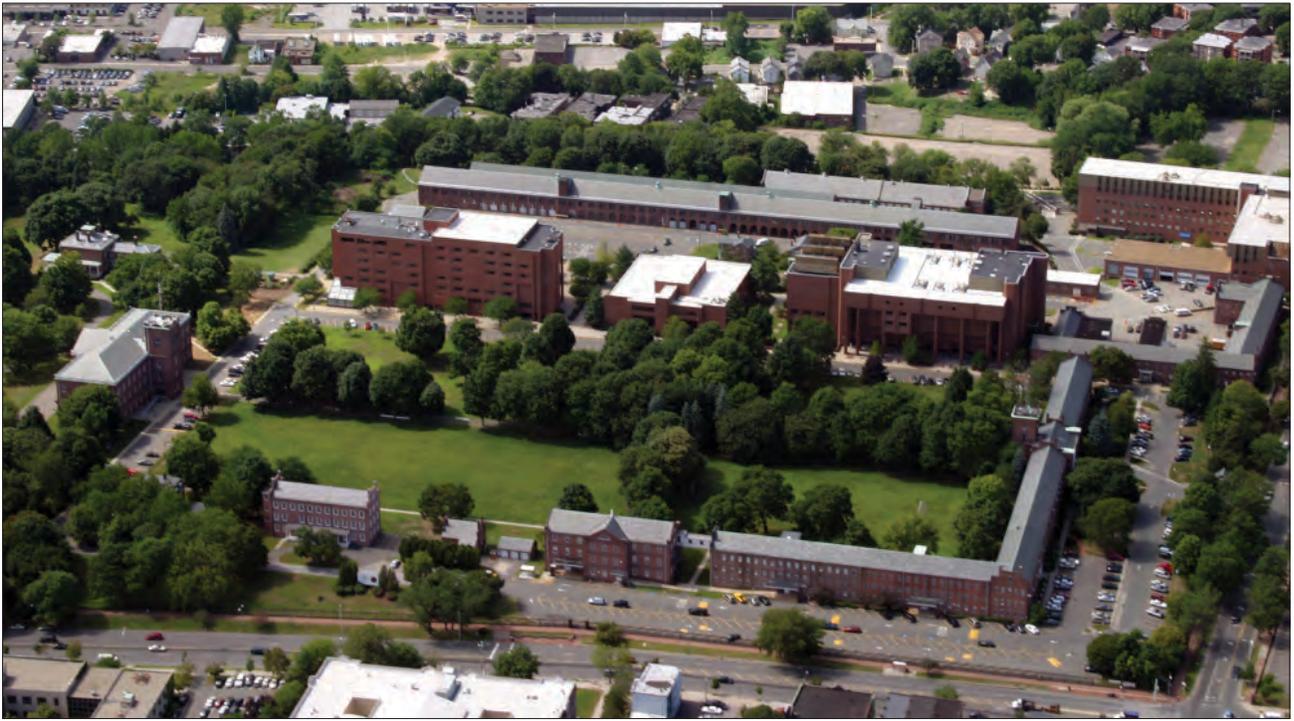
Figure 2.9. Aerial view of the Green showing the tree lined pathways and the open southern portion that is used for recreation. Don Coutoure Aerial Photography, 2007.

Enclosed by a historic iron fence, the organization of the Armory Square complex is structured around a central rectangular green space known as the Green or Central Green (Figure 2.9). The sloping grounds around the perimeter are composed of a rolling lawn with trees, particularly along the steeply sloping western portion and along State Street. The Green has a more structured appearance, with a slightly offset walk extending along the main east-west axis, and cross axis walk extending north-south. These walks join at an offset central oval. Formal single rows of trees line the walks, and roughly line the perimeter of the Green. Informal plantings of trees dot the open space area on the north side of the Green, but its use by the college on the south side as recreational fields has resulted in an expansive lawn for that area of the Green (Figure 2.10).

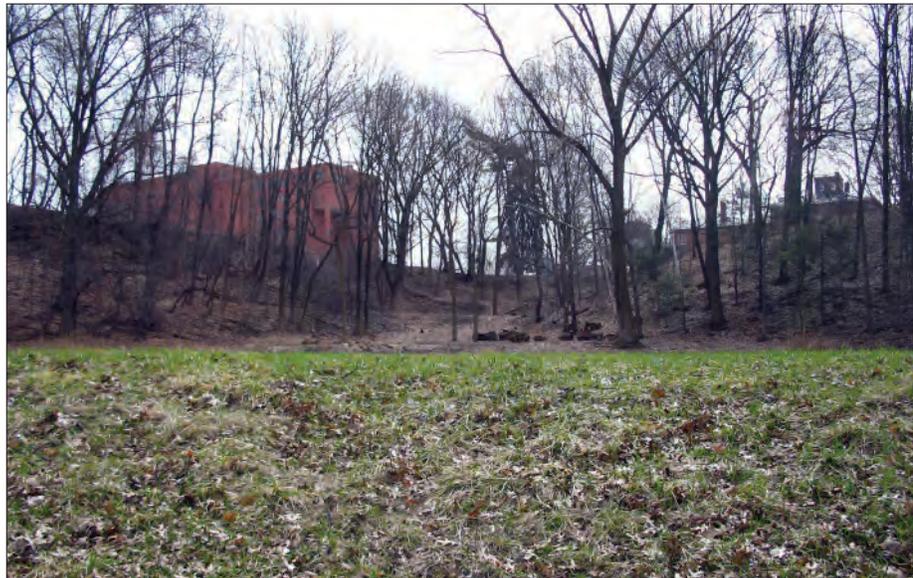
Figure 2.13. View of the west facade of the Main Arsenal. Note the open lawn area with shade trees and the absence of foundation plantings which are historic features of the site. OCLP, 2008.

The landscape around the Main Arsenal is an open lawn studded with trees, including maidenhair (*Ginkgo biloba*), elm (*Ulmus americana*), mulberry, (*Morus alba*) and spruce (*Picea abies*). The building is free of foundation shrub plantings in keeping with the historic character of the structure (Figure 2.13). Trees consist mainly of deciduous shade trees and a large spruce tree just north of the tower base. The closed entry drive leading from the corner of State and Byers streets maintains its historic character with deciduous shrubs lining both sides, spaced approximately five feet apart (Figure 2.14).

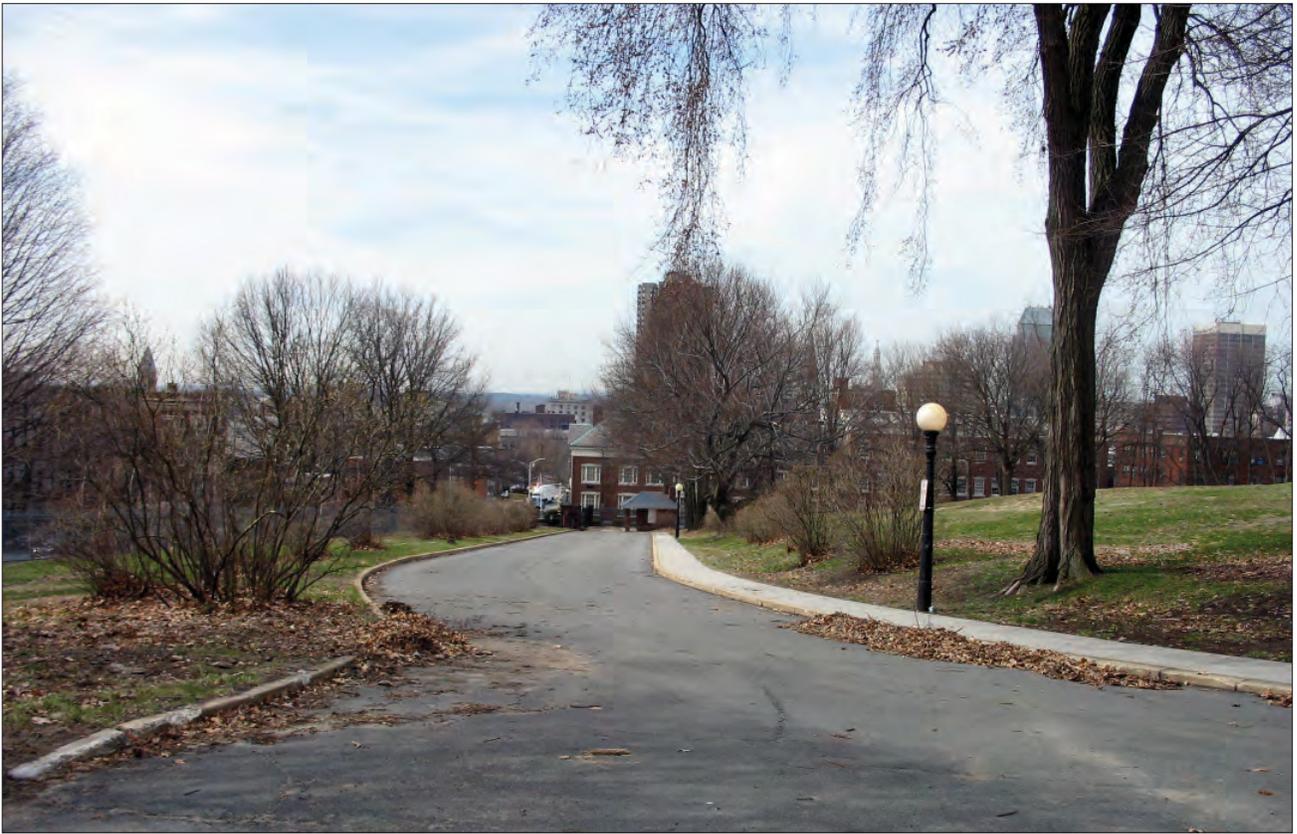
Figure 2.14. Southwest entrance at the corner of State and Byers Street, which is now closed. This area retains its historic appearance in the layout of plants, driveway, sidewalk, and gatehouse beyond. OCLP, 2008.

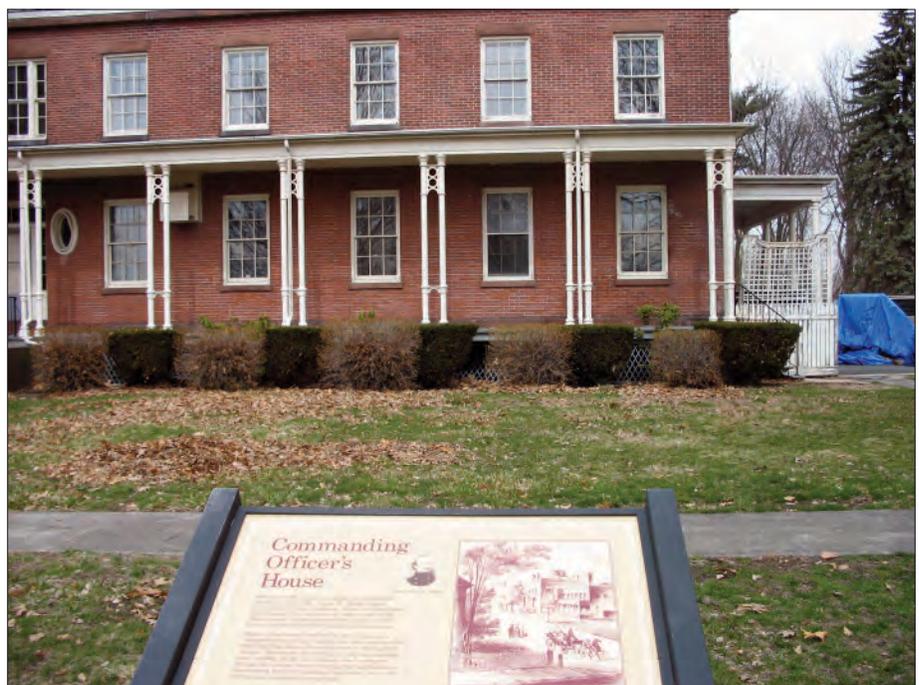
Figure 2.15. Southern facade of the Commanding Officer's Quarters. Note the alternating yew and azalea shrubs maintained at the height of the porch floor level. An interpretive wayside exhibit in the foreground describes the history of the building. OCLP, 2008.

The Commanding Officer's Quarters is surrounded by foundation plantings consisting of alternating yews (*Taxus spp.*), rhododendrons and azaleas (*Rhododendron spp.*) along the southeast side of the porch, maintained at the elevation of the porch floor (Figure 2.15). On either side of the entrance are sheared yew hedges of varying height (Figure 2.16). In the center of the circular

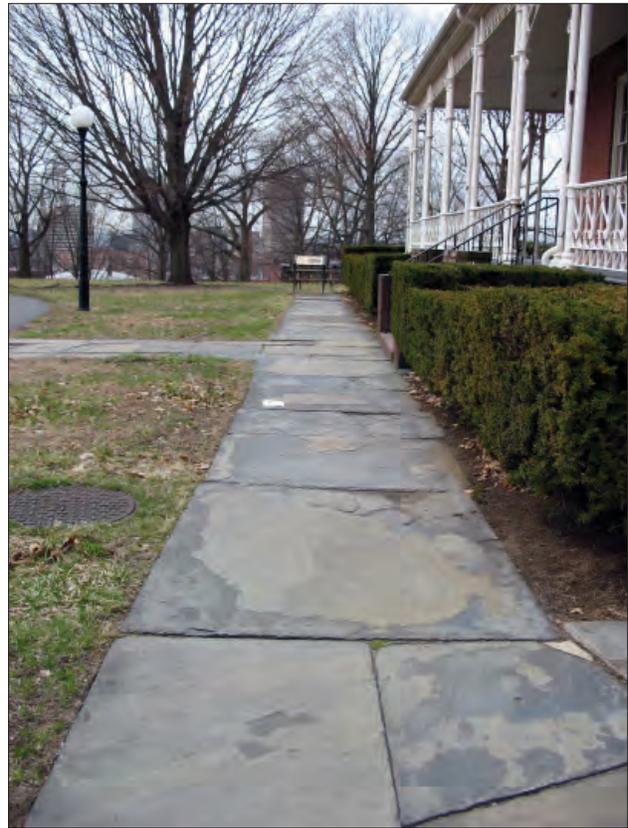
Figure 2.16. Flagstone walkways surround the Commanding Officer's Quarters. Note the sheared yew hedges of varying heights to the right and the lamp post to the left. OCLP, 2008.

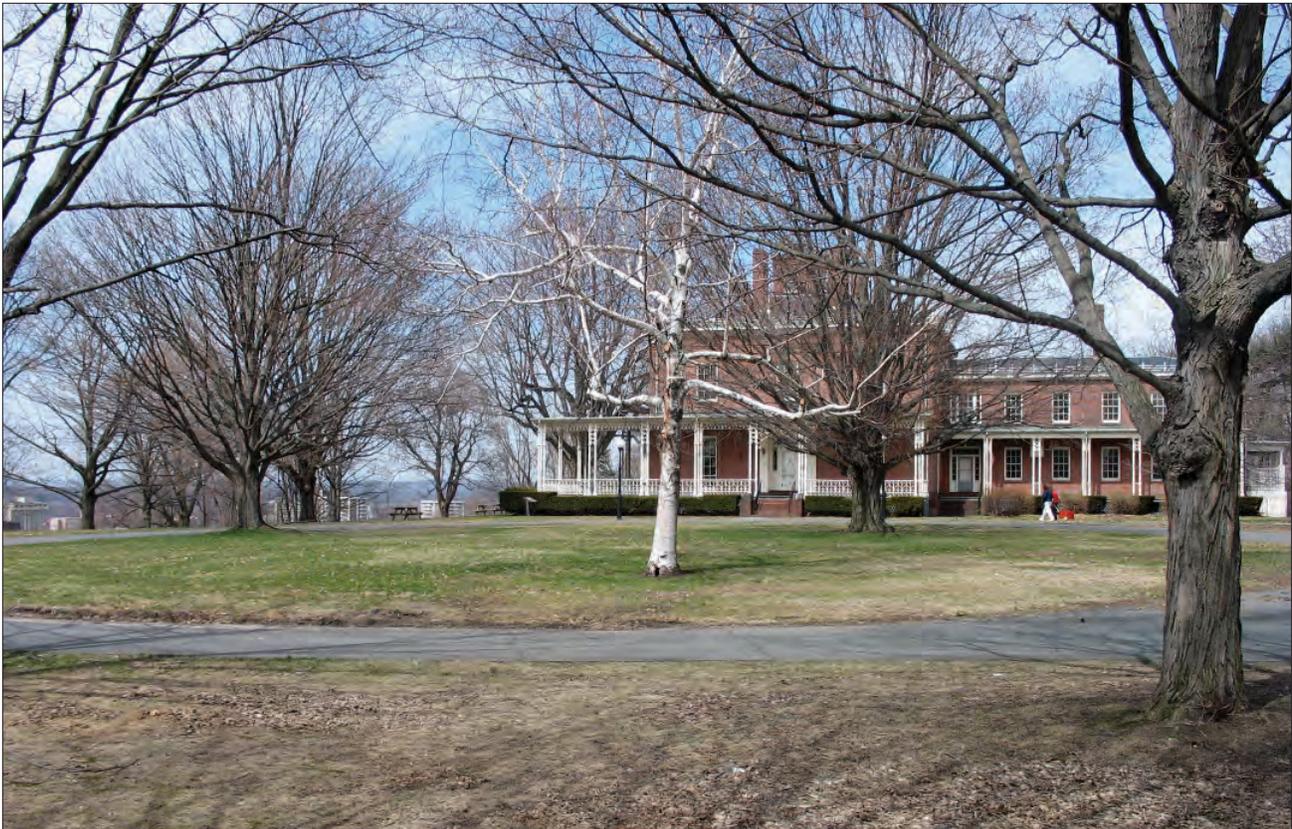
Figure 2.17. Circular drive south of the main entrance to the Commanding Officer's Quarters. Within the circle are two maple trees, a birch tree, and a hawthorn tree. Note the views of the city to the west and beyond on the left. OCLP, 2008.

entry drive is a lawn with two large sugar maple trees (*Acer saccharum*), a paper birch tree (*Betula papyrifera*), and a hawthorn tree (*Crataegus spp.*) (Figure 2.17). Mature shade trees also dot the lawn area immediately adjacent to the house, including an elm tree (*Ulmus americana*).

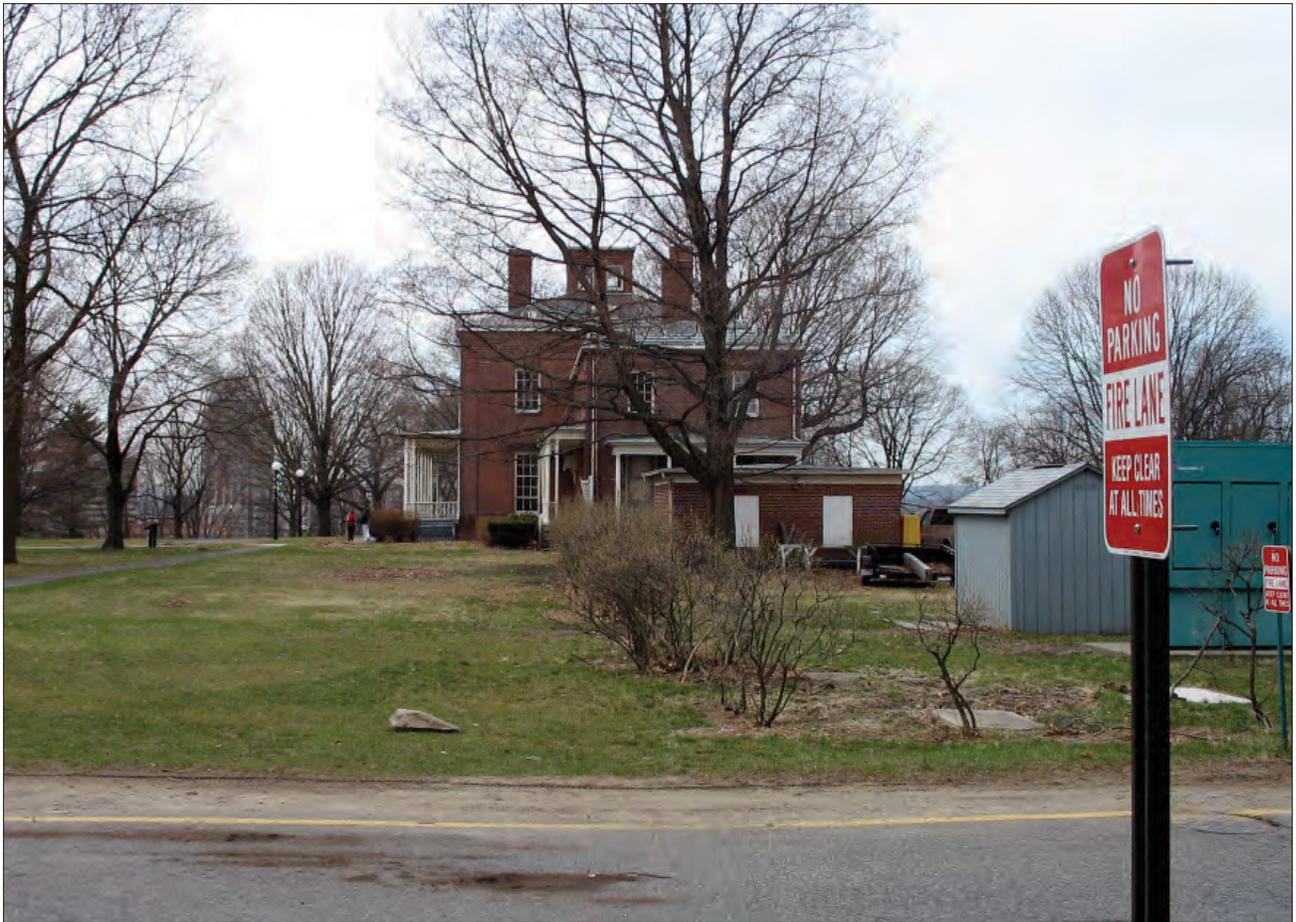
Figure 2.18. Adjacent to the garage at the Commanding Officer's Quarters is a four to five foot high lilac hedge. To the right are a storage shed and transformers, as well as regulatory signs. OCLP, 2008.

A significant historic landscape feature is the four to five-foot high lilac (*Syringa spp.*) hedge that begins at the garage, runs eastward, and turns north to the service driveway (Figures 2.18, 2.19). The hedge starts again across the driveway heading north and ends across from the former Master Armorer's Residence. Historic photographs from the 1920s show this hedge as six to seven feet tall and much wider. Another historic landscape feature is the Hayfield at the northwest area of the site (see Figure 2.12). This area remains an open meadow, but had been previously planted with trees in the nineteenth century.

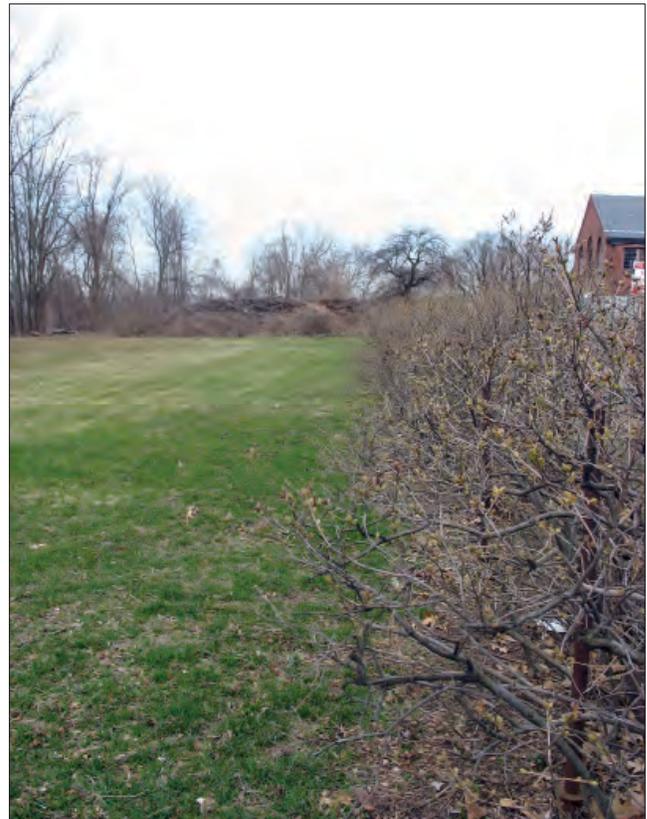
Figure 2.19. View of lilac hedge northeast of the Commanding Officer's Quarters, bordering the road and the site of the former greenhouses and gardens. OCLP, 2008.

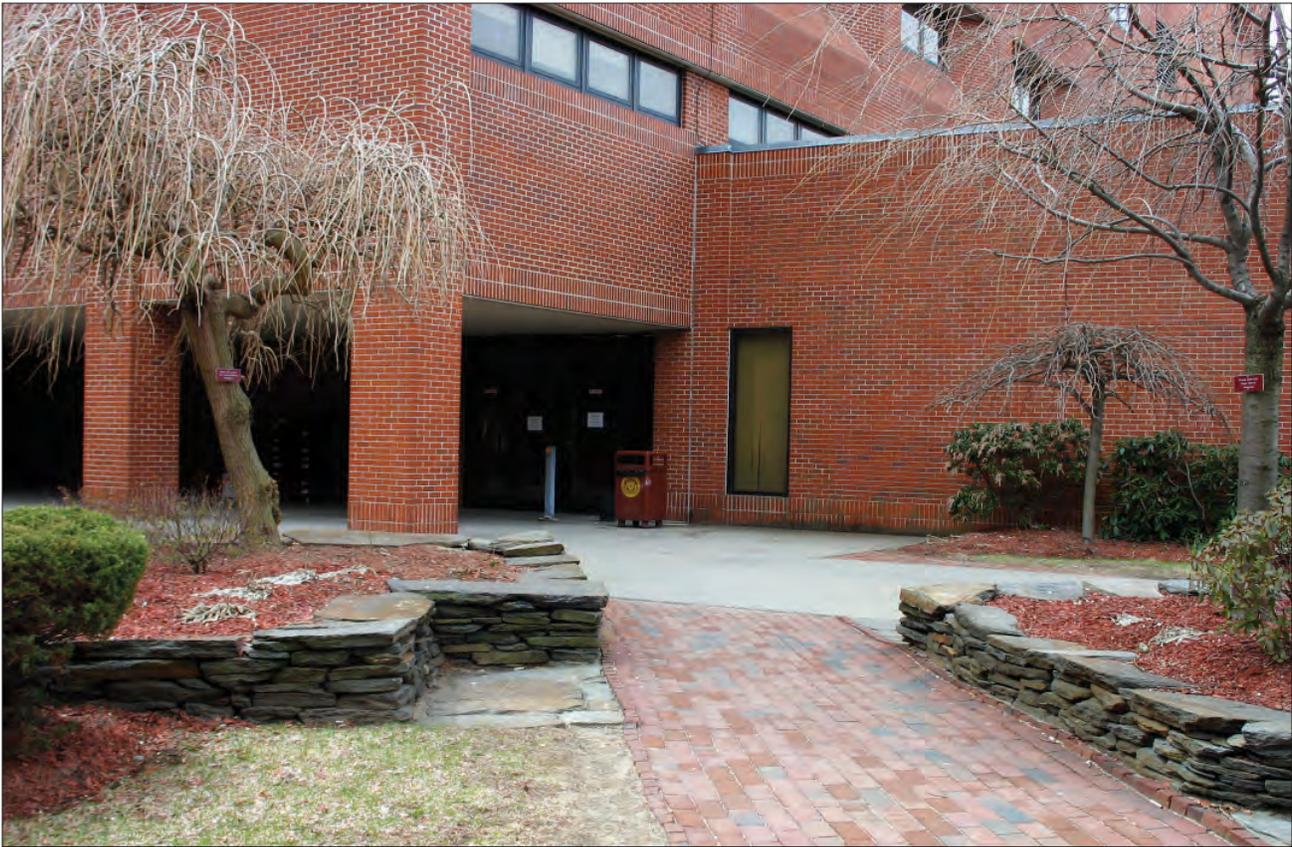
Figure 2.20. View of the space between Deliso Hall and Putnam Hall. The trees are labeled with metal tags for the college horticultural program. Shrubs include yews, rhododendrons, and andromedas. Paving materials include concrete, brick, and stone. Note the low stone wall and built-in seating. OCLP, 2008.

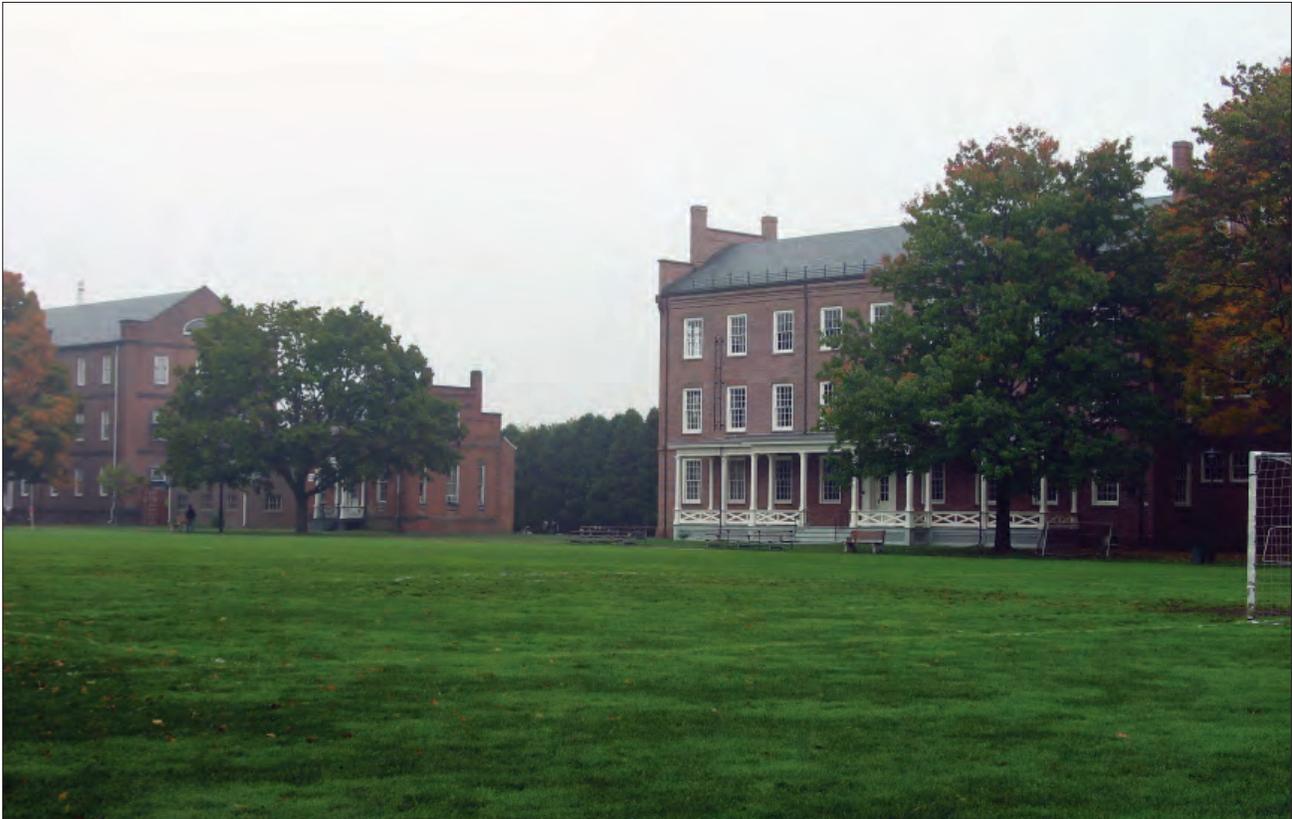
Figure 2.21. View of the historic building facades along the southern edge of the Green. The building exteriors are free of foundation plantings, which is in keeping with the historic landscape character. OCLP, 2008.

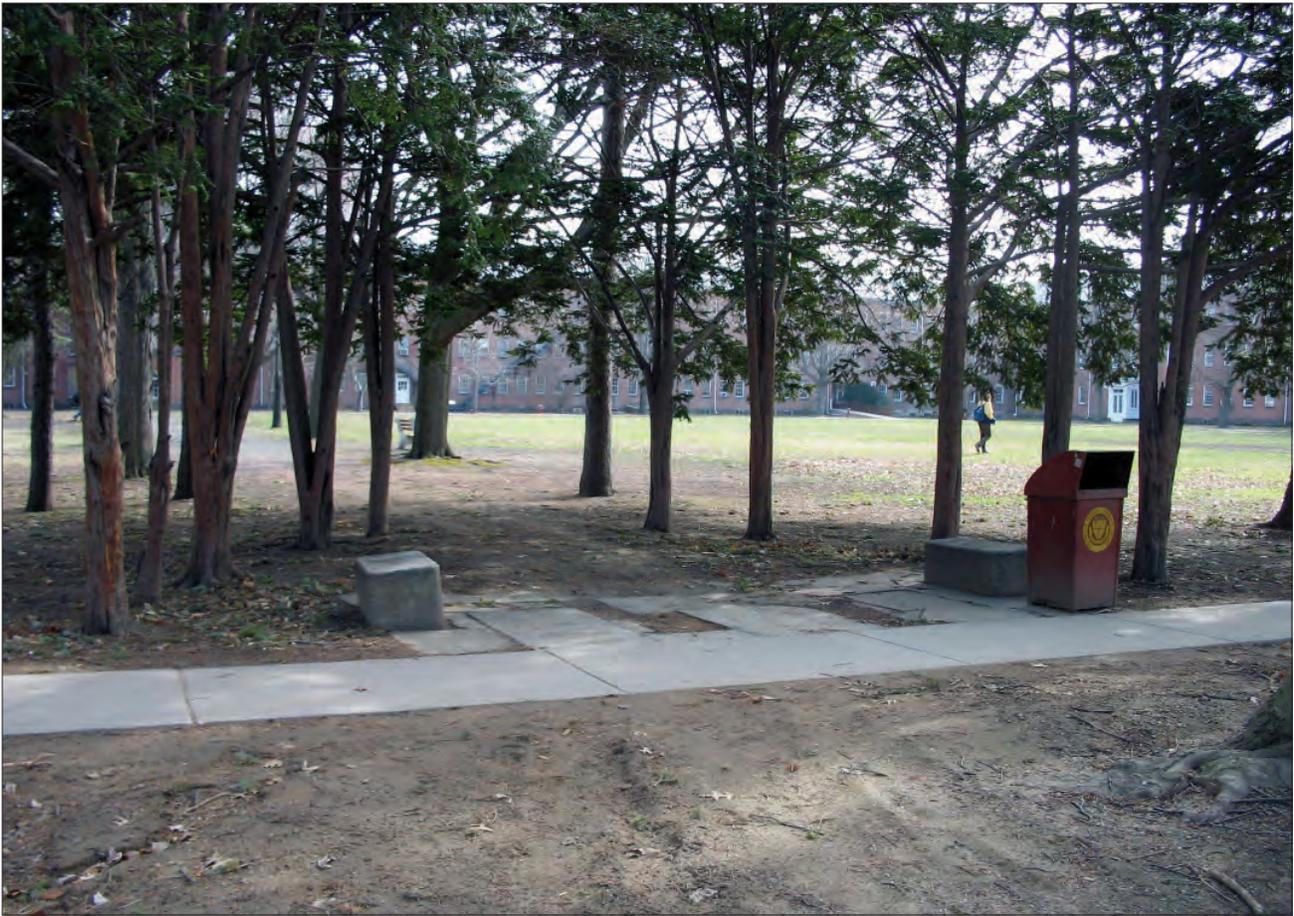
Figure 2.24. View of the main path intersection on the Green with granite blocks and flagstone paving to one side surrounding by two rings of trees. A stone barbecue was originally located between the two granite blocks circa 1940s and 1950s. OCLP, 2008.

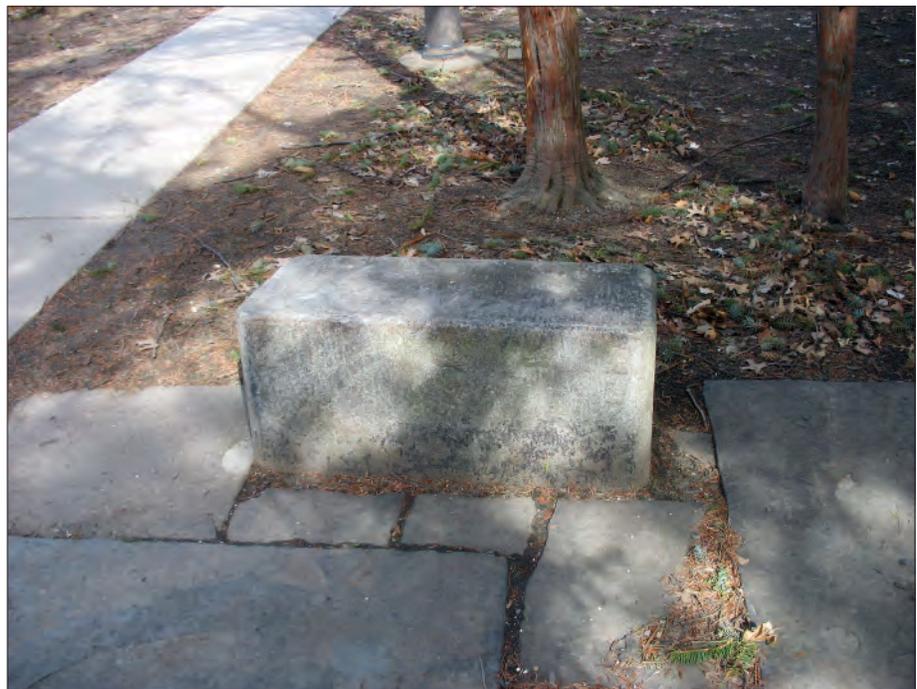
Figure 2.25. Close-up view of one of the granite blocks and flagstone paving in the center of the Green. OCLP, 2008.

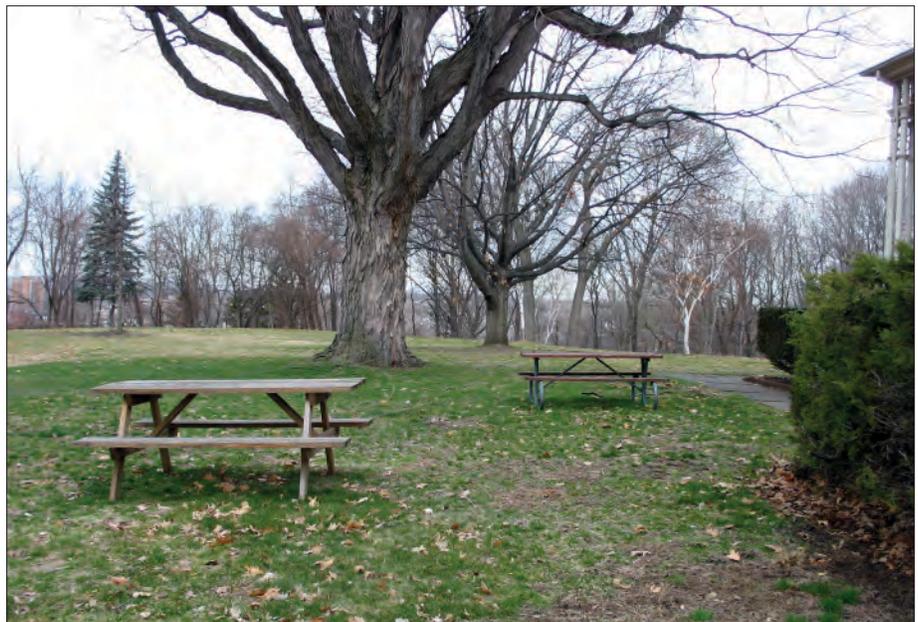
Figure 2.36. View from southeast of Commanding Officer's Quarters. A three-foot wide concrete sidewalk crosses the lawn and the driveway that curves around the Main Arsenal. Note the mature yews to the left of the sidewalk and maple trees to the right. OCLP, 2008.

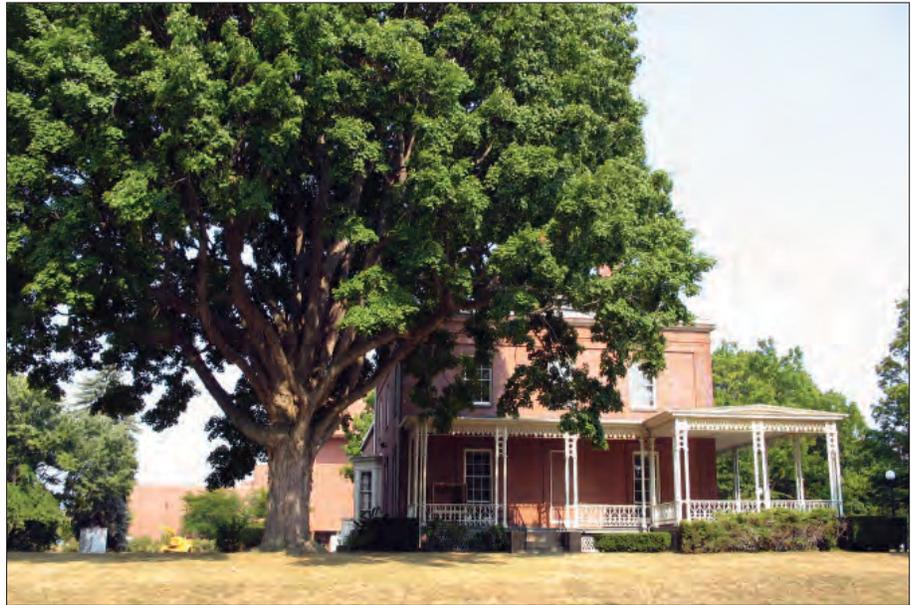
Figure 2.47. View of the western facade of the Commanding Officer's Quarters. Yew shrubs surround the base and a very mature maple tree is located to the left. Scibelli Hall can be seen beyond to the left of the building. OCLP, 2008.

A path adjacent to the Main Arsenal leads to the brick Greek Revival style Commanding Officer's Quarters, constructed in 1847 (Figure 2.47). The existing cast iron porches replaced the original style Doric entrance porch, west-side porch, and ell porch in 1870. Along the driveway near the garage are two very large transformers and a storage shed that detract from the historic setting of the house. Maintenance equipment is also stored outside in the driveway circle.

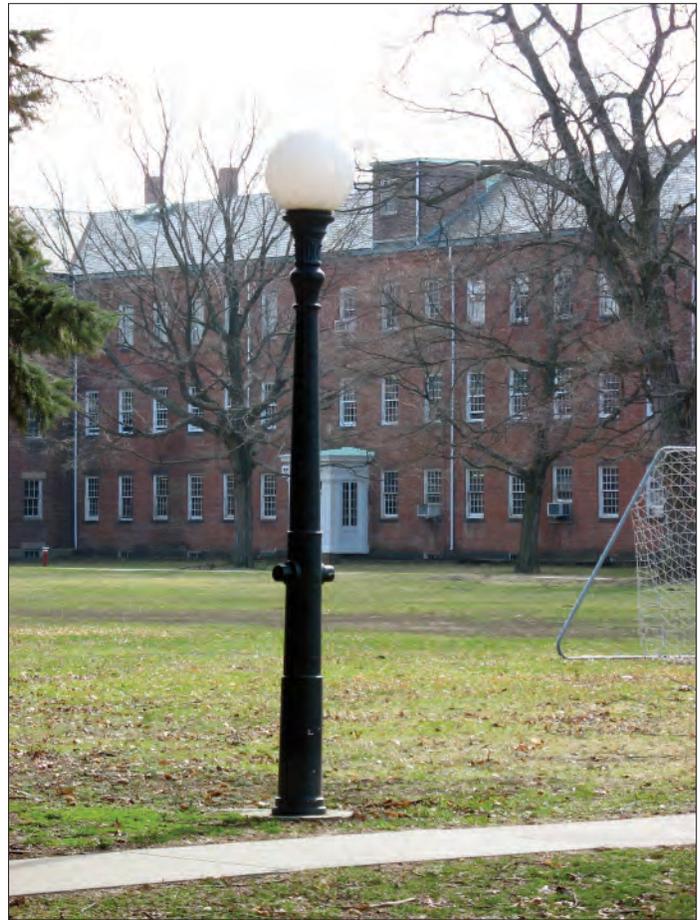
Figure 2.52. View of typical historic lamp post that line the north-south pathway on the Green. OCLP, 2008.

Historic lamp posts are located around the Commanding Officer's Quarters, along the road that curves in front of and to the west of the Main Arsenal and the entrance road from Byers and State Streets. There are also historic lamp posts along the north-south path on the Green (Figure 2.52). In addition, the fence posts at the Byers and State Street entrance and the Federal Street entrance are adorned with historic luminaires (Figures 2.53, 2.54). Additional light pole styles were introduced in the mid-twentieth century (see Figure 2.45). More recently, large-scale contemporary light poles were installed for illuminating parking areas.

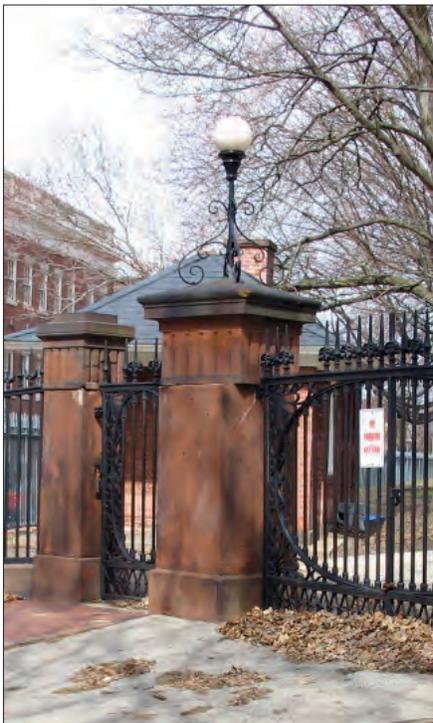
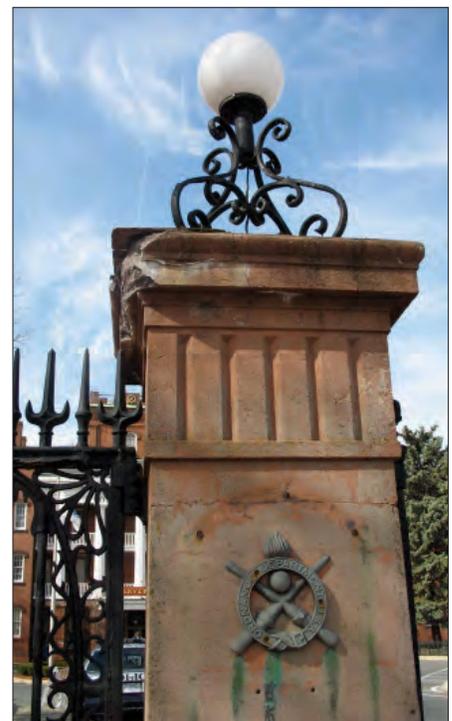
Figures 2.53, 2.54. Historic light fixtures mounted on piers at the corner of Byers and State streets, left, and at the main entrance on Federal Street, right. Some of the sandstone piers have deteriorated and are in need of major repairs, such as the one to the right. OCLP, 2008.

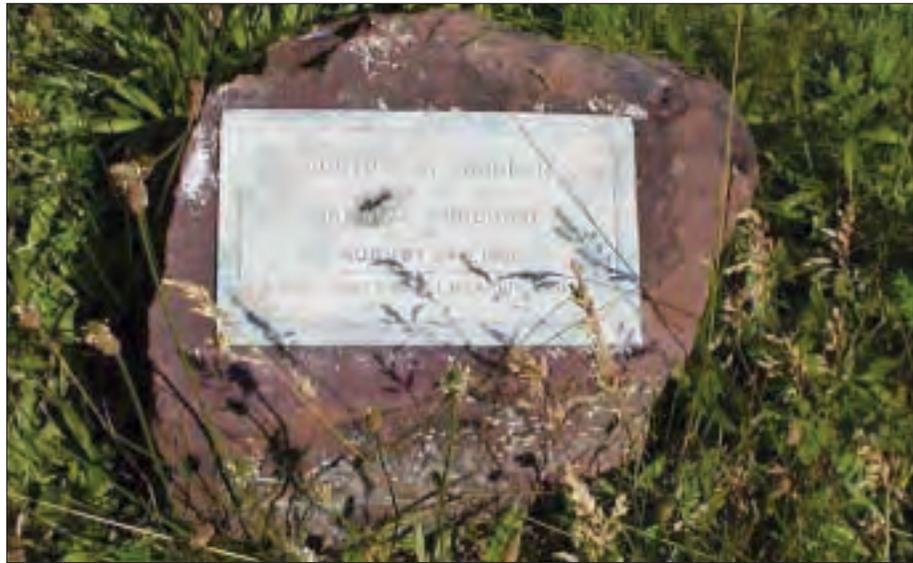
Figures 2.55. Stone with plaque marks the southwest corner of the original land purchase in 1801. OCLP, 2006.

Additional small-scale features include a stone with a plaque marking the southwest corner of the original land purchase (Figure 2.55). A mounting stone is part of the curb structure in front of the Officers' Quarters 5/6 on the southwest corner of the Green (Figure 2.56). A circular drain inlet, a surviving fragment of the site's historic drainage system, is also located on the southwest corner of the Green (Figure 2.57). And a tennis court, built in the late 1930s, is situated on the west side of the Main Arsenal.

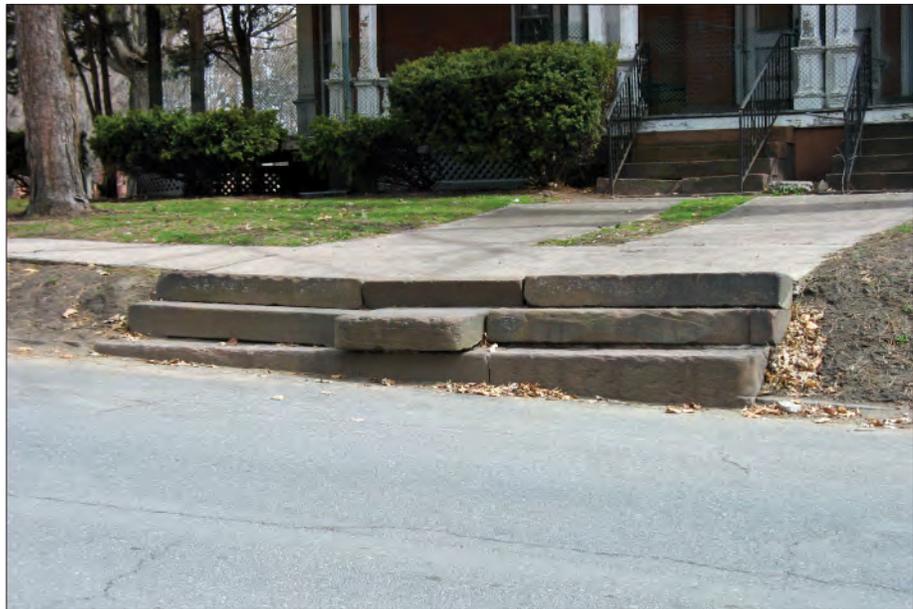
Figures 2.56. A step used for mounting horses and carriages was built into the steps of the Officer's Quarters 5/6 south of the Main Arsenal. OCLP, 2008.

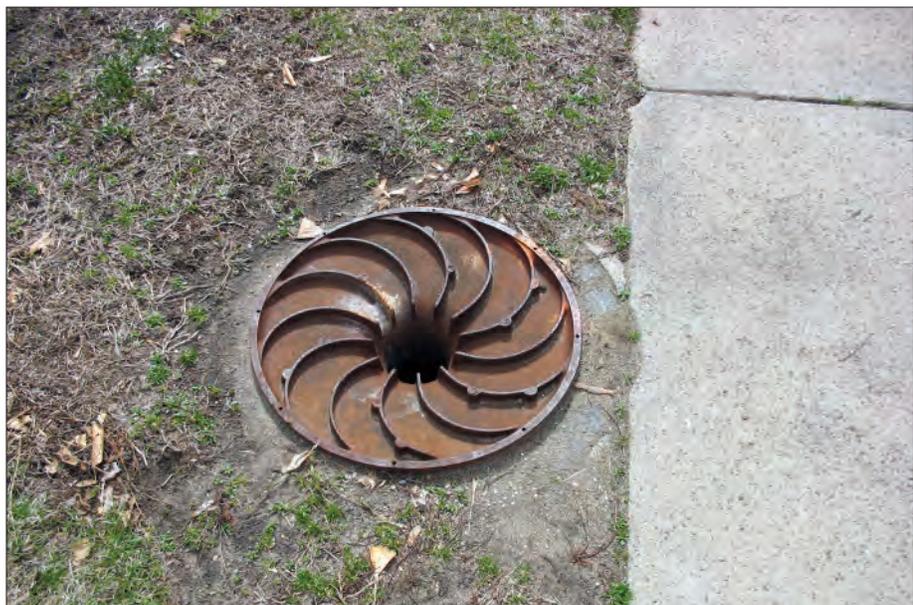
Figures 2.57. At the southwest corner of the Green is a remnant of a turbine housing, most likely formerly used as part of a turbine or pump at the Armory. OCLP, 2008.
