CULTURAL LANDSCAPE REPORT FOR ARMORY SQUARE

SPRINGFIELD ARMORY NATIONAL HISTORIC SITE

Olmsted Center for Landscape Preservation
National Park Service, Boston, Massachusetts, 2010

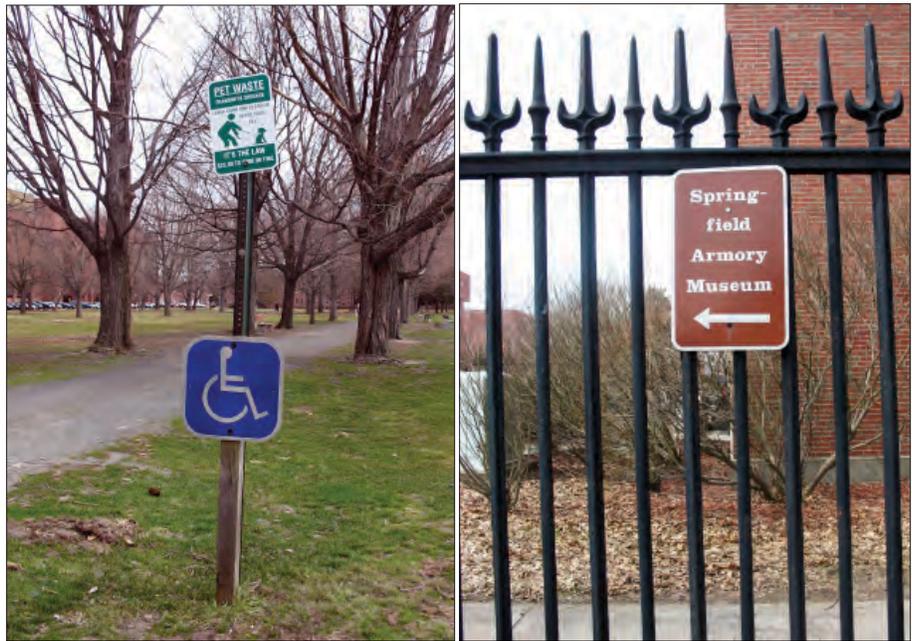
Figures 2.58, 2.59. A variety of metal signs throughout the site are mounted on wooden or metal posts, or directly on the ornamental fence. OCLP, 2008.

Contemporary additions to the landscape consist of benches, bleachers, picnic tables, and trashcans on the Green, as well as National Park Service identification and interpretive signs. Seating types range from concrete benches with recycled plastic slats to built-in seating made of stone or concrete. A variety of signs are located throughout the historic site, some related to interpretation on the National Park Service property, and others related to directions, accessibility, parking, or warning signs (Figures 2.58-2.61).

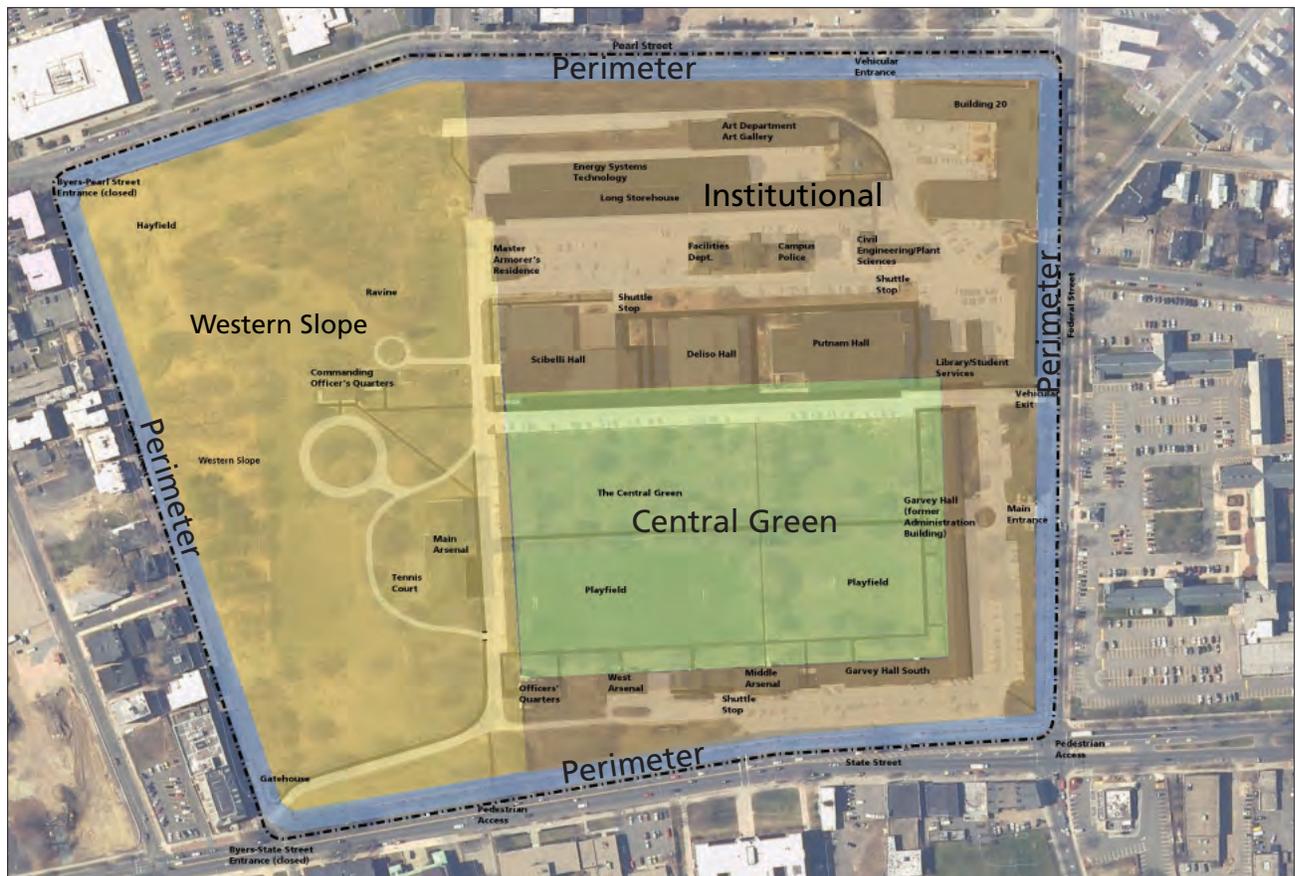
Figure 3.0. Plan illustrating the four landscape character areas, Perimeter Landscape, Western Slope, Central Green, and Institutional Landscape. OCLP, 2009.

For the purposes of the following analysis and evaluation, the project area is divided geographically into four landscape character areas consistent with the earlier description of existing site conditions (Figure 3.0). The Perimeter Landscape includes the historic iron ornamental fence and gates that enclose the entire site, as well as the surrounding brick and concrete sidewalks and trees outside the fence which is now under the City's ownership. The Central Green Landscape comprises the main lawn and tree canopy, and the building facades along the east and southern edges of the Green. The Western Slope Landscape consists of the Main Arsenal and adjacent parking along the western edge of the Green and the terraced area west of the Main Arsenal. This area also includes the Hayfield in the northwestern corner, the Commanding Officer's Quarters, and garage, and the ravine immediately northeast. The Institutional Landscape

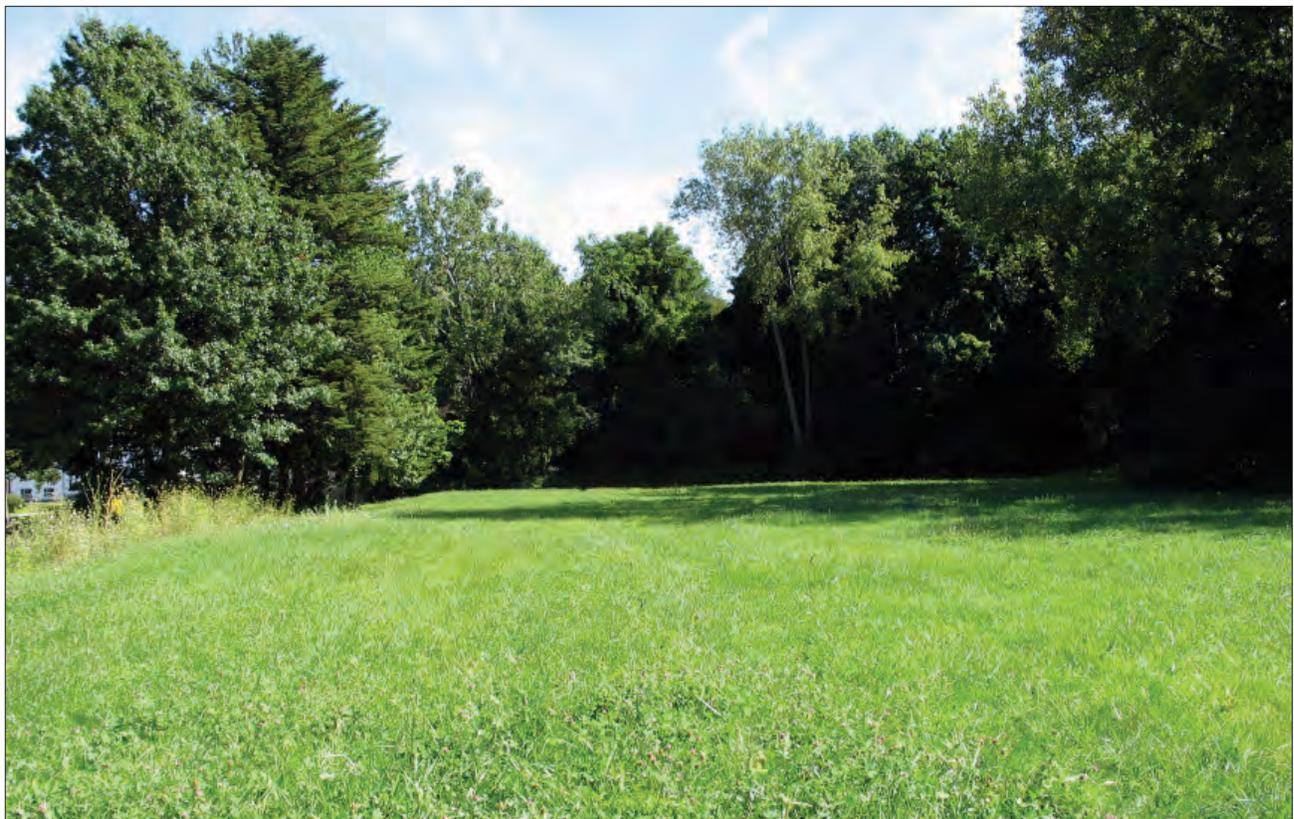
Figure 3.1. View of the northwest corner of Army Square that was regraded for playfields in the late 1960s for the City of Springfield school system. OCLP, 2009.

Existing Condition: The site is still characterized by a fairly level area on top of the bluff and ravine. The site's topography has continued to be modified in an ongoing effort to mitigate drainage problems and accommodate new uses, such as the playfields for the City of Springfield school system at the northwest portion of the site (Figure 3.1).

Existing Condition: The area was regraded in 1969 in order to install playfields for the City of Springfield school system.

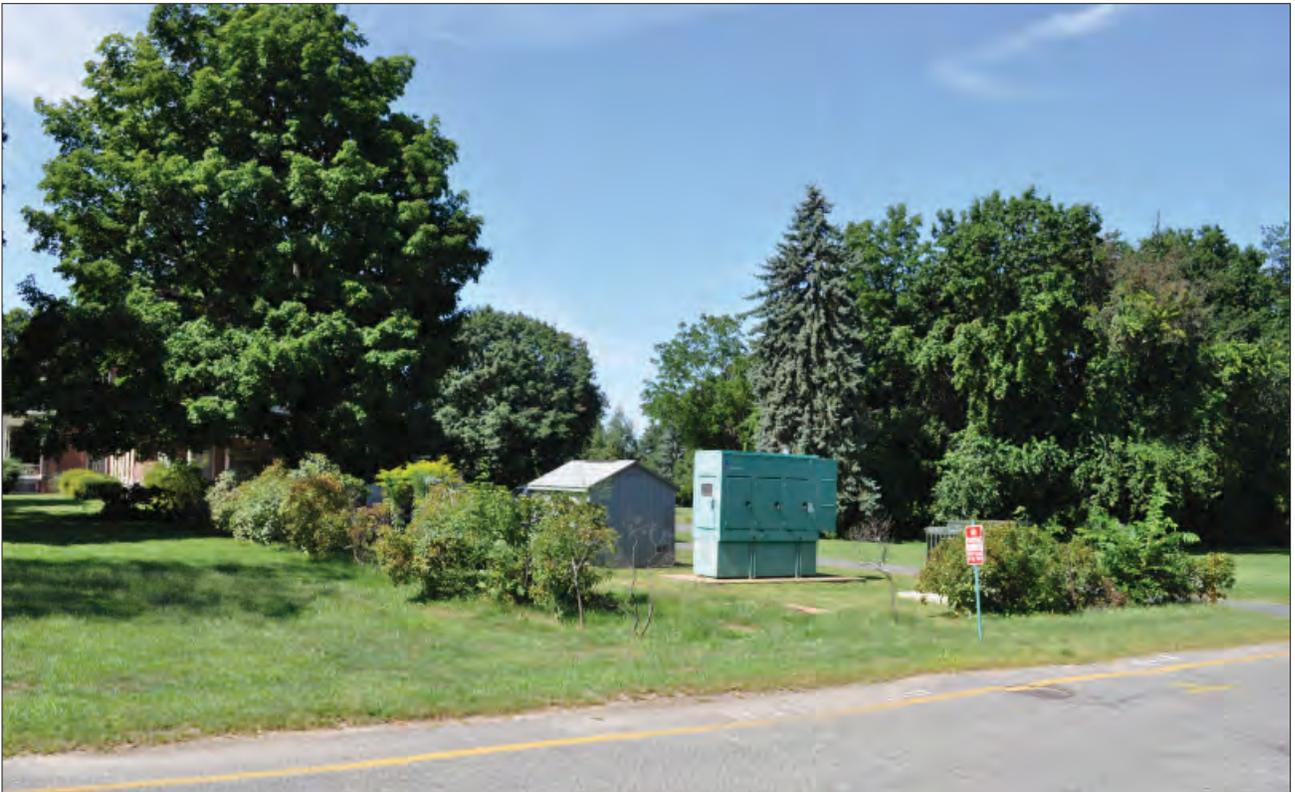
Figure 3.8. View of lilac hedge west of Commanding Officer's Quarters, with missing segments. OCLP, 2009. Extant 1968. Contributing.

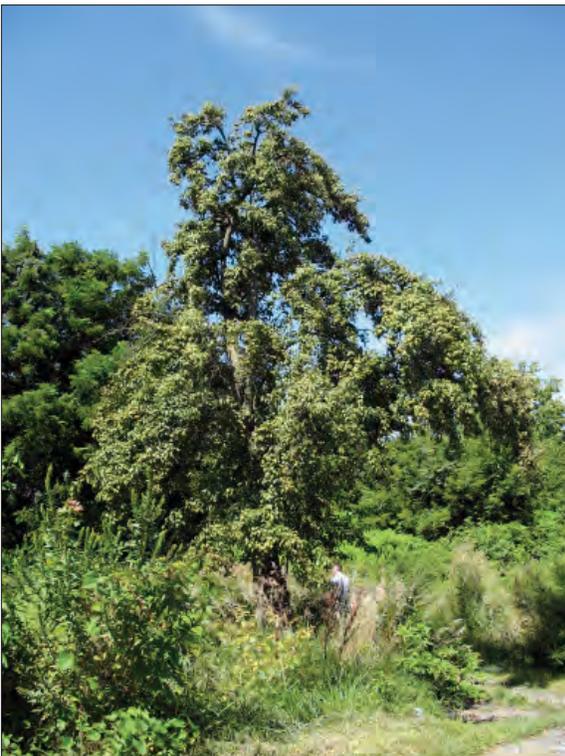
Figure 3.9. Views of pear trees, remnants of an orchard located by the former greenhouse site northeast of the Commanding Officer's Quarters. Extant 1968. Contributing.

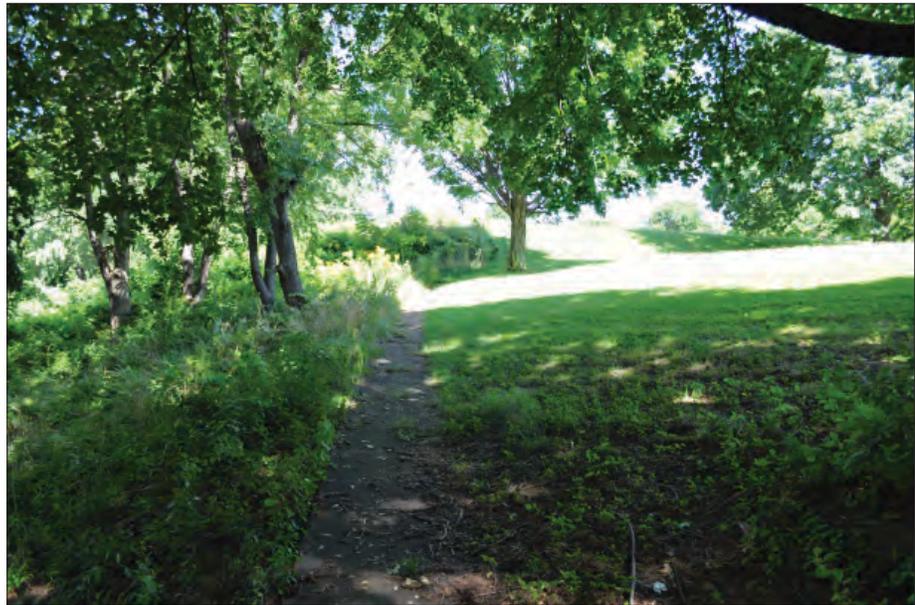
Figure 3.10. View of pathway from Byers/State Street entrance, partially covered with fill from grading operations in the late 1960s by the City of Springfield for playfields. Extant 1968. Contributing.

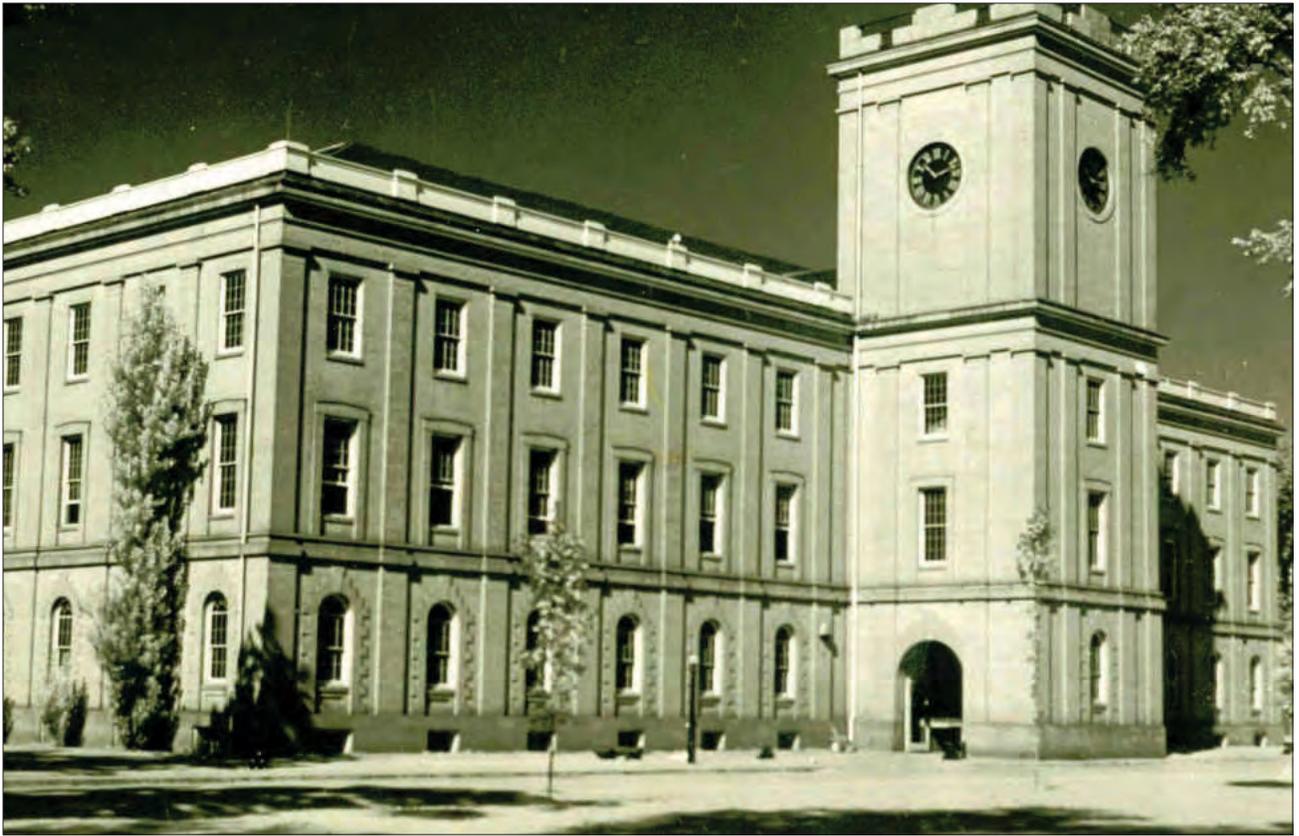
Figure 3.13. View of the Main Arsenal with main entrance, facing the Green, 1942. SPAR Museum Archives, Box 003, Folder 03, NEG 3293-SA.

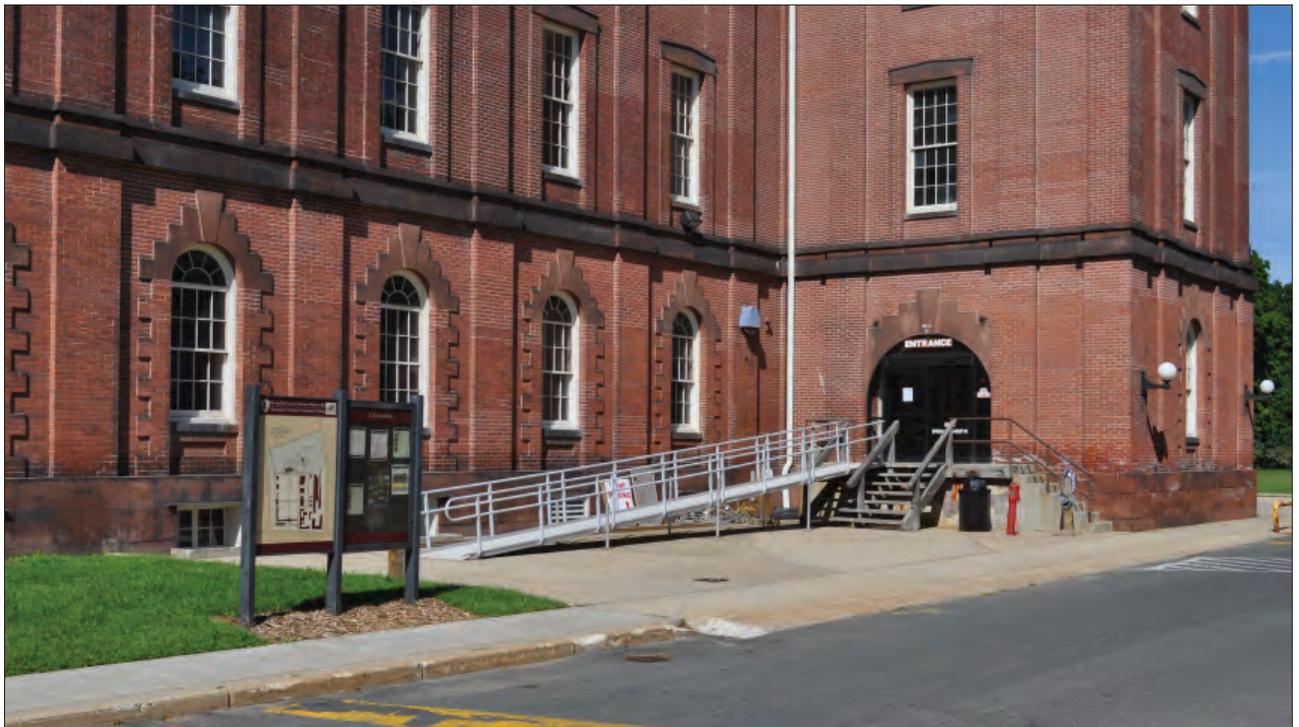
Figure 3.14. View of the Main Arsenal with main entrance, facing the Green, 2009. A metal accessible ramp and wooden steps have been added to the entrance. OCLP, 2009.

Concrete sidewalk along northern edge of drive from Byers and State street corner (LCS No. 040450)	No	Yes	Yes	Military	National	A sidewalk was constructed along with the vehicular drive from the Byers and State streets corner entrance in the late 1870s. Its original paving material is not known.
Accessible ramp (Figure 3.28)	No	No	No	n/a	n/a	A metal accessible ramp is located at the main entrance to the Main Arsenal.
Surface parking	No	No	No	n/a	n/a	A row of parking spaces was installed along the western edge of the Green for park visitors and personnel.
Buildings and Structures						
Main Arsenal (LCS No. 022287)	No	Yes	Yes	Military	National	Built in 1850, the Main Arsenal was one of the largest buildings on the campus with a clock tower on the east facade. A loading dock was added in 1941. The building is now a museum as well as archives, and offices for the NPS.
Commanding Officer's Quarters (LCS No. 022705)	No	Yes	Yes	Military	National	Completed in 1847, the building was designed in the Greek Revival style. The building is currently not in use.

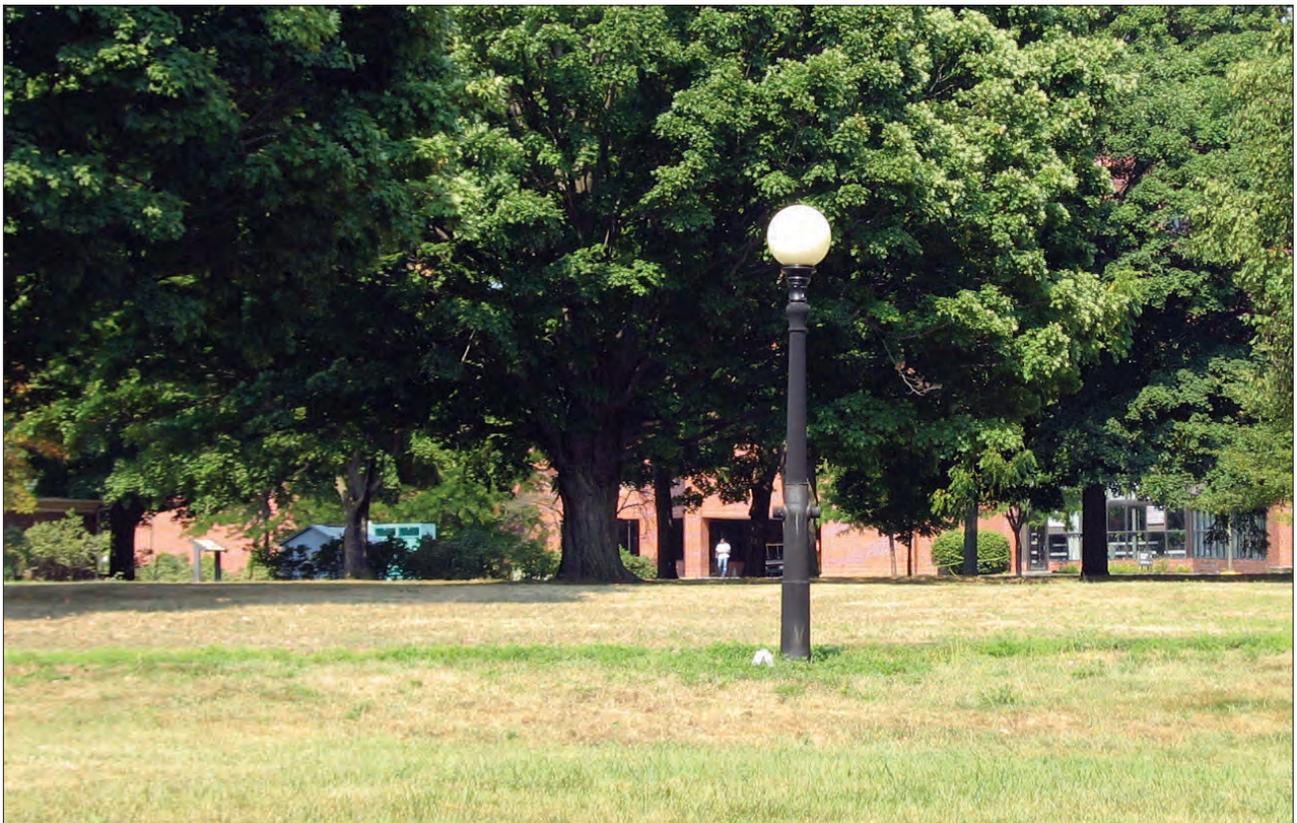
Figure 3.18. View of cast-iron lamp post on the central Green, 2008. OCLP, 2008. Extant, 1968. Contributing.

Small Scale Features						
Iron lamp posts	No	Yes	Yes	Military Landscape Design	National	Installed in the 1840s, cast iron lamp posts were created in a style reminiscent of cannon tubes. The lights were originally glass lanterns, but changed to globe fixtures in the early twentieth century.
Stone blocks (Figure 3.43)	No	Yes	Yes	Military Landscape Design	National	Located in the center of the Green are two stone blocks, possibly old mounting stones.
Institutional Landscape						
Feature	Extant 1794	Extant 1968	Contributing	Theme	Level	Notes
Circulation						
Interior road system	No	Yes	Yes	Military	National	The vehicular circulation system remains intact from the historic period.
Stone steps at western entrance to Quarters 5/6	No	Yes	Yes	Military	National	Built along with the building in 1870.
Surface parking	No	No	No	n/a	n/a	Surface parking was added at the southeastern portion of the campus as well as the area between the Long Storehouse and the new academic buildings.

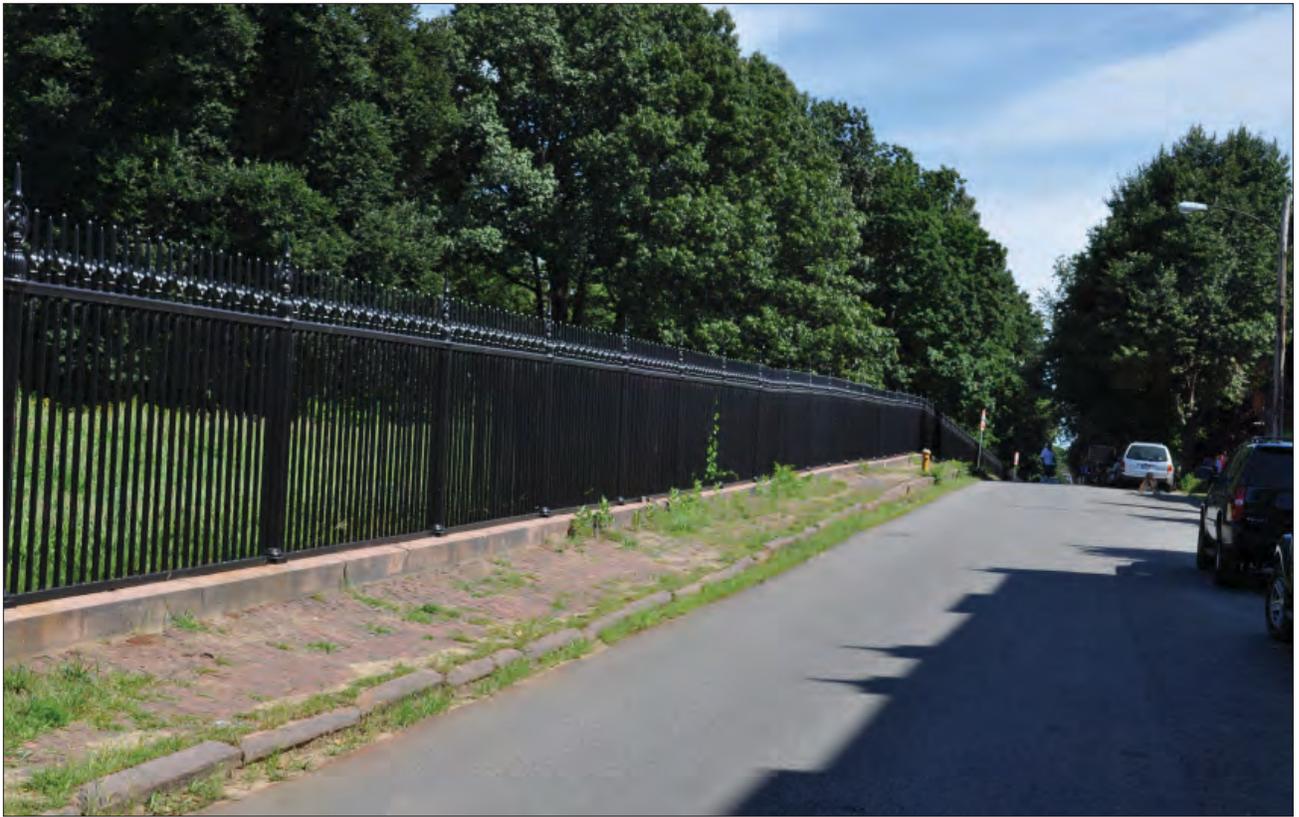
Figure 3.22. View of perimeter sidewalk and street trees along State Street side of Armory Square, 2008. OCLP, 2008. Extant 1968. Contributing.

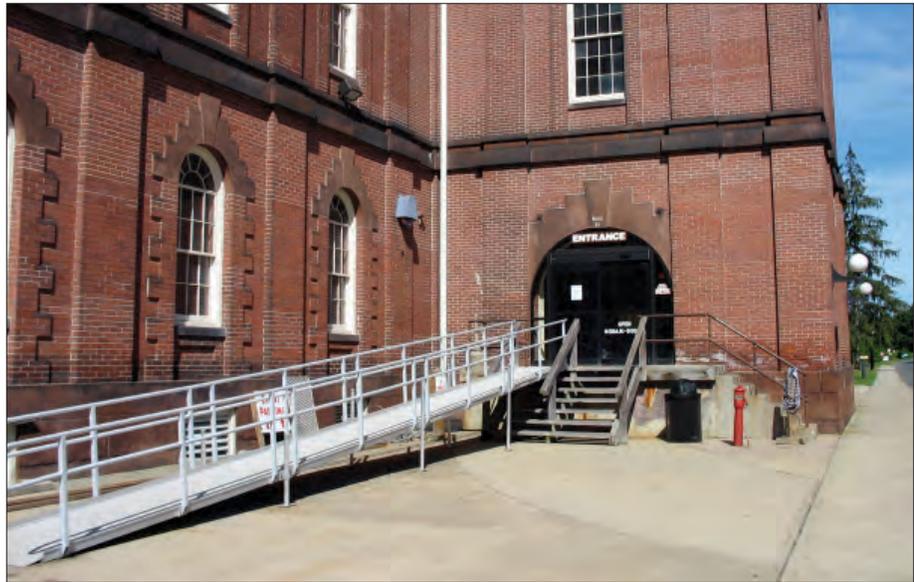
Figure 3.28. View of accessible ramp at entrance to Main Arsenal. OCLP, 2009. Non-extant 1968. Noncontributing.

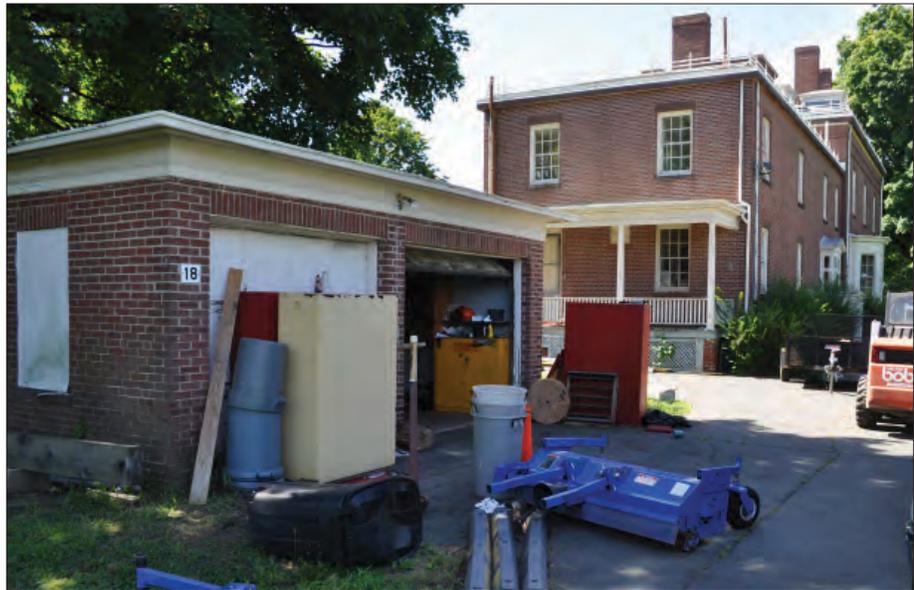
Figure 3.29. View of garage at Commanding Officer's Quarters, now used for storage of park maintenance equipment. OCLP, 2009. Extant 1968. Contributing.

Garage for Commanding Officer's Quarters (LCS No. 022288) (Figure 3.29)	No	Yes	Yes	Military	National	As a Works Progress Administration project in 1937, a two-car, brick-clad garage was constructed west of the Commanding Officer's Quarters. It is currently used for maintenance storage.
Gatehouse at Byers and State Street entrance (LCS No. 022289) (Figure 3.30)	No	Yes	Yes	Military	National	The gatehouse was constructed in 1908, replacing an octagonal structure. Alterations are believed to have occurred in 1937 as a Works Progress Administration project.
Vegetation						
Lilac hedge (see Figure 3.9)	No	Yes	Yes	Military Landscape Design	National	The lilac hedge was most likely installed in the 1870s along with ornamental gardens under Benton's administration.
Foundation plantings around Commanding Officer's Quarters (Figure 3.31)	No	Yes	Yes	Military Landscape Design	National	Some of the foundation plantings date to the historic period of significance, such as the yew shrubs and possibly the rhododendrons. The exact dates of installation are not known. The other plantings are in keeping with the historic character of the landscape.

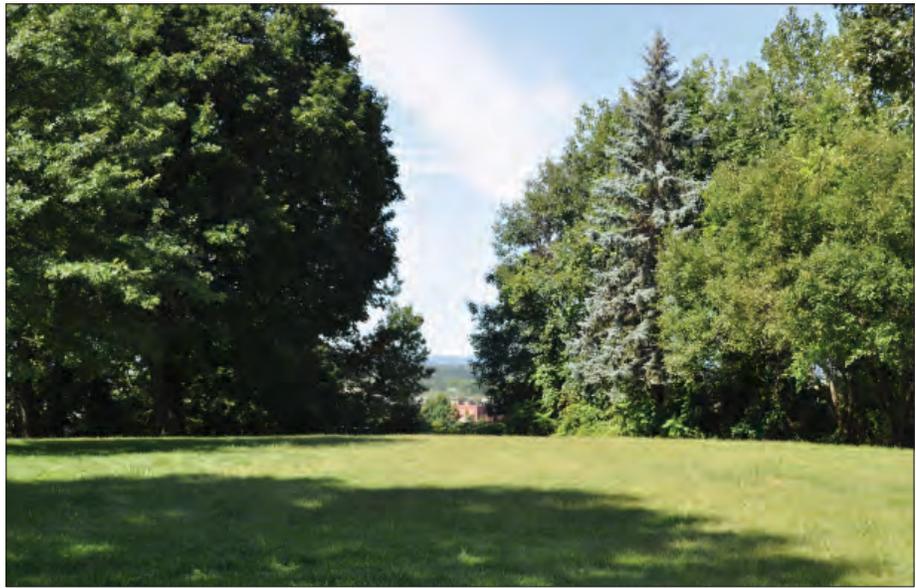
Figure 3.34. View out from western hillside of Armory Square, obscured by growth of trees. OCLP, 2009. Extant 1968. Contributing.

Views and Vistas						
Views from western hillside (Figure 3.34)	Yes	Yes	Yes	Military	National	Views from the hilltop out to the surrounding landscape and cityscape are obscured by new buildings and the growth of trees.
View from Main Arsenal clock tower	No	Yes	Yes	Military	National	Public access to the tower is no longer allowed.
Small Scale Features						
Cast iron lamp posts (LCS No. 040454)	No	Yes	Yes	Military	National	Installed in the 1840s, cast iron lamp posts were created in a style reminiscent of cannon tubes. The lights were originally glass lanterns, but changed to globe fixtures in the early twentieth century.
Tennis court (LCS No. 022602) (Figure 3.35)	No	Yes	Yes	Military	National	In the 1930s, a tennis court was constructed west of the Main Arsenal. It may have been a Works Progress Administration project.
Asphalt pad (Figure 3.36)	No	Undetermined	Undetermined	Undetermined	Undetermined	A roughly 8'x8' square asphalt pad is located west of the Main Arsenal. It may possibly be used for supporting a cannon display during ceremonies and holidays.

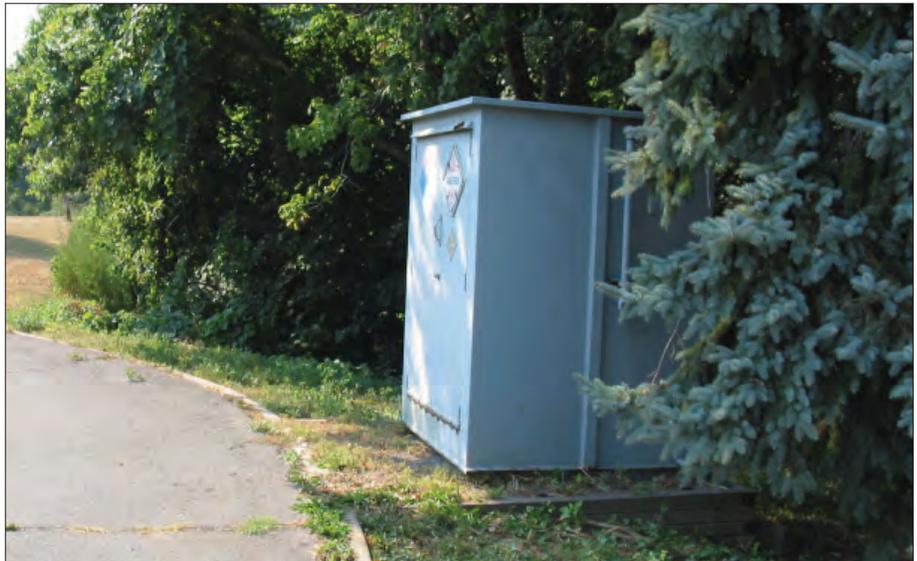
Figure 3.37. View of electrical shed on north edge of service drive at Commanding Officer's Quarters. OCLP, 2008. Non-extant 1968. Noncontributing.

Electrical shed, maintenance shed and generator (Figures 3.37, 3.38)	No	No	No	n/a	n/a	The electrical shed is located on the north edge of the service drive at the Commanding Officer's Quarters. The maintenance shed and electrical generator are located southeast of the service drive at the Commanding Officer's Quarters.
Mulch pile (Figure 3.39)	No	No	No	n/a	n/a	Located northeast of the Commanding Officer's Quarters is a large mulch pile.
Interpretive wayside exhibits	No	No	No	n/a	n/a	NPS interpretive waysides are located throughout the park.
Picnic tables (Figure 3.40)	No	No	No	n/a	n/a	Several picnic tables are located near the Commanding Officer's Quarters.
Directional signage	No	No	No	n/a	n/a	A number of regulatory signs are located along the western edge of the Green and the west side of the interior access road.
Information panels (Figure 3.41)	No	No	No	n/a	n/a	Metal and wood information panels are located near the main entrance to the Main Arsenal.

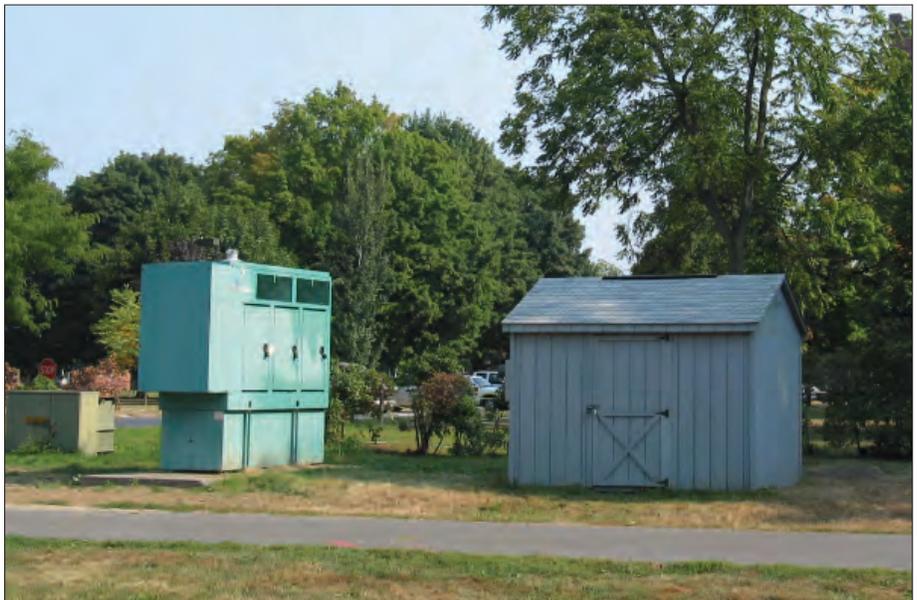
Figure 3.38. View of generator and maintenance shed south of service drive at Commanding Officer's Quarters. OCLP, 2008. Non-extant 1968. Noncontributing.

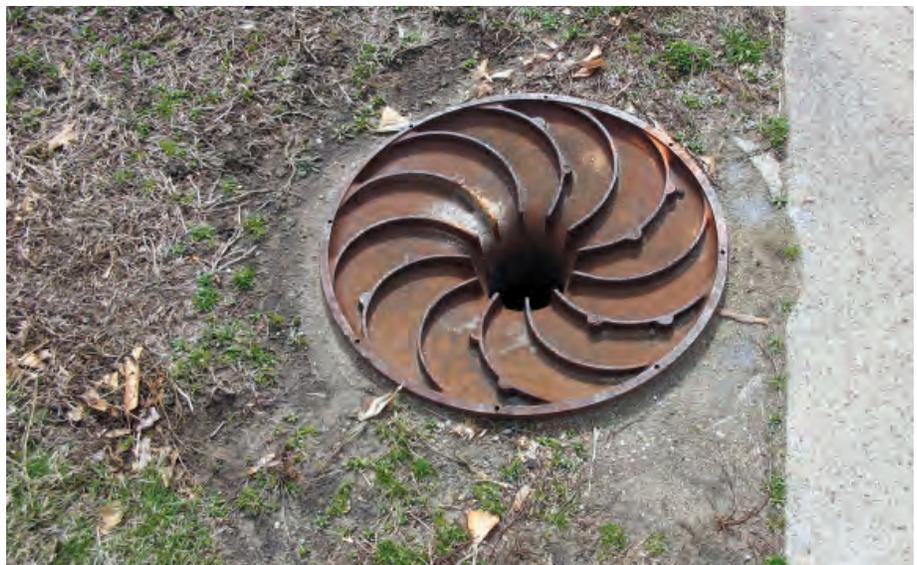
Figure 3.45. Drain inlet located at the southwest corner of the Green. OCLP, 2008. Extant 1968. Contributing.

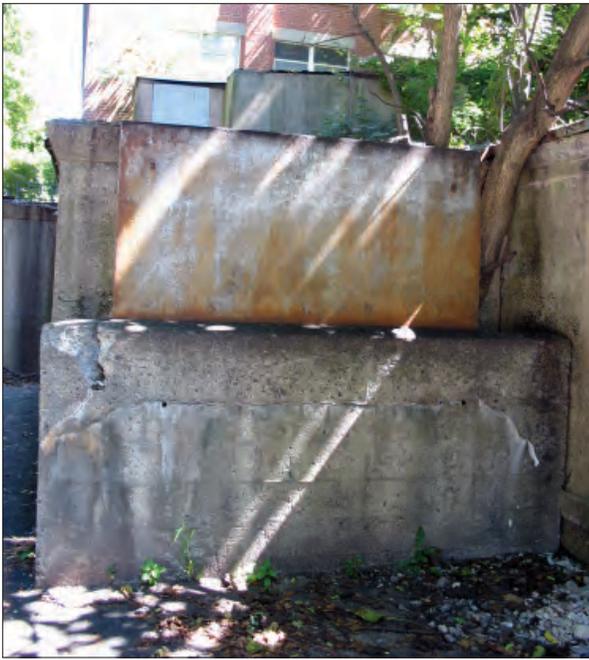
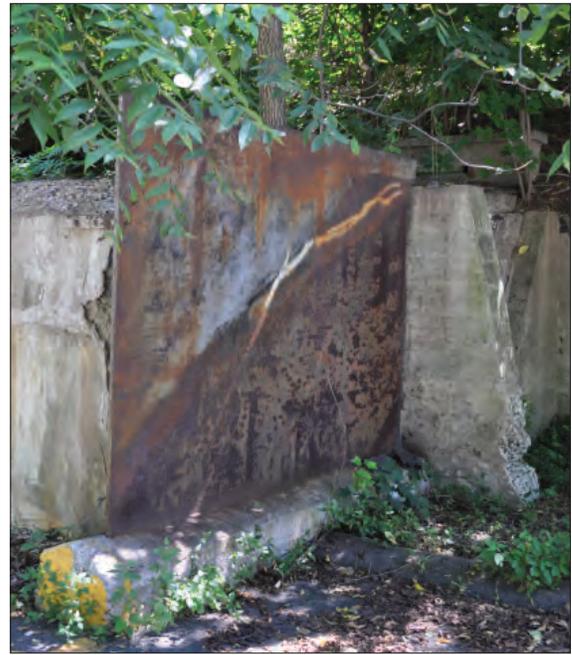
Figure 3.46. View of steel backstops located on the north side of the shooting range. OCLP, 2009. Extant 1968. Contributing.

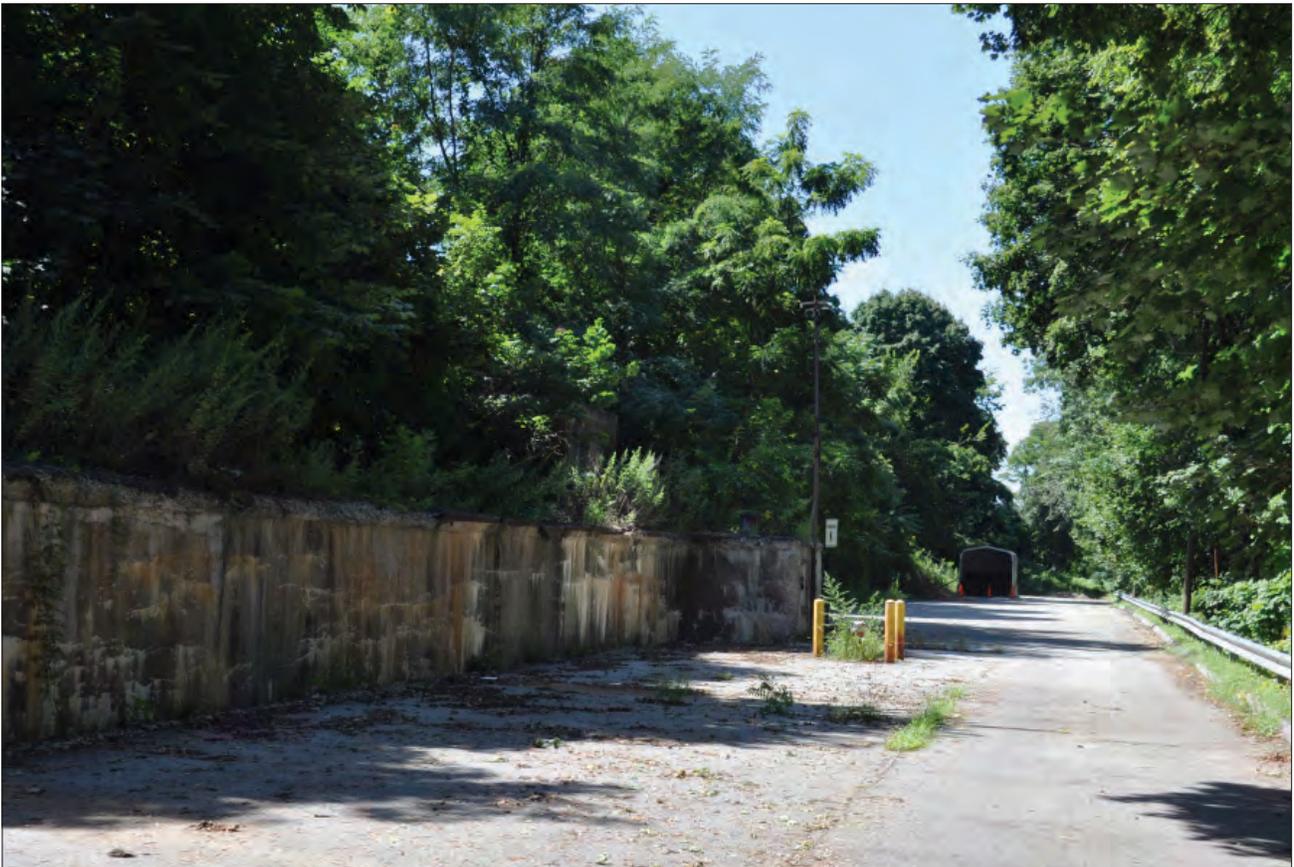
Figure 3.47. View of concrete retaining wall, part of the underground shooting range, at north side of campus. OCLP, 2009. Extant 1968. Contributing.

Concrete retaining wall (Figure 3.47)	No	Yes	Yes	Military	National	Located on the north slope of the campus, the retaining wall is part of the shooting range structure.
Metal building sign numbers (Figure 3.48)	No	Yes	Yes	Military	National	All of the former Armory buildings have a small, square metal sign mounted on the exterior, denoting building number. Exact date of installation is not known.
Mounting stone (Figure 3.49)	No	Yes	Yes	Military	National	A mounting stone is built into the steps at the western side of Officer's Quarters 5/6, used for mounting onto a horse.
Concrete splash blocks (Figure 3.50)	No	Yes	Yes	Military	National	Concrete splash blocks are located at the base of Buildings 20 and 27.
Original purchase marker (LCS No. 040455)	No	Yes	Yes	Military	National	A stone with a plaque marks the southwest corner of the original land purchase. Information regarding date of installation has not been found.

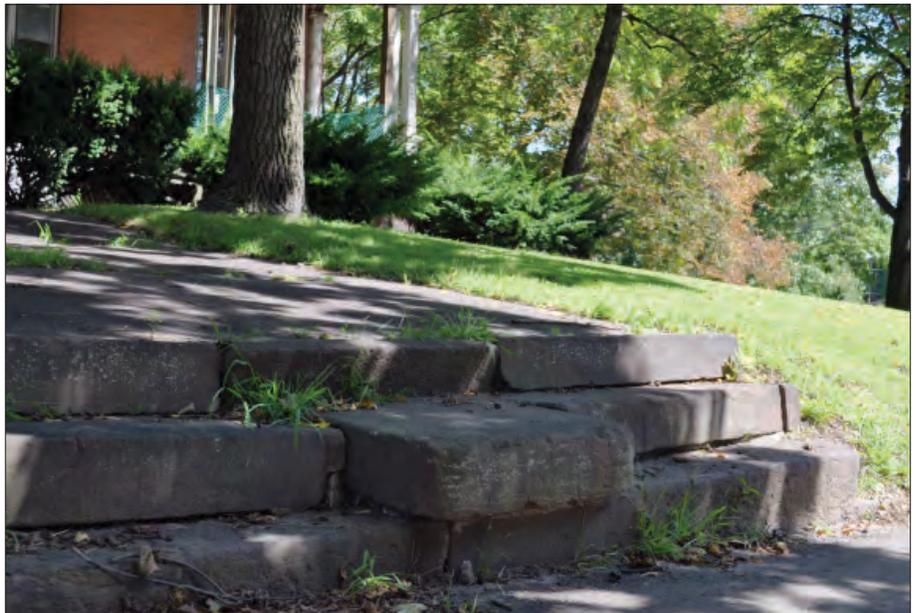
Figure 3.50. Typical stone splashblock, located along east facade of Building 27. OCLP, 2009. Extant 1968. Contributing.

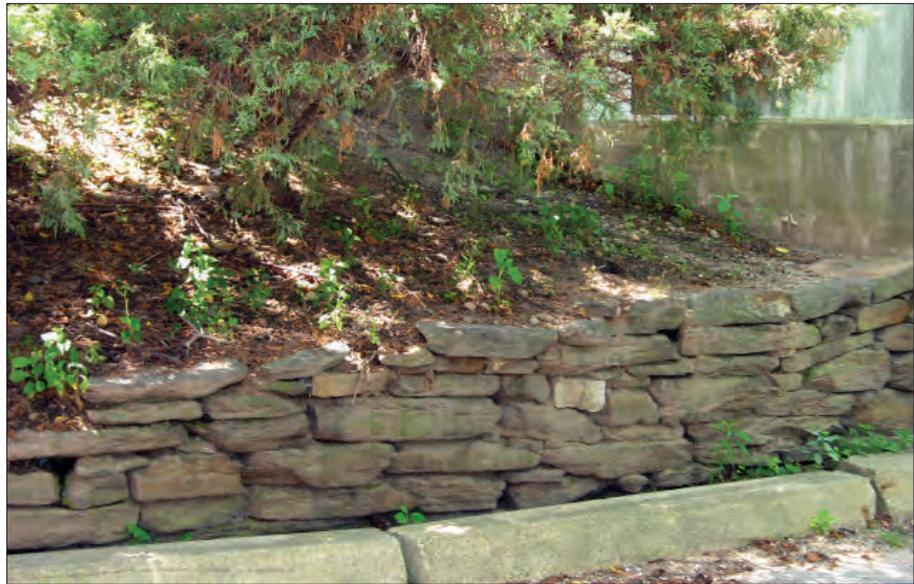
Figure 3.51. Drylaid stone retaining wall at the northeast corner of the Fine Arts Building. OCLP, 2009. Extant 1968. Undetermined.

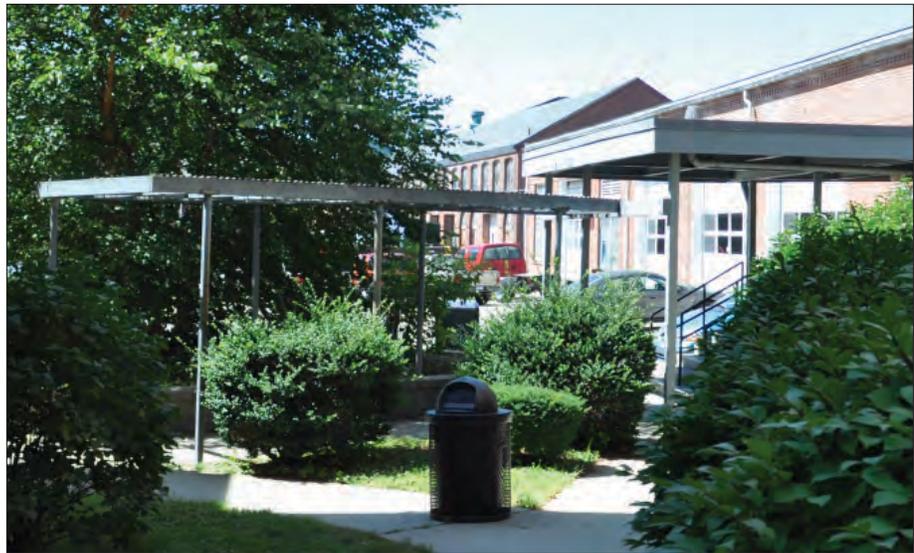
Figure 3.52. View of metal arbor over walkway between Buildings 20 and 25. OCLP, 2009. Extant 1968. Undetermined.

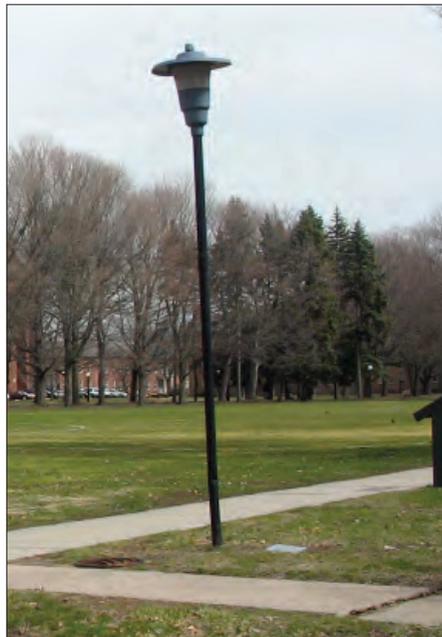
Figure 3.53. View of light posts at the southwest corner of the Green, and a view of a typical light post located throughout the college campus. OCLP, 2009. Non-extant 1968. Noncontributing.

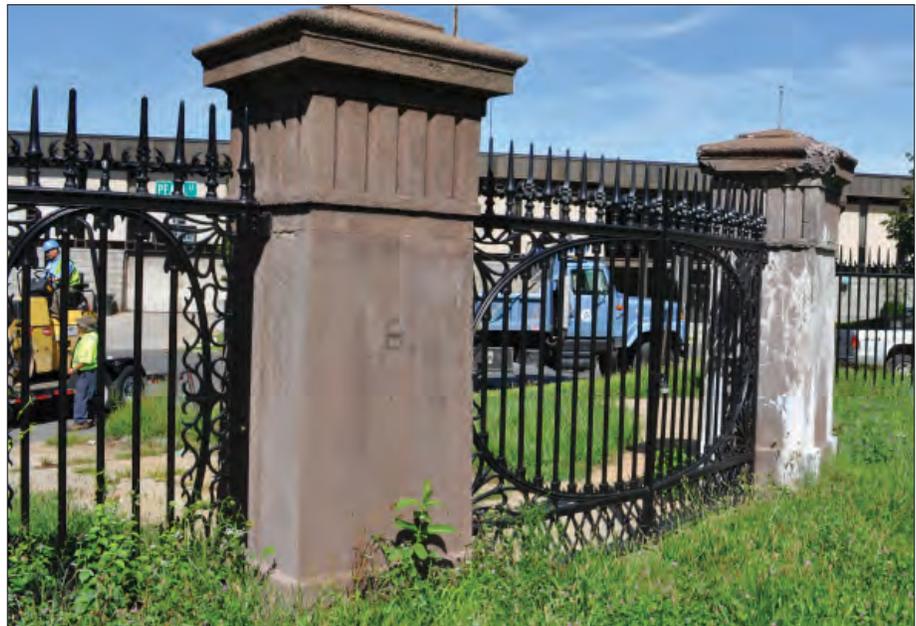
Figure 4.1. View of gate at Pearl and Byers Street corner with deteriorated pier to the right. OCLP, 2009.

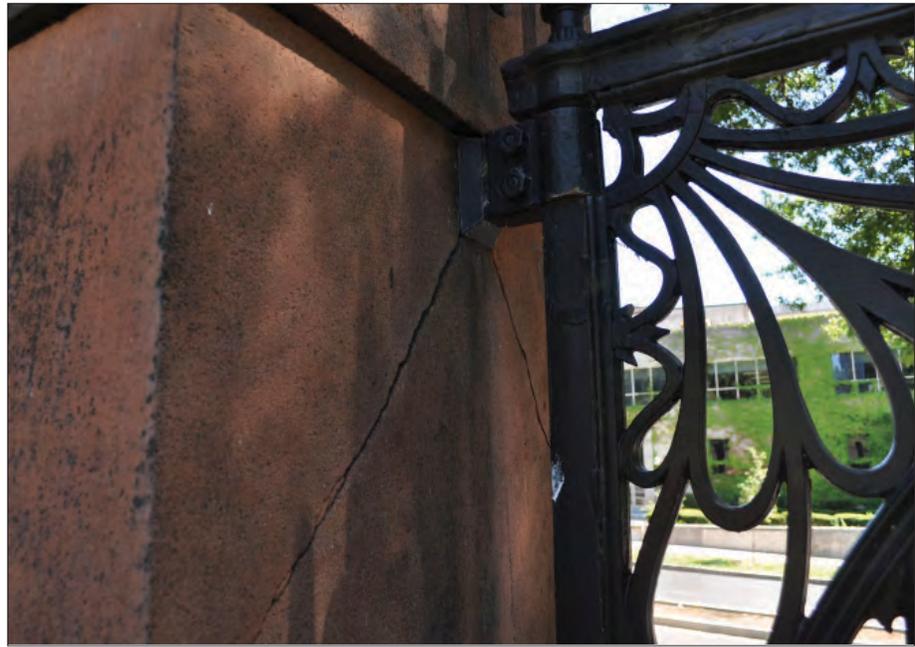
Figure 4.2. View of damaged pier on Federal Street. As a Perimeter Landscape treatment task, identify deteriorated portions of the perimeter fence and prepare a plan for prioritizing repairs. OCLP, 2009.

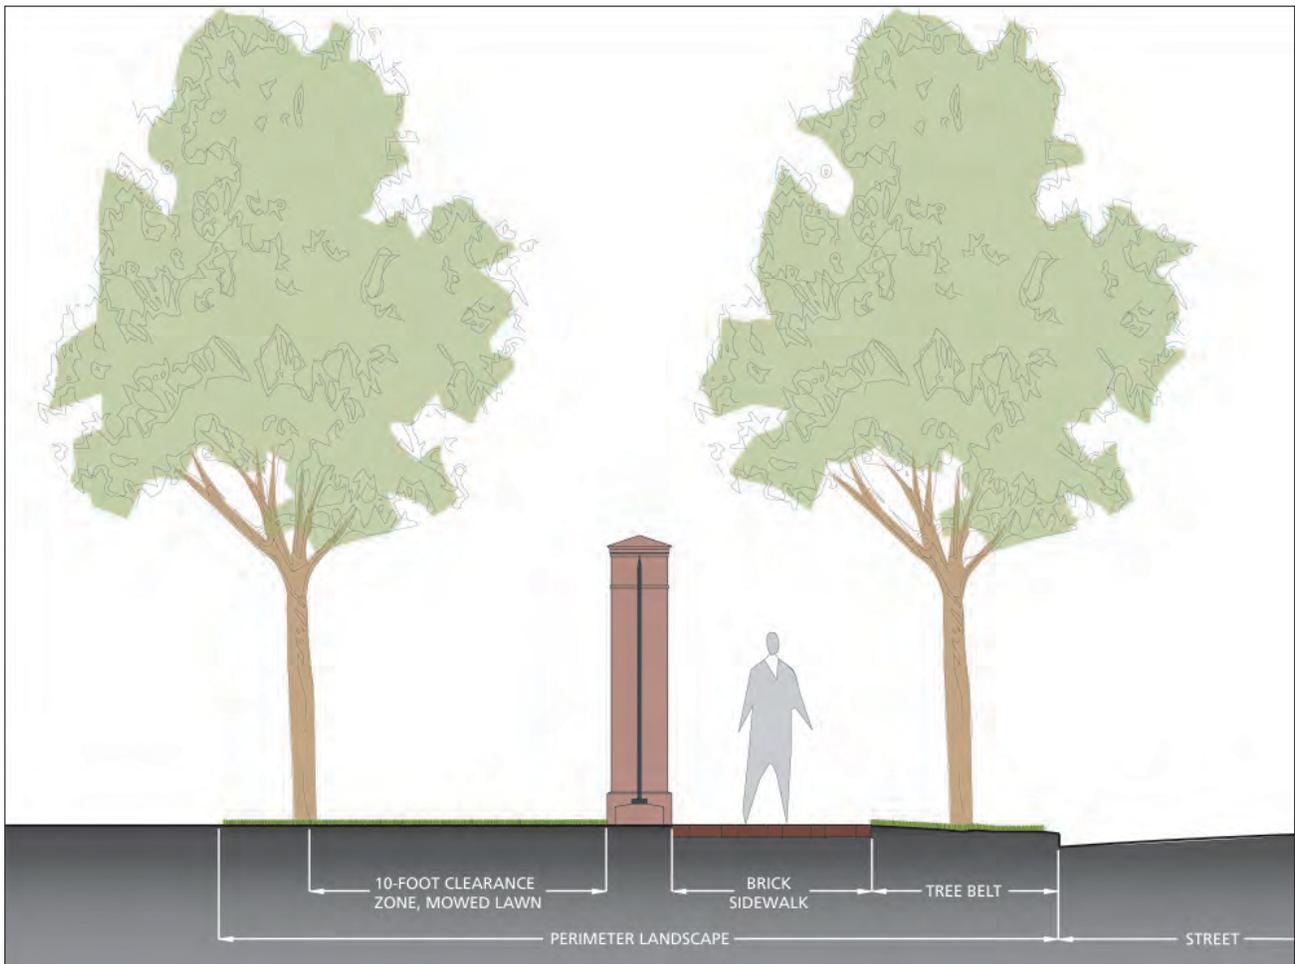
Figure 4.3. Elevation showing proposed landscape treatment for the Perimeter Landscape, including a clear zone planted with grass ten feet from inside the fence and tree belt along the sidewalk. OCLP, 2009.

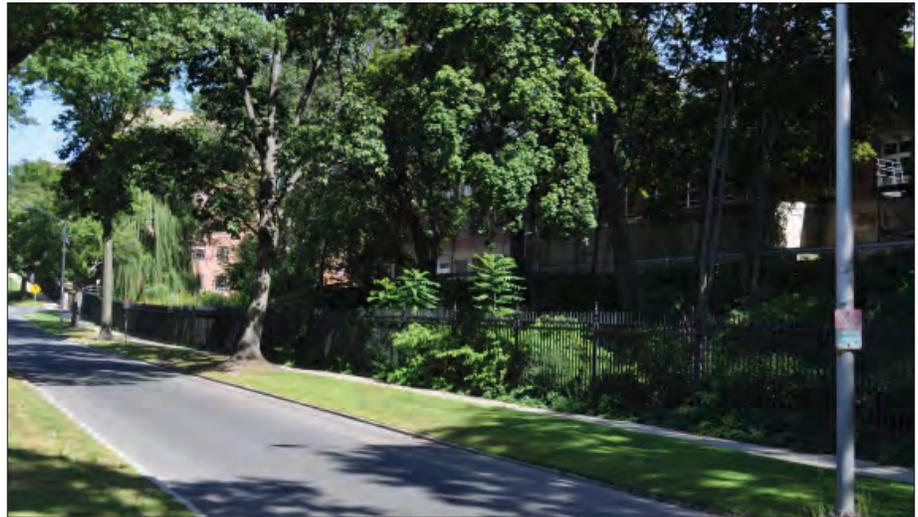
Figure 4.5. View of the perimeter fence along Pearl Street. Note the growth of volunteer trees and shrubs through the fence. OCLP, 2009.
