CULTURAL LANDSCAPE REPORT FOR ARMORY SQUARE

SPRINGFIELD ARMORY NATIONAL HISTORIC SITE

Olmsted Center for Landscape Preservation
National Park Service, Boston, Massachusetts, 2010

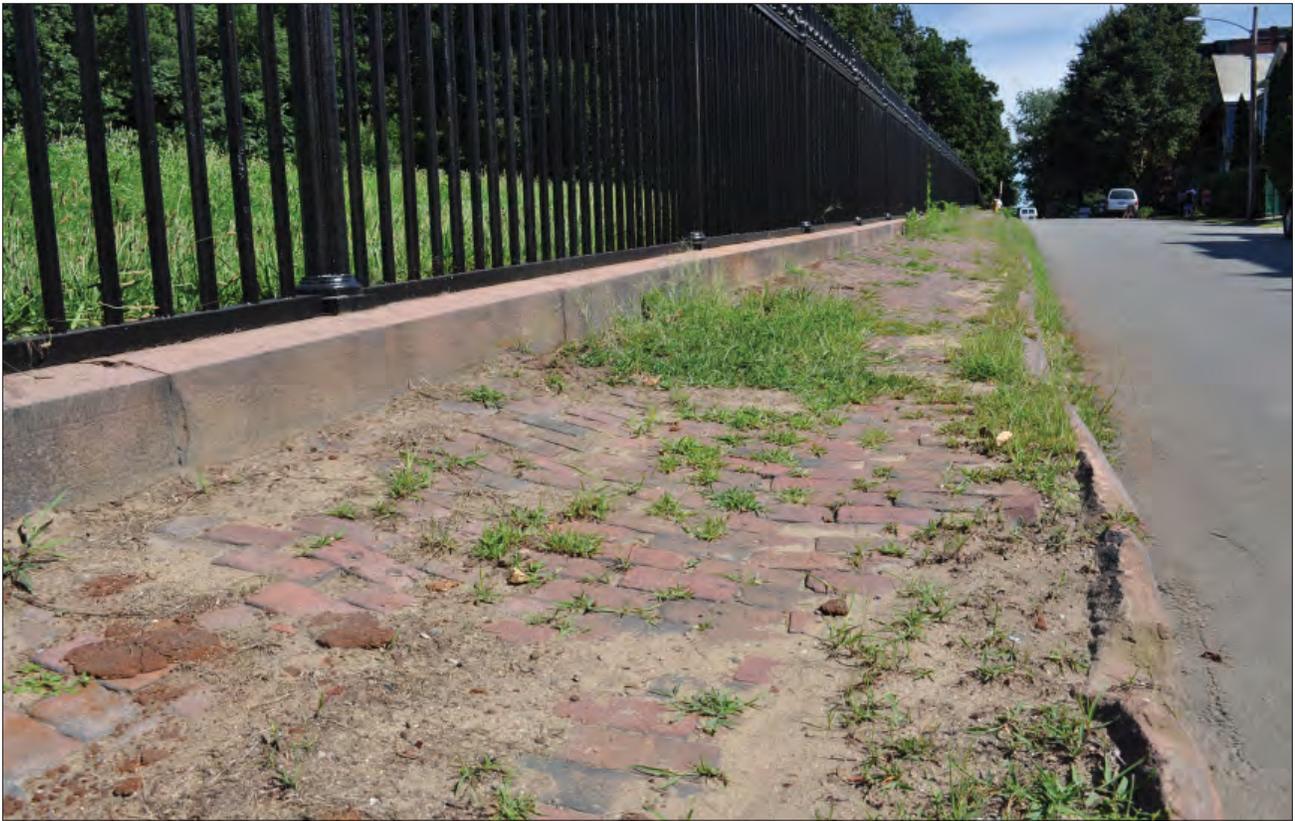
Figure 4.7. View of deteriorated brick sidewalk and sandstone curbing along Byers Street. OCLP, 2009.

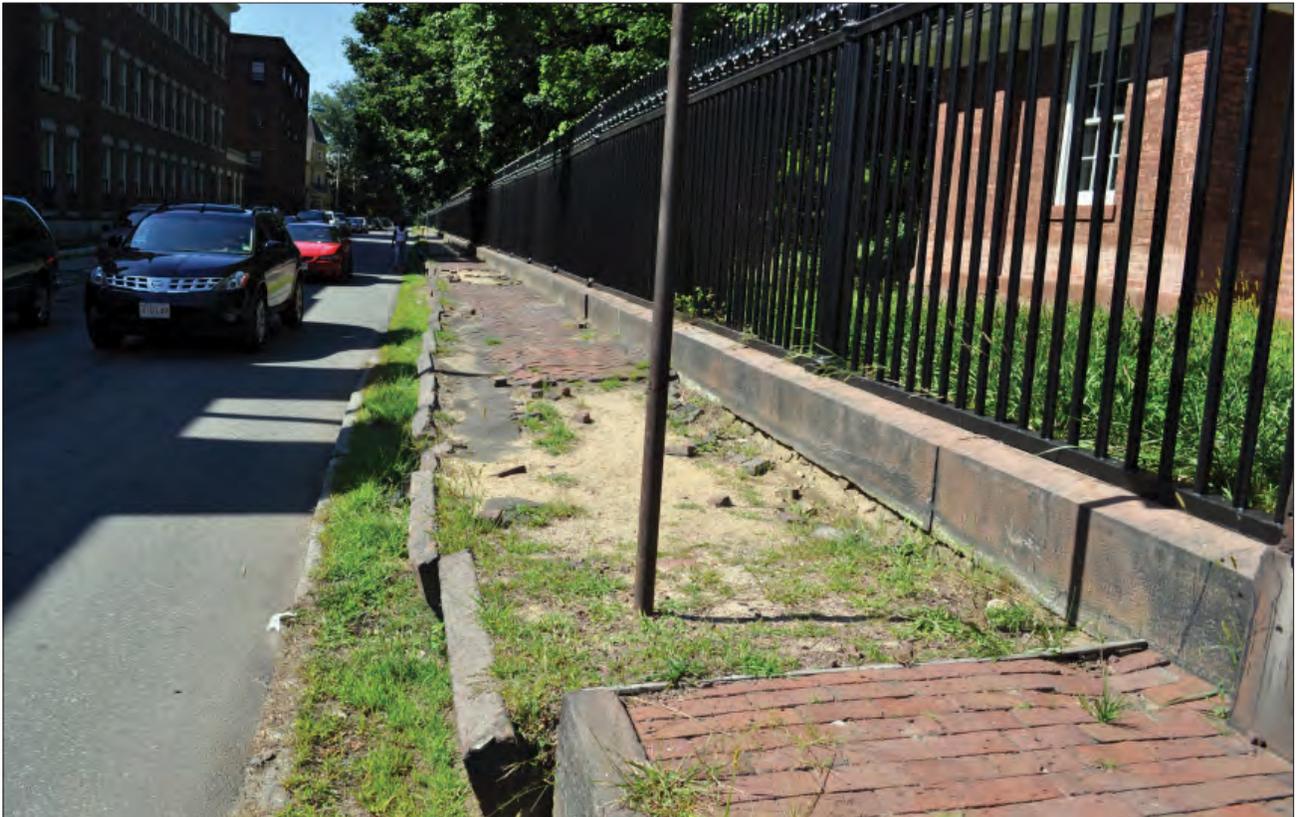
Figure 4.8. View of sidewalk in disrepair along Byers Street. The deterioration extends to the base of the perimeter fence. Note the pedestrian in the distance walking in the street to avoid the difficult sidewalk. OCLP, 2009.

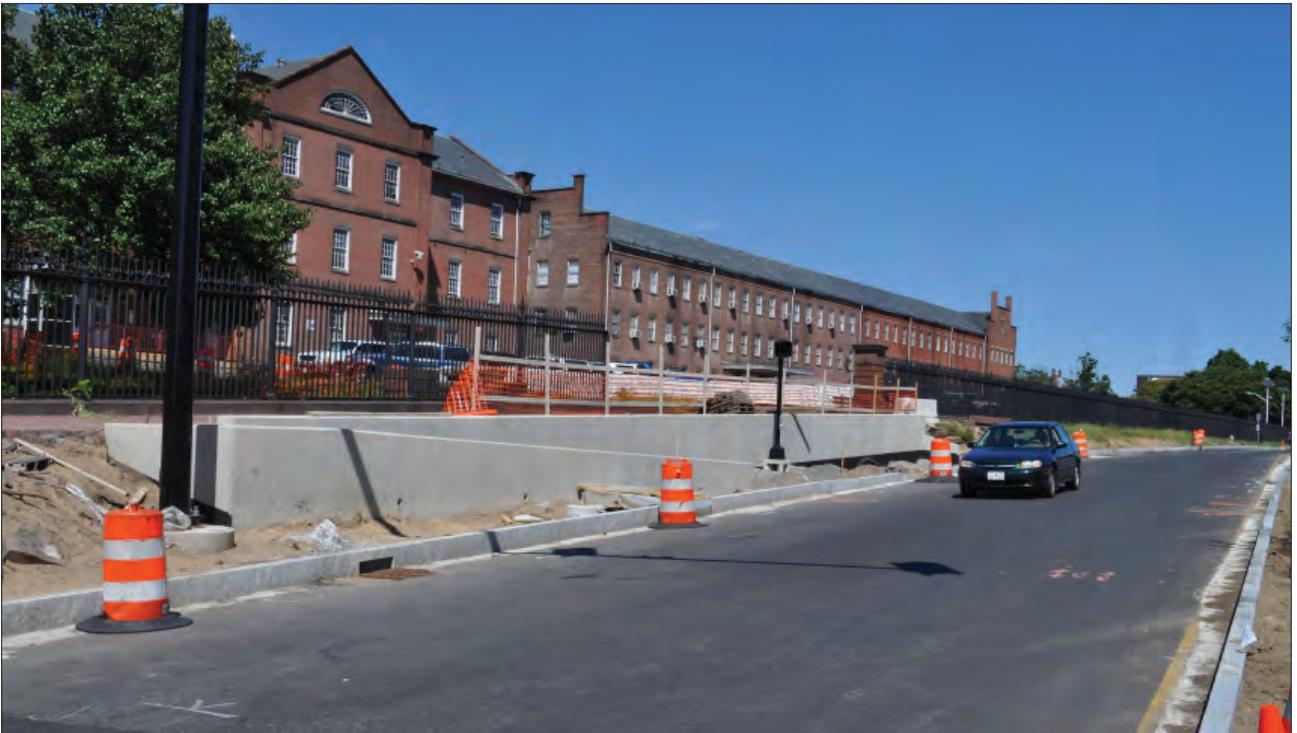
Figure 4.9. View of recently constructed concrete accessible ramp on State Street. The scale and overall massing overwhelms the street edge of Armory Square. OCLP, 2009.

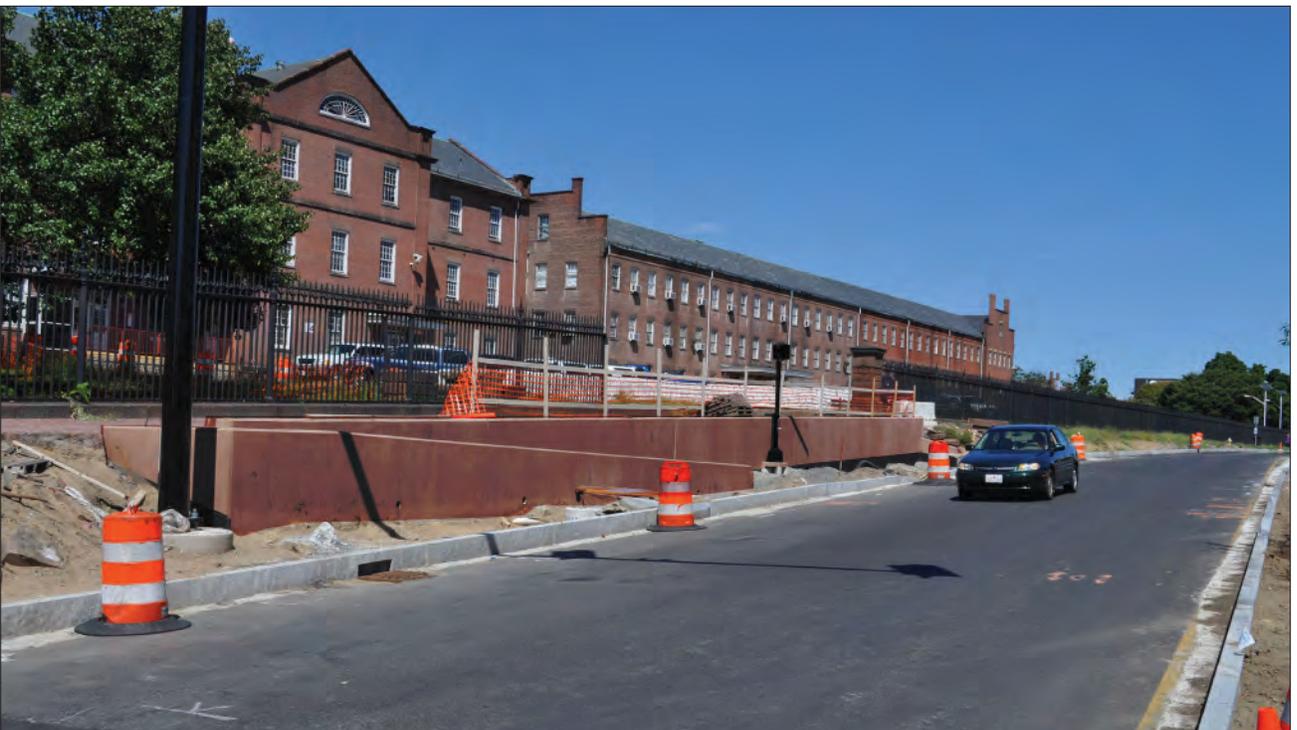
Figure 4.10. Photosimulation illustrating the modification of the new accessible ramp on State Street with tinted concrete to be more compatible with adjacent campus architecture. OCLP, 2009.

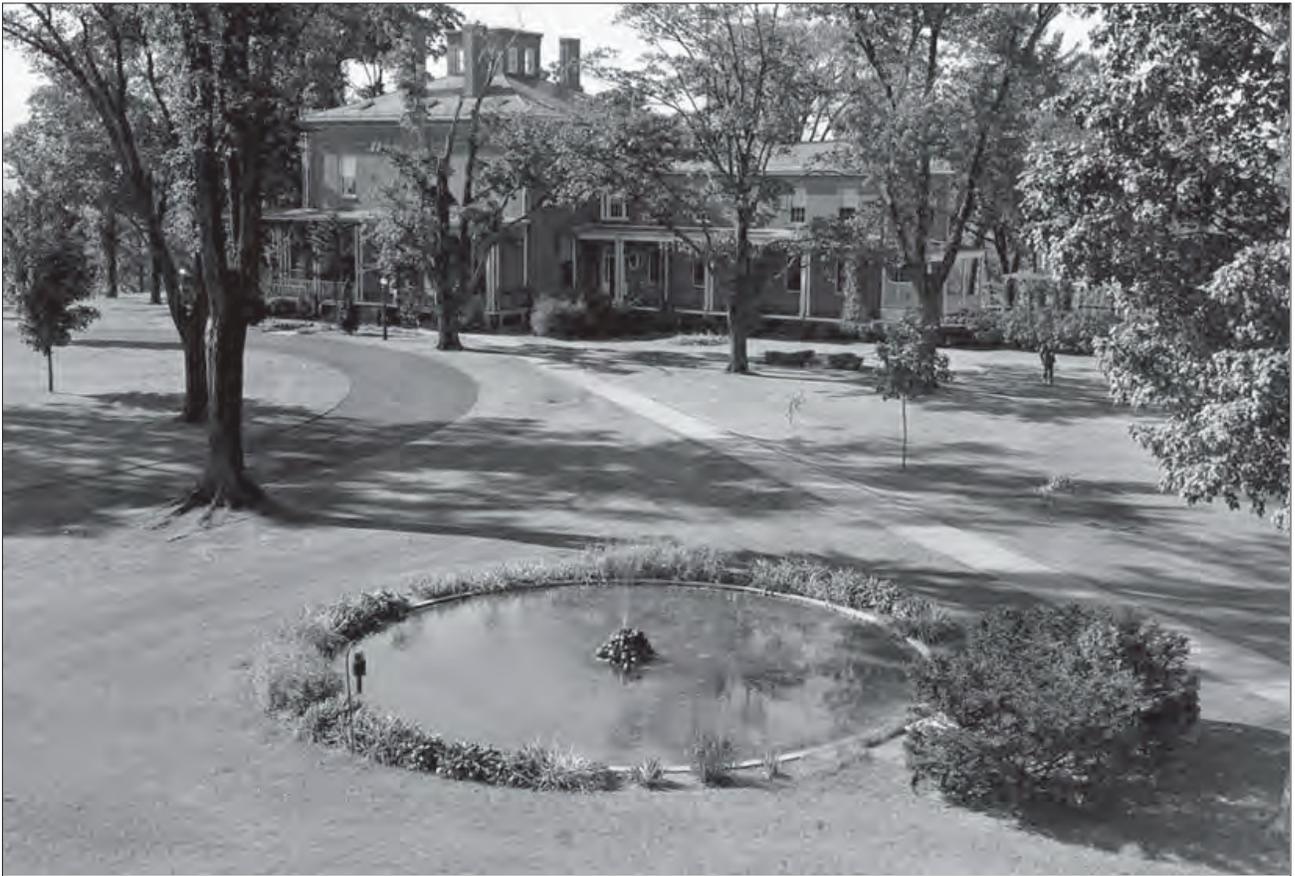
Figure 4.13. View of fountain at Commanding Officer's Quarters in the early 1950s. A bench to the right is obscured by the yew shrub. The fountain was removed by the end of the 1950s. SPAR Museum Archives, Box 001, Folder 08, NEG.

Since the late 1950s, many ornamental gardens and landscape features, such as the greenhouses, the rose arbor, the water fountain, planting beds, and hedges have been removed. Horticultural use of the Armory Square landscape dates to the early development of the federal Armory in the 1800s with agricultural plots west and north of the Green and ornamental gardens in the late nineteenth through the mid-twentieth century. These historic landscape patterns are no longer present on the site. In addition, volunteer vegetation has infiltrated the ornamental fence and other portions of the site, diminishing the historic character of the Armory Square landscape.

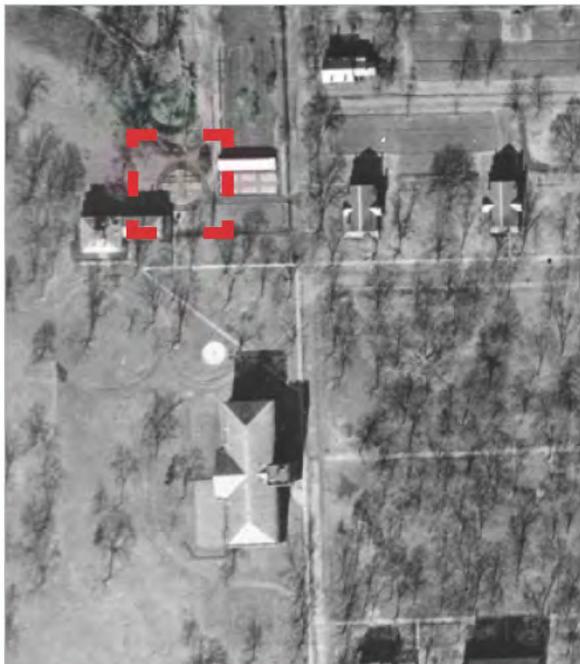
Figure 4.16. Aerial views from 1932 showing the rose arbor north of the Commanding Officer's Quarters, outlined in red. The photographs reveal the general orientation of the arbor structure. SPAR Museum Archives, Box 011, Folder 02.

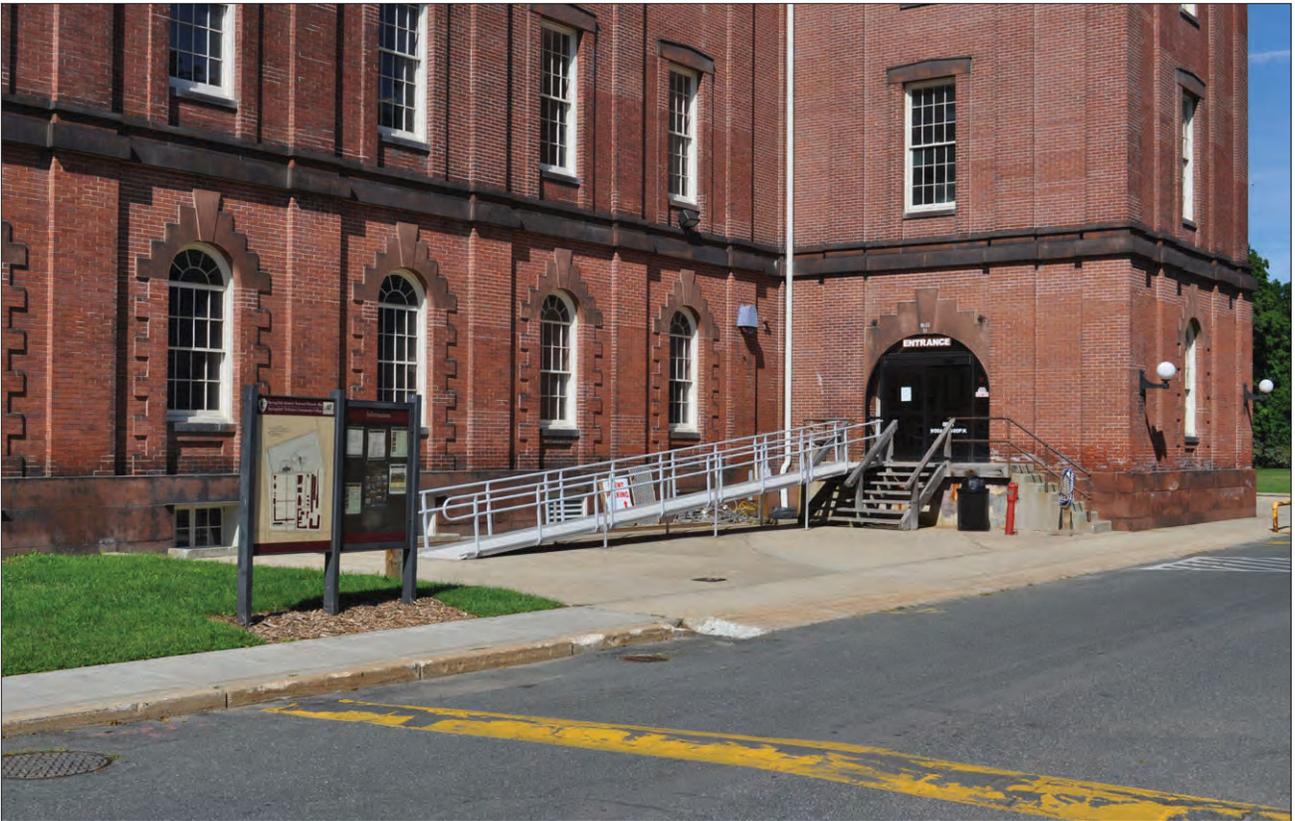
Figure 4.17. View of existing metal accessible ramp at the entrance to the Main Arsenal/Museum. OCLP, 2009.

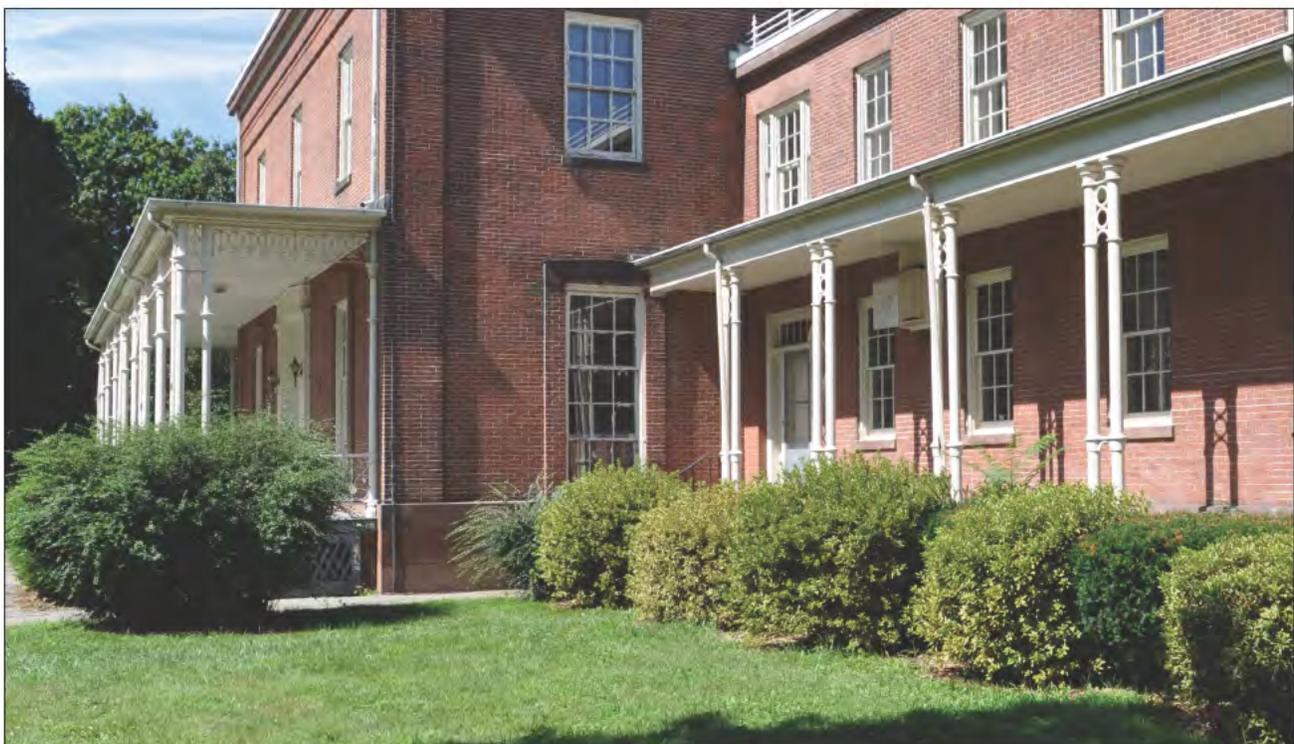
Figure 4.20. View of Commanding Officer's Quarters. An accessible ramp is proposed for the main entrance to the left. OCLP, 2009.

porch structure at the main entrance at the south façade of the quarters (Figures 4.19, 4.20).

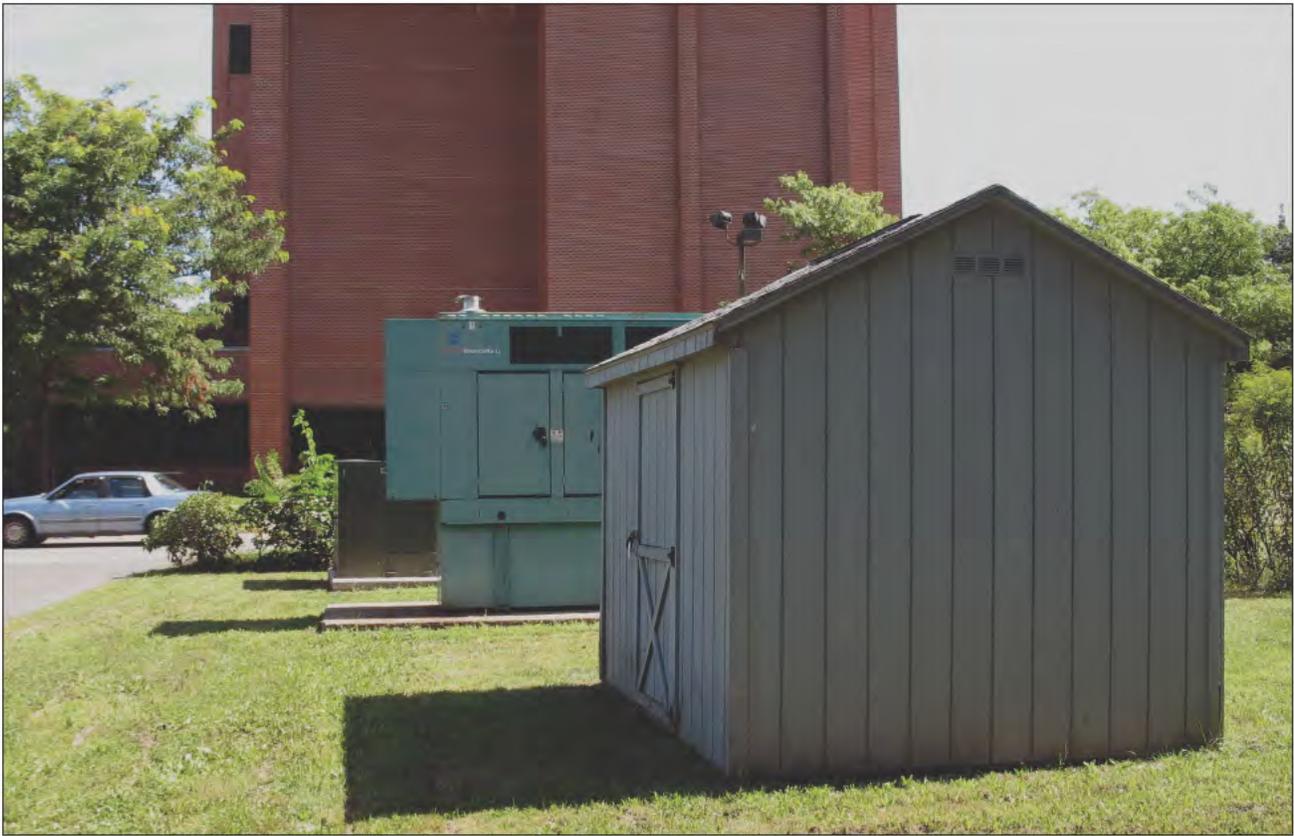
Figure 4.23. View of storage shed and utility structure adjacent to the garage at the Commanding Officer's Quarters. These structures are located in a prominent area and detract from the historic character of the site. OCLP, 2009.

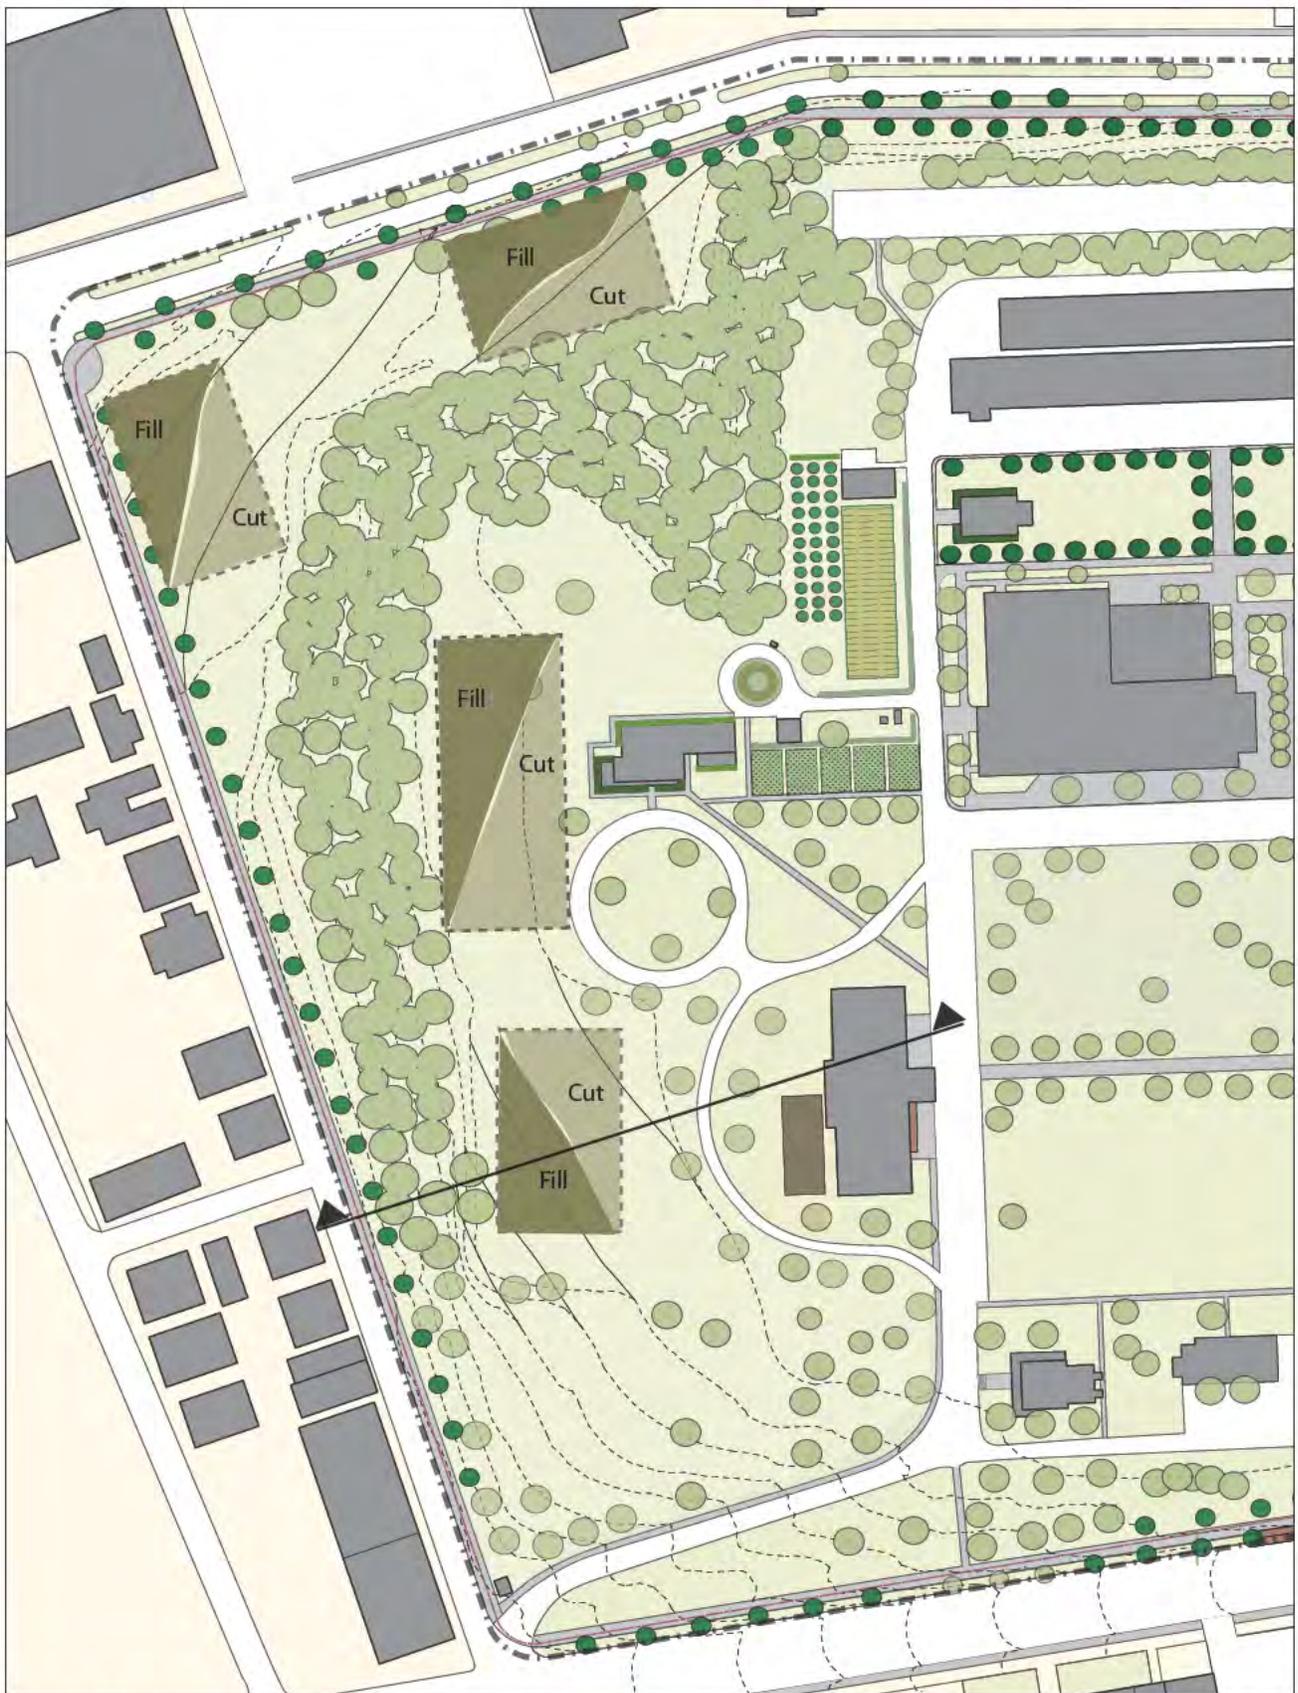
Figure 4.25. Plan showing proposed regrading of the Western Slope Landscape to restore historic grades prior to the construction of ballfields in the late 1960s. The dashed outlines denote approximate ballfield configurations. The cutline across the slope indicates the location of the section in Figure 4.26. OCLP, 2009.

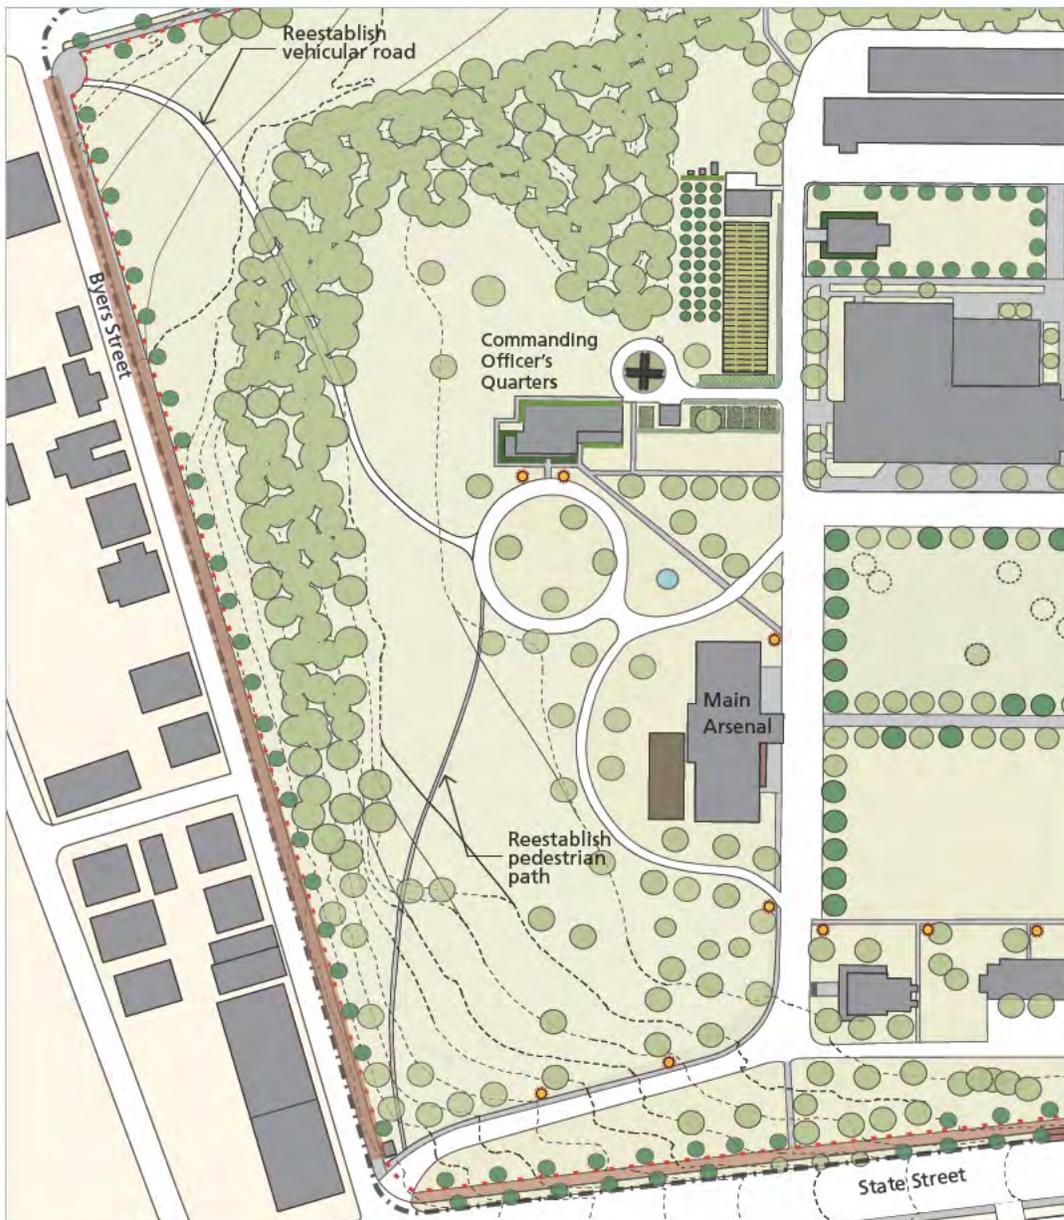
Figure 4.27. Plan of the Western Slope showing the reestablishment of pedestrian and vehicular circulation after regrading. OCLP, 2009.

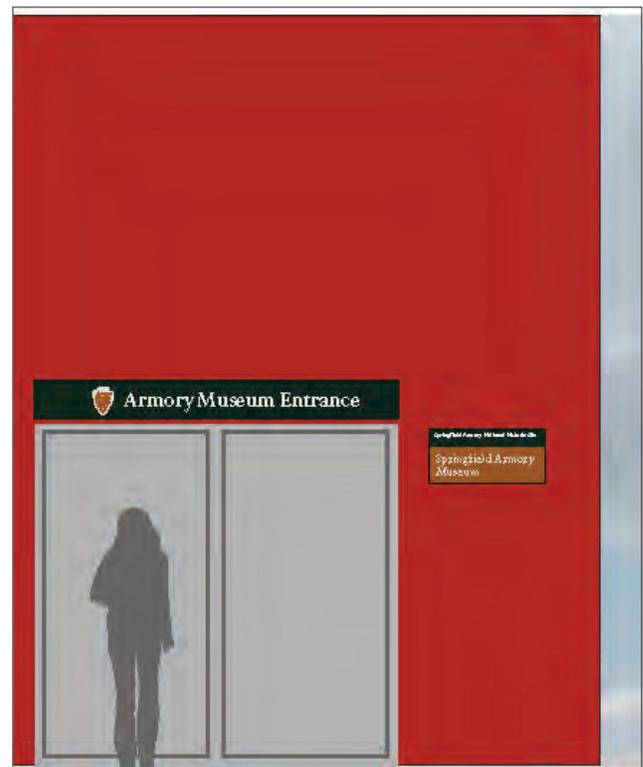
Figure 4.28. Proposed signage design for building facades from 2008 Signage Survey and Assessment. Care must be given to appropriate scale to prevent signs from detracting from historic character. Bunting Graphics and Sasaki Associates, 2008.

As part of the signage program outlined previously for the Perimeter Landscape, signs were developed for building facades and for wayfinding. For building identification, signs that are attached to the facades should be at an appropriate scale which prevents the sign from overwhelming the building and detracting from the overall historic character of the landscape (Figure 4.28). For wayfinding purposes, the scale is also important as well as the placement within the landscape, and the number of signs installed (Figure 4.29). Too many signs will overwhelm and detract from the historic character of the site. Ideally, some views within the landscape should remain unobstructed by contemporary elements to allow visitors the opportunity to more fully experience the historic landscape.

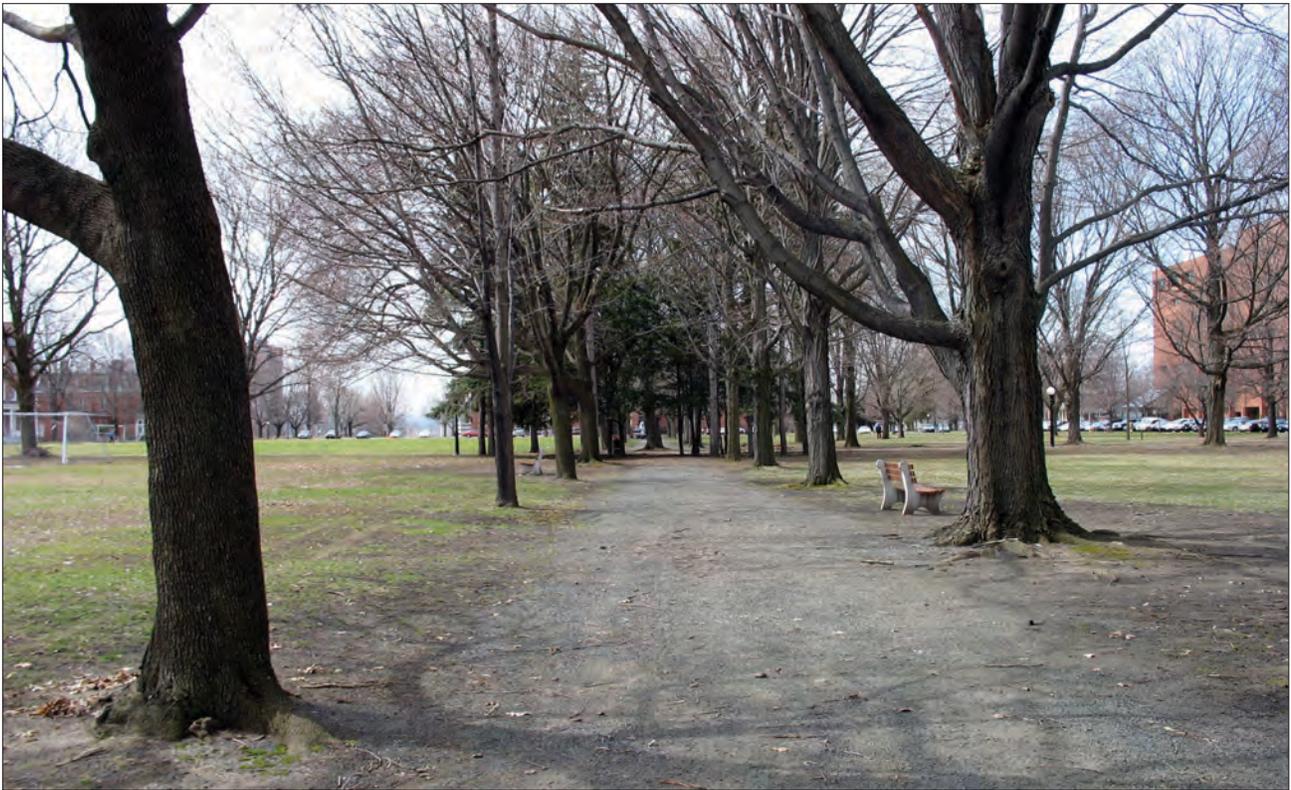
Figure 4.30. View of existing condition of the east-west pathway on the Green. OCLP, 2009.

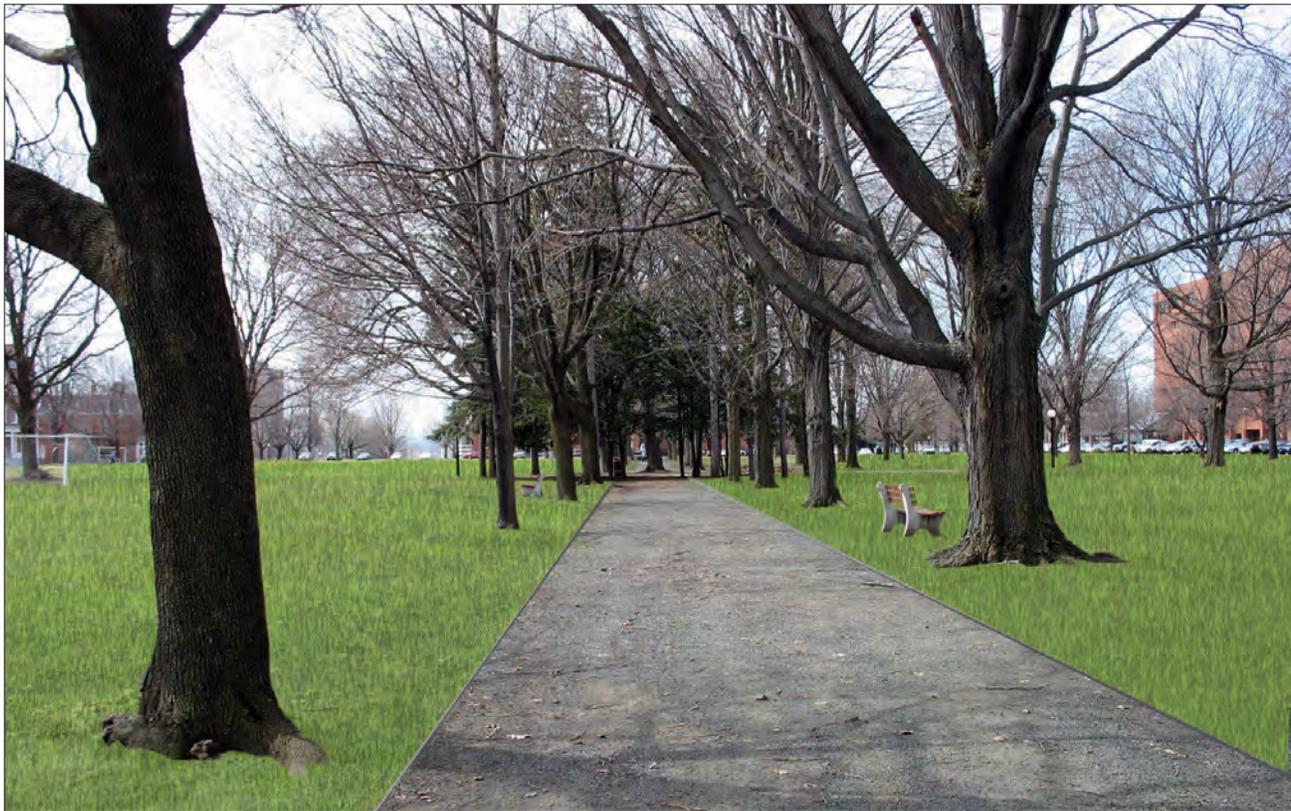
Figure 4.31. Photosimulation of the east-west pathway on the Central Green illustrating the effect of installing a paving restraint to define and contain the gravel pathway. OCLP, 2009.

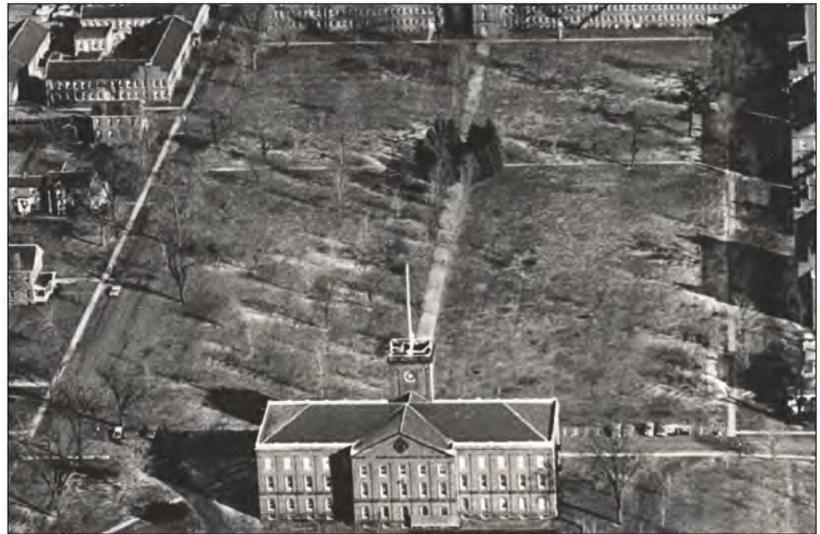
Figure 4.32. Aerial view of the circle of evergreen trees in the central Green in 1965. SPAR Museum Archives, Box 016, Folder 01.

Replant the two semi-circles of yew shrubs and spruce trees, with spacing that allows for full growth without overcrowding. The yews and several blue spruce trees have recently been removed due to their decline, but the beech tree is extant. Historic images show a planting of yews (*Taxus baccata*) and spruce trees (*Picea pungens*) dating to at least the early 1960s (Figure 4.32). Located at the pathway intersection on the Green, the half colonnade of trees consisted of a semi-circle of mature yews enclosed by a row of blue spruce trees (Figure 4.33). In addition, as the national holidays celebrated on the Green evolved into major public events, a stone barbecue was constructed in the middle of the Green adjacent to a ceremonial cannon in the early part of the twentieth century. The barbecue was most likely demolished in the early 1960s. A beech tree (*Fagus sylvatica*) was planted in the center of the Green at an unknown date.

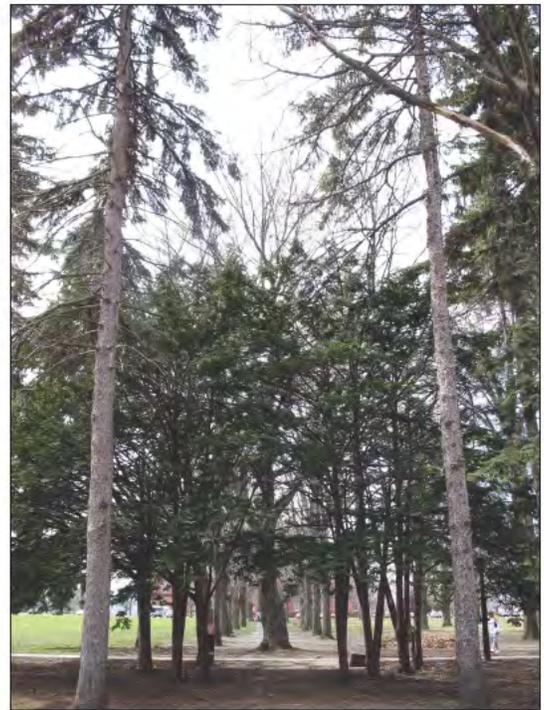
Figure 4.33. View of mature yews and spruce trees in the center of the Green that need to be replaced. OCLP, 2009.

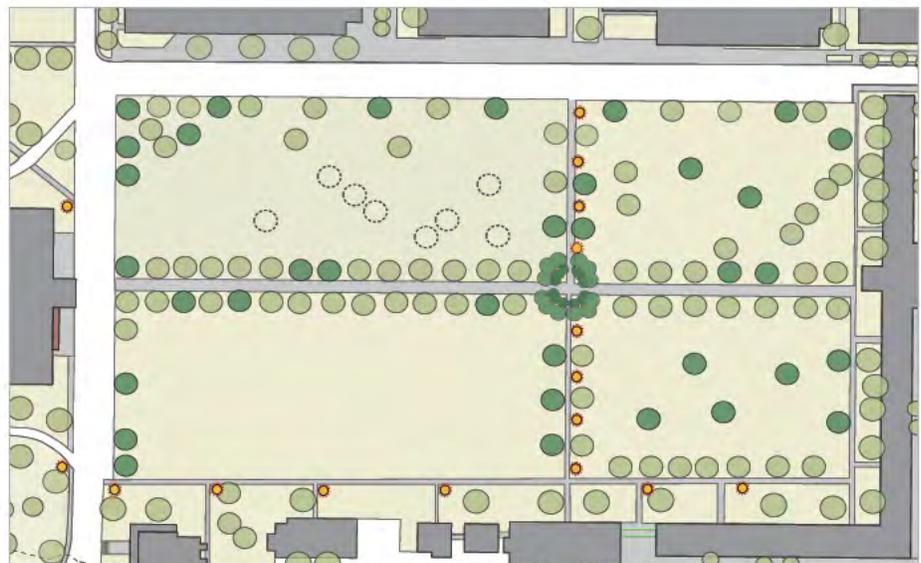
Figure 4.34. Plan of the Central Green showing trees to be removed (dashed lines) as well as proposed plantings of trees (dark green). OCLP, 2009.

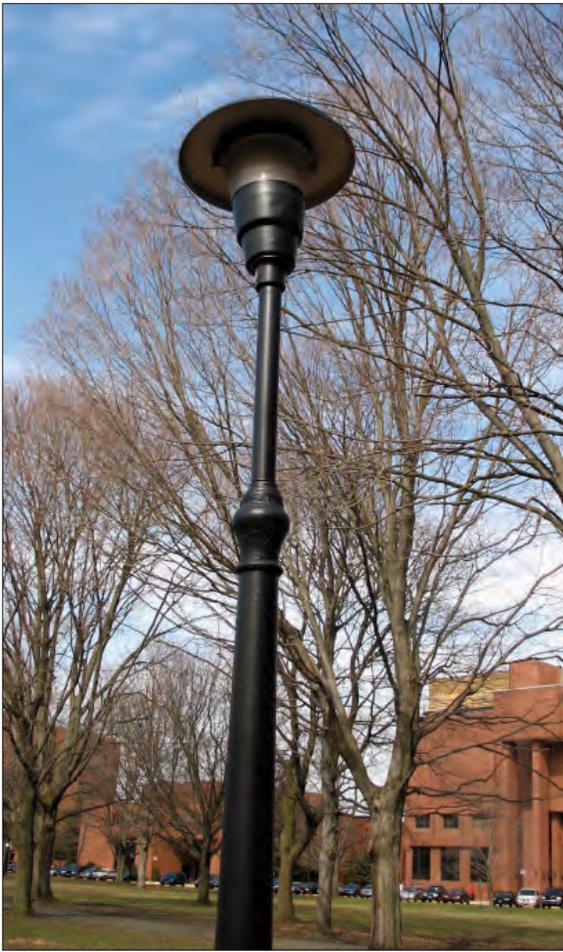
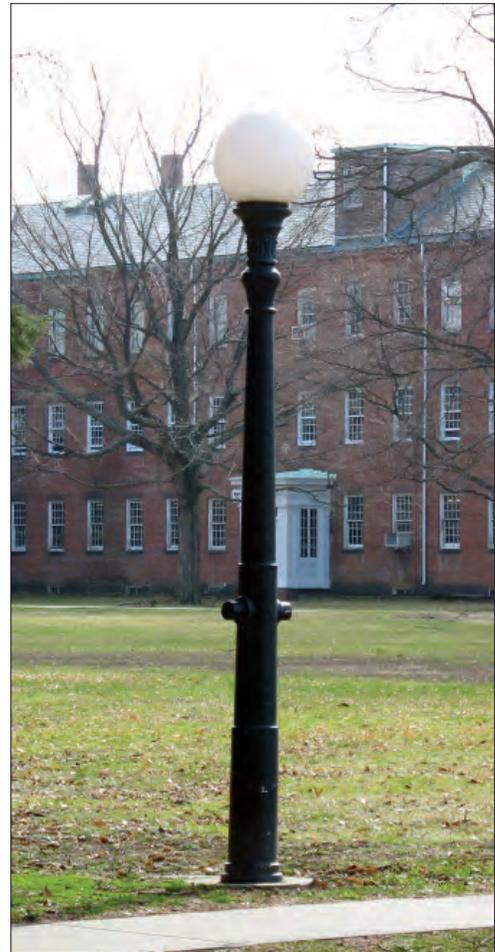
Figures 4.35 and 4.36. View of existing iron lamp post with non-historic luminaire to the left and historic globe style luminaire to the right. Maintaining a consistent use of light fixtures will help to visually unify the campus landscape. OCLP, 2008.

Maintaining a consistent use of one luminaire style will help to unify the landscape and reinforce the perception of the site as a single entity (Figures 4.35, 4.36). Under Superintendent Ripley, gaslight lamp posts were installed throughout the campus in the 1840s, consisting of tapered cast iron shafts modeled after cannon tubes. The original luminaires were urn-shaped glass lanterns and were replaced with globes possibly in the early 1900s when the gas lighting was converted to electricity (Figure 4.37). The use of a single lamp post style visually reinforced the uniform military character of the site. Today, the lamp posts are located along the north-south pathway on the Green as well as around the Main Arsenal/Museum and the Commanding Officer's Quarters. Several existing lamp posts on the Green have different luminaire fixtures, which detract from the historic character of the landscape.

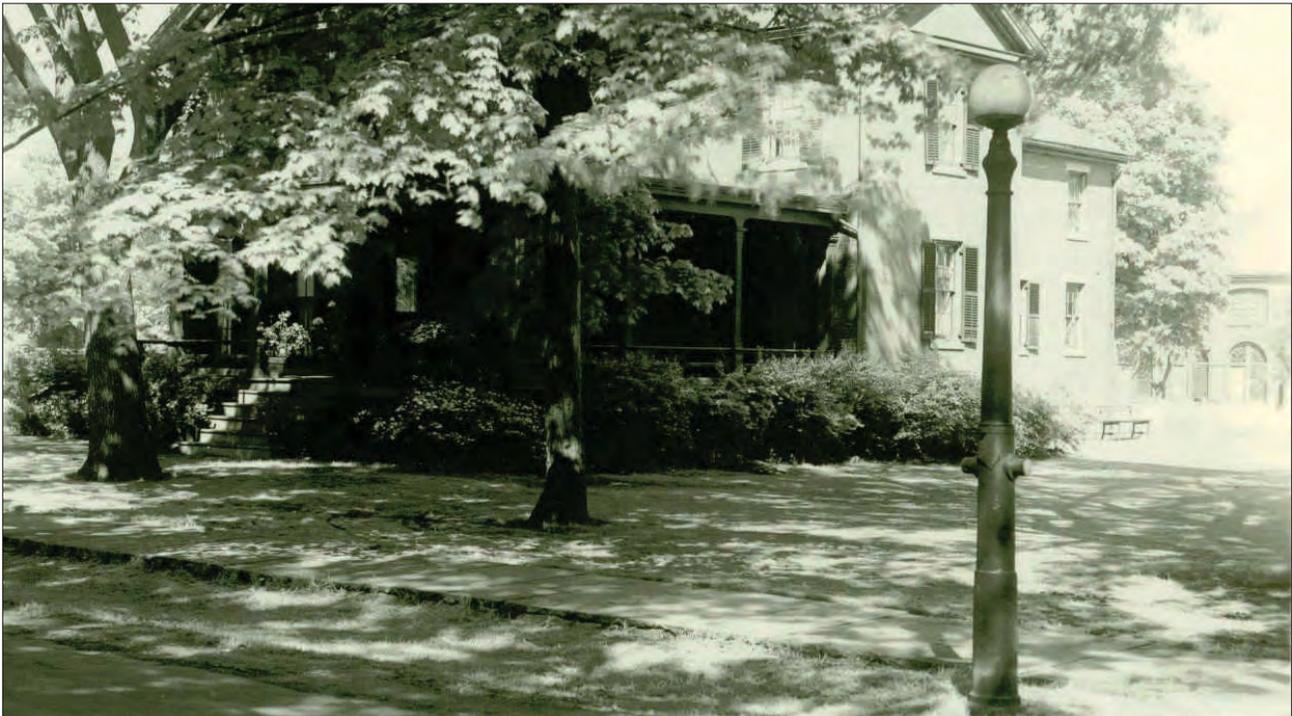
Figure 4.37. View of original iron lamp post in 1931 near one of the Officers' Quarters. SPAR Museum Archives, Box 002, Folder 05, NEG 1803-SA.

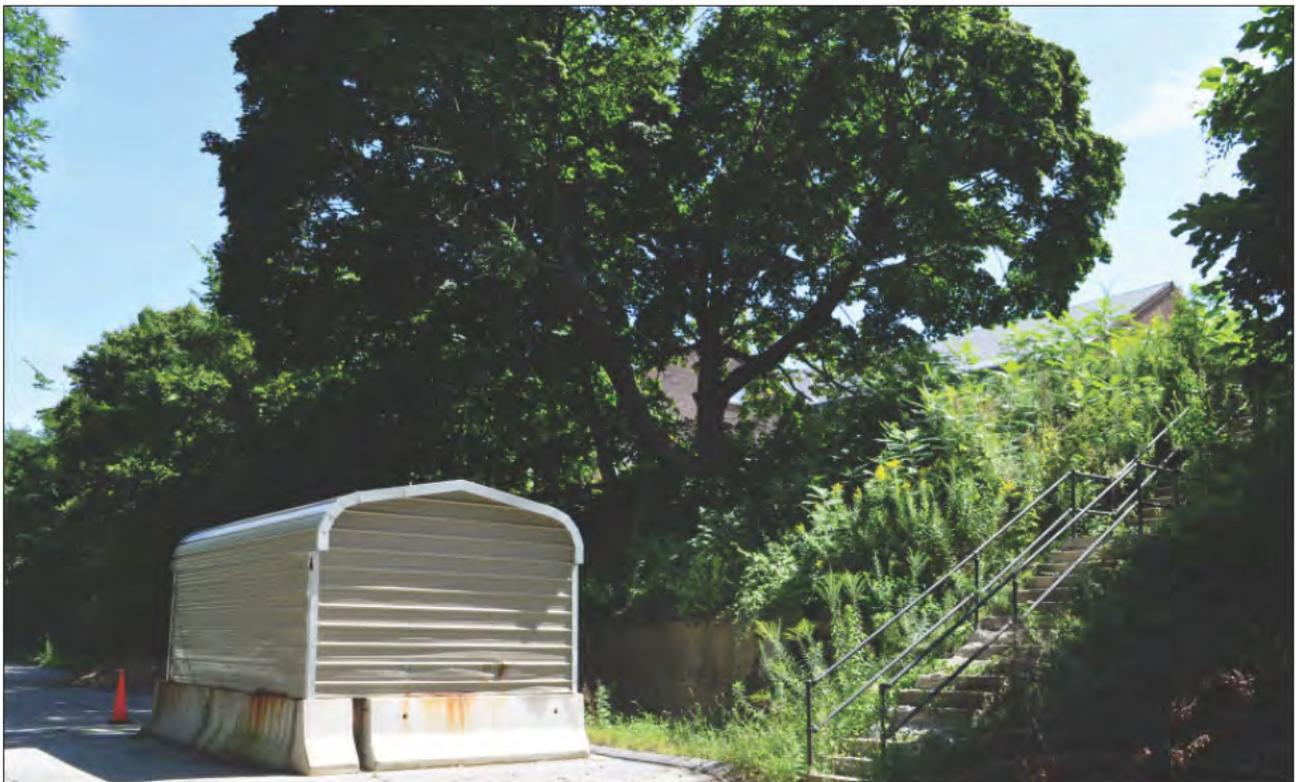
Figure 4.39. View of mature trees that need to be removed from the top of the shooting range structure, Building 28a, located on the north side of the campus. Trees of this size could destabilize the structural integrity. OCLP, 2009.

Large, mature trees located on top of the ballistics building north of the Long Storehouse should be removed to prevent damage to the structure (Figure 4.39). Constructed in 1920, the building has most likely been unused since the closing of the Armory manufacturing facility. National Park Service-28 provides standards for the management of earthworks, including that earthworks be maintained with healthy, vigorous vegetation cover to minimize erosion and loss of integrity.²⁵ The existing smaller trees, shrubs, and groundcover should be sufficient to maintain and stabilize the slope, but periodic removal of mature trees is essential.

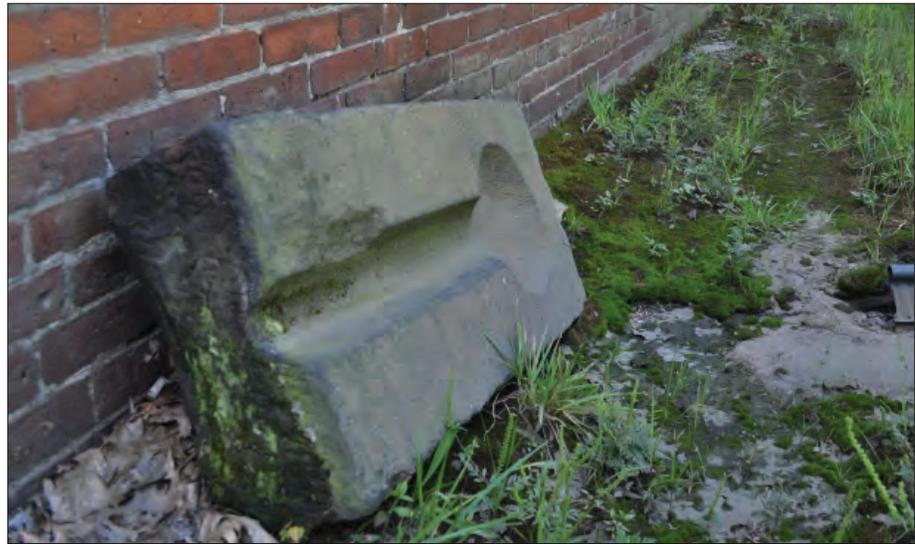
Figure 4.40. View of typical stone splash block located on the eastern side of Building 20. The splash blocks are currently unused and should be reinstated. OCLP, 2009.

Within the Institutional Landscape area, there are several small scale features that contribute to the historic quality of the site. For instance, hand-carved stone splash blocks that help to drain water away from the building edge are located behind Building 27 (Figure 4.40). They are currently unused and lay on their sides, giving an impression of neglect. Reinstalling the splash blocks will improve the building's appearance as people walk by on the adjacent walkway that overlooks the space.

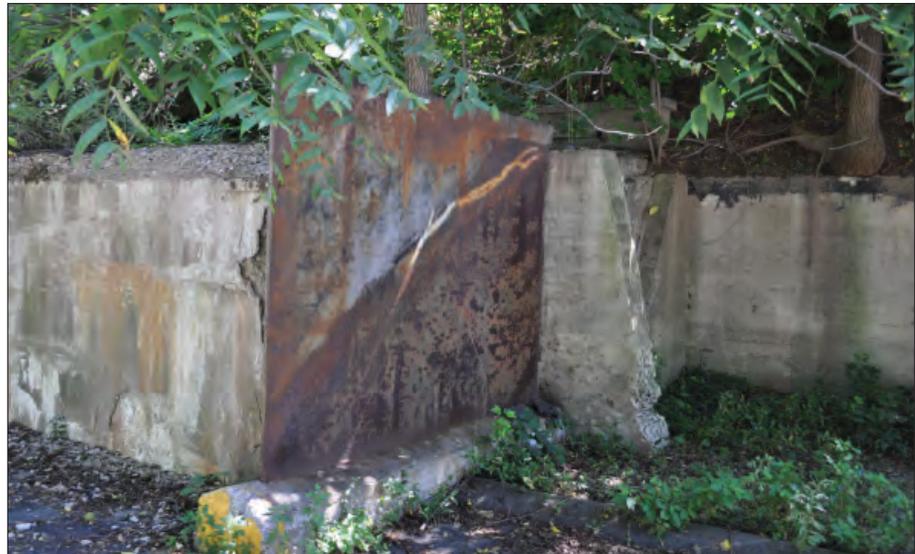
Figure 4.41. View of one of two steel back stops north of Building 28a. These structures were most likely constructed in the early 1920s, along with the building, and should be preserved. OCLP, 2009.

Steel back stops are located north of Building 28a and appear to date to the construction of the ballistics building in the early 1920s (Figure 4.41). As landscape features, the backstops speak to the history and purpose of the site, providing a visual clue to the activities that took place during the historic period of significance. In addition, metal numbered signs located on building facades throughout the campus date to the historic period and should be preserved. Maintaining these features helps to tell the story of the historic landscape.
