Metals in America's Historic Buildings

Uses and Preservation Treatments

U.S. Department of the Interior
National Park Service
Cultural Resources
Preservation Assistance
Washington, D.C.
1992

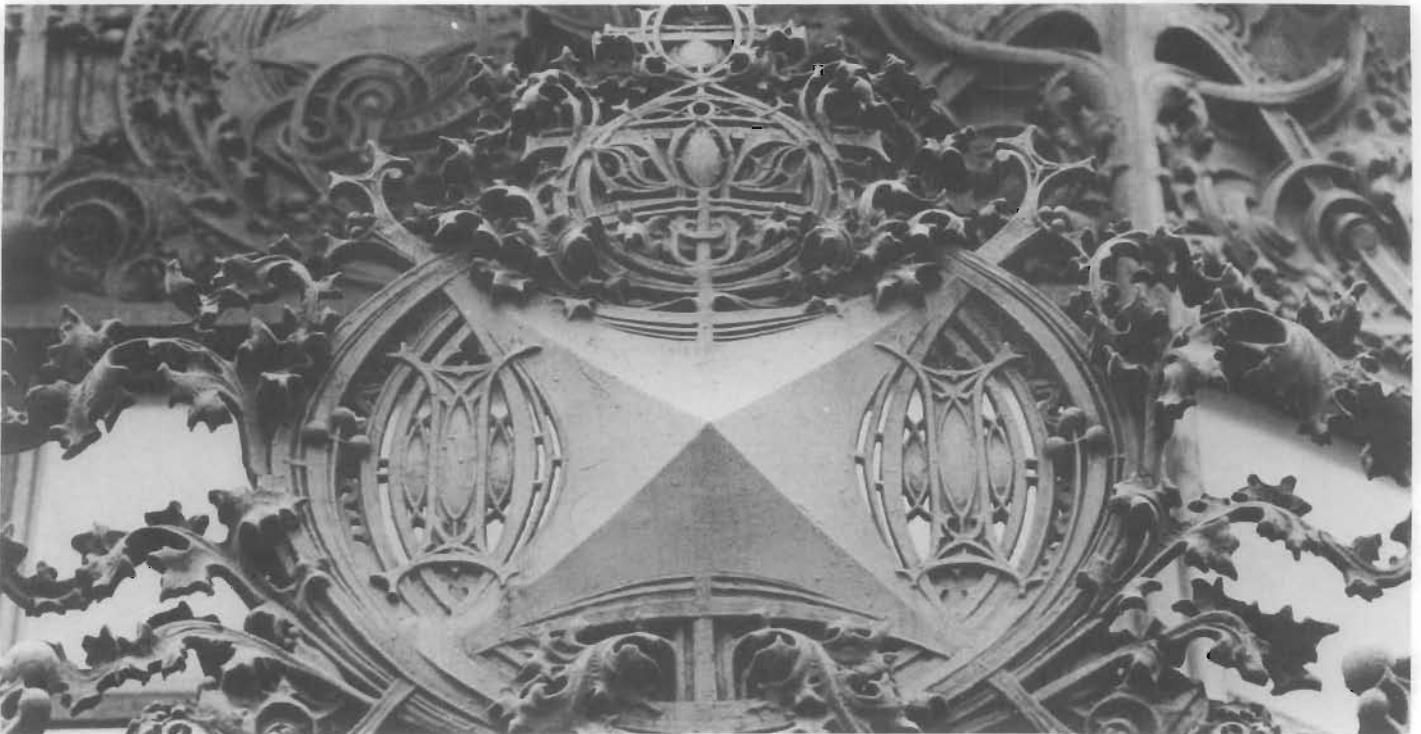
Figure 1. Cast-iron Ornamentation, Carson Pirie Scott and Company Store, Madison and State streets, Chicago, Illinois, 1899-1906; Louis H. Sullivan, architect; Winslow Brothers, foundry. *The two lower floors of this building are embellished by Sullivan's extraordinarily complex designs executed in cast iron which enframe the windows and curved corner entrance. Cast iron was used in every conceivable form in the 19th century; it was the utilitarian metal. Cast-iron columns, storefronts, whole building facades, and stairs appeared, as did cast-iron doors, windows, clocks, fountains, and furniture. What could not be made of cast iron was made of wrought iron or steel. Beams were made of wrought iron or steel, and metal ceilings and roofs were made of sheet iron or steel. Often ironworkers combined cast iron and wrought iron in a design, using each metal for the elements for which it was best suited.* (Becket Logan)

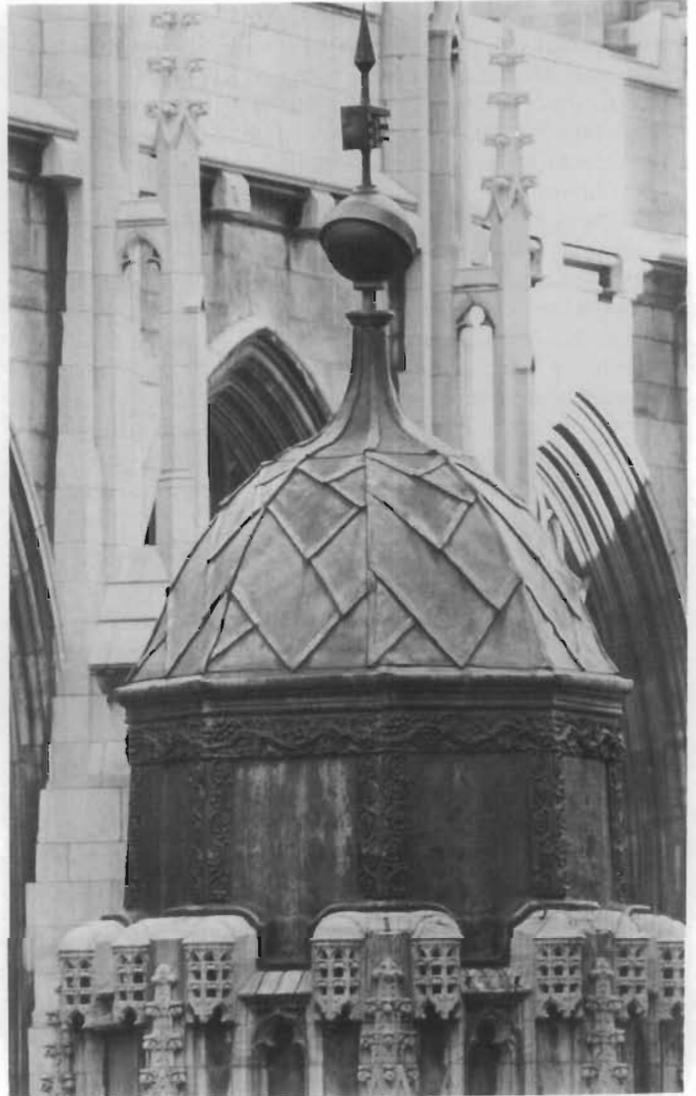
Figure 6. Lead Roofing, Saint Thomas Church, Fifth Avenue and 53rd Street, New York City, 1909–1914; Cram, Goodhue, and Ferguson, architects; Henry Hope and Sons, lead craftsman. Ralph Adams Cram designed St. Thomas Church using the spirit and many of the techniques of medieval builders, including the use of small overlapping sheets of lead for roofing curved surfaces. The decorative grapevine frieze and panel borders, also of lead, show the versatility of this material, which can be cast with sharp detail. (Becket Logan)

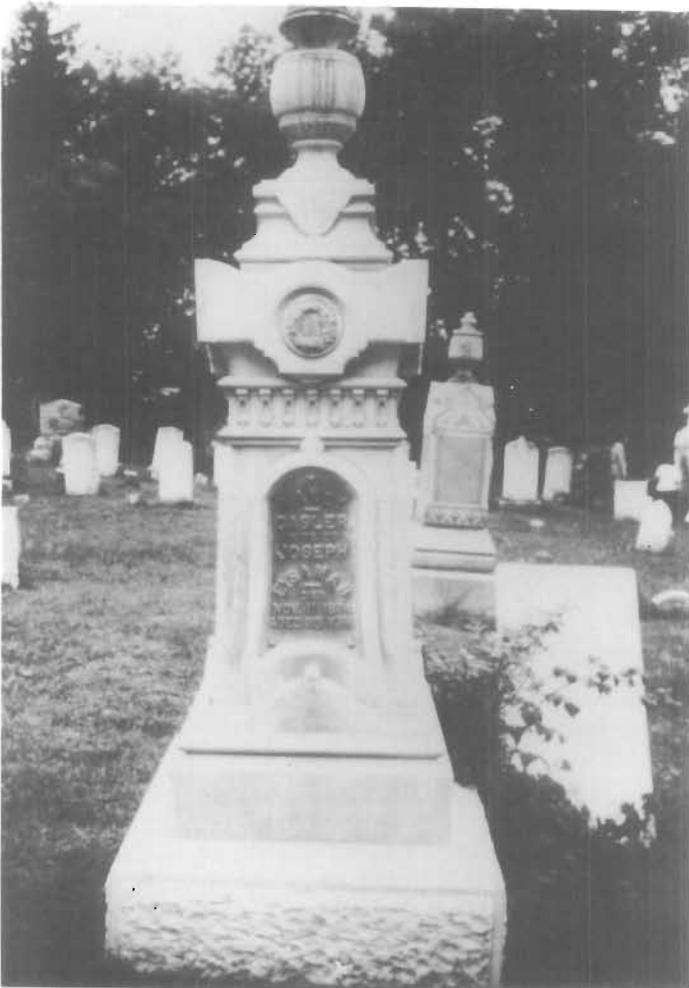
Figure 14. Zinc Grave Marker, Herkimer, New York, ca.1874; Monumental Bronze Co., Bridgeport, Connecticut. *The manufacturer's name is discreetly recorded in small letters along the edge of the plinth. This company's 1882 catalog used the phrase "pure cast zinc" while insisting that "unlike commercial zinc ours is a pure metal, like gold or silver." The embossed epitaph is still crisp and new looking. In some respects the zinc monuments have survived in better condition than their stone counterparts. These light gray markers were cast in many sections, sandblasted to produce a rough stone-like surface, then bolted together with the connections disguised. (Margot Gayle)*

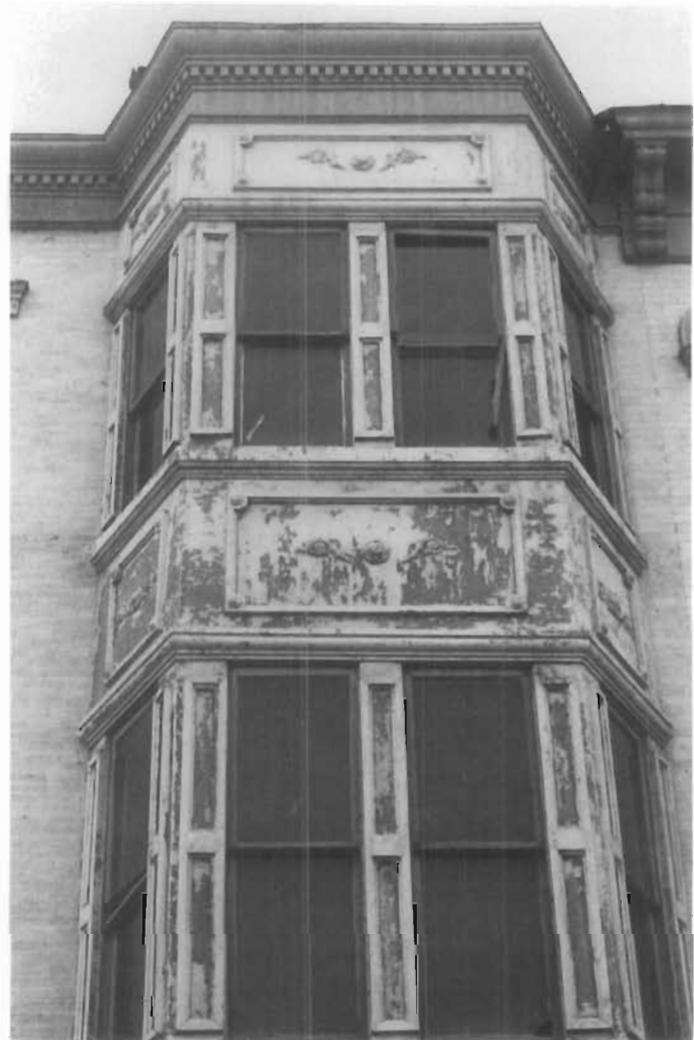
Figure 18. Galvanized Sheet Iron Bay with Applied Zinc Ornament, 608 Indiana Avenue, NW, Washington D.C. When sheet metal work is kept well painted, it is very difficult to identify it as sheet iron or steel, galvanized or tinned. However, if the metal is not maintained, its composition becomes more obvious. Paint does not adhere well to pure zinc, or to galvanized iron or steel. When the paint peels, it usually comes off completely, including the primer, to reveal a clean metal surface. If the metal is galvanized, it will have a spangled appearance and may show some rust or rust stains from the iron base metal. If it is cast or pressed zinc, it will have a grayish-white appearance. This bay is covered with galvanized sheet iron with pure zinc ornaments on the surface. Even if well painted, a magnet test will reveal what is galvanized iron or steel (which is magnetic) and what is pure zinc (which is non-magnetic). (David W. Look)

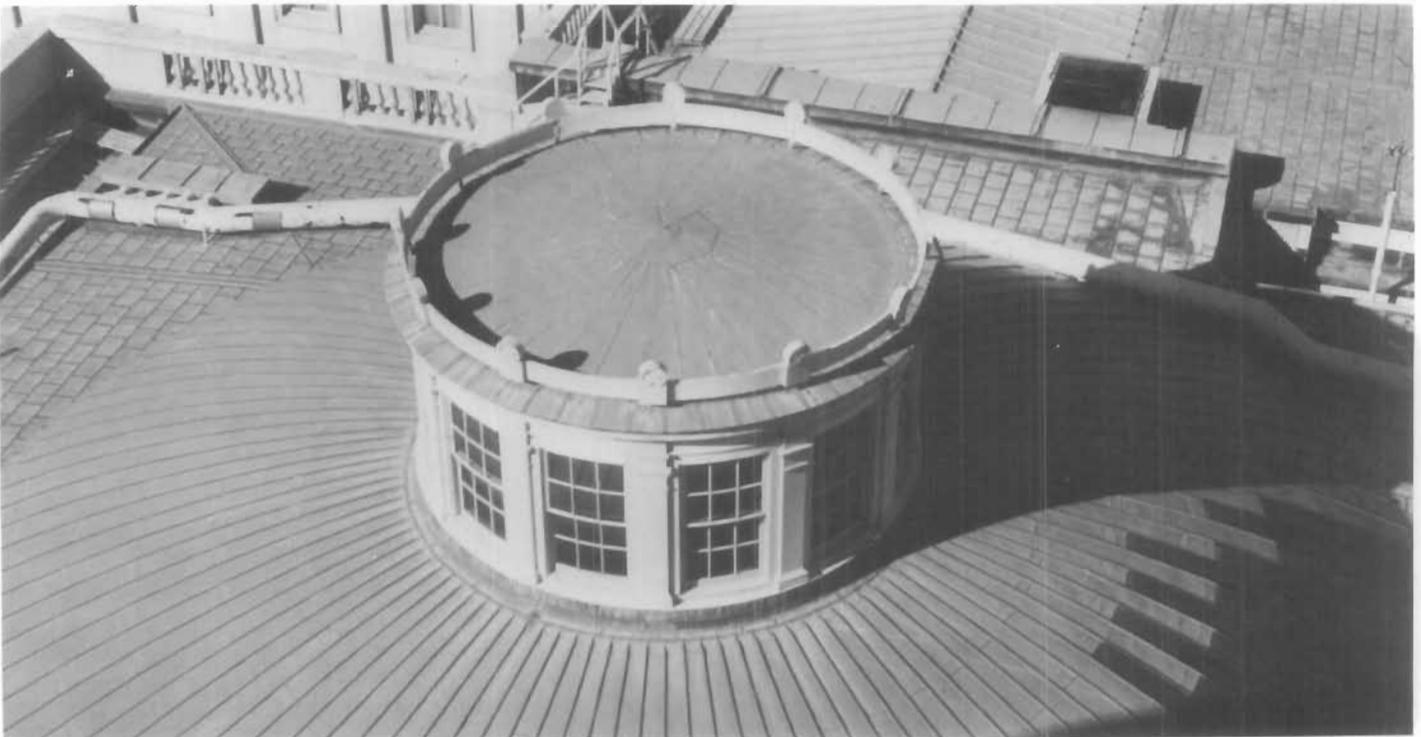
Figure 19. Copper Roof, Old Senate Chamber, United States Capitol, 1819; Benjamin H. Labrobe, architect. After the British burned the Capitol in 1814, the entire structure was rebuilt, including a new copper roof. Little is known about the roofing installed in 1819 since it was removed in 1900. It was probably all flat seams because the machine for forming standing seam roofing was not invented until about the time of the Civil War. When the surfaces were reroofed in 1975, every effort was made to duplicate the 1900 roofing patterns, configuration, and size of sheets. Sheet copper can be shaped to cover many types of curved surfaces. The dome has standing seams while the cupola and the area around the dome, which is flatter, have flat seams. (Charles Parrott)

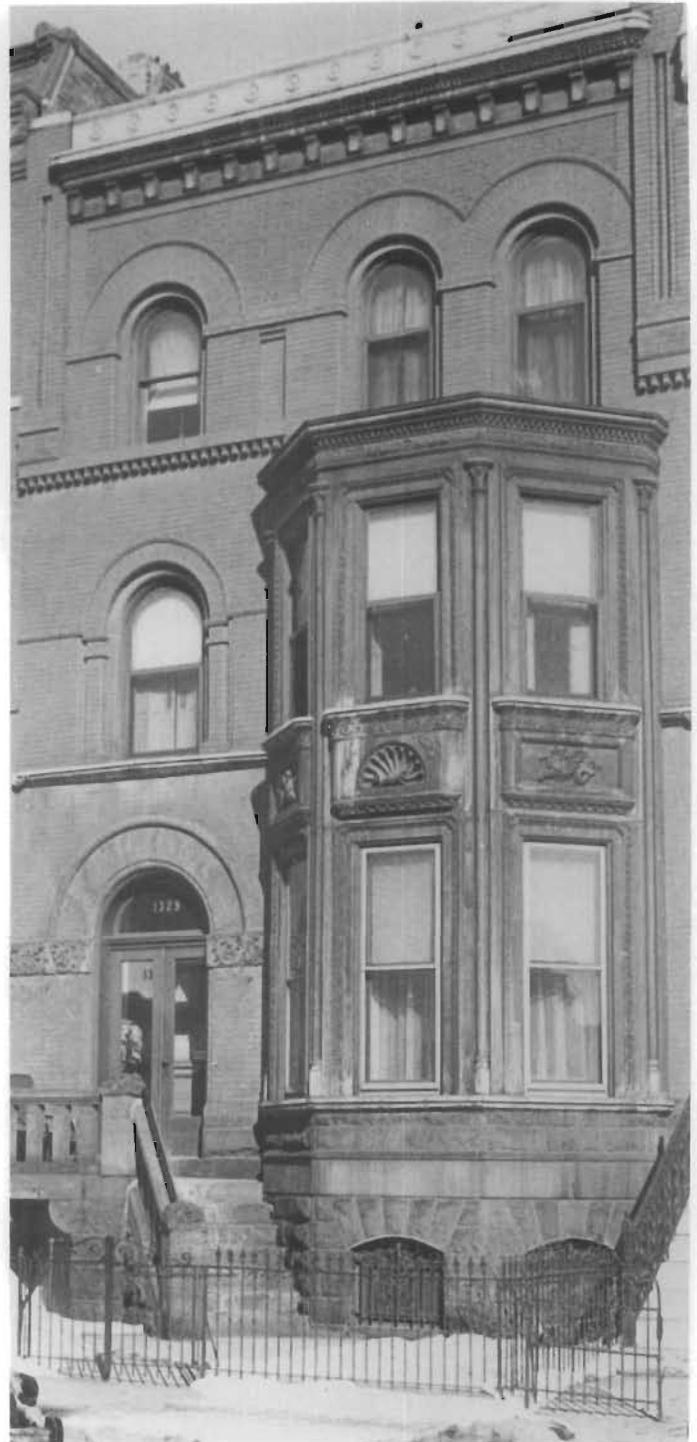
Figure 24. Copper-Clad Bay Window and Cornice, Thomas C. Whyte House, 1329 R Street, NW, Washington, D.C., 1892; George C. Johnson, architect. *From the first-floor window sills to the cornice above the second floor, the bay window is sheathed entirely with pressed sheets of copper, and there are slender two-story copper pilasters flanking the windows. The spandrel between the first- and second-floor center windows has a shell design and the side spandrels have winged sea creatures. Both the cornice of the house and the cornice of the bay window have copper classical dentils and modillions.* (David W. Look)

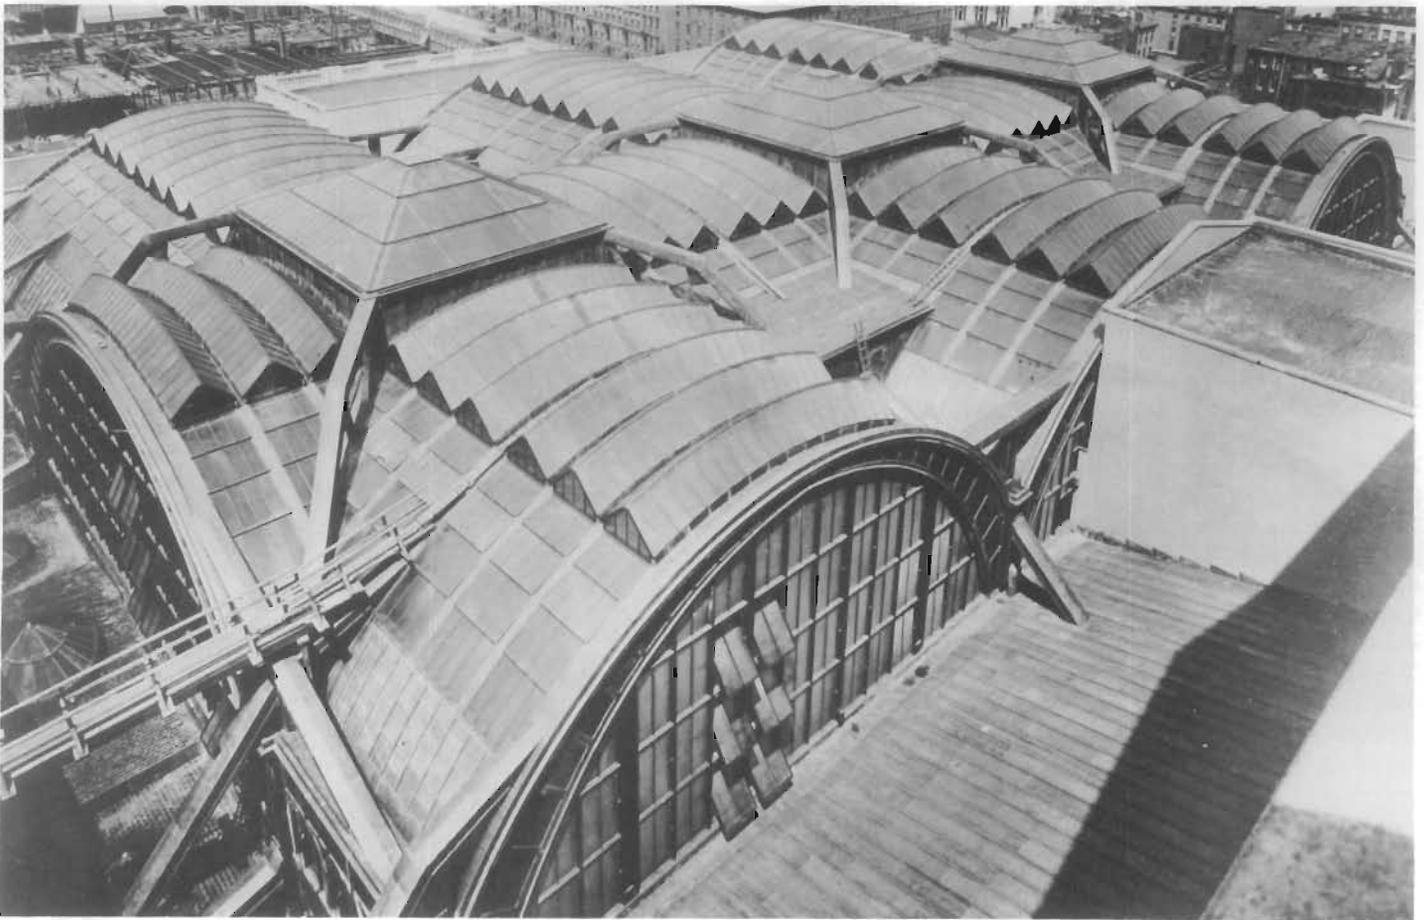
Figure 47. Monel Roof, Pennsylvania Railroad Terminal, New York City, 1907-1910; McKim, Mead and White, architects; International Nickel Company. *The first architectural use of Monel metal was the sheet roofing of the Pennsylvania Station, which was completed in 1909. When the station was demolished in 1965, the Monel roof was in excellent condition, having needed no major repairs since its installation. (International Nickel Company)*

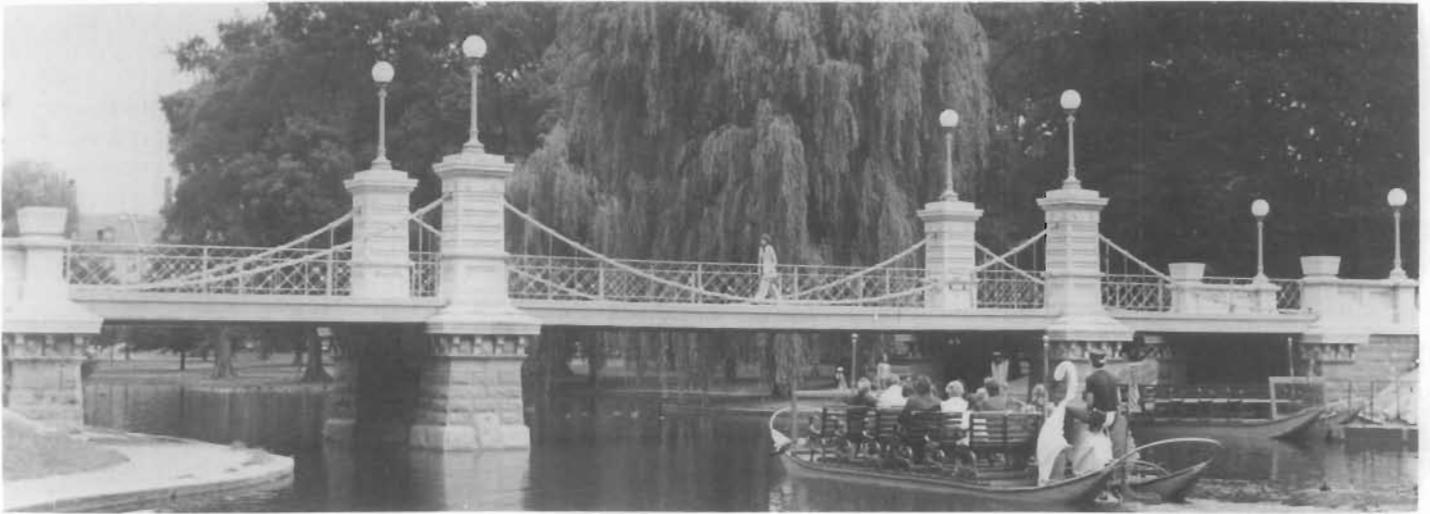
Figure 61. Suspension Bridge, Public Garden, Boston, Massachusetts, 1867; Eimens Herschel and William Preston, engineers. Popular among Bostonians, this small suspension bridge originally consisted of plank flooring hung from chains made of flat wrought-iron links. In 1921 the bridge's deteriorated wood was replaced with steel beams; the bridge was reinforced in 1975 with more steel and concrete. Although the deck has been replaced, the masonry piers and the chains hung between them are still largely original. (Carleton Knight, III)

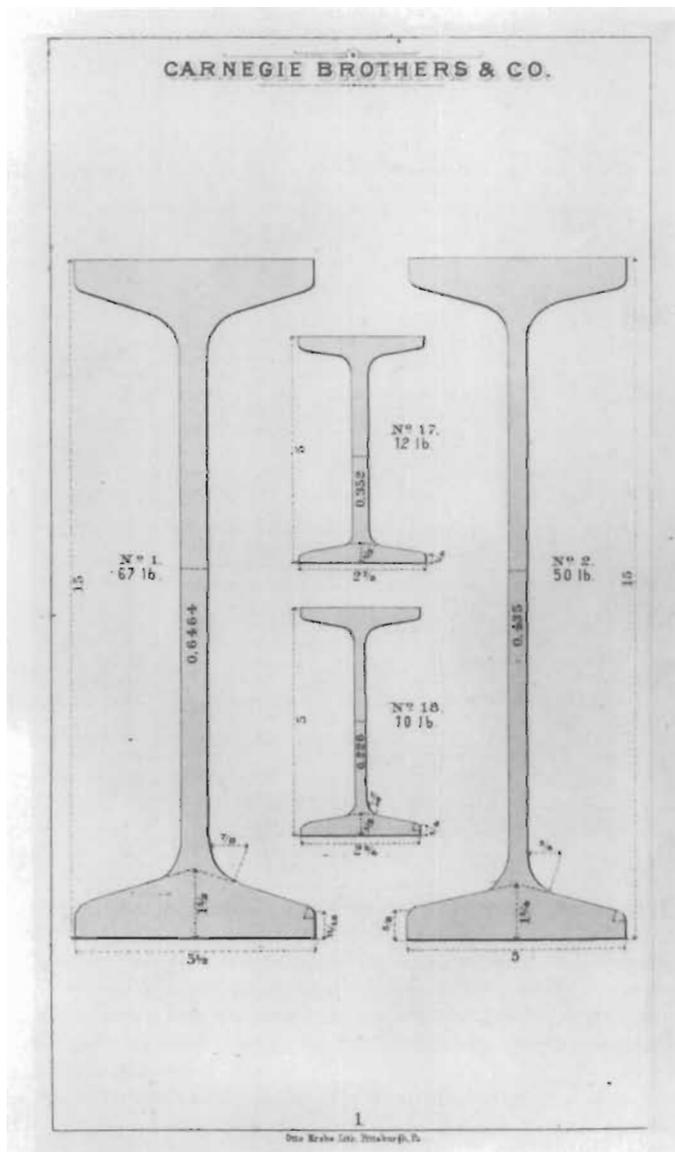
Figure 62. Wrought-iron Beams, Carnegie Brothers and Company's Pocket Companion . . . , 1876. The earliest known wrought-iron handbook of wrought iron structural shapes was published by Carnegie Kloman and Co. in 1873, some 18 years after the first wrought-iron I-beams were rolled in the United States by the Trenton Iron Works, founded by Peter Cooper. Copies of the 1873 handbook are quite rare; however, the Library of Congress has a copy of the 1876 handbook of Carnegie Brothers and Co. The Iron and Steel Beams: 1873 to 1952, published by the American Institute of Steel Construction, Inc., is a valuable resource book because it documents the handbook dates, the sizes, weights, and properties of all rolled beams during this period. The largest beam in the 1873 handbook was 15 inches deep and 67 pounds per lineal foot, the same as the beam shown in this illustration at the far left. (Library of Congress)

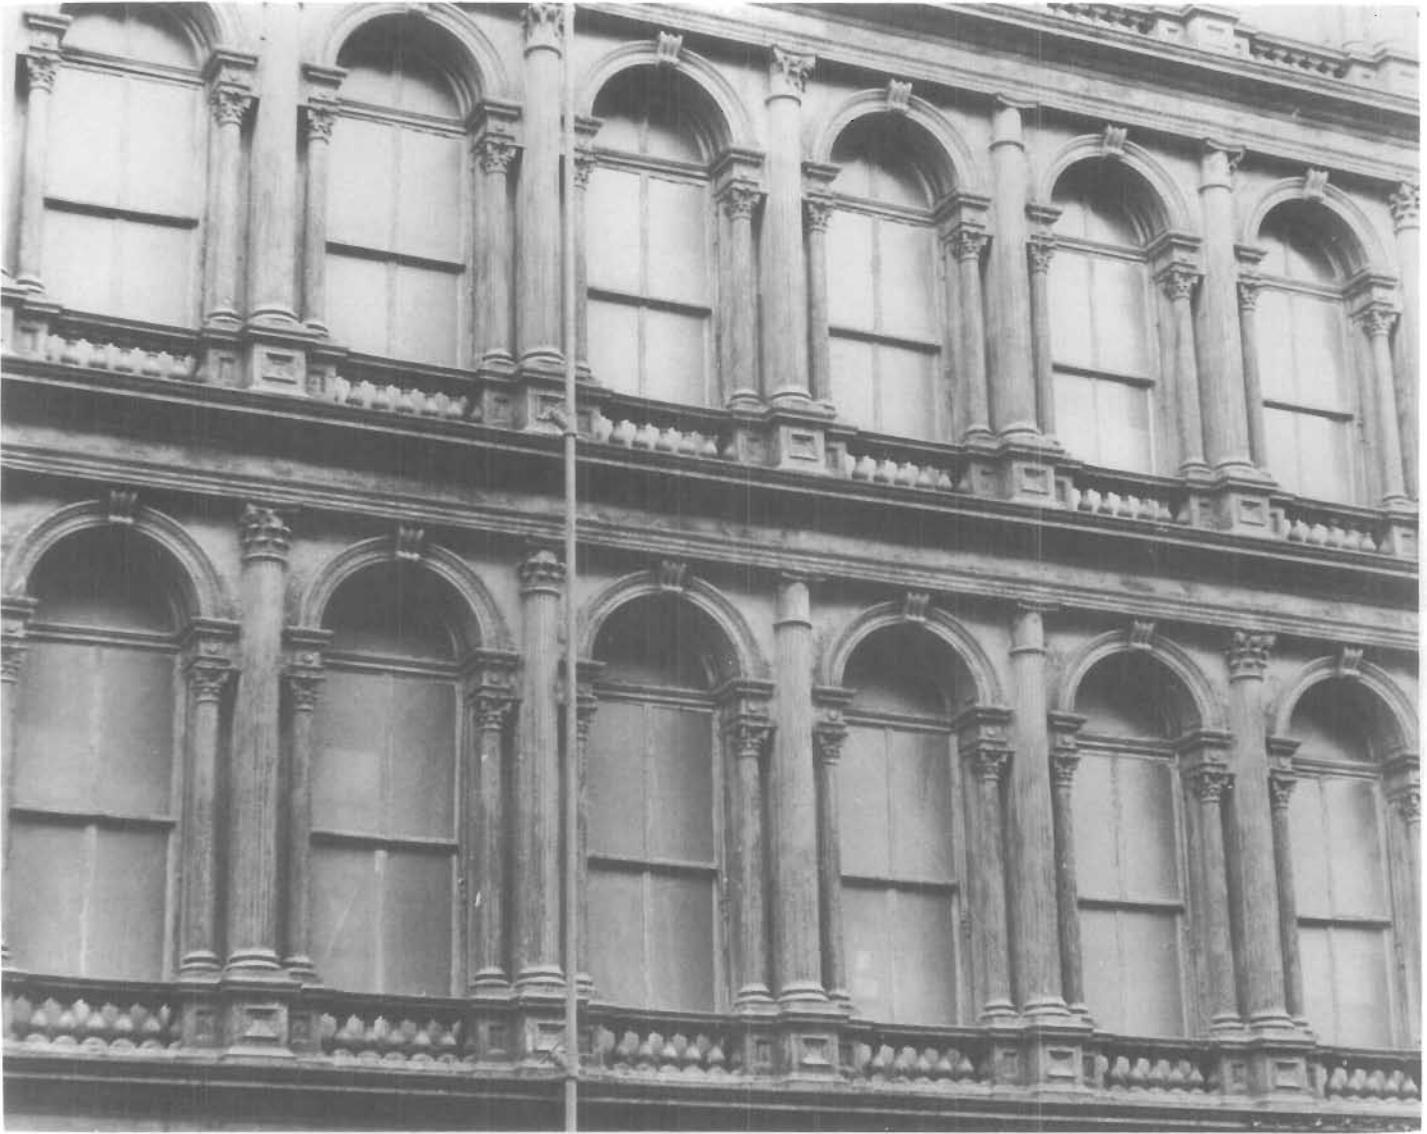
Figure 65. Cast-iron Haughwout Building, 490 Broadway, New York City, 1856; John P. Gaynor, architect; Daniel D. Badger's Architectural Iron Works of New York City. Some of the best iron front buildings stand in the SoHo area of the city. There are excellent examples of the quality and character of mass-produced 19th-century ironwork. Once foundry patterns were prepared, any number of like building fronts could be cast. The facade of the Haughwout Building consists of a single module, Palladian in character, repeated again and again. The result was an impressive design at a moderate cost. (Clover Vail)

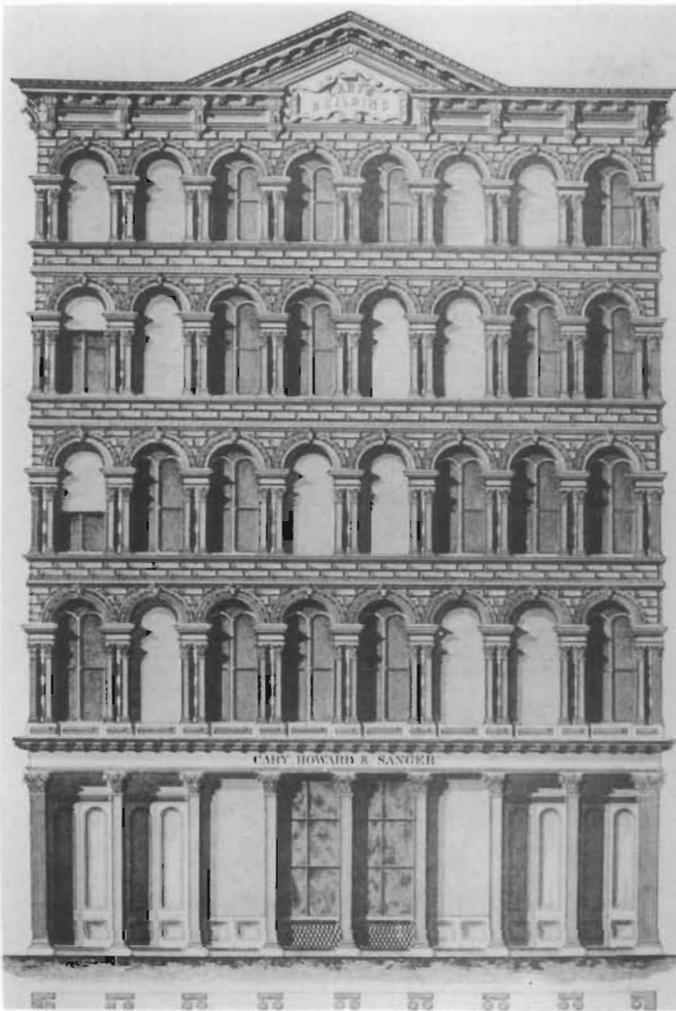
Figure 66. Catalog Illustration, Cary Building, New York City, 1856; John Kellum, architect; Daniel D. Badger's Architectural Iron Works of New York City. This iron front design depicted in the 1865 catalog of Badger's foundry is still standing in downtown Manhattan. Although the iron is scored to look like ashlar, the slender freestanding colonettes between the windows reveal that the facade is metal, not stone. Many of the rolling metal shutters at the windows have been pulled shut. Badger sold rolled iron shutters before he started promoting cast-iron storefronts. (Avery Library, Columbia University)

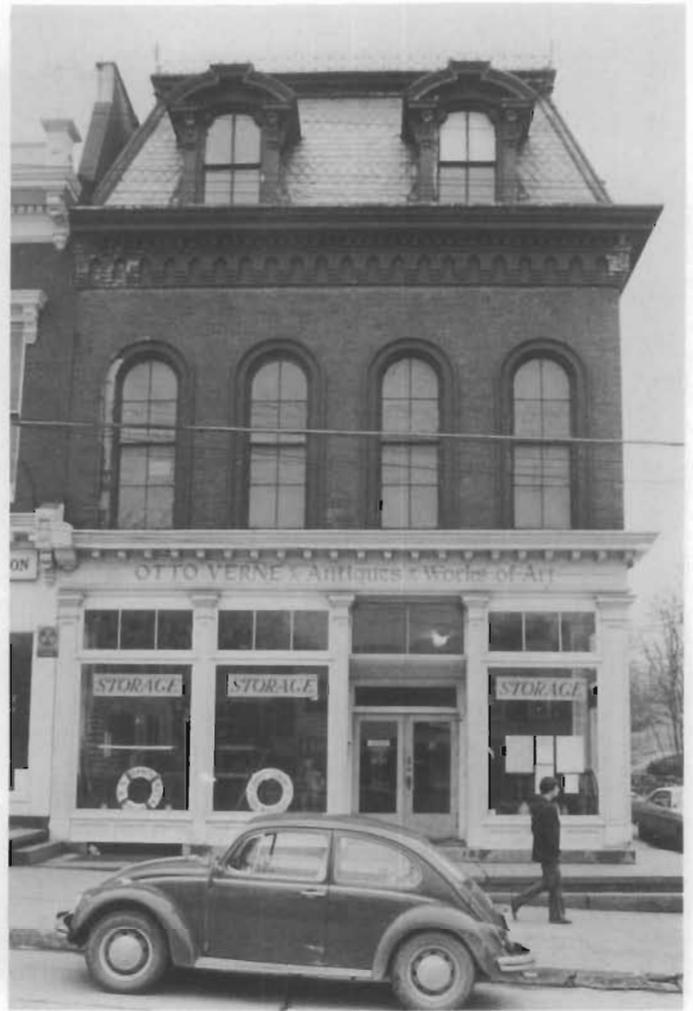
Figure 67. One-story Cast-iron Storefront, 75 Main Street, Cold Spring, New York. This modest facade is typical of cast-iron storefronts popular for decades after their introduction about 1825. Fabricated by both small local foundries and large nationally known companies, storefronts were available in a variety of styles and sizes, and could be ordered from catalogs. The slender piers and columns could support the weight of several stories, usually masonry, while providing the framework for broad expanses of glass. The open front was perfect for the display of merchandise. (Otto Verne)

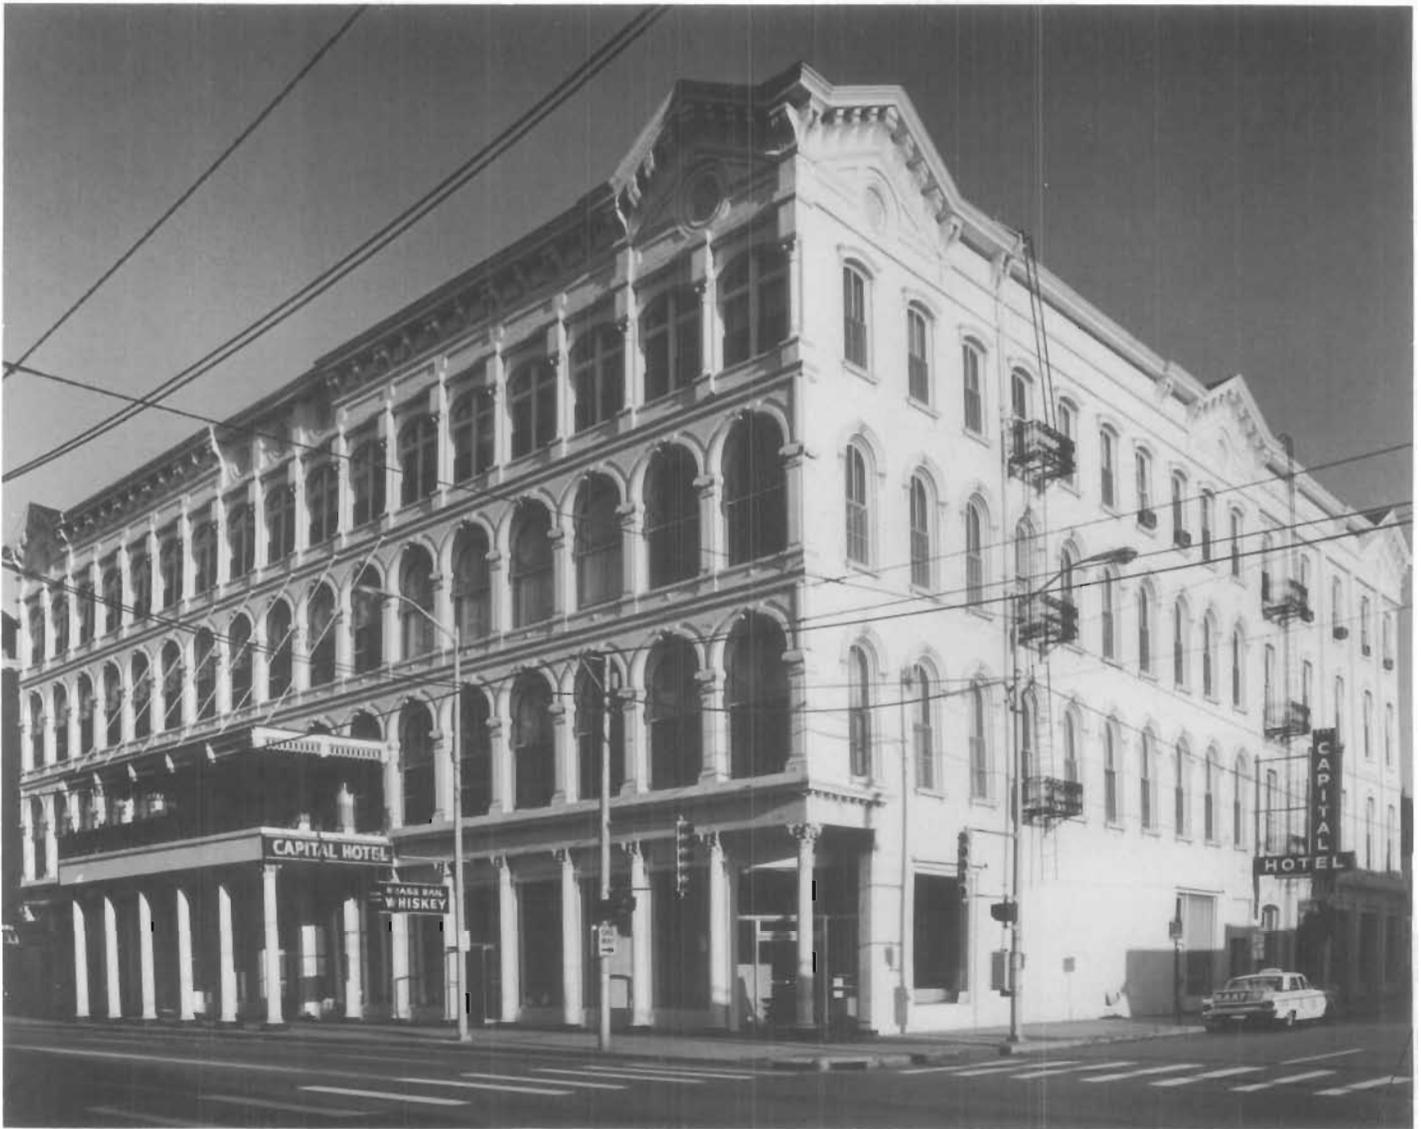
Figure 68. Cast-iron Facade, Capital Hotel (originally the Denkla Office Building), 117 West Markham Street, Little Rock, Arkansas, 1873. The Italianate office building was converted in 1877 into a hotel. Being located near the state capitol, it became popular with politicians and was often used as campaign headquarters. Note the difference in window size in the facade and the masonry sidewall. The larger windows of the cast-iron front provided a great deal of natural light, which the building's original use (offices) required. Although not apparent from a distance, the top story of the front facade and the cornice are pressed sheet metal, probably galvanized iron. (Earl Saunders)

The skillful application of lead and glass in doorway fanlights and sidelights appeared in some late Georgian and many Federal houses. Later, during the Victorian era, stained-glass windows, doors, and decorative skylights became fashionable for public buildings and residences as well as for churches. The stained-glass skylight in the Capital Hotel in Little Rock, Arkansas, is a good example of this (figure 8).

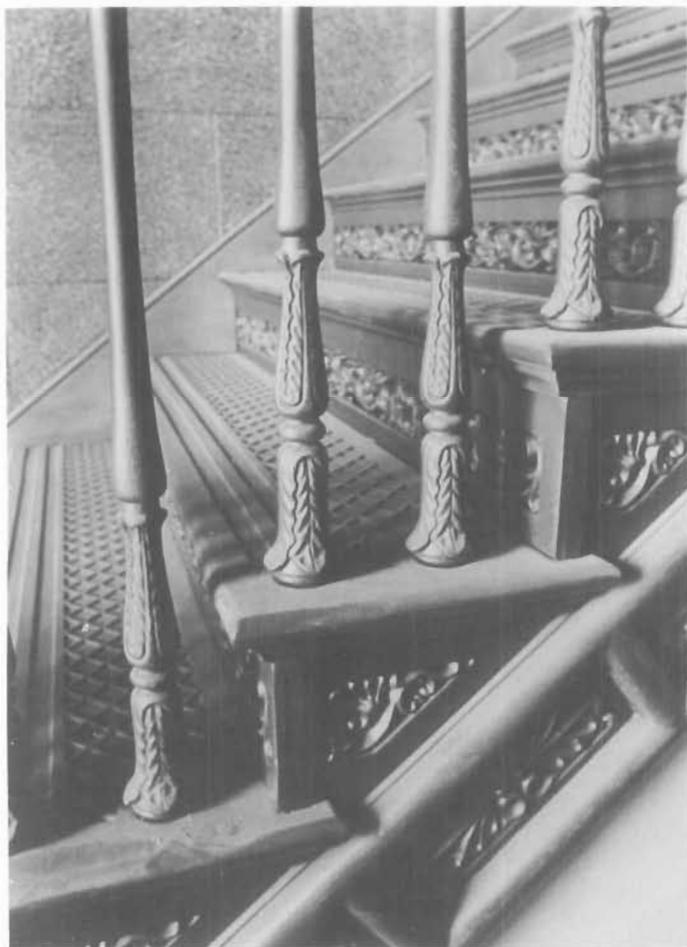
Figure 81. Restored Cast-iron Stairs, Old Customs House (now known as West Virginia Independence Hall), Wheeling, West Virginia, 1859; Ammi B. Young, Architect of the Treasury. In this building the people of western Virginia declared their independence during the Civil War and joined the Union. These cast-iron stairs and balusters have recently been restored with the recasting of missing or damaged pieces. Perforated stairs were originally designed to combine decorative, functional, and economical detailing; to provide elaborate but strong construction; and to reduce the weight and quantity of iron required. (West Virginia Independence Hall Foundation)

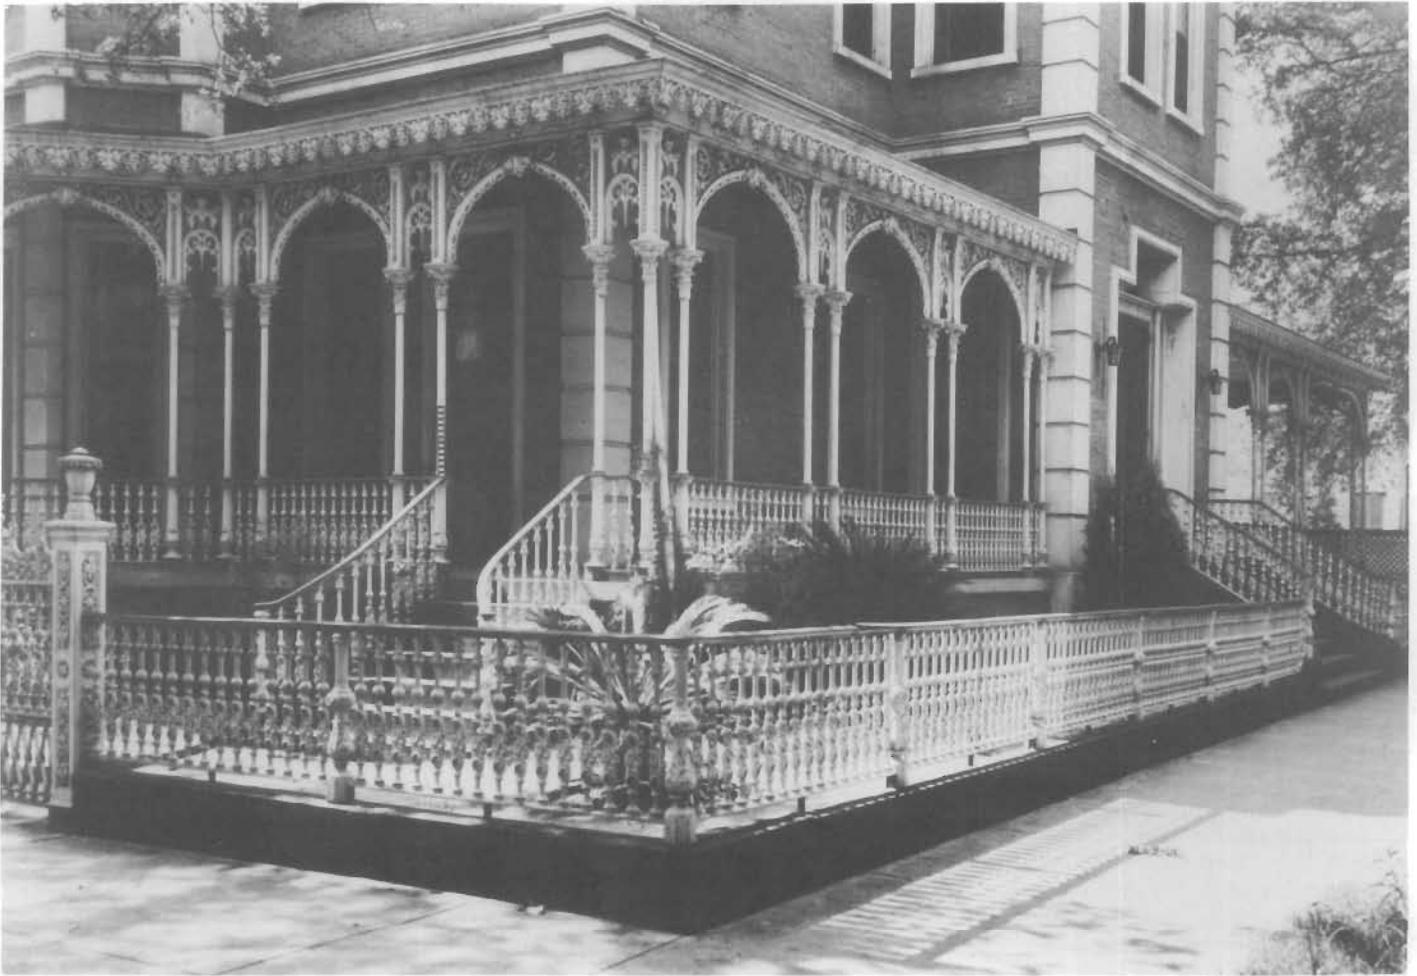
Figure 87. Cast-iron Veranda and Fence, Ketchum Mansion, 400 Government Street, Mobile, Alabama, 1861; Wood and Perot, foundry, Philadelphia. *This veranda, skillfully produced in decorative cast iron, as well as the cast-iron railing, fencing, gates, and gate posts, are painted white to contrast with the warm-colored brick of the Italianate mansion. (Jack E. Boucher, NAER)*

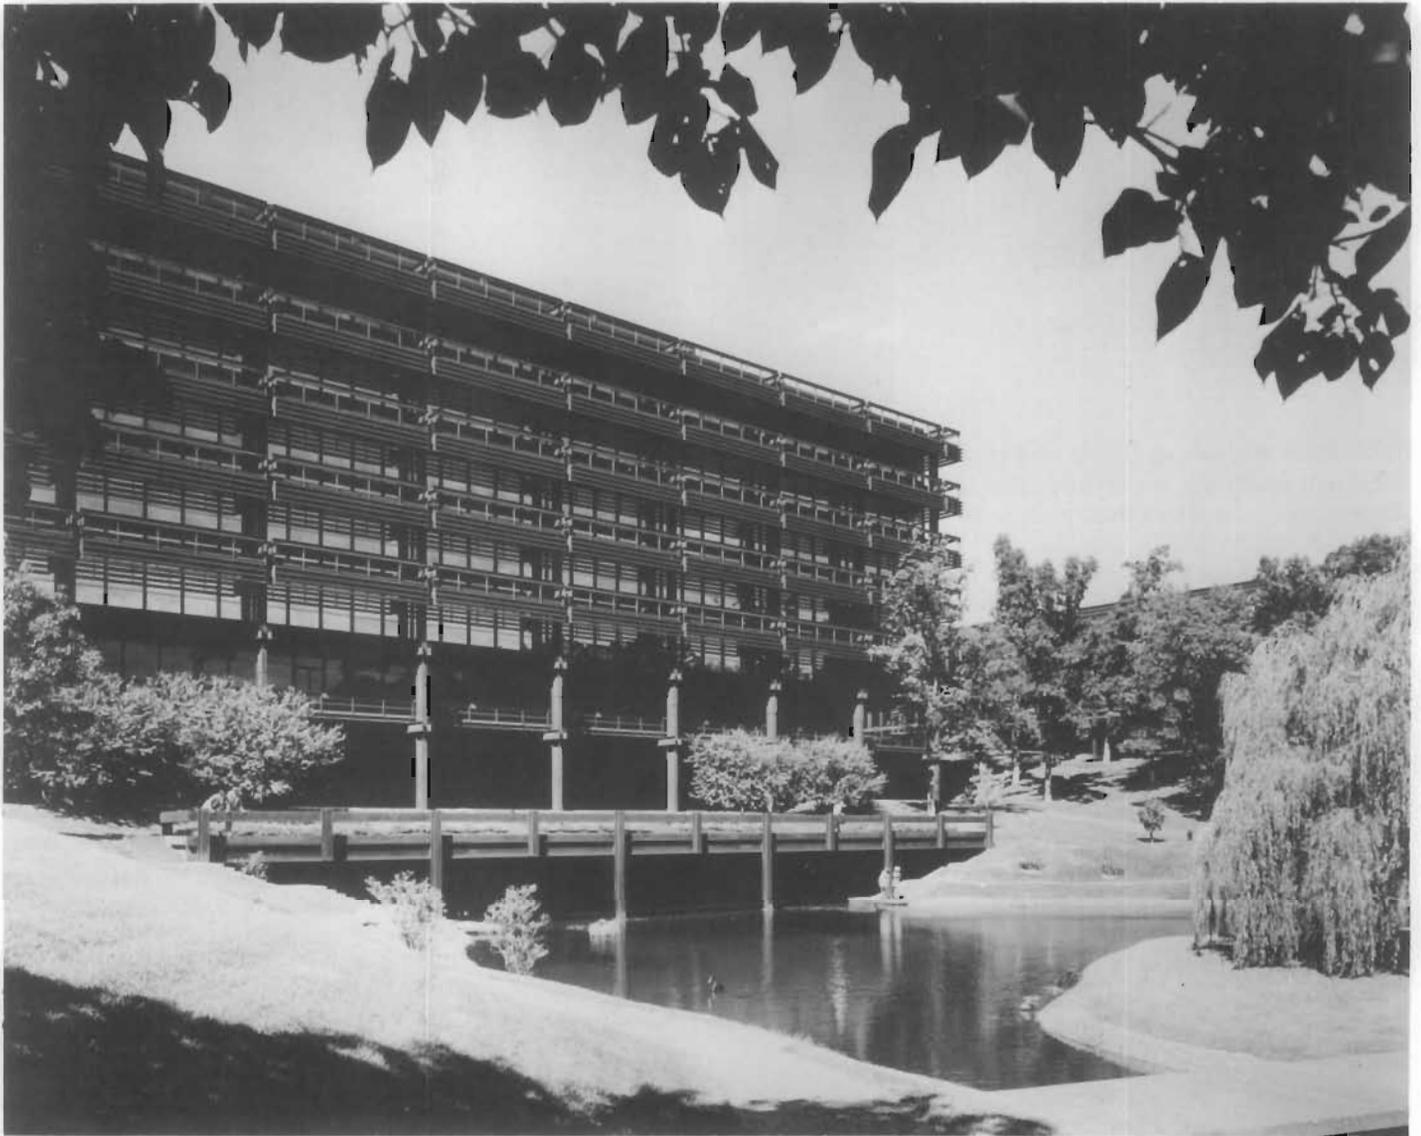
Figure 110. "Corten" Steel, Deere and Company Administrative Center, Moline, Illinois, 1964; Eero Saarinen, architect. *The Deere and Company building, which received many architectural awards, was among the first to make extensive architectural use of this unpainted, corrosion-resistant material for exterior steel members. (Deere and Company)*

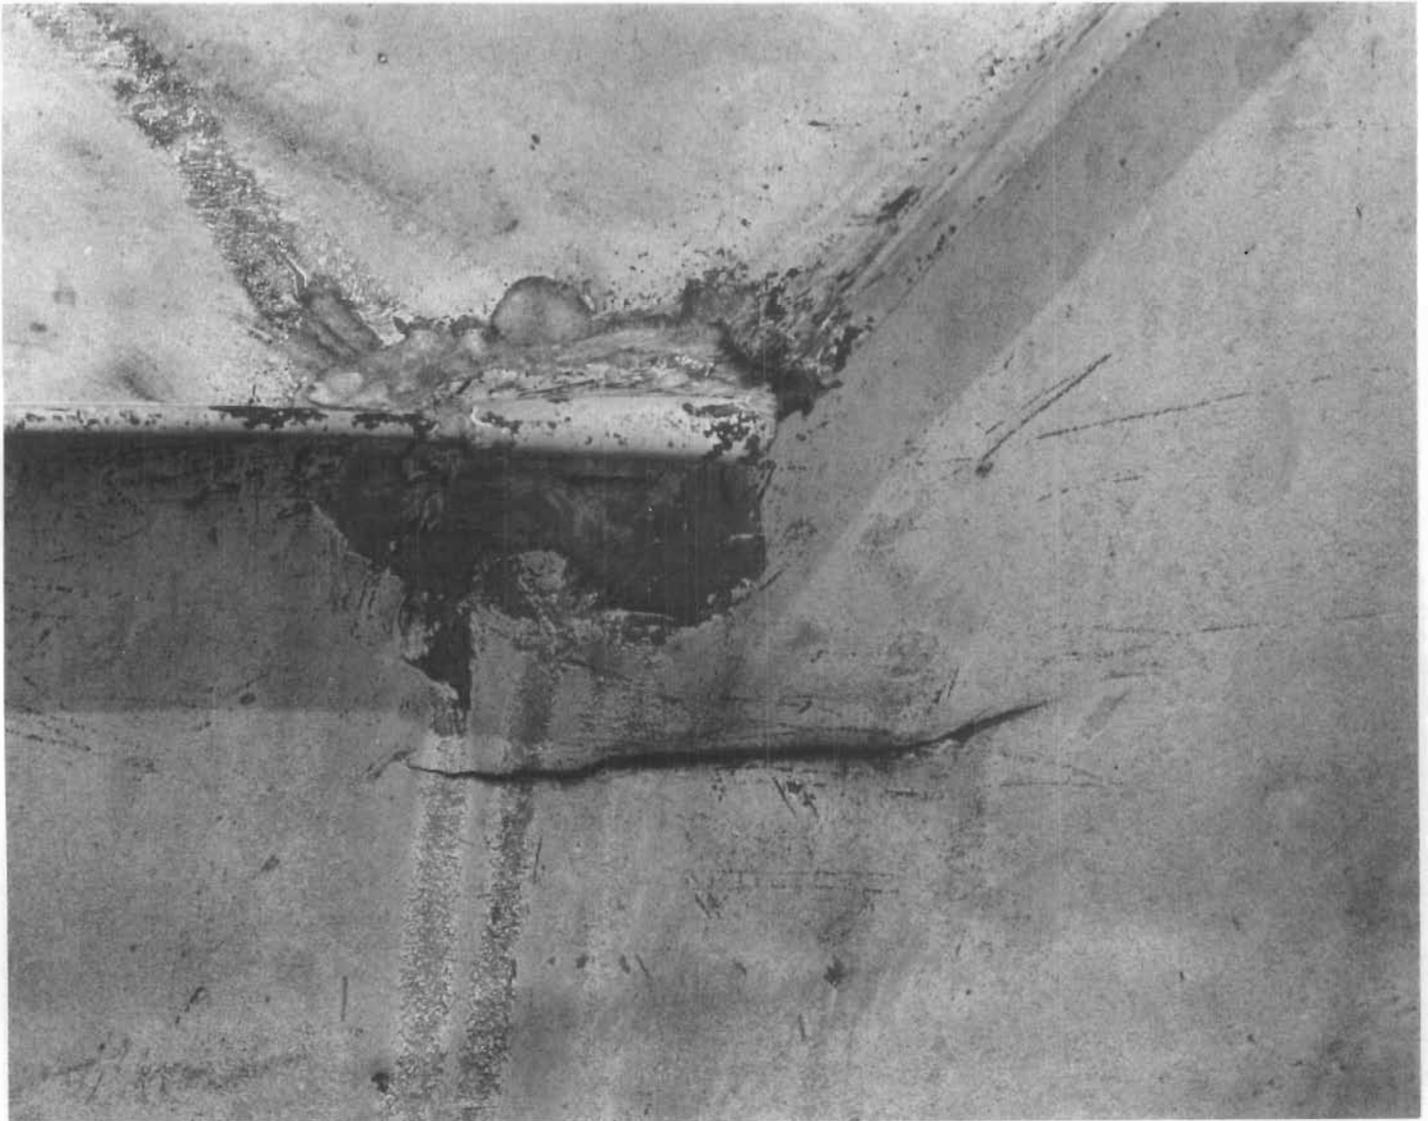
Figure 118. Fatigue Failure. This is an example of fatigue cracking of the copper roof of the Senate House, Kingston, New York. Repeated expansion and contraction due to daily and seasonal temperature changes has caused this sheet-copper roof to crack. Note cracking both at the joint and on the planar surface. (John C. Waite)

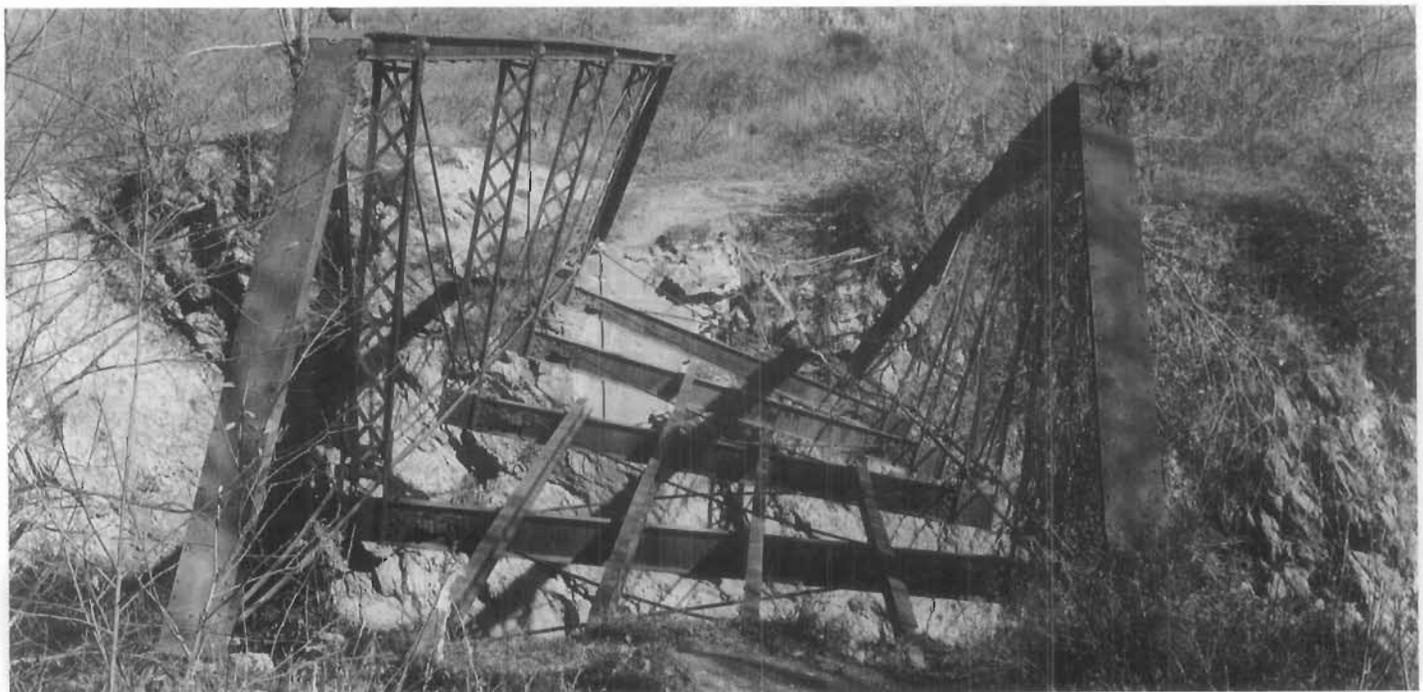
Figure 122. Structural Failure. This 19th-century wrought-iron truss bridge at Brunswick, New York, partially collapsed because the cut-stone abutment supporting it washed away. Once the support was removed, the bridge twisted. (John G. Waite)

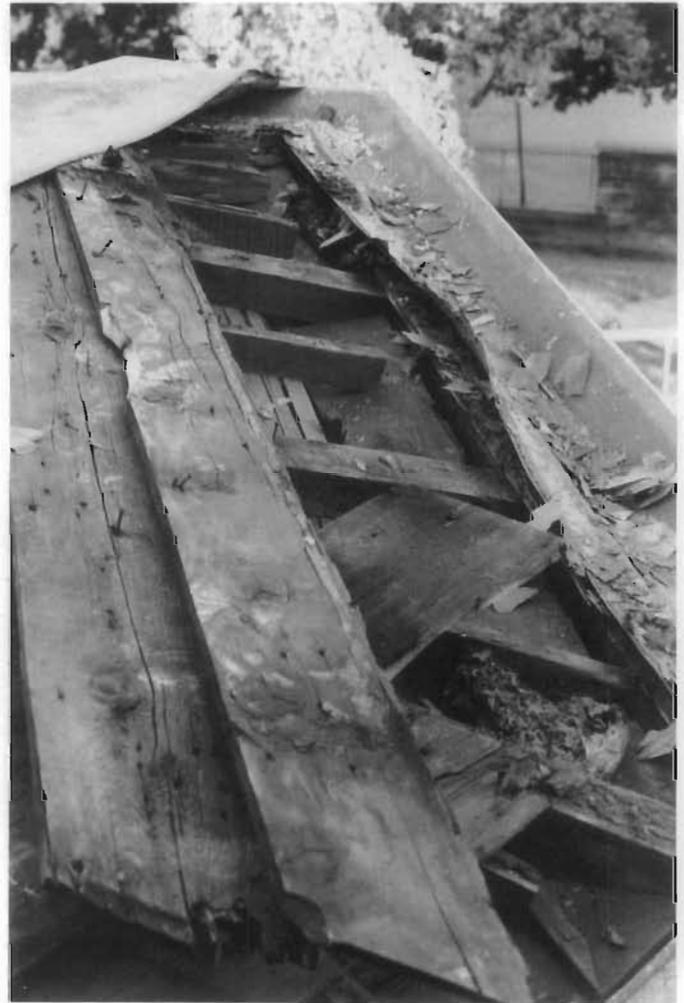
Figure 124. Successive Failure. If a metal architectural element such as a tinplate roof fails, more than just the tinplate may be destroyed. (a) Deterioration is evident in the original framing and roof sheathing of the Schuyler Mansion entrance wing in Albany, New York. The entrance wing was added to the building about 1817 and reroofed with tinplate sheets during the 19th century. The tinplate gutter liners eventually deteriorated and were replaced with copper during the 1930s. However, the tinplate roof remained and electrolysis occurred along the roof perimeter where the copper and tinplate were in contact. (b) Consequently, the tinplate was completely corroded away (as seen here) when the deteriorated roofing was removed. This resulted in major damage to the sheathing, framing, and masonry walls of the entrance. (John G. Waite)
