Metals in America's Historic Buildings

Uses and Preservation Treatments

U.S. Department of the Interior
National Park Service
Cultural Resources
Preservation Assistance
Washington, D.C.
1992

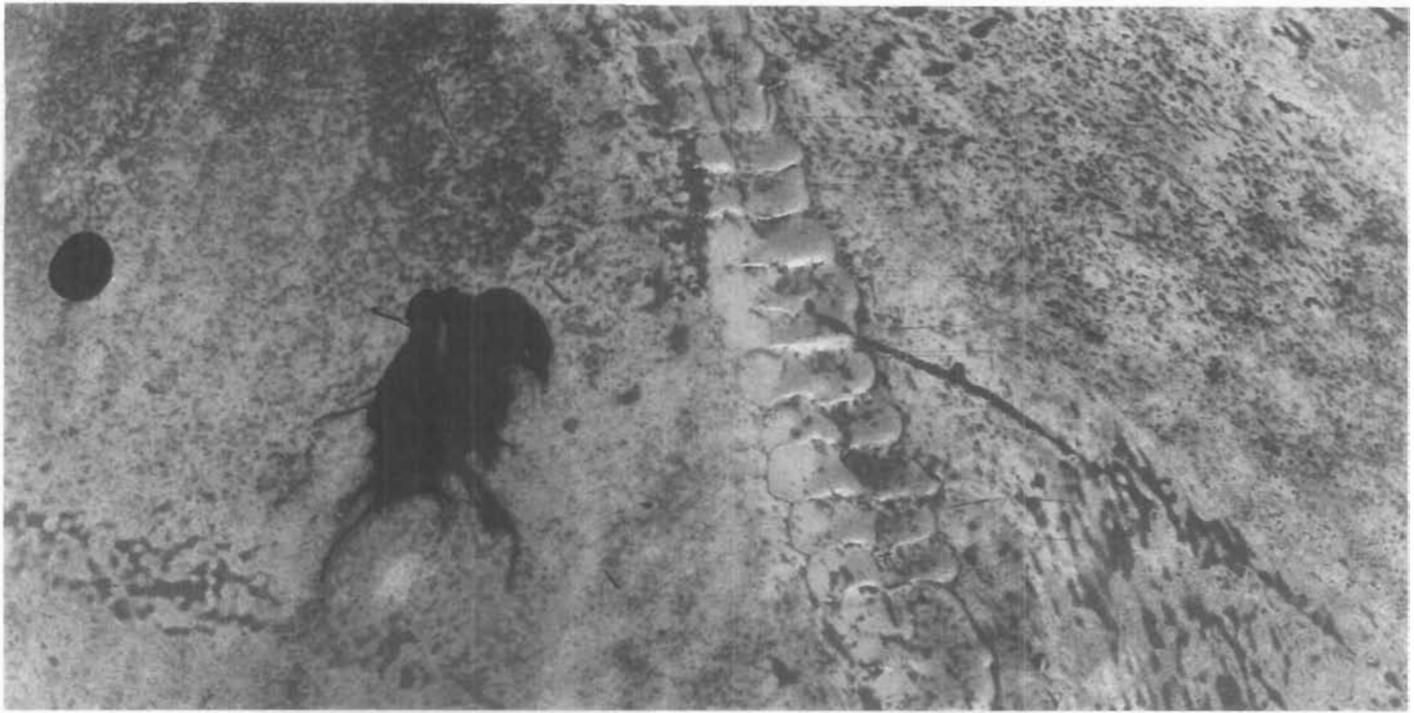
Figure 130. Modern Solder Joint on a Terneplate Roof. Solder was used to make watertight joints at the edges of terneplates on flat-seam roofs. Nineteenth-century soldered joints were almost invisible, that is, the solder was confined to the seam. These wide-soldered joints are on the Old Pension Building in Washington, D.C. The problems with wide-soldered joints are: (1) they facilitate galvanic corrosion because they provide a wider surface area with which the plates can react, and (2) they tend to fail because of the different coefficients of expansion and contraction of the solder and the terneplate. The black spots to the right of the solder are asphalt or a bituminous roof patching compound, which may cause deterioration of the terneplate and should be removed. (David W. Look)

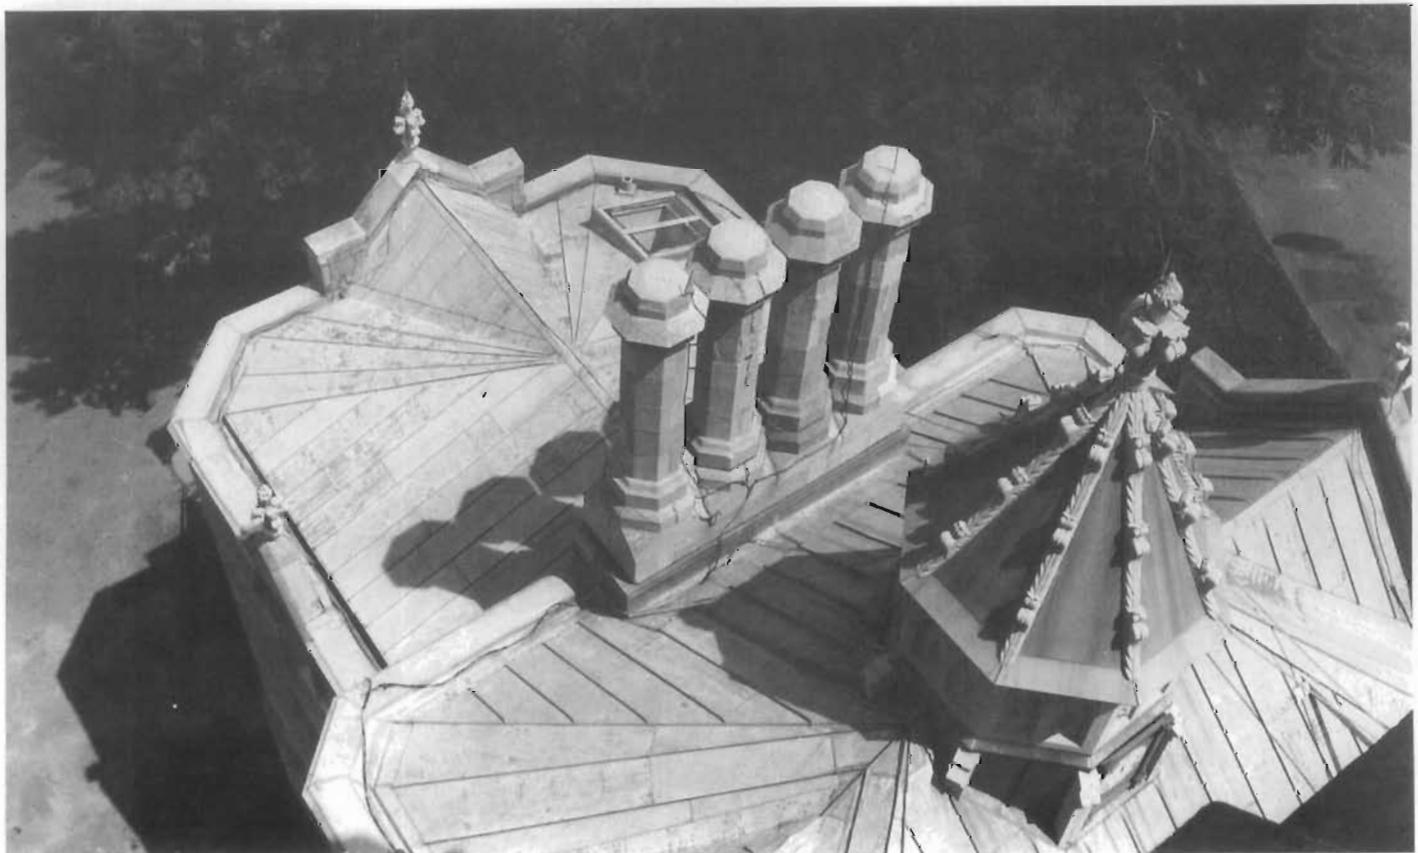
Figure 135. Complete Substitution of Lead-Coated Copper Roofing for Terneplate Roofing. The 1864 wing addition of Lyndhurst, Tarrytown, New York, originally had a terneplate roof. In an attempt to find a more permanent roofing material, a lead-coated copper roof was substituted for the terneplate, duplicating the pattern and sheet sizes of the original roof. In such substitutions, details may have to be redesigned because of differences in expansion and contraction rates and differences in workability of the material. The color of lead-coated copper is not the same as terneplate because terneplate roofing was never left unpainted. Therefore, lead-coated copper roofing substituted for terneplate should also be painted if it seen from normal viewing angles (usually from street level). (John G. Waite)

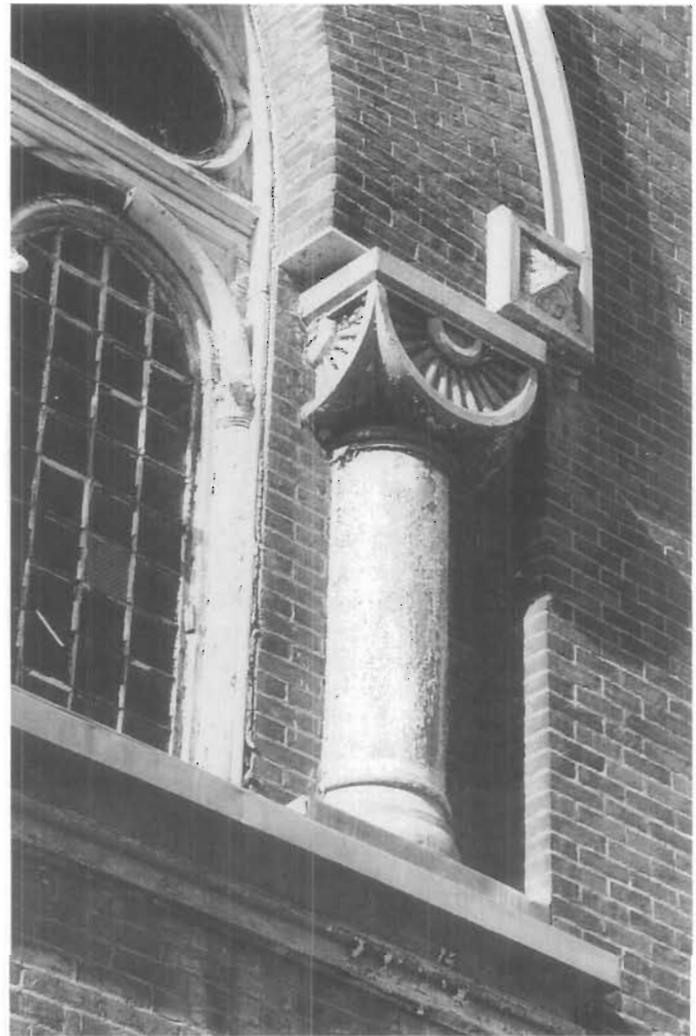
Figure 138. Zinc Deterioration and Staining. On the First Presbyterian Church in Alexandria, Virginia, the engaged columns, arch molding, corner blocks, and the sill molding are fabricated of cast zinc and galvanized sheet iron (the windows and frames are wood). The paint has deteriorated, leaving the surface of the metal bare in some places. The zinc or zinc coating on iron has oxidized. Notice the whitish corrosion stain on the brick from the zinc carbonate coating which continues to wash over the surface of the bare metal and then down over the bricks. The metalwork should be scraped down to remove all loose zinc carbonate. Joints should be caulked and/or resoldered, and repainted with a zinc chromate primer. (Baird M. Smith)

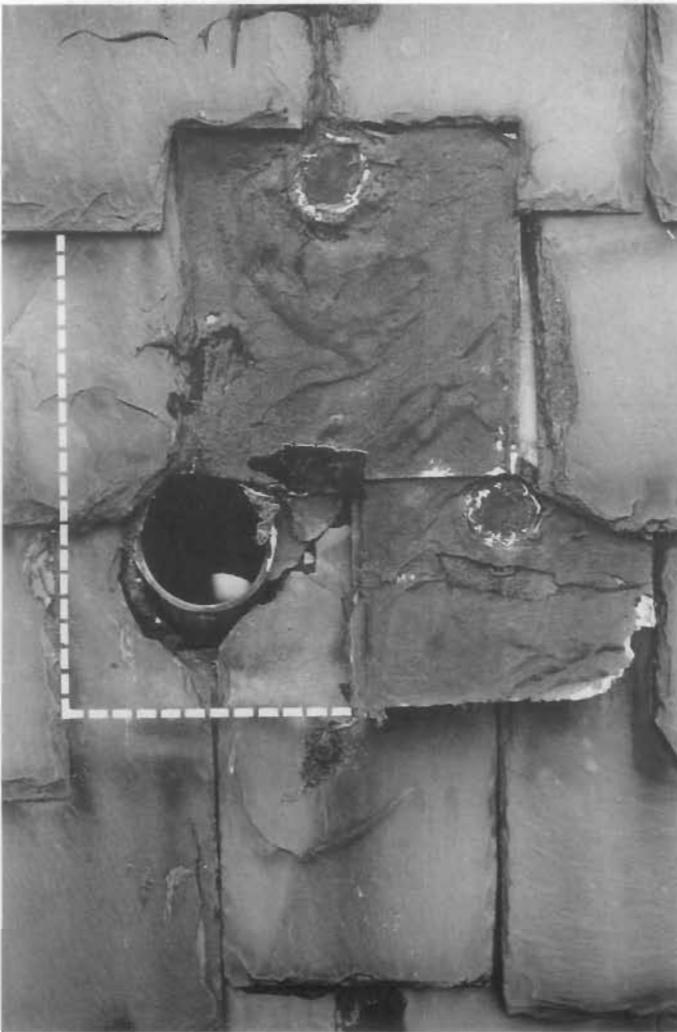
Figure 139. Zinc Corrosion, Erosion, and Inappropriate Repairs. In construction of the Nott Memorial at Union College in Schenectady, New York, during the 1870s, architect Edward Tuckerman Potter used “illuminators” in the ornamental slate roof. These were slate-sized zinc plates with a small colored-glass disc 1 3/4 inches in diameter inserted in the center. Barely discernible from the outside, they transformed the vaulted dome within a “heaven” of red, yellow, purple, orange, and green stars. Shown here is a cluster of three illuminators, each consisting of a zinc plate with a small colored-glass insert and the connecting tube through the metal deck and plaster to the interior. The zinc was inaccessible and not kept painted. Small fragments of slate broke off and tumbled down with gravity. The wind and rain eroded the layer of corrosion from the zinc surface. The left plate is missing (see dotted line), showing the connecting tube. The corner of the lower right plate is missing because it became brittle and fractured off. Unfortunately, modern roofing cement applied over the zinc plates is accelerating the deterioration. (John I. Mesick, *The Nott Memorial: A Historic Structure Report Schenectady, New York: Union College, 1973. p. 65*)

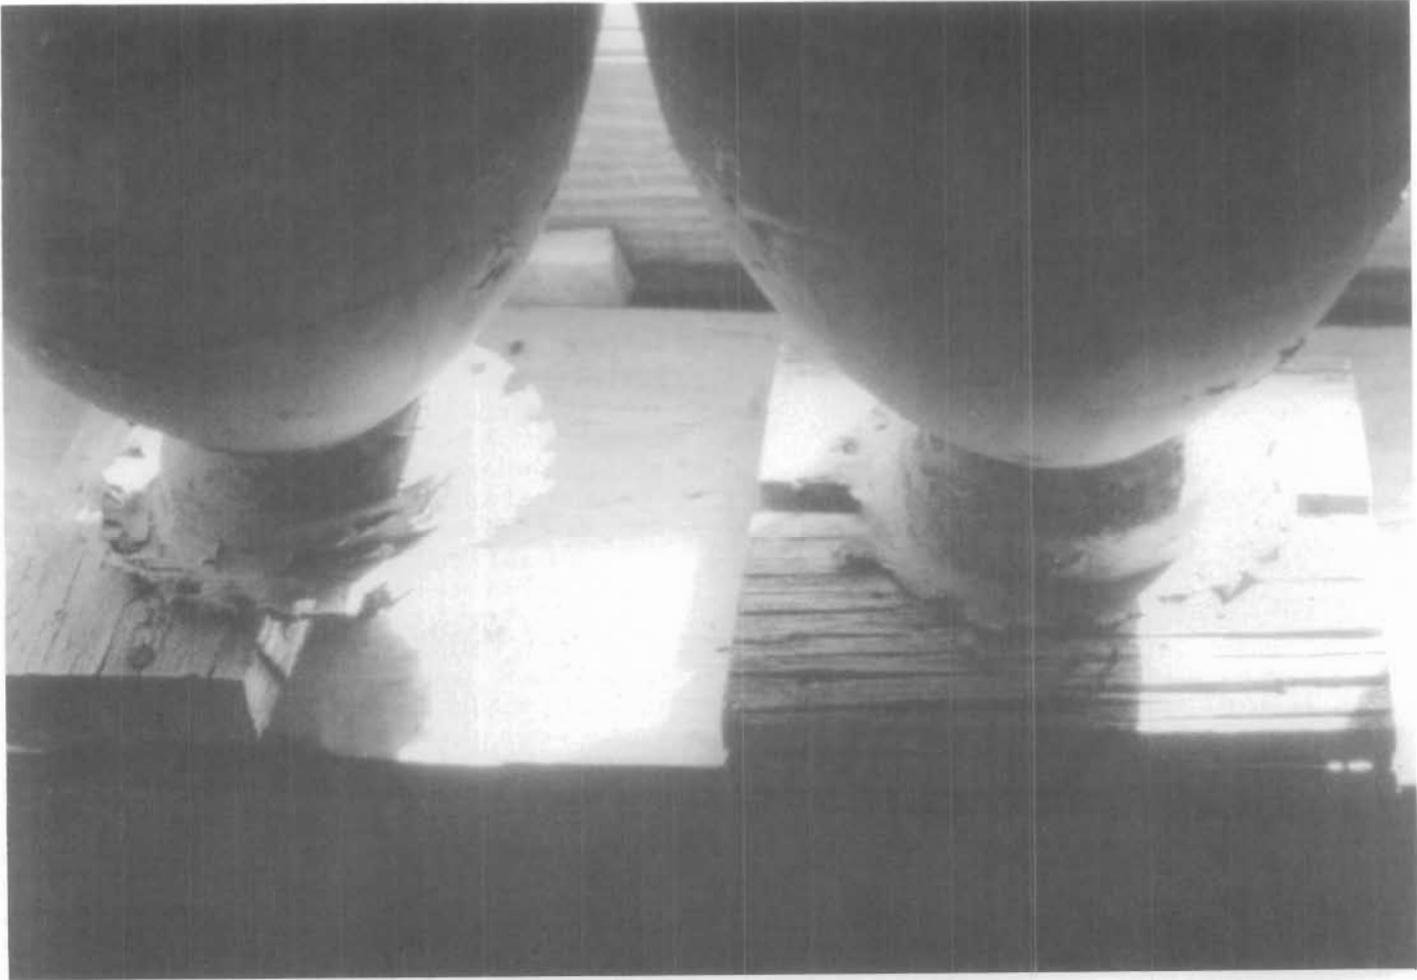
Figure 140. Galvanic Deterioration. Bases of zinc vases from the roof balustrade of Lorenzo, Casenovia, New York, have deteriorated because of the electrolytic action between the zinc and the machine-cut iron nails used to fasten the vases to the balustrade. The zinc was sacrificed in favor of the iron because the iron is more noble than the zinc. (Douglas Clinton)

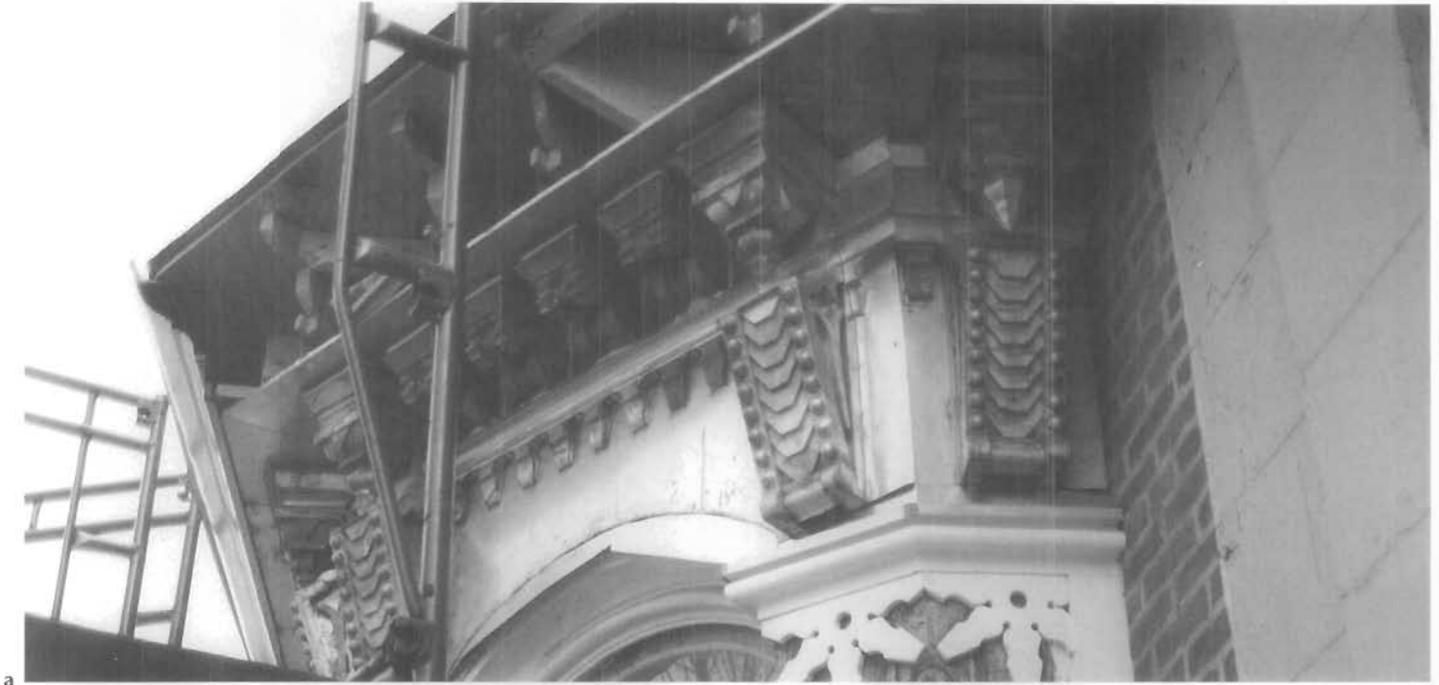
Figure 142. Restoration of Galvanized Sheet Iron and Cast-Zinc Cornice. This is the upper third of a wooden bay window on a Second Empire brick rowhouse in the Logan Circle Historic District of Washington, D.C. (a) From the window down, the bay is wood and glass. The roof of the bay had leaked for years and the wooden roof rafter and projecting supports for the cornice had rotted. The bay window was carefully disassembled and rebuilt replacing all deteriorated lumber. The surviving pieces of galvanized sheet-iron and cast-zinc cornice were taken to a sheet-metal shop. The pieces that were repairable were cleaned; missing portions of brackets on the right were replicated of galvanized sheet iron using the originals as a model. (b) On the opposite side of the bay, all of the brackets and modillions are repaired originals but all of the flat and molded sections are new 26-gauge galvanized steel. The 65-year-old sheet-metal worker on this job said that the only two major advances in metal cornices in his lifetime are the use of pop rivets for fasteners (used also in leatherwork) and the use of autobody putty to patch holes, mold small missing details, and waterproof joints. The putty dries hard and can be sanded. (David W. Look)

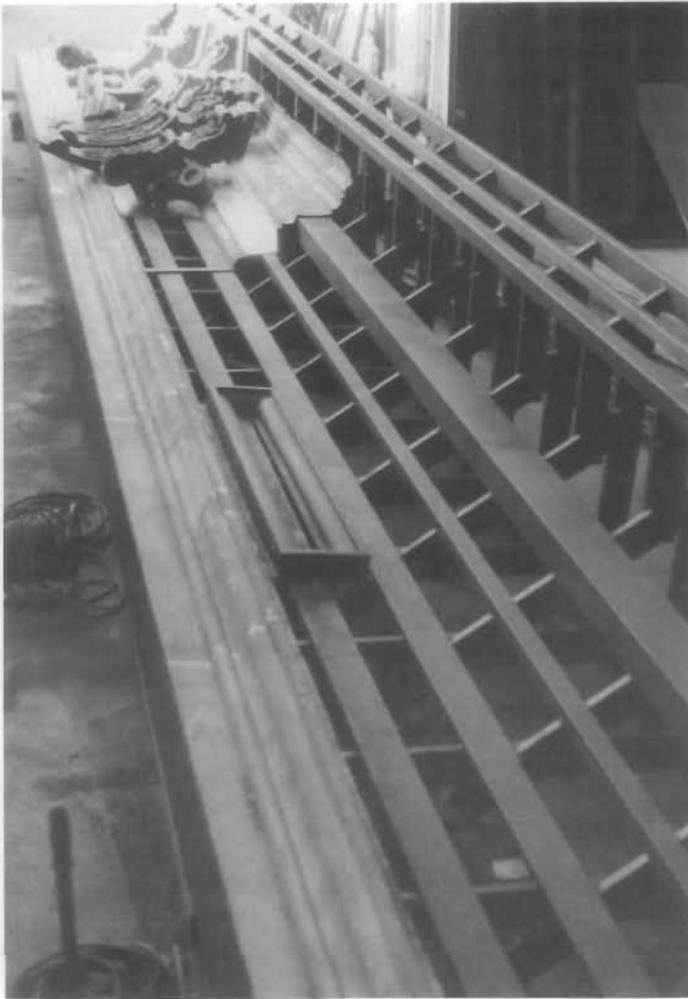
Figure 143. Preassembling Cornice. As illustrated in figure 142, most sheet-metal cornices were supported by wooden support members projecting out from the facade of the building either as an extension of the roof framing or as a cantilever from a parapet wall. In either case, these wooden support members are often found to be rotten and have to be replaced. For large cornices high above the street level, it may be economically unfeasible to use scaffolding for in situ repairs and reconstruction unless the scaffolding is also needed for other work. The entire galvanized sheet-iron cornice of the ZCMI Store in Salt Lake City, Utah, was preassembled on the ground with repaired original parts and some new pieces onto a new support system fabricated on small steel angles. Fifty-foot sections of the preassembled cornice were then hoisted to the top of the facade and bolted onto the building without the need for scaffolding. (Steven T. Baird)

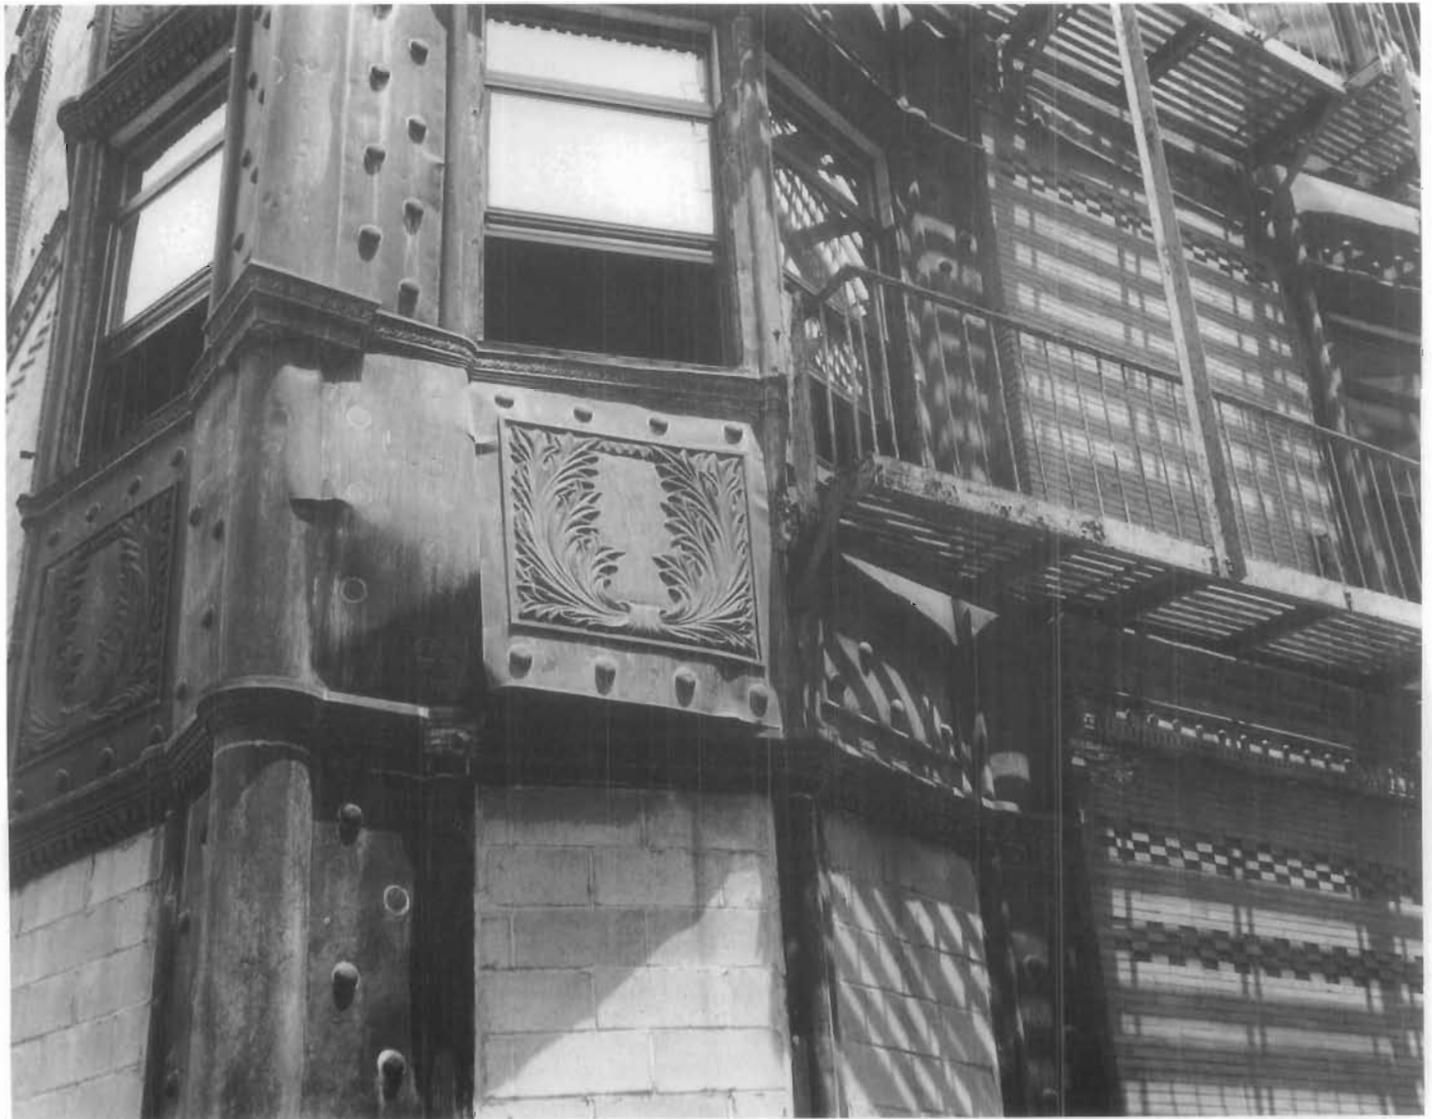
Figure 146. Loose and Damaged Copper Cladding and Deteriorated Steel Fire Escapes. *The corner bay of the Hotel Margaret (1889) in Brooklyn Heights, New York, was clad in ornamental panels of pressed sheet copper. Anchors have deteriorated and the wind has lifted the corners. Galvanic action between the noble copper and the baser steel (in the fire escape) has caused the steel to deteriorate.* (David W. Look)

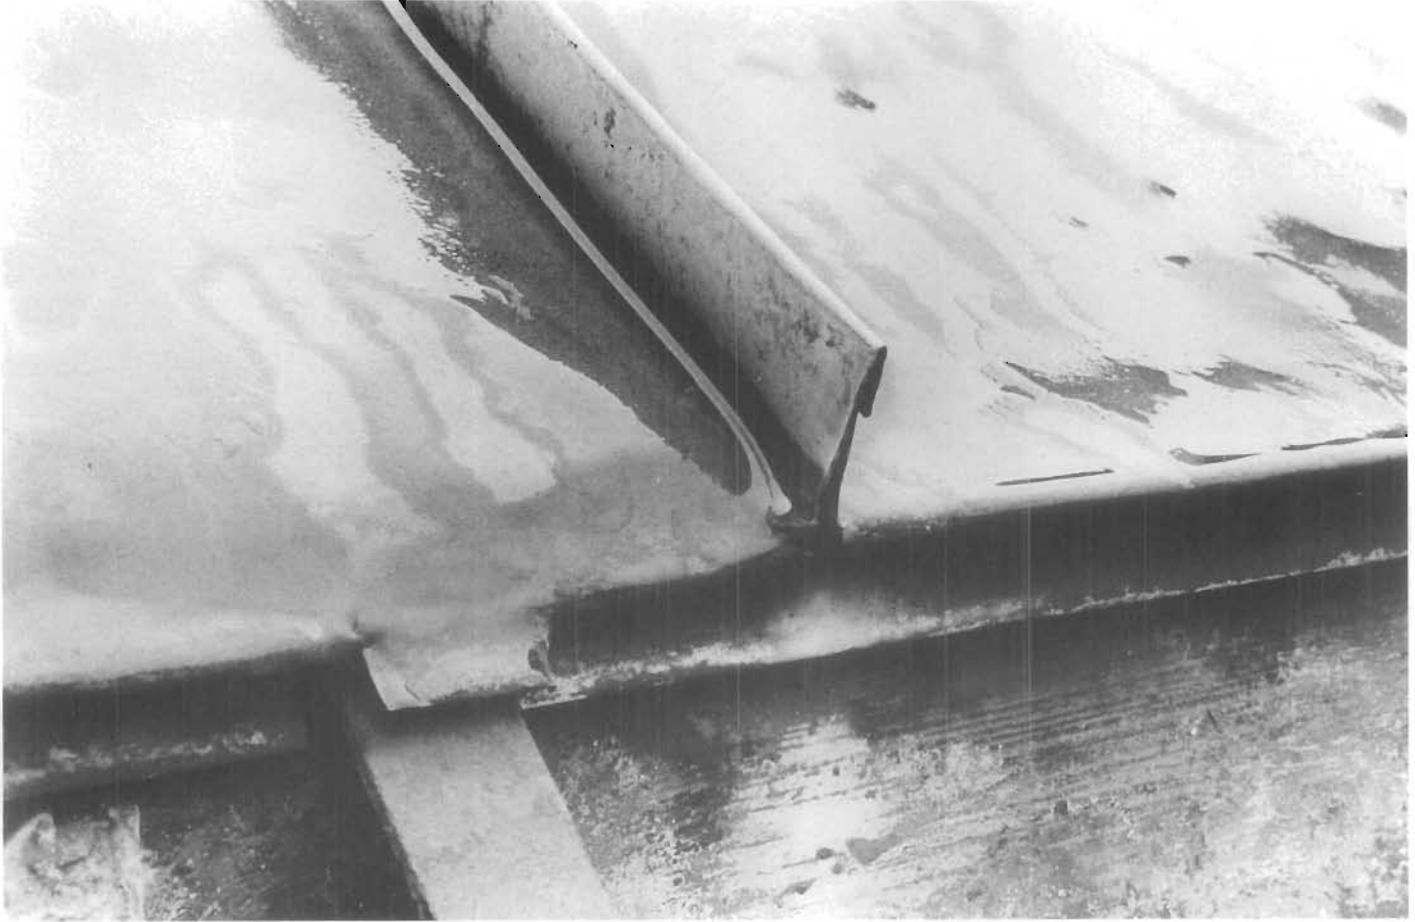
Figure 150. Erosion of Copper. *This eaves detail of the 1920s copper roof on the Senate House State Historic Site in Kingston, New York, illustrates erosion of the copper at the edge of the roof caused by continued exposure to rain and snow, which scoured the roof as it flowed to the gutter. Fatigue failure has also occurred at the base of the standing seam, resulting in a tearing of the copper. This failure was caused by the lack of provision for expansion and contraction, as well as the use of bituminous roofing felts, which restricted the movement of the copper. (John G. Waite)*

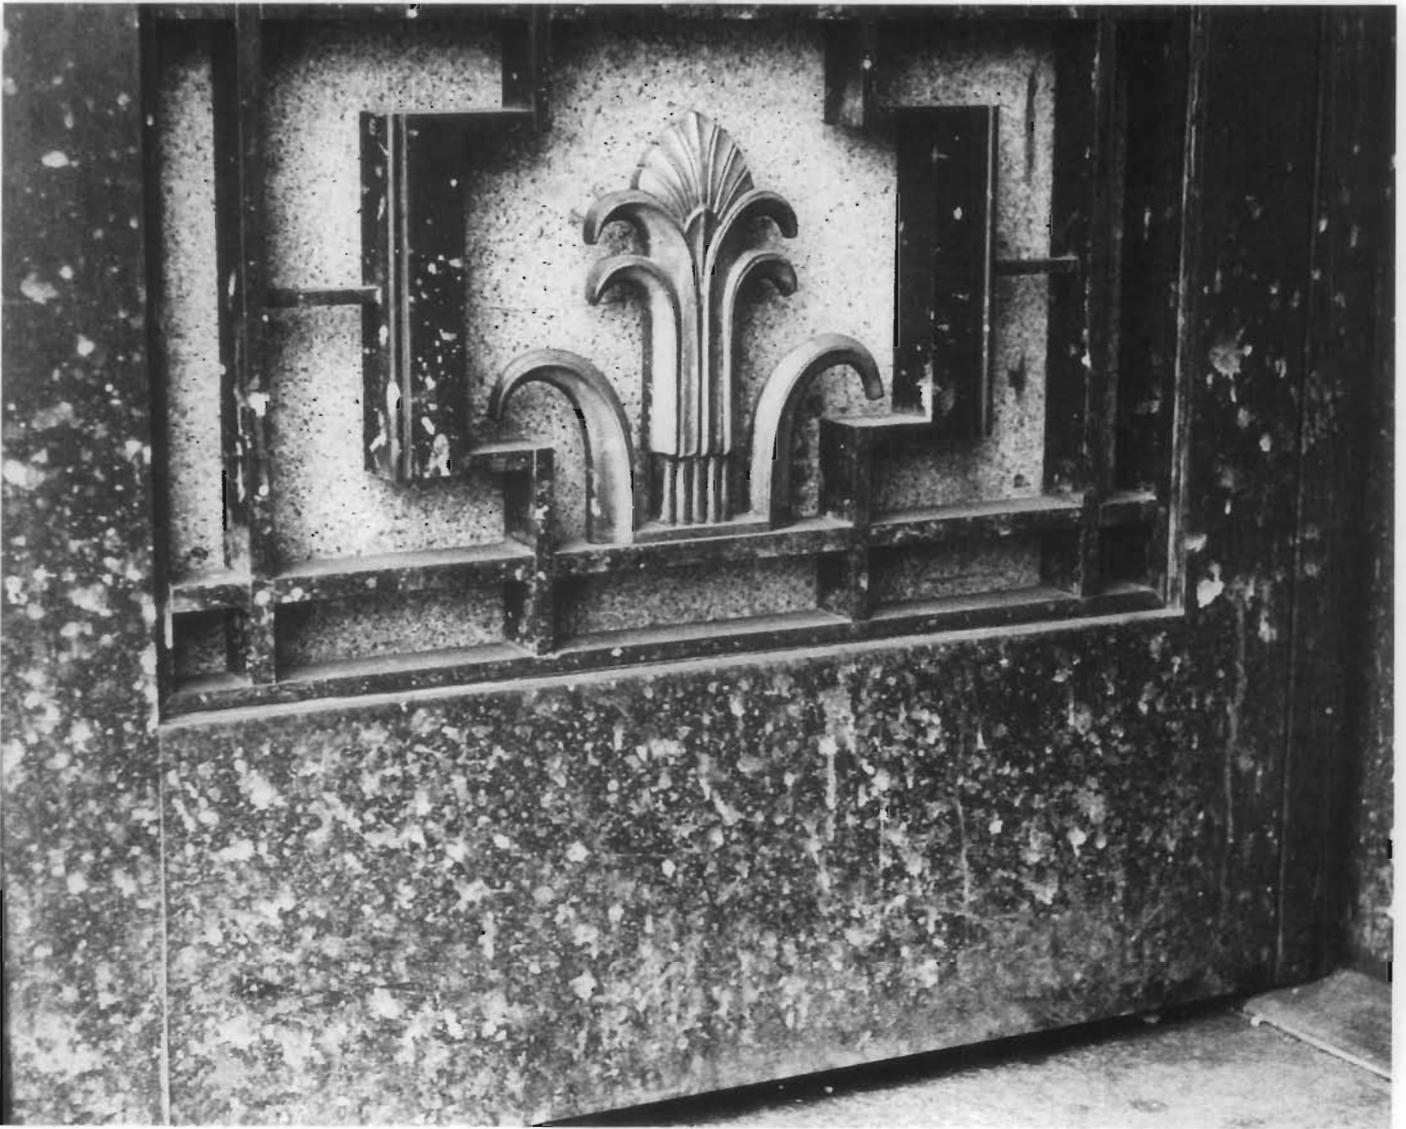
Figure 152. Snow Salt Damage. *On the Circuit Court of Appeals Building in Washington, D.C., the lower extremities of the exterior-bronze gates are discolored and unsightly from repeated splashing of snow-removal salt. As long as the salt remains on the gates, the bronze will continue to deteriorate and its surface may even become pitted. (David W. Look)*

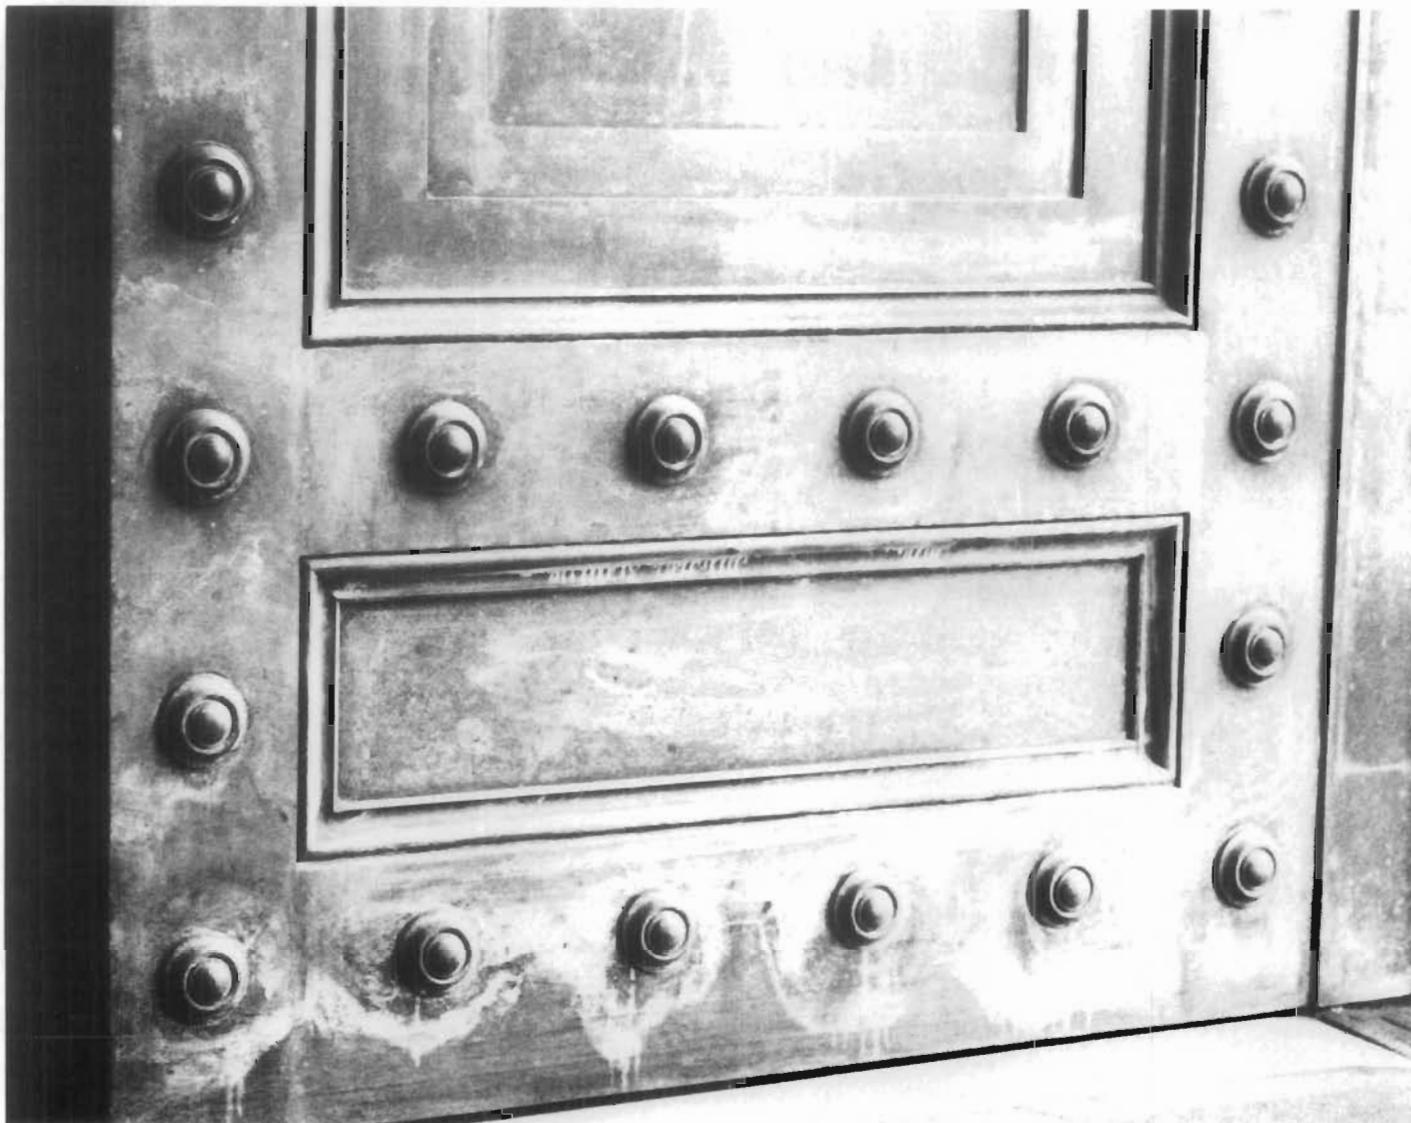
Figure 153. Improper Cleaning of Bronze. *The bronze doors on the Pennsylvania Avenue side of the National Archives in Washington, D.C., were cleaned improperly. They now vary in color from a golden bronze to green to copper orange and brassy yellow. Some of the original artificial patina applied at the foundry has been removed, leaving a blotchy appearance. Part of the corrosion from the deicing salt remains, and the doors have a streaked, unattractive appearance. At this point, the only feasible treatment would be to clean the doors thoroughly (down to the bright metal), by mild chemicals or soft abrasive cleaning. A new artificial patina could be applied to return the doors to their original appearance. To protect against future damage, the doors should be given a barrier coating of wax which will need to be renewed periodically. The maintenance staff should be notified not to use salt near the doors and not to clean or polish the doors other than washing them down once a year with a nonionic detergent. When washed, the doors should be thoroughly rinsed with distilled water and wiped dry with a clean cloth to prevent water spots and streaks. (David W. Look)*

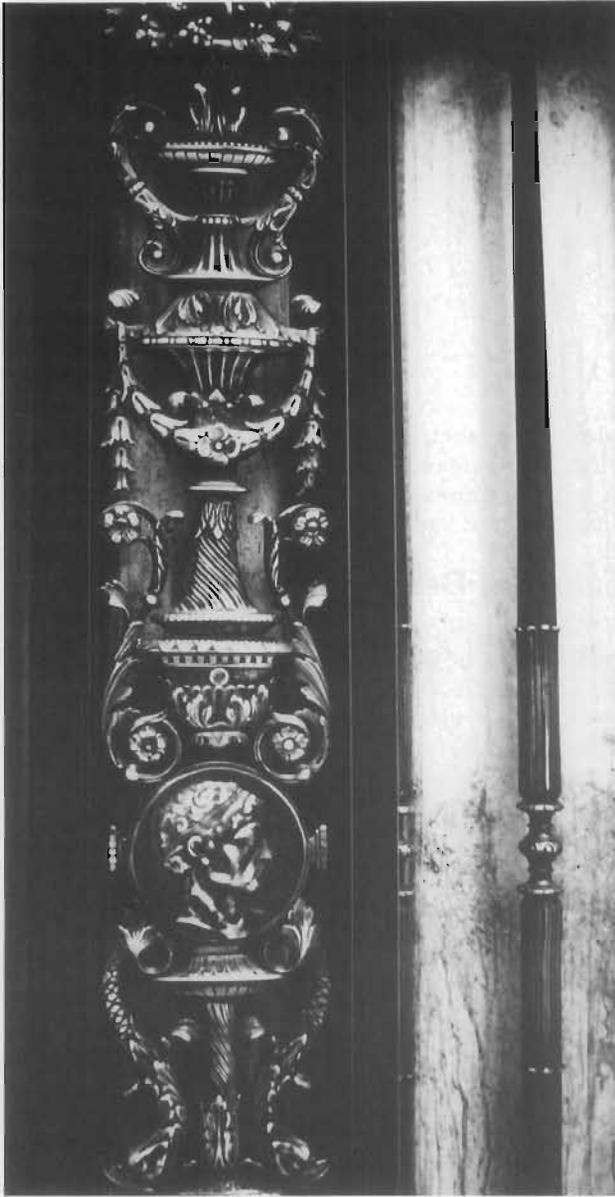
Figure 155. Cleaning Bronze. *Recently, the exterior bronzework was cleaned on the Morgan Guaranty Trust Company on the corner of Wall and Board streets in Manhattan. The original finish of the bronze was a statuary brown artificial patina (a chemical process developed in the 19th century) with the bas-relief sculpture highlighted in a lighter pinkish-gold color, probably just the natural color of bronze without artificial or natural patina. The bronzework was cleaned and sealed with a clear coating. Without a coating, a natural patina would form, causing slow color change from pinkish gold to brown to black and eventually to green over an 8-10 year period. The colors are usually uneven and streaked because of the local pattern of wind and rain. The formation of a natural patina would eventually destroy the contrast between the statuary brown and pinkish gold, which was the original intention of the architects, Trowbridge and Livingston, when the bank was built in 1913. (David W. Look)*
