ITS  
NUMBER 55

## Interpreting The Secretary of the Interior's Standards for Rehabilitation

**Subject:** Retaining Industrial Character in Historic Buildings

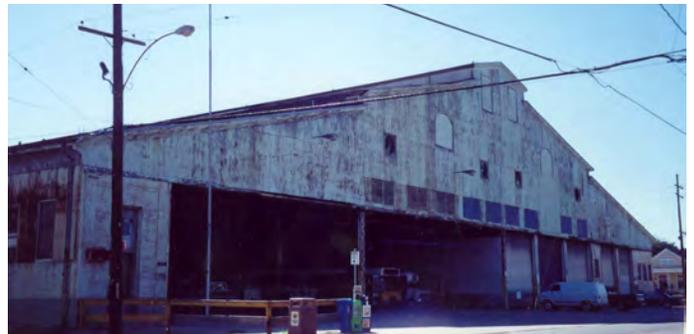
*Above: The historic bus barn before rehabilitation.*

**Application 1** (*Compatible treatment*): This historic car barn was built c. 1893, originally to house streetcars and remained in use until it was closed in the 1990s when a new facility was constructed. After years of disuse, it was proposed to be converted into a grocery store. The sheer size and volume of the interior proved to be a good match for the new use. The car barn was large enough that the grocery store itself could fit into the front half of the building, leaving the rear portion available for parking. The openness and immense height of the interior with its exposed metal structural system contributes to the market's appeal and is also ideal for the parking area which, after all, was the building's original use. New corrugated metal replaced the rusted historic metal sheathing on the exterior. The large historic vehicular openings on the back allow access to the parking and also provide ventilation. The vehicular doors on the front were infilled with a butt glass storefront system to retain the open appearance the building had historically. This project meets the Standards.

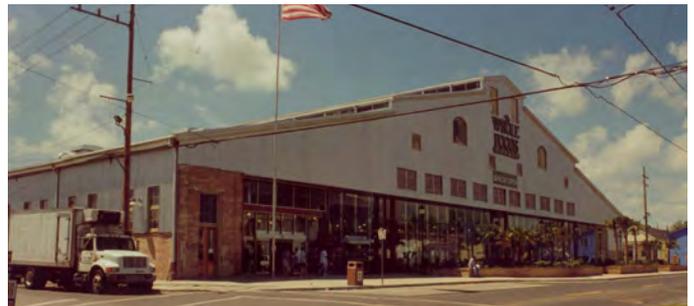
*Below: The historic bus barn after conversion to a grocery store. A butt glazed storefront was installed in the former garage bays to retain the sense of openness.*

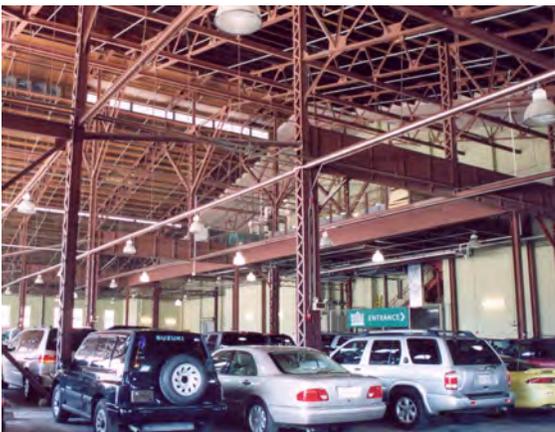
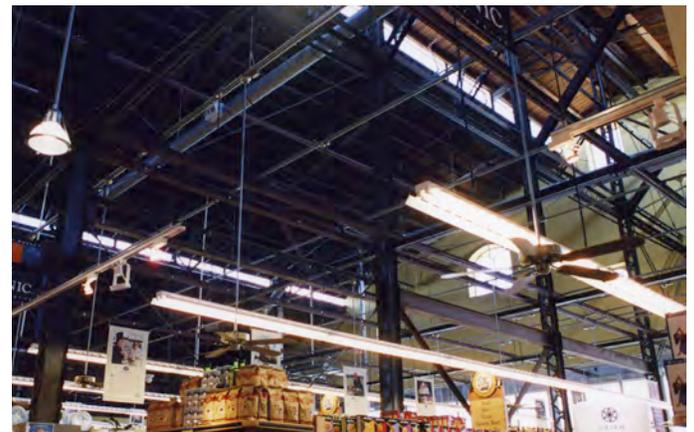
*Left and Right: The exposed trusses on the interior, both in the parking area and in the grocery store, emphasize the structure's industrial character.*

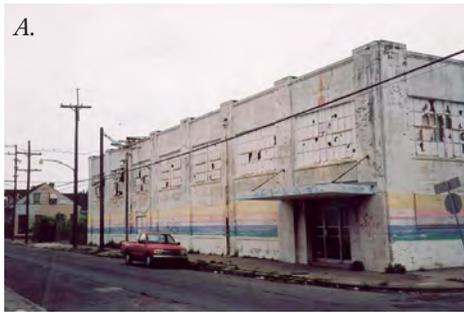
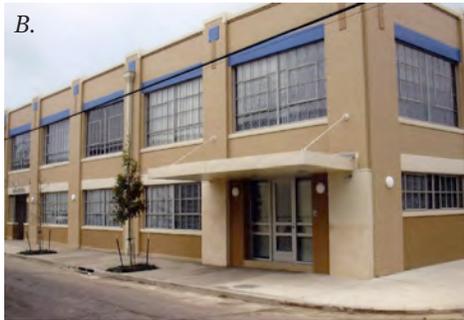
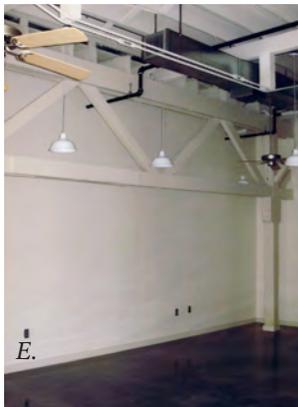
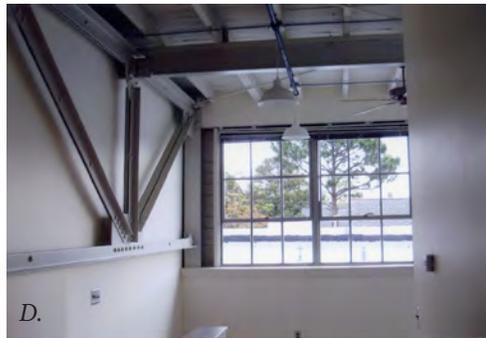
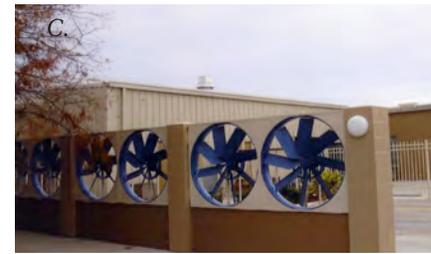
*Clockwise from top:*  
 A. The early-twentieth century garment factory before rehabilitation.  
 B. After rehabilitation, historic windows shine again after repair and paint removal. New windows have been installed in bricked-up openings and new matching windows have replaced historic windows too deteriorated to repair.  
 C. Old fans have been reused decoratively as part of a fence around the parking lot.  
 D & E. Accented by new industrial lighting fixtures, the historic character of the interior is clearly expressed in the exposed wood and steel beams and trusses, as well as in the original concrete floor.

**Application 2 (Compatible treatment):** This small brick garment factory was constructed c. 1930 with later expansions. After being vacant for many years the building was rehabilitated as low-to-moderate income residential units. The character-defining industrial metal windows were retained where possible, while those that were deteriorated beyond repair were replaced to match the existing. Bricked-up windows were reopened and matching windows were installed. The simple metal canopy over the entrance in the front was retained and the deteriorated corrugated metal siding on one elevation was replaced to match. The industrial nature of the building is also clearly evidenced on the interior in the exposed wood ceiling and metal trusses. Even the large fans that cooled the sewing area of the factory were incorporated as decorative elements in a fence at the rear of the building. This project has preserved the industrial character of the structure and meets the Standards.

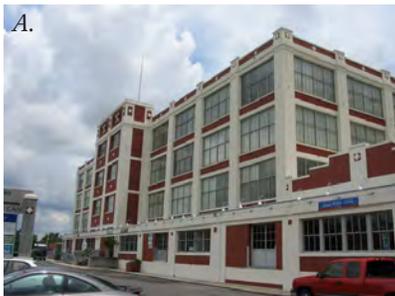
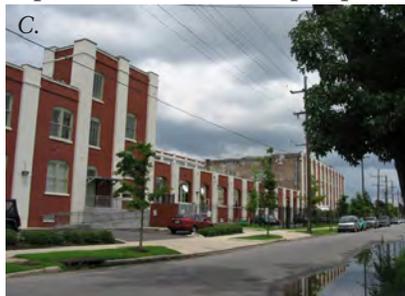
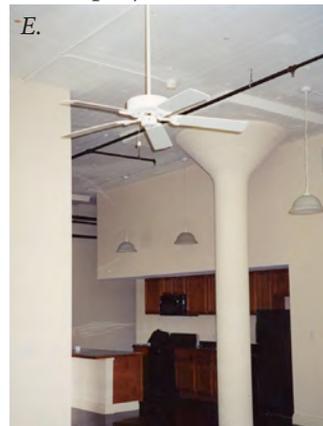
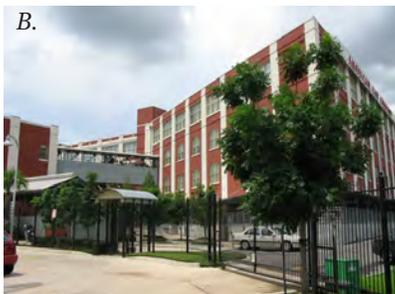
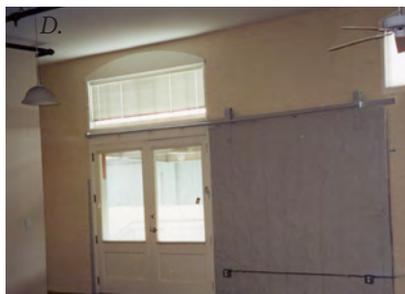
*Clockwise from left:*  
 A. After rehabilitation, this section of the factory complex includes a restaurant and shops on the first floor with apartments on the upper floors. Partially-glazed infill in the loading door openings is compatible with the character of the building. B & C. The historic industrial bridge was retained, as were the ruins of walls that remained after a fire. D & E. The industrial nature of the interior is evident in the mushroom-capped cast concrete columns and the fire doors that remain in several of the buildings.

**Application 3 (Compatible treatment):** A group of early-twentieth century factory buildings, the oldest of which dates to c. 1908, was rehabilitated into a multi-use residential, retail and commercial complex. As part of the rehabilitation, the existing windows--both wood and metal--were retained and repaired or, where necessary, replaced to match. Compatible, partially-glazed infill was installed in many of the loading dock openings on the first floor. An existing corrugated metal industrial bridge connecting two buildings was retained and the ruined walls of a fire-damaged structure were also retained as part of the complex. On the interior, mushroom-capped columns and the unfinished cast concrete ceiling were left exposed throughout. Historic metal fire doors were also kept and secured in an open position. This project, too, meets the Standards.
