Burned Area Emergency Response Plan

El Portal Fire

Yosemite National Park, California

OCTOBER 2014

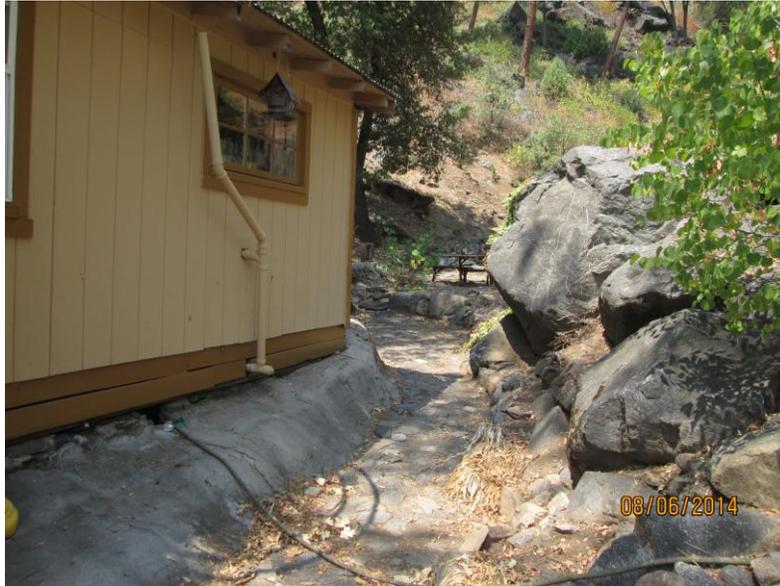
Photo 1- House #1 at 5674 Forest Road. House is located in flood plain of channel and has constricted the cross-sectional area of the channel. This house has slopes above with moderate debris flow hazard and the potential for 1000-10,000 yds³ of debris flow material to pass through this narrow channel. There is a very high risk to life and property at this site.

For the Foresta Road residence, one firm recommended clean-out of the existing debris basin and constructing a more substantial deflection barrier above the home. It noted, however, that while these treatments *might* be adequate for low magnitude debris flows, flooding and mudflows triggered by higher probability precipitation events (e.g., 2-year storms), the potential hazards caused by larger, lower probability storms (10- and 50-year) could only be mitigated with engineered solutions far exceeding the parameters of BAER. As such, the firm declined to design. The other firm recommended clean-out of the existing debris basin, hillslope treatments and rockfall fences in the drainage above the home. It agreed to design the hillslope treatments and rock fences.

As noted, the debris basin clean-out above the Foresta Road residence was completed and will be performed as needed. NPS subject-matter experts (Geologists, Hydrologists) were consulted regarding hillslope treatments and rockfall fences. The proposed hillslope treatment method—straw wattles—has been minimally effective similar landscapes (very steep and rocky slopes), and alternative methods (e.g., mulches) do not fare much better (Napper, 2006). This was also noted in the El Portal Fire Soils Assessment Report (p. 5, Appendix A). The rock fencing treatment recommendation was rejected on the basis of several considerations:

- To mitigate large debris flows, the most effective locations to place fences would be above the gabion dam. This area offers no ready vehicular access, and material transport and fence construction would result in a high risk working environment.
- That portion of the watershed below the gabion dam is unlikely to produce debris flows of a magnitude that would warrant the installation of rockfall fences.
- Rockfall fences, especially those engineered for substantial debris flows, are expensive. Despite this expense, however, such fences are not guaranteed to prevent structural damage or total structure loss.
- The preexisting risk associated with the Foresta Road residence being located directly in the active channel of the fire-affected watershed.

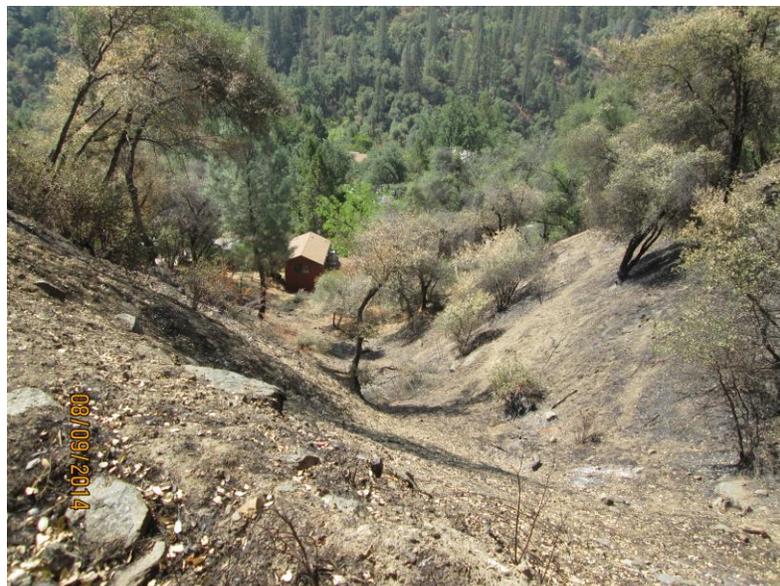
Photo 2 - House #2 at 9722 Buckeye Road. House is located below channel with slopes that have a with moderate debris flow hazard and the potential for 1000-10,000 yds³ of debris flow material to pass through this narrow channel. There is a very high risk to life and property at this site.

At the Buckeye Road residence, one of the firms recommended a gabion dam and deflection barrier above the structure to account for low magnitude debris flows, flooding and mudflows. As with the Foresta Road residence, this firm felt that the Buckeye Road home could not be adequately protected from higher magnitude events with the limitations imposed by BAER. The other firm also recommended a gabion dam and deflection barrier, as well as piped drainage network for runoff, hillslope mulching, and rockfall fencing. It agreed to design these

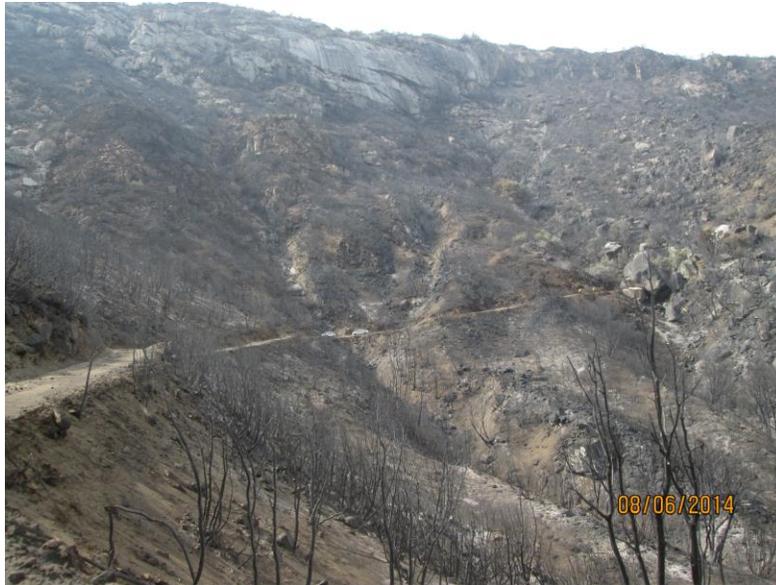
Photo 3 - Foresta Road (FR2S84) This road has high and moderate debris flow and rock fall hazard. People driving this road could get trapped behind rock fall and are at risk from getting hit by a rock.

- *Install gates.* On Foresta Road, close the existing gate at the NPS/Stanslaus National Forest boundary, install a new gate south of Foresta, and replace the burned gate at the entrance to McCauley Ranch. Install a gate just north of the Fly Spur Ranch access road on Old Coulterville Road. This treatment will be completed in October-November 2014.

- *Install warning signs.* Install burned area warning signs and replace fire-damaged signs at the northern and southern ends of the Foresta Road closure. This was completed in September, 2014. In addition, interpretive type warning signs will be designed and installed in November, 2014 to warn of Foresta and Old Coulterville/Davis Cutoff Road hazards.

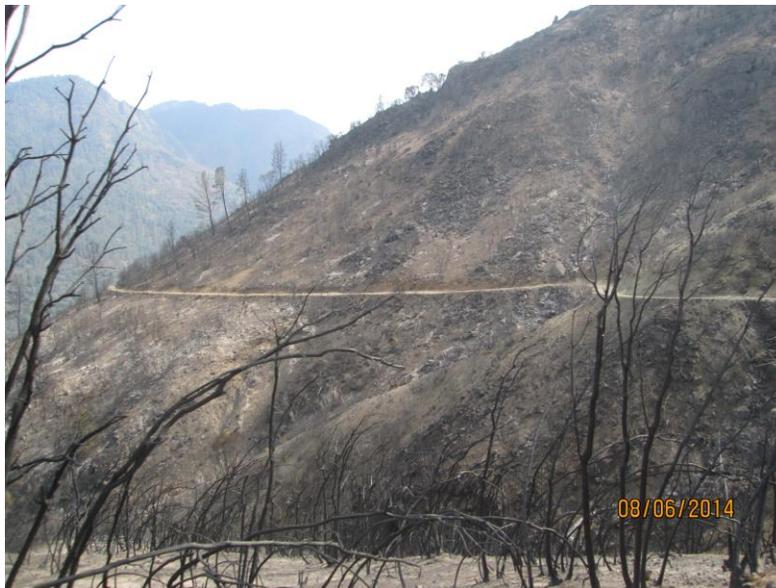
Photo 4 - Foresta Road (FR2S84) This section of road has a moderate rock fall hazard. People driving this road could get trapped behind rock fall and are at risk from getting hit by a rock.

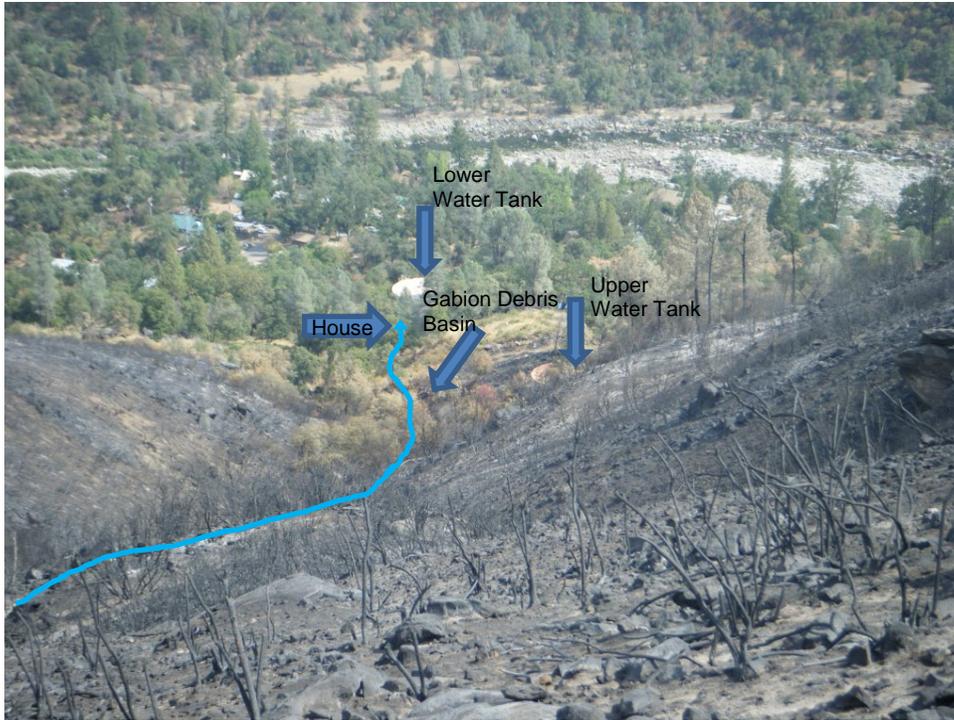
Figure 2: Looking down into water tank drainage from Foresta Road

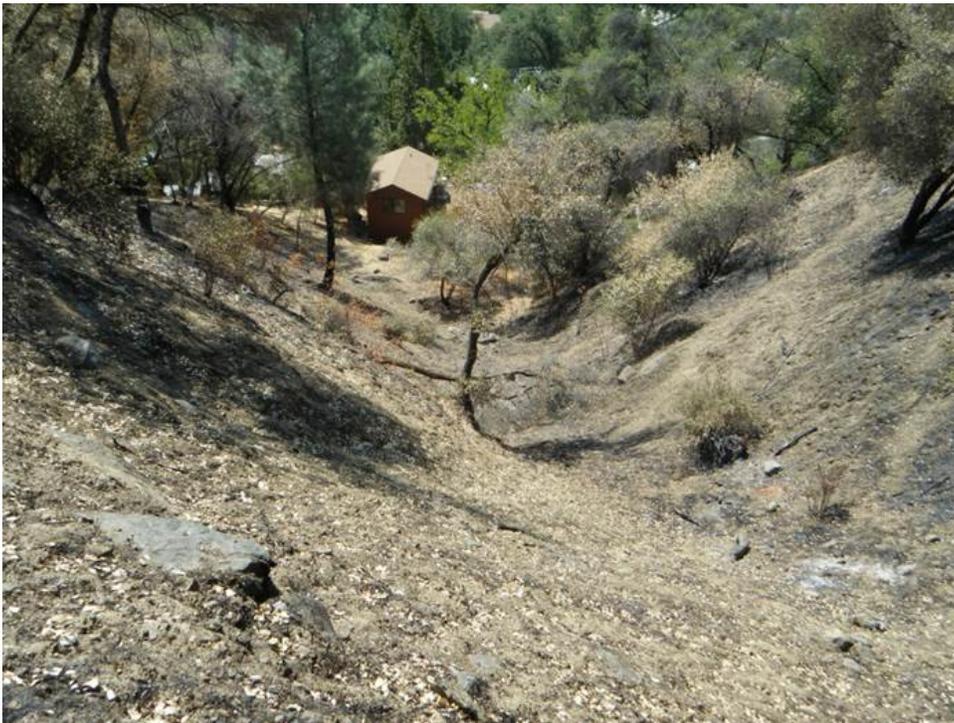
Figure 3: Looking down into Buckeye Road drainage from Foresta Road

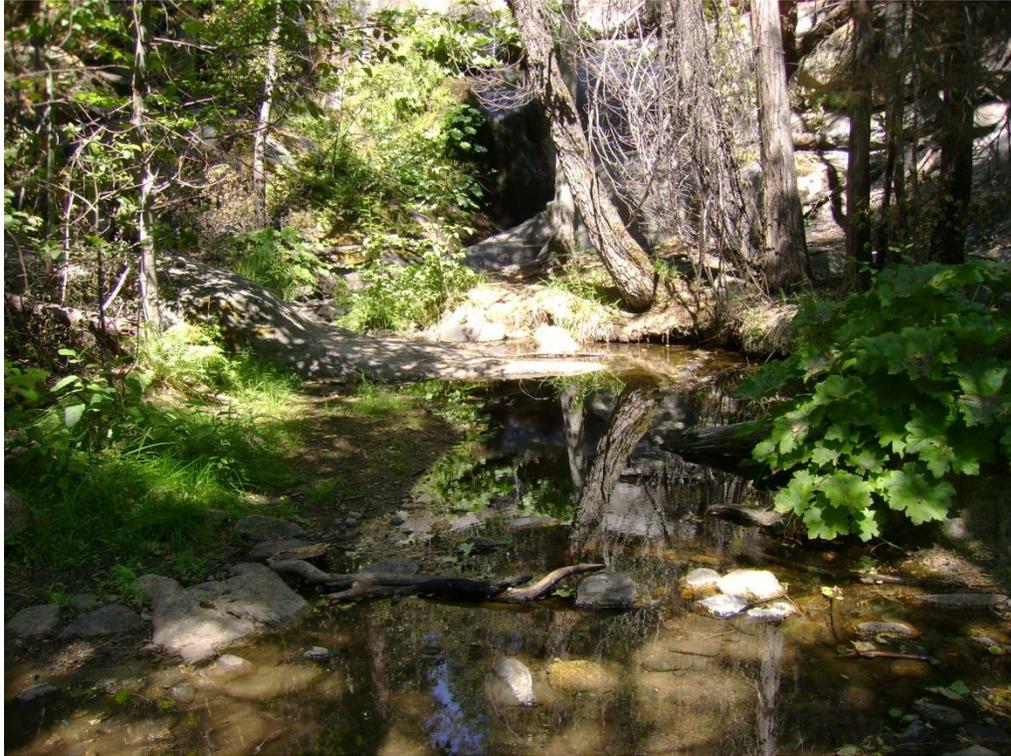
Moderate effects to aquatics habitat within Little Crane Flat Creek above 2S84.

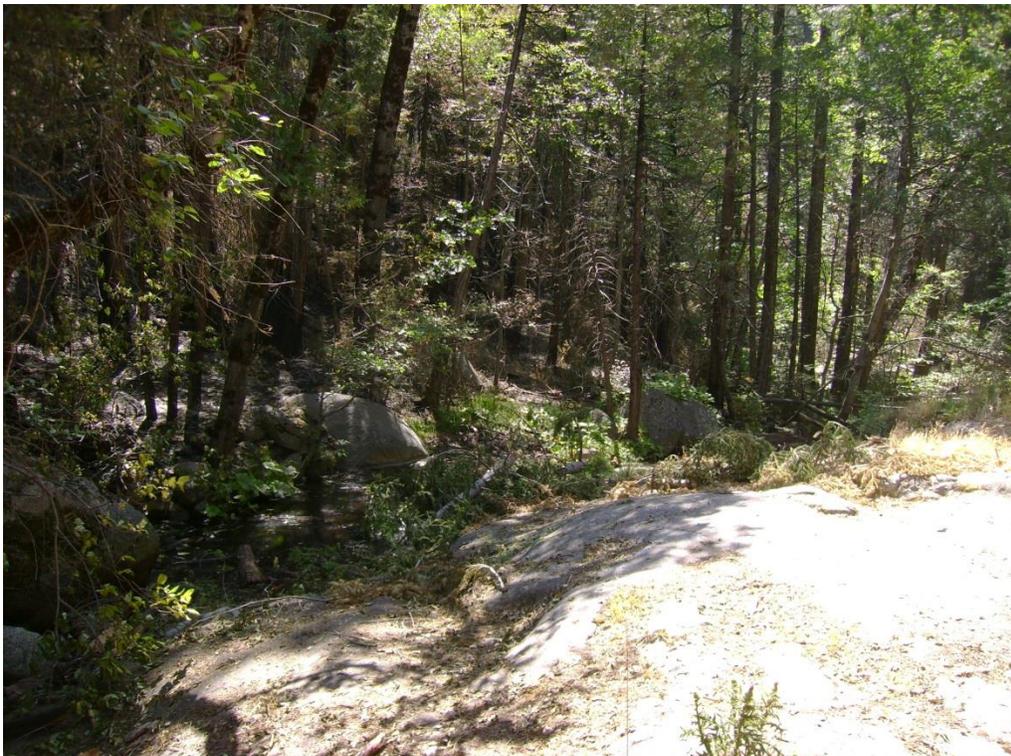
Moderate effects to aquatics habitat in Little Crane Flat Creek below 2S84.
