# SPRINGDALE STREETSCAPES AND MULTI-MODAL CONNECTIVITY ANALYSIS AND RECOMMENDATIONS

## Section Overview

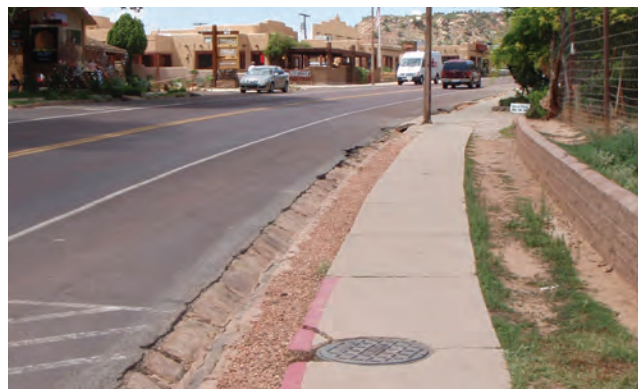
- Sidewalks are worn and deteriorating in some places. Signs of deterioration include spalling and erosion of edges/corners.
- In many instances, sidewalks that cross driveways are not up to Americans with Disabilities Act (ADA) guidelines.
- Where sidewalks cross gravel driveways or are adjacent to gravel surfaced parking areas, gravel is spilling over onto sidewalk surface in some locations.
- See sidewalk gap details in Table 4-1.

**Sidewalk cracking at manhole cover**

- Repair and/or replace all sidewalks that are worn and unsafe.
- Repair and/or replace sidewalks at driveway entrances to meet ADA standards.
- Add sidewalk in areas where it is missing

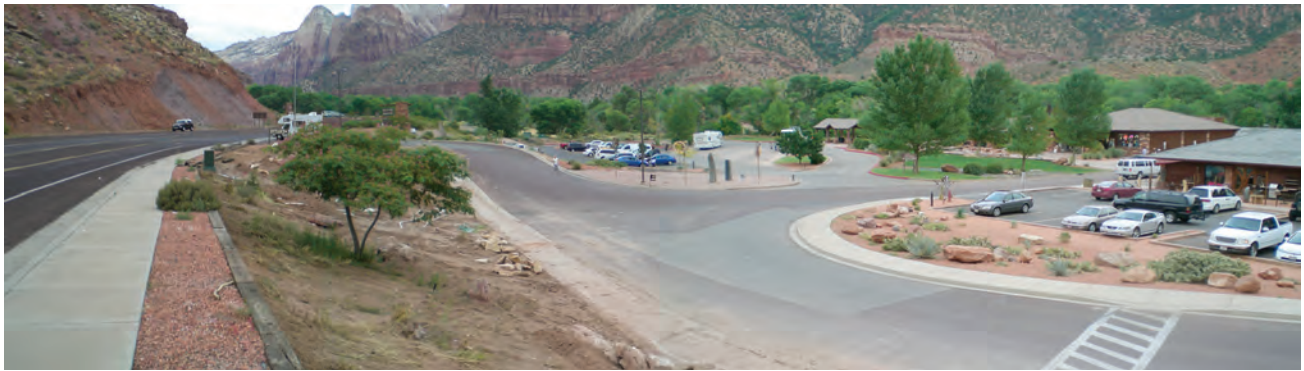
*The view of the park pedestrian entrance and shuttle stop from Zion Park Boulevard. (Topographic conditions are steeper than this photo depicts.)*

- There are circulation and accessibility challenges at the Zion Canyon Giant Screen Theater driveway entrances, shuttle stop, and pedestrian entrance to the park. It is difficult to spot the pedestrian entrance from Zion Park Boulevard as well as when disembarking the shuttle.

- Create a clear, designated pedestrian connection (sidewalk or markings in pavement) between Zion Park Boulevard and the pedestrian park entrance.
- Further study of the pedestrian circulation between the Zion Canyon Giant Screen Theater shuttle stop and visitor center is recommended. Improvements could include reconfiguration of the space, a hierarchical network of wayfinding signs, and/or a pattern in the sidewalk to clearly direct visitors to the park entrance.

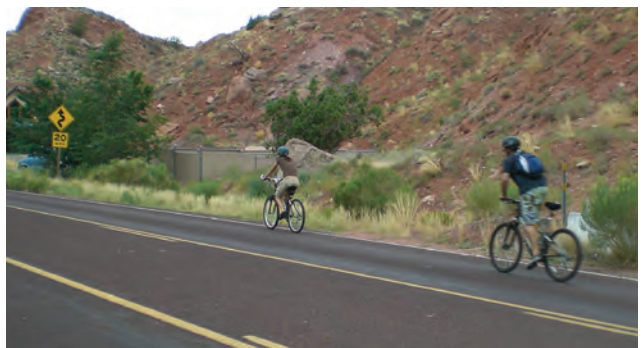
*Bicyclists riding in the travel lane at the landslide area*

- Southbound, between the park vehicular entrance gate and the Cliffrose flag stop, there is no shoulder. The roadway has become pinched by a landslide area, forcing bicycles to travel in the vehicle travel lane.

- Designate a bicycle lane in the road or place shared use bicycle symbol (sharrow) in the roadway especially at constricted areas. Sharrows indicate that motorists should expect to see and share the lane with bicycles. Unlike bicycle lanes, sharrows do not designate a particular part of the roadway for the use of bicyclists, but rather that the roadway is to be shared.
- Implement the proposed Zion Canyon Trail (begins in Rockville and continues to park) and create connections between Springdale shuttle stops and the multi-use trail.

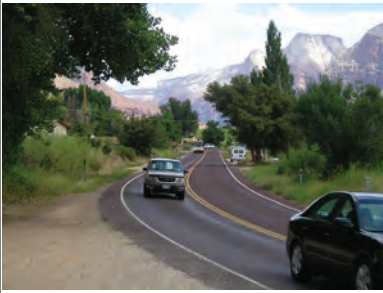
Direction		Gap Location	Photo	Gap Description
NB	SB			
•	•	Springdale Fruit Company to the LDS Church and Driftwood Lodge

The typical road condition in this segment has asphalt/gravel shoulders on both NB and SB lanes. Springdale is in the process of constructing the first phase of the Zion Canyon Trail. The first section will start in the dirt pull-out south of Majestic View Lodge and continue to Silver Bear. The trail will be on the NB side of the road.

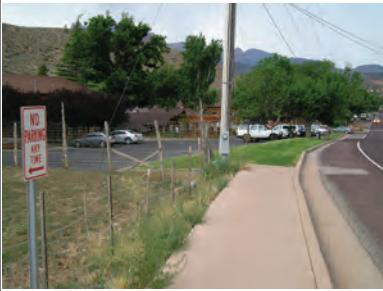
•		Driftwood Lodge

There is no sidewalk between the Driftwood Lodge shuttle stop and the northern property line of the Driftwood Lodge. It is currently lawn.

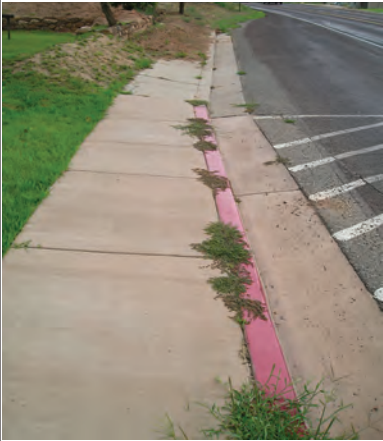
•	Quality Inn to the Bit & Spur Shuttle Stop

The sidewalk ends just north of the Quality Inn. It becomes an asphalt/gravel shoulder.

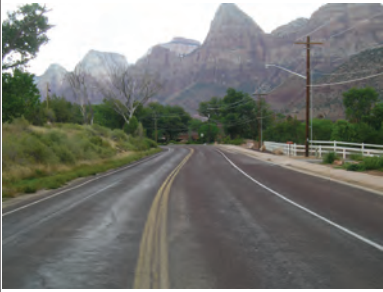
The typical road condition between Driftwood Lodge and Zion Park Inn is an asphalt/gravel shoulder on the NB side and a concrete sidewalk on the SB lane.

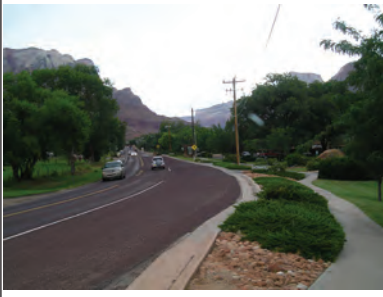
Direction		Gap Location	Photo	Gap Description
NB	SB			
•	•	Zion Park Inn Driveway

Along the Zion Park Inn frontage, the sidewalk ends at the northern driveway. A regular sidewalk adjacent to the road continues NB from here.

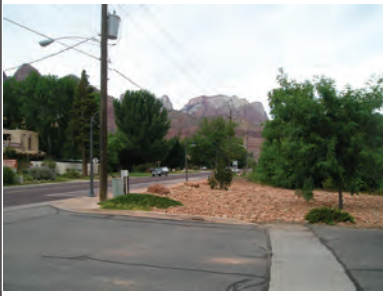
The sidewalk ends in a planting bed at the Zion Park Inn northern driveway.

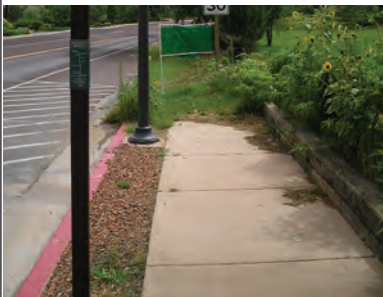
The SB side sidewalk ends at the Bit and Spur shuttle stop and becomes grass.
	•	Shell Station Driveway

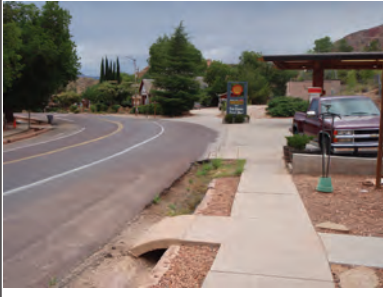
The driveway is concrete, with no sidewalk, and is spalling heavily.
•		Zion Park Motel Driveway to the Springdale Candy Company/Simply Birkenstock Storefront

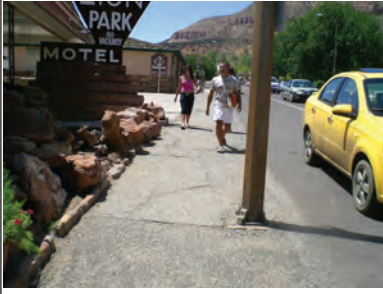
The material in this area is asphalt, with no adjacent sidewalk, and is exhibiting many cracks and buckles.

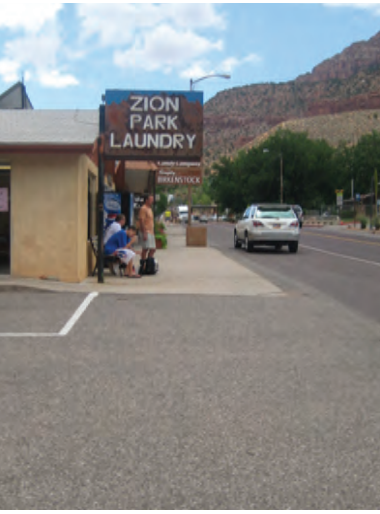
Direction		Gap Location	Photo	Gap Description
NB	SB			
•		Zion Park Laundry to the Indian Village Gift Shops

Asphalt surface with no sidewalk adjacent to Zion Park Laundry
	•	Big Chief Frontage

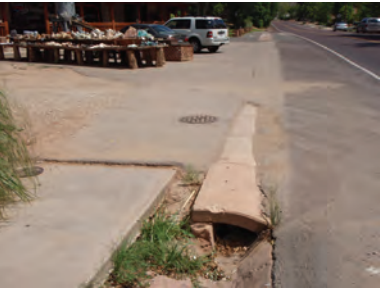
Asphalt surface with no sidewalk at Big Chief
	•	Canyon Ranch Frontage

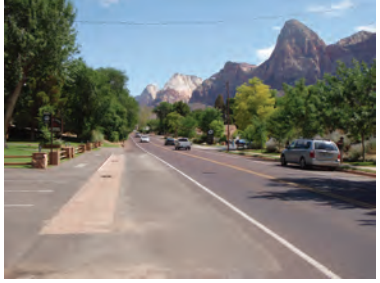
There is no sidewalk at Canyon Ranch. There is a shuttle stop near the driveway with asphalt surfacing. A concrete strip covers utilities at the shuttle stop. The town plans to install a sidewalk in the future on the Canyon Ranch side of the road.
	•	Canyon Ranch Motel to the North Side of Lion Boulevard

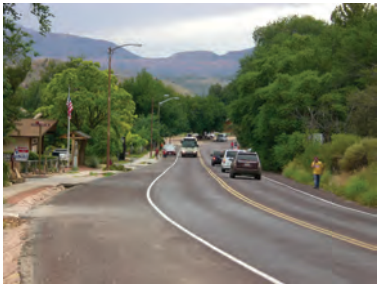
The SB lane is an asphalt/gravel shoulder and the NB lane has a continuous concrete sidewalk. Many pedestrians opt to use the SB shoulder instead of crossing the street to the sidewalk.

along Zion Park Boulevard. As previously mentioned, the town is proceeding to build sidewalks as funding allows. The southbound lane of Zion Park Boulevard north of Canyon Ranch is a high priority area as pedestrians are currently using the shoulder in this area.

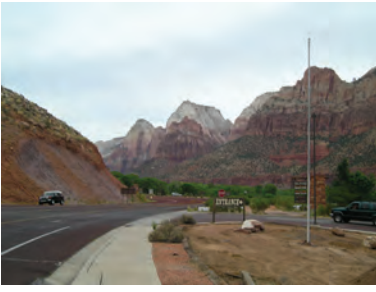
Direction		Gap Location	Photo	Gap Description
NB	SB			
•		Zion Canyon Giant Screen Theater to the Park Entrance.

The sidewalk ends just beyond the northern driveway to the Zion Canyon Giant Screen Theater.

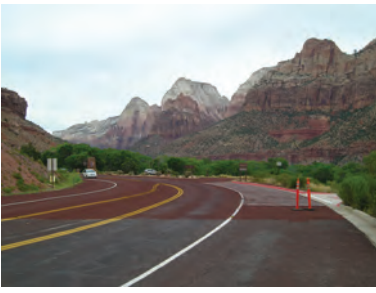
The road north of the Zion Canyon Giant Screen Theater leading to the park entrance has wide asphalt shoulders for parking.
		South Side of Lion Boulevard

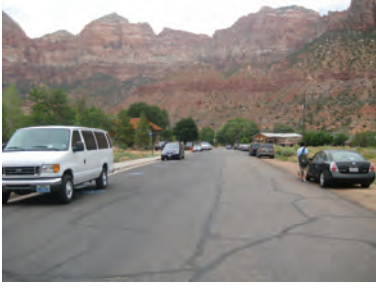
Lion Boulevard has concrete sidewalks on the northern side of the road, but only wide dirt shoulders for parallel parking on the southern side.

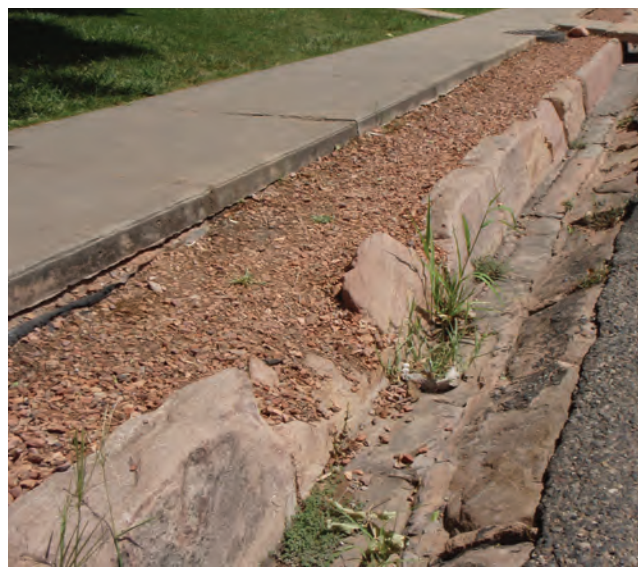
**Rock ditch in disrepair between the elk ranch and Pioneer Lodge**

- The existing historic stone curb and gutter is in disrepair in several locations.
- Some utility boxes and conduits are in need of repair.
- Debris is building up in the curb and gutter/ditch at some locations.

- Repair the historic stone curb and gutter where it is cracking, eroding, or falling apart.
- Keep the gutter clear of debris along the entire corridor.
- Repair utility boxes and conduits where needed.

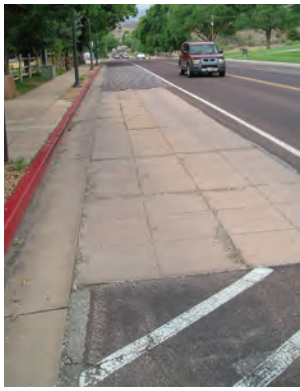
**Concrete shuttle pad at Driftwood Lodge**

Concrete shuttle pads are chipping and spalling in places, maintenance is recommended; restripe "no parking" zones

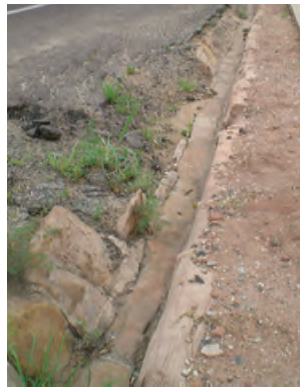
**Eroding gutter at Terrace Brook Lodge**

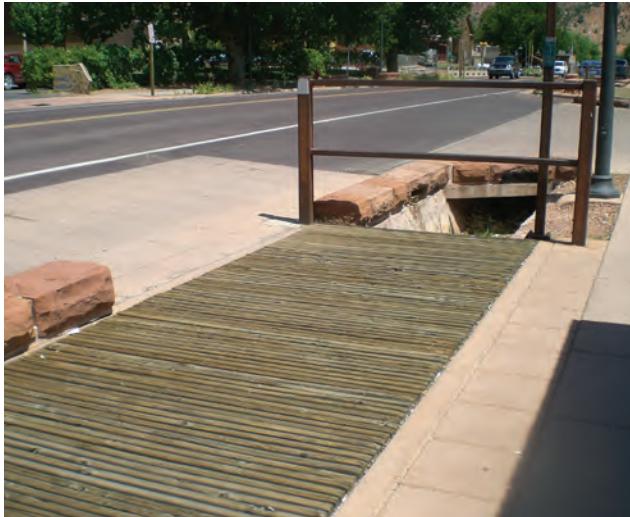
**Wood slat platform at Bumbleberry/Zion's Bank shuttle stop platform**

- The Bumbleberry/Zions Bank shuttle stop has a platform made of wood slats (2x4s on end). These slats have large gaps in between them that are difficult to pass over for wheelchair or stroller users. Multiple concerns and problems have been raised about this shuttle stop, in addition to the wood slat surface. The metal railing on either end of the wood slat decking provides some protection from the ditch drop down on either side, but it does not meet typical standards. Shuttle operators have reported that it is a difficult location to pull in and out of due to the proximity of nearby driveways for the bank drive through. These conditions also make pedestrian access to and from this stop more challenging. The location is surrounded by activity and businesses signs, and as such, the shuttle stop is not as highly visible or “legible” as some of the other locations.

- Reorienting the wooden slats to run horizontally at the Bumbleberry/Zions Bank shuttle stop is recommended, or potentially moving this stop. Improvements

should be made here to the surfacing and railing. As an alternative, this stop could be relocated and rebuilt at a nearby location. There is an open area adjacent to the street in front of the Zion Park Motel, and the owners there have indicated a willingness to consider moving the stop to that location. To construct the stop here, parking places (which appear to be little used) in front of the motel and pool area would need to be removed. This could be a better location for the shuttle stop because it aligns more directly across from the southbound stop and it is located in place with less vehicular conflict/driveway activity.

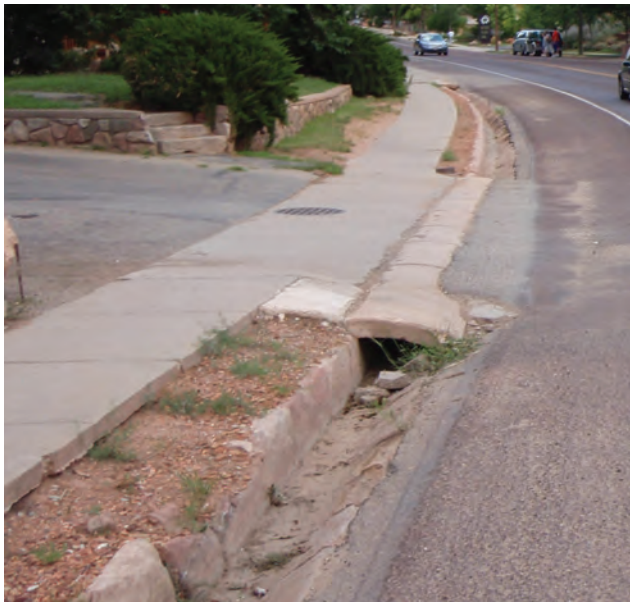
**Debris in gutter and deterioration of the rock ditch wall at the elk ranch**

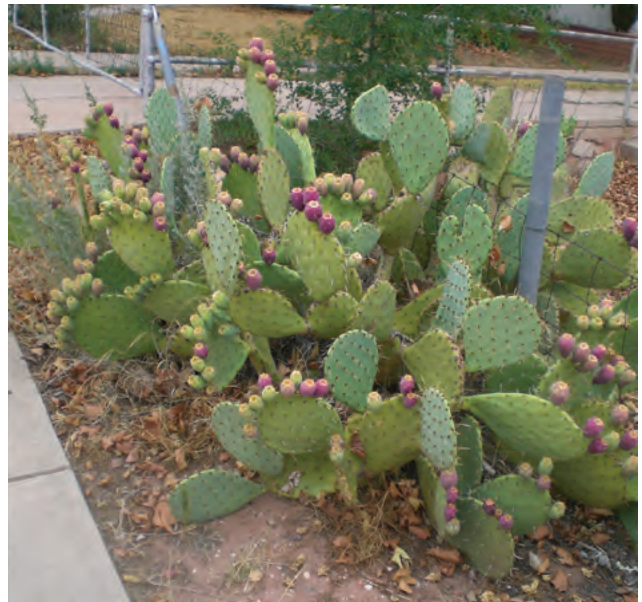
**Prickly pear along the sidewalk, heading north towards Lion Boulevard**

- There are many plants along the sidewalk that have thorns or sharp spines. These plants are not pedestrian friendly.
- The red rock mulch in the planting beds has shifted in many areas, exposing the black geotextile fabric beneath.
- The landscape areas in the vicinity of the Giant Screen Theater need improvement. The planting beds are mostly exposed soil.
- Lion Boulevard and Zion Park Boulevard are in need of vegetation maintenance.

- Replace thorny and spiny plants with other plants.
- Use native and low maintenance plants. The landscape should extend the park environment into Springdale.
- Replace and add red rock mulch where it is missing.
- Keep planting beds free of weeds.
- Consider engaging the community in a clean up and vegetation maintenance program.
- Improve the landscaping in the planting beds at the Giant Screen Theater area.
- Plant shade trees where space allows, without blocking important scenic vistas, and continue to enhance the pedestrian environment along Zion Park Boulevard (working closely with adjacent property owners) to encourage walkability and pedestrian activity.

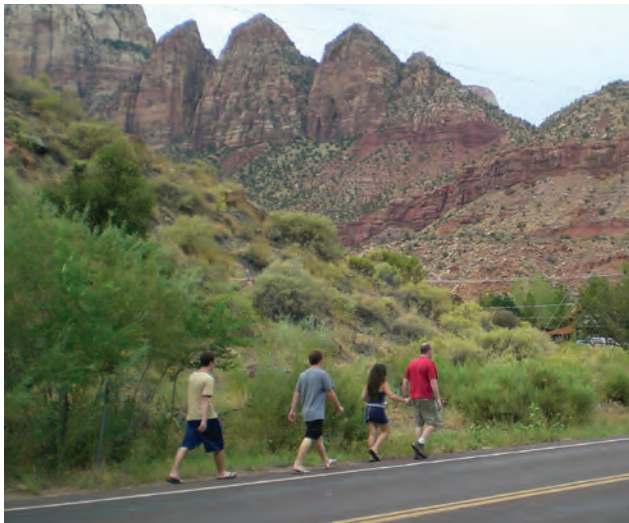
*People walking on road shoulder, just south of Lion Boulevard*

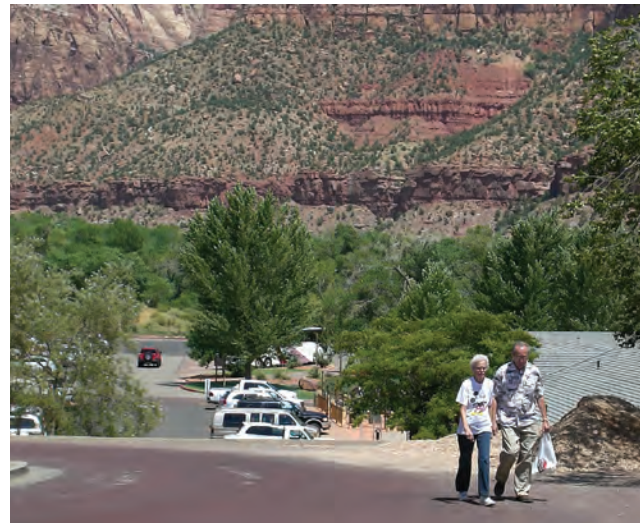
*Pedestrians on driveway to pedestrian park entrance; notice how they are walking on the side of the road with no sidewalk because this is less steep*

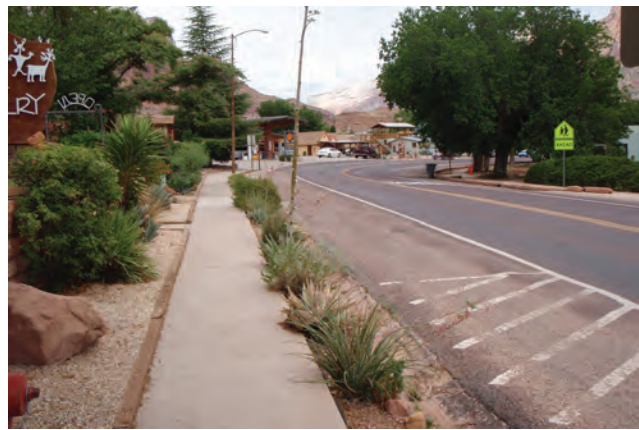
*Spiky plants in planting bed near Red Rock Jewelry*
