Seacoast Fortifications Preservation Manual

Golden Gate National Recreation Area
San Francisco, California

July 1999

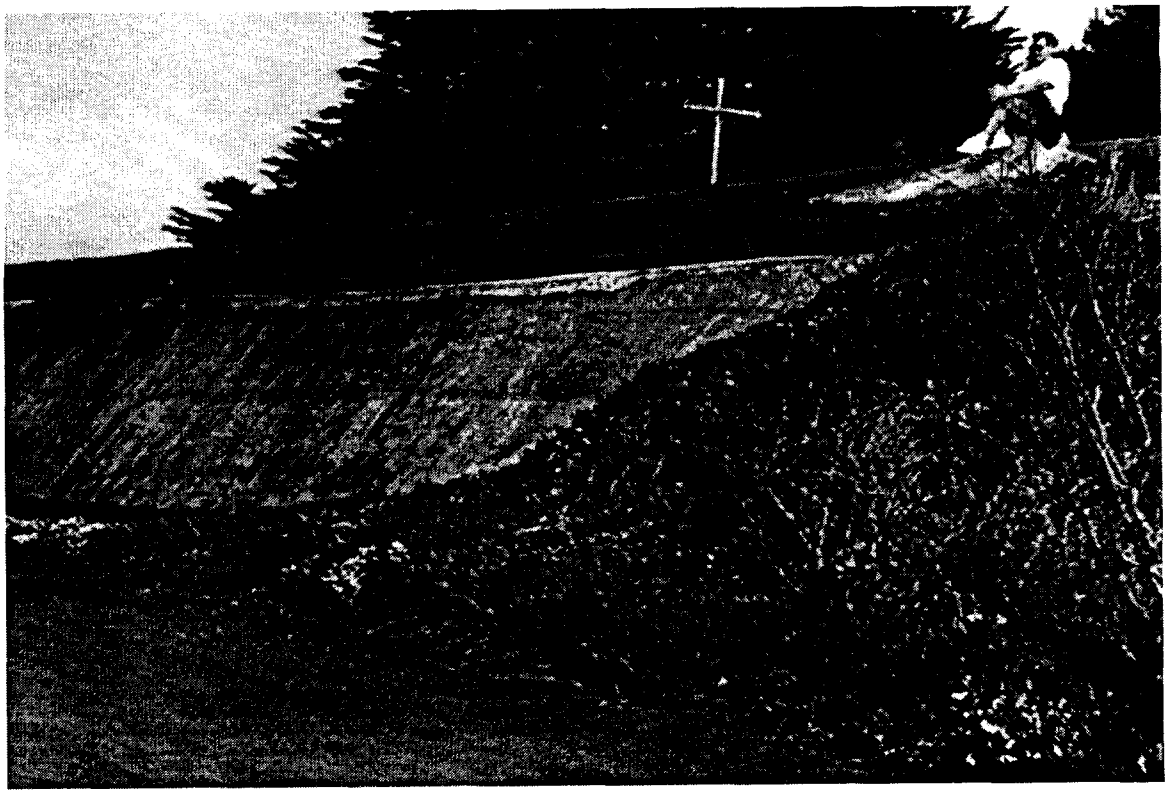
Plate 12. Earth was a critically important component of fortification construction: its loss can distort the intended appearance of a structure. Battery Godfrey.

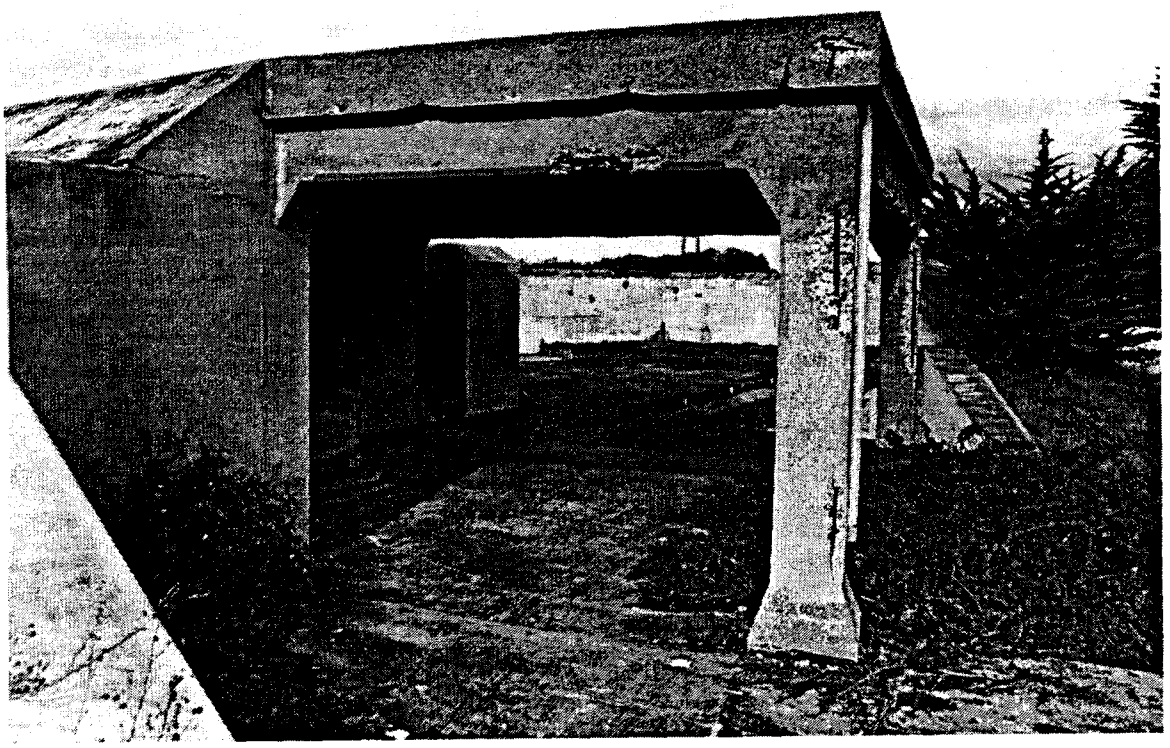
Plate 47. Concrete spalling is evident in the splinterproof at Battery Crosby, Fort Winfield Scott, constructed 1899-1900. Splinterproof added between 1904 and 1912.

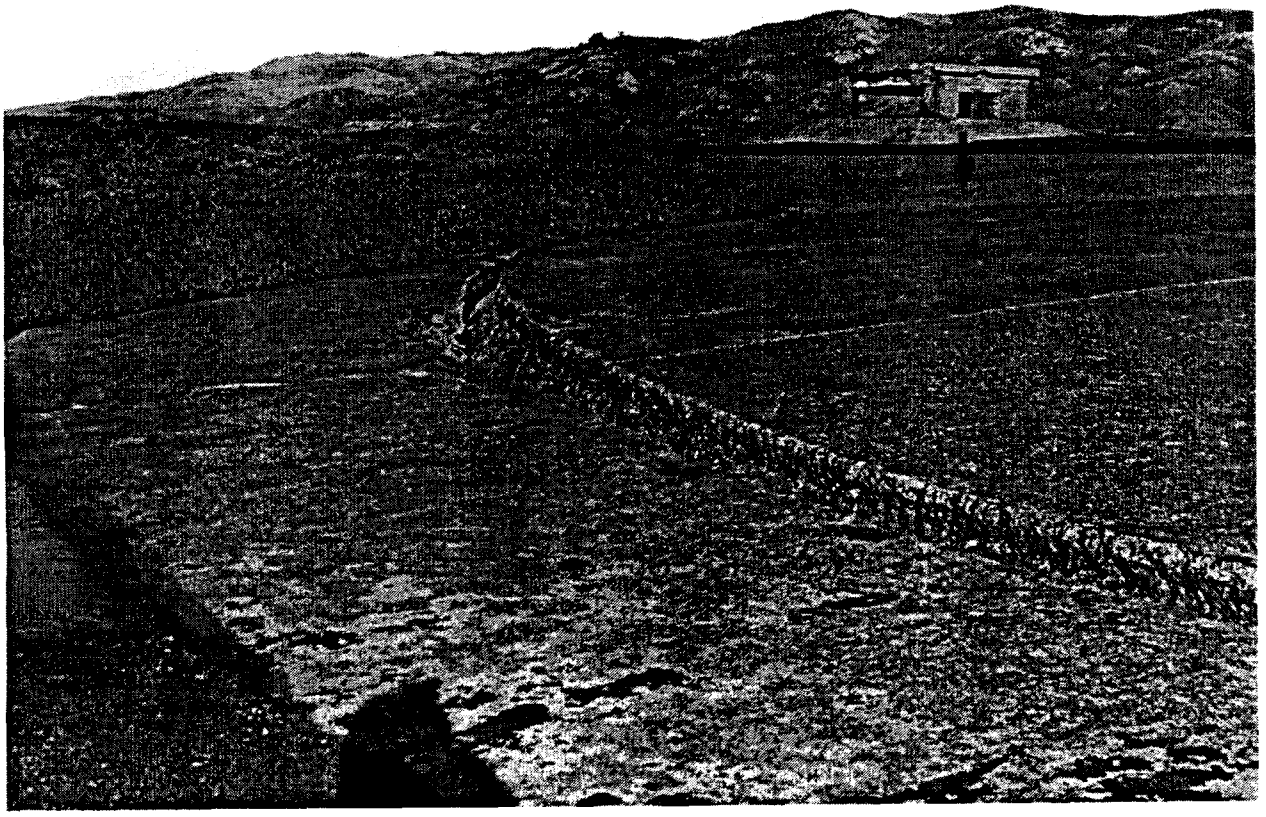
Plate 49. Battery Mendell. Looking North to BC station from front of emplacement two, showing separation and subsidence of blast apron from concrete mass.

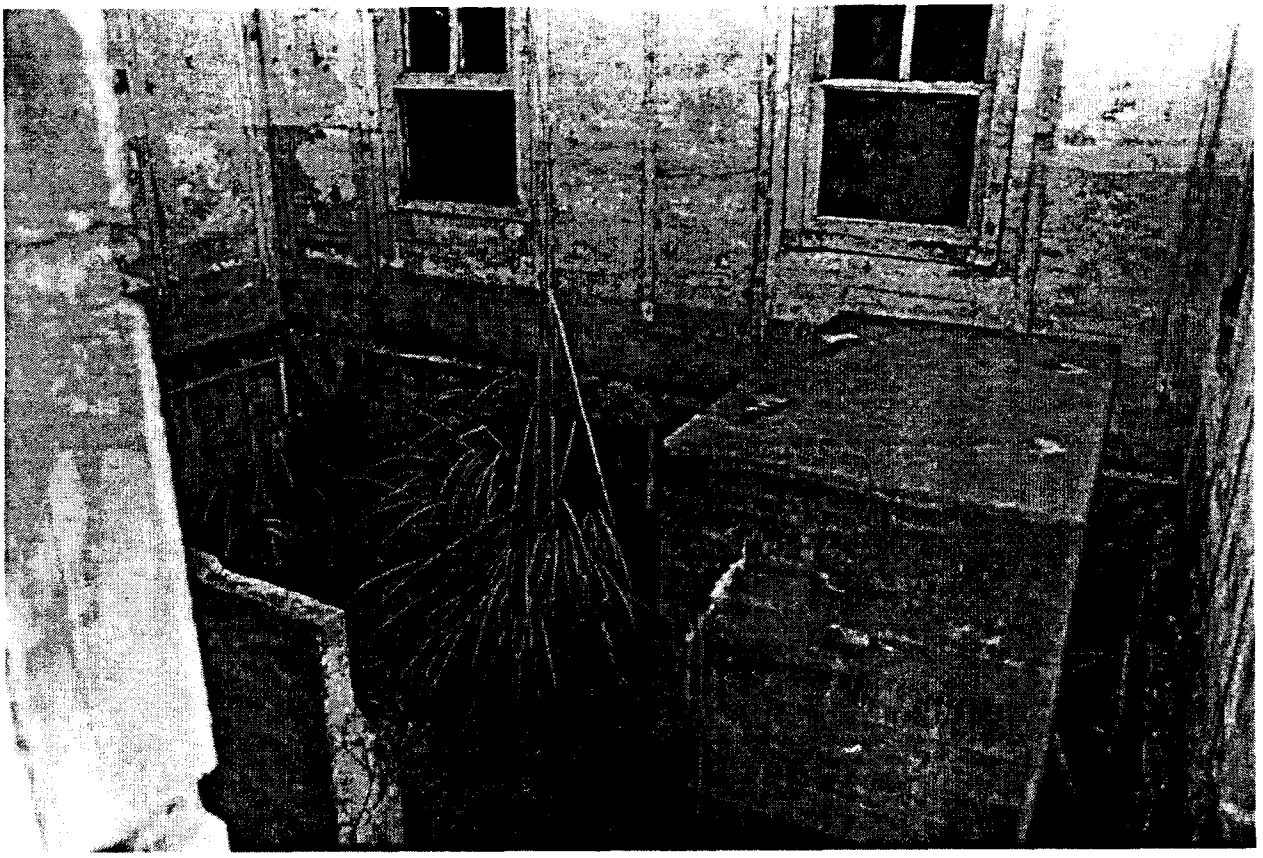
Plate 50. Absence of flooring, at the entrance to the switchboard room, mine casemate, Fort Barry.

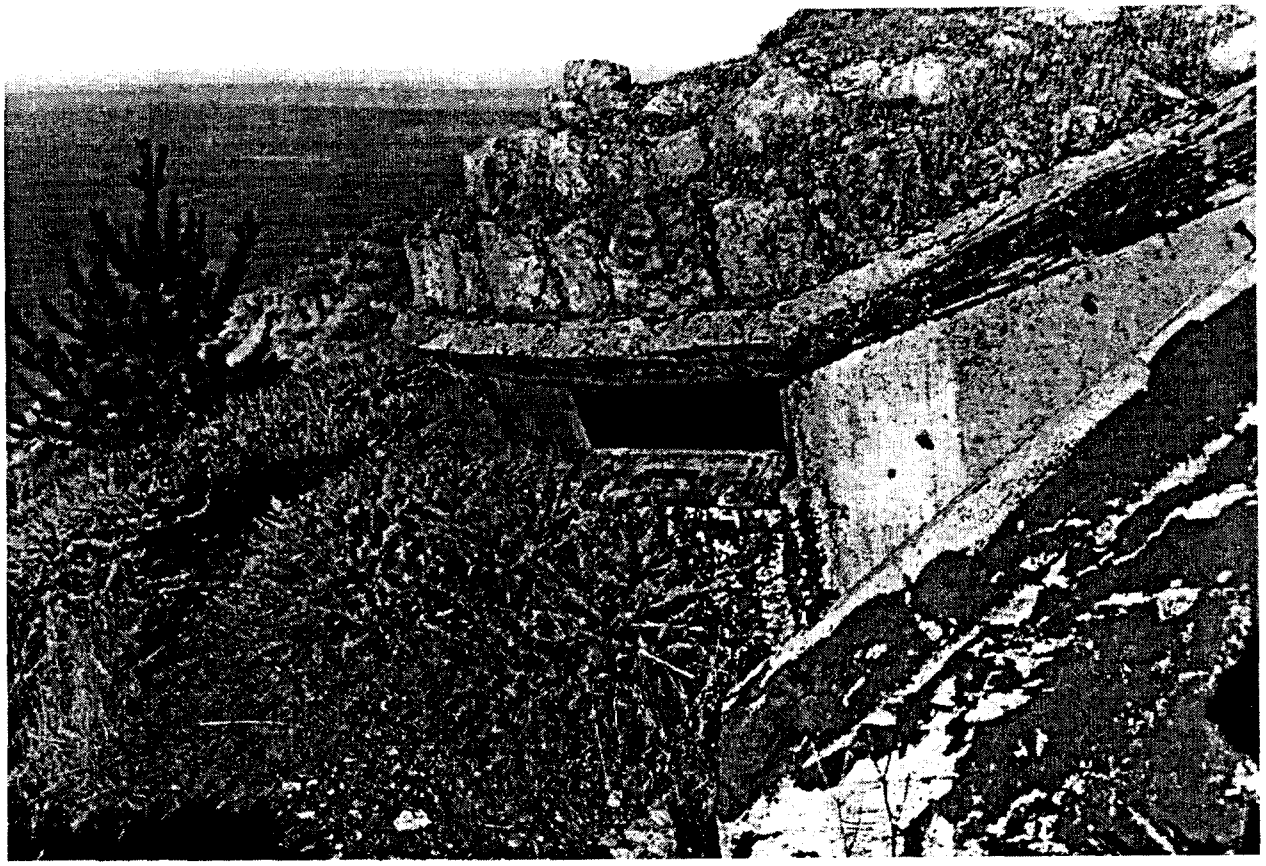
Plate 51. B[1]S[1] for Battery Construction #129, Fort Cronkhite. Detail of roof camouflage and observation slit shutters. Subsidence at site.

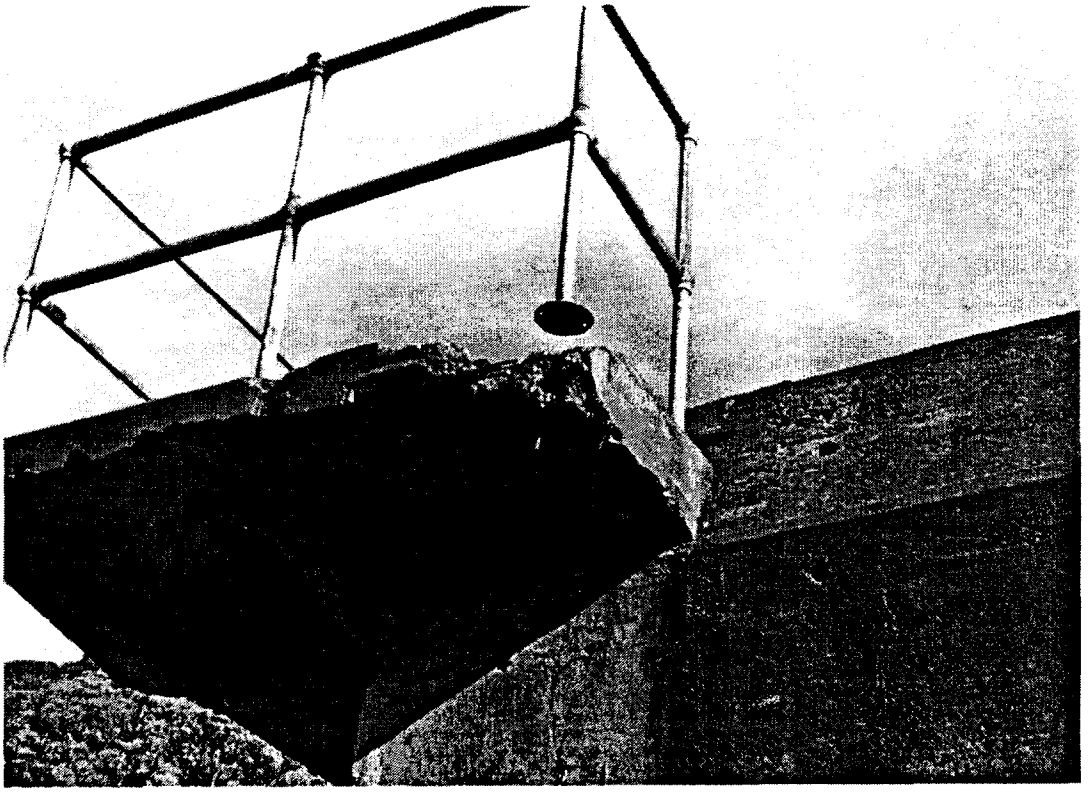
Plate 52. Major spalling and loss of concrete, underside of the battery commander's walk, Battery Kirby, Fort Baker, constructed 1899-1900. Battery commander's walk added after 1904.

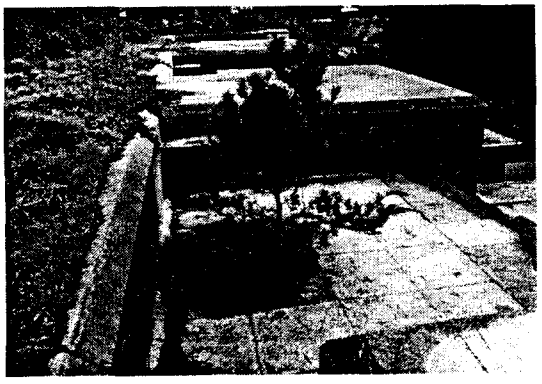
Battery Blaney. Volunteer coniferous tree growing through a gun mounting ring.

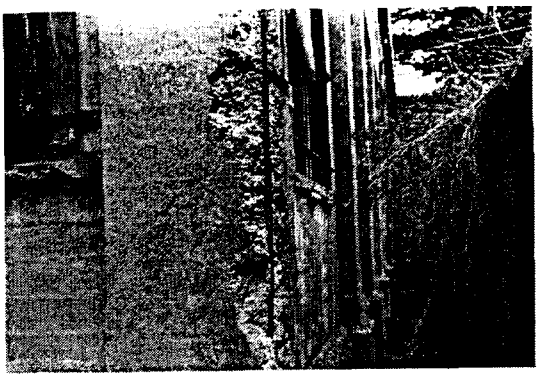
Battery Dynamite power plant. Spalled concrete and exposed rebar.

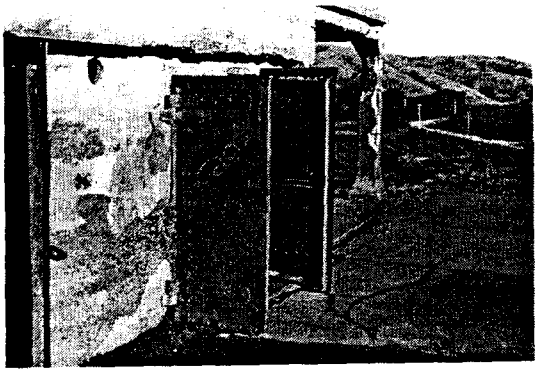
Battery Mendell, emplacement one. Steel doors for truck access. Note deterioration at base of door. Also spalling at drip mold and splinterproof columns.

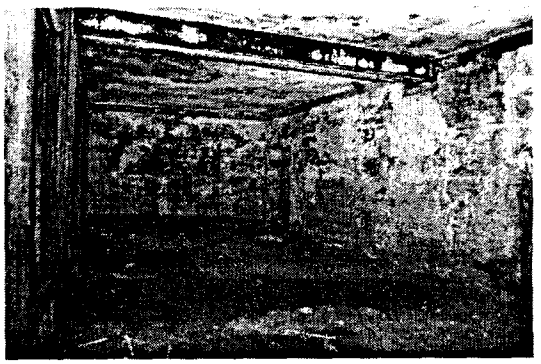
Battery Kirby. Interior of plotting room. Remnants of wall and ceiling finishes. Note accumulation of mud on floor.
