THE HEXAGON (Ephraim Shay House) Harbor Springs, Michigan

Tech Notes

NUMBER 3

In-Kind Replacement of Historic Stamped Metal Exterior Siding

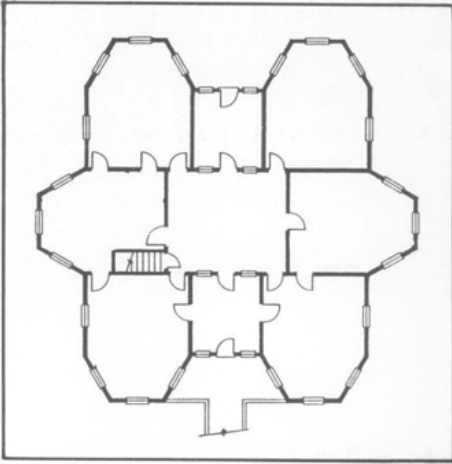
1. Windows in each elevation of the hexagonal wings offer views in every direction from the center of the house. This first floor plan of the Hexagon shows the new, post-rehabilitation uses. Drawing: Jeffrey Pascale, from plans by Richard Hiler.

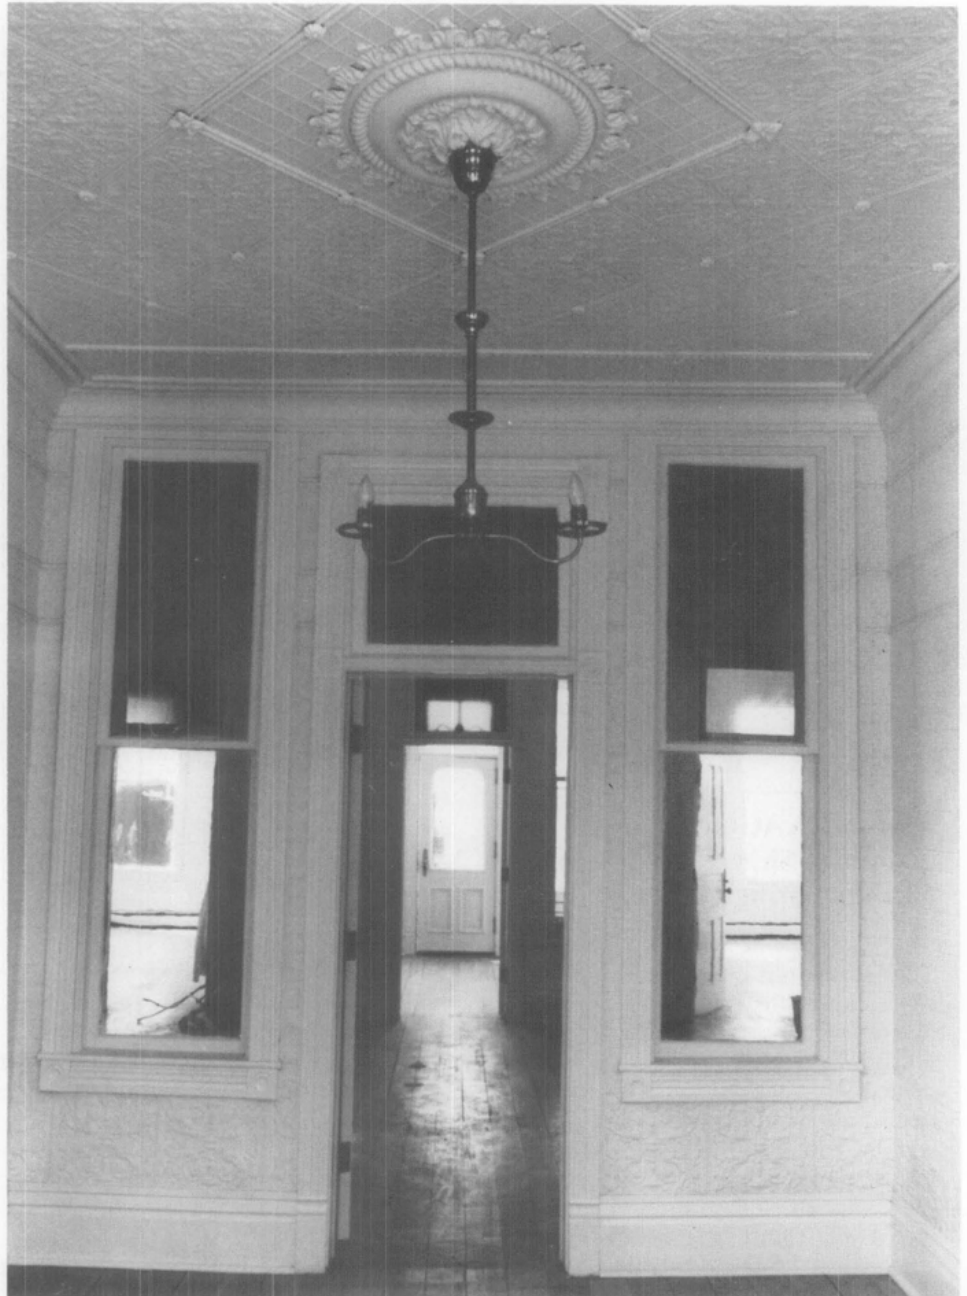
In contrast to the exterior metal siding, the interior stamped ceilings and walls remained in good condition. All of the interior metal was retained, with only isolated areas requiring patching due to minor rust. In addition, the exterior window hoods had not deteriorated like the siding and only routine repairs were necessary for their retention.

2. The walls and ceilings of each interior room are sheathed with stamped metal siding in a variety of decorative patterns. Photo: Brian Conway.

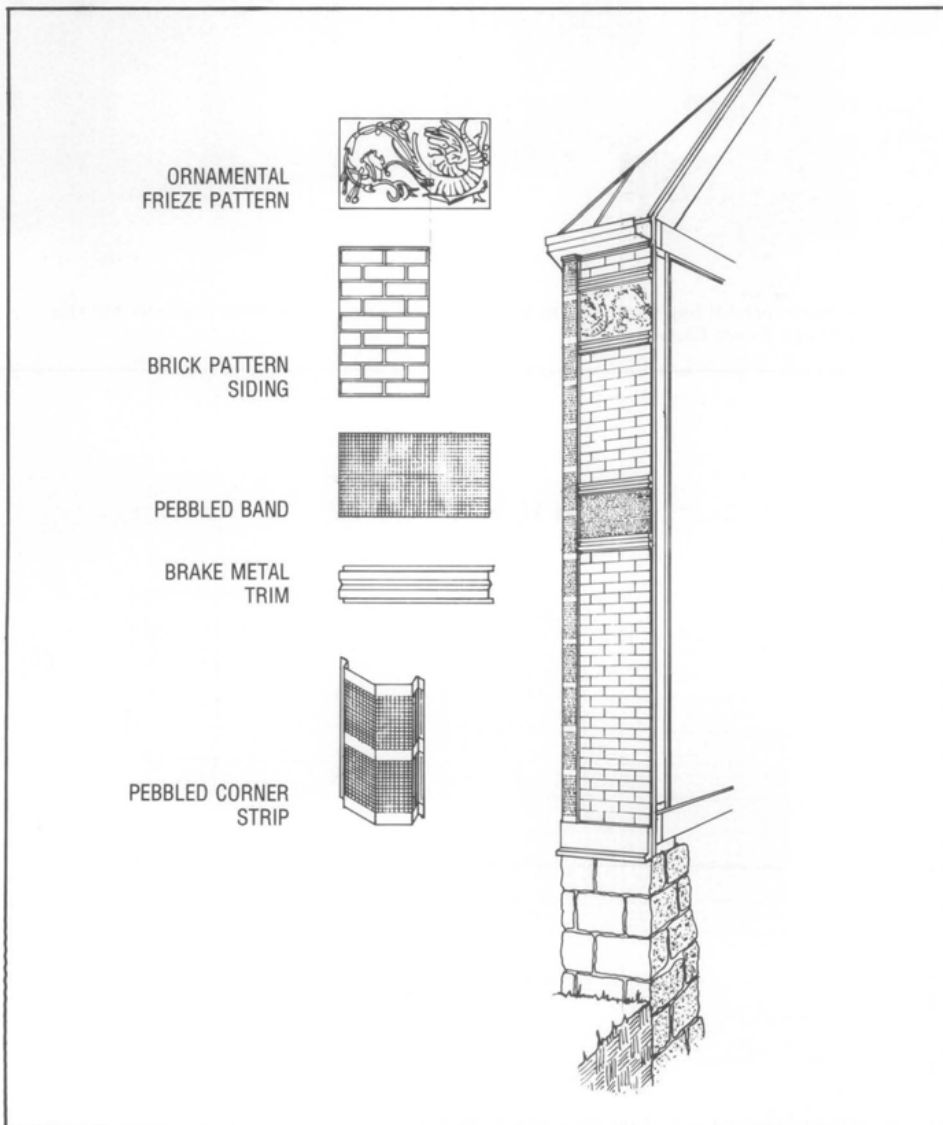
Five exterior sheet metal patterns required replacement: the brick pattern that covered more than half of the exterior, two ornamental band patterns, the wall corner pattern, and the molding that separated the ornamental bands from the brick pattern (see figure 5).

5. Five different sheet metal patterns were used to cover the exterior wall. Drawing: Timothy Buehner.

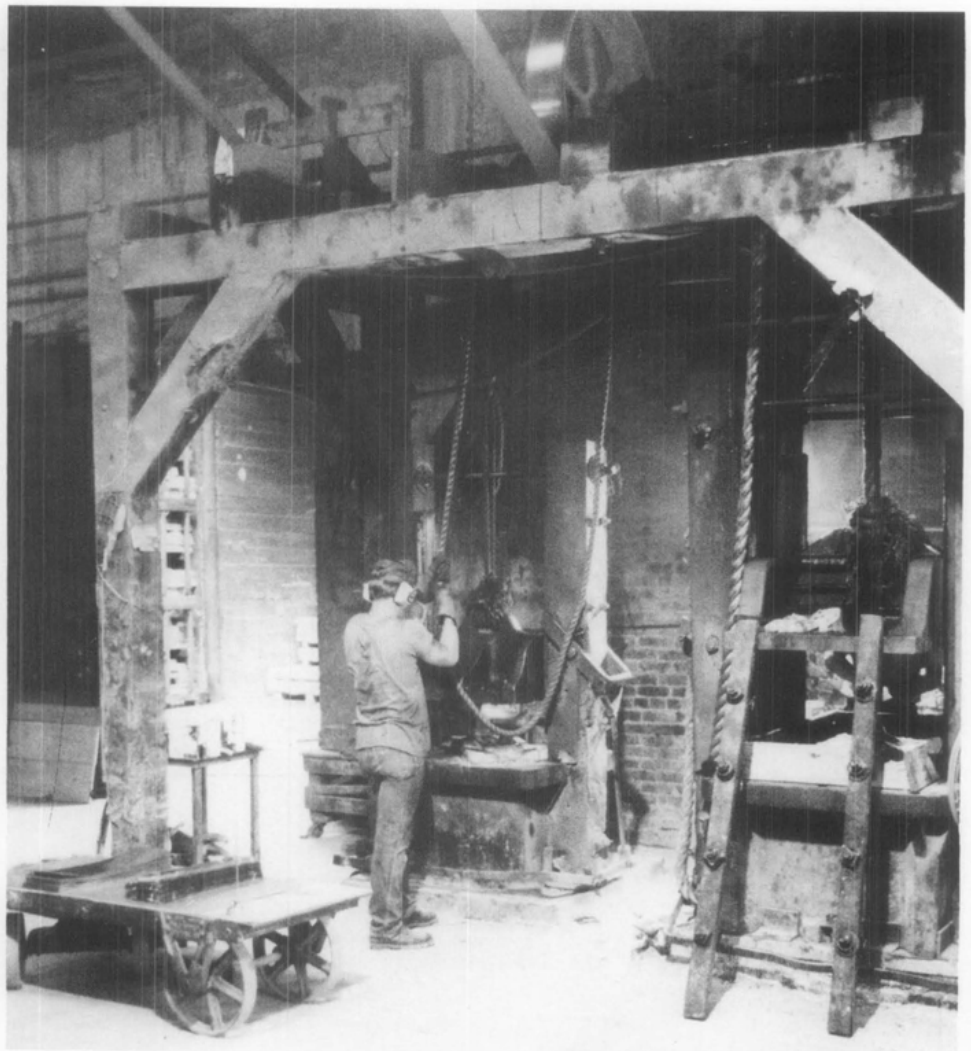
6. The stamped-metal siding was made the traditional way using gravity drop hammers and cast-iron dies. Photo: Lance Carlson.

After being awarded the contract, the sheet metal company proceeded first with making the cast-iron die sets that were needed for four of the five sheet metal patterns used on the exterior of the building. Two different approaches could be used to make the die sets. Where samples of the historic design have survived in relatively good condition, as with the case of the Hexagon, they can be cleaned and repaired to serve as a three-dimensional model for the casting of the dies. Since the cast-iron will shrink in casting as it cools from a liquid to a solid (approximately 3/16" per foot), the new die set will create a pattern that is slightly smaller than the original.

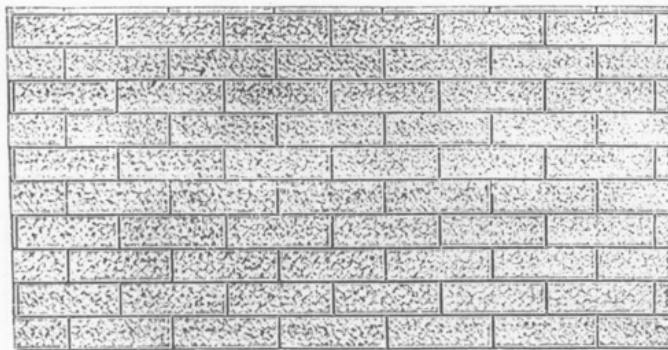
Made in all gauges No. 24 and lighter. Sheets 28 inches by 60 inches. 8 4/7 sheets required to cover 100 square feet. This siding should be applied over solid sheathing. Always lay the concave or hollowed part of the joint to the outside.

7. The brick pattern was a stock design still available from the company. The description from their 1913 catalogue is unchanged from today.

Each of the stamped designs was reproduced in the same metal used to make the original. The stock brick pattern was stamped into 28-gauge galvanized steel sheets measuring 28" by 60" (see figure 7). Galvanized steel is often used for exterior installations, due to its resistance to corrosion. Moreover, galvanized steel is strong enough to produce very stiff sheets of stamped siding in large sizes that can cover a fairly large area with minimum nailing support.
