Preservation Tech Notes

NUMBER 21

Replacement Wood Sash Utilizing True Divided Lights and An Interior Piggyback Energy Panel

BEATTY'S MILL (CORAL STREET ARTS HOUSE) Philadelphia, Pennsylvania

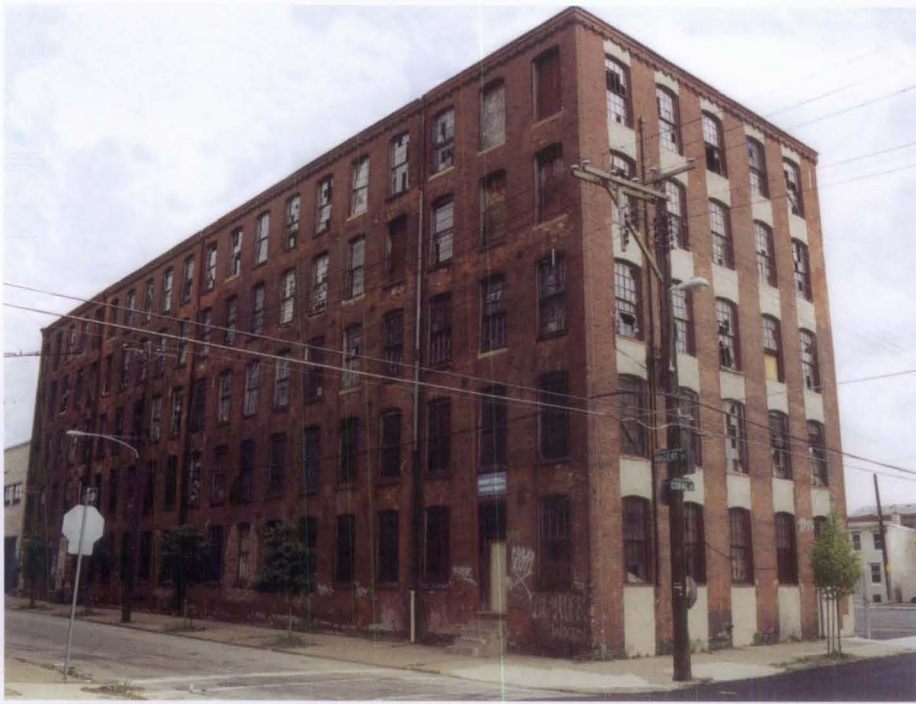
Figure 1. Constructed in 1886, the Beatty's Mill is located at a street intersection. The segmental arched windows are a distinguishing feature of the building.
