# Preservation Tech Notes

## WINDOWS NUMBER 22

### Maintenance and Repair of Historic Aluminum Windows

**Kaaren R. Staveteig**  
Technical Preservation Services  
National Park Service

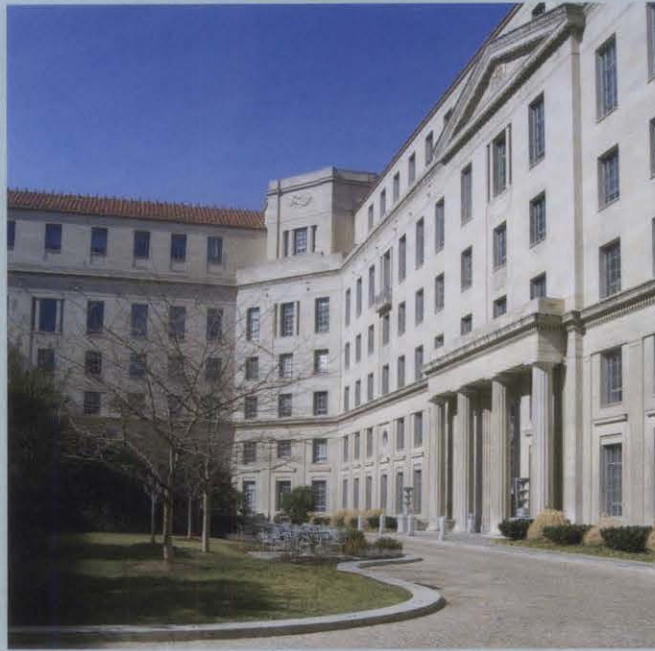
*Figure a. In the primary courtyard within the U.S. Department of Justice Building, the aluminum windows emulate the appearance of steel windows with true divided lights. Depending on the floor level and location, the windows differ in size and consist of a varying combination of fixed lights, casements, and a hopper-style unit.*

A window survey was first undertaken to record the condition of each window and to inventory the hardware, fasteners, and missing frame pieces. Although the windows retained a high degree of historic integrity, some changes had been made over the years. To allow for the installation of ventilation louvers or window-mounted air conditioning units, over 400 of the hoppers below the casements had either been removed or had been rendered inoperable and the wide vertical muntin removed. Although the historic windows were not designed for weatherstripping, some of the windows had been retrofitted with weatherstripping to reduce air infiltration as a result of worn hardware or deflections in the operable units. At various times, caulk had been applied to set in replacement glass or to fill in unwanted gaps. Areas of surface deterioration were also evident including discoloration and varying degrees of corrosion and pitting.

The renovation plan called for cleaning the aluminum window parts, replacing the existing glass and any missing or damaged parts, and making the historic windows fully operable again. Mock-ups of all phases of the work were required early on to establish the work standard to which the finished job would be held. It was anticipated that most of the work could be done in place, with work on the interior and exterior portions of each window done simultaneously.

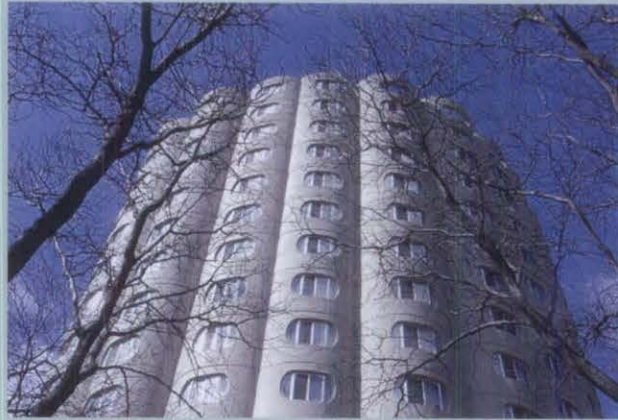
Figure a. One of two identical 16-story senior citizen apartment buildings within the Raymond M. Hilliard Center, each with 182 apartment units. The window openings are elliptical in shape and center on each reeded bay. (Photo: Holsten Real Estate Development Corp.)

Nearly all of the original windows had survived 40 years of Chicago's harsh winters and numerous abuses from high-density occupation. The architect completed a condition survey of 120 typical windows and found that 61% of the windows lacked the original glazing (replaced with Plexiglas or similar material), 31% had damaged operating sash, 29% were boarded up with damage to the frame, 25% were missing their original operating glazing sash, and 71% were missing screens. Only 15% of the windows had no visible defects.

The decision was made to save the historic windows for the first four floors of the towers, since they would be most visible from the ground. Units on the first four floors in bad condition were to be replaced by windows in better condition relocated from above floors. Matching aluminum replacement windows were to be installed on the upper floors.

The window survey provided an overall view of the necessary repair work to the historic units. There were standard components within each of the different window types and the aluminum had proved durable where not abused. Thus it would not be necessary to replace large numbers of the entire window assembly within each bay on the lower floors. The windows could be repaired, utilizing parts easily salvaged from other units within a building to replace worn-out or missing ones. In the total project, 336 original windows were to be repaired and 2,016 to be replaced.

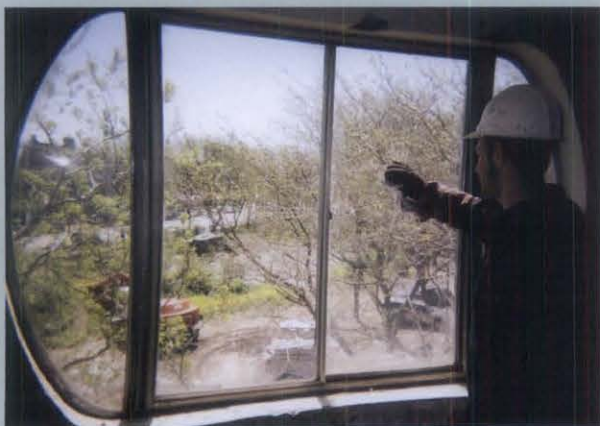
*Figure f. Repair and replacement work was done from the inside to lessen the risk of damage to the outside finish. (Photo: Holsten Real Estate Development Corp.)*

The cost for window repair, including both labor and materials, totaled \$1,486 per window. The cost for a new aluminum unit ran \$1,700 per window.
