**Repair and Upgrade Washington Monument Elevator –
Washington, DC**

NAMA-224923

**Pre-Design Report
Final Submission**

CH2M HILL, Inc.

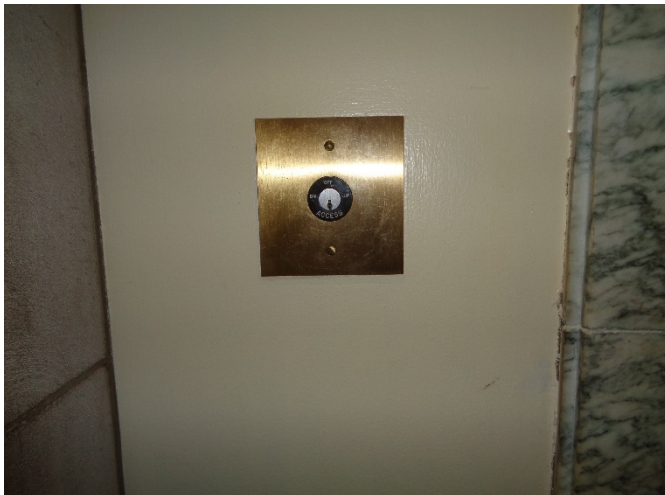
3. Existing wall mounted hoistway access switch

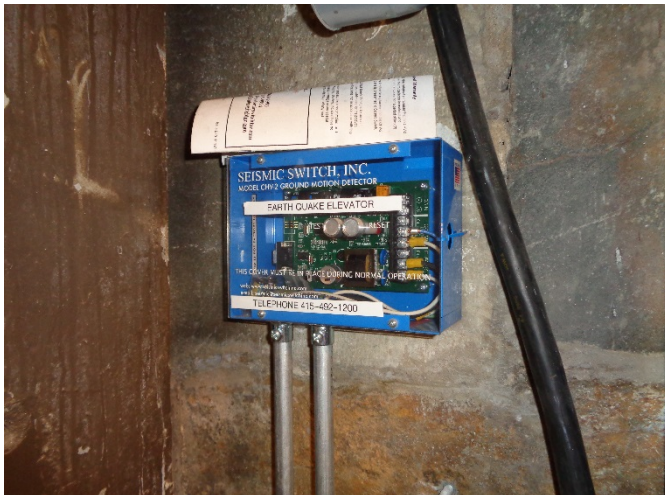
11. Existing seismic monitor to be retained.
