REHABILITATE THE HISTORIC STRUCTURE AT MONROE STATION

BIG CYPRESS NATIONAL PRESERVE
EAST OCHOPEE, FLORIDA

HISTORIC STRUCTURE ASSESSMENT REPORT

AUGUST 2007
FY07

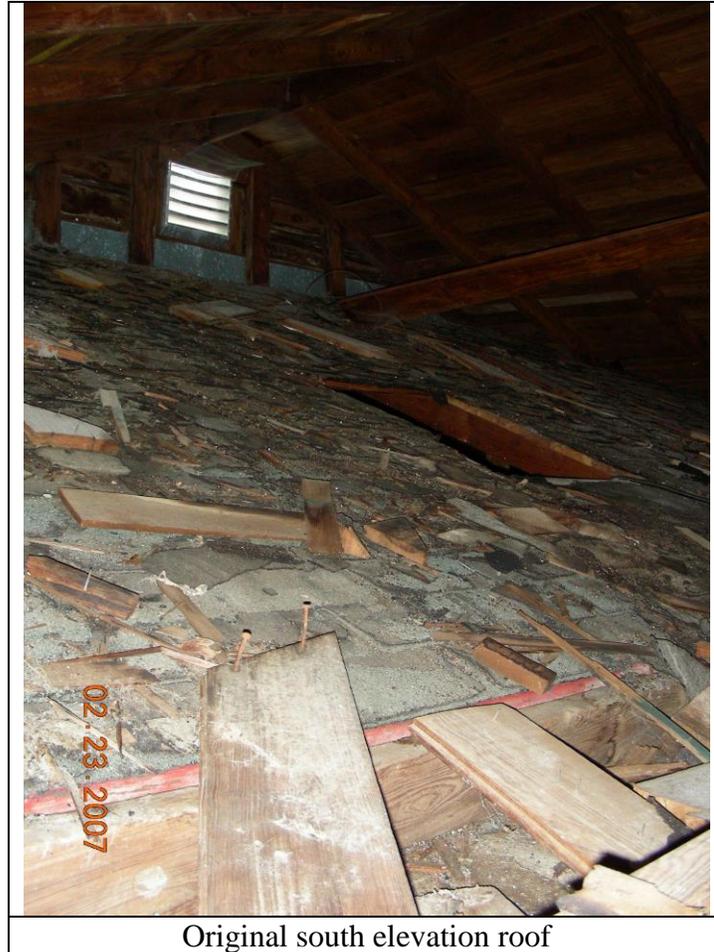
Original south elevation roof

The roof surface covering currently on the original roof and the additions is three tab asphalt shingles. This includes the south elevation which is enclosed by the gable roof

addition. The standard multi-tab shingle that is common today was widely available by 1935, therefore it is probable that this was the original roof covering. Also, no previous nail pattern was discernable on the sheathing boards to indicate a prior roof surface covering.

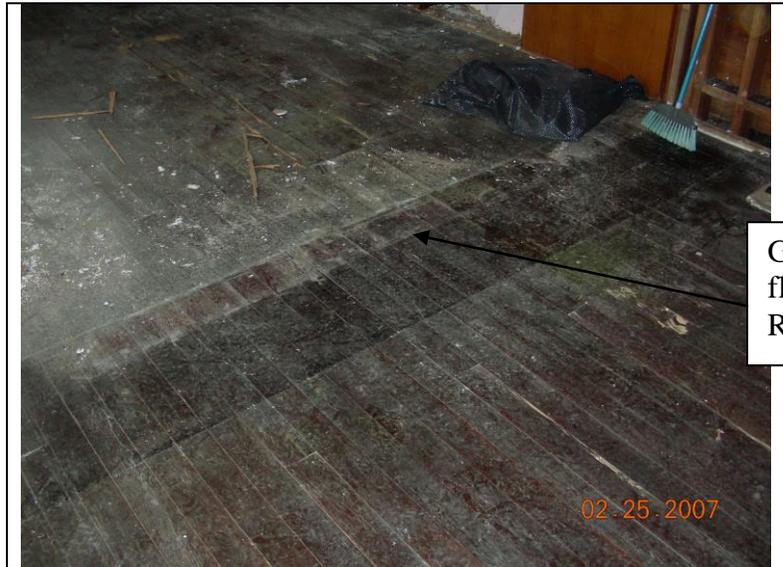
Ghost lines on floorboards in Room 201

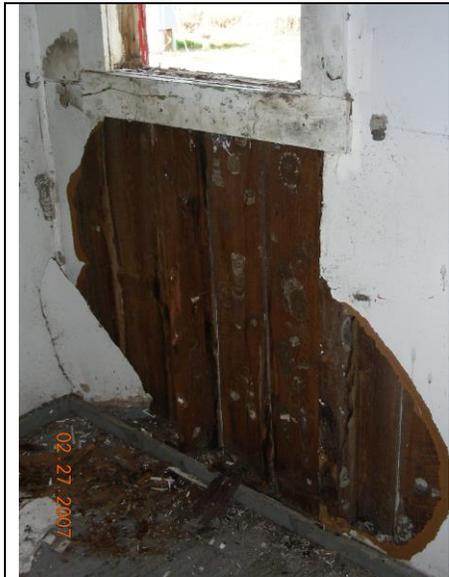
Shed wall structure

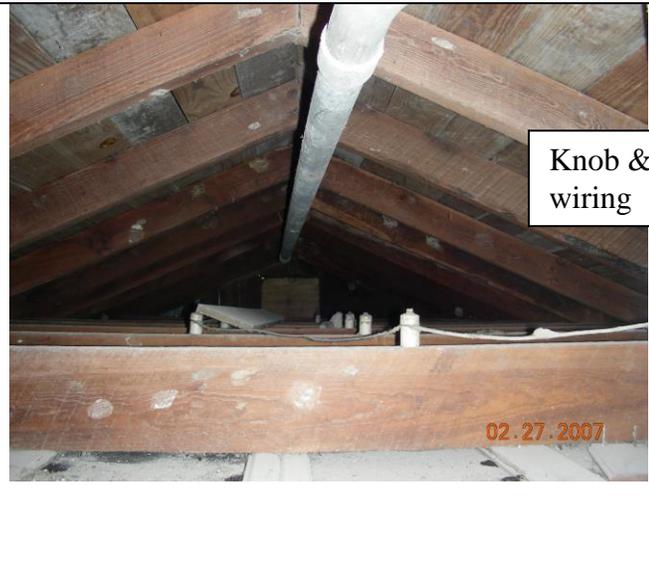
Knob & Tube wiring

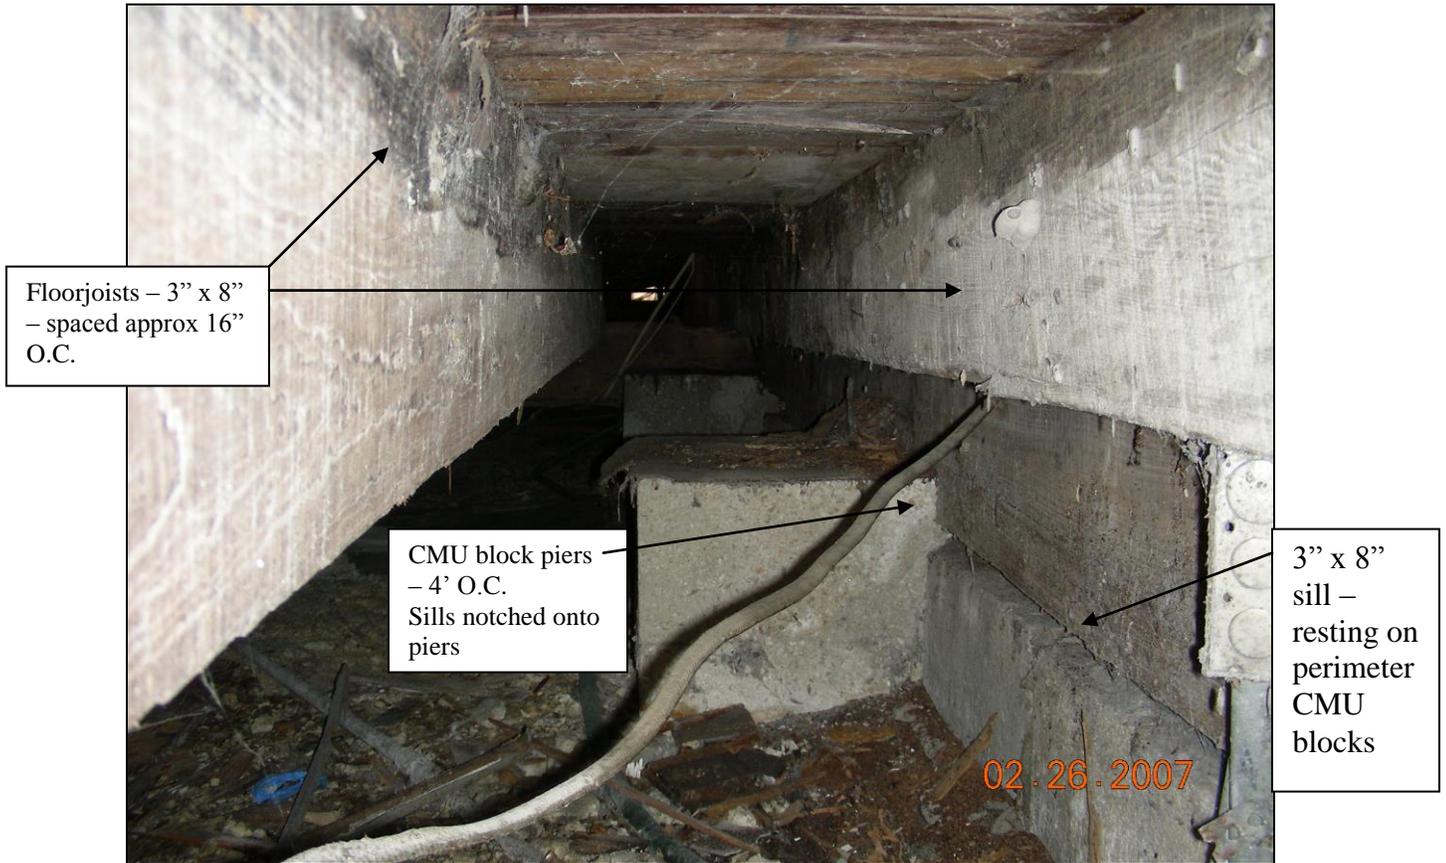
Feature	Material Type	Joinery/Tool Marks	Condition Rating	Priority Rating
Floor Structure	Indigenous Hardwoods	Circular Sawn	Fair to Poor	Serious to Critical

- Repair/replace deteriorated floor joists
- Sister joists where necessary
- Replace deteriorated floorboards

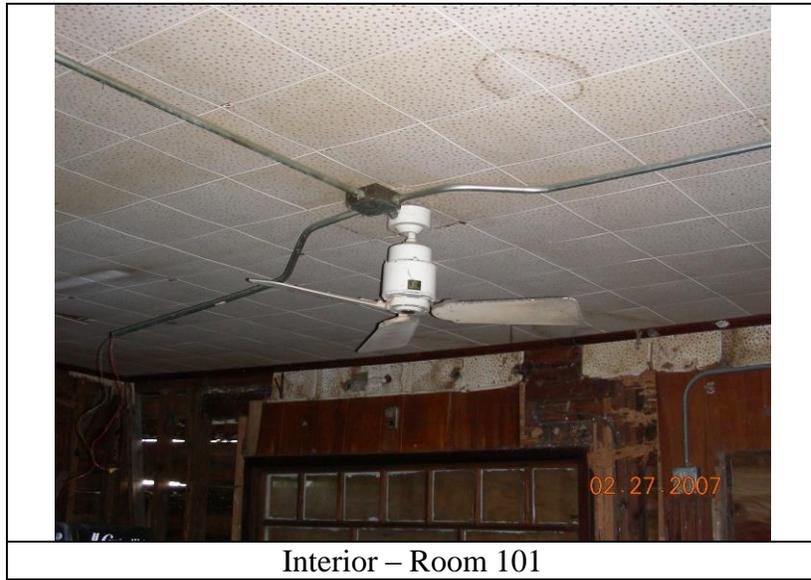
Interior – Room 101

CONDITION ASSESSMENT REPORT MONROE STATION FEATURE INVENTORY ASSESSMENT REPORT					
FEATURE	FEATURE NAME	MATERIAL TYPE	JOINERY/ TOOL MARKS	CONDITION RATING	PRIORITY RATING
Interior Envelope	First Floor – Room 101	Various	N/A	Fair to Poor	Serious

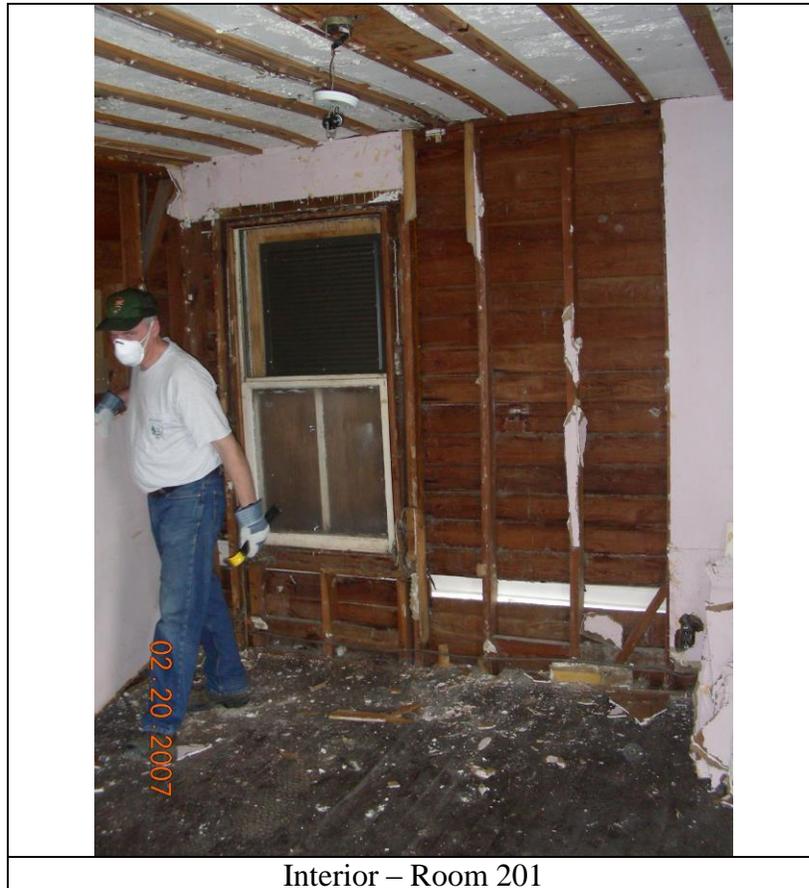
Interior – Room 201

CONDITION ASSESSMENT REPORT MONROE STATION FEATURE INVENTORY ASSESSMENT REPORT					
FEATURE	FEATURE NAME	MATERIAL TYPE	JOINERY/ TOOL MARKS	CONDITION RATING	PRIORITY RATING
Interior Envelope	Second Floor – Room 201	Various	N/A	Fair to Poor	Serious

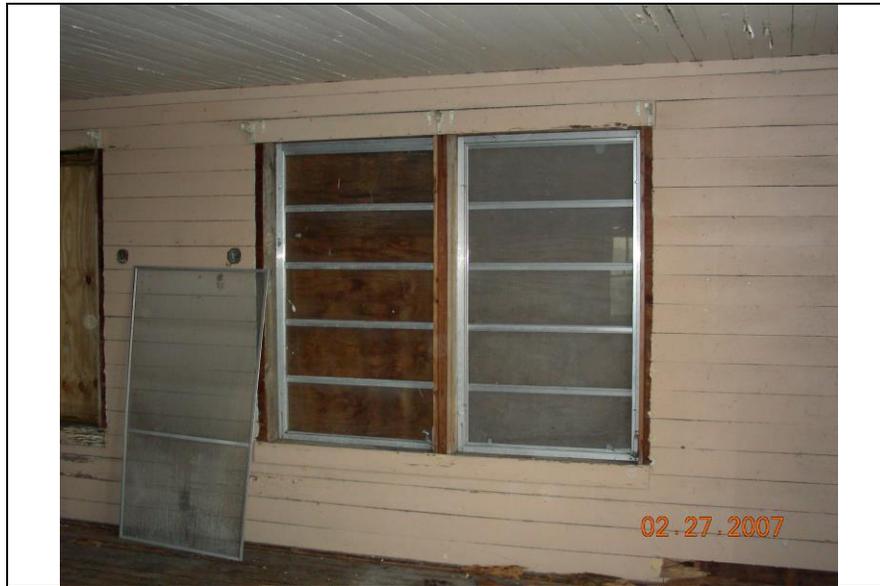
Jalousie window in second floor gable addition

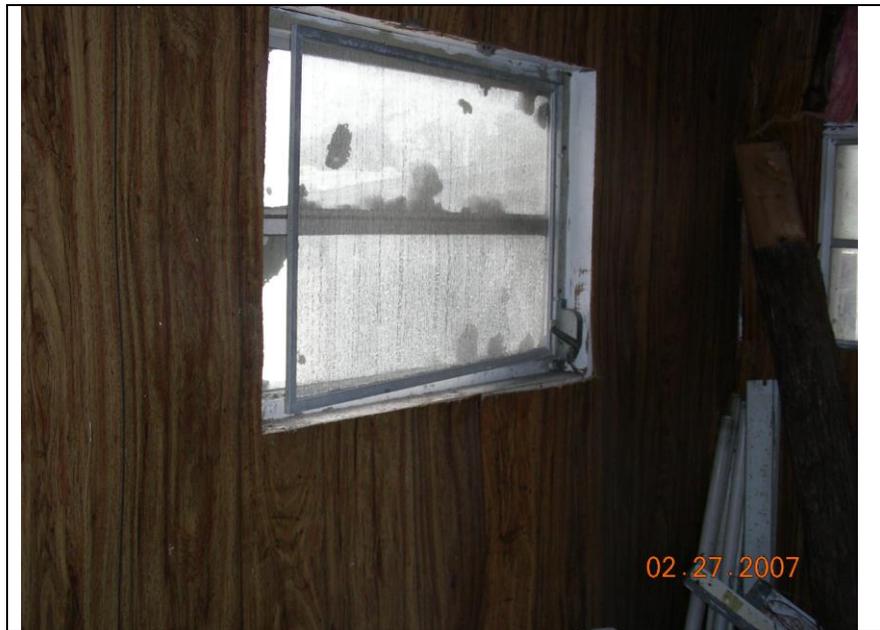
Awning style unit in Addition #3

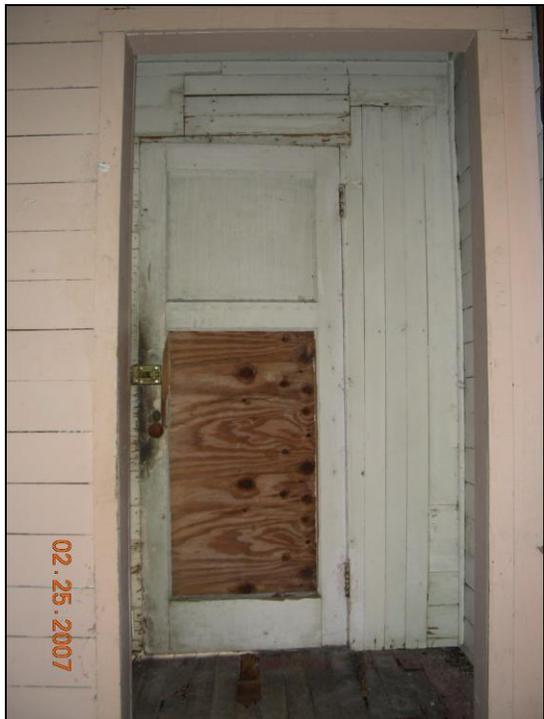
2nd floor entry door

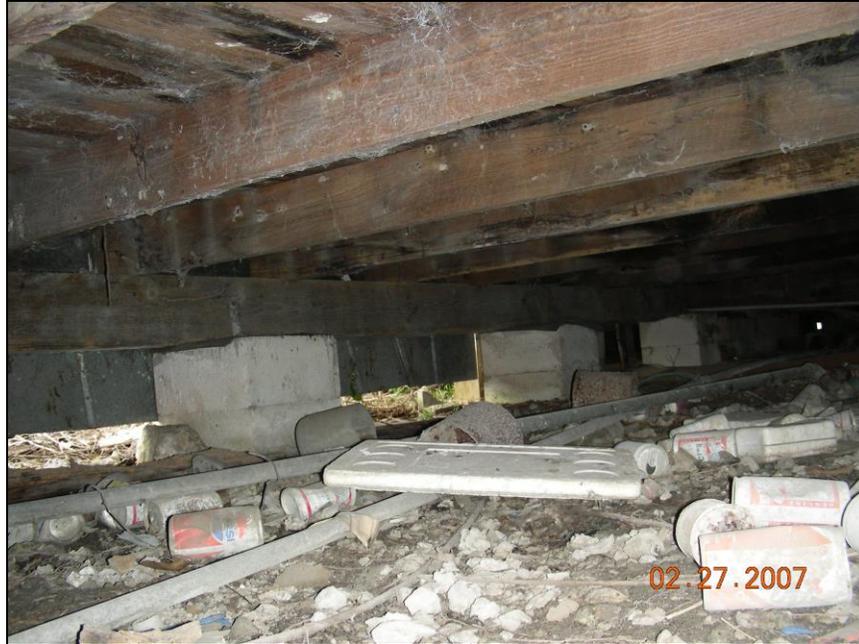
Shed foundation and floor structure

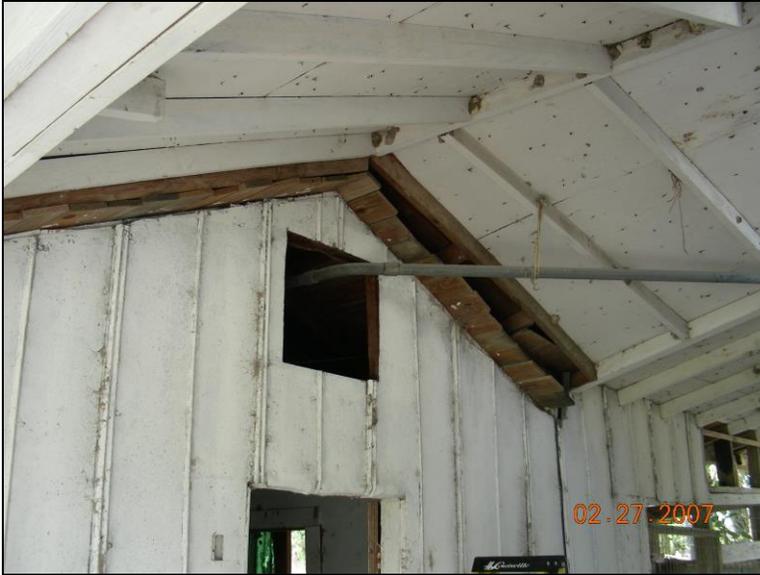
Feature Condition – The various wall treatments are in varying states of disrepair. Much of the siding is rusted and has been pulled out on the south elevation. Numerous boards are deteriorated and the paint system has failed.

North wall of shed

- Remove deteriorated metal pans and replace with random width tongue & groove boards
- Replace deteriorated siding with random width tongue & groove boards

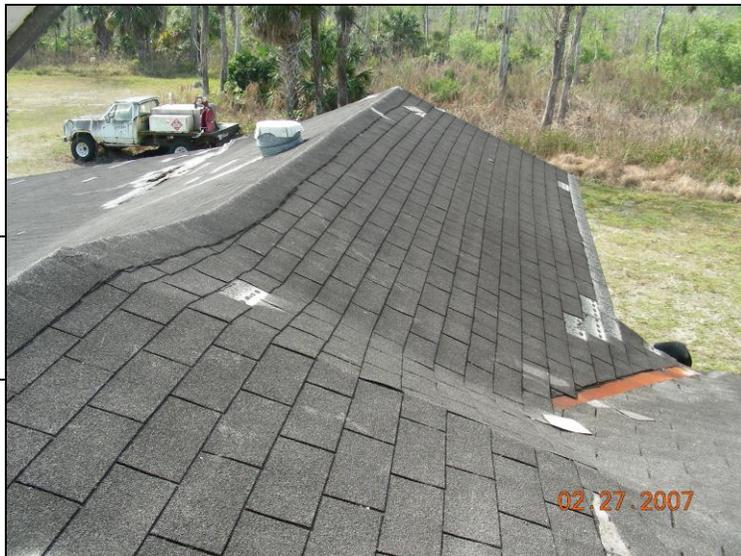
Asphalt shingle roof

Feature Condition – Many of the shingles are broken or missing and evidence of moisture infiltration is apparent.
