# Blackstone River Valley National Heritage Corridor Commission Blackstone Canal Alternative Transportation Feasibility Study Uxbridge and Northbridge, MA

NPS Contract No. GS-10F-0281R; VHB Project No. 33281.02  
Document No.

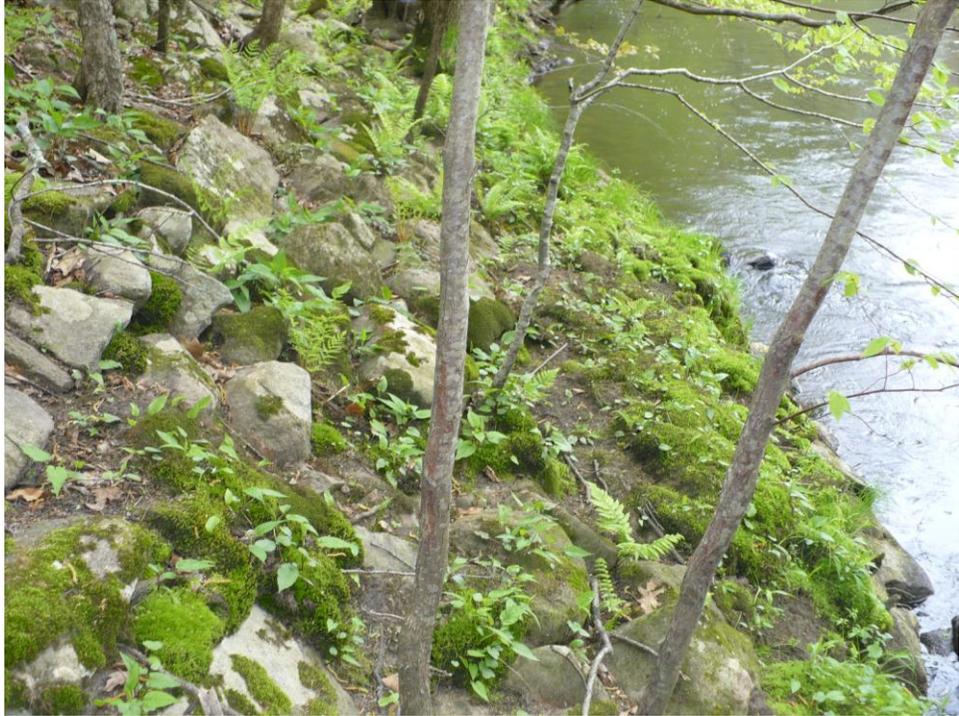
Original Rip Rap at Skull Lock

- Repair the northern breach of the River into the Canal trench by rebuilding the Canal towpath embankment to the original dimensions and elevation. The River side and Canal side of the embankment should be armored with rip-rap to prevent future breaches (see Figures 3 and 4). The rip-rap should sized and laid in courses to replicate the rip rap used in the original Canal construction. (Refer to the photos of original rip rap construction at Skull Rock Lock.) All work would meet the Secretary's Standards. Any interpretation should explain the use of historic erosion control techniques.

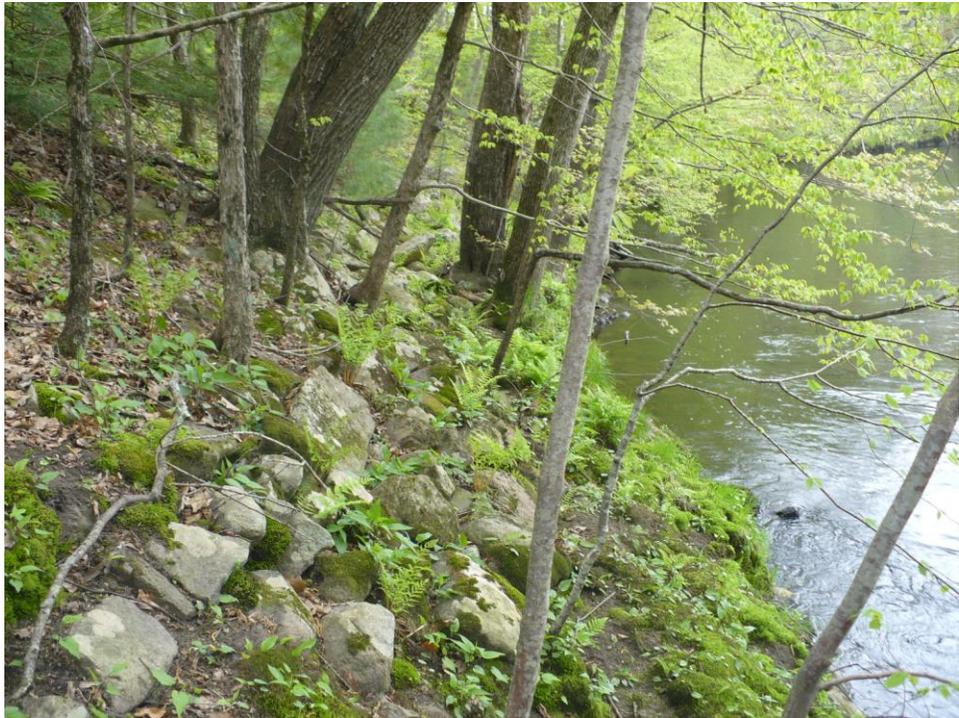
Original Rip Rap at Skull Lock

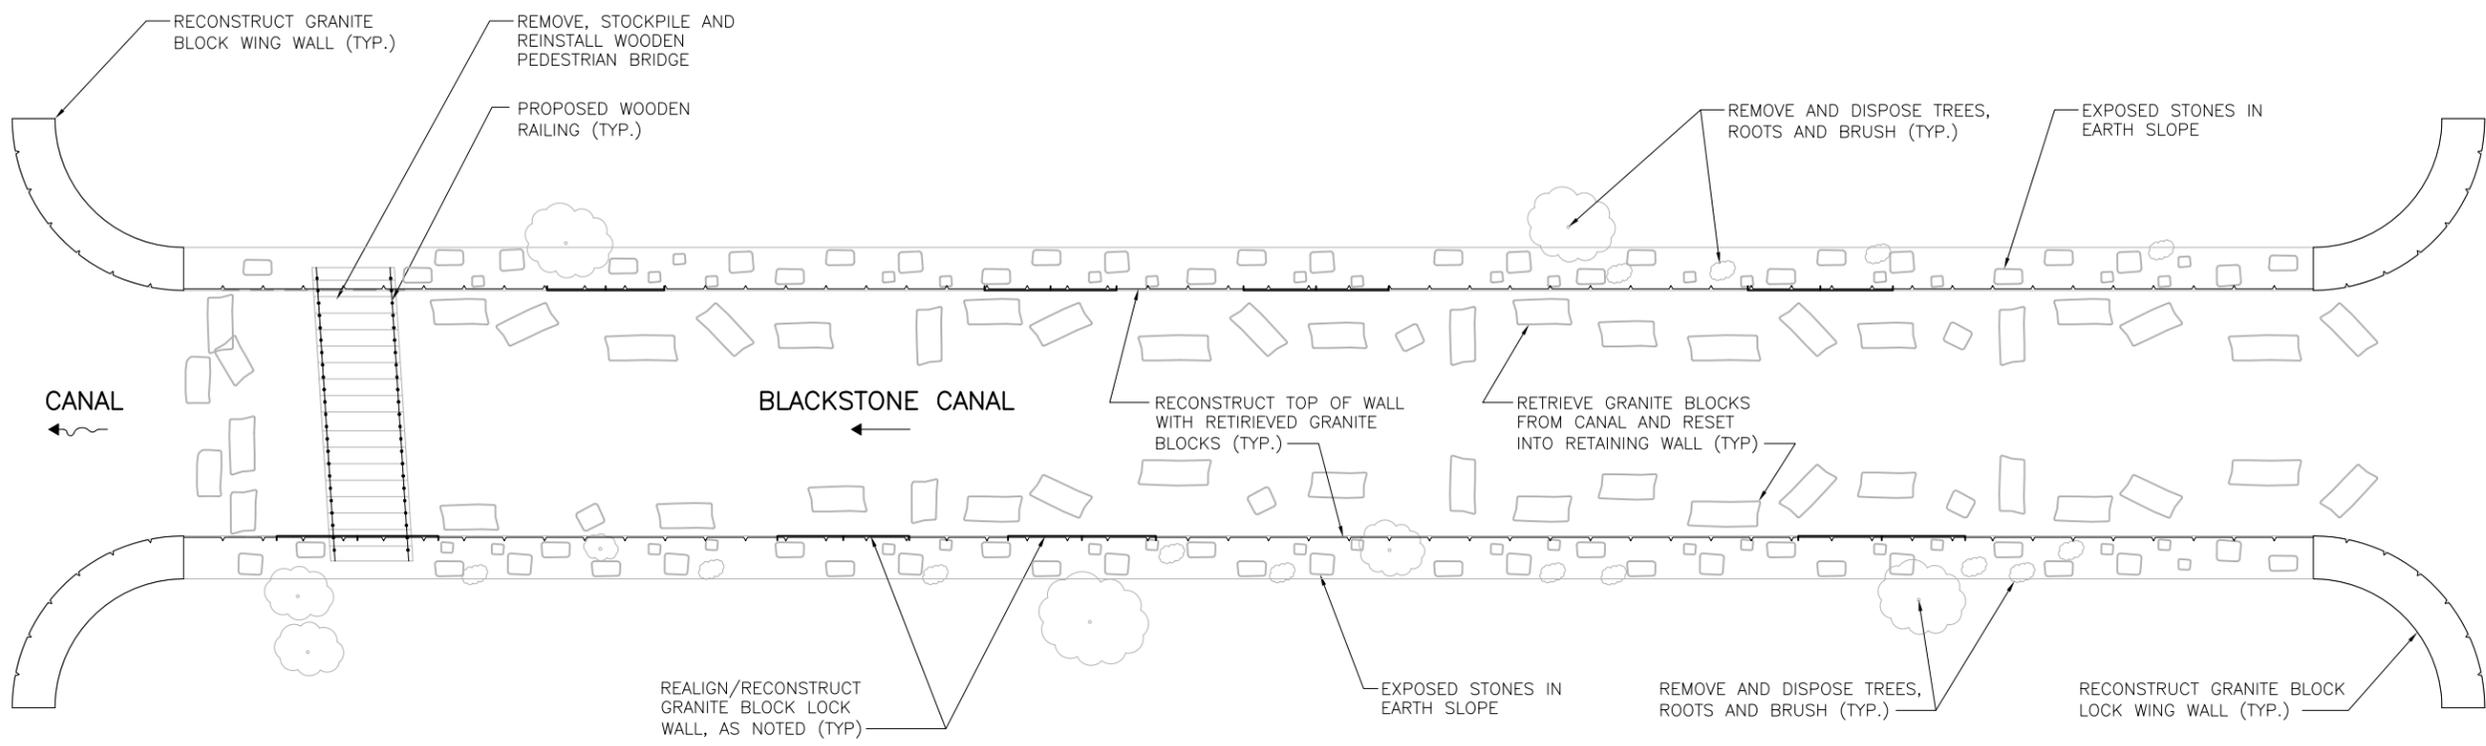
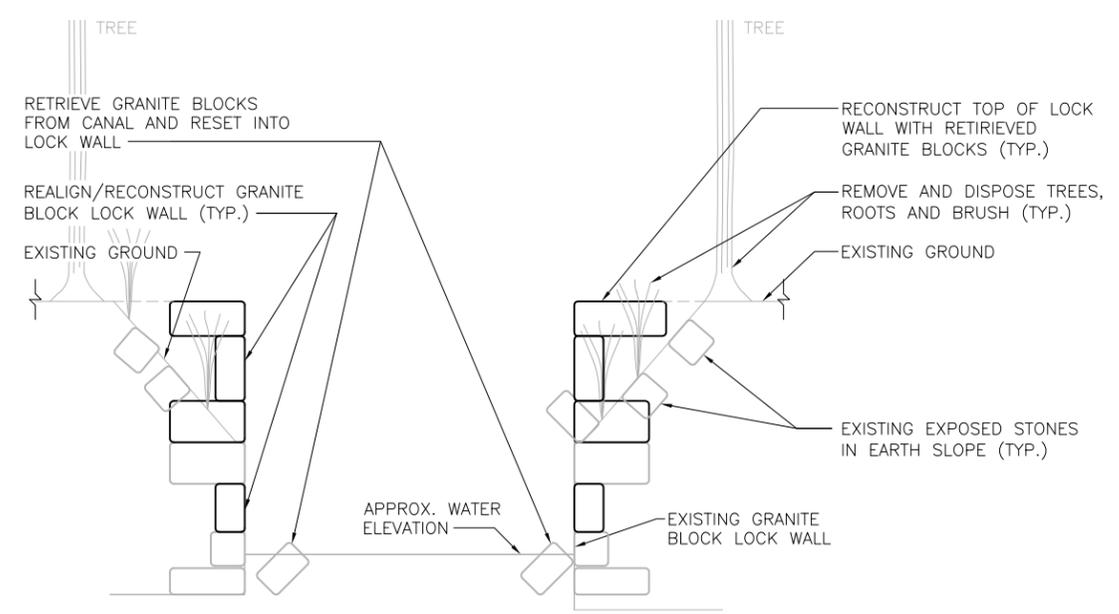
**Figure 5**

Figure 5, Goat Hill Lock . Leonard Loparto notes that he was under the impression that the lock walls were flared on the downstream side of the locks.

a granular material and filter fabric to promote free-flowing drainage of the subgrade behind the lock walls. The cut granite stones which have fallen into the lock should be retrieved and reset into the lock walls and wingwalls. Replica timber leaf gates could then be fabricated and installed. This would require temporary dewatering of the Canal and lock. A historically sensitive timber walkway with railings could be constructed to replace the substandard existing structure (see Figure 5).

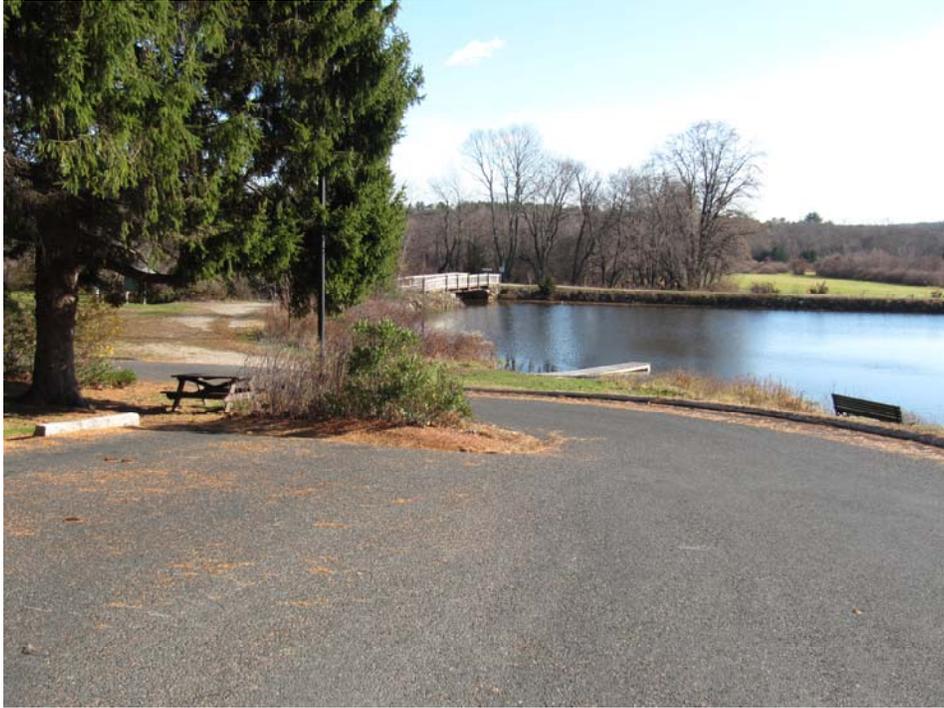
**Photo 13 – Visitor Center Parking and Pond Dock/Canoe Landing, Looking East**

In addition to bicycling and walking, the park offers visitors the opportunity to canoe and kayak in the Canal and River. The BRVNHCC produces maps for River and Canal canoe/kayak tours, including a river tour from Plummer’s Landing to the Visitor’s Center; a Canal tour that begins at the Visitor’s Center and heads north to the Goat Hill Lock; a Canal tour that begins at the Visitor’s Center and heads south to the Stanley Woolen Mill; and a loop tour that includes a leg from the Visitor’s Center to Stanley Woolen Mill in the River. There are several put-in locations in the park: one in the River at Plummer’s Landing on the south side of Church Street; one in the River, near Gate #1 just south of Hartford Avenue (the Canal can be accessed from this location by portaging over the Gate #1 head gate embankment); one in the Canal, at the pond adjacent to the Visitor’s Center (see Photo 13); and one in the Canal, at the south end of the towpath just north of the Stanley Woolen Mill.

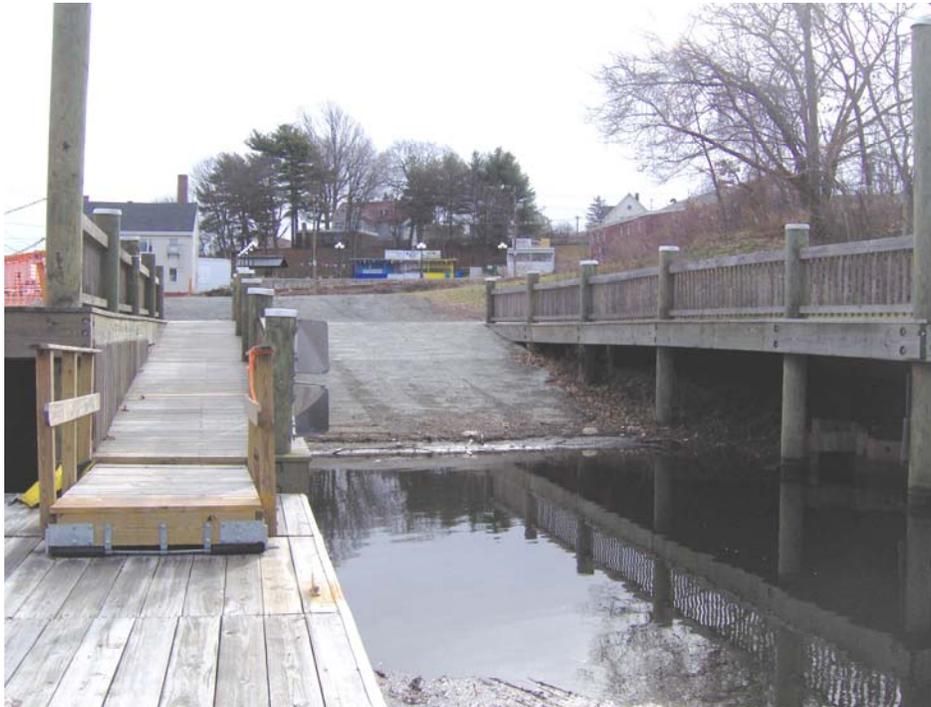
**Photo 14 – View of Explorer Boat Ramp and Docks at Central Falls Landing, Blackstone River, Central Falls, RI/Cumberland, RI**

- Due to its size, the Council has encountered difficulties in launching the *Explorer*. On numerous occasions, the transport trailer has gotten stuck in the River mud and was damaged because the launch ramp was not of sufficient length. For these reasons, the *Explorer* is no longer transported by trailer and is currently launched via crane only. It operates from the Central Falls Landing, a facility that includes a paved boat ramp, pile-supported dock, floating docks and a gang plank (see Photo 14). The BVTC, through funding from the RI
