CAPE LOOKOUT NATIONAL SEASHORE  
Cape Lookout Village  
FISHING COTTAGE #2

# HISTORIC STRUCTURE REPORT

**2004**

2004  
Historic Structure Report  
Fishing Cottage #2  
Cape Lookout National Seashore  
Cape Lookout Village  
LCS#: 091833

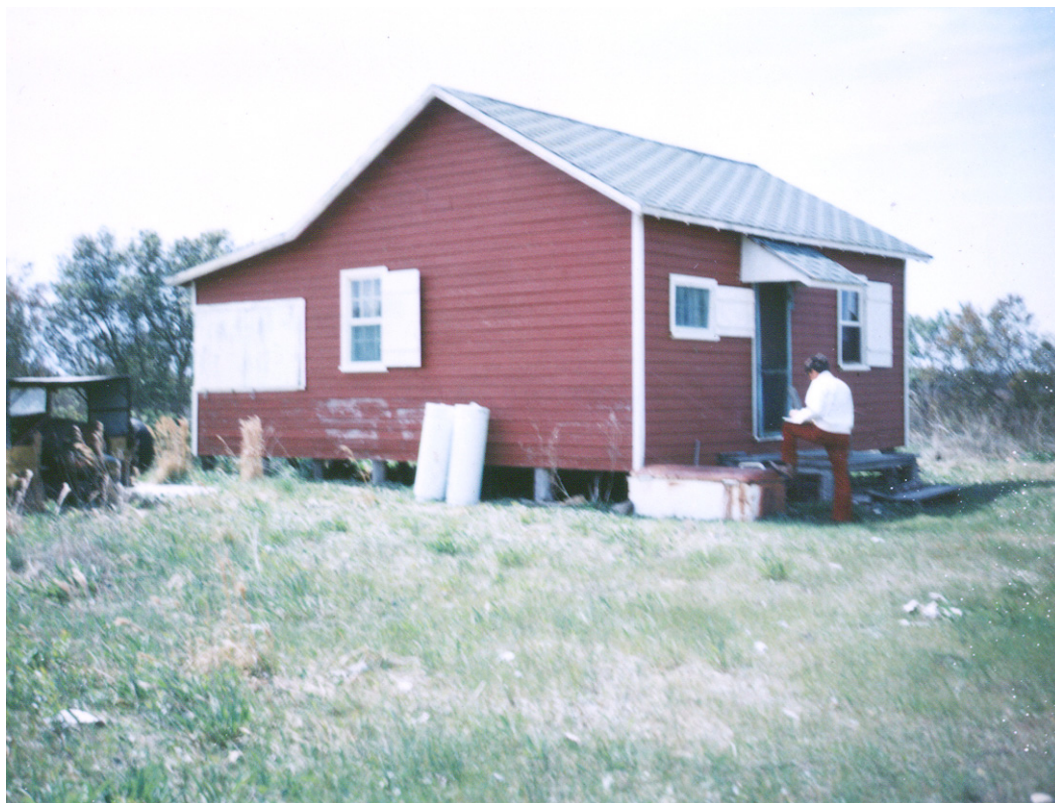
This building has undergone very few alterations since it was originally constructed, and nearly all of these appear to have occurred in the last twenty- five years. At some point, perhaps because of the growth of trees and shrubs on that side of the house in recent years, the steps to the porch were removed and the porch now functions as a utilitarian back porch to the house. At the southeast end of the porch, the wall has been altered and a ramp constructed so that all- terrain vehicles and other equipment can be stored on the porch. The house may have originally been painted red, its color in 1976, but has been painted white in recent years. The asphalt- composition roof covering has also been changed from bright blue shingles, which may have been original, to the present white roll- type roofing.

**Figure 11** View west of house in 1976. (CALO Land files)

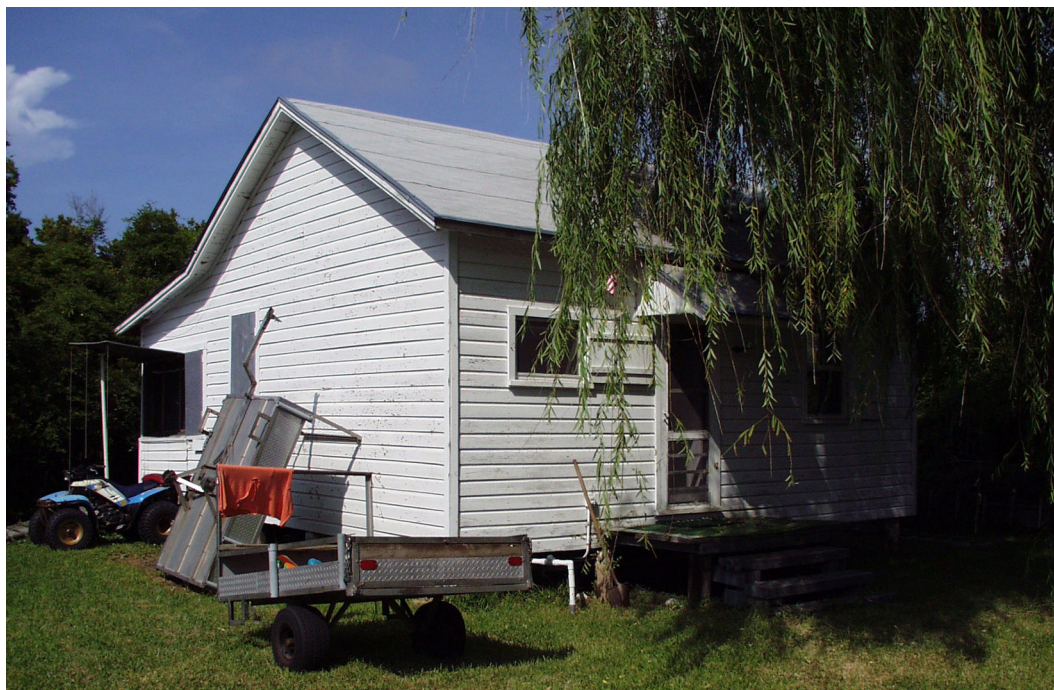
Built about 1950, Fishing Cottage #2 is a small, wood- framed, end- gabled structure located a few hundred yards northeast of the Coast Guard Station. The house is wood- framed with an end- gabled roof and a shed- roofed porch, continuing a vernacular tradition embodied in the Gaskill- Guthrie House, the Bryant House, and others of the older “fish houses” in the village. The porch door is now closed and inaccessible, and the main entrance to the house is at the small, sheltered stoop on the opposite side of the house. The footprint of the building, including the porch, measures about 22’- 4” by 26’- 2” and contains about 380 square feet of interior floor space plus about 165 square feet on the porch. Unlike most of the other private residences in the village, this house, though simple and utilitarian, is a sturdy, well- constructed building. Materials are generally uniform and of standard dimensions typical of the mid- twentieth century. In general, it is in very good condition, although threatened by termite activity and a failing roof covering.

**Figure 12** View west. (NPS-SERO-CRS, 2002)

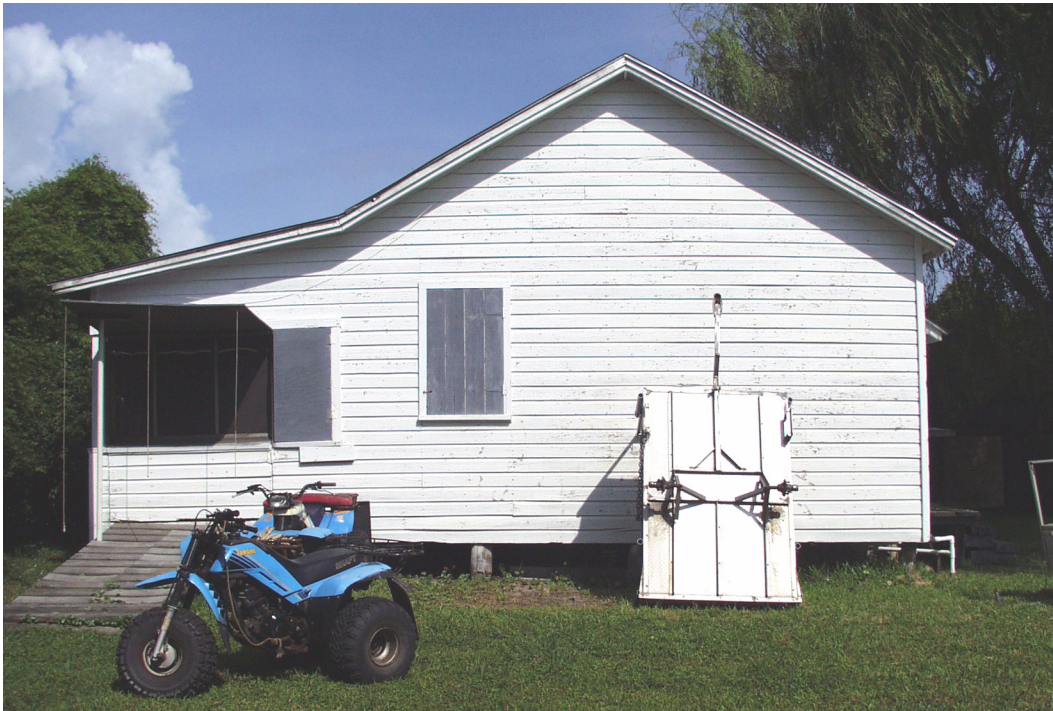
**Figure 13** View northwest.  
(NPS-SERO-CR, 2002)

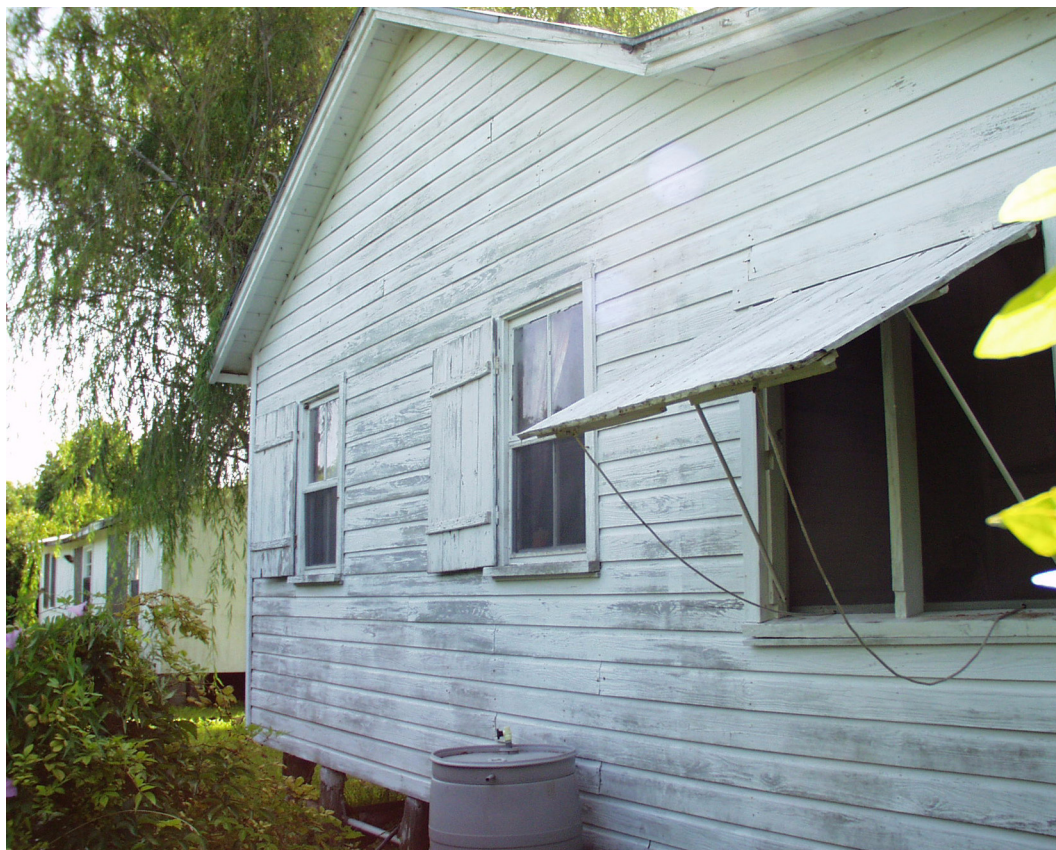
**Figure 14** View east showing typical exterior finishes. (NPS-SERO-CR, 2002)

Exterior siding, window and door casing, and trim are intact and in good condition. Except for the porch, where more- extensive repairs may be needed, maintenance of painted finishes is all that is necessary.
