Cape Lookout National Seashore  
O'BOYLE - BRYANT HOUSE  
**HISTORIC STRUCTURE  
REPORT**

2004  
Historic Structure Report  
O'Boyle- Bryant House  
CAPE LOOKOUT NATIONAL SEASHORE  
Cape Lookout Village  
LCS#: 271581

## Historic Structure Report

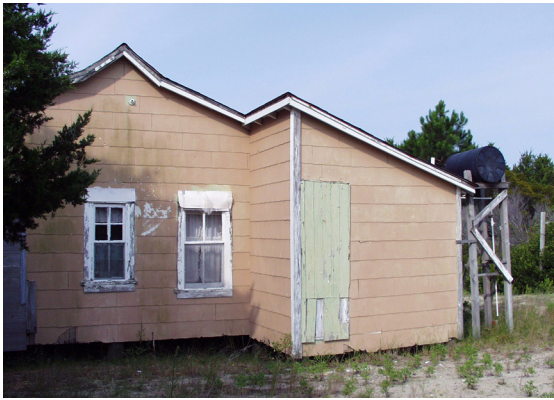
**Figure 26** View of house from northeast showing bathroom addition. (NPS-SERO-CRS, 2002)

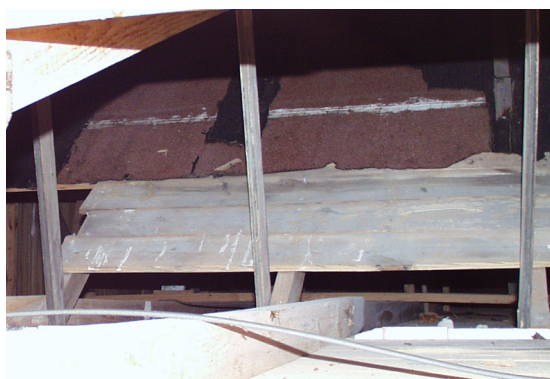
**Figure 29** View of original (1939) asphalt roll roofing in attic. (NPS-SERO-CR, 2003)

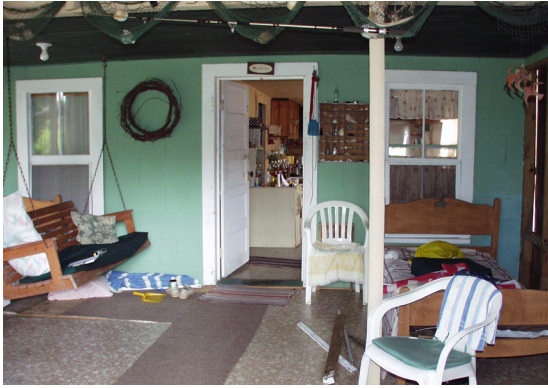
**Figure 32** View of front porch.  
(NPS-SERO-CR, 2002)

*Floor:* The entire floor framing system was replaced when the porch was expanded. Plywood flooring is now covered with a modern vinyl floor covering.

*Ceiling:* The historic porch ceiling is finished with 3- 1/2", V- joint, tongue- and groove boards, painted green and in excellent condition. This ceiling dates to the first expansion of the house in the early 1940s.

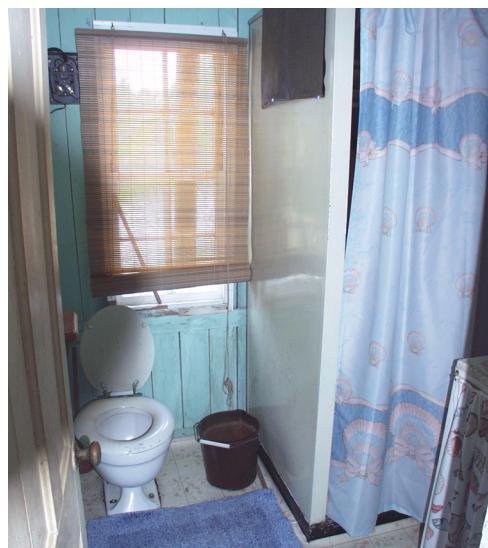
**Figure 38** View of bathroom.  
(NPS-SERO-CR, 2002)

*Fixtures:* In the north corner of the room is a metal shower enclosure, 32" by 32", apparently installed when the room was constructed. The toilet, which also appears to date to the room's original construction, is missing its tank and appears to be flushed using water from the metal water tank mounted on the wooden frame just outside the window. The original sink (if there was one) has been replaced by the present wooden cabinet with a modern, imitation marble sink.
