Cape Lookout National Seashore

Portsmouth Life- Saving Station

Historic Structure Report

2006

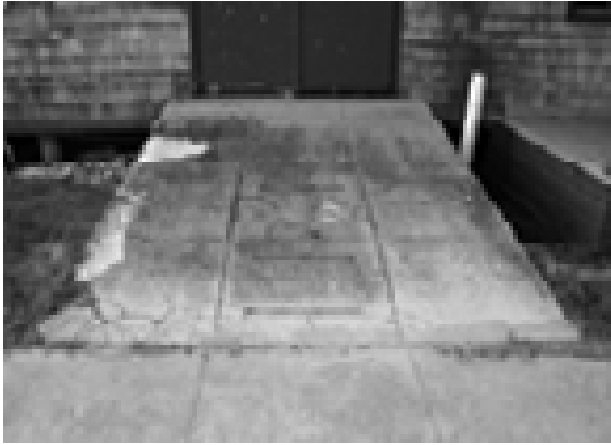
FIGURE 55. View of ramp to smaller boat room door on northwest side of building. (T. Jones, NPS, 2005)

Condition: The ramp from the easternmost door on the northwest side of the building is basically sound, but the finish layer of concrete on the other two ramps is spalling away from the base along part of the edges of the ramps.

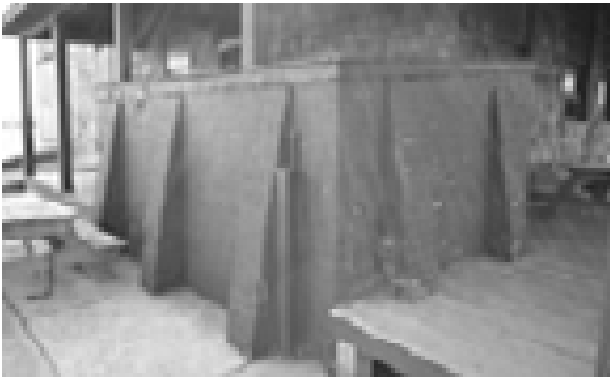
FIGURE 61. View east of cistern. (T. Jones, NPS,

FIGURE 62. View southwest of cistern. (T. Jones, NPS, 2005)

Condition: The cistern appears to be in sound condition, but downspouts from the gutters no longer

keep it filled. The wooden cover is in fair condition. The hatch that provides access to the interior of the cistern is nailed shut, and the condition of the interior of the cistern was not inspected.

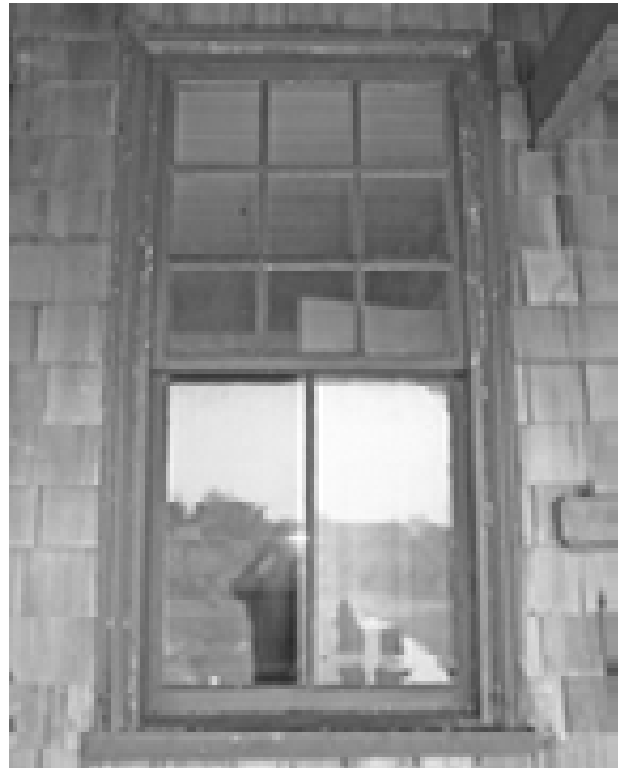
Condition: Some of the sash may have been replaced, and most are in good condition, although many of the counterweight ropes are broken and there are several panes of broken glass. The sash in the attic window, which are almost certainly original, are badly weathered, primarily because the interior side of the sash has not been maintained. At the northeast end of the boat room (Room 107), recent storms badly damaged both windows (w- 6 &

FIGURE 76. View of W-2, a typical nine-over-two window. (T. Jones, NPS, 2005)

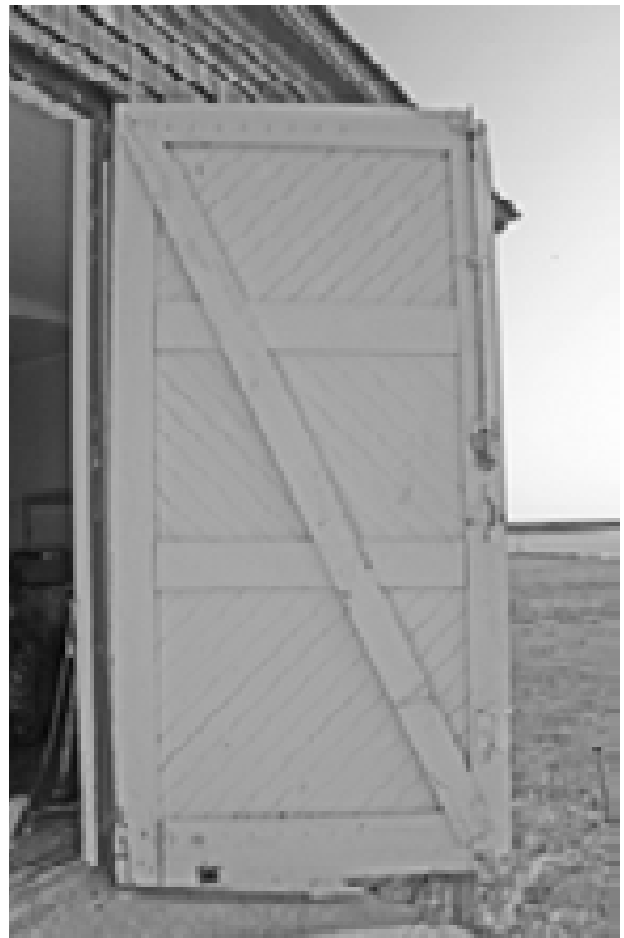
FIGURE 82. View of one leaf of Boat Room door D-3. The diagonal brace is not an historic feature. (T. Jones, NPS, 2005)

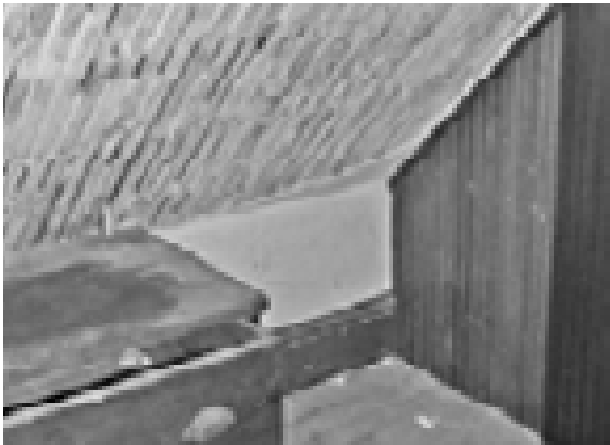
FIGURE 88. View of original plaster on wood lath in one of the closets in Room 201. (T. Jones, NPS, 2005)

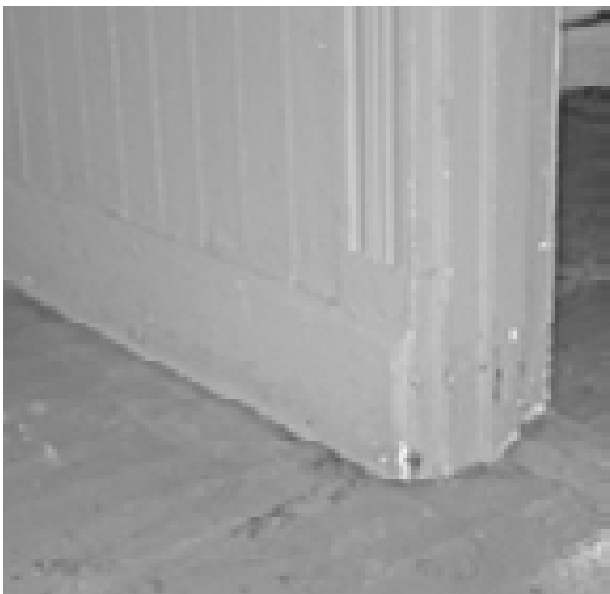
FIGURE 90. View of typical flooring, wainscot, and baseboard. (T. Jones, NPS, 2005)

Condition: Flooring is in good condition on the second floor, but the recent storms and accompanying flooding tore loose a large section of the flooring in Room 107 and buckled a section of the flooring in Room 104. The remainder of the flooring on the first floor is in fair condition, with only slight cupping of the boards as a result of the flooding. Flooring on the second floor remains in good condition.

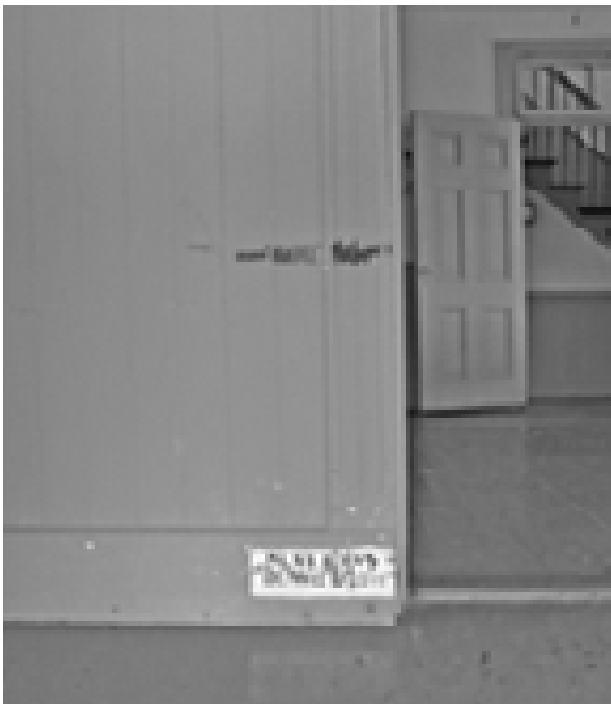
Condition: The lower two or so feet of the plaster walls on the first floor have been severely damaged by the recent flooding, when water rose as high as 22" inside the station. Above the water line, the upper walls and ceilings are in fair condition and can be easily repaired. In the closets, where the original plaster on wood lath was not replaced, much of the plaster is missing, although the wood

FIGURE 103. View of marks showing high-water marks for recent hurricanes. (T. Jones, NPS, 2005)

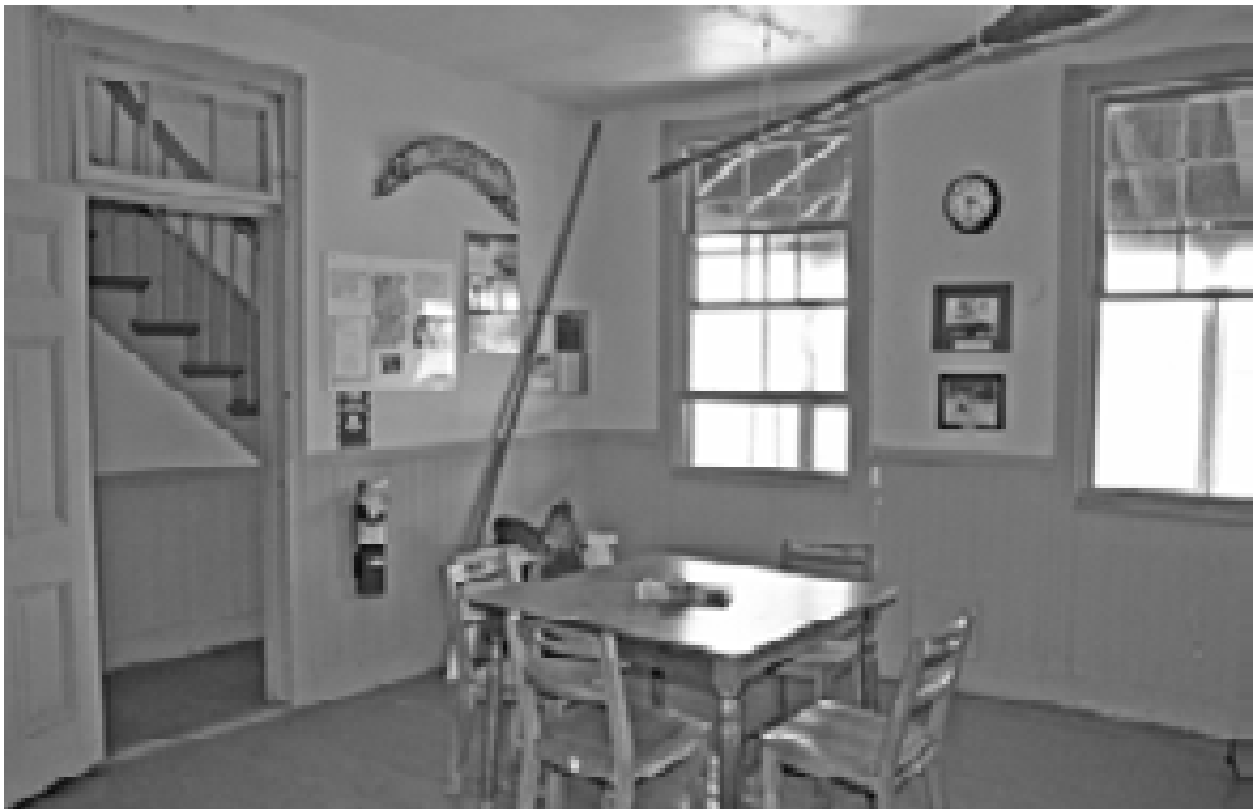
Flooring: The entire floor is laid with painted, 2- 1/2” wide, tongue- and- groove flooring, the only floor in the building laid entirely with the narrower flooring. As a result of storm flooding, flooring is severely buckled on the northwest side of the room.

FIGURE 104. View east in Room 104. (T. Jones, NPS, 2005)

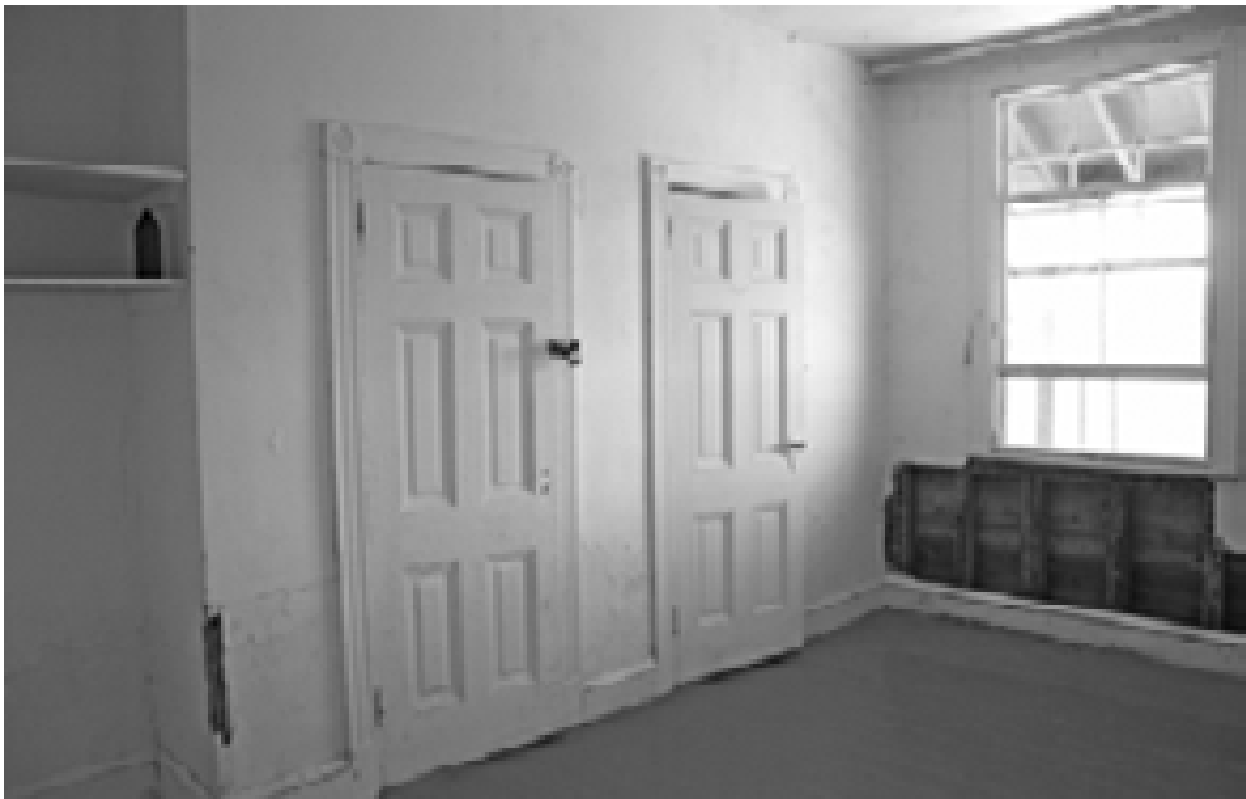
Walls and Ceilings: Walls and ceiling are finished with plaster on plaster board. Recent flooding badly damaged the lower portions of the walls, and some of the plaster board has been removed. Residue from the original plaster on wood-lath walls is visible on exposed studs.

FIGURE 117. View west in Room 106. (T. Jones, NPS, 2005)

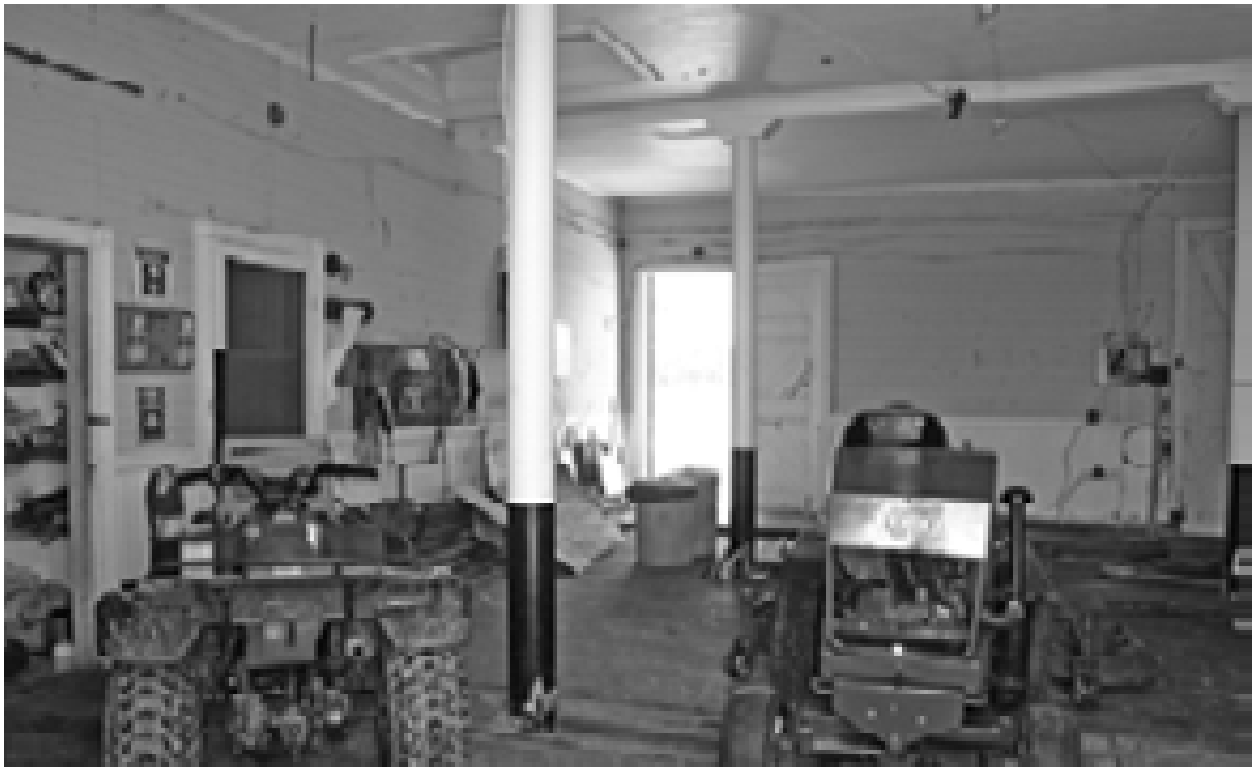
FIGURE 123. View west in Room 107. (T. Jones, NPS, 2005)

Windows: The room has two windows, both located on the room's northeast wall and typical nine-over-two windows, 3'-4" by 5'-10". The north window of the pair was badly damaged by the storm surge during Hurricane Isabel. The sash and most of the frame were knocked from the opening, but the sash were not destroyed.

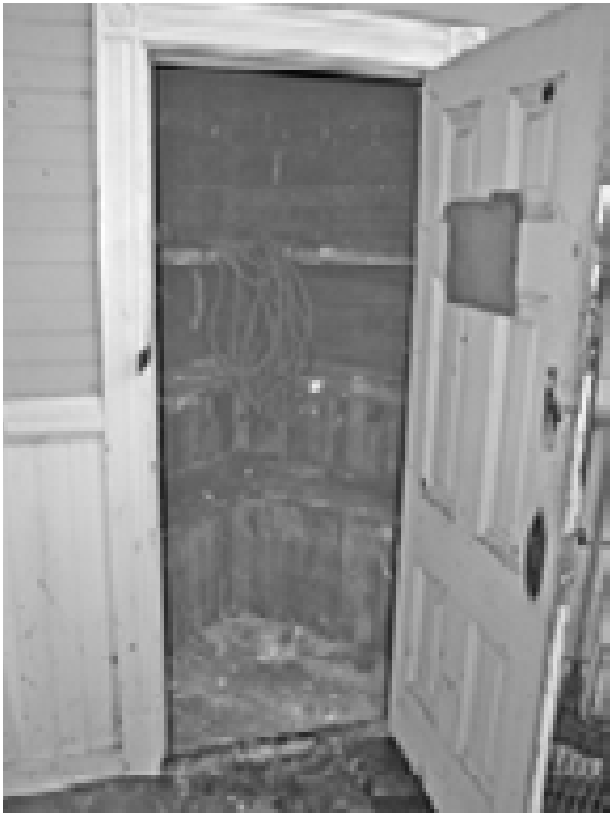
FIGURE 126. View of corner closet in Room 107. (T. Jones, NPS, 2005)

closet under the stairs is a three- drawer chest similar to those found in the crew's closets on the second floor. Although in poor condition, some of the building's only surviving plaster on wood lath is also found in the closet beneath the stairs.

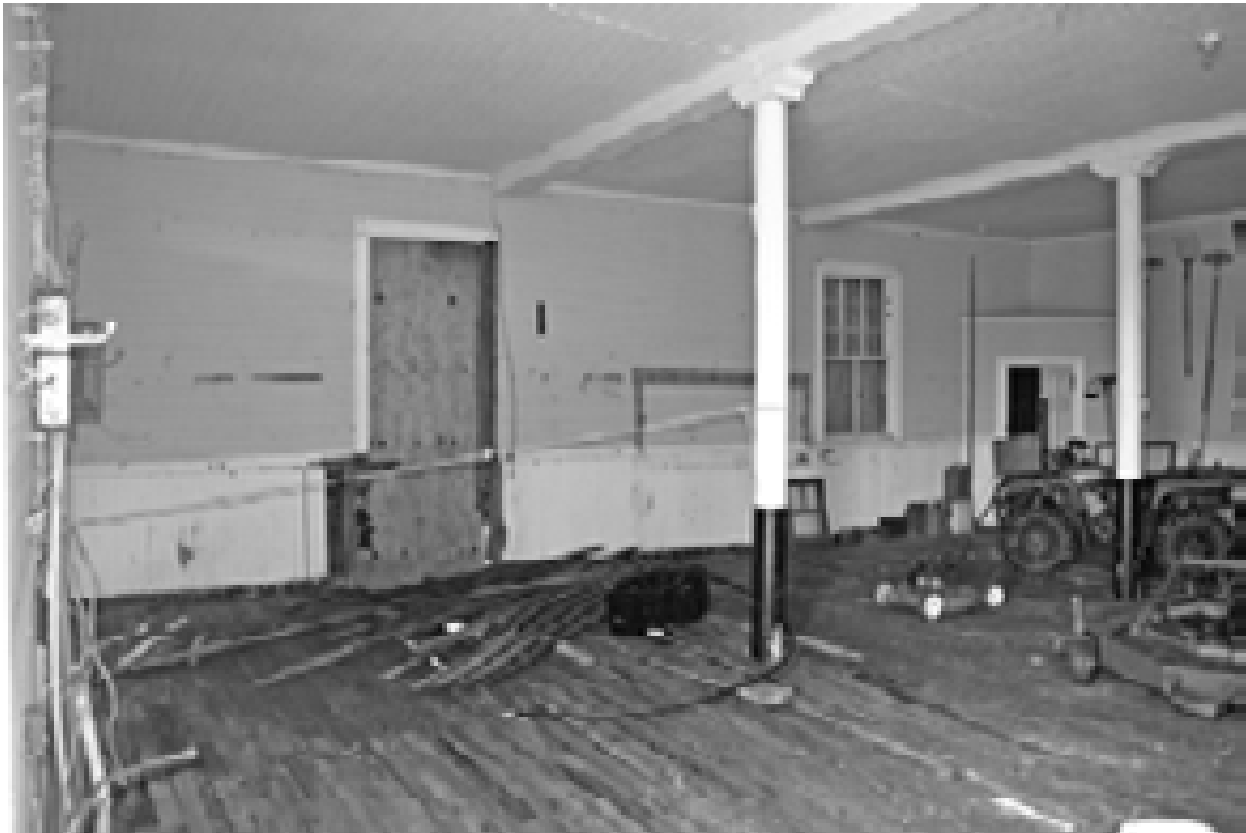
FIGURE 127. View east in Room 107. (T. Jones, NPS, 2005)

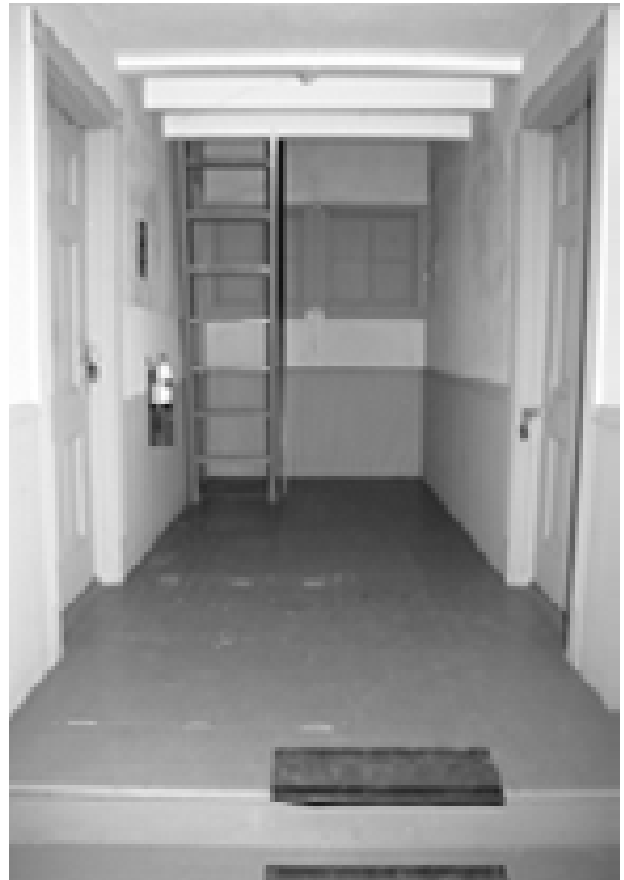
Walls: Walls are also plaster on plaster board along with a 37"- high wainscot of 3" beaded tongue- and- groove boards like that in the hall (Room 105) below. Paint is peeling badly from some portions of the walls.

Doors: Three doors open out of this space into the three adjacent rooms. All are typical six- panel doors measuring 2'- 10" by 6'- 10". The door into Room 201 also has an 18"- high, three- light tilting transom. Escutcheons and knobs are missing from the doors to Rooms 202 and 203.

FIGURE 128. View northeast in Room 200. (T. Jones, NPS, 2005)

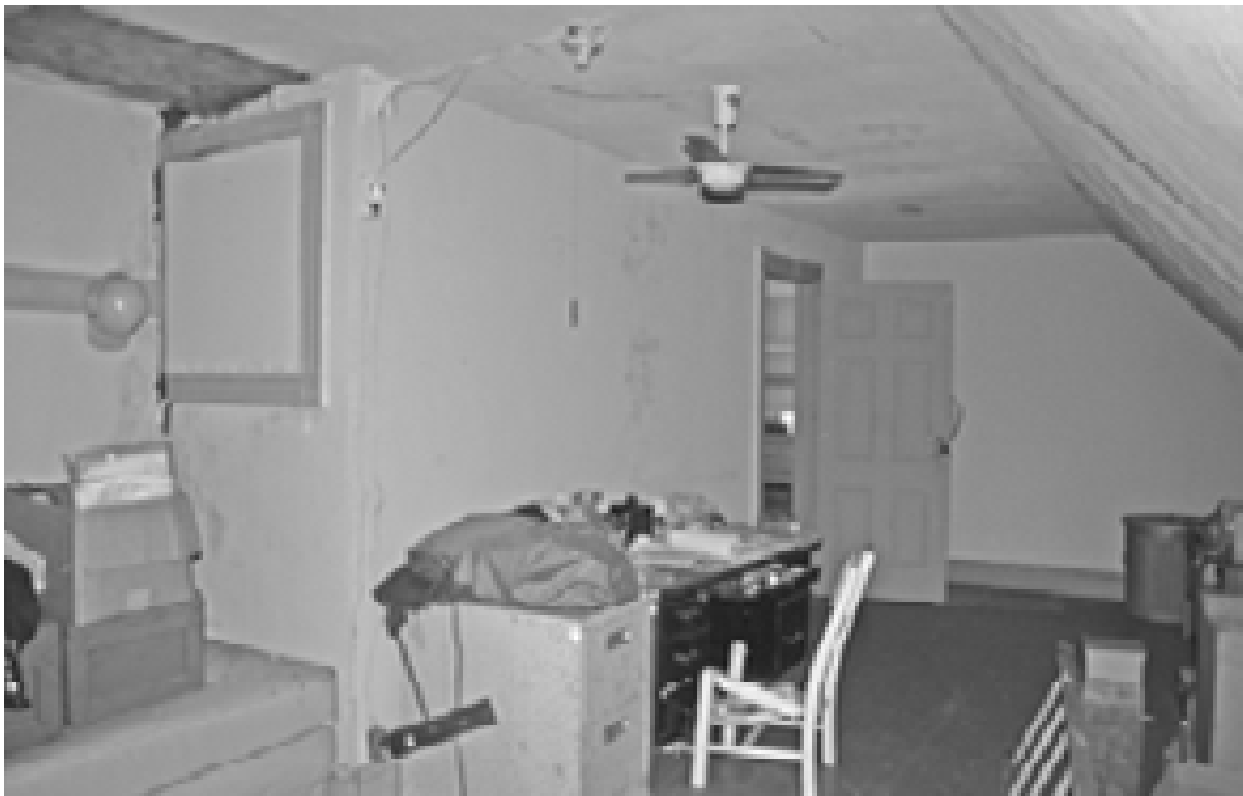
FIGURE 140. View southwest in Room 202. (T. Jones, NPS, 2005)

Miscellaneous: The wall below the dormer window has been severely damaged, apparently due to water penetration.

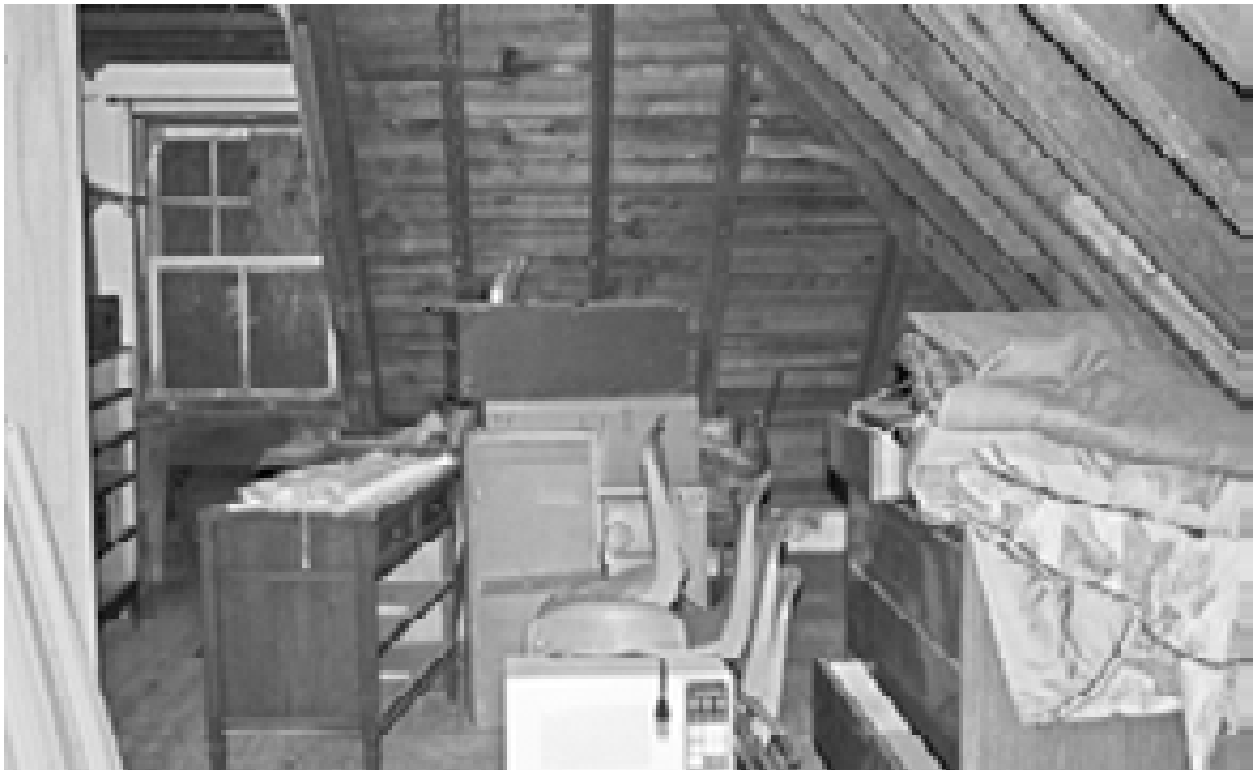
Windows: As in Room 202, this room has two windows. One of the double dormer windows provided light for this room but is now boarded up. The six- over- two sash is in poor condition. Also as in Room

FIGURE 141. View northeast in Room 203. (T. Jones, NPS, 2005)

202, opposite the dormer window, there is a borrow light for the adjacent hall (Room 200). It, too, is missing all glass and is boarded over.

Trim: Wooden casing, baseboard, and other trim were not used in this room. Instead, when the fiberboard walls and ceiling were installed, 4"-wide strips of fiberboard were used for casing and baseboard. Most of that material is now missing.

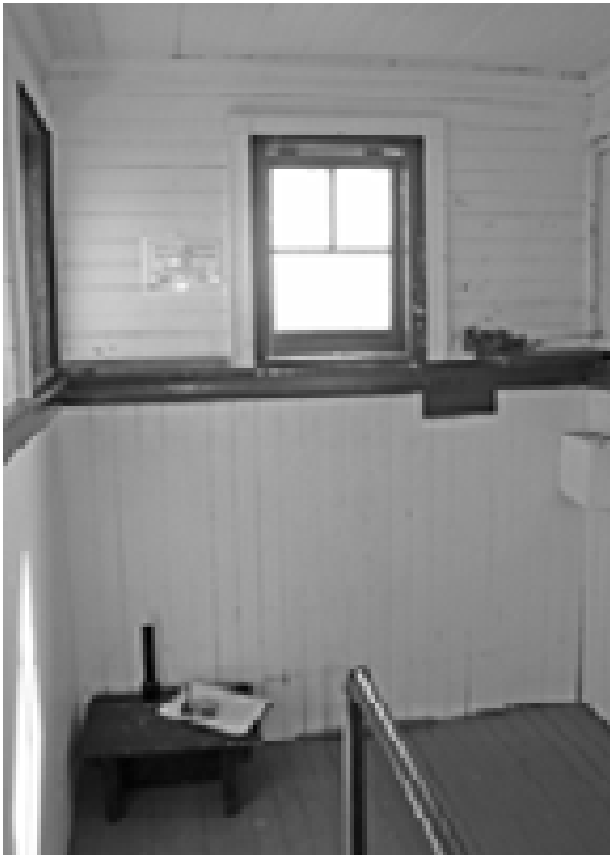
FIGURE 149. View northeast of watch room. (T. Jones, NPS, 2005)

Flooring: Flooring is painted, 3"- wide, tongue- and- groove. A small area of water- damaged flooring in the west corner of the room is covered with plywood.
