Chapter 11:

Treatment Projects

BROMIDE SPRINGS AREA: REHABILITATION TREATMENT

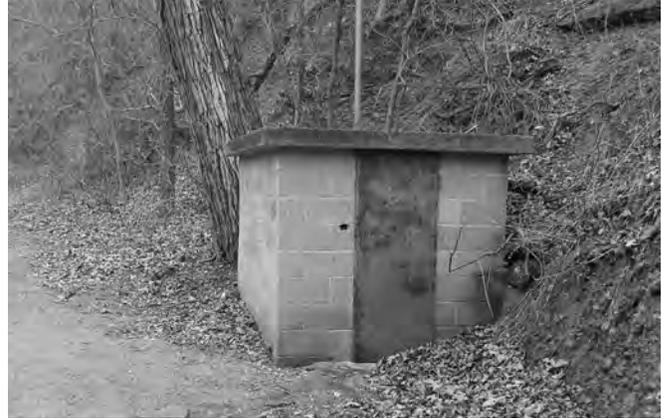
Rationale: The pump house (Figure 11-3) is no longer functioning and cannot be retrofitted to restore function. Since it detracts from its surroundings, does not date to the period of significance (1933–1940), and is not on the LCS, it may be removed. A pipe in Rock Creek just upstream from the low-water crossing is part of this structure and should be located and removed along with the structure.

Figure 11-3. Concrete block pump house to be removed as part of Project B2.

Recommendations: This project should probably be done prior to and/or in conjunction with restoring water to the pavilion (Project B9, below), since its demolition may provide additional clues to the original plumbing of the pavilion. Removal should include capping off the wellhead to prevent contamination. Once the pumphouse has been removed, the area should be regraded and replanted with understory vegetation.

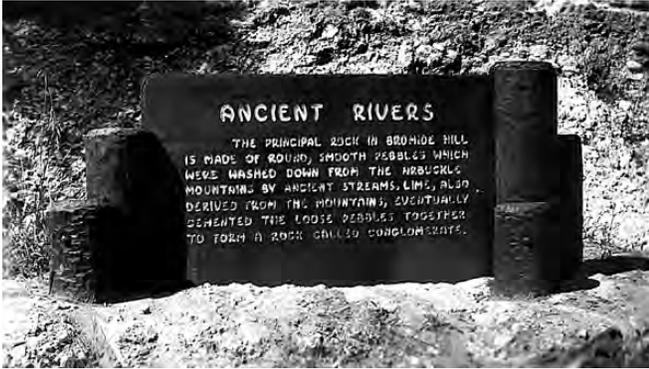
Figure 11-7. Original “Ancient Rivers” sign, no date. Current sign should be replaced with sign duplicating original as shown here. The sign at Travertine Island can be used as a template for reconstructing new sign.

Recommendations: When existing sign fails, replace with a sign closely matching the historic sign, based on photographs and original plans (Figure 11-7 and Figure 9-22). However, if interpretive needs indicate a new text message is preferred, a new sign following current NPS signage guidelines should be instituted.

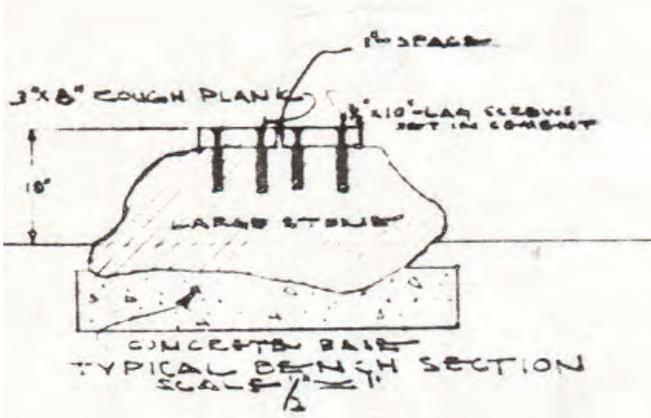
Rationale: The semi-circular bench (Figures 11-10 and 11-11) is a missing part of the pavilion and an important lost landscape feature.

Figure 11-11. Cross-section showing construction of semi-circular bench, to be duplicated in reconstruction.

Recommendations: Replace the bench based on historic photos and historic plans (such as Figure 11-12), utilizing extant stone bases. Cedar or other rot-resistant laminated wood should be used to reconstruct the bench surface. Brown Trex® plastic lumber might be investigated as a bench material, but while durable, it may prove to be too

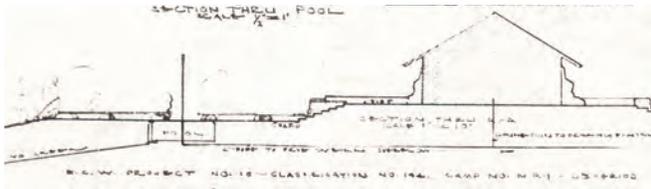
Figure 11-12. Portion of “Spring Development. Bromide Pavilion Springs,” NP-PLA-3048B, 1935. Cross-section showing relationship of semi-circular bench to the terrace wall and pavilion, to be duplicated in reconstruction.

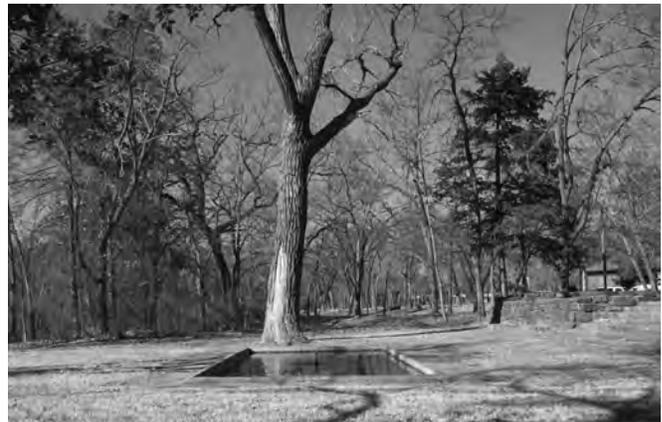
Rationale: Though currently in good condition, the cottonwood (Figure 11-15) adjacent to the Lily Pond is beginning to move past maturity and into decline. Cottonwoods often do not live past 100 years and this tree, mature in the 1930s, is beginning to reach that age. As one of the tallest trees in the area, it is also potentially vulnerable to lightning strikes.

Figure 11-15. Cottonwood tree near Bromide Lily Pond. Tree replacement should be planned.

Recommendations: When this tree dies, it should be replaced in-kind with a native cottonwood. A large tree might be located elsewhere in the park and brought in

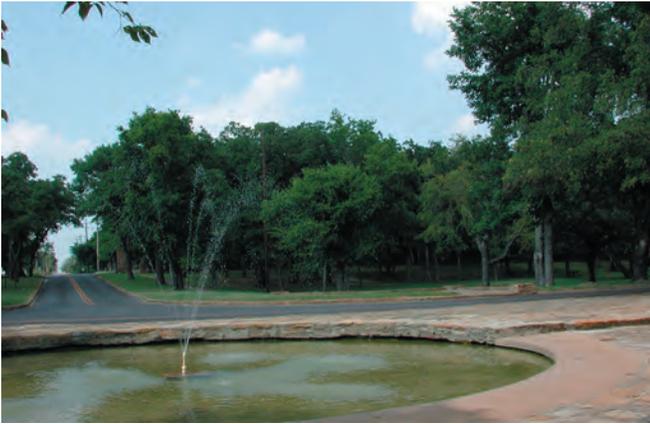
Rationale: During the period of significance, the 12th Street Fountain had a 30-foot artesian jet (Figure 11-16). Today the fountain is a delicate jet, run off of city water (Figure 11-17). Returning a central visual feature to the fountain, will restore the appearance and feeling of the entry.

Figure 11-17. Existing fountain lacks powerful, artesian well jet.

Recommendations: Given water supply issues within the region, it is unlikely that an artesian well to supply a jet at the scale of the original will be practical to locate

and drill, either within or without the park. The easiest way to recreate the water feature as it appears in historic photographs would be to install a mechanical fountain supplied by a re-circulating water pump to save water. This will require an electrical line and, most likely, new plumbing, and a timing system may be useful to regulate the jet and to replenish evaporation. For efficiency, this project should be linked with the repair of the lily pond (see above), since these two water features are currently linked. The rehabilitation should install two valves for the two water features; currently they both utilize the same valve and line. Depending on the status of the existing piping and requirements of a new jet, this project has the potential to be disruptive to the existing masonry paving and walls. Therefore, this work should also be coordinated with other water and masonry repair projects at the entire fountain area (see **Project B13** below).

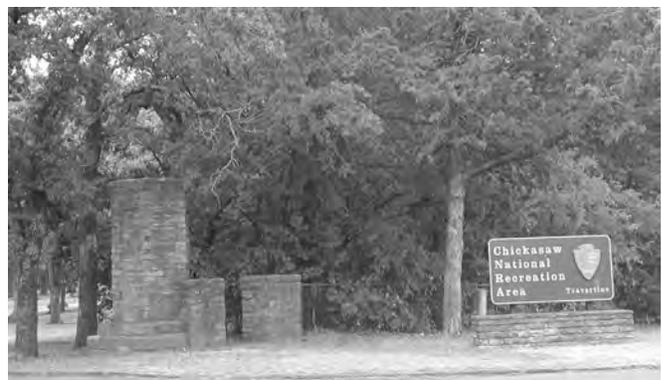
Rationale: Entry piers once had cast iron lettering on their south elevations. This lettering was removed, and a new sign is located adjacent to the piers (Figure 11-21).

Figure 11-21. Entry pillars (left) should receive cast iron lettering to match original. “Platt Historic District” text will clearly identify the historic district and will complement existing CNRA sign.

to help provide a visual identity for the district. “Platt Historic District” is suggested as lettering to complement existing NPS signs. Lettering should be returned to both sets of piers, as per the original conditions.

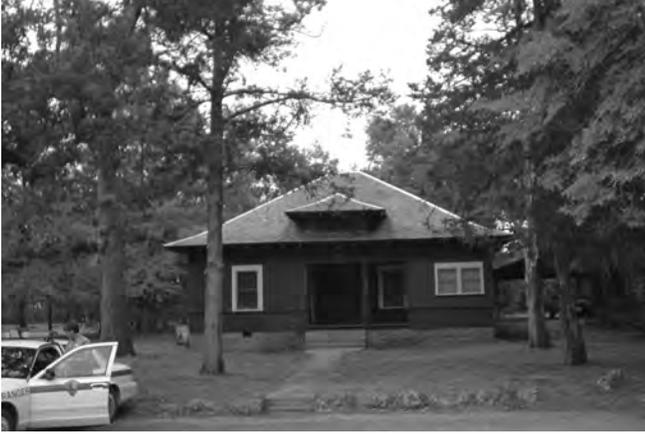
Figure 11-22. The Bromide Ranger Station should have non historic features removed and, over the long term, non-historic doors and windows replaced.

Rationale: Existing doors and windows do not match historic photographs and plans (Figure 11-22).

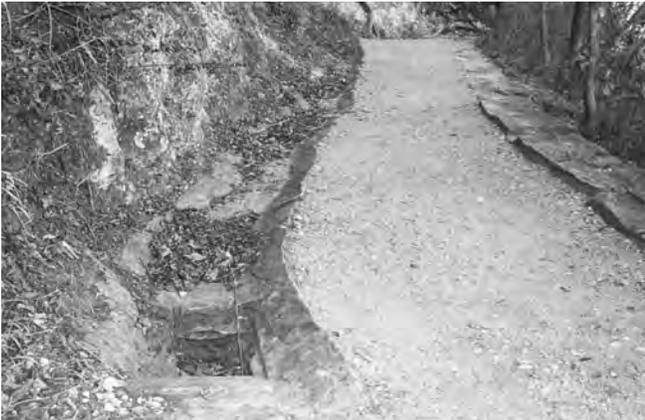
Figure 11-23. Clogged gutter and drain on Bromide Hill. Adding grates over the inlets may help reduce erosion and the need for periodic trail resurfacing.

Rationale: Current gutter inlets on Bromide Hill trail do not have grates and clog with debris (Figure 11-23) and as a result, stormwater backs up on and erodes trail surface.

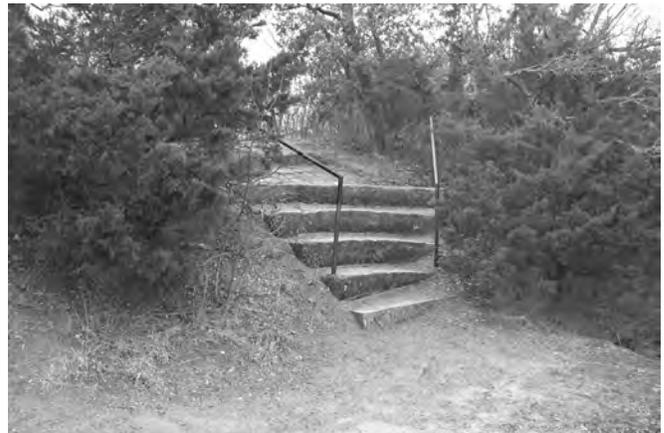
Figure 11-25. Existing concrete steps at the Bromide Hill overlook are inaccessible, and small overlook structure should be added up the trail to provide access to the view.

An accessible overlook area should also be constructed. This could be constructed as a widening in the trail, located just above the flat ledge currently used as a viewing platform for fully-abled people. A retaining wall will need to be constructed and shrubby vegetation between the trail and the flat ledge will need to be removed. The concrete steps (Figure 11-25) at the end of the trail could either be replaced or retained.

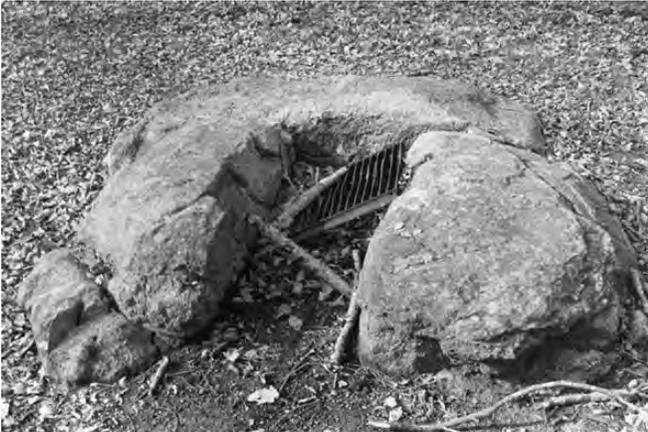
Figure 11-27. Second of four firepits to be repaired. This structure may not support firebrick interior.

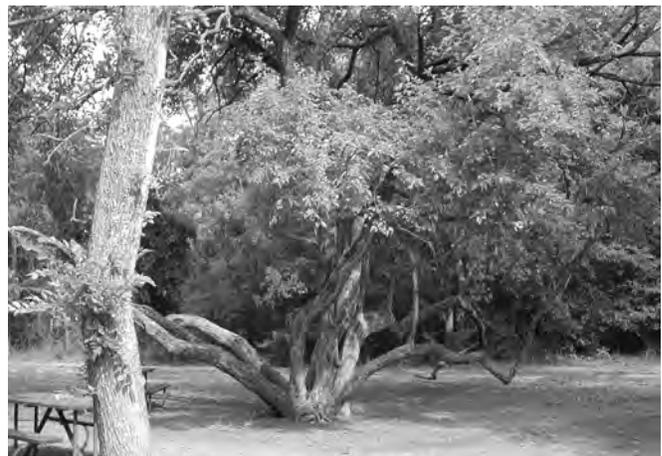
Figure 11-29. Monkey Tree, 2001. Note loss of bark and branches.

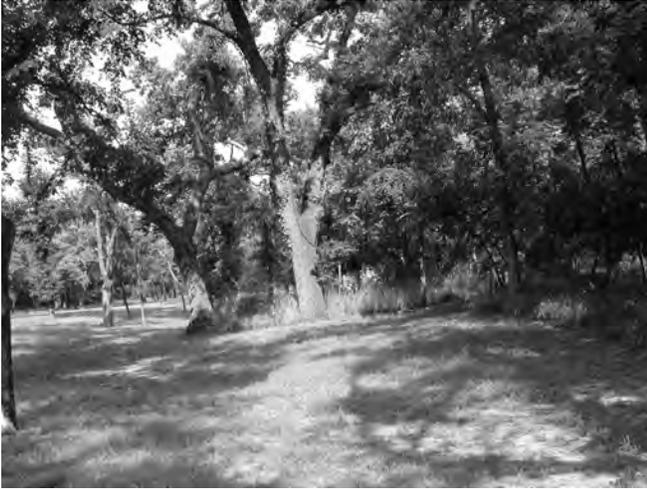
Rationale: Wild rye establishing itself in the foreground of Walnut Grove is somewhat inconsistent with the traditional mowed setting of the area, but is a low-maintenance native groundcover. A change in mowing patterns could recreate historic appearance, while retaining wild rye in the area (Figure 11-31).

Figure 11-31. Canada wild rye grows in the understory at the northern, back edge of Walnut Grove. Reducing mowing along this wooded forest edge might be “exchanged” for increased maintenance in the understory at the front of the picnic area.

Recommendations: Mow areas along the perimeter road, and reduce height of understory in clumps of trees located along the perimeter road. Concurrently, reduce mowing at edge of vegetated slope at the north and west sides of the area and establish and encourage wild rye in the understory.

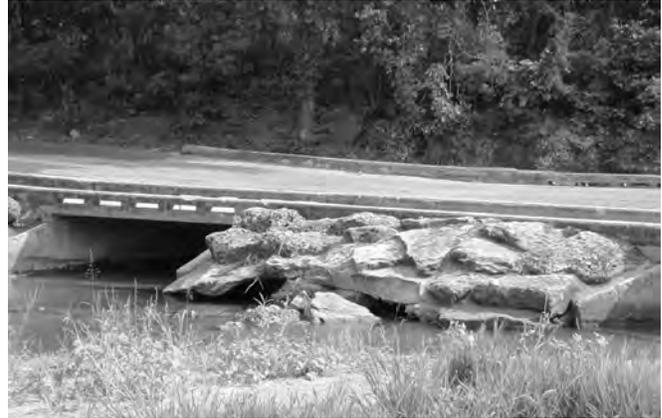
Figure 11-38. Dark areas at base of stones indicate places where stream is undercutting causeway. Masonry repair is required.

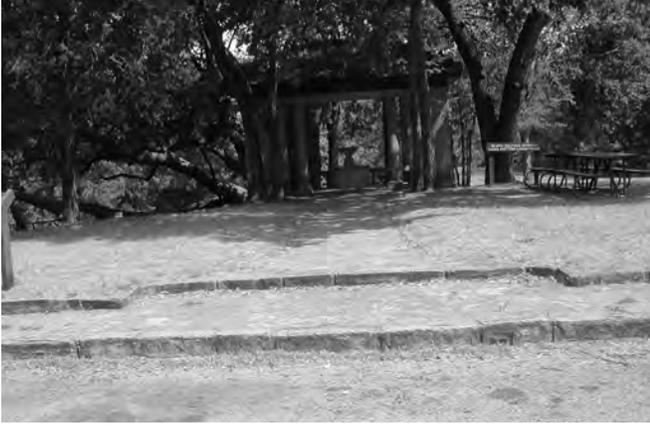
Figure 11-41. Two low curbs at the entry to the pavilion are barriers to ADA accessibility. While the lower curb can be easily surmounted by constructing a ramp at the north end of the parking area, the second curb is still a barrier. A long-term solution of ramping between the second curb and the grade of the pavilion is proposed.

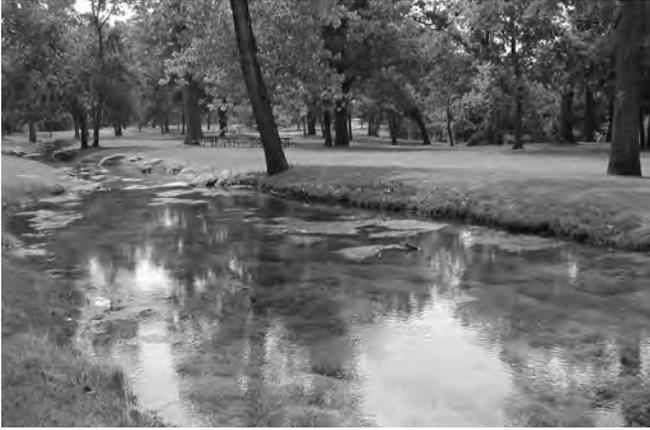
Figure 11-46. The upper wading pool is narrowed in size, and its edges do not have the same boulder edges as the rest of the stream. Pool should be enlarged to original size.

Rationale: The stone edges of the Vendome stream are deteriorating and in some places are being undercut by stream flow (Figures 11-44 and 11-45). The stream's pools have narrowed over time and no longer reflect their historic configurations (Figure 11-46).

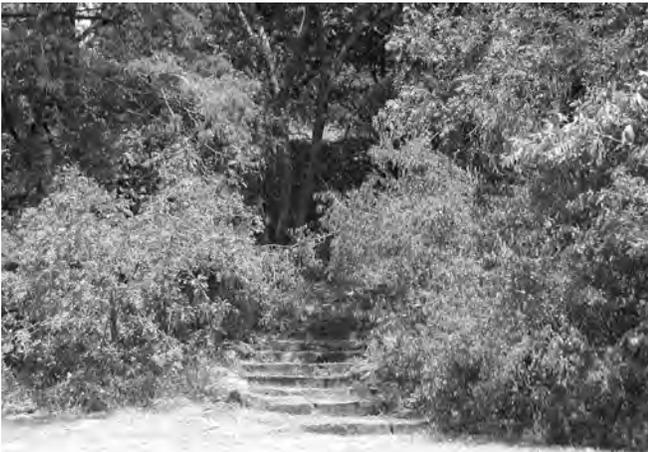
Figure 11-52. Dense vegetation east of the Flower Park comfort station discouraged use of upper trails. Clearing here has already begun as part of the 2003 trail rehabilitation (see Project FP0).

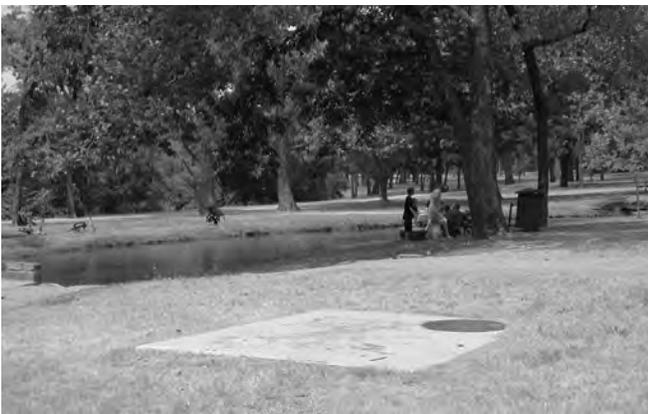
Figure 11-53. Large concrete siphon covers and manholes without regular maintenance needs could be placed below grade, but only when infrastructure is replaced in the future.

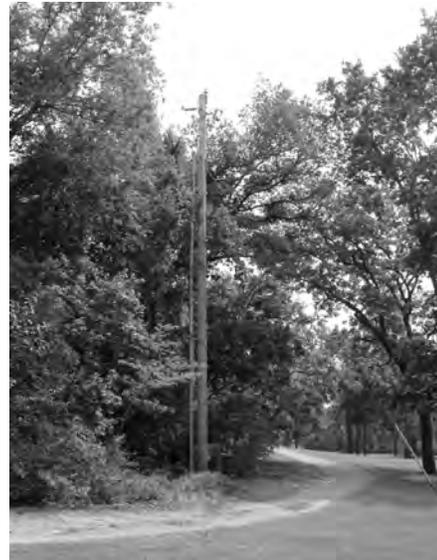
Rationale: Interpretive activities and civic events sometimes use park at night and existing lighting, may be insufficient. Current lighting is provided from a light standard southeast of Lincoln Bridge, on a standard utility fixture, with service provided via a utility pole near the comfort station (Figure 11-55).

Figure 11-55. Extant utility pole in Flower Park might be relocated or placed underground, possibly as part of area lighting plan.

Recommendations: New lighting, if deemed necessary, should be functional for events rather than ornamental. Because lighting was never a character-defining feature of the area, fixtures should be unobtrusive and kept to a minimum. Fixtures should also be clearly non-historic, yet compatible with the historic setting. Returning light fixtures to Lincoln Bridge is not recommended. If electrical fixtures are added or changed, the visually intrusive power pole located near the comfort station (Figure 11-55) should be relocated at the same time.

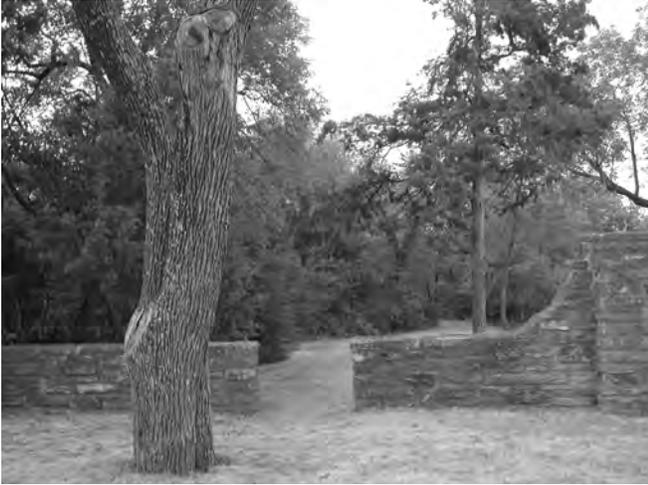
Figure 11-56. Extant entry piers in Flower Park should be retained as is, but enhanced with plantings in keeping with historic plans.

Recommendations: While it might be possible to reconstruct the original gateway's missing, semi-circular walls (Figures 4-42, 4-43, and 5-20), this may require a major reconfiguration to locate the walls and piers at a reasonable distance from the road's curb line (Figure 11-56). Such a reconfiguration would, in turn require a relocation of the entry's associated pathways which connect with the rest of the Flower Park paths. If restoration is feasible, it should be done. If not, the remaining elements might be strengthened with additional ornamental plantings in keeping with the original.

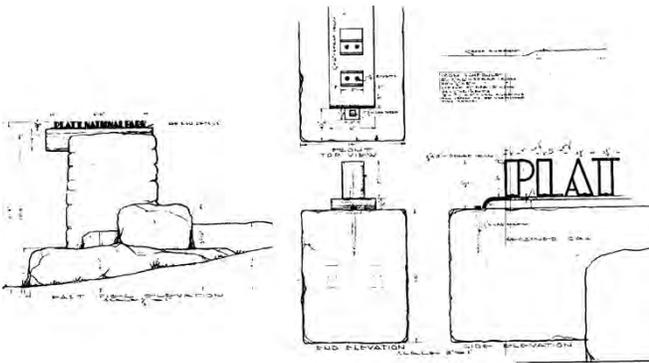
Figure 11-61. Portion of “Entrance Portal, South Entrance,” Drawing NP-PLA-3038A. Strap iron lettering could be replaced on south entry piers to match original design.

Recommendations: An entry setting reinforcing the historic character of the area might be created at the south entry. This could be done by returning the piers to their historic appearance (Figure 11-61). Strap iron lettering that matches the original (Figure 11-61) should be replaced on the piers, and the contemporary CNRA sign relocated to complement the piers. This will aid in identifying the area as the “Platt Historic District.”

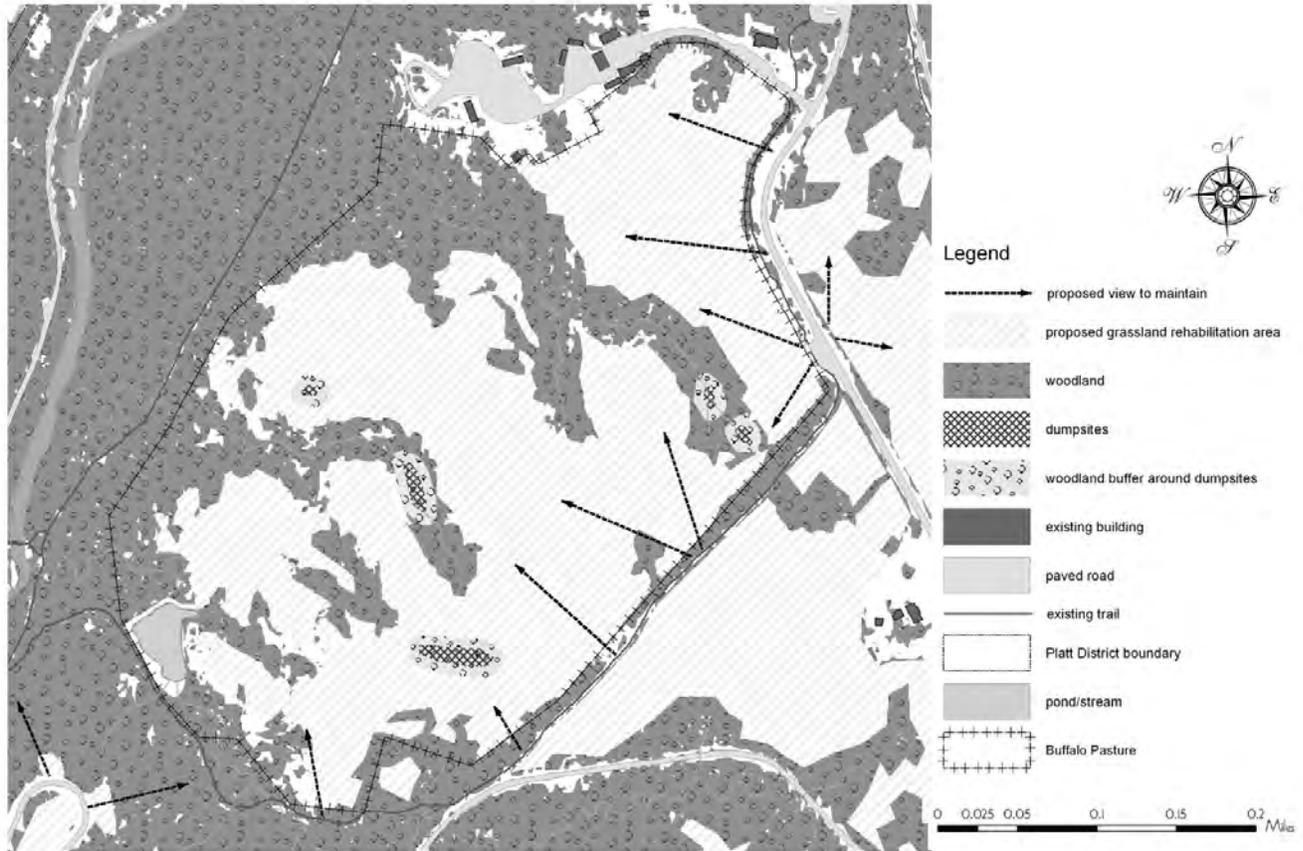
Rationale: The invasion of red cedar into the formerly open grassland of the Buffalo Pasture is a result of fire suppression in the district. Cedar growth has shaded out forage plants and reduced the ability of the land to support the bison. If no action is taken, most preferred native grasses will continue to be gradually replaced by species better adapted to increased shade, soil compaction, and cooler temperatures. In general, the condition of the pasture will decline and the remaining grasslands will convert to additional red-cedar woodland.

Figure 11-62. Proposed plan for the rehabilitation of vegetation in the Buffalo Pasture area, in keeping with the overall vegetation treatment described in Chapter 10 and depicted on Drawing 35. Clearing is proposed for the higher and flatter portions of the pasture, to result in conditions closer to historic conditions, including more open views.

Recommendations: Much of the Buffalo Pasture should be cleared of woody vegetation through a combination of prescribed burn and mechanical removal as described above. Cedar removal will improve pasturage for bison and open views from the perimeter road and the Buffalo Pasture Trail into the pasture. The extent of proposed clearance is shown on Figure 11-62, which can be used as a reference for management, though localized field conditions should also be taken into consideration. In general, clearance is proposed for the higher and flatter elevations of the pasture. Existing woodland should be maintained in the ravines, where woodlands were historically. Historic dump sites should also be maintained in woodland cover, to protect their potential archeological values. In zones adjacent to the woodlands, a transitional zone, providing protective cover for livestock and wildlife, should be created by selective mechanical removal of female red cedar trees.

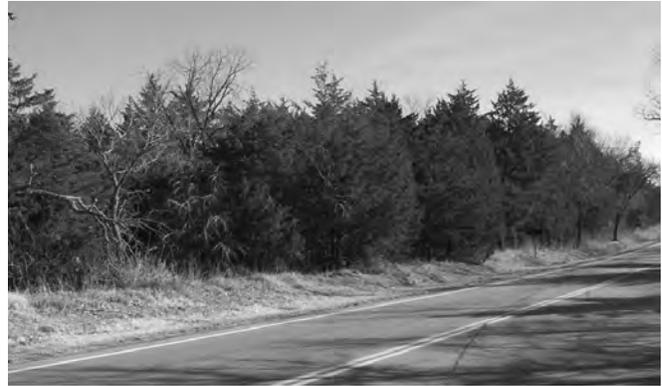
Rationale: Like the Buffalo Pasture, open grassland in the Upland Prairie has been taken over by invasive cedars, in part due to fire suppression in the district. Red cedar has enclosed open spaces, creating conditions which were not present during historic period (Figure 11-65).

Figure 11-65. The Prairie Uplands are densely vegetated and enclosed with cedar and other woody species. These should be removed and replaced with open prairie.

Recommendations: Like the Buffalo Pasture, the Prairie Uplands should be cleared of woody vegetation through a combination of prescribed burn and manual removal. The uplands east of Highway 177 should be cleared of large areas of cedar, as shown in Figure 11-66. This figure shows woodlands maintained along the area's streams and ravines, and maintained in areas where woodlands existed historically, as determined from an analysis of the 1940 aerial photograph. In addition, some woodland should be maintained as a screen along the urban interface near Veteran's Hospital and area residences. However, woodland along the interface should be thinned, with female, over-mature and masses of young cedars (less than 3", as described in the 2001 "Hazard Fuels Assessment") removed from the area, as per urban interface guidelines listed above.

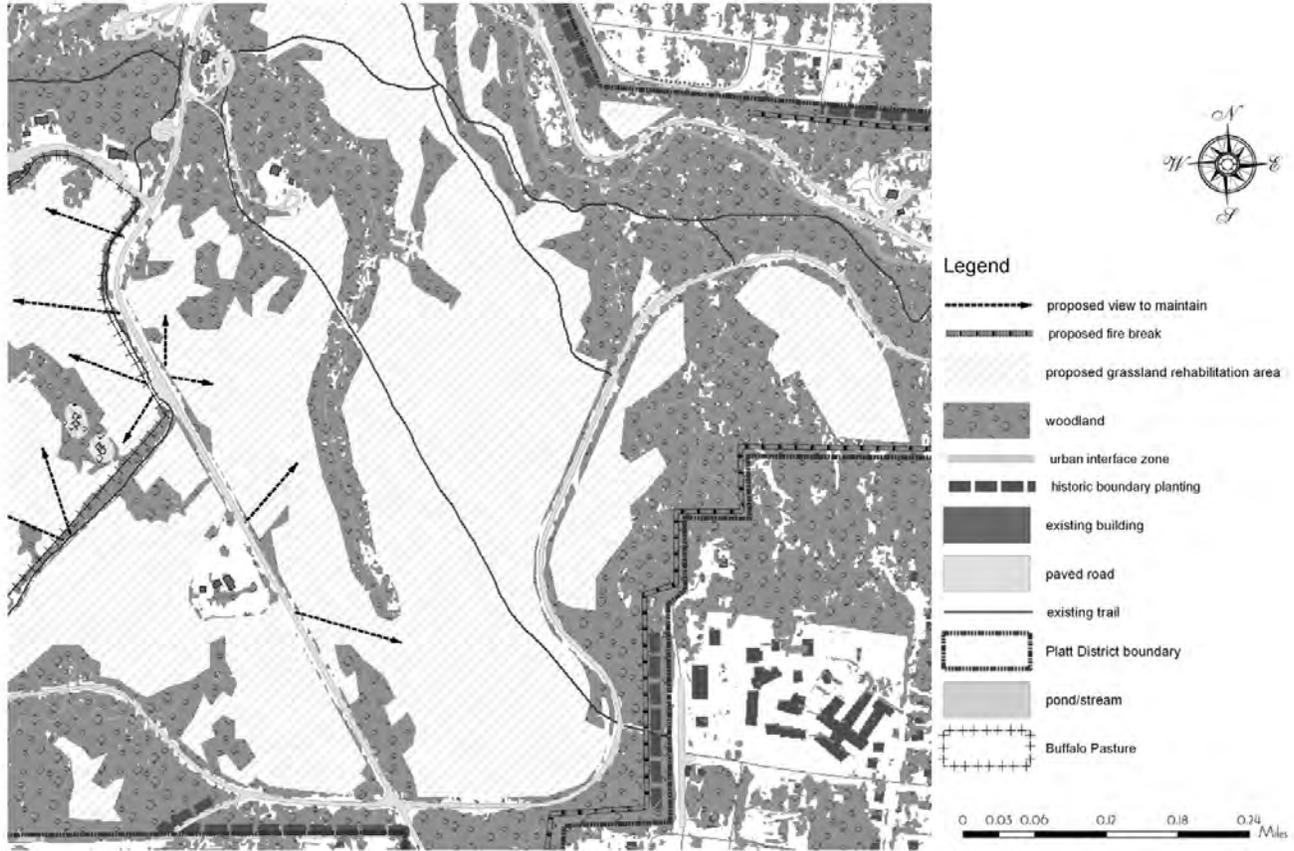
Figure 11-66. Proposed grassland rehabilitation for the Prairie Uplands area, to return area to more visually open historic and more ecologically healthy conditions. See Chapter 10 and Drawing 35 for additional information.

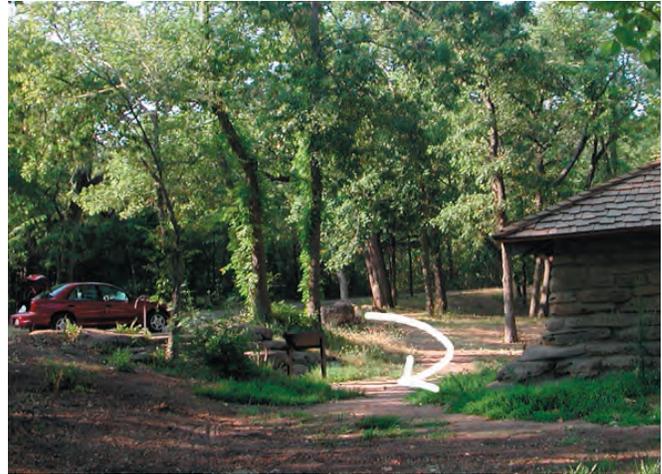
Figure 11-67. Improved, if not full, ADA access can be provided by constructing a ramp between the parking area and the entrance to the pavilion, along the arrow shown in the photograph.

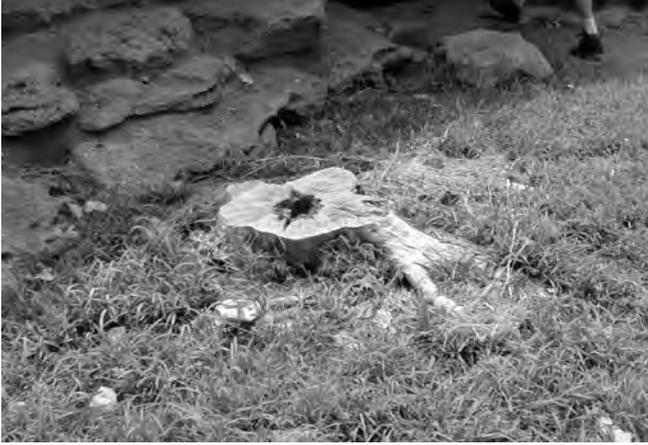
Figure 11-69. Trees lost near the building, as demonstrated by this trunk, and trees in the open landscape immediately south of the pavilion should be replanted to retain the area's shady setting.

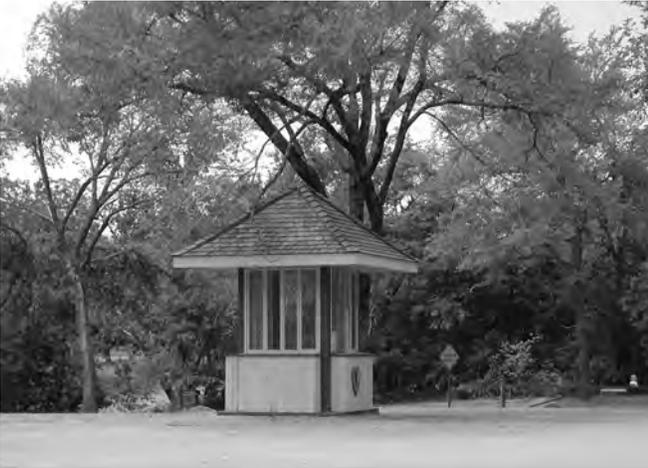
Figure 11-70. No longer used, the non-historic information kiosk north of Pavilion Springs should be removed.

Rationale: This structure (Figure 11-70) does not date to the period of significance and is no longer used.

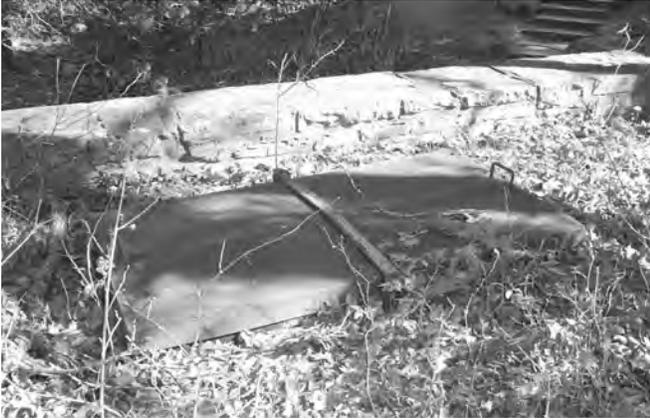
Figure 11-74. Lid on the spring container is rusted, and should be replaced.

Rationale: Lid is rusting and in poor condition that could lead to contamination or debris entering spring and clogging pipes (Figure 11-74). It is not clear if the holes in the lid are contributing to bacterial contamination of the spring.

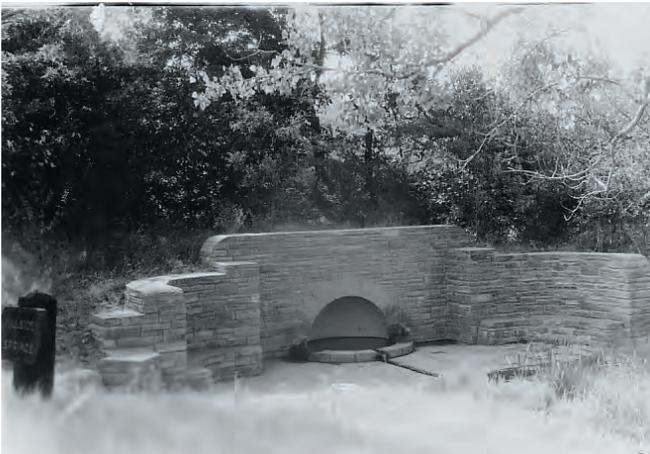
Figure 11-75. Hillside Spring, shortly after construction. Note low post locational sign to the left and more open, sunny aspect of area.

Recommendations: The Hillside Springs sign should be replaced with a low post sign (Figure 11-75) duplicating the original sign. The unsafe water sign should be removed and replaced with a smaller sign with a similar warning message in a new location. The low location of the bubblers and lack of true drinking fountain also already discourage some visitors from drinking the water. Therefore, a new warning sign does not need to be so prominent. It might be located on the flat rim of the basin, or on the wall next to the arch.

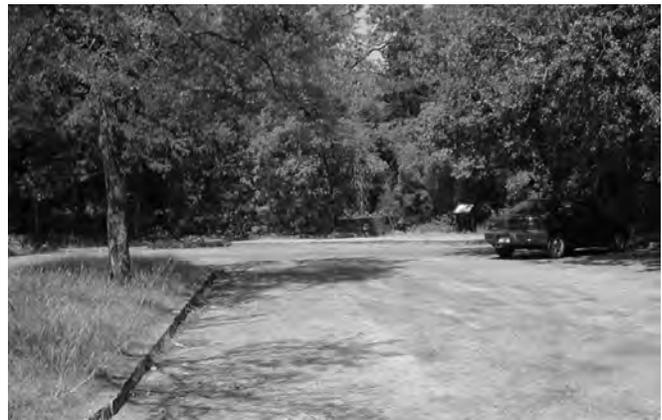
Figure 11-77. Additional trees should be planted in island as per historic photographs, such as Figure 4-72.

Rationale: Trees historically were planted in the island for shade.

Recommendations: Based on historic photos, replace two trees in parking island (Figure 11-77). These trees appear to have been elms and should be replaced with either cedar elm or winged elm. Additional trees in this parking area will be particularly helpful if the lot is used to accommodate training center users.

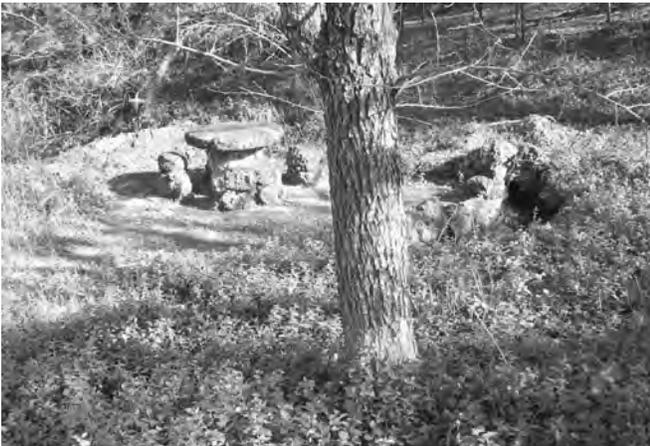
Figure 11-79. Stone seats and pond at Employee Residence should be preserved.

Rationale: Stone seats and pond have suffered from lack of maintenance over time (Figure 11-79).

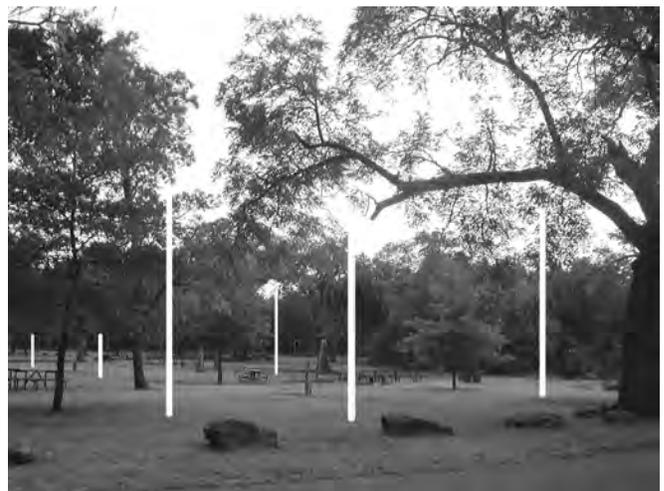
Rationale: Loss of trees due to age and weather has reduced shade in this campground (Figure 11-87).

Figure 11-87. Trees should be replanted in open areas to provide additional shade for campers.

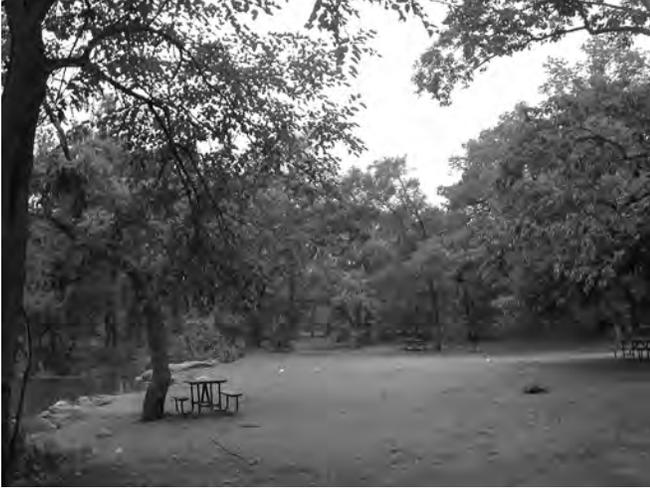
Figure 11-88. Trees should be planted in the open areas of Panther Falls, to anticipate future tree losses.

Rationale: Loss of trees due to age and weather has reduced shade in this picnic area (Figure 11-88).

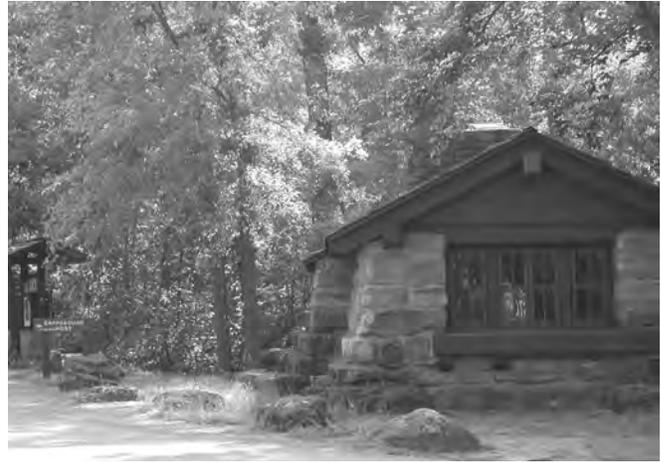
Rationale: The checking station is a wonderful example of CCC architecture that should be used and if possible made available to the public (Figure 11-90).

Figure 11-90. Regular use of the checking station will help preserve the building.

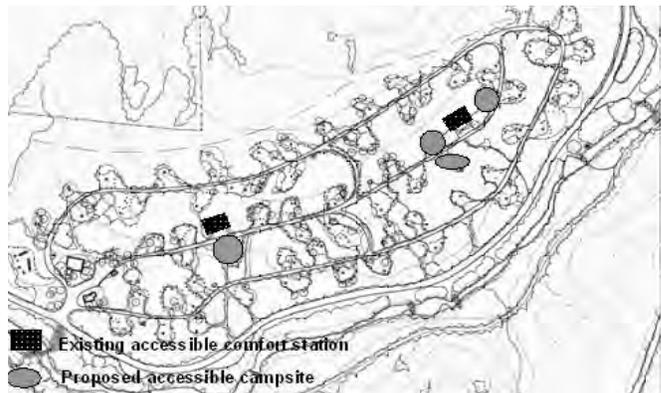
Figure 11-91. Proposed numbers and locations for accessible campsites. While image shows sites clustered around comfort stations, some of these might also be dispersed throughout the campground to allow for different camping experiences.

Rationale: All visitors should be accommodated in the Cold Springs Campground, one of the most popular camping sites in the park. Accessibility guidelines indicate that for every 50 to 75 campsites, 4 accessible campsites should be provided.

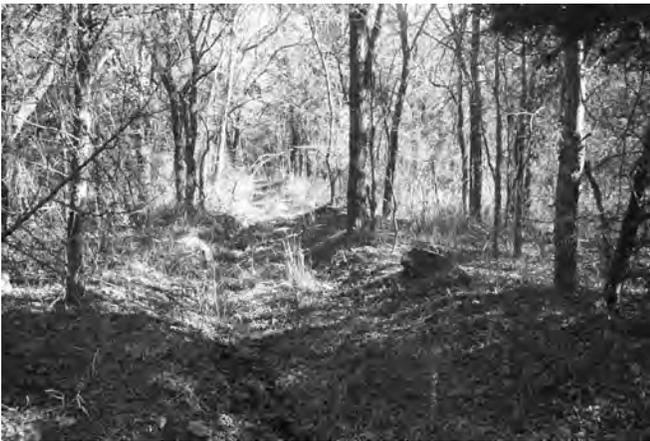
Figure 11-93. Swale north of campground should continue to be cleared.

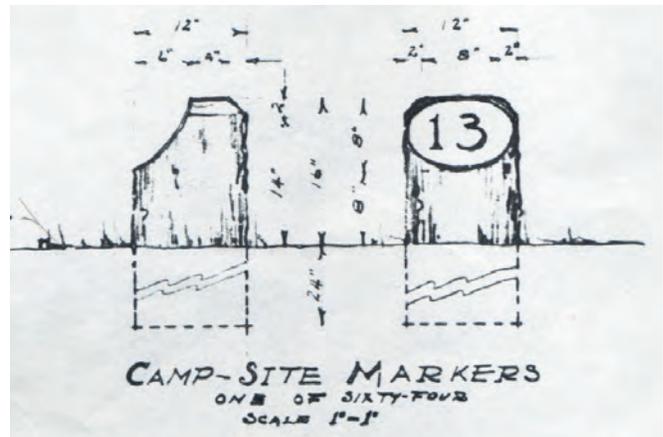
Figure 11-95. Historic campsite markers.

Recommendations: Historic markers were similar to extant bollard-like markers (Figure 11-95). Any new marker should be in keeping with the historic style, but should have a means of indicating occupancy. This might be a red metal flag attached to the back of the bollard. Like a mailbox flag, the bollard flag could be raised when the site is occupied or reserved. To reduce overcrowding on campsites, the two tent and ten-person limit per

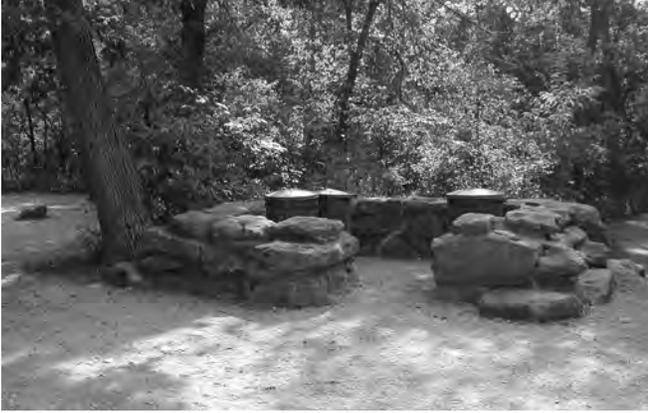
Rationale: Wood and garbage can enclosures (Figure 11-96) are historic structures.

Figure 11-96. Existing wood and garbage can enclosures should be preserved.

Recommendations: Although raccoon-proofing garbage is a high priority, locating the large, brown garbage cans within these enclosures is not recommended. Rather, continuing the use of standard garbage cans with lids is

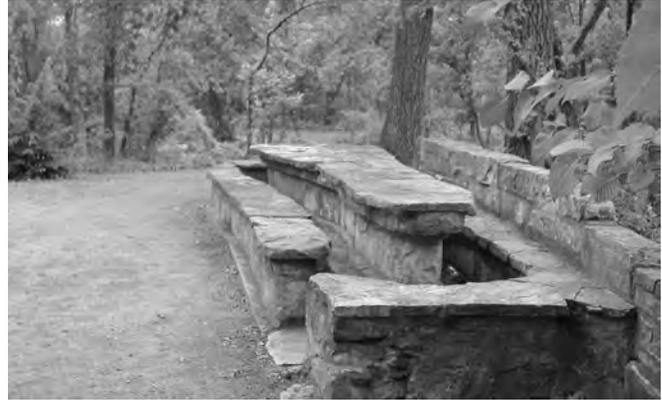
Figure 11-99. Elements at the large picnic area, such as the flaking table top, seats, and walls shown here, should be repaired with new flagstone, using historic masonry techniques.

Rationale: These important historic features, despite previous repairs, continue to deteriorate.

Recommendations: Although portions of this area have been lost, extant features should be restored (Figure 11-99). This will involve repointing the extant walls, and significantly repairing the tables and benches. Concrete parging, which has protected some of the original surfaces, should be removed and the original flagstone surfaces restored. In general, replacing missing features in this area is recommended only if sufficient documentation is located. Although a limited number

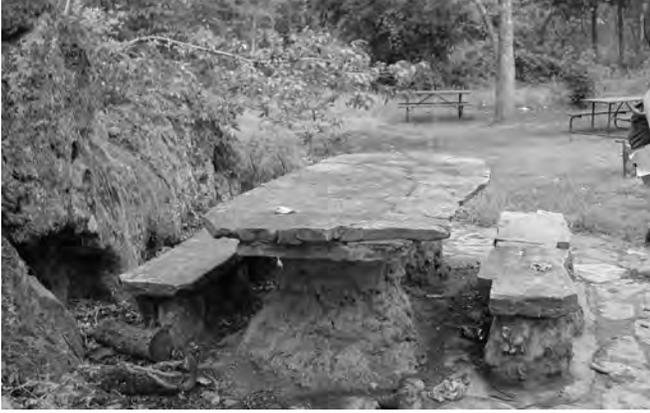
Figure 11-100. Table at the “End of the World” should be repointed and its cracked bench repaired.

Rationale: Condition of cracked bench and spalling table will continue to worsen (Figure 11-100).

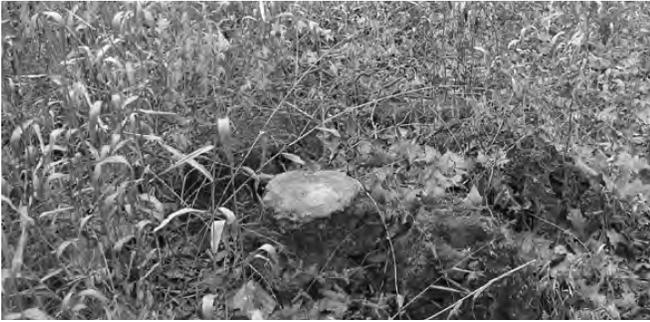
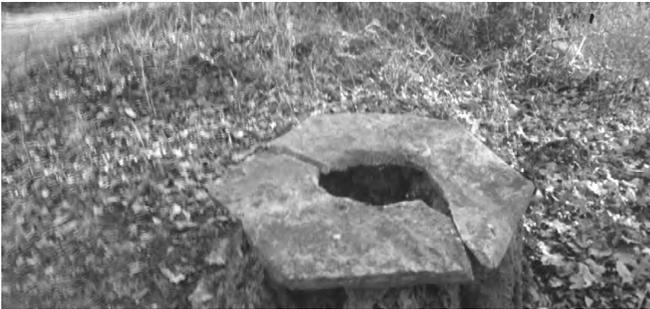
Figure 11-101. Circular stone bench in 2004 (top) and 1993 (bottom). Repair of this feature may not be possible.

Rationale: Table (Figure 11-101) is a historic structure, but is currently only partially intact.

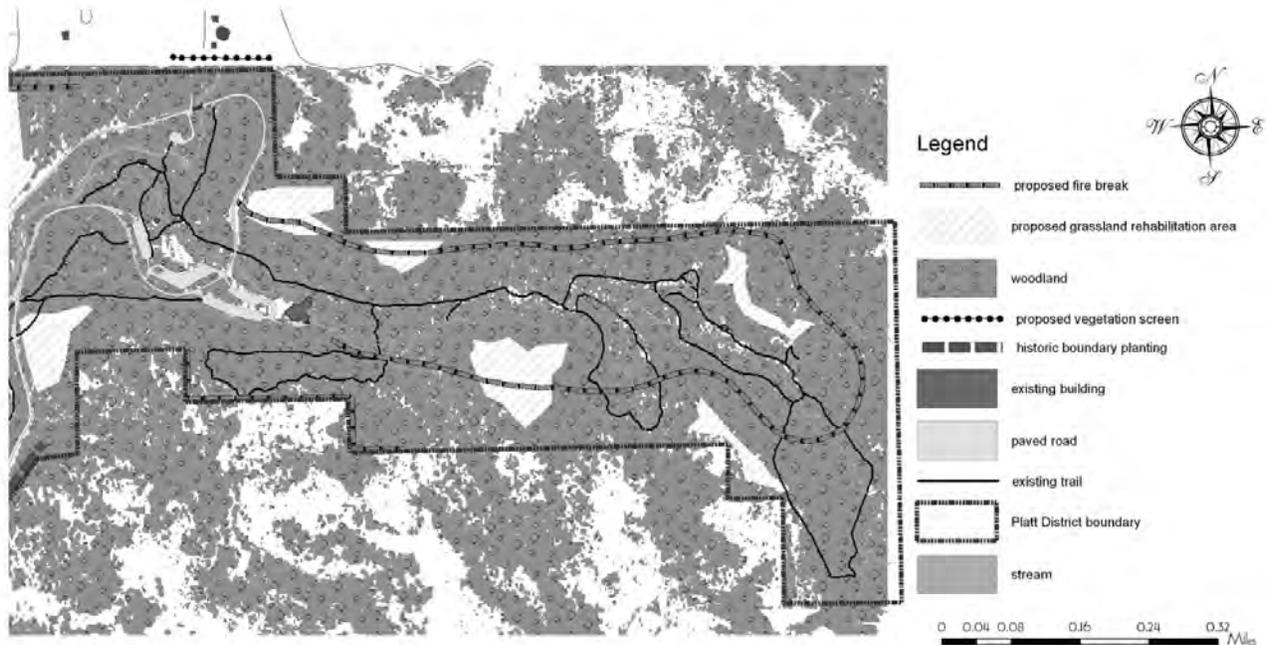
Figure 11-105. Proposed vegetation management for the Antelope and Buffalo Springs area, focusing on cedar control with some grassland rehabilitation.

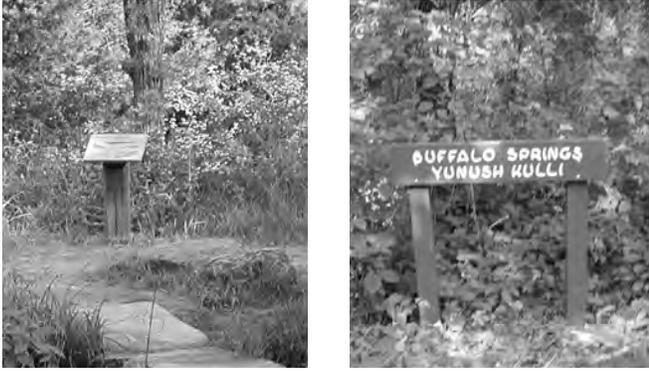
Rationale: There are at least four types of signage throughout area, including plant interpretation; a single NPS standard interpretive sign, low half log signs, and roofed signs constructed at the same time as the Nature Center (Figure 11-106).

Figure 11-106. Just two of the numerous types of signs located at Antelope and Buffalo Springs.

Recommendations: The historic half-log sign at Antelope Spring should be preserved, repaired, and painted as necessary, and the half log sign at Bromide retained and made more historically accurate when

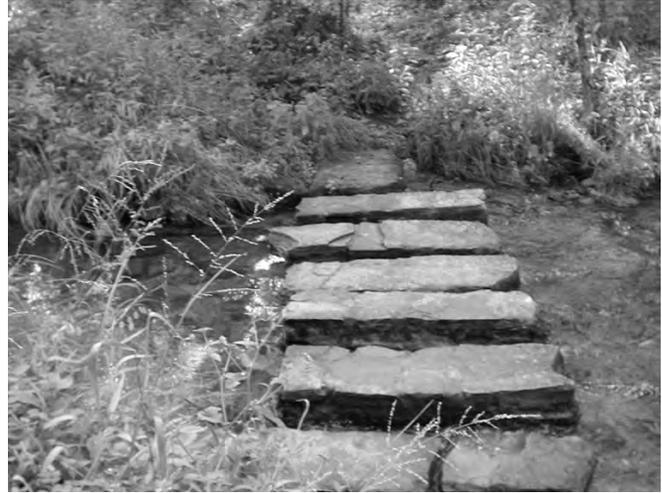
Figure 11-108. Stepping stones within the Antelope and Buffalo Springs area should be preserved, even those under bridges.

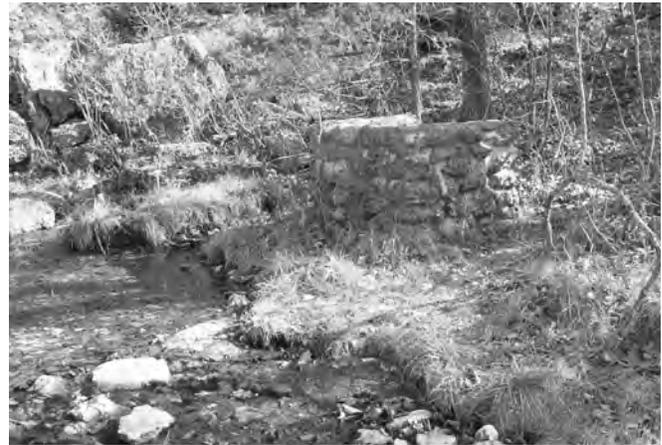
Figure 11-109. The USGS gauge box is again being used to store water flow measuring apparatus, and should be preserved.

Rationale: This feature (Figure 11-109) dates to the historic period and should be maintained. New measurement tools, recently installed, are visually intrusive.

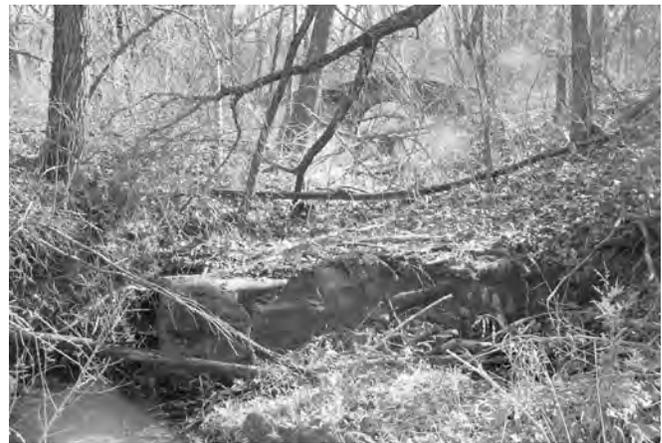
Rationale: Recent tree losses in this area have reduced the area's sense of seclusion and enclosure by canopy (Figure 11-113).

Figure 11-113. Vegetation at Buffalo Springs should be rehabilitated through pruning and replanting.

vertically layered with shrubs, small trees, and canopy trees. This sense of layering has been lost and should be reinstated. Weedy species should be removed and new vegetation encircling the spring enclosure should be planted. The area should be surveyed and a planting plan developed and implemented

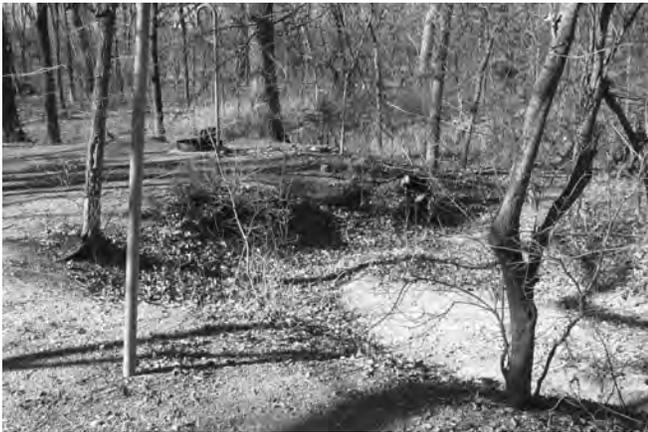
Figure 11-115. Erosion occurs along the drainage ways in the southern part of the campground. Culvert cleaning, regrading, bioengineering, and other techniques should be used to correct these problems.

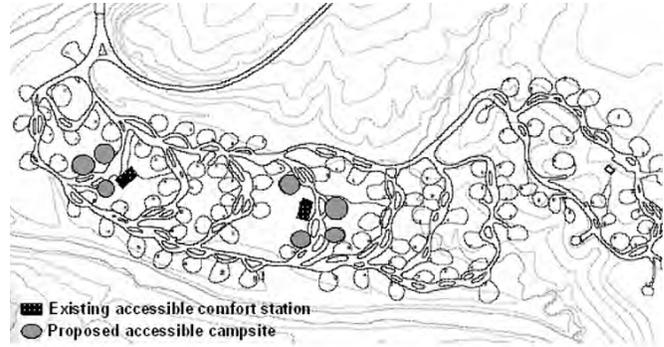
Recommendations: Proposed accessible campsites are recommended on relatively level sites located near the

Figure 11-116. Proposed numbers and locations for accessible campsites. While image shows sites clustered around comfort stations, some of these might also be dispersed throughout the campground to allow for different camping experiences.

comfort stations (Figure 10-116). Alternatively, three sites may be located further from the rest rooms, along an accessible (less than five percent slope) route. Because of the steep grades in the Chigger Hill area, locating accessible campgrounds in this area is not recommended.

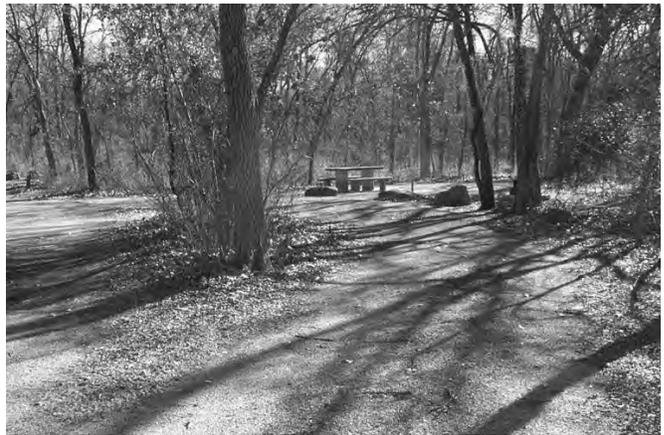
Figure 11-117. Outside loop campsite is appropriate for installing RV electrical and water hook-ups.

Recommendations: Hook-ups, if provided, should be added to sites in a manner and in locations where they will be as unobtrusive as possible. Hookups should be installed on the outside sites, so that RV doors open onto campsite area instead of roadway (Figure 11-117). Water and electrical pedestals should be placed on the islands for driver side hookups.
