# HISTORIC STRUCTURE REPORT The Wright Cycle Company Building

(HS - 01)

Dayton Aviation Heritage National Historical Park  
Dayton, Ohio

March 31, 1999  
Final Submission

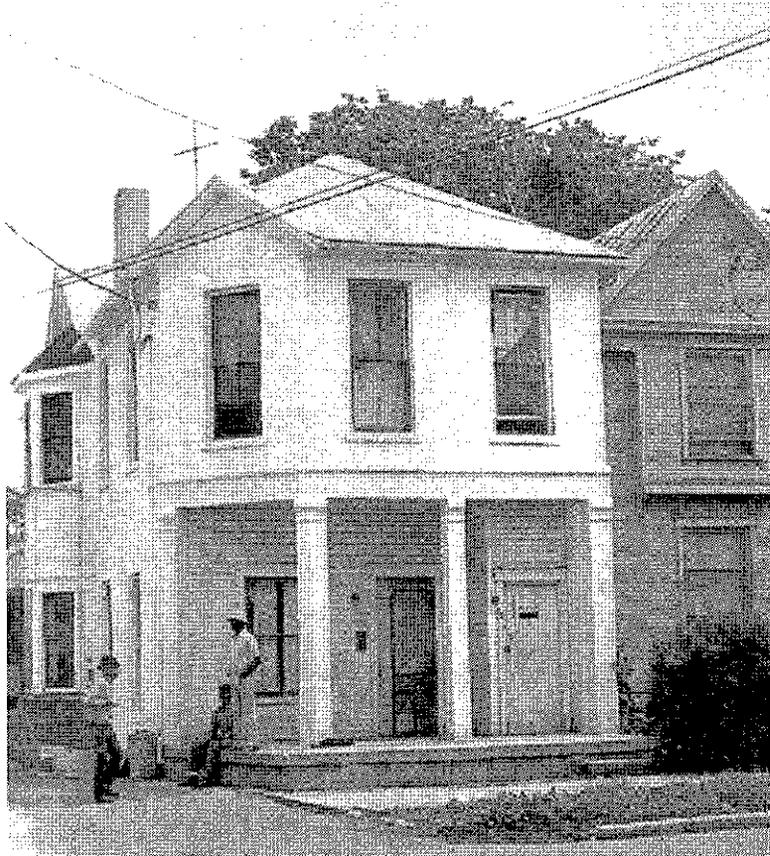
The brick chimney on the north elevation is still in place although it is missing its corbelled detailing. The second chimney visible in the photo belongs to the adjacent house to the south. The shingles at the roof appear to have been replaced with rolled roofing membrane over the main body of the building, and dark shingles are visible over the bay window. The exterior stairway to the basement can be seen at the north elevation. Almost every surface of the building has been painted white.

*Figure 3 View of The Wright Cycle Company building in 1982. (Aviation Trail, Inc.)*

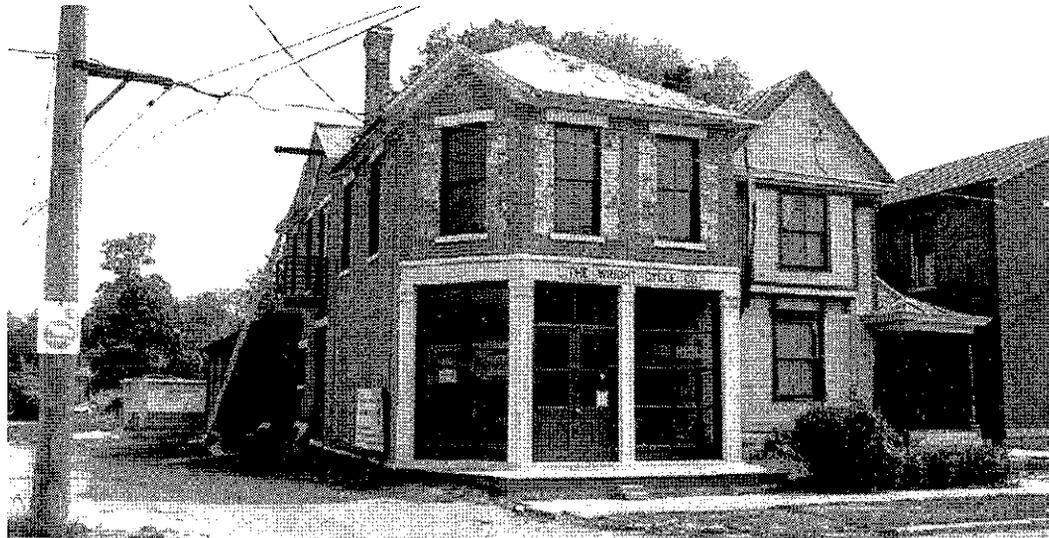
Figure 4 View of The Wright Cycle Company building in 1986 with most of the restoration work completed. Photo courtesy of Aviation Trail, Inc.

- The replacement shutters only have two divisions, while the original shutters were divided into three sections, as evidenced in the 1896 photo.
- The small square window on the north elevation at the first floor is not in the same location as the window in the 1896 photo. Originally, the window was centered between the two second floor windows above it.

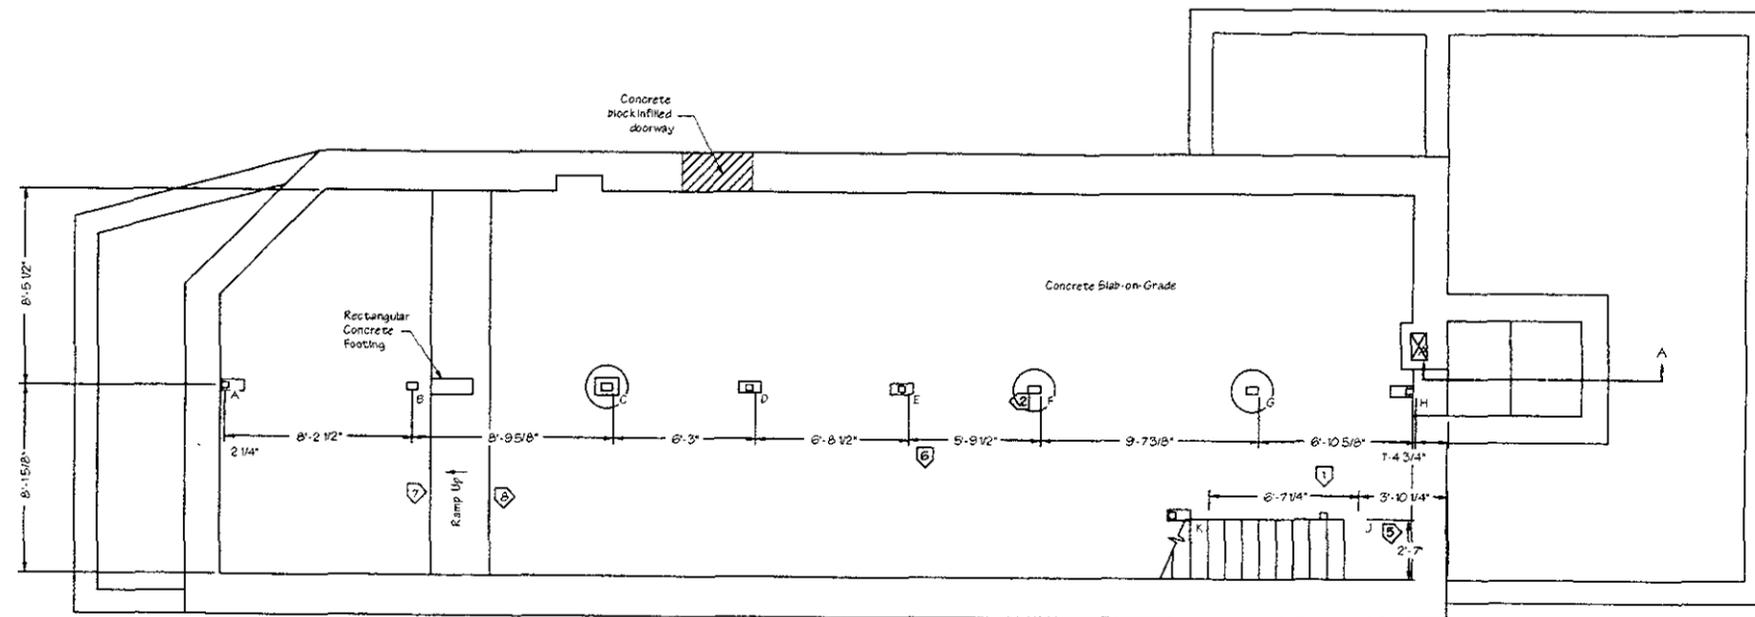
- FIGURE KEY**  
 The number inside the polygon corresponds to the figure number used in the report. The point of the polygon indicates the direction from which the photograph was taken. The polygon symbols are placed in the approximate location where the photograph was taken.
- South Foundation Wall at Stair
  - Columns E (in Foreground) and D (in Background)
  - Eastern Connection Between Stair Header, Joist and Wood Post
  - Joists Rotted on South Bearings and New Metal Joist Hangers
  - Termite Damaged Joist
  - Western End of First Floor Framing

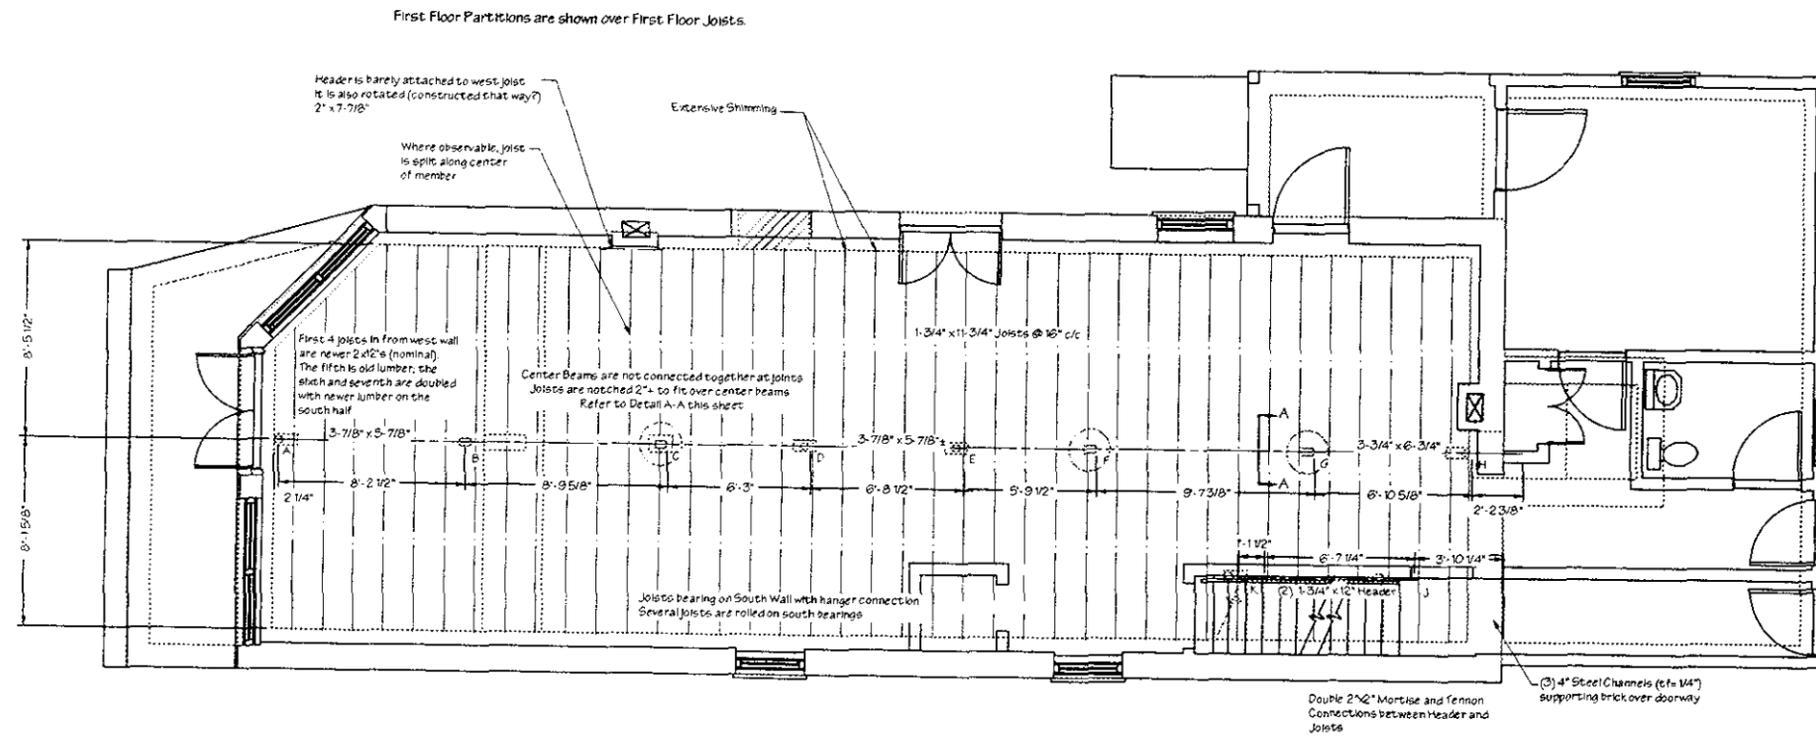
DETAIL A-A: Joists Notched over Center Beam
