FORT MATANZAS

HISTORIC STRUCTURE REPORT

FORT MATANZAS NATIONAL MONUMENT
ST. JOHN'S COUNTY, FLORIDA

THE FORT MATANZAS STABILIZATION TEAM

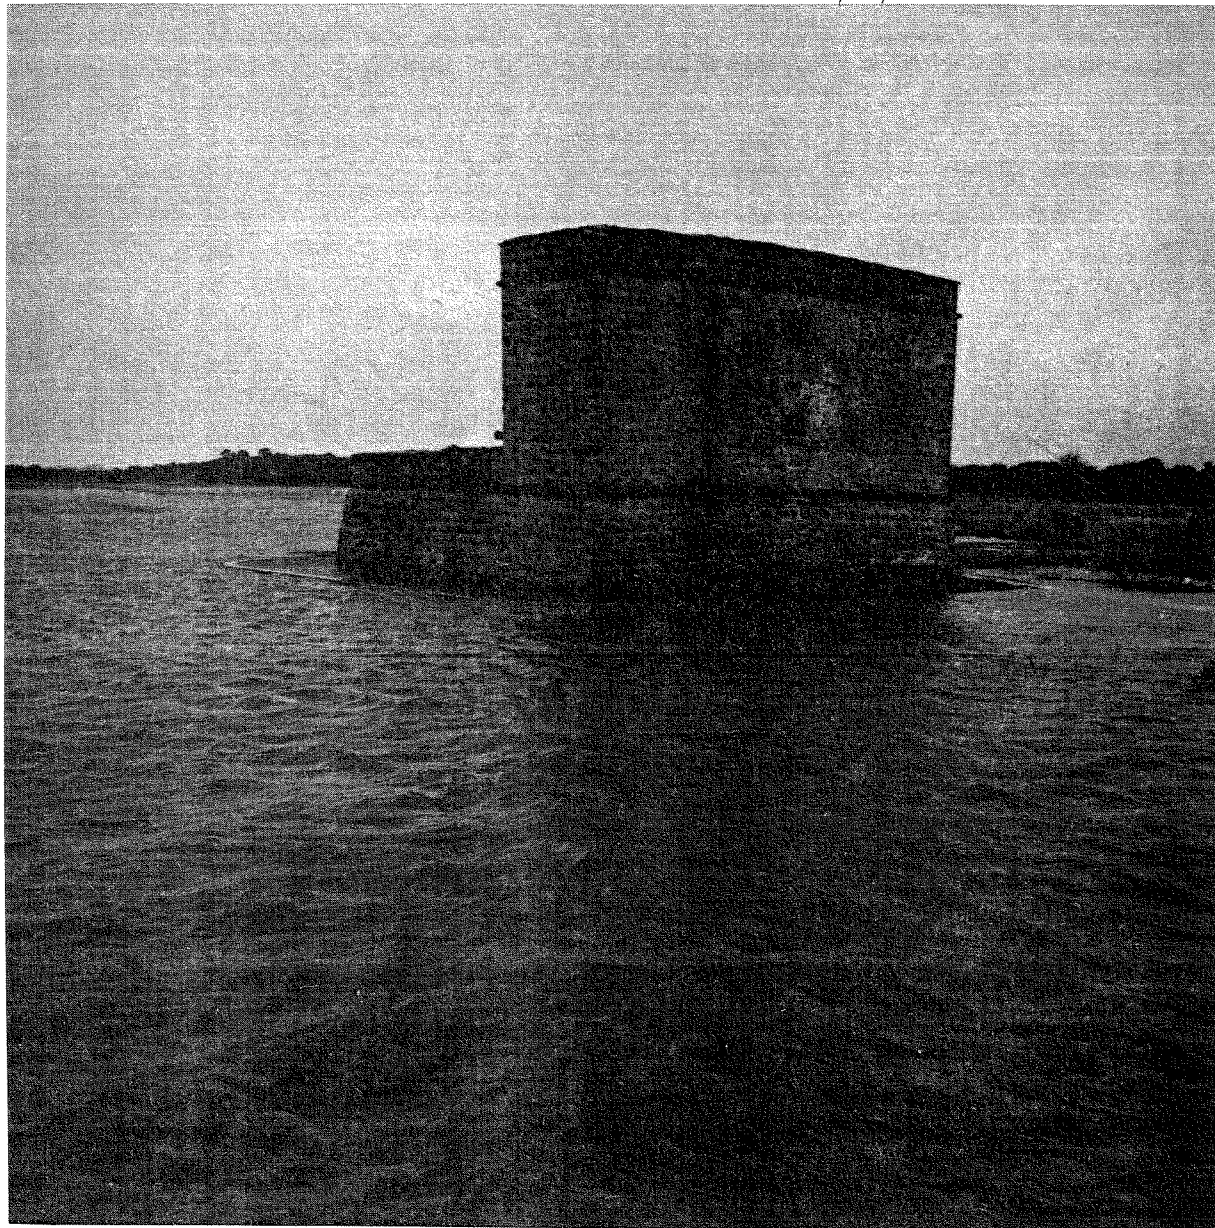
Illustration 17

Presently, even though the site is still subjected to abnormally high tides which rise to the base of the fort at least once each year (Illus. 17) various shore protection projects have partially stabilized the land in the vicinity of the fort. In some instances these measures, although incremental, have performed very effectively. However, they have created an undesirable visual impact on the historic scene, and more important have not dealt with the total erosion problem.

Fort Matanzas During Storm High Tide, November 3, 1978.

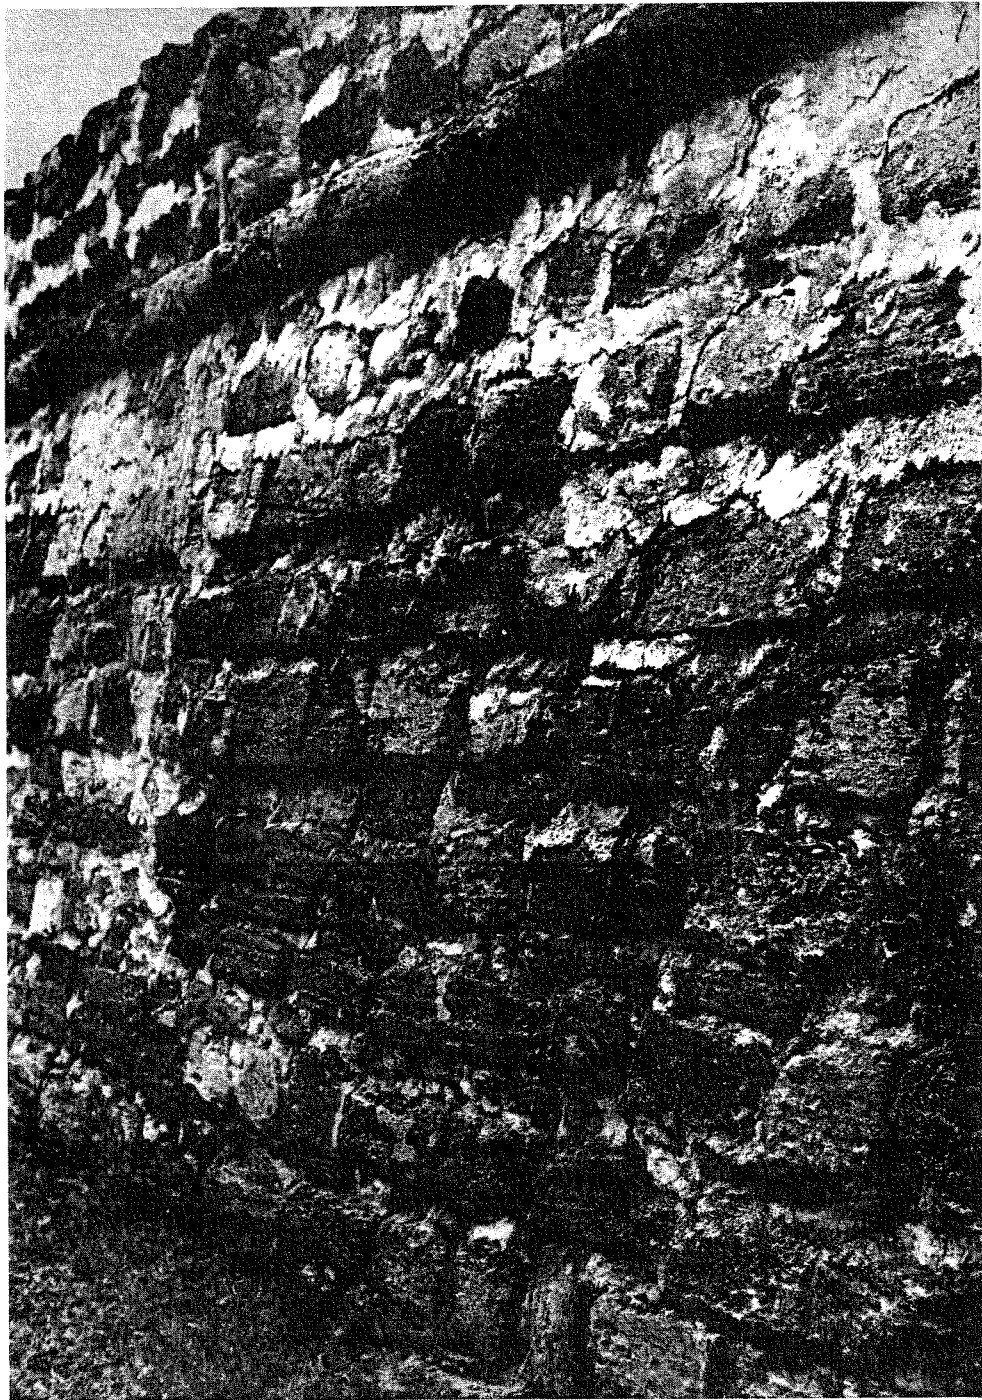
Illustration 19

Weathering of the parapet walls has made the original superior slope almost indistinguishable, except near the tower's south face where they are protected from much of the weathering forces. The embrasures and areas of the parapet copings are highly eroded and in need of repair. The terreplein parapet coping has received periodic pargeting. The surfacing is cracked, allowing increased water penetration into the stone fabric.

Detail of South Scarp Erosion

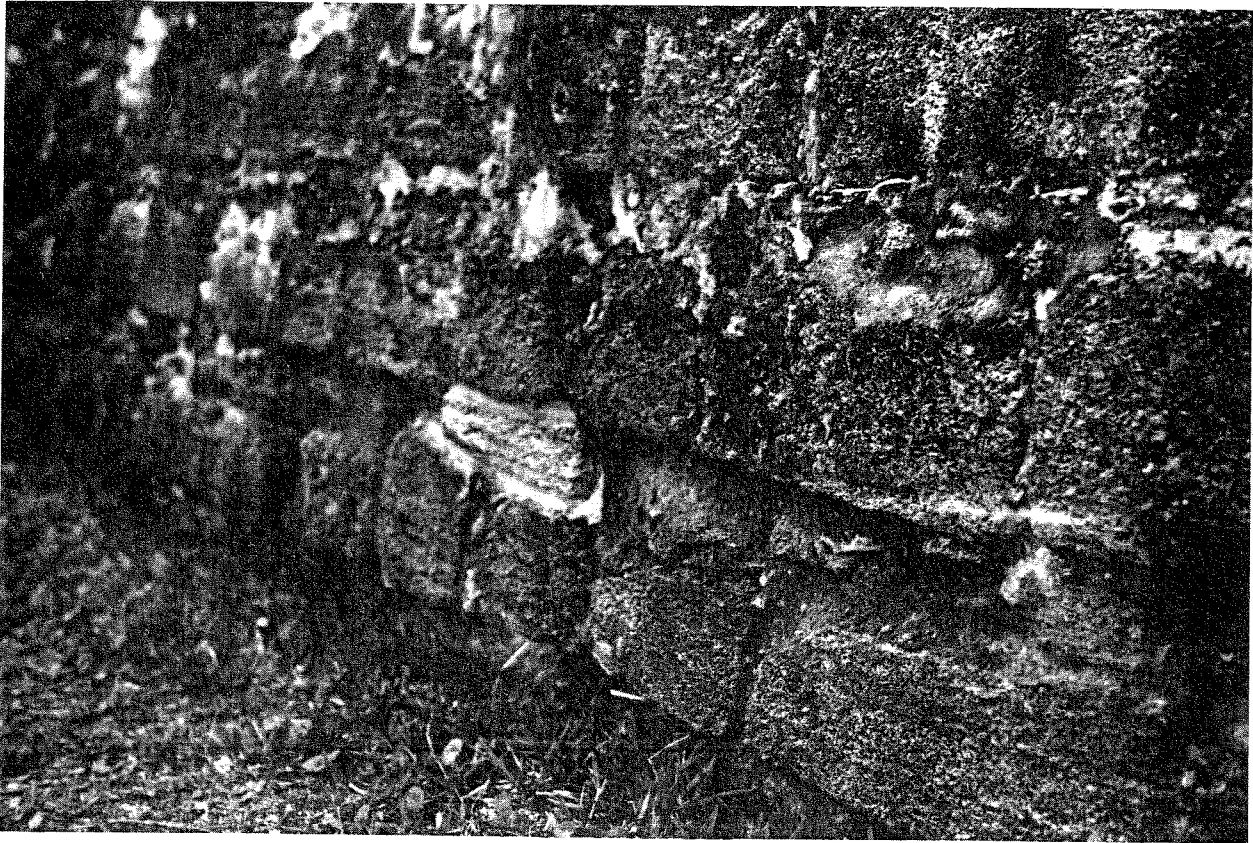
Illustration 20

Detail of East Scarp Erosion

Weathering due to exposure to wave actions.

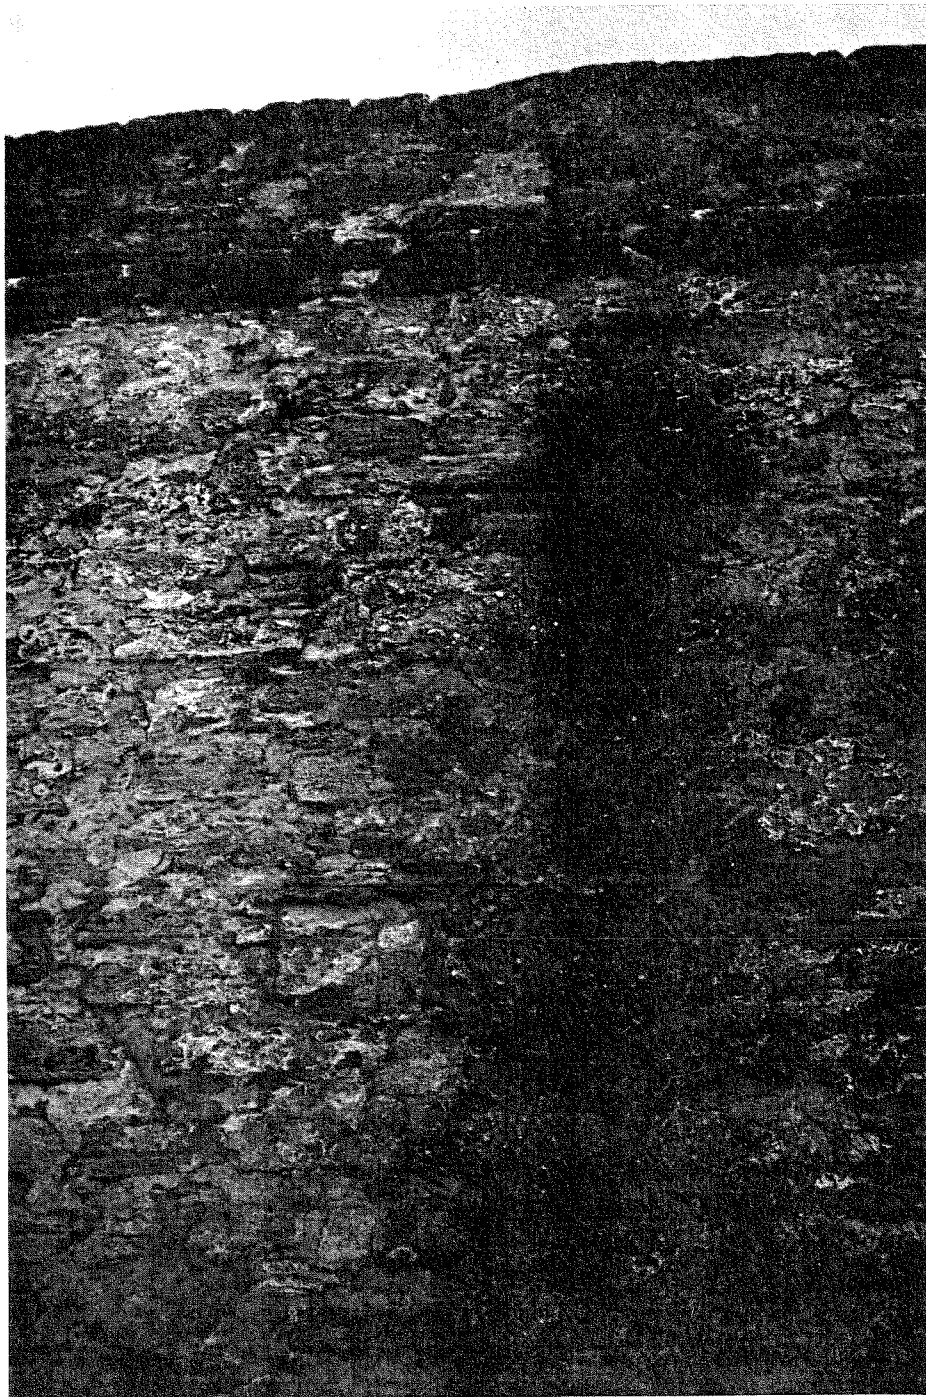
Illustration 21

Detail of North Face Under Non-Historic Scupper

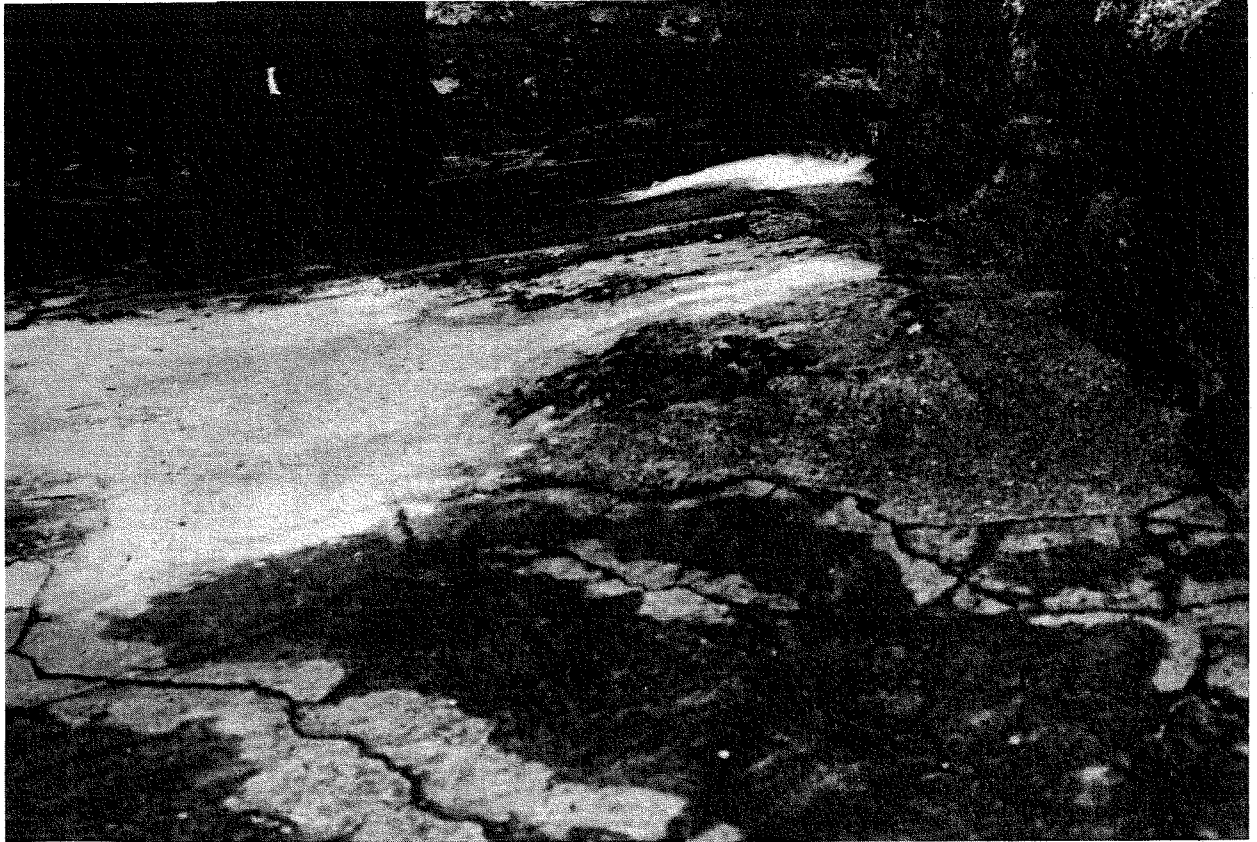
Illustration 23

Non-historic masonry is also in need of preservation. This includes the portland cement mortar used in 20th Century repair work and concrete usage for the terreplein and tower deck. The problems associated with the use of portland cement are due to its hardness and incompatible expansion/contraction properties. In areas where cement mortar was used in repointing as well as in reconstruction work, this material has hastened the deterioration of adjacent coquina fabric. Subsequent weathering of the stone has left cement "ledges" which collect water and accelerate the problem (Illus. 19 and 20). As used for the surface of both the terreplein and réduit deck, no expansion joints were installed and cracks have developed throughout, more noted on the lower than the tower deck. Many of the gundeck's cracks are associated with the settlement of the fill within the southeast corner, although cracks have developed over the entire area (Illus. 23). In addition

Detail of Terreplein

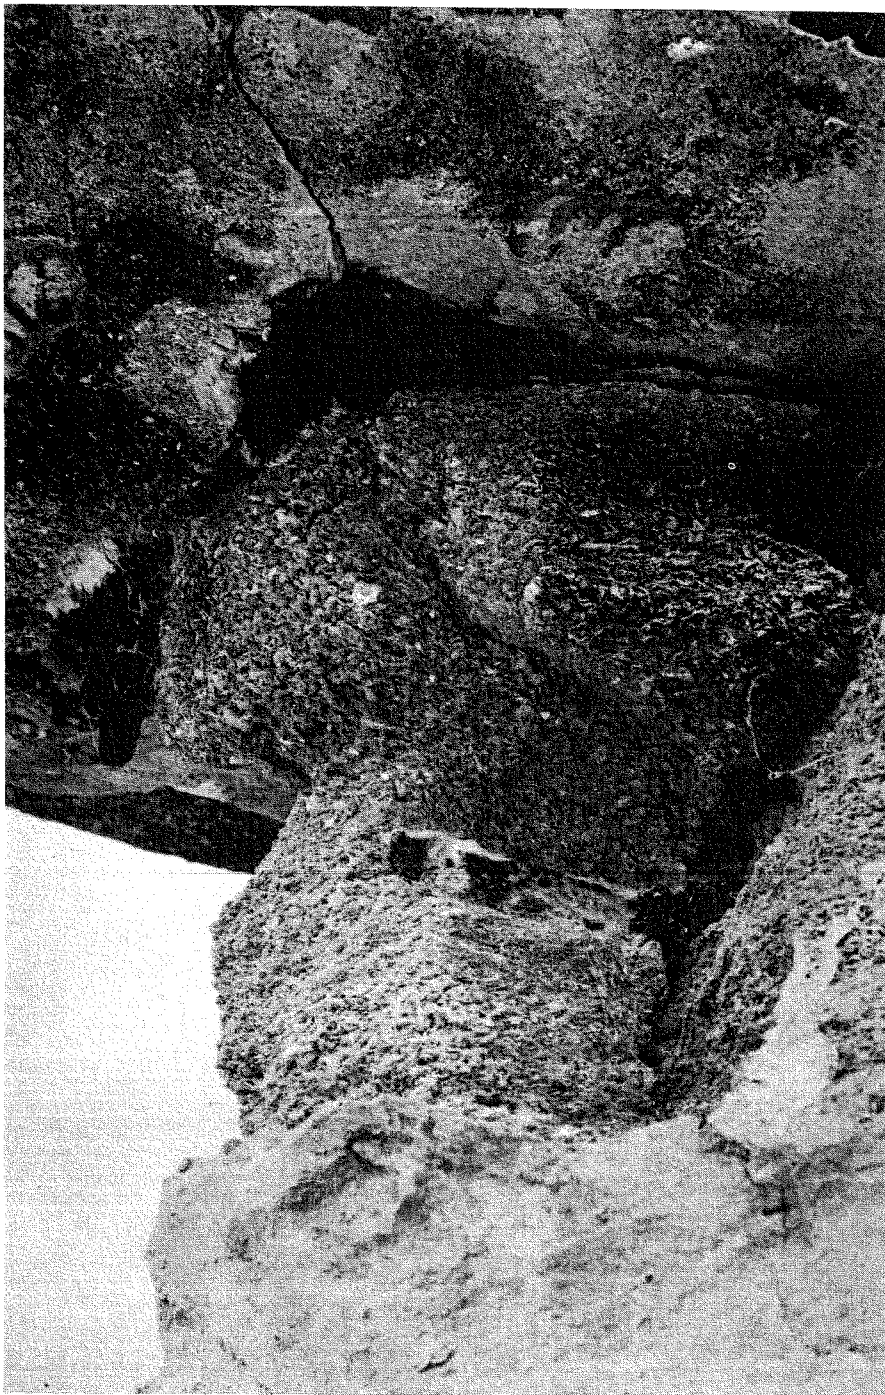
Illustration 26

Detail of Sentry Box Base

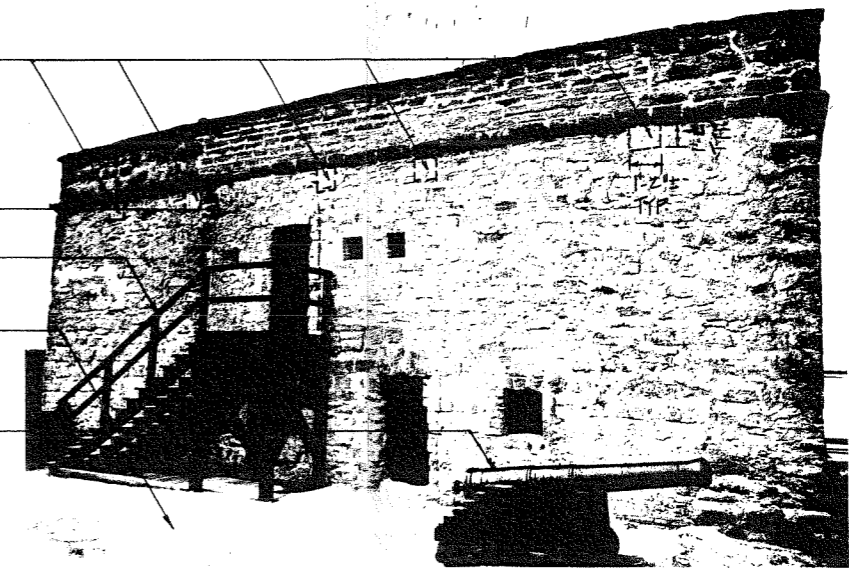
3 TOWER SOUTH ELEVATION
8 NO SCALE

Notice the courses of the face stones covering the tie rod and plates, particularly the lower which is being dislodged due to the plate exfoliation. The upper course appears intact although the same forces that caused the lower steel plate to exfoliate are at work on the upper set as well as the east face, and in time could cause similar problems.

REMOVE FACING STONES, END PLATES (CHANNEL) AND TIE RODS (A)

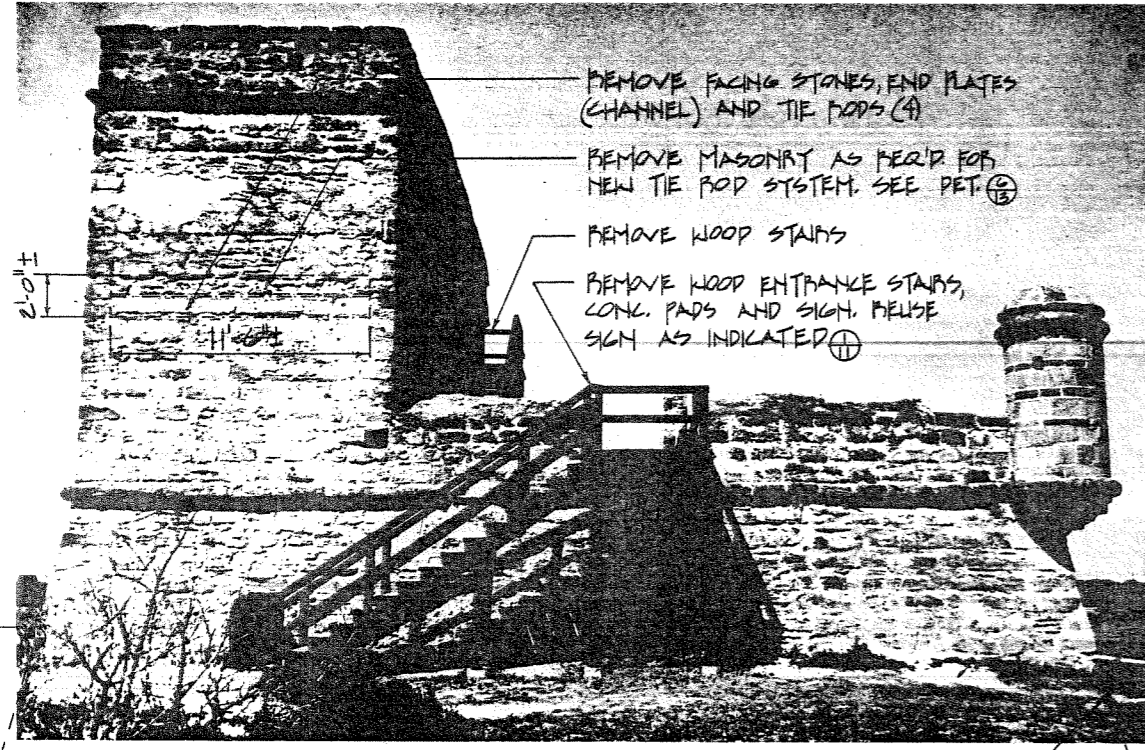
1 WEST ELEVATION
8 NO SCALE

ESTIMATED ELEVATION AT TOP OF FOOTING IS 3'±. BASE OF EXCAVATION FOR SUBGRADE SCARP WALL TREATMENT. EXCEPT ON WEST ELEVATION, EXISTENCE AND EXACT DEPTH OF "COLLAR BEAM" IS UNCONFIRMED.

NOTE:
SALVAGE ALL FACING STONE REMOVED FOR REUSE.

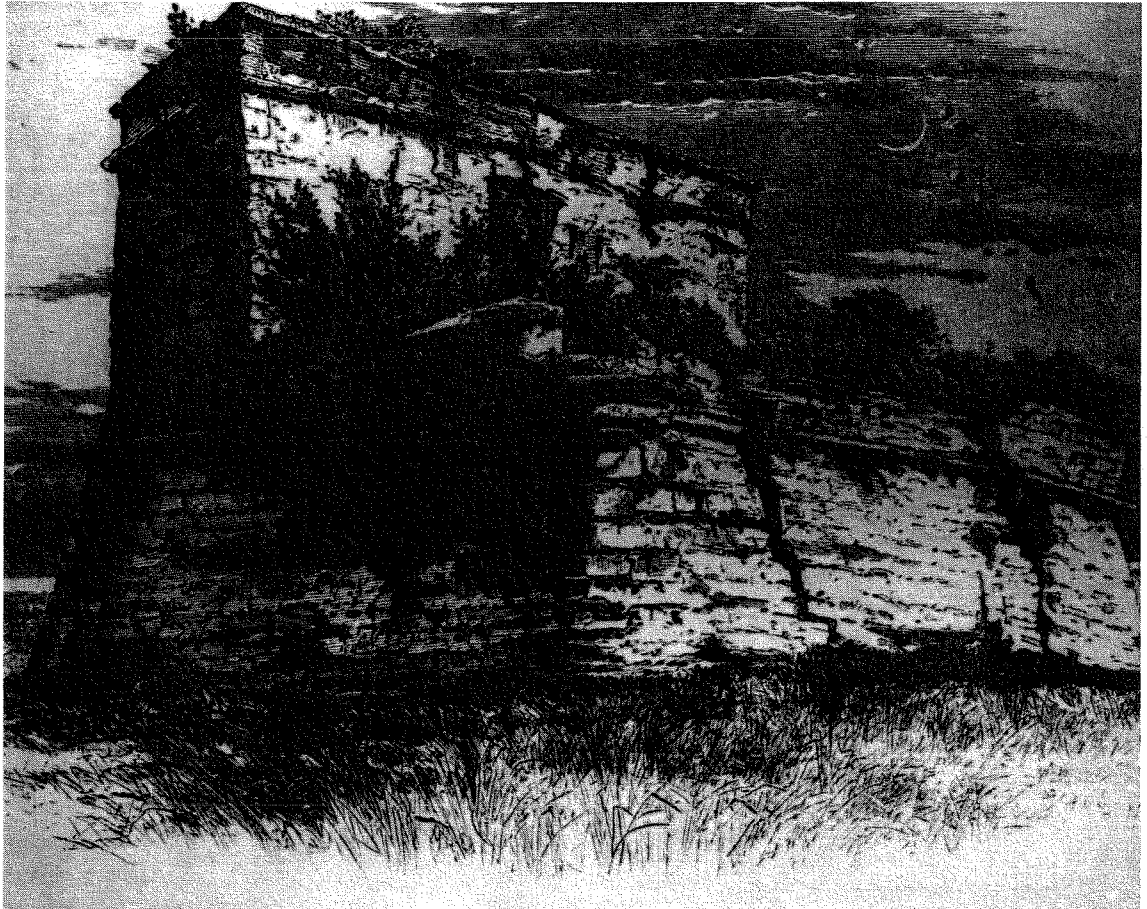
Illustration D-3

Fort Matanzas published in Picturesque America, 1872, (Photo M-42)

Note missing sentry box and south terreplein parapet at height lower than east and west parapets.

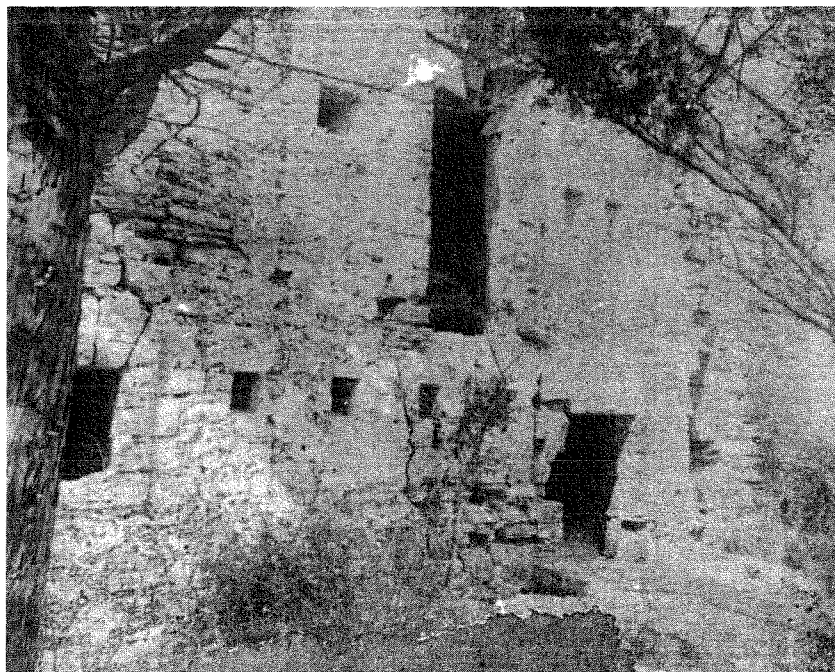
Illustration D-6

View of Terreplein and South Face of Tower, circa. 1914, (Photo M-168)

Note faint outline of a fourth loophole to the right of the three clearly visible.

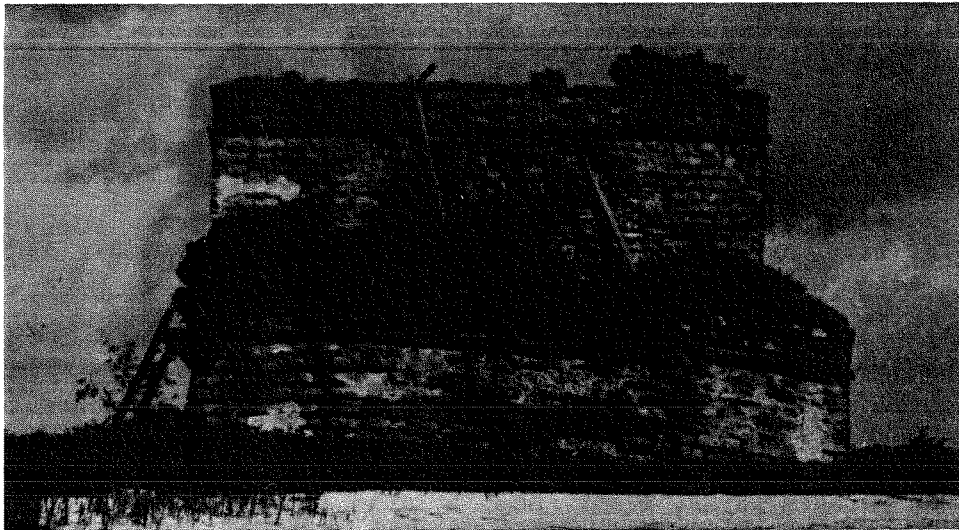
Illustration D-9

View of Fort Matanzas, 1916, (Photo M-70)

Taken after tower stabilization but prior to vegetation removal.
Note construction bracing yet to be removed.

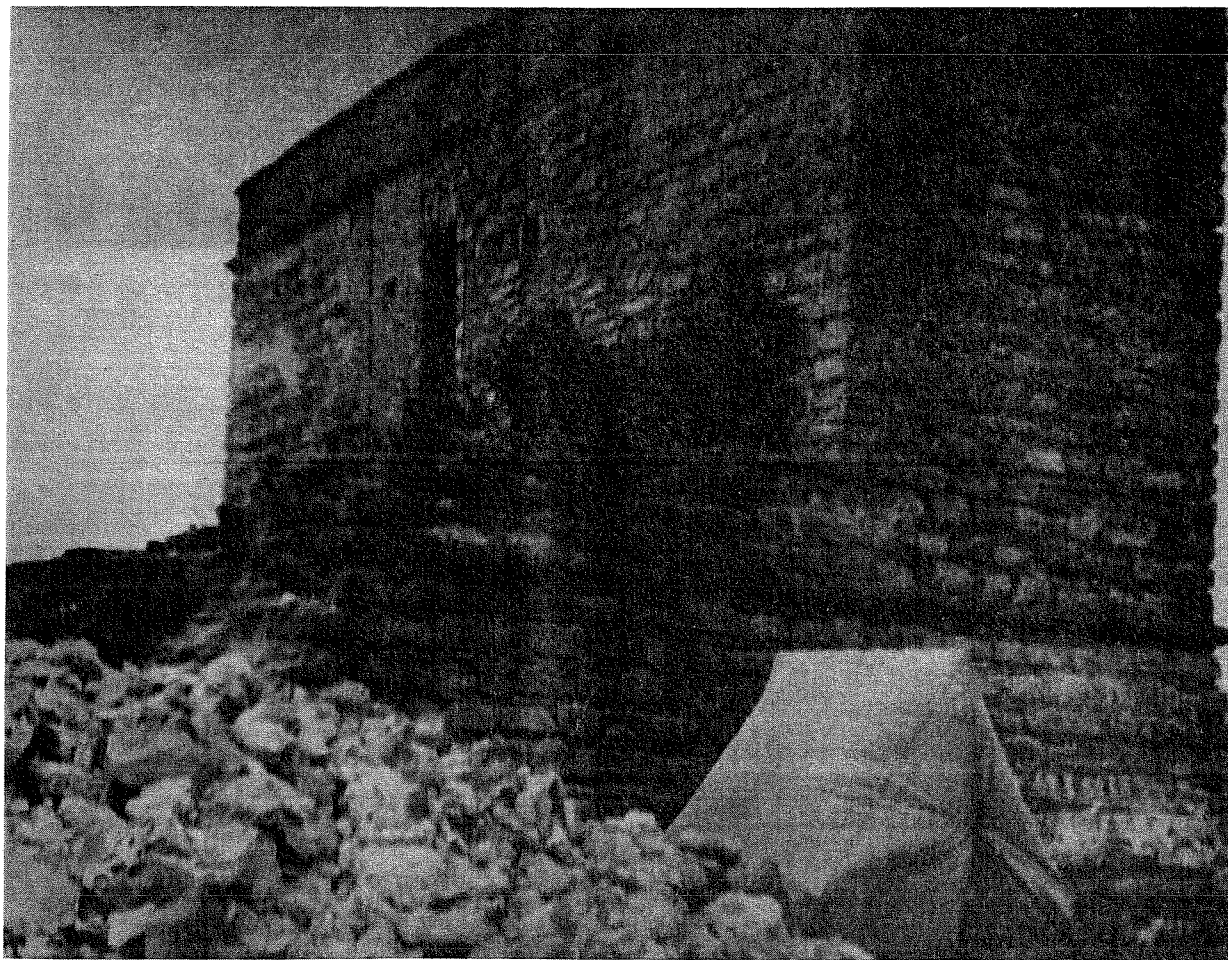
Illustration D-13

Dismantled East Scarp During 1924 Reconstruction (Photo M-76)

Notice tie rod end plates near tower cordon on east face as placed in 1916 preservation project. Also, notice iron cannon lying on terreplein as reported as early as 1885 by Scriven.

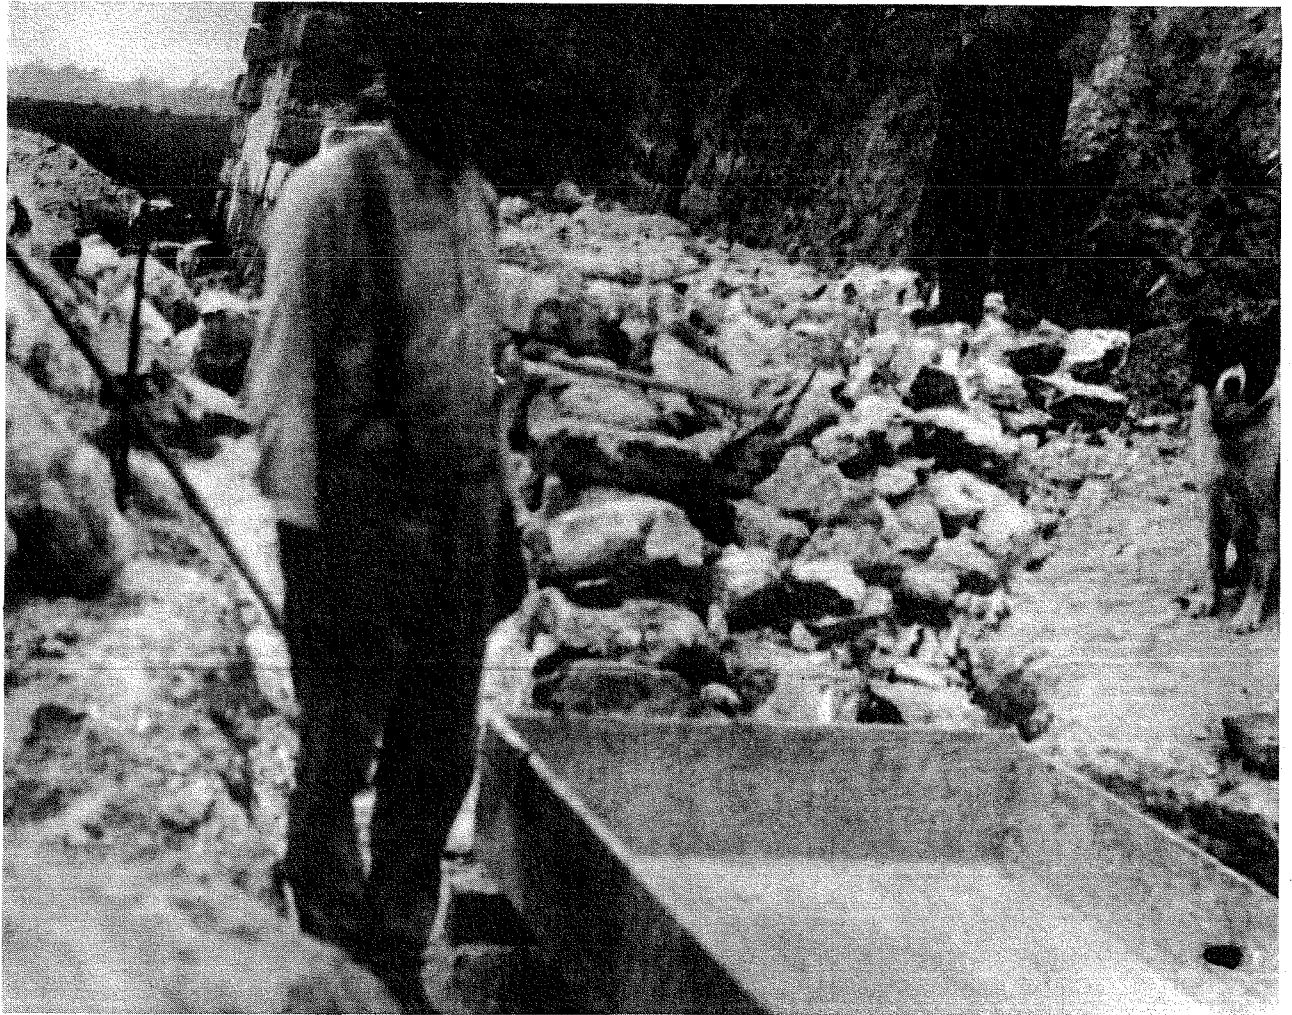
Illustration D-14

Dismantled South Scarp During 1924 Reconstruction (Photo M-76)

Contractor Bud Deyo is pictured here at the foot of the fort. It is interesting that the marsh mud fill of the base is dry enough to have cracked along with the shear failure of the south salient. It appears that the scarp wall is mostly rubble fill with cut stones forming the exterior face.

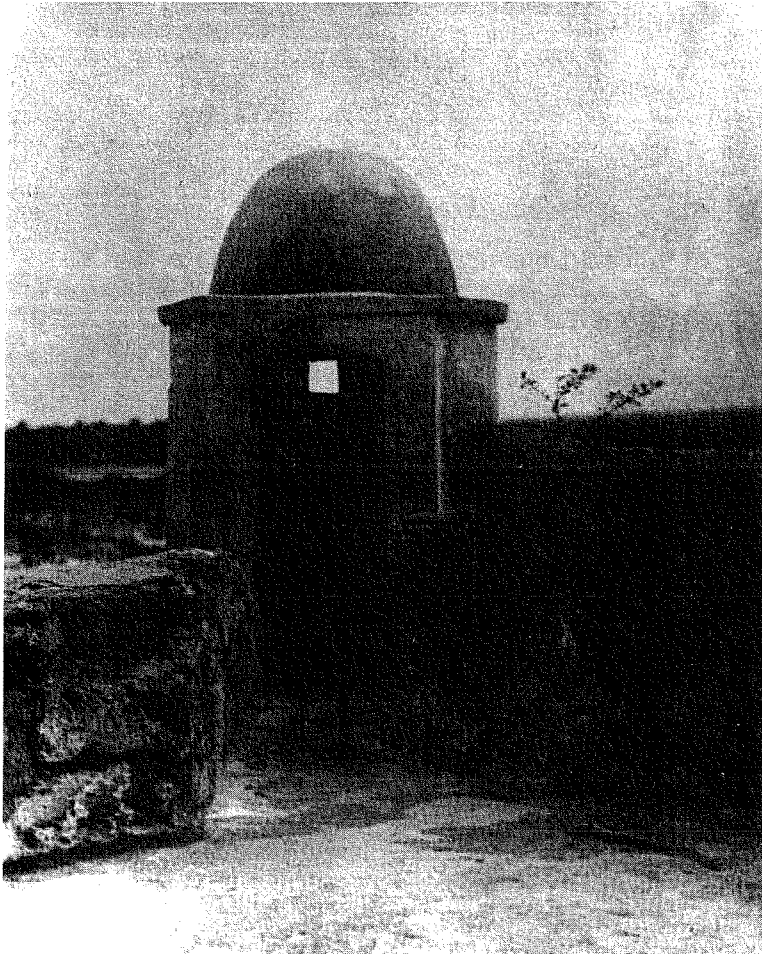
Illustration D-18

View of 1926 Reconstructed Sentry Box from Terreplein

This reconstruction used brick and coquina-concrete to produce an appearance which was quickly judged inappropriate.

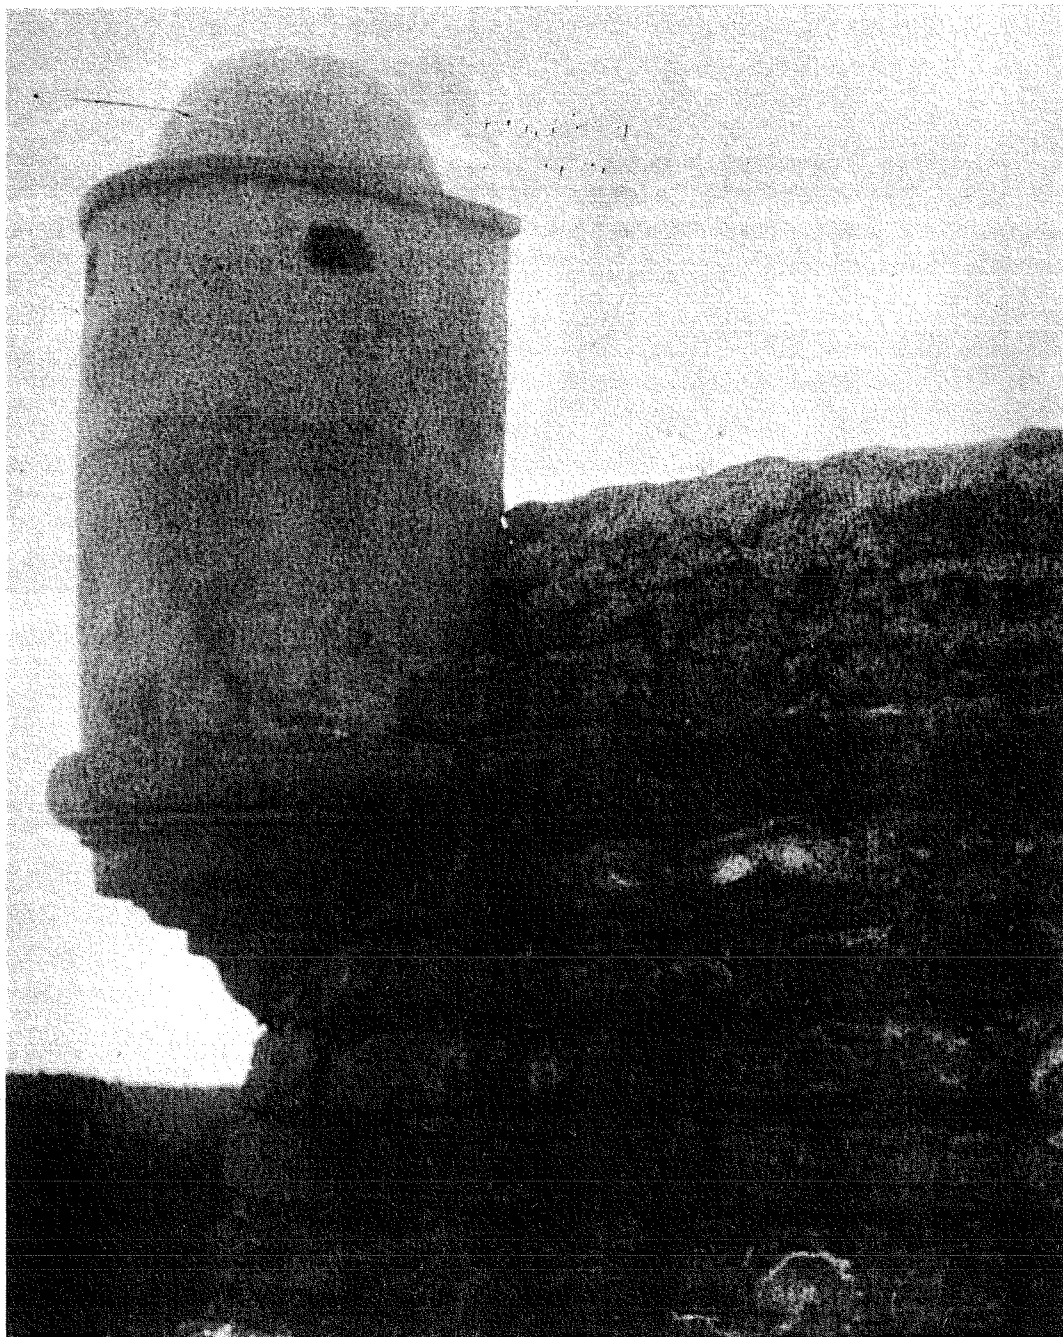
Illustration D-19

View of 1926 Reconstructed Sentry Box, Exterior View, August 1929,
(Photo M-14)

In this documentation of the first reconstructed sentry box in August 1926, we are offered a detailed view of the historic masonry coursing employed by the Spanish. This portion of the south scarp was not disturbed by Deyo.

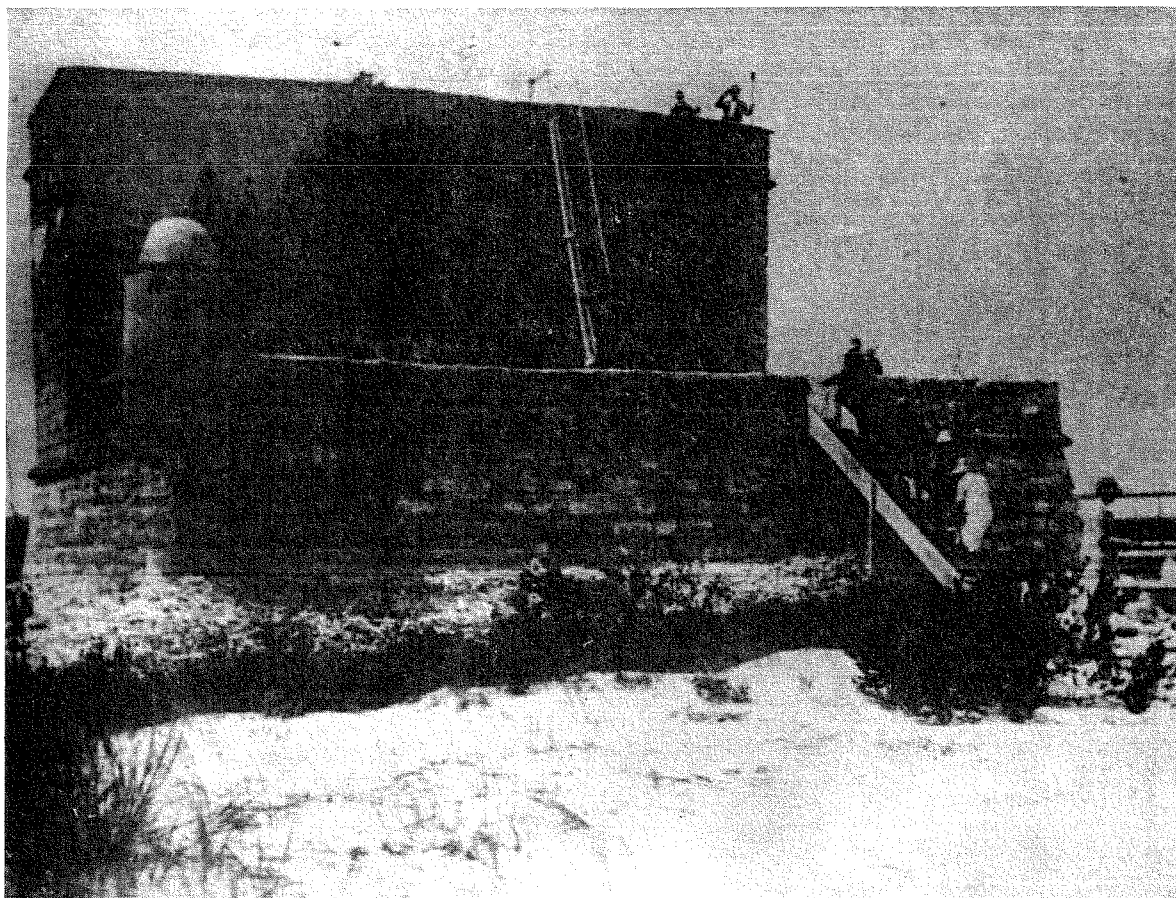
Illustration D-20

View of Fort with Oyster Shell Protection at Base and New Access Ladders, Between 1925 and 1929, (Photo M-12)

Taken about 1928, this photograph shows the Fort open to visitation after the preservation undertaken between 1916 and 1927. The ladder access visible here was supplemented by an additional ladder or stair inside going to the reconstructed concrete floor at the second level of the réduit. (See H.A.B.S. drawings, Illus. 24.)

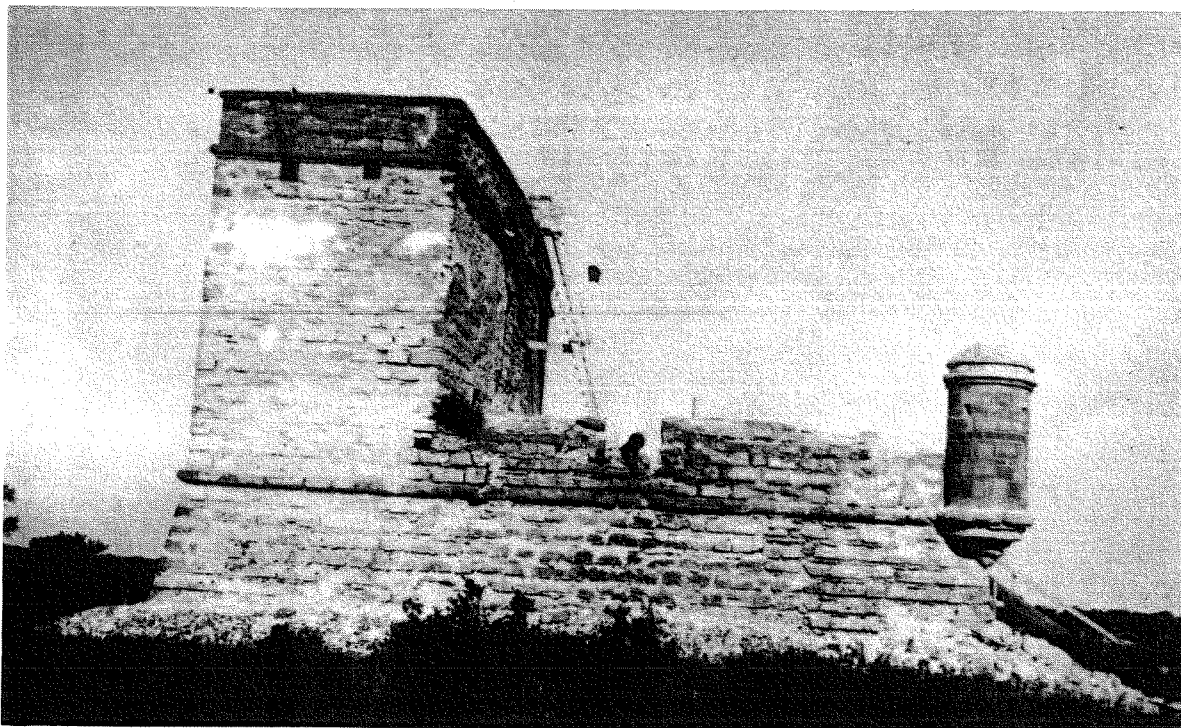
Illustration D-21

View of 1929 Reconstructed Sentry Box, 1930, National Archives

This photograph was taken January 11, 1930, and shows the newly completed sentry box still present today.

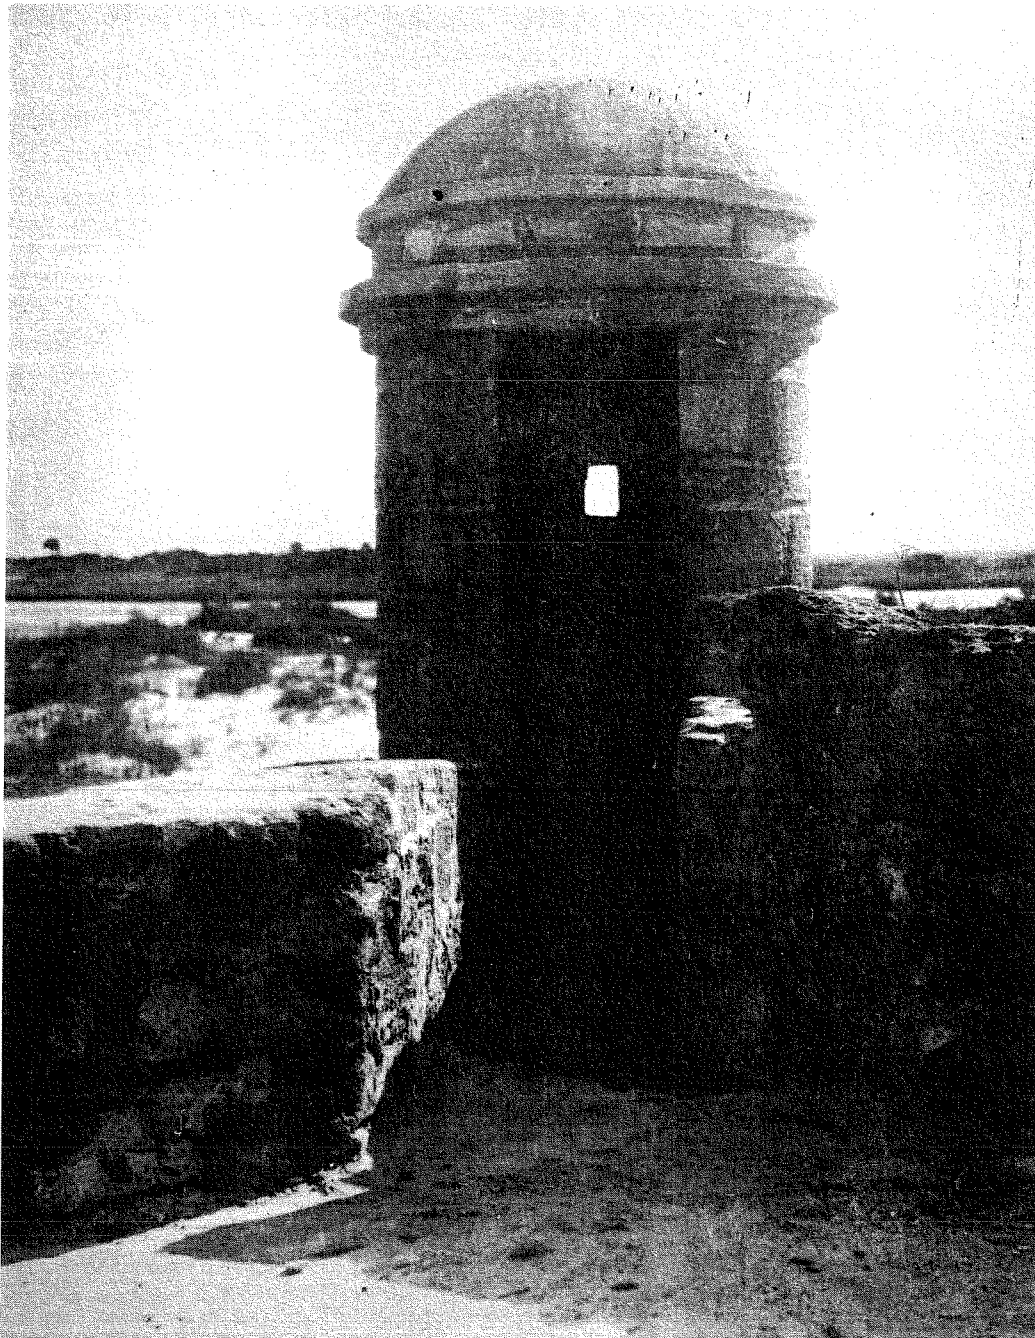
Illustration D-22

View of 1929 Reconstructed Sentry Box from Terreplein, (Photo M-381)

Notice the iron lintle ring visible at the doorway which has deteriorated and is no longer present.

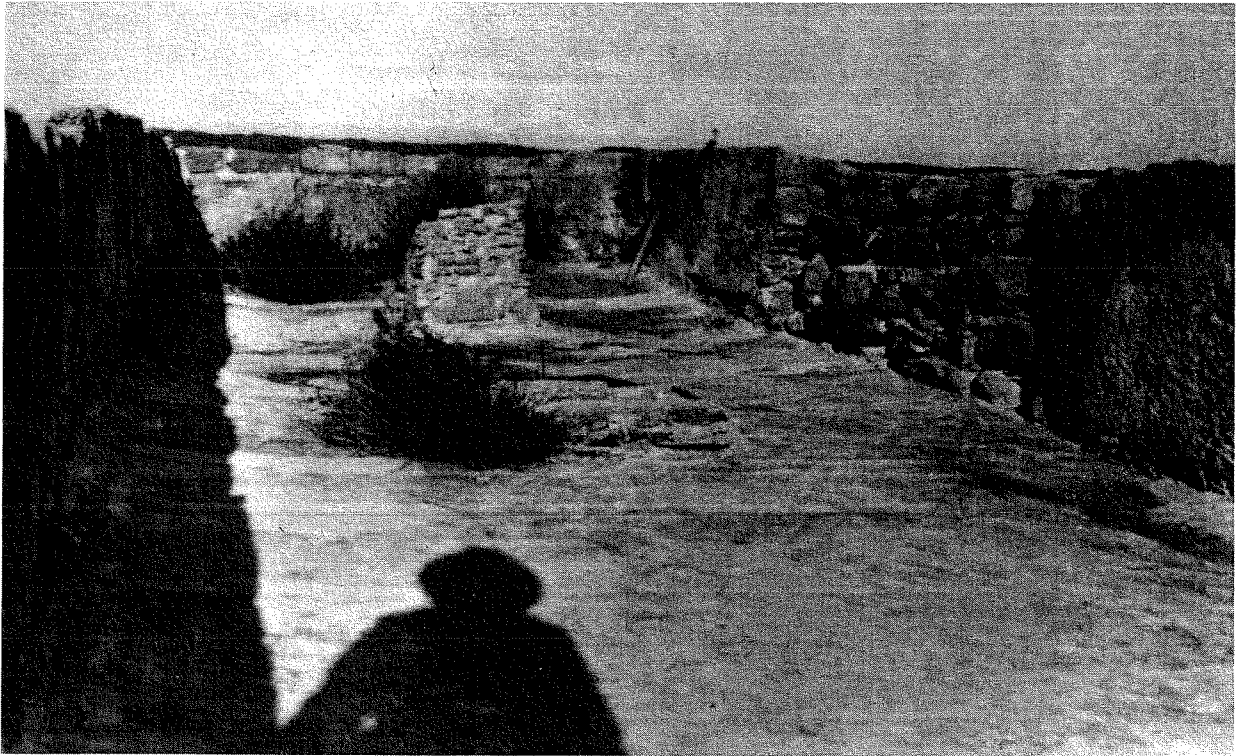
Illustration D-25

View of Tower Roof, 1934, (Photo M-798)

This photograph, taken about 1934, shows the problems of the tower roof: vegetation growth, cracks and poor water drainage. Notice the height of the chimney flue compared to today's low curb.

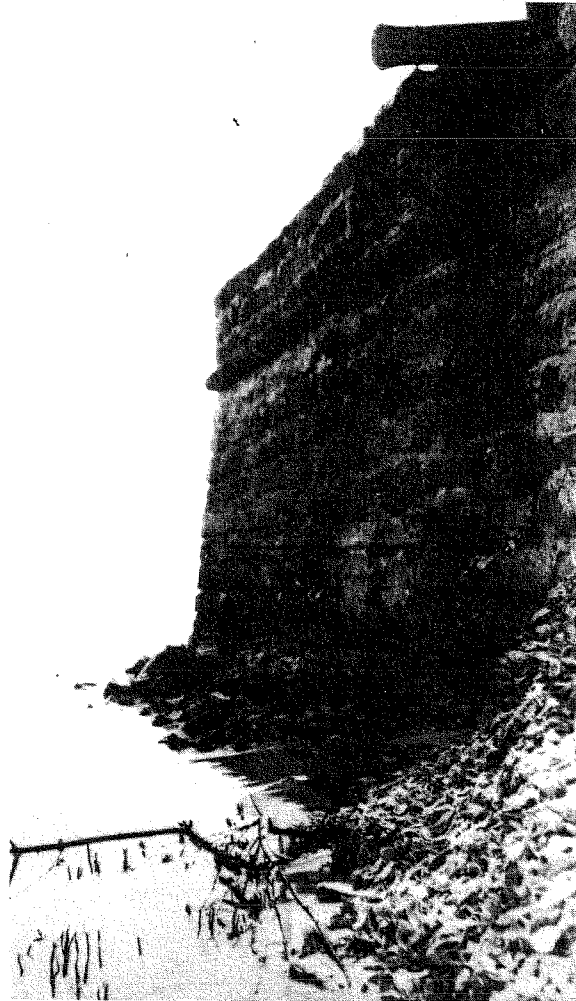
Illustration D-27

View of Matanzas River at Base of East Scarp of Fort, circa. 1935,
(Photo M-812)

This picture (as well as D-26 and D-28) was probably taken about the same time as the 1935 erosion report. It illustrates the danger of undermining which has begun due to the wave action of the Matanzas River. At right, remains of the 1924 oyster shell protection which has been completely removed from the base of the southeast scarp.
