FORT MATANZAS

HISTORIC STRUCTURE REPORT

FORT MATANZAS NATIONAL MONUMENT
ST. JOHN'S COUNTY, FLORIDA

THE FORT MATANZAS STABILIZATION TEAM

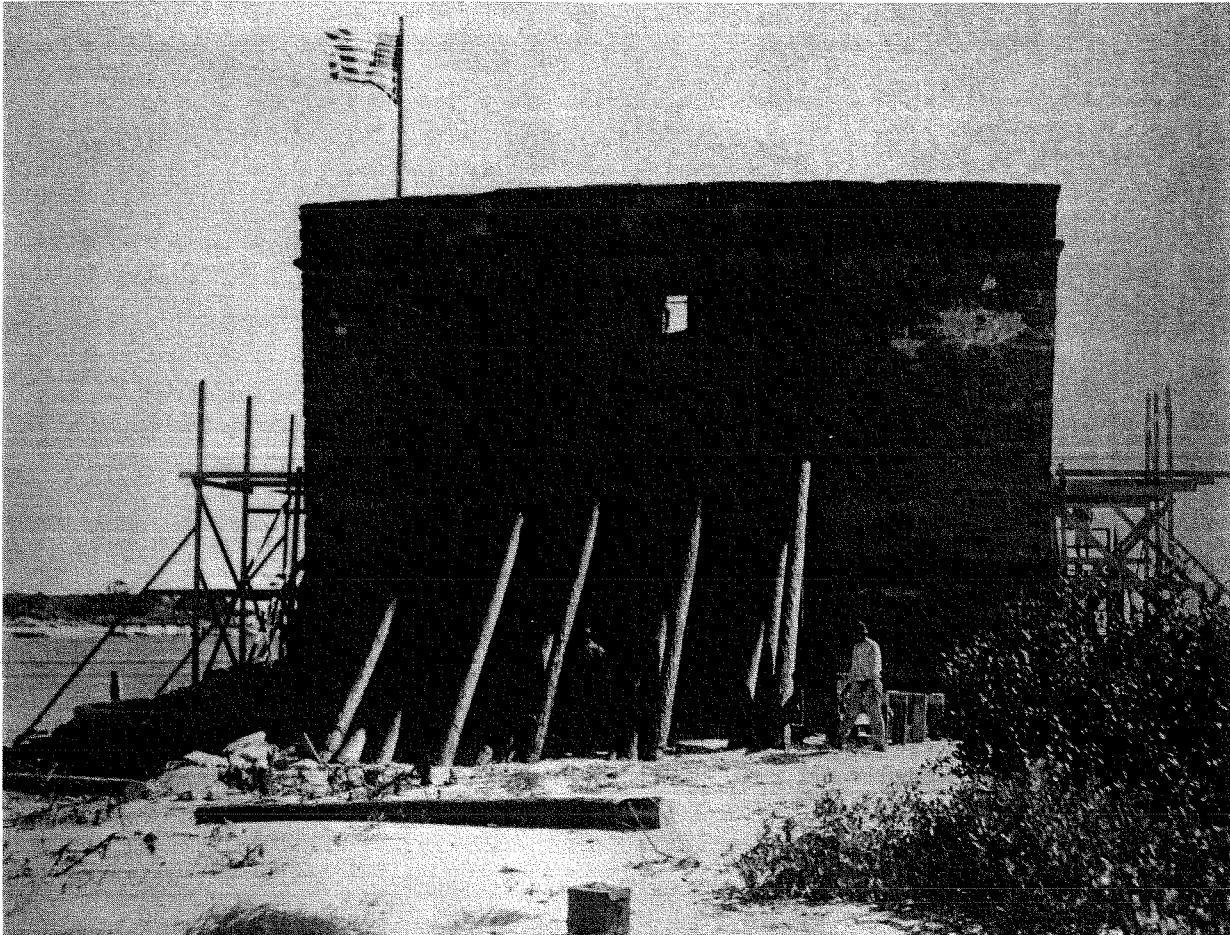
Illustration D-32

View of Vault Stabilization Project, December 1938, (Photo M-40)

The massive bracing system pictured here was necessary as the south face of the tower and north-south tie rods were removed leaving the free-standing north wall.

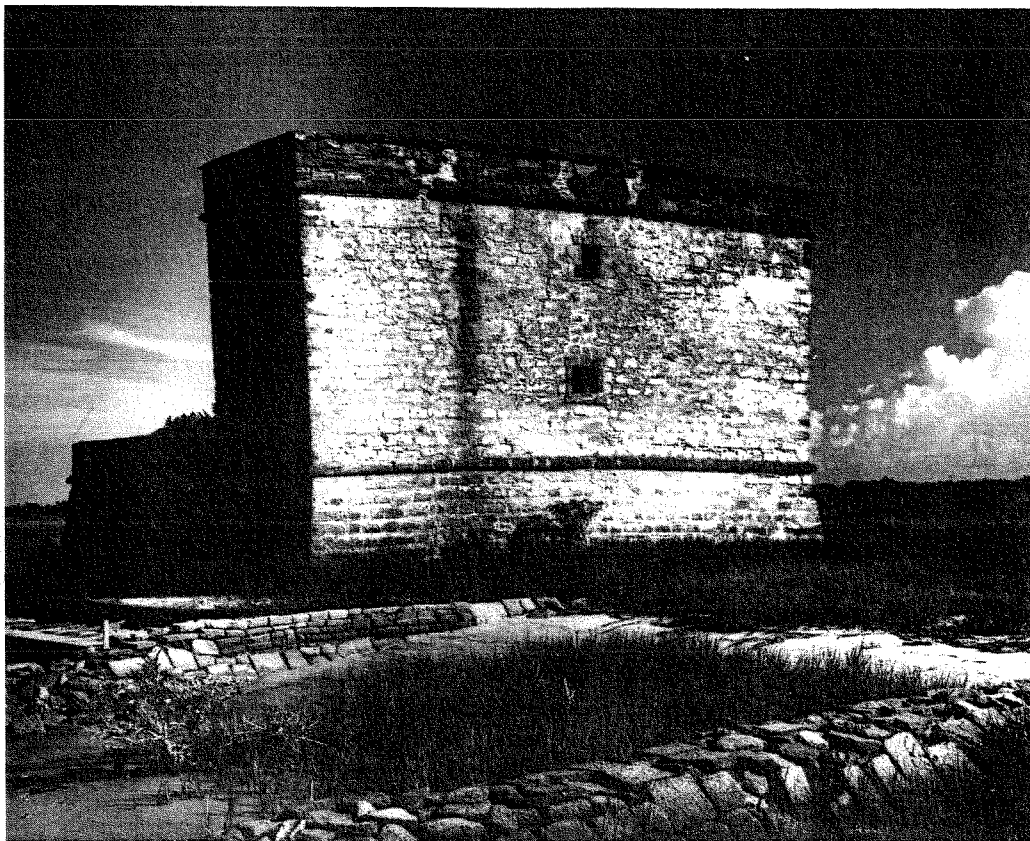
Illustration D-34

View of Fort and New Groins, circa. 1942, (Photo M-134)

This photograph shows the new goins and incomplete coquina sea wall. Notice that the paving stones placed behind the steel bulkhead are no longer present--perhaps they were used in the construction of the new shore protection features.

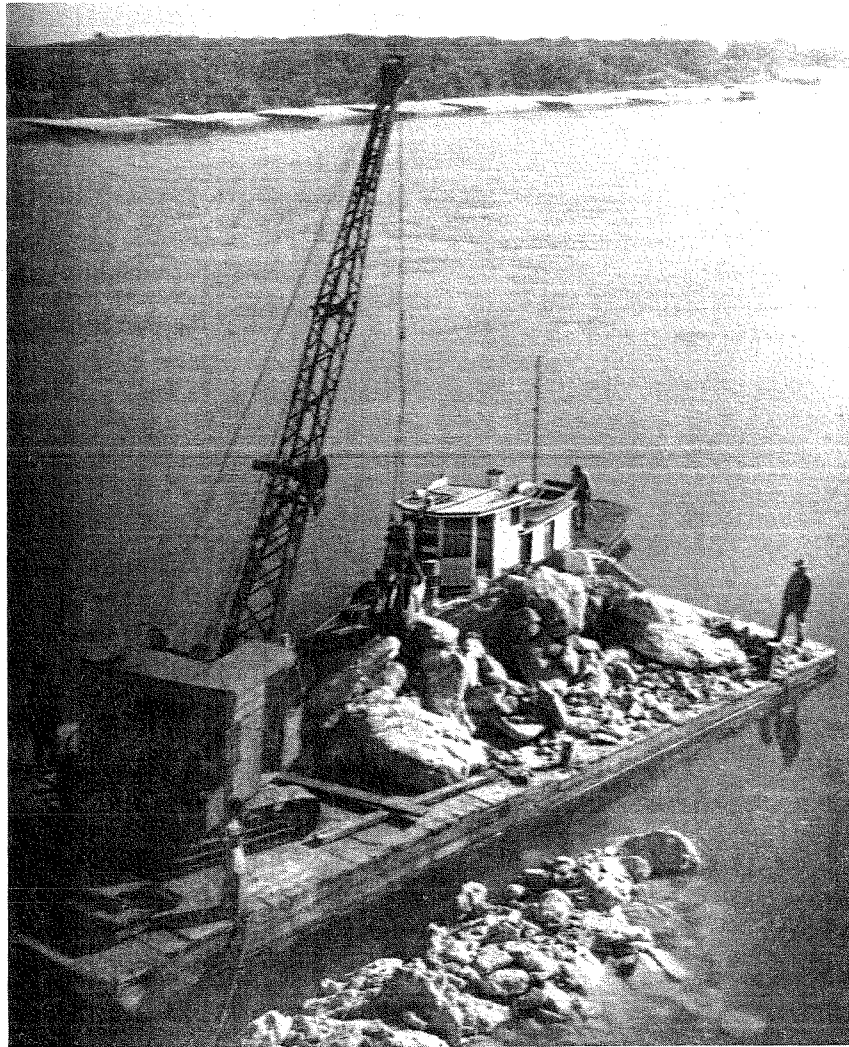
Illustration D-39

Construction of 800 Cubic Yard Groin, December 15, 1948, (Photo M-144)

Massive riprap was used to repair the southeast corner of the fort site after the storms of 1944 and 1947 removed the coquina sea wall.

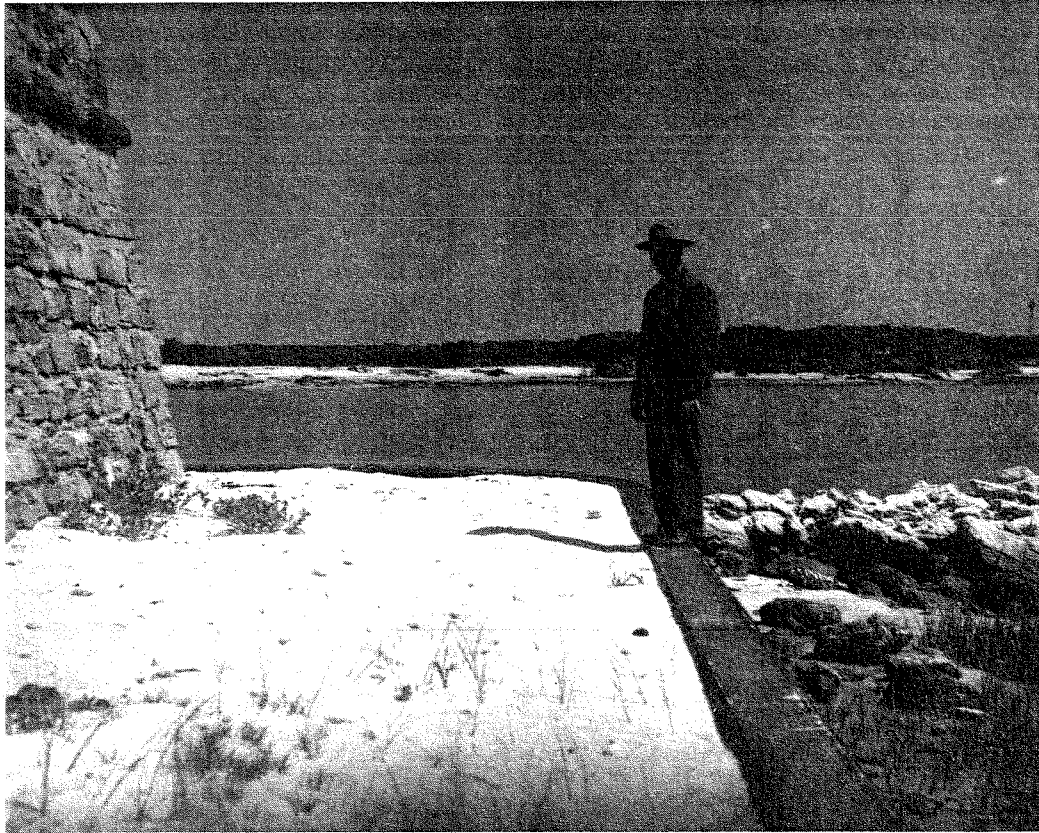
Illustration D-41

View of Backfilled Steel Bulkhead, March 23, 1949, (Photo M-157)

After the steel sheet piling was treated (Illus. D-40), backfilling was performed. However, the area between the new 800 cubic yard groin and steel bulkhead was not filled until 1966.

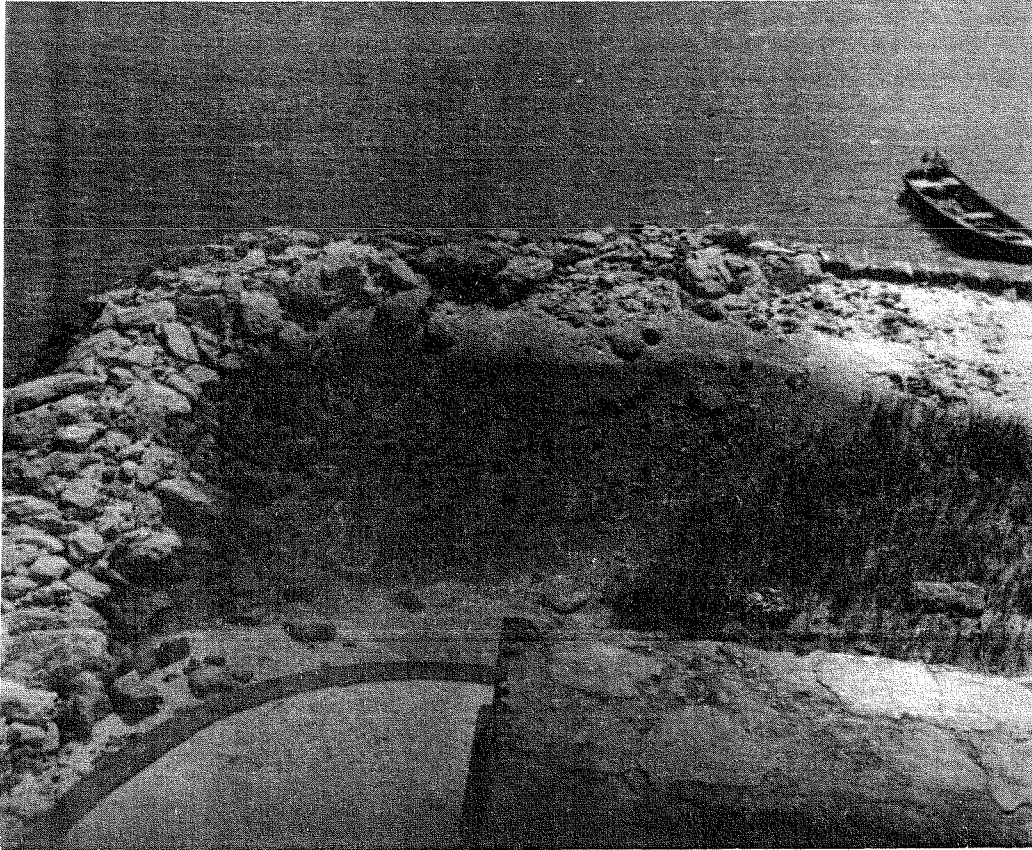
Illustration D-42

View of New 800 Cubic Yard Groin, March 23, 1949, (Photo M-154)

This massive riprap groin created an unsightly condition, but probably performed its protective function for fifteen years.

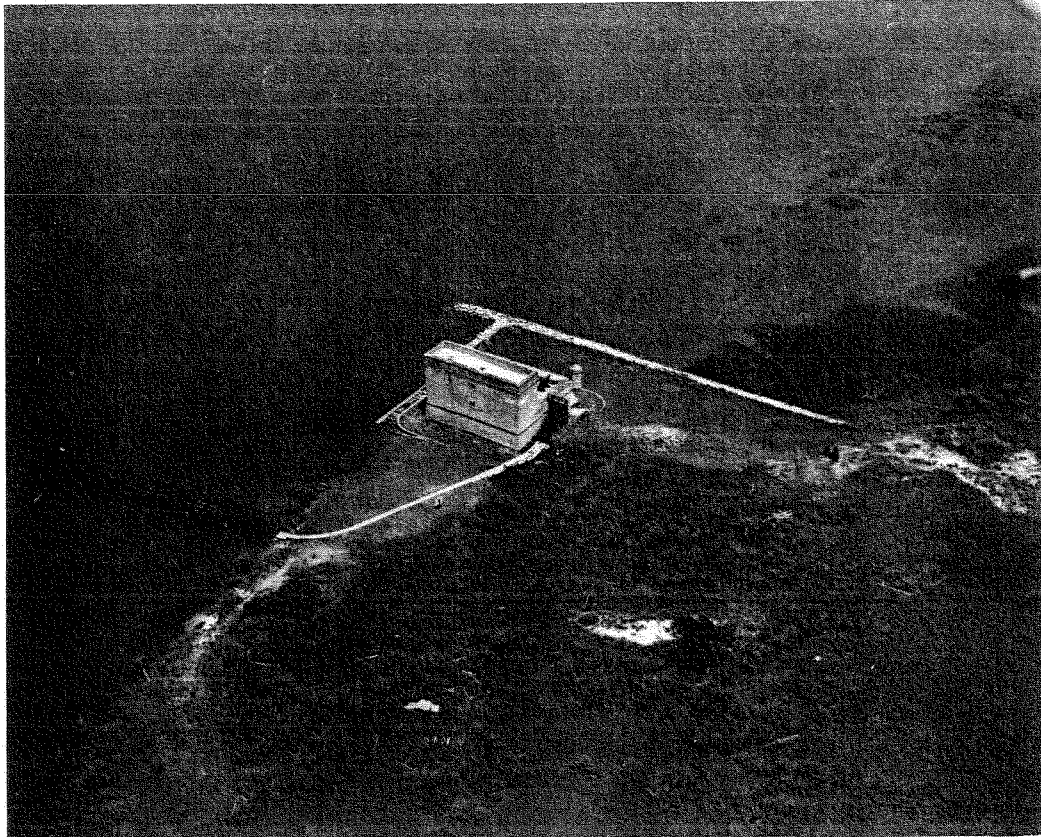
Illustration D-46

Aerial View of Fort Site, 1971, (Photo M-535)

In this photograph we see the condition created by the 1966 shore protection project. Even at a fairly high tide condition we see the presence of the small barrier island south of the fort. This sand bar seems to have formed due to the change in tidal prism resulting from Hurricane Dora's removal of the dike connecting the north and south sections of Rattlesnake Island.

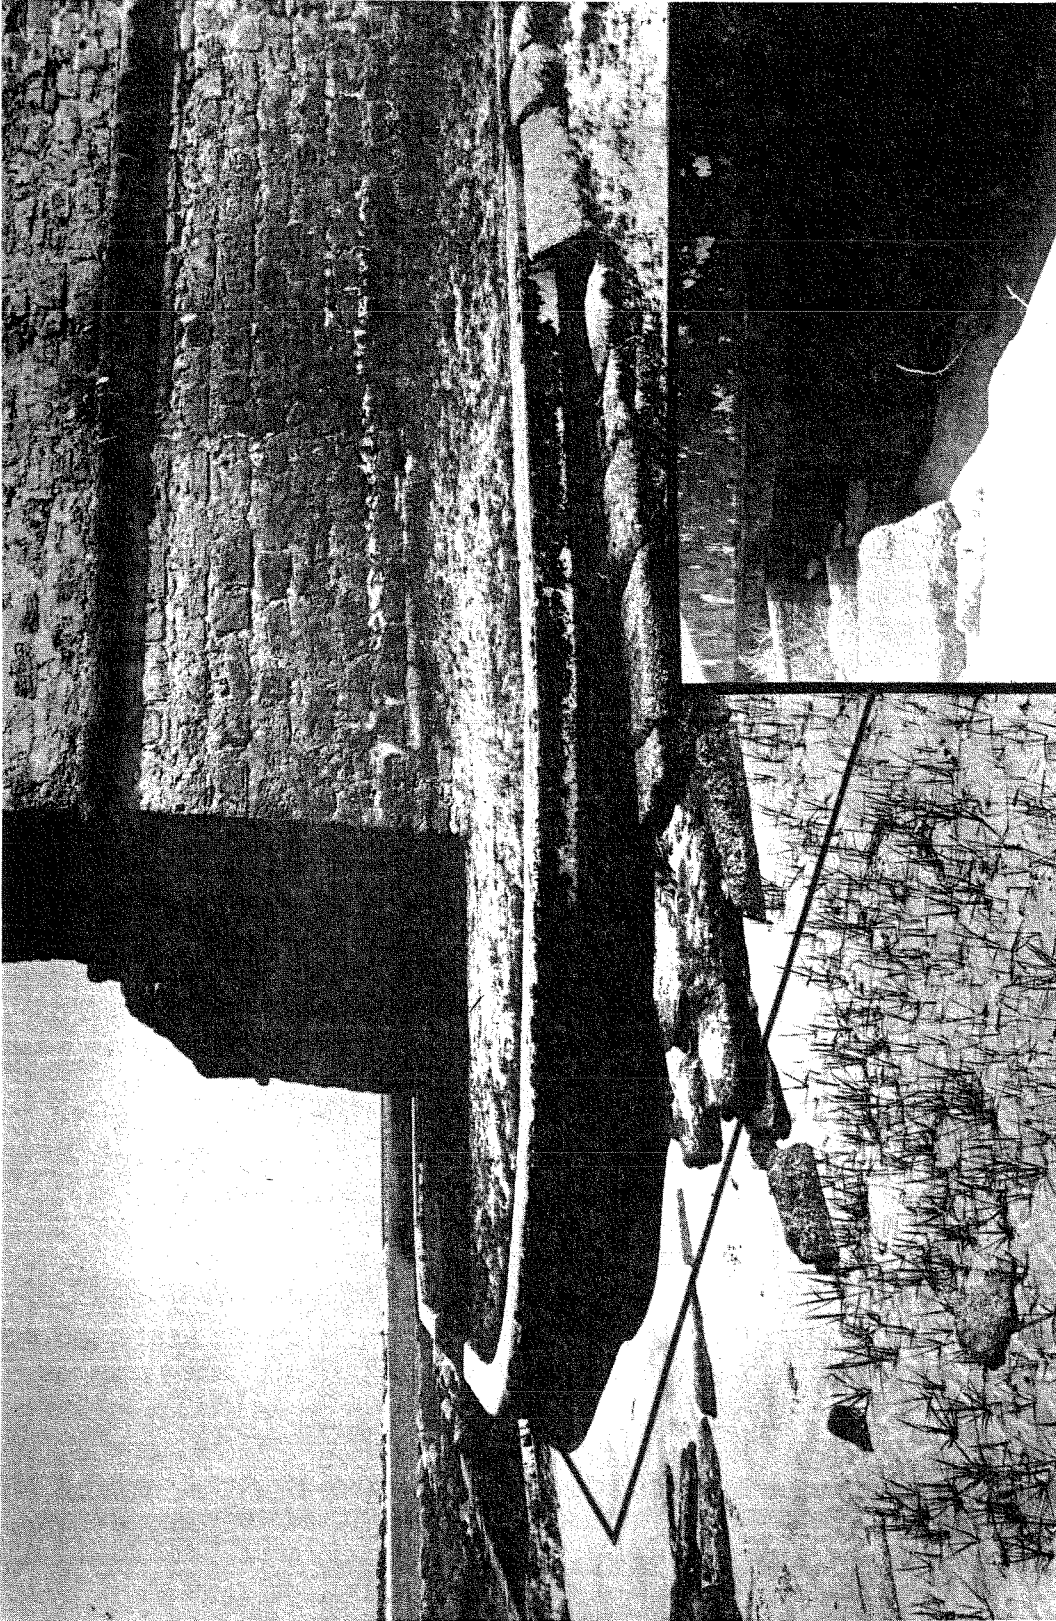
Illustration E-1

Based upon recommendations by the District Engineer, sheet piling was placed only on the south and east sides of the fort, topped by a concrete cap at elevation 4.5± above MSL. The purpose for this work was to confine the soils around the foundation and to protect the fort walls against river currents during abnormally high tides. (Purposes which have been partially superseded by later treatments.) This has worked to a certain extent, however water still washes over the concrete cap and when it does, it becomes trapped between the fort and the bulkhead after the tide has receded. Despite additional treatments performed in later years the top of the piling above grade is rusted, particularly where exposed (Illus. E-1). H-piles, driven to support the piling, are in worse condition and the top of these members are corroded through in some locations. The concrete cap is in good condition.

Detail of Steel Sheet Bulkhead

Excavate the ground on each side of the steel bulkhead to the full depth of the sheet piling and remove rust by chemical or mechanical means. Coat the steel with a protective membrane material. This action, if done on a cyclical basis, will preserve the fabric indefinitely. No action other than cosmetic finishing is required on the concrete cap. By restoring the integrity of the

steel bulkhead, soil around the fort foundation will remain confined. This will prevent scouring of the coquina fabric below grade, as well as minimizing the amount of surface erosion during storm tides.

Excavate the ground on each side of the bulkhead only to the depth of the water table (approximately 5'). Remove rust and coat steel similar to Alternative One. This action is based on the fact that the steel below the water table is constantly submerged and thus only limited corrosion occurs. Coating of the top portion of the bulkhead would prolong its life expectancy, and if done on a cyclical basis would preserve it even longer.

No action would be performed on the steel bulkhead; however, periodically fill would be piled against the bulkhead so that it will not be directly exposed to wave action. The concrete cap would be repaired as necessary. Under this alternative the remaining life expectancy of the steel bulkhead is estimated at 30-50 years.

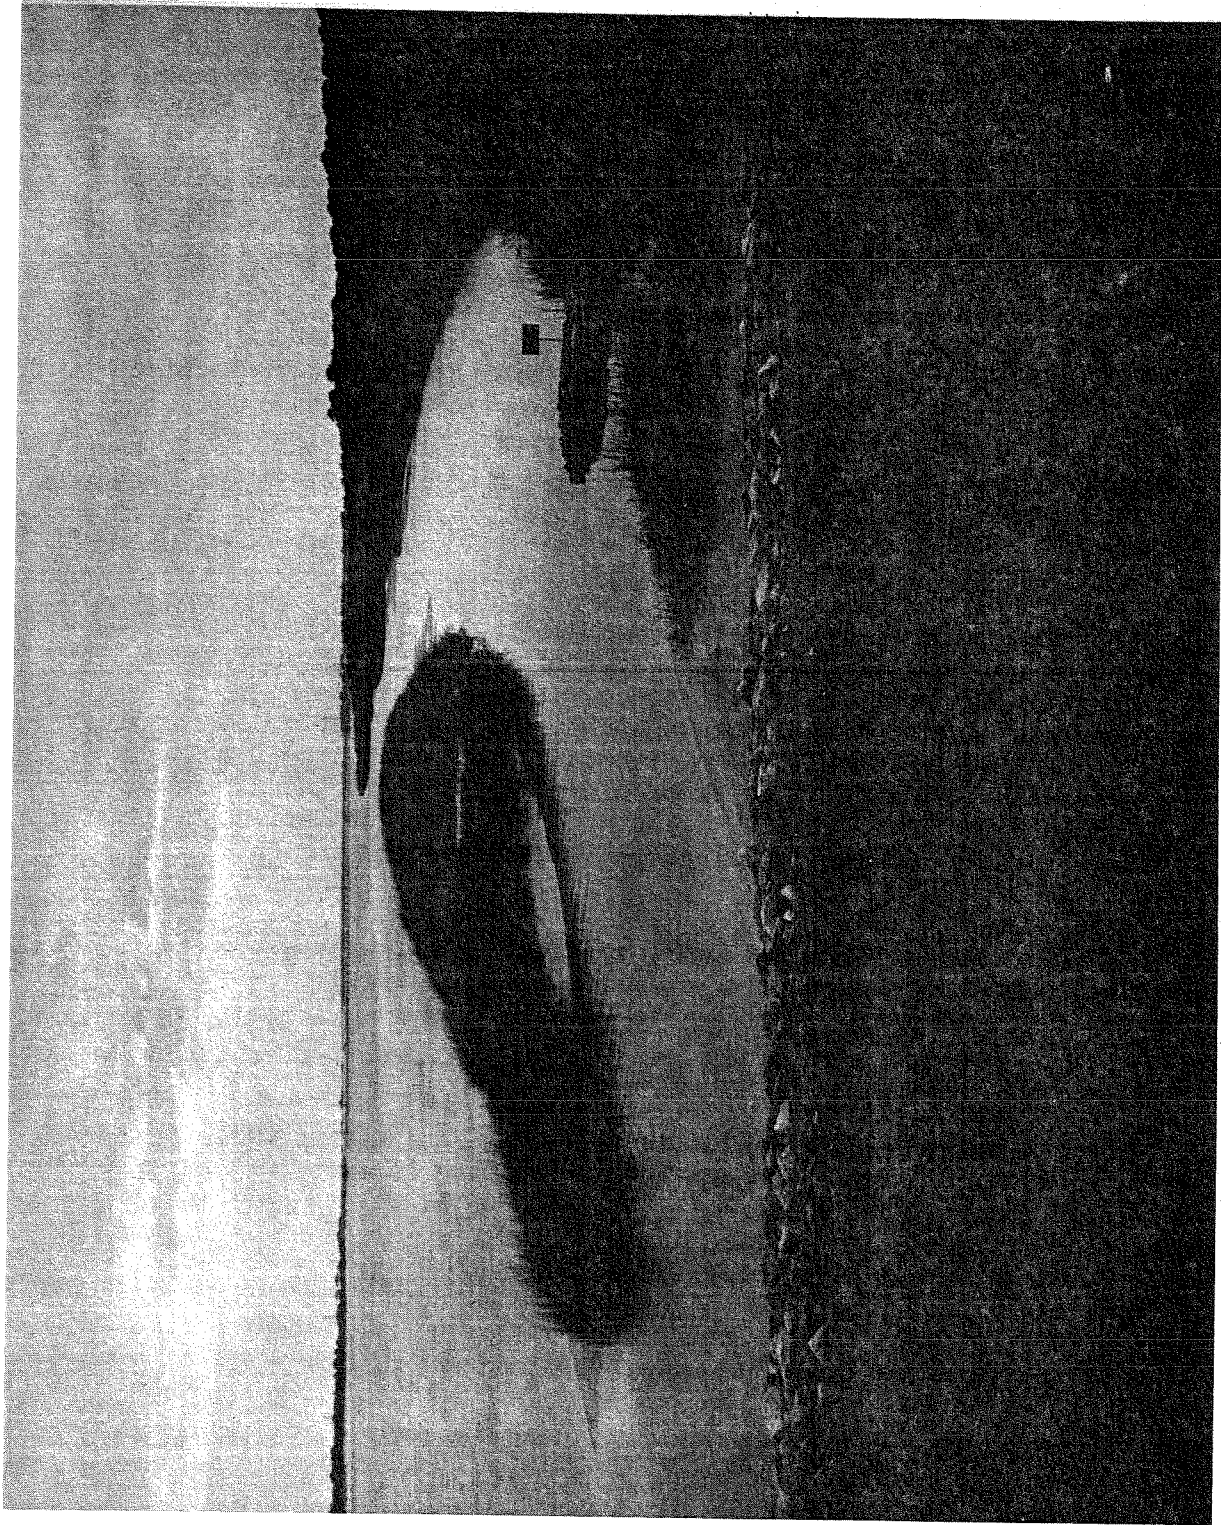
Illustration E-4

This groin has somewhat deteriorated due to a lack of maintenance. At one time it may have functioned well; however, an accumulation of sand east of the groin has resulted in the formation of a barrier island, thus decreasing the need for effectiveness (Illus. E-4).

Area South of Fort--South Groin and Barrier Island

Repair, raise and extend groin. This treatment may require complete dismantling of the existing structure in order to provide an adequate base. Although this side of the site is well protected by the barrier island, this action will assure its stability. This is particularly true if the barrier island continues to recede. Also, the groin will act as a collector of littoral drift, resulting in a build-up of sand in the area. This feature will provide additional shore protection for the south side of the site. Flow between the barrier island and Rattlesnake Island will be impeded.

This treatment will only provide for repair of the groin. Basically, this will be an interim solution to the problem of continual change. This feature will provide additional protection (the barrier island is the primary protective source at this time) during normal flood and ebb tides, but lose its effectiveness during storm tides.

Because of the many unknowns in this area due to continual changes, it may be appropriate to wait for this area to stabilize before any action is taken. Therefore, coquina stones from the groin will be removed and used elsewhere. This will also resolve the negative visual impact caused by the deteriorated feature. If the barrier island continues to recede, Rattlesnake Island will again be subjected to direct currents of the Matanzas River. This may require additional shore protection at a future date.

This alternative is proposed for the same reason as Alternative Three. Under this action, the groin will remain in the same damaged condition and may eventually disappear. Shore protection may be required in the future, based upon a more extensive analysis of the shore.

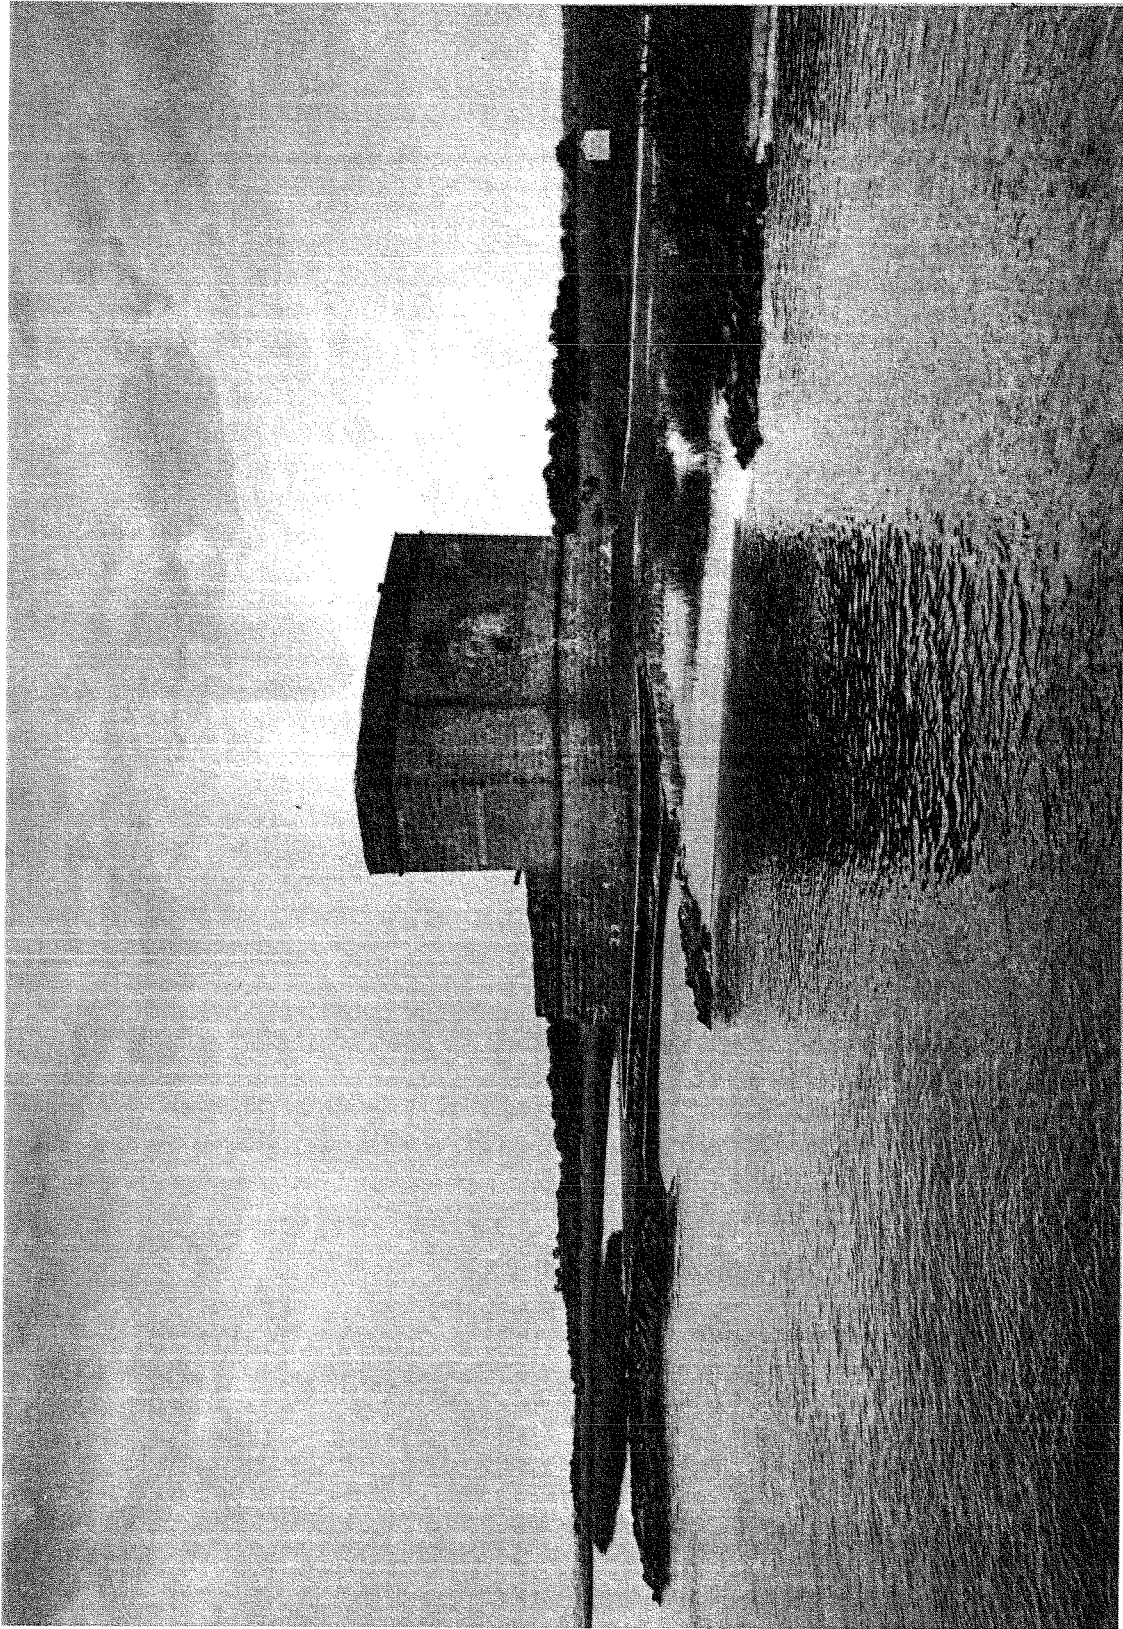
Illustration E-5
View of Shore East of Fort

Both groins are in a deteriorated condition, with the groin nearest to the dock in the worse shape; it has little effectiveness. The groin on the north side of the coquina stone wall is in a better state and is partially responsible for the accretion of sand at the coquina seawall. Nevertheless, the condition of this groin has also declined. The armor stones are now displaced leaving the rubble core stones exposed. The position of these small core stones have been and still are disrupted during storm surges (Illus. E-5).

Repair, raise and extend groin(s). This alternative will provide protection for the shore by slowing wave currents, thus retarding erosion, during normal flood and ebb tides, as well as some storm tides. Also, collection of littoral drift would increase in some areas. Possibly, total dismantling of the groin(s) may be required. This treatment will provide a solution for protection of the Fort Matanzas site. Some effect will occur relating to the flow of the Matanzas River. However, obstruction of the river flow and littoral drift would be negligible.

This treatment will provide only for repair of the groin(s). This will provide additional protection during normal flood and ebb tides. However, during high storm tides, the effectiveness of the groins would be reduced because of the flow of current over the groins. Because the groins were underdesigned initially, this alternative will need to be incorporated into another protection feature.

The coquina stones from the deteriorated groin(s) will be removed and used elsewhere in the project. Another method of shore protection will be designed to offset the loss of the groin(s).

Deterioration of the groins will continue under this alternative. Any expected shoreline protection resulting from the groins will eventually become negligible, therefore another method of shore protection will be required. Continued visual impact from the scattered arrangement will occur.

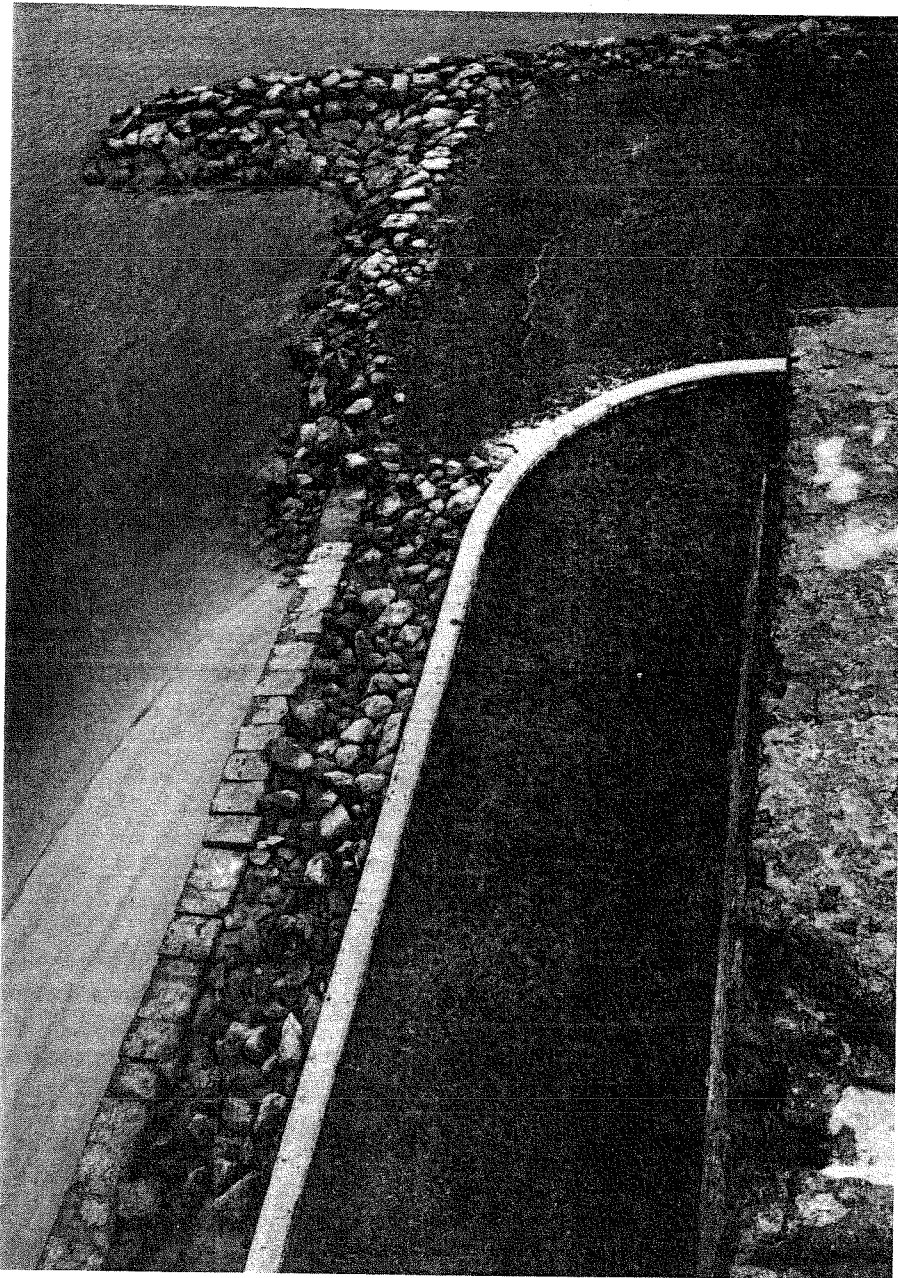
Illustration E-6

Following the destruction of the southeast corner of the 1940 seawall in 1944, this corner of the site suffered erosion which resulted in minor damage to Fort Matanzas. Finally, in 1949 a coquina stone revetment and groin was constructed to prevent erosion and protect this area. This shore protection structure stabilized the southeast corner, but evidently some problems occurred which were not anticipated for in 1966, another structure was constructed to replace this one. The coquina stone was probably salvaged and used in the new construction.

Southeast Corner of Site

Included under this alternative will be restoration of the groin with additional structures as required. This may include a

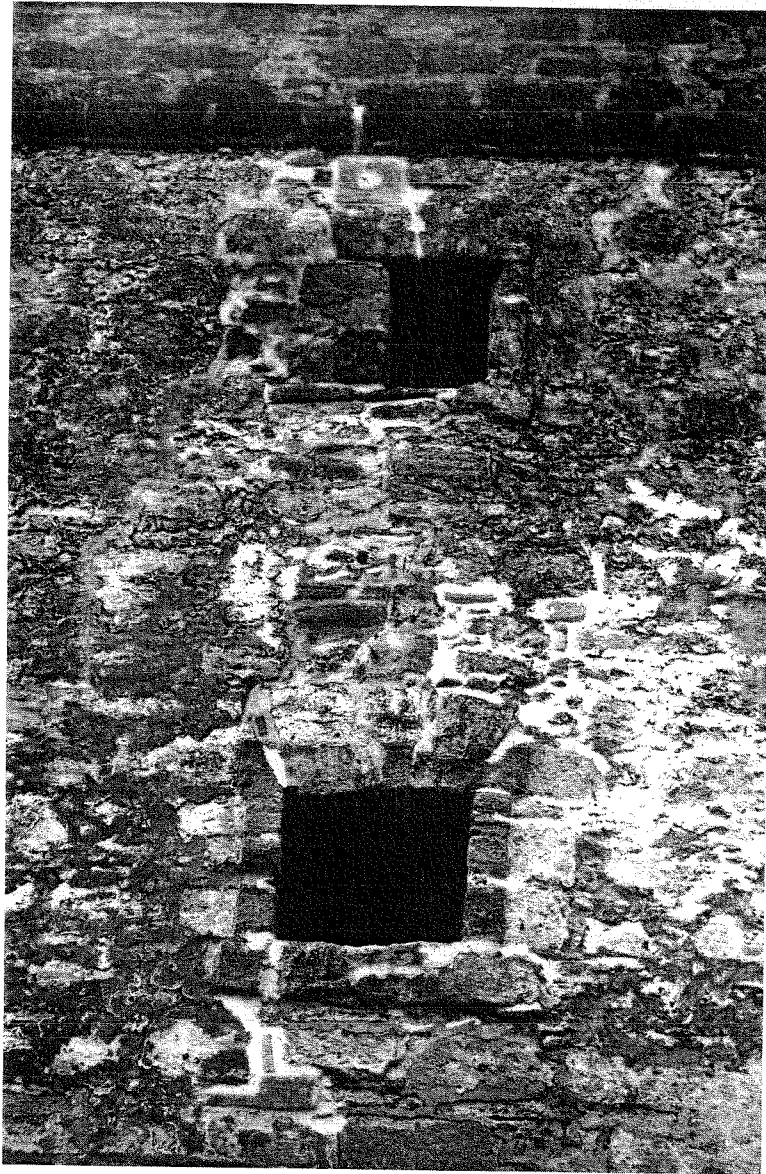
Illustration E-8

Currently, a cordon stone is missing on the upper cordon course (Illus. 21). A cordon stone of the lower band has been recently replaced. The north face today noticeably reveals the historic structural deterioration that has occurred. The 1916 work failed to remove the vertical splay resulting from foundation settlement with subsequent shear cracking; as repaired, the wall has 12" of outward splay on the east end and 6" on the west (from tower cordon to base cordon). A north-south splay of $7\frac{1}{2}$ " is noticeable in the center of this wall. Although readily noticeable, these splays pose no apparent structural problem.

Detail of North Face Windows

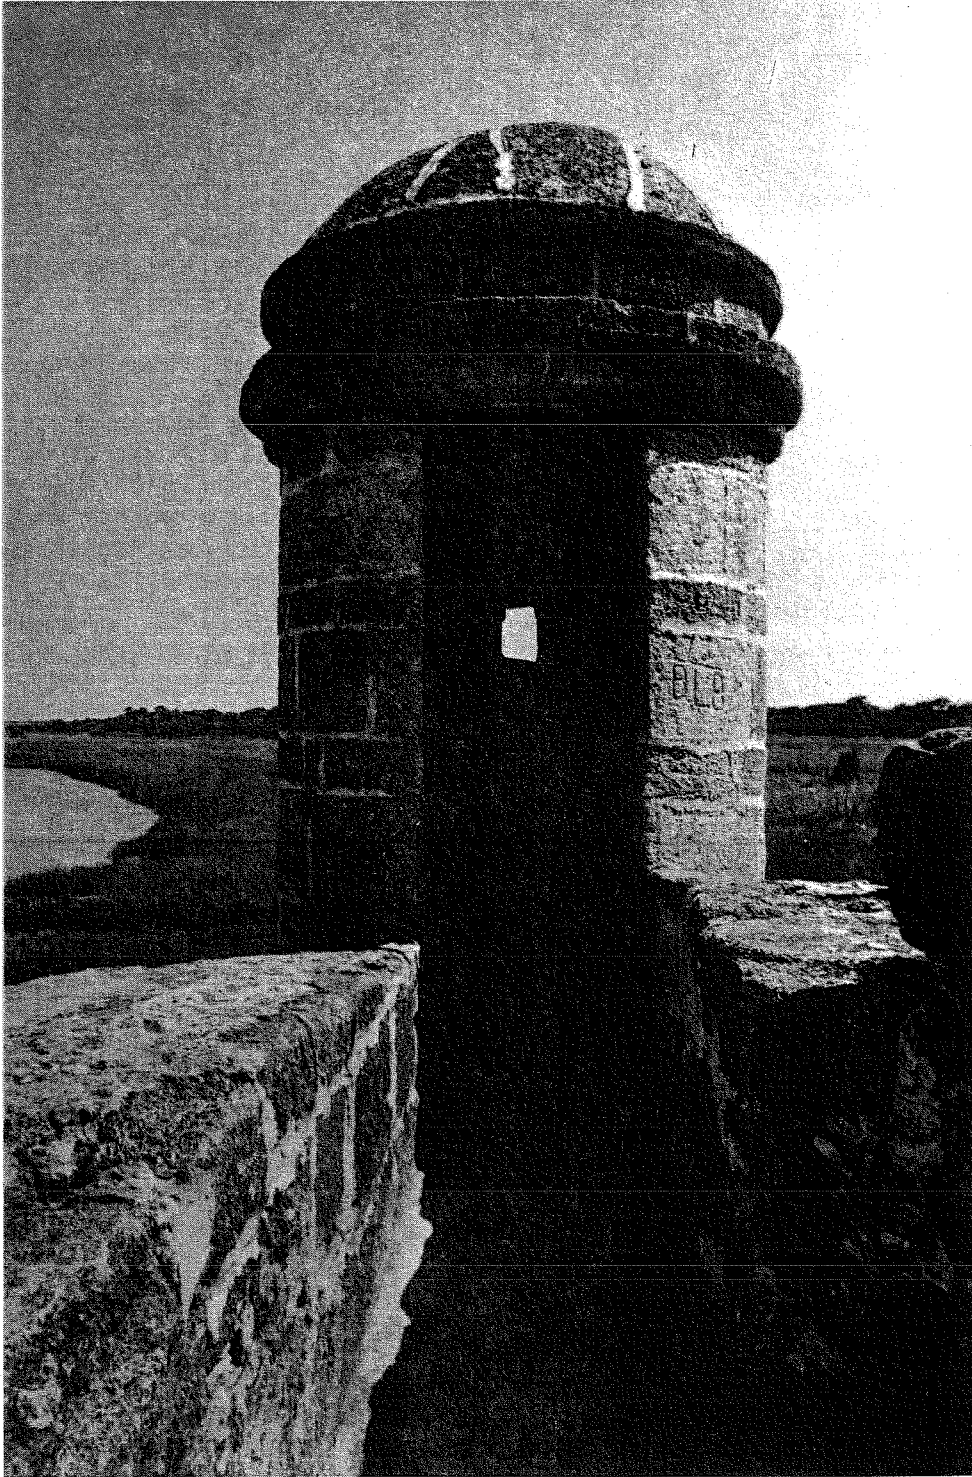
Illustration E-14

Detail of Sentry Box Entrance

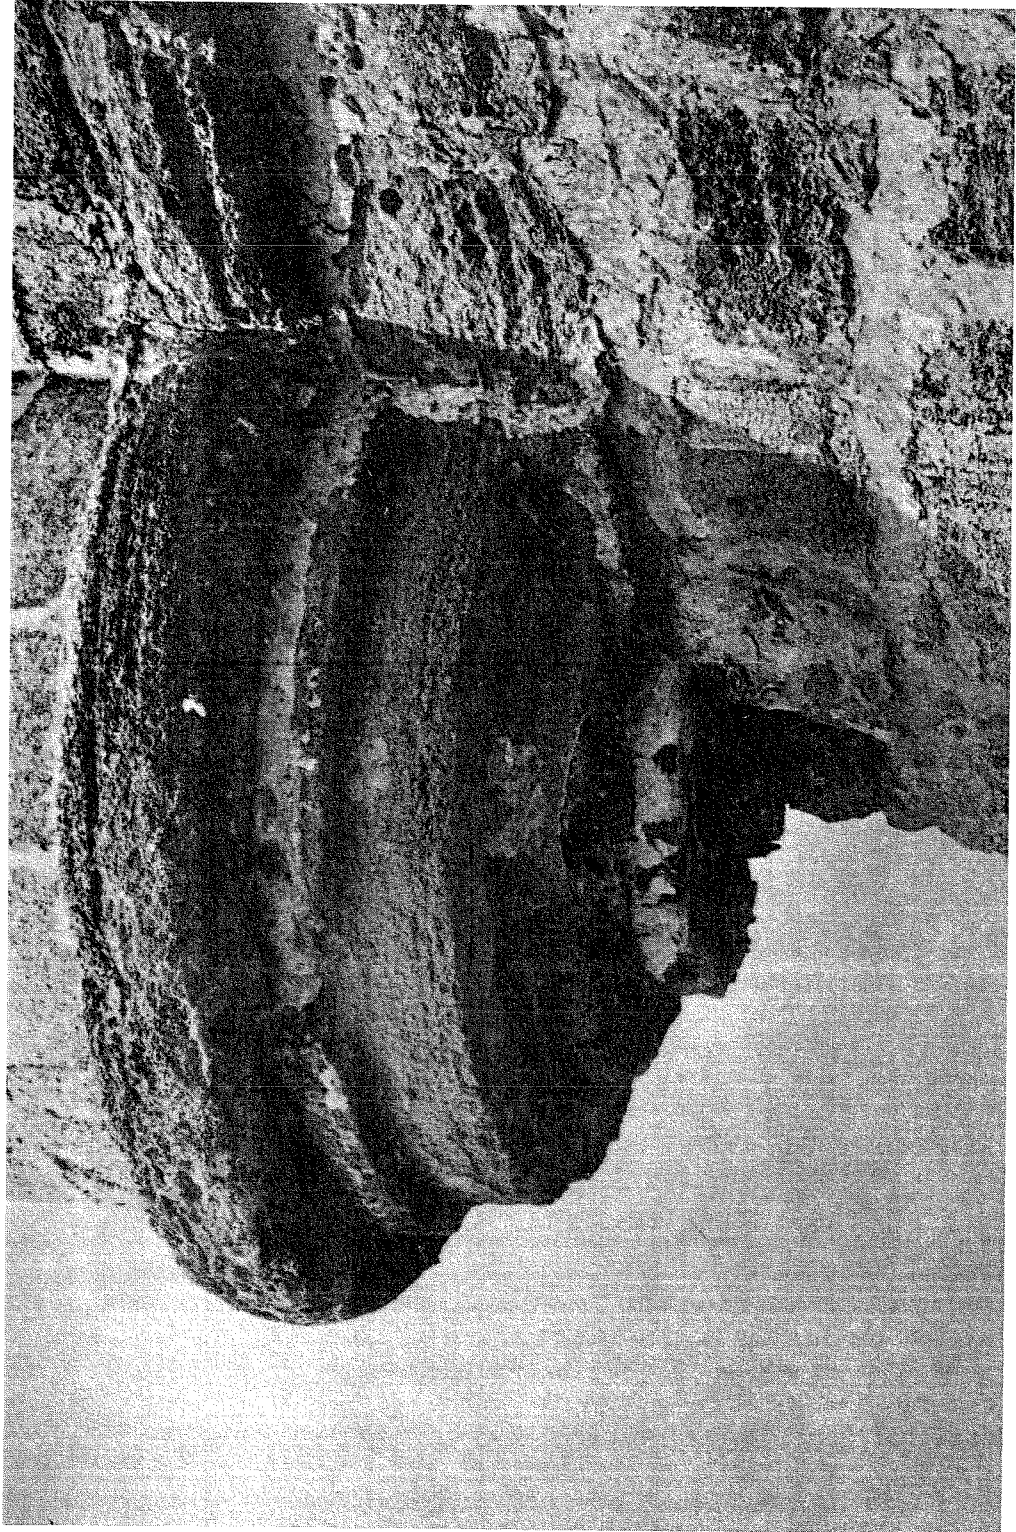
Illustration E-15

The sentry box is in good condition, but portions of the corbeled base are missing (Illus. E-15), exposing some of the iatrogenic steel reinforcement (Illus. 26). The visible steel is in an advanced exfoliated condition and probably caused the base's displacement. Steel rings were used to support the sentry box at the lower base courses and railroad irons connect it into the parapet walls (see history p.135 for details). The lower ring is visible and reveals steel deterioration (Illus. E-16).

Detail of Sentry Box Base

Will involve an intensive maintenance/repair effort in which visible iron brackets are cut out of the corbeled masonry base; new reinforcement will be installed and corbeled base stones replaced. Architectural details of the masonry base will thus be restored. Other metal elements above the base and at the dome level will not be treated, but will require observation and maintenance as required at a later date.

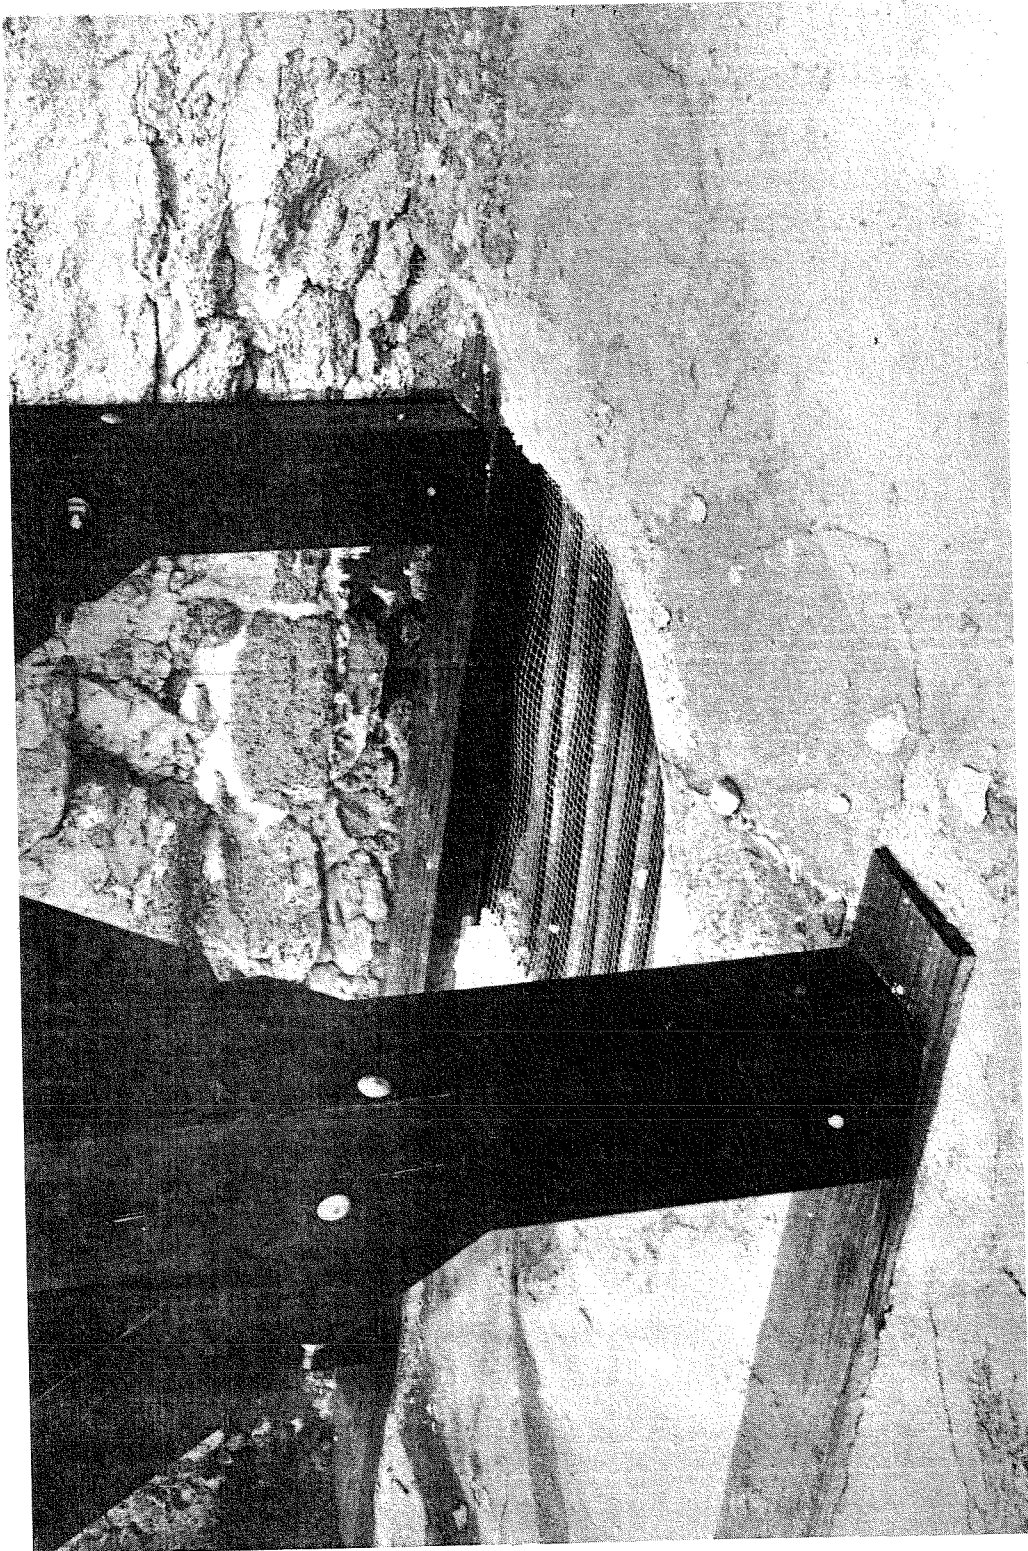
Illustration E-18
Detail of Cistern Opening

The cistern is in remarkably good condition and continues to hold water. It is made of red brick, at least three layers thick with a plaster coating. The plaster coating has several inscriptions, some dating from the 19th century.

No treatment is recommended because the cistern is in good condition and needs no repair. It is possible that the historic function of wooden downspout and cistern be restored. In this event, repair of some plaster in the cistern could be performed.

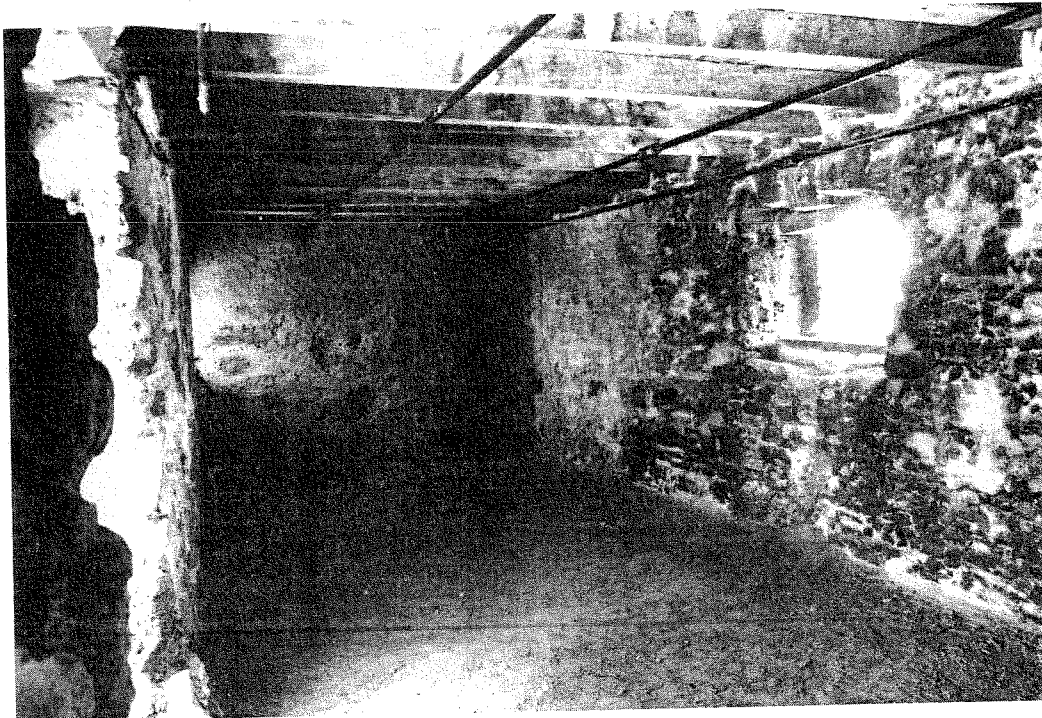
Illustration E-19

The first floor of the observation tower which housed the garrison troops and kitchen facilities has little resemblance to its historic appearance (Illus. E-19 and E-20). Although it is still about the same size (27' x 10'8") it is undifferentiated and cell-like. If rain has occurred within the previous day or two, the sandy-dirt floor will be moist if not muddy and dripping water will be coming from the decayed wooden ceiling. The visitor will notice broken and badly eroded coquina masonry around windows, the fireplace and door. Wall surfaces are also eroded with patches of plaster here and there; initials and other graffiti are cut into some stones; sloppy repointing and repairs made in the 1930s and 40s will be obvious. Visitors have, on occasion, used this space as a toilet.

First Floor Interior--Looking West

Notice joist pockets in corner.

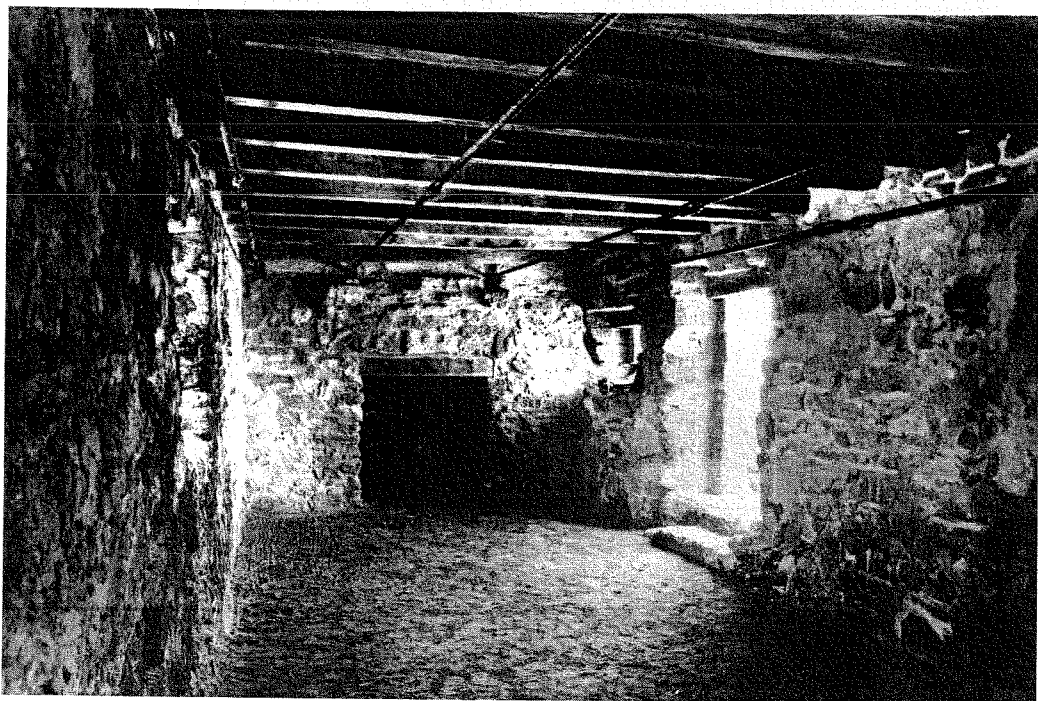
Illustration E-20

First Floor Interior--Looking East
