FORT MATANZAS

HISTORIC STRUCTURE REPORT

FORT MATANZAS NATIONAL MONUMENT
ST. JOHN'S COUNTY, FLORIDA

THE FORT MATANZAS STABILIZATION TEAM

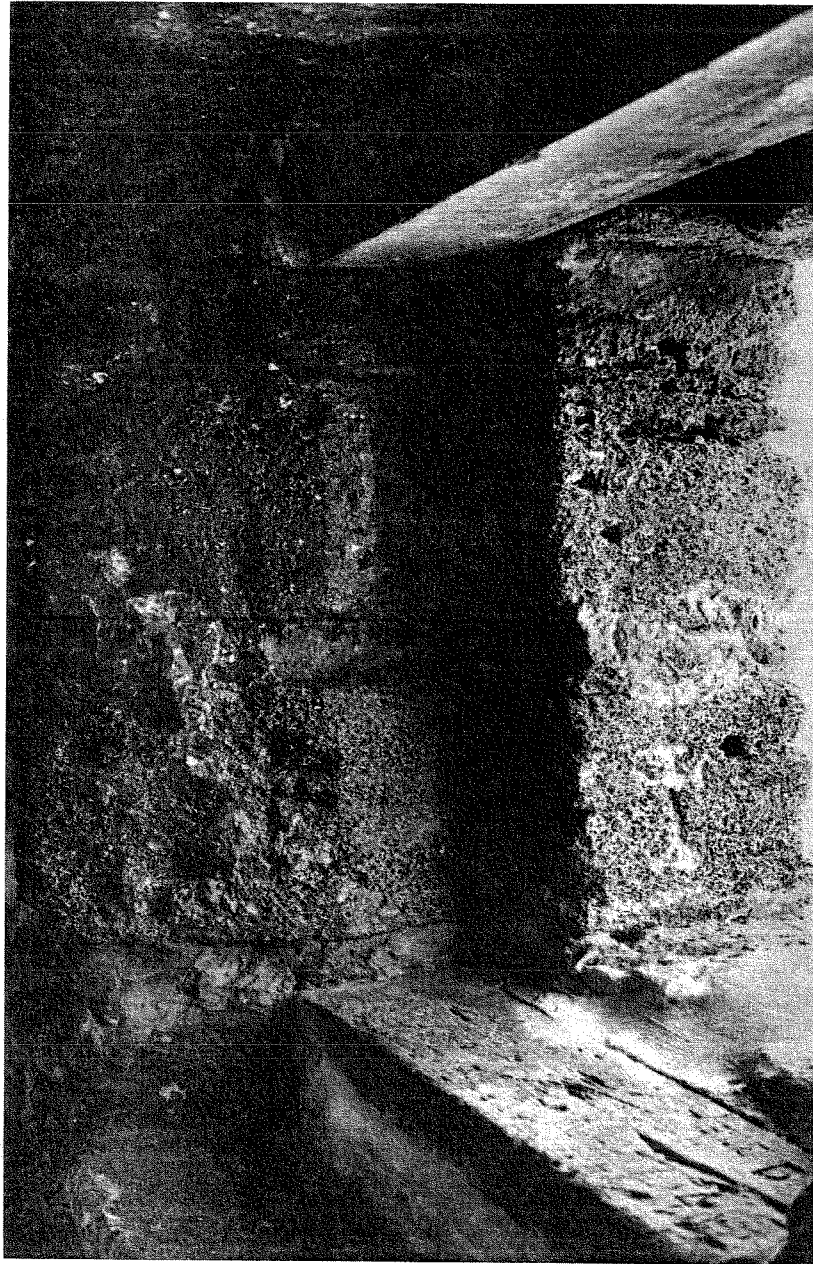
Illustration E-23

Detail of First Floor North Window--Interior

The stabilization of the windows could include treatments which will restore their historic appearance as well as protect existing fabric. This would involve replacing highly eroded stones of the frame, filling cracks and voids and repointing with a soft mortar; installation of the two timber sill beams noted above, installation of timber jambs in all three frames, and construction of wooden shutters with appropriate metal hardware.

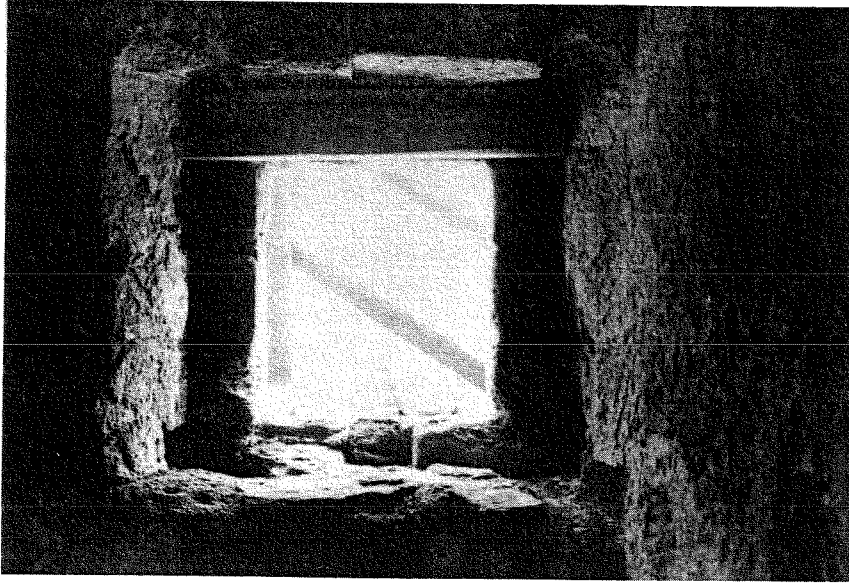
Illustration E-24

Detail of First Floor Southwest Window--Interior

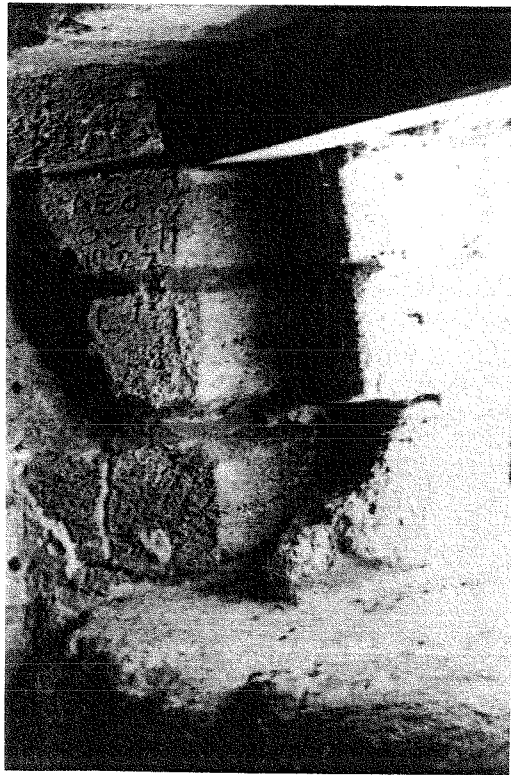
Illustration E-25

Detail of First Floor Southeast Window--Interior

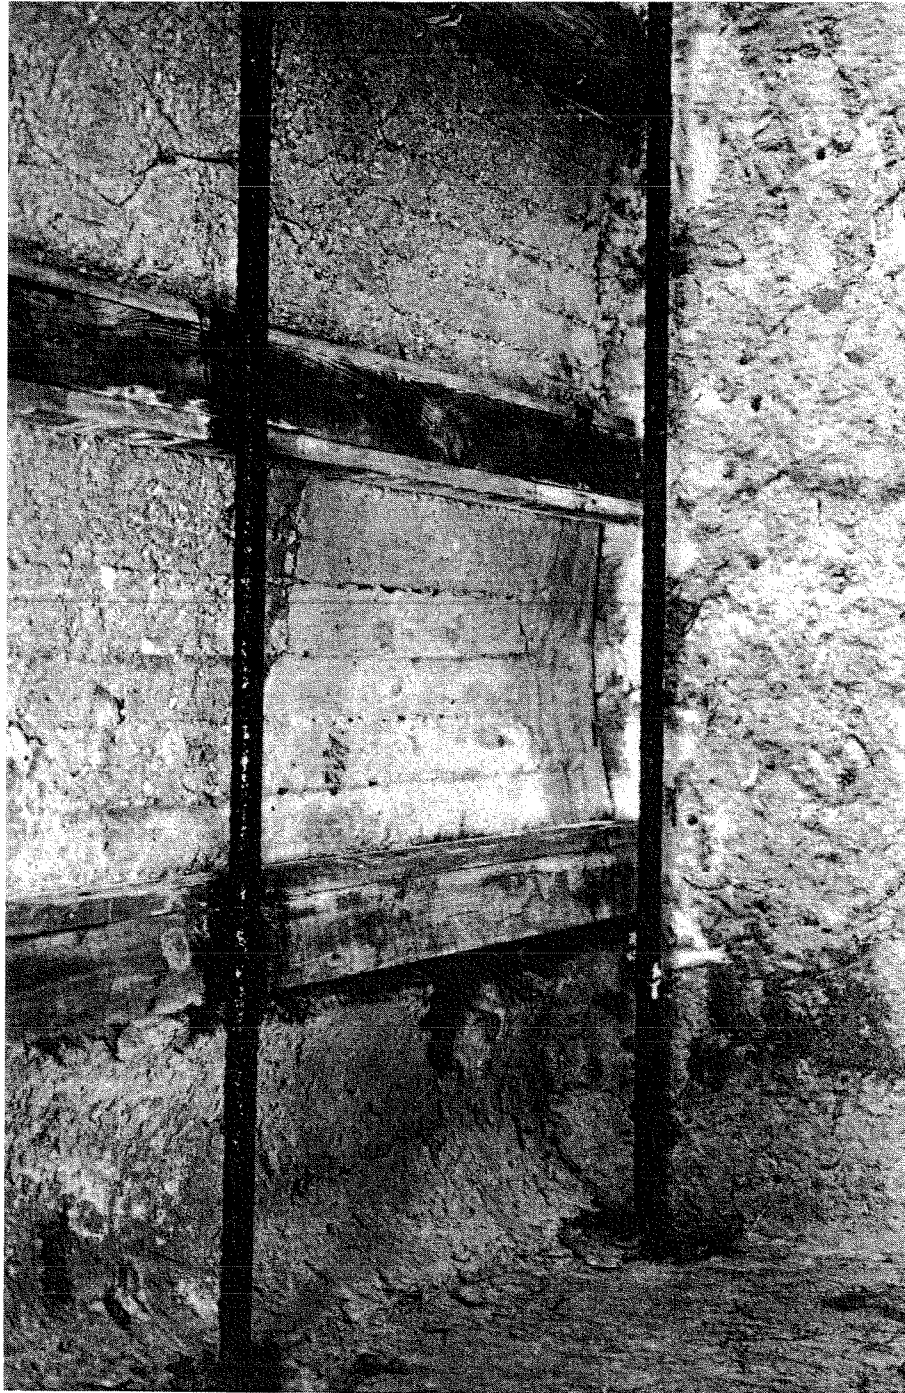
Illustration E-26

The ceiling in the tower first floor consists of three segments, the eastern two-thirds of wood (1939), 6' of concrete reconstruction (1916) and the westernmost bay of historic tabby (1740s). Under this ceiling four 1½" diameter tie rods run east-west visually intruding into the space. The ceiling is one-fourteenth historic and even that single bay is badly deteriorated and intruded upon by the 1938-39 tie rods. (Illus. E-26)

Detail of Vaulted Ceiling--West End

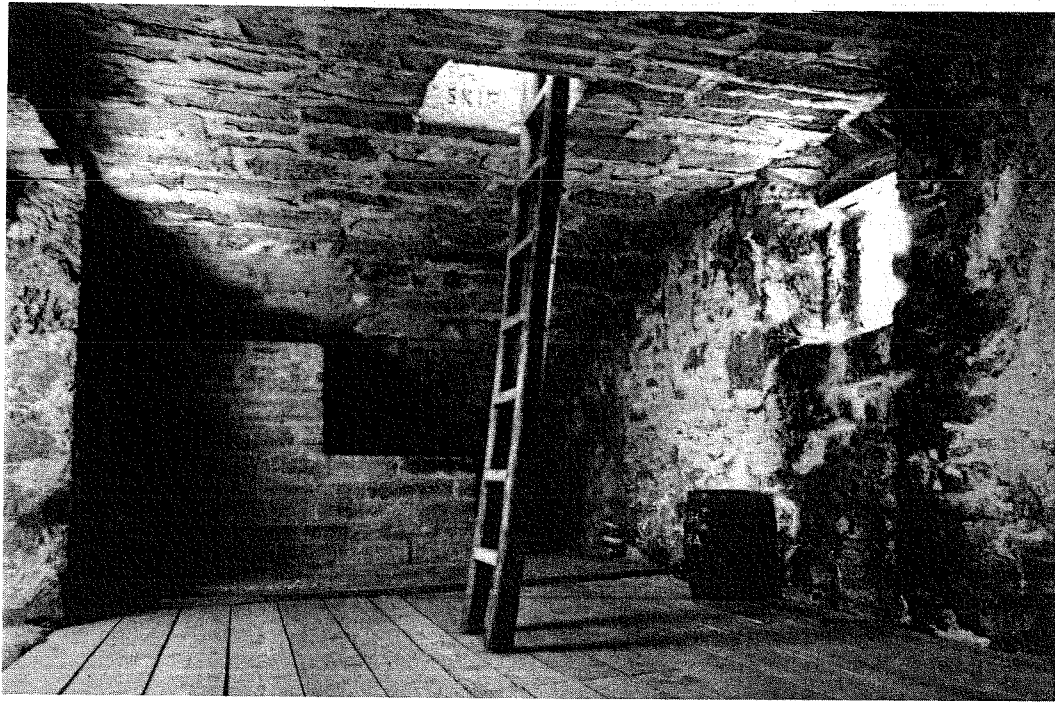
Illustration E-27

Presently, however, the visitor enters the space and is confronted with a wooden floor, the joists being decayed, and an undifferentiated space with eroded walls and a poor replica of a partition in front of the powder magazine entry. Visitors find puddles on both the wooden floor and behind the partition on the reconstructed concrete floor and dripping water coming from the vault if it has rained within the past day or two. A wooden ladder in the center of the room takes them through a 2'2" X 1'9" hatch up to the observation deck. Although coquina surfaces, which were plastered historically, are cracked, voids exist, and erosion is evident, the structural integrity of the space appears sound. Except for the joists of the floor system, until a concerted restoration effort is mandated, few actions need be taken to stabilize this space beyond cyclic maintenance. Each feature is discussed in more detail below.

Second Floor Interior--Looking West

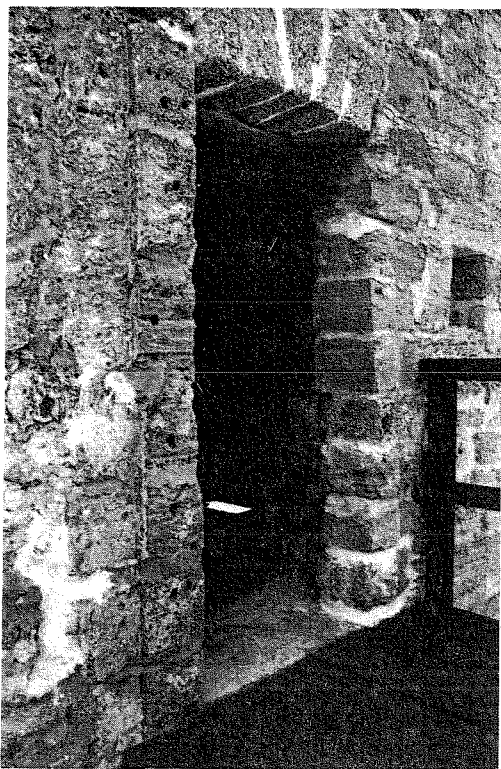
The earliest major shear crack split the center of the réduit through the jack arch of this doorway in the middle of the south wall of the second floor. The reconstruction in 1916 was undertaken again in 1938-39 and is basically accurate although incomplete. Some of the stones are in good condition while the original masonry is pitted and edges are broken. In addition, two voussoir stones are missing leaving unsightly voids. A 6" X 4" timber lintel has been placed but no other door frame elements are present. The opening (Illus. E-28 and E-29), 6'± X 2'8", is at least 6" narrower than reported by Benham in 1843, but generally exhibits the same molded shape as other doors and the windows of the fort. Since the entry is open, there is no barrier to wind or rain.

Illustration E-28
Second Floor Door--Exterior

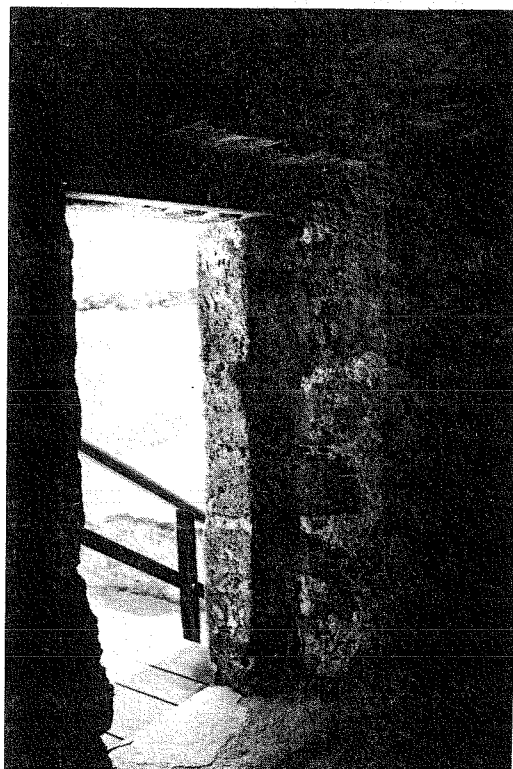
Illustration E-29
Second Floor Door--Interior

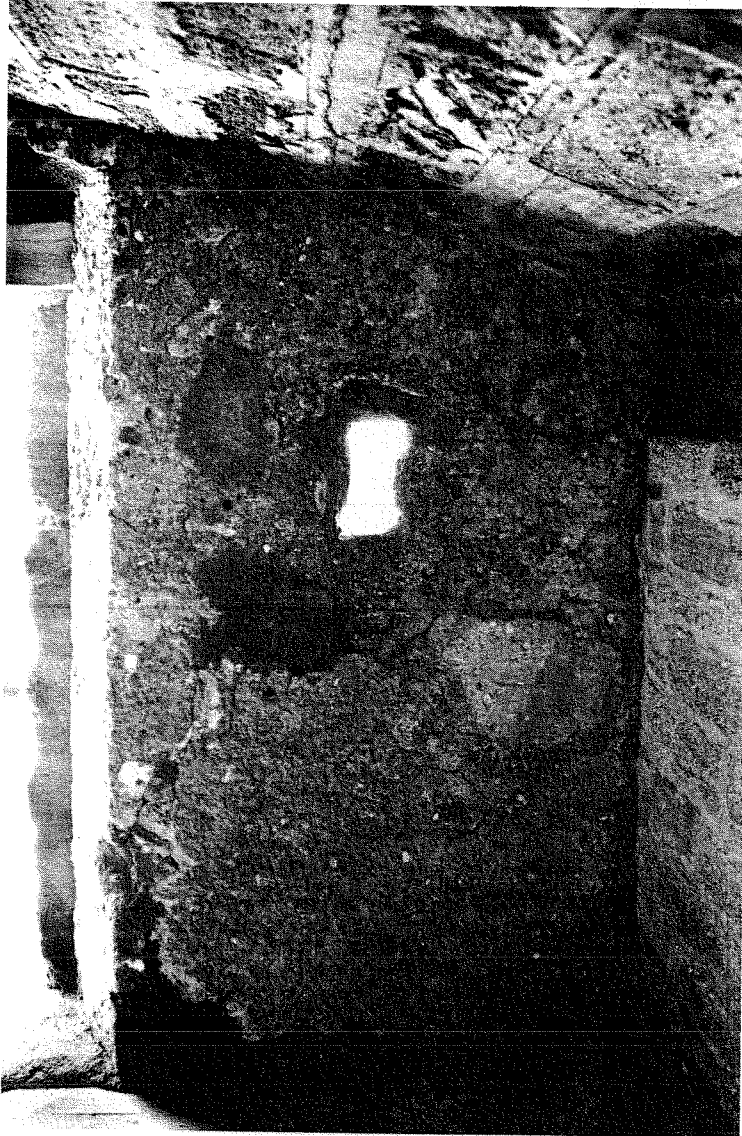
Illustration E-32

Detail of Second Floor Interior--South Wall

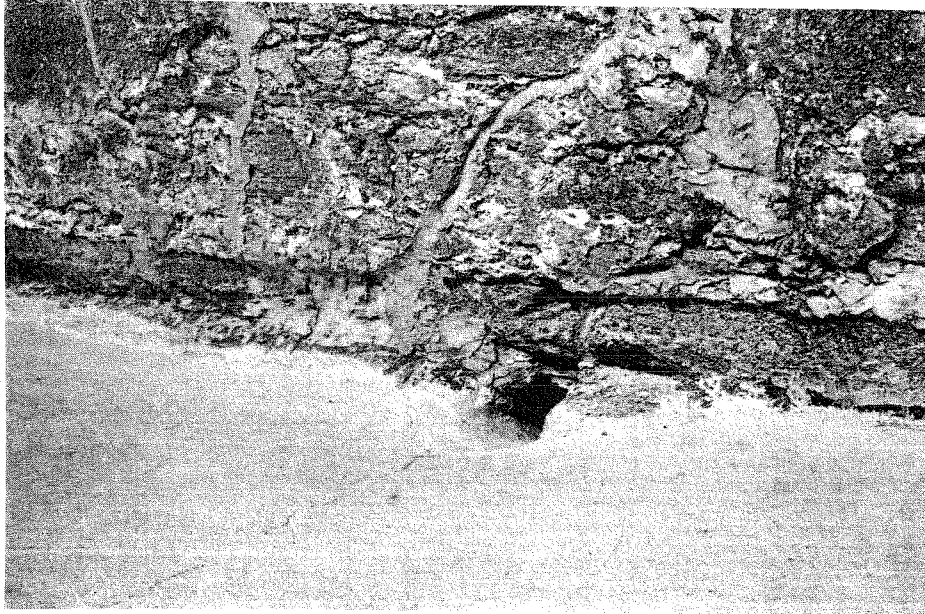
Illustration E-35

Detail of Scupper--North Parapet

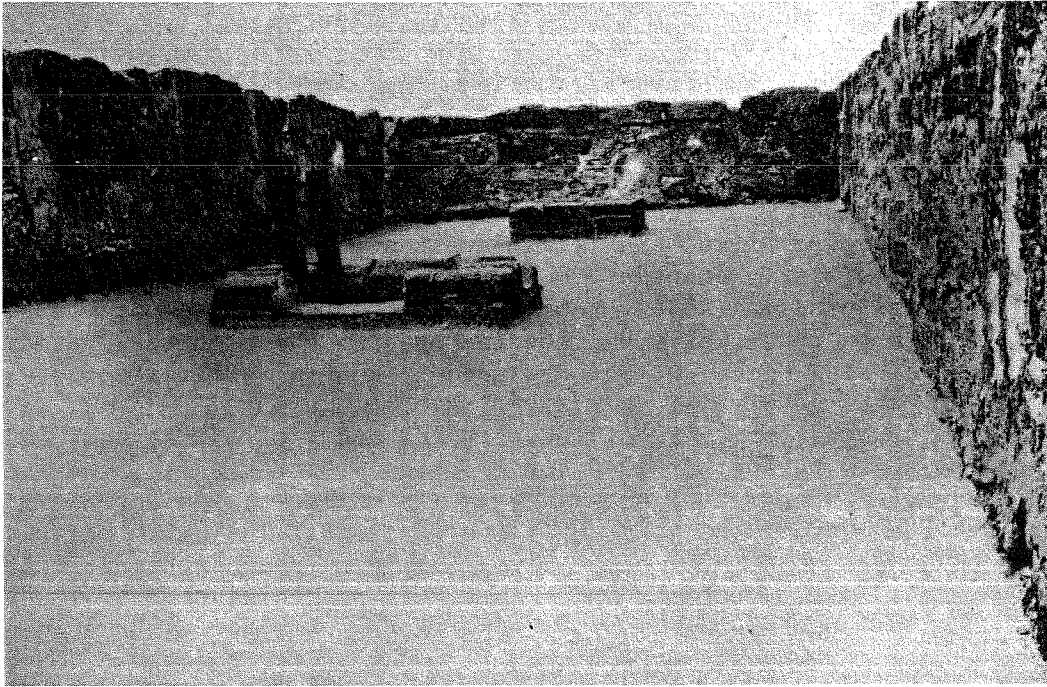
Illustration E-36

View of Tower Deck--Looking Northeast

It will not be possible to completely restore the tower deck parapet walls without rebuilding the tower, which is out of the question at this time. So, accepting the curvatures and splay, some deformation could be corrected. The coping stones would be

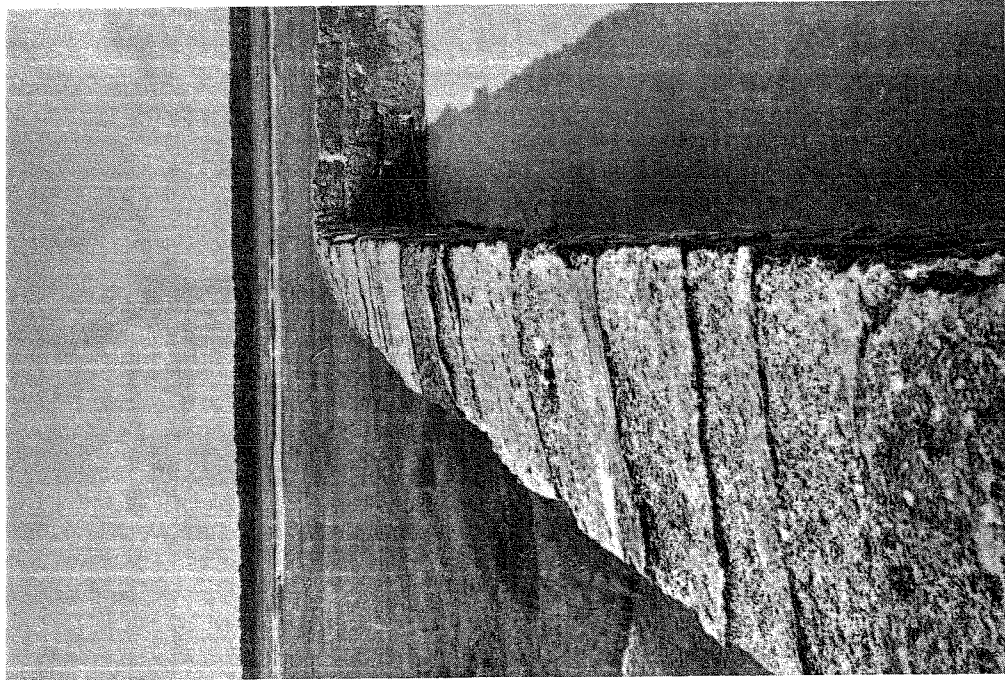
Illustration E-37

View Along South Parapet--Tower Deck

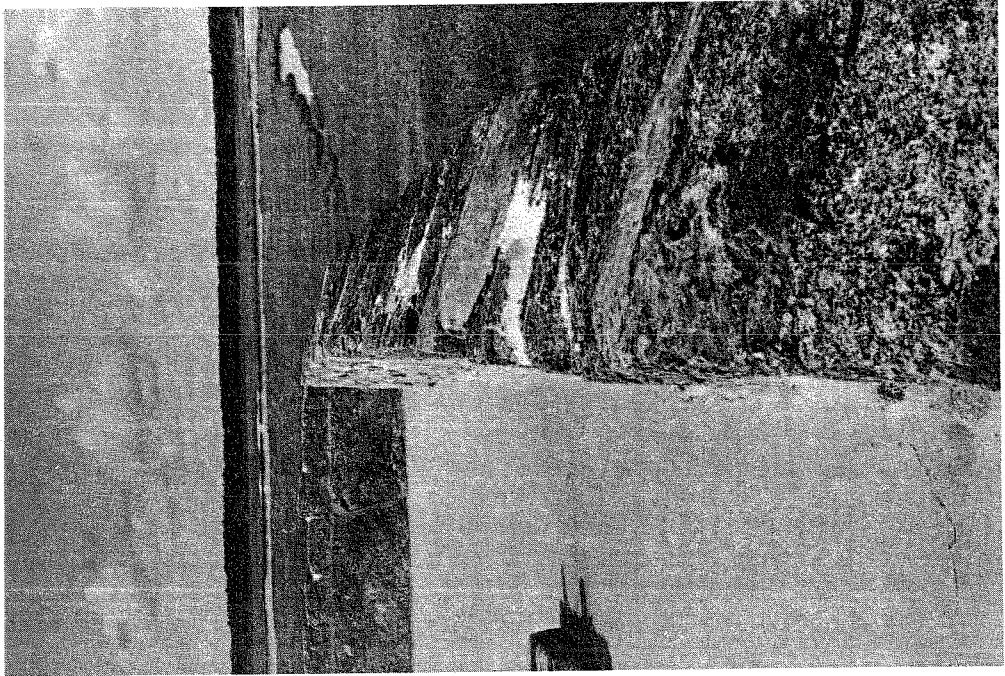
Illustration E-38

View Along North Parapet---Tower Deck

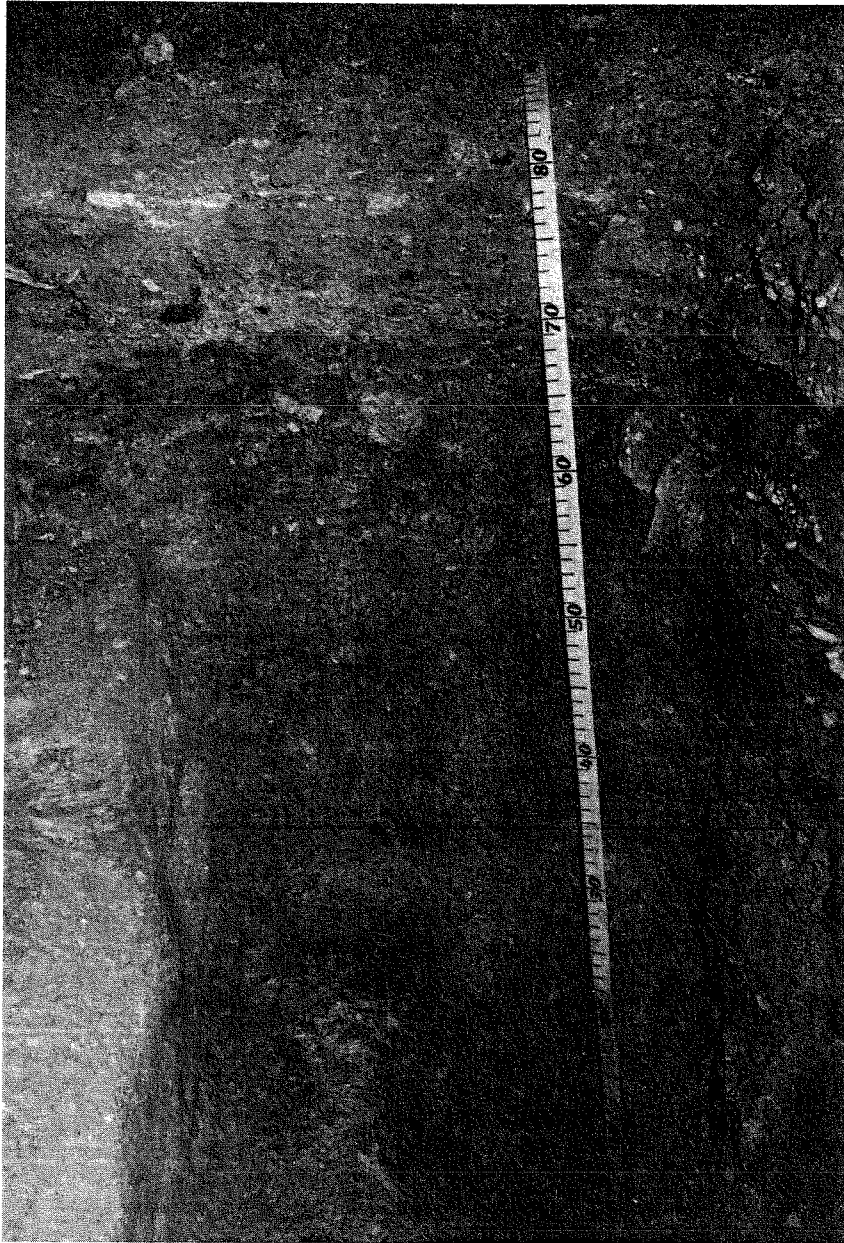
Illustration G-6b
Trench B, South Profile

Floor 1 designated in Trench B, was of modern grey concrete over mortar rubble, and corresponds to the Floor 1 remnant in the northwest corner of Trench A. Below this level, several interesting features were encountered.

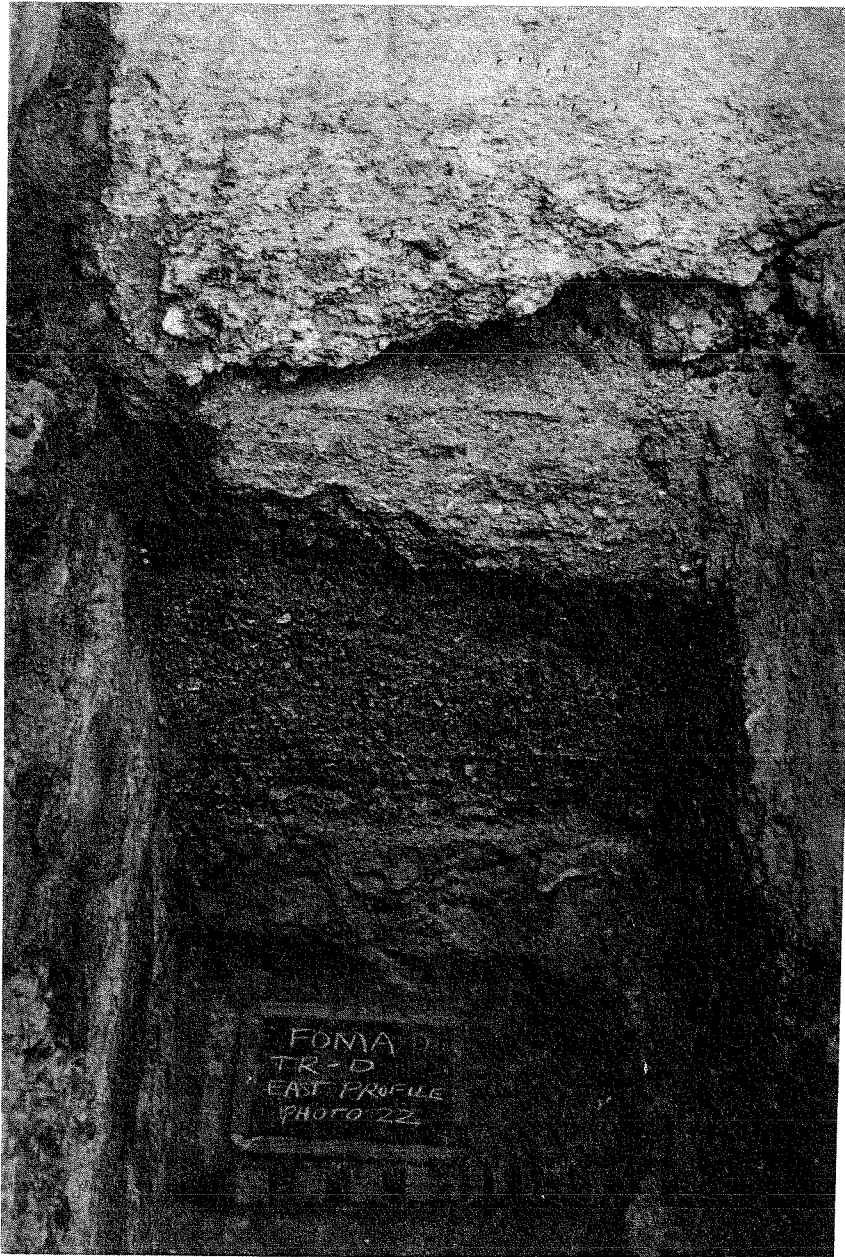
Illustration G-9b
Trench D (Terreplein)
East Profile

These layers of coquina and sand rested on a base of grey-green, compacted clay with patches of white beach sand on the surface (3.61mmsl). Coring revealed that this clayey-mud continued for at least 18" more below the base of the excavation, and is believed to be the fill beneath the terreplein. It is the same material found in Trench A beneath the lowest floor in that room, and was present at 3.58mmsl there; an elevation highly consistent with the suggested fill elevation in Trench D.

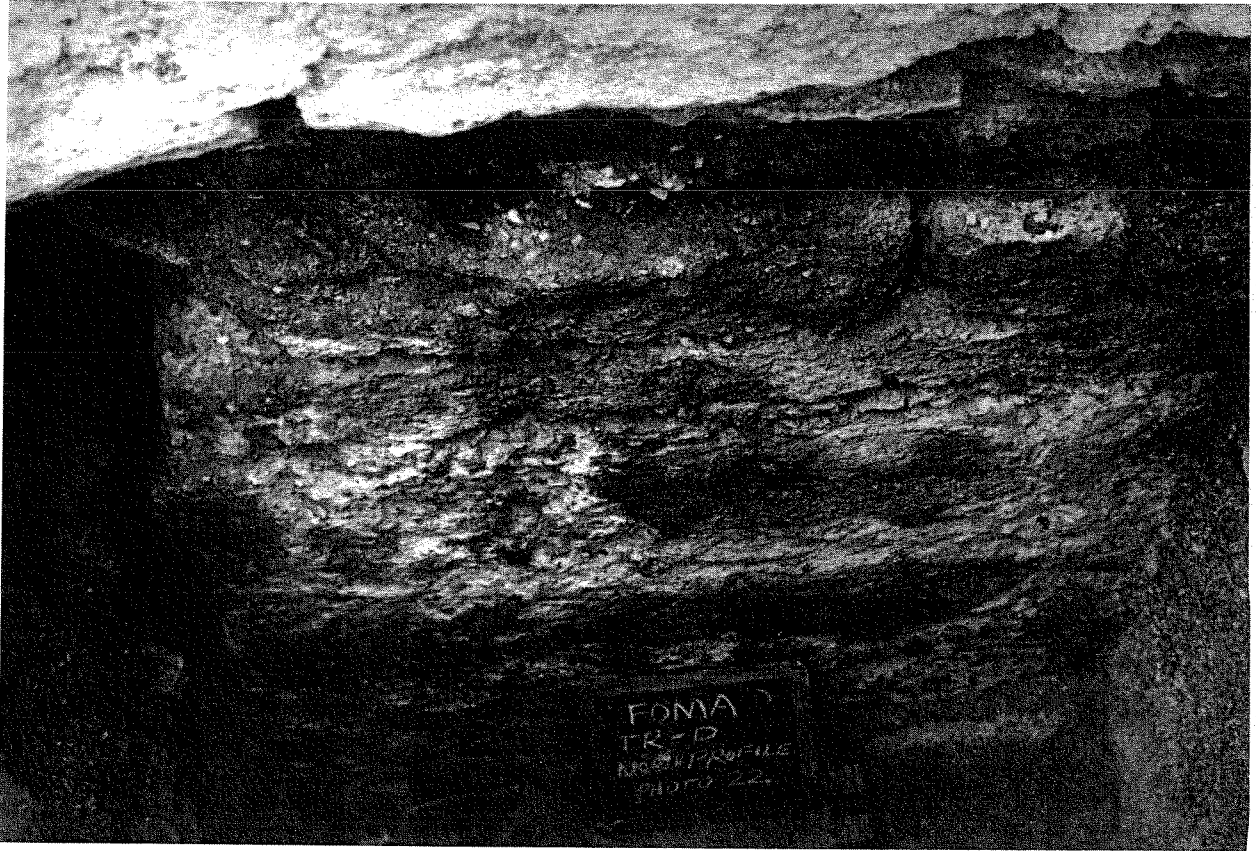
Illustration G-9c
Trench D (Terreplein)
North Profile

The north wall of Trench D was the south wall of the observation tower lower floor. Illustration G-9c shows this profile, revealing that the coquina blocks of the wall extend to the base of the excavation, and, as probing indicated, down into the terreplein fill. It was beyond the scope of this investigation to determine the total depth of this wall. Illustration G-9c shows a large, vertical crack in the foundation of the OTLF south wall, beginning at the base of Floor 2, and extending to the base of the excavation. Approximately 10 to 20 centimeters wide, the crack was in the same position as that shown in the early photographs of the fort south wall (see Section 4), and appears to be a below grade extension of that crack. This was repaired above grade in the 1916 tower restoration, indicating that at that time the grade level was at the base of Floor 3 (3.71mmsl), since the crack today begins at the base level of that floor.

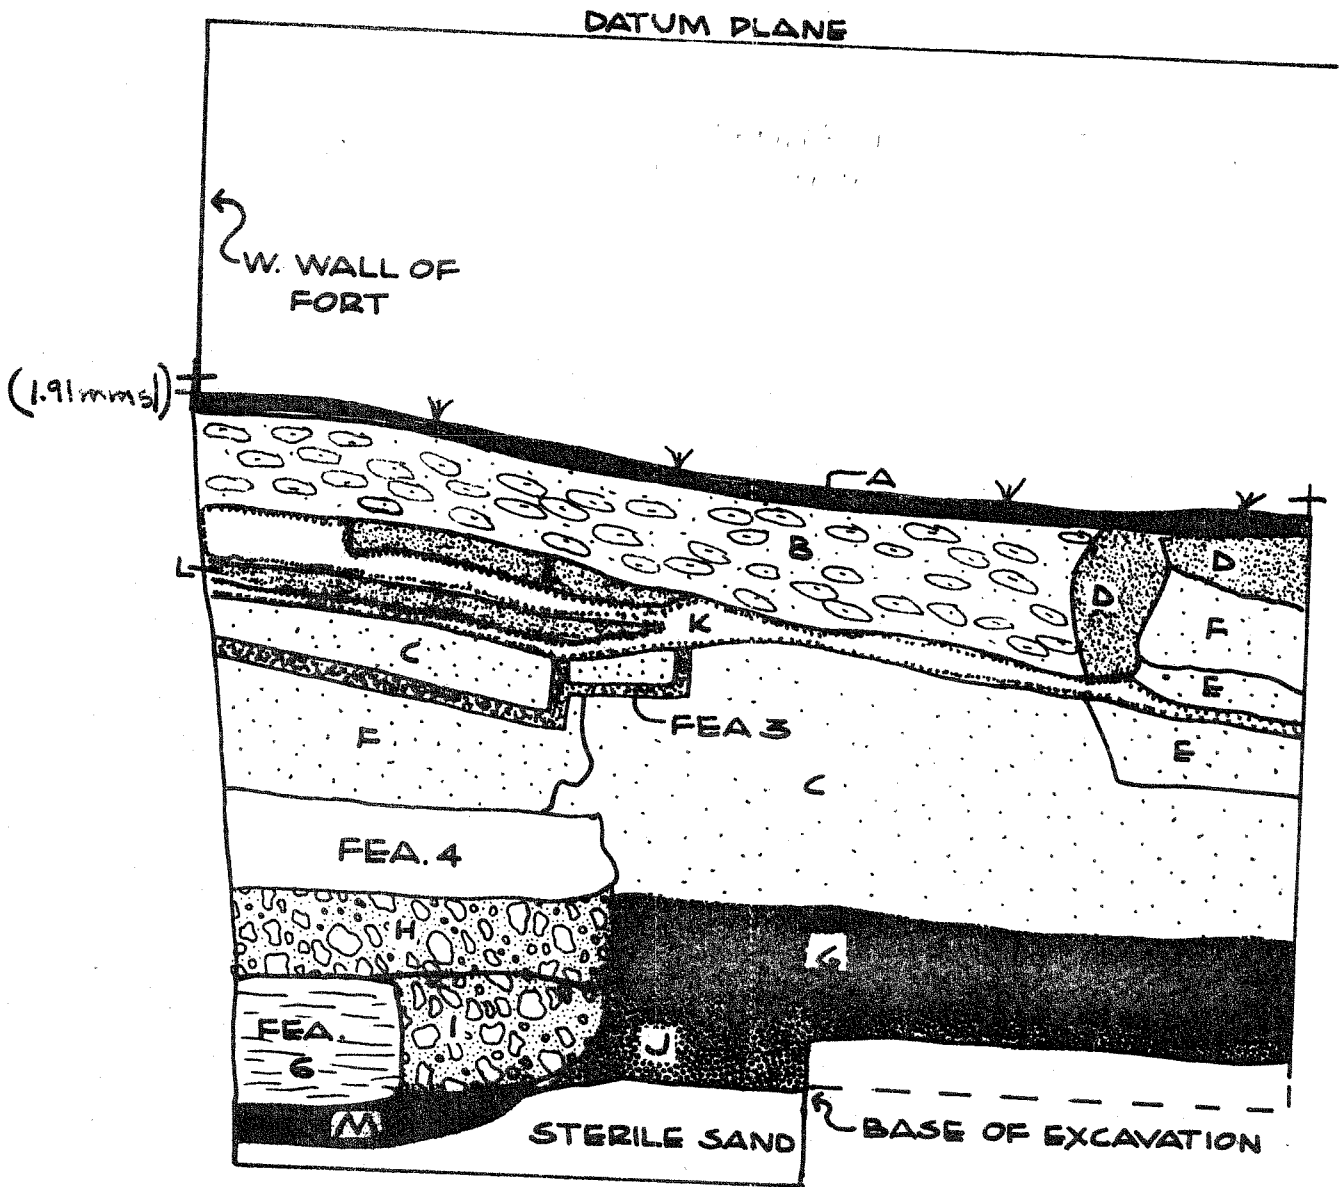
Illustration G-10a
FOMA 1978
TRENCH E
SOUTH PROFILE

The south profile of the trench (Illustration G-10, a-b) reveals the sequence of events at this part of the fort foundations. Layers B and C, and related deposits, represent fairly recent (twentieth century) activity. B is a layer of packed oyster shell extending west from the fort wall for a distance of 2.4 meters. Beginning at five centimeters below the present grade surface, it is 30 centimeters thick at the maximum. At the western end of this layer several coquina slabs were recovered, and are probably part of the 1935 stabilization project. The shells and rocks rest on a series of thin, humic-stained layers and crushed coquina lenses,

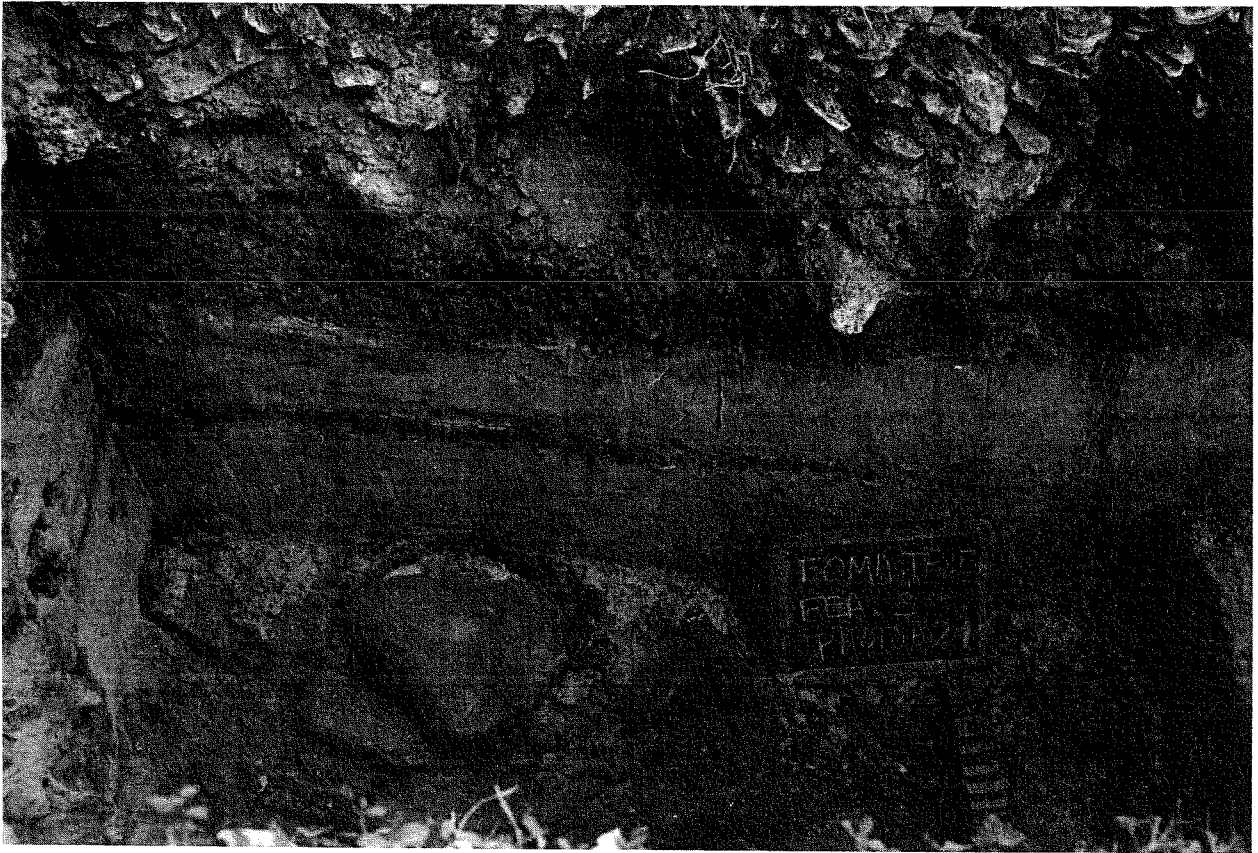
Illustration G-10b
Trench E - South profile
(East 1.5 meters of trench)
Upper 1.1 meters of trench

which may represent humic debris and storm deposit dating to just prior to the 1935 stabilization. Feature 3, below these layers (Illustration G-10b), is particularly interesting in its regularity and angularity. This is a brown humic stain present on all trench walls except the west wall, and seems most likely to have been stained from rotted planking, boards, or wood boxes. Feature 3 is present in a matrix of white beach sand, which extends to a depth of 1.75mmsl. At this level, direct evidence for the foundation of the fort, and for a possible late-eighteenth century repair of it were encountered.

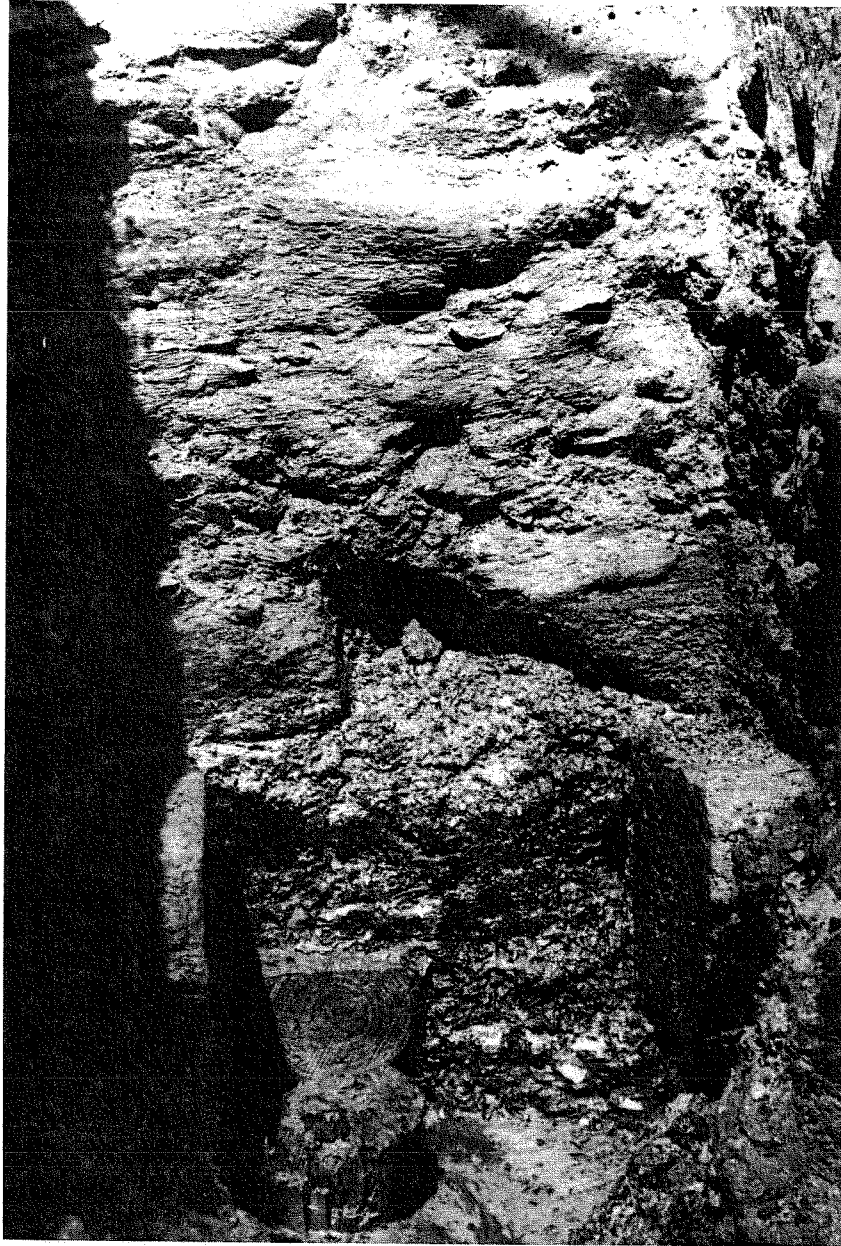
Illustration 11b
Trench E - East Profile showing
Fort foundations

Illustration G-11 (a-b) shows the stratigraphic situation of the east wall of the trench, against the fort foundation itself. Feature 6 rests against coquina blocks on the fort's west face, and rests above a horizontal support log extending east-west underneath the fort foundation at .08mmsl. The base of this

The decay of the wall is revealed in the sand- and shell-filled voids seen in profile. The upper void (sand-filled) extended for 38.5 centimeters into the fort wall, while the shell fill of the lower void was not removed in excavation. The position of the voids (as those portions of the wall most subject to erosion and ground surface activity disturbance), the change at that level in the size of the coquina blocks, and also the top of Feature 4 in profile (as a possible result of wall segments deteriorating and falling to the ground) all combine to suggest that the construction grade for the fort was between .7 and 1.0 meters below the grade of today (1.21mmsl to .91mmsl).

At .37mmsl., a pine log system of support was encountered seen in Illustrations G-11b and G-12. This consisted of a vertical piling 20 centimeters to the west of the base of the foundation, over which an east-west support beam was placed, extending underneath the fort wall. Above this, a massive north-south horizontal log was placed against the wall of the fort (leaving, in fact, bark impressions on the coquina blocks of the wall). This upper log was plastered on the top and bottom surfaces (but not the sides). The wooden support system was surrounded by a .50 meter thick layer of mud and oyster shell, which extended to the west of the fort for a distance greater than 3 meters. Artifact and stratigraphic evidence suggest that the uppermost pine log (Feature 6) and Zone 4 of this excavation were the result of the de Salas 1796 foundation repairs. While no artifact evidence exists to support or disprove the in-situ originality of the two lower wood support pieces, stratigraphic evidence suggests that this is the case. For more detailed descriptions and measurements, refer to Section 6.

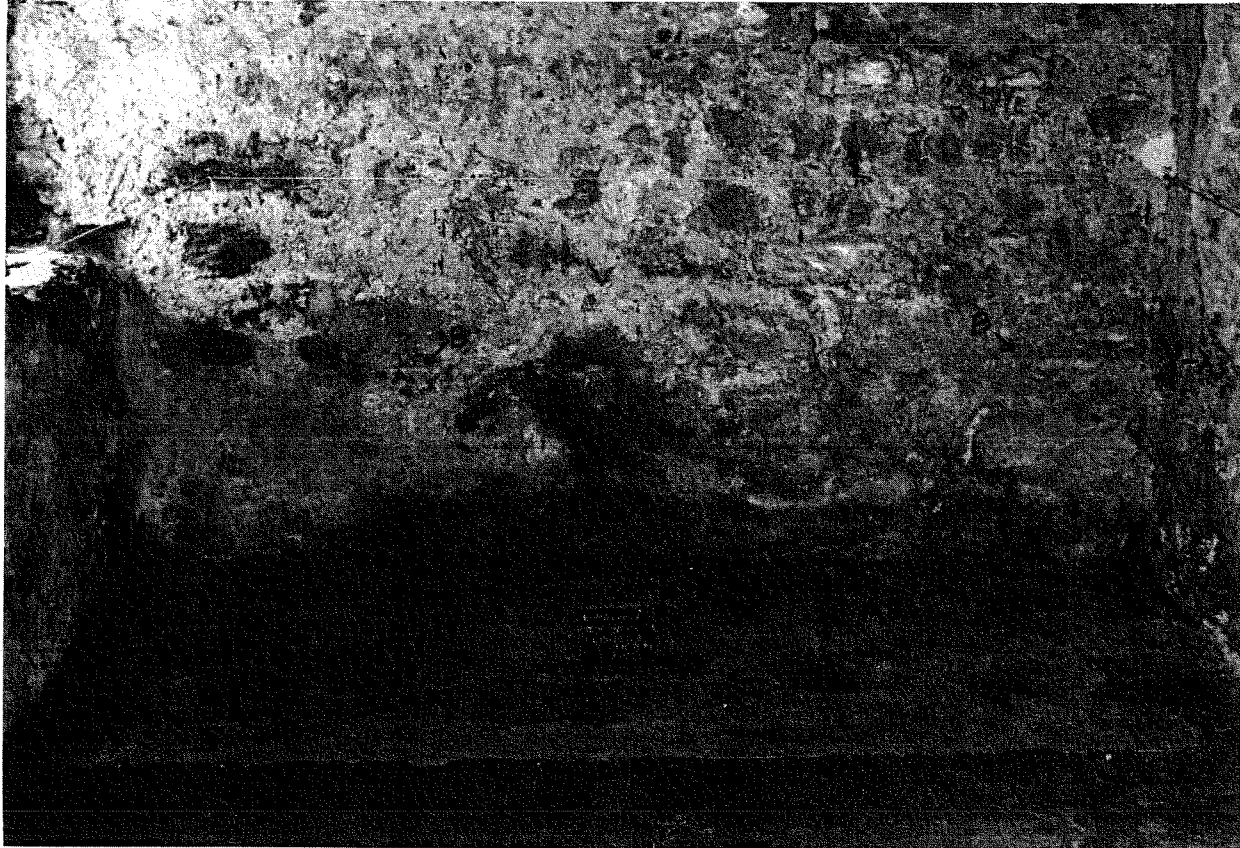
Illustration G-13
Above grade indication of wooden platform
A- Square holes in north wall
B- Sloping scar in west wall
C- postmold in Trench A

The only below grade evidence for any kind of platform support was found in the southwest section of Trench A, and was a postmold directly opposite the south end of the scar on the west wall (Illus. G-13c). This feature, however, initiated at 4.44mmsl, high up in the deposit dating to post 1916, and thereby could not have been associated with a colonial platform. Given the above ground elevations discussed above, the only reasonable association for the hypothesized wooden platform would have been the final colonial grade occupation (4.12mmsl) which covered Feature 7. A platform, at this almost certainly second Spanish period grade level, could have replaced the function of the earlier stone platform. It was no longer present at the time of Scriven's 1885 description of the fort. Unfortunately, the extent of below-grade disturbance and repair make the likelihood of such fragile evidence as postmolds' survival quite low.

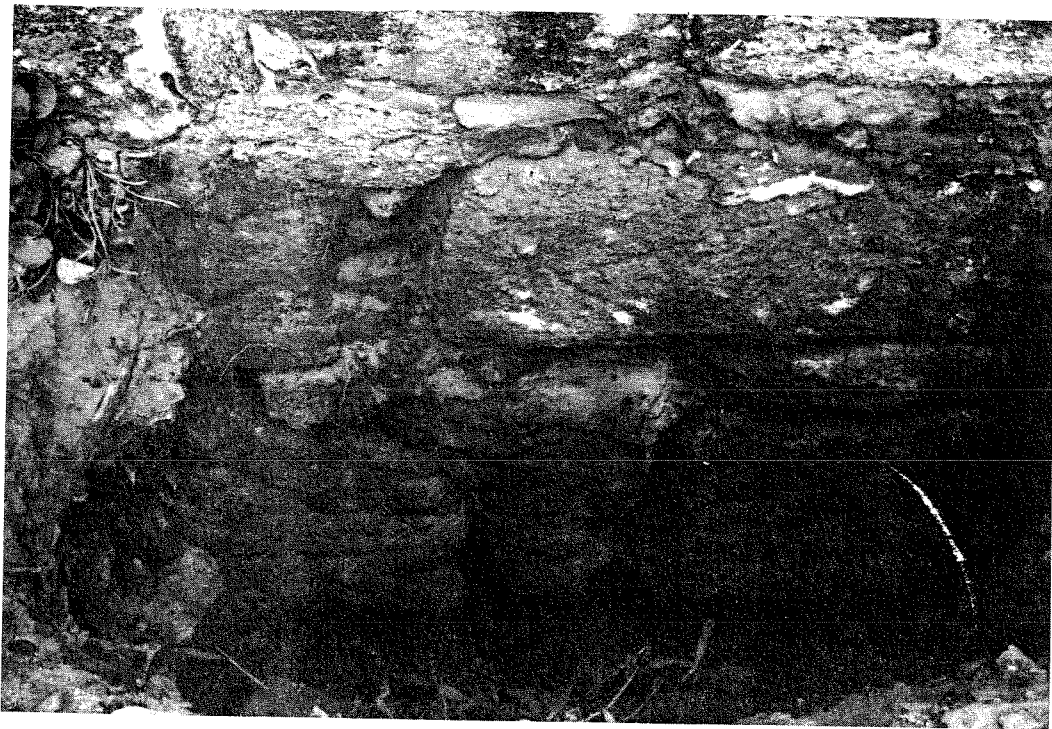
Dig Number 4 - Along West Scarp

The archeologist found no cultural material, of previously
unknown context, during the investigation. The material culture
that was found, was of late deposit, probably early 20th century.
It was noted that tests #4 and #5 had complete foundation stones
missing. All test showed heavy erosion of mortar from between
foundation stones. The water table variation, due to tides, was
suggested by the architects as the cause of mortar deterioration.
