# SPERMACETI COVE LIFE-SAVING STATION

Fort Hancock, New Jersey  
Sandy Hook Unit, Gateway National Recreation Area

## **HISTORIC STRUCTURE REPORT**

**Sandy Hook Unit  
Gateway National Recreation Area  
Fort Hancock, New Jersey**

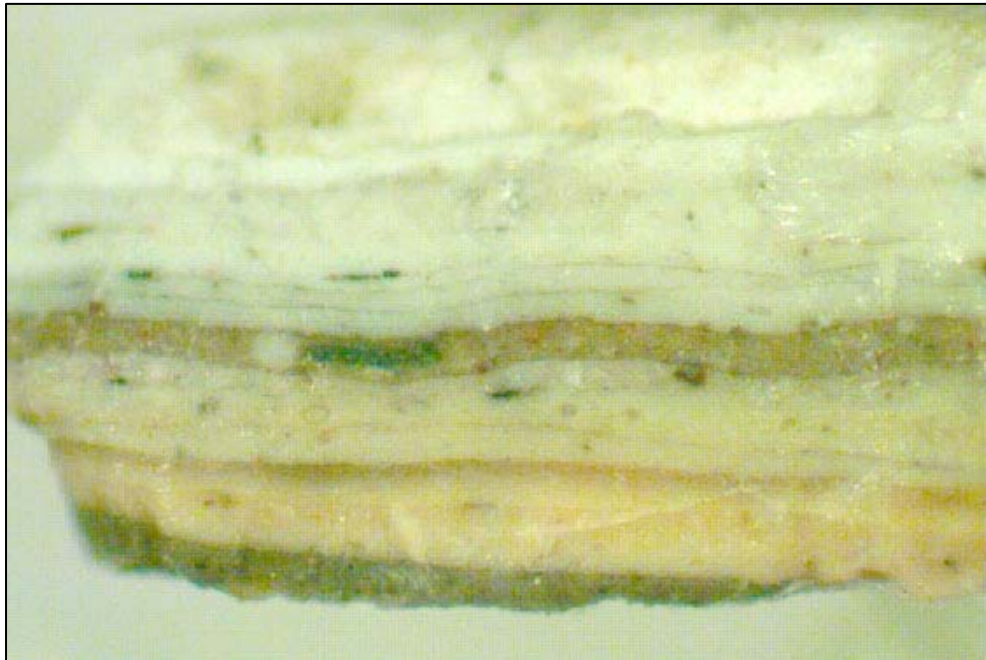
**Figure 65.** Spermaceti Cove Life-Saving Station, sample P087 taken from the East/Front Porch original northeast half-post.

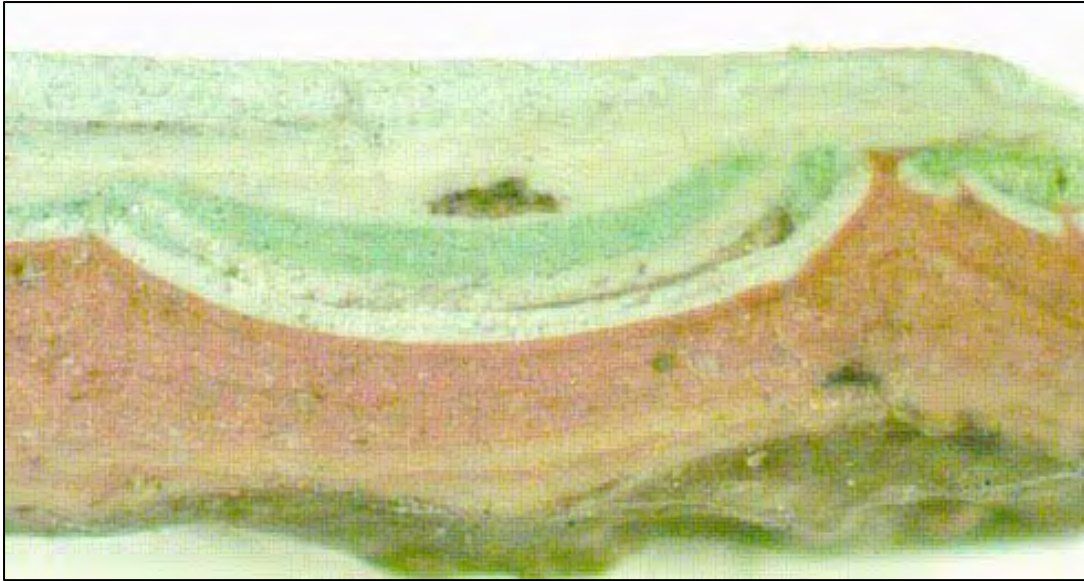
**Figure 69.** Spermaceti Cove Life-Saving Station, sample P014 taken from Room 102 plaster wall above D110.
