Historic Structures Report

Fort Point US Coast Guard Station
Gulf of the Farallones National Marine Sanctuary

April 1, 2008

by
Carey & Co. Inc.

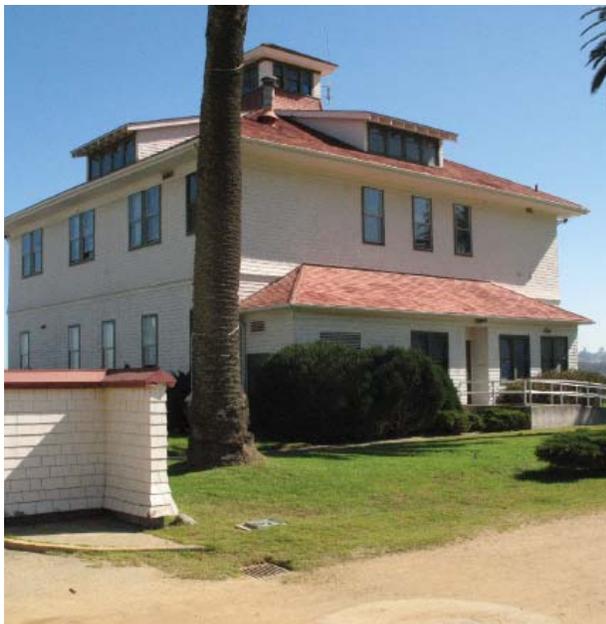
Fig. 41 : South elevation, enclosed porch of the Main Boat-house

- Replace damaged shingles with fire-retardant shingles to match size and exposure of original.
- Should shingles require replacement, careful research, design, specifications and selection of a skilled roofer are necessary.

- Avoid sparse shingle coverage and heavy building papers.
- Avoid staples and inferior flashing. Use stainless steel nails instead. Stainless steel and copper

- flashing is recommended.
- Avoid patching deteriorated roof lath or sheathing with plywood or composite materials.
 - Avoid spray painting raw shingles after installation. Shingles should be coated prior to installation to prevent warping.
 - Clean and maintain gutters and leaders on a regular basis. Clogs in these systems will cause water to back up and seep into roofing units.
 - Implement a regular maintenance plan to extend the life of the roof. Maintenance would include regular visual inspections and re-coating when needed.

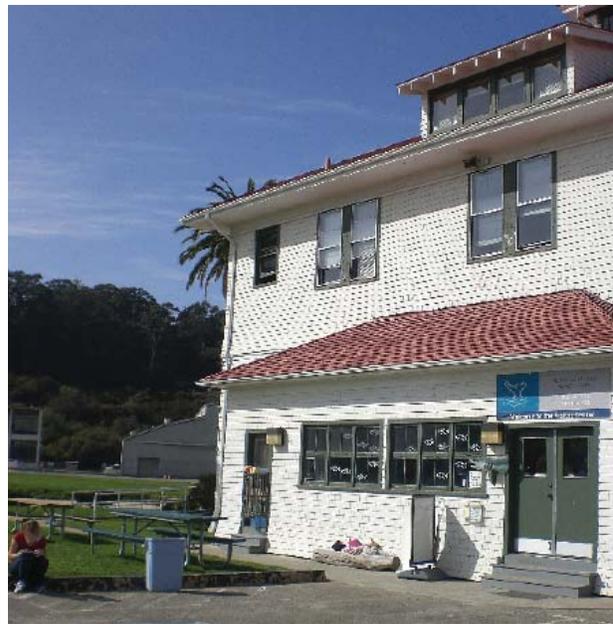
Fig. 42 : East elevation, enclosed porch of the Main Boat-house

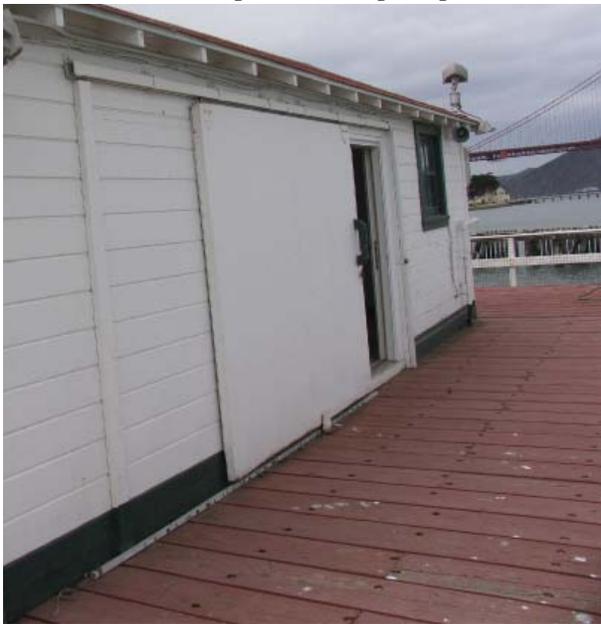
Fig. 47: Sliding wooden door at the Buoy Shack

Buoy Shack: Has a sliding wood door with a wood rope-wrapped handle that covers a modern sliding glass door. There is also a solid five panel wood door.

Recommendations: Replace non-contributing doors with replicas of the originals. Repair existing doors as follows:

- Perform a detailed survey/inspection of all doors to identify specific repair locations.
- Remove all dirt, debris and miscellaneous attachments.
- Remove finish if necessary to perform repairs.
- Repair splits and separations with waterproof glue as required.
- Consolidate deteriorated with wood epoxy or perform Dutchman repairs. Replace extensively deteriorated components in kind.
- Install weather stripping.
- Recondition extant original hardware. Install new hardware, where missing, to match original.
- Ensure the smooth operation of the doors.
- Finish doors to appropriate interpretive period.
- Inspect doors regularly for deficiencies of finish and operation.

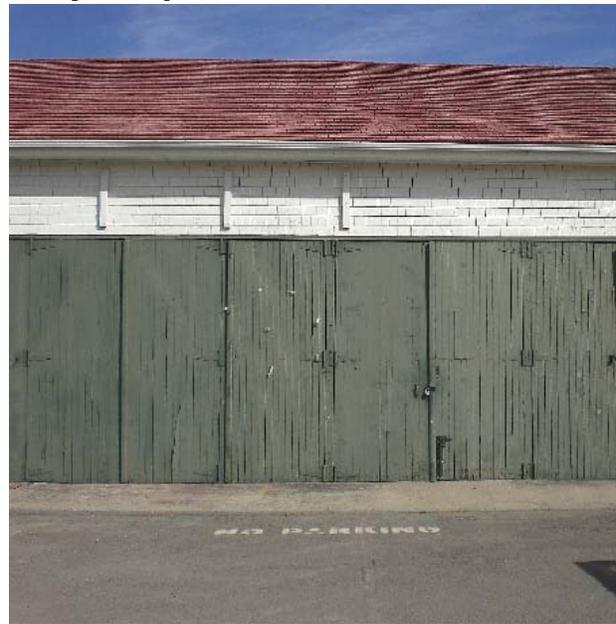
Fig. 48: Vertical tongue-and-groove wood doors at the Shop & Garage.

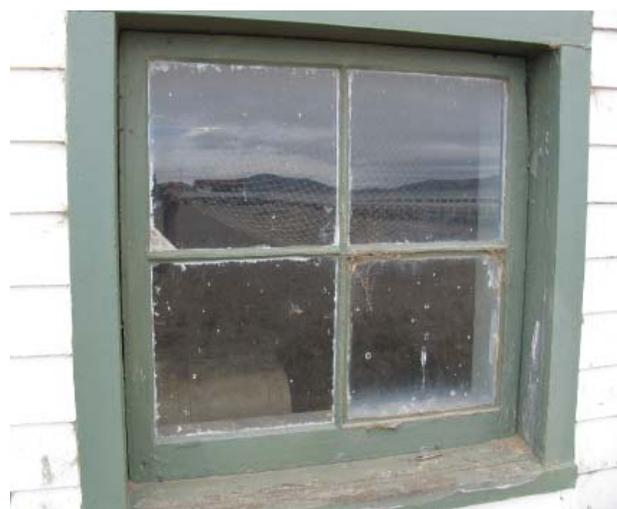
Condition: The paint has deteriorated, and is alligatored, peeling, or missing over the majority of all five structures primarily on the window elements (see figure 52).

Fig. 52: Four-lite awning window at the Shop & Garage.

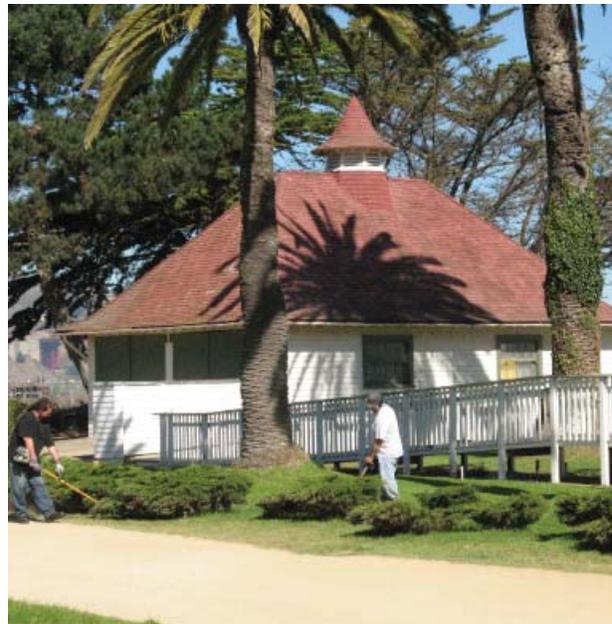
Fig. 58: Surrounding vegetation at the 1890 Boathouse.

Recommendations: Cut back trees and bushes in contact with the buildings. Swinging tree branches could cause impact damage. Roots can damage building foundations, underground building services and drainage systems. Additionally, vegetation can hold moisture against the buildings, providing an ideal climate for biological growth. Proposed landscape plans should use historic landscaping as a guide.

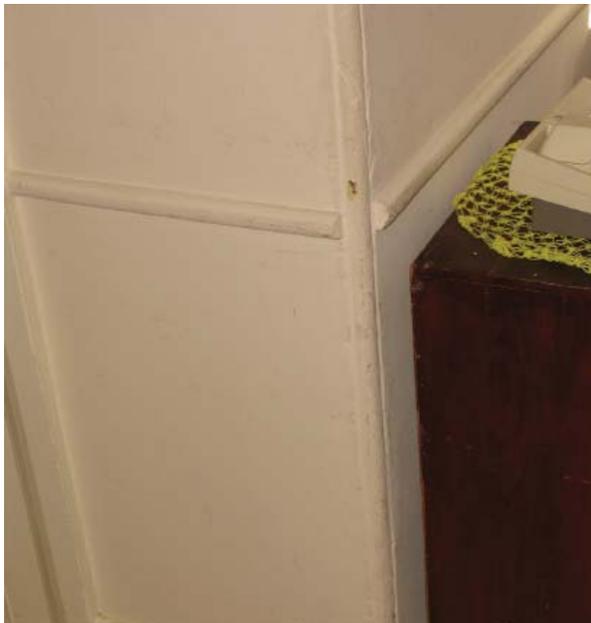
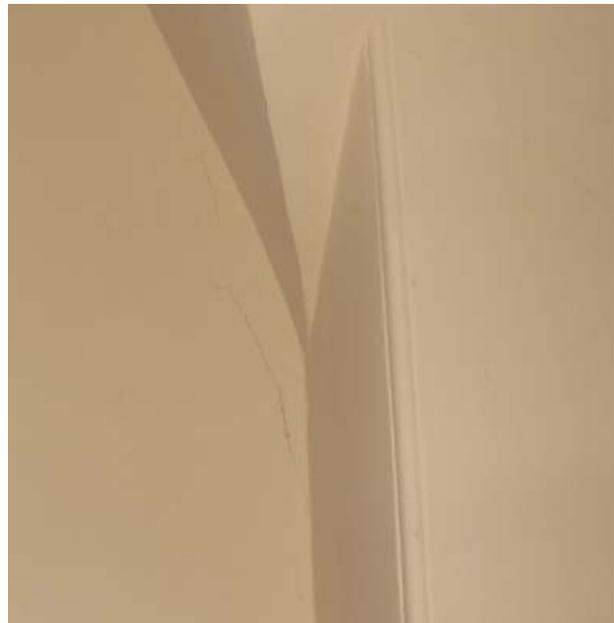
Fig. 59 :Flat plaster wall and corner bead at the interior of the Officer in Charge Quarters.

Fig. 60 :Flat plaster wall and corner bead at the interior of the Officer in Charge Quarters.

Condition: The conditions of the plaster walls is generally good. Some areas have been damaged by water infiltration.

Recommendation: Replace missing or debonded flat plaster. Refer to Preservation Brief 21: Repairing Historic Flat Plaster.¹⁰ Where plaster is damaged due to natural, structural or any other occurrence, repair as follows:

- Repair hairline cracks with no debonded material with commercial patching material.
- Cut plaster back in larger cracks and around debonded areas to sound material.
- Install new three-coat plaster over expanded galvanized metal lath.
- Finish plaster to match existing adjacent surfaces.
- Prepare and paint to match adjacent surfaces or historic condition. See Paint Analysis report in the appendix for color recommendations.

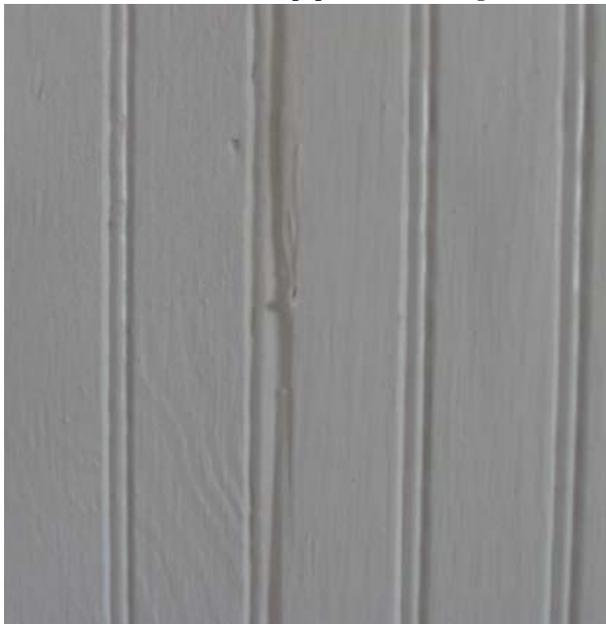
Fig. 61 : Beadboard wall cladding in the Buoy Shack.

Description: The walls of the Buoy Shack, the Tide Gauge House, and the Main Boathouse are vertical beadboard (see figure 61). The walls of the Shop & Garage, and the 1890 Boathouse are board (see figure 62). All of the walls are painted.

Condition: The conditions of the wood walls are generally good. Some are marked by ghosts of earlier building configurations, and/or have miscellaneous inappropriate attachments.

Recommendations: Repair wood wall cladding as follows:

- Conduct a detailed, wall survey to document condition of each elevation and determine, on an individual basis, required repairs.

- Remove paint and refinish to match original where necessary. Carefully remove, salvage, label and appropriately store any boards, hardware and trim that must be removed.
- Restore missing boards which have been removed during alterations. Match original with respect to profile, wood type and finish.

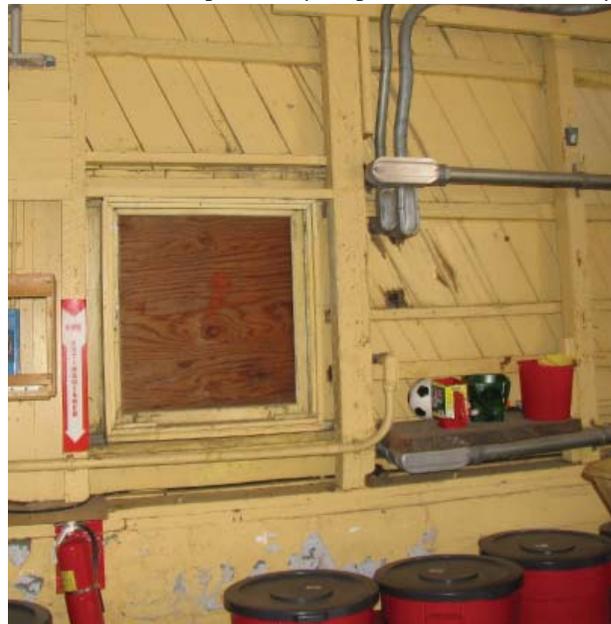
Fig. 62 : Diagonal board walls at the Shop & Garage.

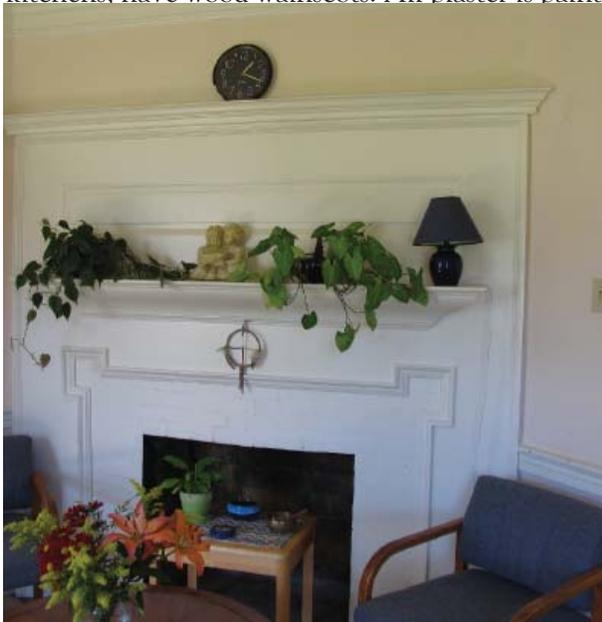
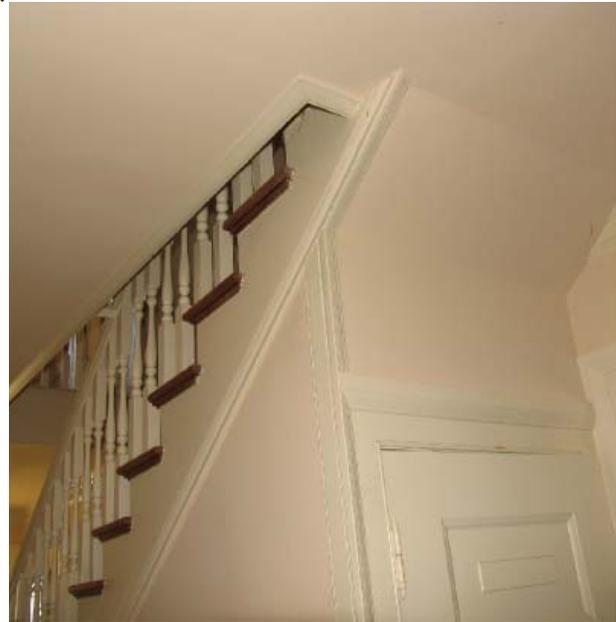
Fig. 63 :Painted wood fireplace,mantle,and wooden elements at the Officer in Charge Quarters.

Fig. 64 :Painted wood stair, balustrade, and door at the Officer in Charge Quarters.

Description: All interior plaster and woodwork is currently painted (see figures 63 & 64).

Condition: The interior finishes are in fair condition, showing signs of normal wear and tear such as chipping and scratching.

Recommendations: Following thorough preparation, including the removal of loose, flaking or chalking paint, prime the walls using a high-quality primer. Follow with two coats of quality acrylic paint. If the existing paint contains lead, follow all regulations for worker protection and material disposal. In most cases, well-adhered lead paint may be left in place and encapsulated, rather than completely abated.

Strip paint from originally clear-finished woodwork. Refinish with varnish to match color and gloss of historic material. This will involve preparing samples of available stains and varnishes on substrates similar to the woodwork, and comparing them to historic varnishes prior to stripping.

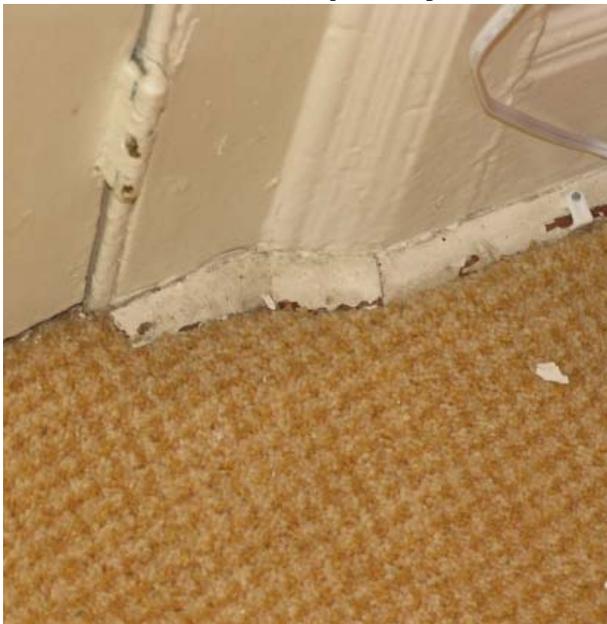
Fig. 65 : Wood baseboard, bead molding, and carpet at the Officer in Charge Quarters.

Description: Extant finish flooring of the Main Boathouse and Officer in Charge Quarters currently includes wall-to-wall carpet over an unknown substrate (see figure 65). The flooring in the 1890 Boathouse, Shop

Condition: The non-contributing finish flooring is in fair condition. The historic wood floors beneath the carpet are in unknown condition. The historic wood clear finished floors are in good to fair condition. It is likely that the wood flooring beneath the carpeting, reasonably protected from wear, is in good condition.

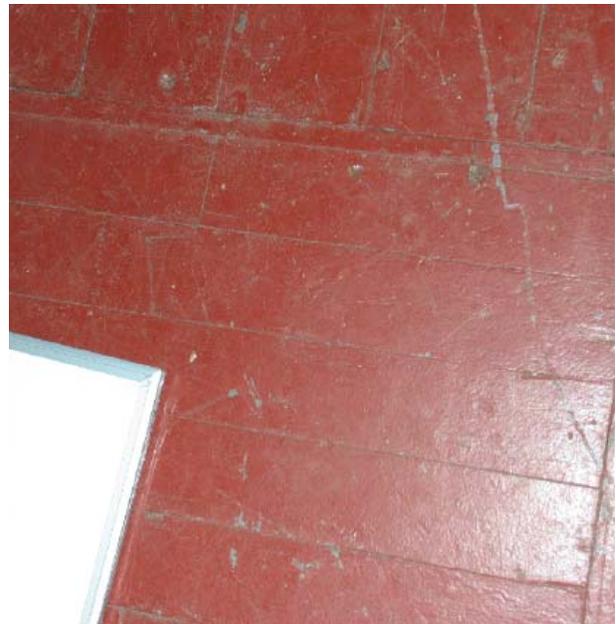
Fig. 66 : Original wood flooring at the Shop & Garage.

& Garage, Buoy Shack, and Tide Gauge House are clear finished wood. The clear finished wood floors are in generally good condition; however, the floors in the 1890 Boathouse, Shop & Garage, and Tide Gauge House are in need of refinishing. Presumably, original wood flooring survives beneath the later carpeted finishes of the Officer in Charge Quarters and Main Boathouse. Wall-to-wall carpeting protects the floors; however, it makes it very difficult to verify the original flooring material and assess its condition.

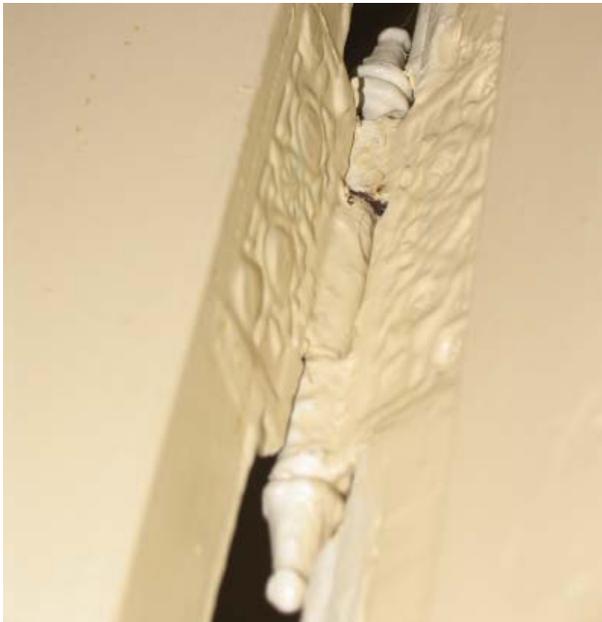
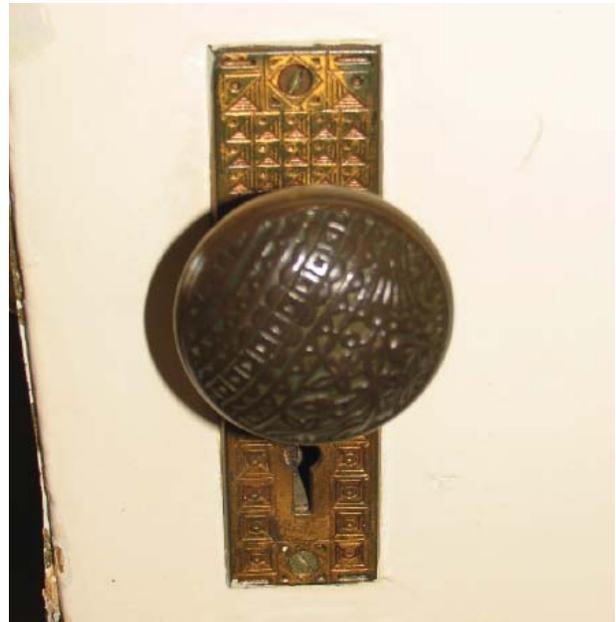
Fig. 69 : Original hardware at the Officer in Charge Quarters.

Fig. 70 : Original hardware at the Officer in Charge Quarters.

Condition: Most interior doors appear to be in good condition, with normal wear and tear such as finish abrasion in evidence, and only minor repairs needed. Hardware is also in good condition, although in most cases in need of reconditioning (see below).

Description: The majority of the hardware is original and intact. It consists of bronze doorknobs, bronze faceplates and hinges, and bronze window catches (see figures 69 & 70). Several locks on the exterior doors have been replaced with modern dead bolt locks.

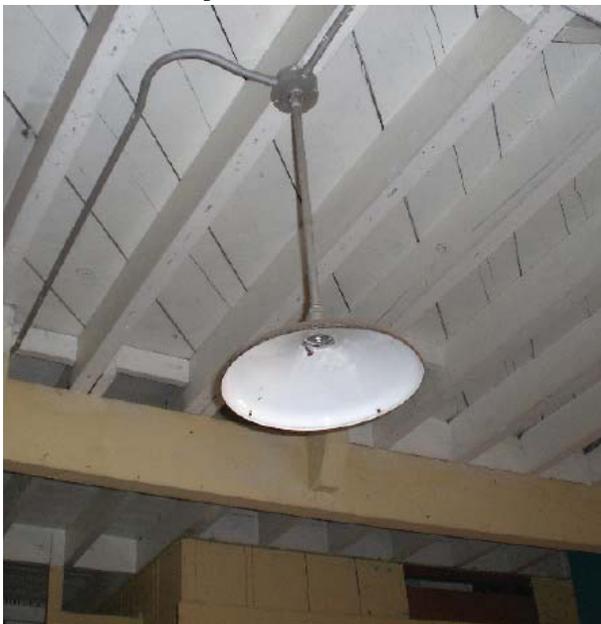
Fig. 71 : Historic pendant light fixture at the Shop & Garage.

Description: Interior light quality directly affects the perception of both space and material finishes. Existing light fixtures include historic exposed single-bulb hanging pendant fixtures in the Shop & Garage;

and later, non-historic exposed single-bulb hanging pendant fixtures and ceiling-mounted fluorescent light fixtures, in the other buildings (see figure 71).

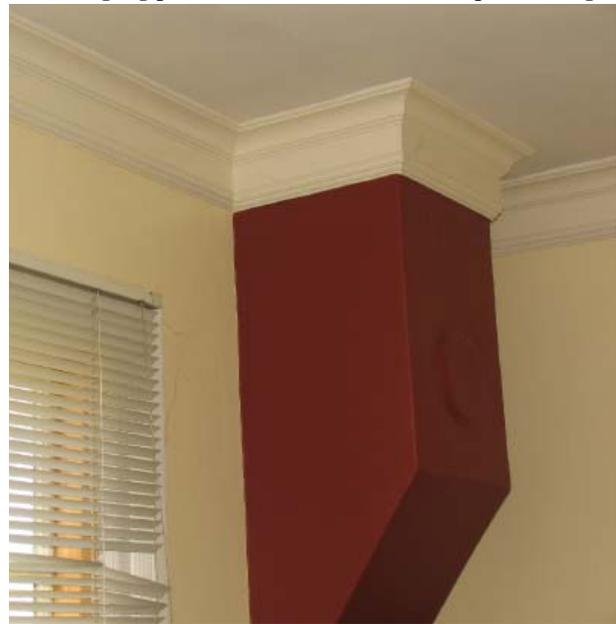
Fig. 74 : Flue and flue cover at the Officer in Charge Quarters, remnant of earlier stove heating system.

Description: The Officer in Charge Quarters was originally heated by stoves. Flue holes, covered over by plates, survive in many rooms, as do fireplaces in the parlors and dining rooms (see figure 74). A propane-fueled forced air system has been installed in the house, and grates are visible in the majority of the rooms. It is unknown whether or not any of the other structures were heated. The Officer in Charge Quarters appears to be heated by a propane-fueled forced air system.
