Golden Gate Dairy (Lopes Brothers Dairy, Ranch M)

Cultural Resource Reports and Site Treatments: Cultural Landscape Report Historic Structure Reports Archeological Assessment and Treatment Report

June 10, 2013
United States National Park Service,
Golden Gate National Recreation Area
Division of Cultural Resources

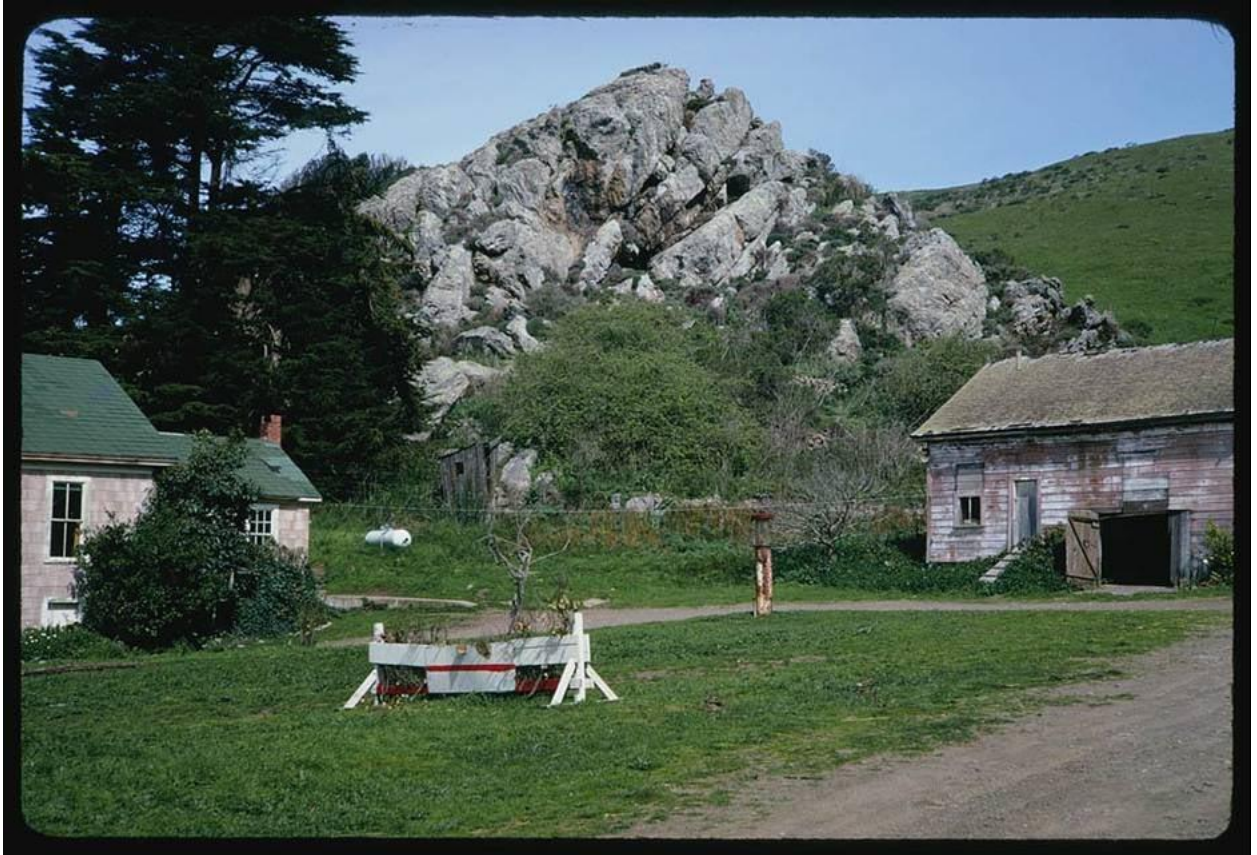
Recommendations include removing structures from the central core. This photograph from 1968 shows the internal road encircling an area free of structures. The Main House is to the left and the Creamery is to the right.

- Restore the central open space to its historic condition.
 - Remove all non-historic structures within this area, including horse stalls and sheds.
 - If possible, retain the use of the central, open area as a single space, with only a perimeter fence and no interior divisions.

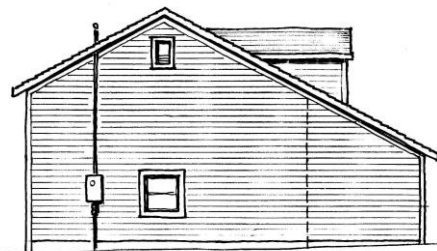
MBVFD Barn Remodel Concept Side (East) Elevation

Not Recommended: Changing the building form and shape by extending the north wall and modifying the roofline, adding a dormer; changing important elements of the building style (rake boards and corner returns).

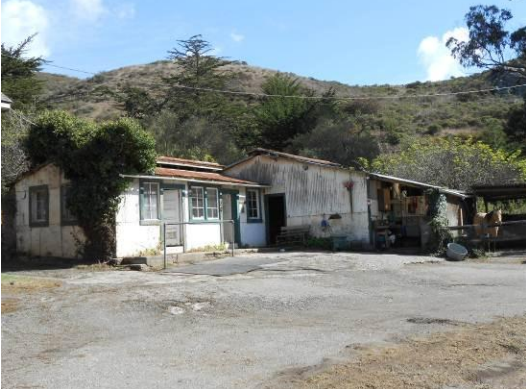
<p>Looking southeast at dairy house and stable (NPS Photo, 2012)</p>	<p>North east corner at outhouse (NPS Photo, 2012)</p>

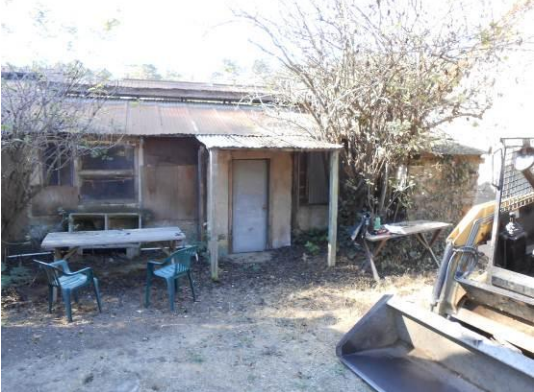
<p>East wall (north end) milk cooler door and outhouse (NPS Photo, 2012)</p>	<p>South end stable wall (NPS Photo, 2012)</p>

The 26'-0" long east wall is roughly 7'-6" tall to the top plate. On the farthest north end of the wall is located the 5'-0" square wood shed outhouse addition. The outhouse addition is founded on a concrete slab at ground level that appears to be integral with exterior concrete wall and/or floor slab. The shed addition encloses a small portion of the exterior building wall, where there is extant abandoned water piping – perhaps from a water heater on the opposite side of the wall. On the floor of the outhouse is a small raised housekeeping pad that could be a mount for an electric pump motor. Adjacent to the outhouse addition to the south is a small modern ramshackle wood shed roof porch

addition that protects the extant front wall and door of a walk-in milk storage room addition. The extant wall is constructed of cementitious plaster painted gray over wood studs with 4" cork insulation. The extant door opens inward (3" below existing grade) and is a manufactured refrigerator door dating from the late 1930s. The wall between the outhouse and the refrigerator door is typical, unpainted and there is a knob from the early electrical wiring extant. A three foot section of vertical siding adjacent to the door on the north is missing and the exposed wood studs and sills are badly rotted and damaged by insects. The wall adjacent to the refrigerator door to the south is composed of salvaged plywood patches abutting a unique wood sash window with raised concrete floor slab below. The window is composed of a fixed 36" square window divided horizontally into two lites by 2" thick wood framing and is adjacent to a narrow 38"x 17" wood sash casement window divided into 6 lites by narrow wood muntins set into the remaining 2x4 framed opening. This window (both frame and sash) has insect damage and is in fair condition. The bottom pane of the divided sash is missing and is covered with plywood. The wall at this window has cementitious plaster up to the top of the window frame on both sides, which is unusual. The transition between the low-walled dairy house wing and the attached stable is not expressed on the building exterior on this façade; neither in the wall nor the roof. The wall at this location has a full height plywood patch perhaps indicating the presence of an in-filled doorway. The exterior wall of the stable portion of the building is composed of concrete with form board patterns and corrugated steel, is unpainted and is in fair condition. At the far end of the wall (centered in the stable room) is a 6'-6"x 4'-0" wooden 2-panel sliding window. Sliding wood panels are composed of three 1x12 boards and one 1x6 board oriented vertically, butt-joined with 1x4 horizontal batten boards on the exterior – 2x4 framing is exposed at bottom and covered with 1x4 trim at top. Window panels, framing and trim is unpainted redwood and is in fair condition. Faintly carved lettering was noticed on the wood window panels. Vegetation along this wall of the building is overgrown, set too close to the building and should be removed.

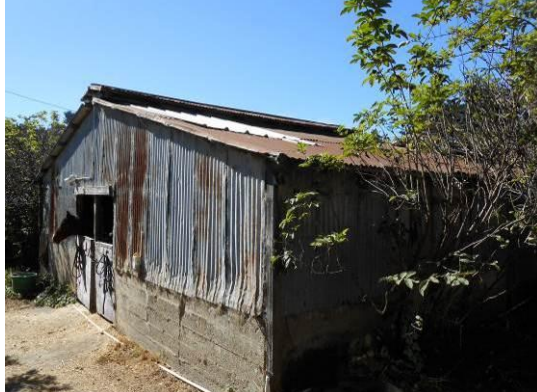
The south wall is the 31'-4" long gabled wall of the stable room, is composed of concrete and corrugated steel, is unpainted and is in fair condition. As with the north wall, the roof has a full length ridge vent that is capped such that the vented opening and ridge cap is expressed on this façade, but in this case the stable room is almost twice as wide and the ridge vent is centered above a 7'-0" wide door opening. This main door opening has been modified with 2 paddock gates inset in the opening and the original sliding door is no longer extant (a sliding door is evidenced by extant rail brackets and the "ghosts" of the rails are visible on the corrugated steel wall panels for a door that opened to the east). Similarly, a sliding door is evidenced at the far west side of the wall where the feed alley is located. This 3'-0"x 6'-4" opening has been in-filled with a Plexiglas and wood. The concrete stem wall on the east side of the main door has a 10" wide form board pattern finish whereas the wall on the west side of the main door is finished in a smooth cementitious plaster.

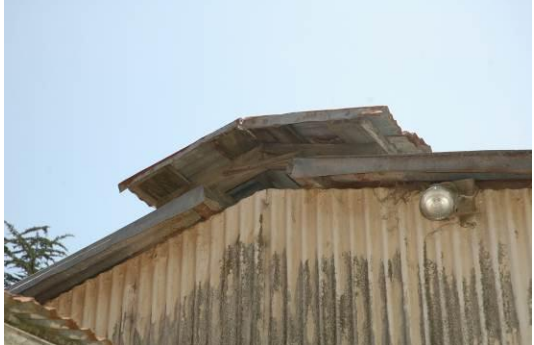
Window trim is 1x6 wood painted deep green and is in fair condition with one piece missing. Window sash and frames are painted white and are in fair condition. The roof has a full length ridge vent that is capped such that the vented opening and ridge cap is expressed on this façade. The majority of this wall was obscured by dense ivy at the time of survey and is presumed damaged, rusted or rotted. Ivy has intruded into the building and can be seen on the interior and in the attic space. In the northeast end of the gable is a patched 6" diameter hole from a vent stack – possibly from a water heater on the building interior. A corresponding section above the hole at the roof overhang is further evidence of the vertical chimney vent. Under the easternmost window is a full length crack in the concrete wall that is severe and may need extensive repairs. Window sash of this eastern window appears to be original, although it appears as though sash hinges on the interior have been replaced. Into the bottom trim under this window is an armored electrical cable protected ground for the electrical panel on the interior side of the wall. Adjacent to the east trim board of the westernmost window is a PVC conduit that runs into the ground. Window sash of this western window is a shoddy replacement. Somewhere above this window is presumed an historic wood mast for the electrical power supply to the Creamery, which formed support structure for the ivy but it was completely obscured by dense vegetation at the time of survey. This vegetation should be removed immediately and the electrical power supply and circuits inspected by a licensed electrician.

<p>Northeast corner inside outhouse; abandoned water piping possibly from boiler or heater on opposite side; north room (NPS Photo, 2012)</p>		<p>Capped ridge vent detail (NPS Photo, 2012)</p>

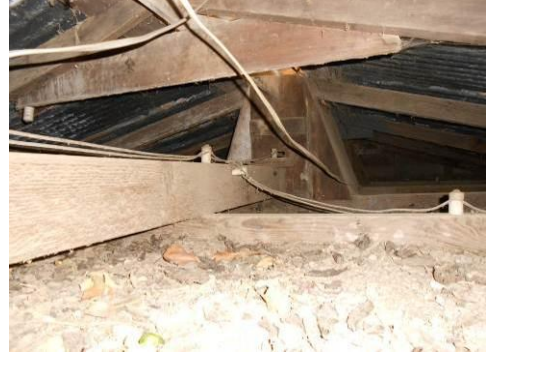
Above the three rooms that compose the low gabled north portion of the building is a low attic accessed by hatches in the room ceilings. Since no original ceiling hatch doors are extant, it is possible that the hatches had mesh covers to allow the gravity ventilation system of the full length ridge vent to function. The north room hatch opens to the attic and the ridge vent. The ceiling hatch openings in the milk cooling room and the room with raised floor are boxed-in with wood up to the ridge vent above (the attic space being open including at the eaves, except for the 3 wood box-ducts). The design must have made for sufficient cooling especially at night in the coastal climate. The 2x4 rafters are tied beneath the ridge by a 2x6 collar tie on alternating rafters, and by the ceiling joists at the bottom. A 2x6 stiffening member spans the full 26' on center from wood box to wood box, stiffening the ceiling from north to south.

<p>Milk room cooler door (NPS Photo, 2012)</p>		<p>Attic framing in ceiling of north room looking south at milk cooler room hatch and boxed duct (NPS Photo, 2012)</p>

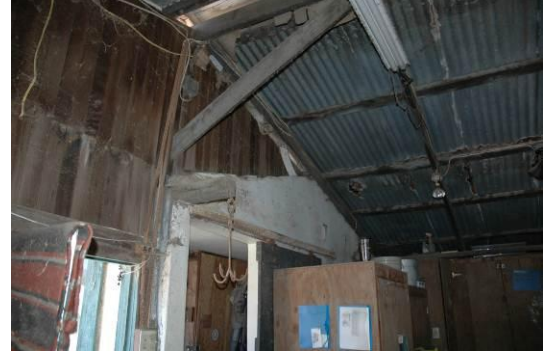
<p>Milking stable north end gable showing ridge bracing and gabled end of milk house (NPS Photo, 2012)</p>		<p>Milking stable south gable showing beadboard wall finish, wood bracing and piping (NPS Photo, 2012)</p>

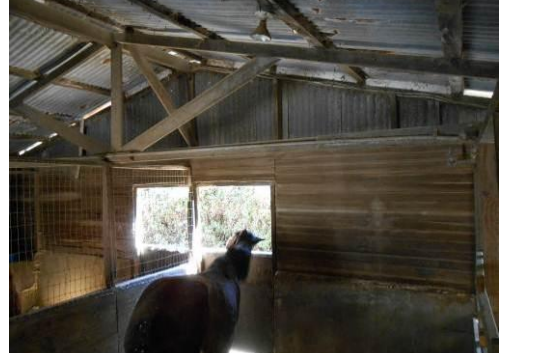
are visible. The steel corrugated galvanized sheet roofing panels are rusted mainly at the seams, are in fair condition and still bear the mark of Columbia Steel (the company that most notably supplied the steel for the San Francisco/Oakland Bay Bridge). The wood roof framing appears to be in good condition - some wood members have insect damage. In the northwest corner of the south feed alley there is a concrete tank that was most likely used to hold grain or feed. The majority of the interior wood frame walls are finished in horizontal tongue and groove redwood beadboard in four foot sections (spanning three wall studs) laid up to form vertical joints at every other stud. The board appears to be in good condition though the age of this finish is unknown; it could be a 1960s installation or salvaged material. In the northwest gable wall the beadboard is vertical and is in two sections with a horizontal battened joint at 4'-0" above the stem wall. There is a cementitious stucco gable outline of the low gabled milk house portion of the building on this wall, and this gives the appearance that the stable was an addition, perhaps built very soon after the dairy house portion of the building. Following the line of the south wall of the dairy house, a heavy wood beam (top plate from the dairy house wing) is cantilevered one foot out into the stable space and a rudimentary 4-prong metal hook is hung from it, presumably for hanging tack. The beadboard in the south gable is oriented horizontally but does not extend the full height of the gable (perhaps the salvage material ran short). The stable is accessed via a 9'-0" wide doorway at the south, which spans the length of the central litter alley. A small doorway at the north connects to the sidewalk at the front of the building. Historic photos show the south wall of the stable had windows that are no longer extant, and the majority of this wall has been removed to create a pass-through with the shed addition to the south. The pass-through in this area allows for the hot water heater to feed the sink in the wash room shed addition.
