## **PART II: TREATMENT AND WORK RECOMMENDATIONS**

#### **GULF OF THE FARALLONES NATIONAL MARINE SANCTUARY, FORT POINT COAST GUARD STATION REHABILITATION OF THE MAIN BOATHOUSE/LIFE SAVING STATION (PE1903)**

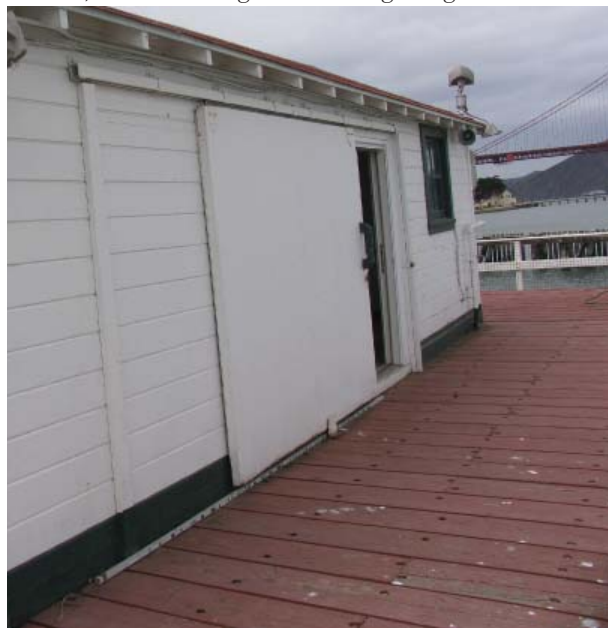
Fig. 47: Sliding wooden door at the Buoy Shack

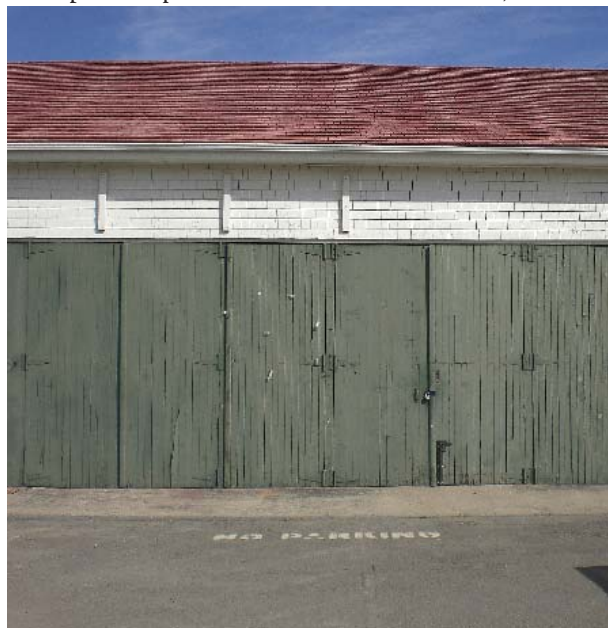
Fig. 48: Vertical tongue-and-groove wood doors at the Shop & Garage.

Condition: The doors are in fair condition. The wood doors have been altered slightly by the removal of the original locks and addition of modern dead bolts. Several do not close properly. Many of the thresholds are worn as well. The garage doors are in poor condition due to improper clearance between the doors and the concrete driveways. The vertical boards drag across coarse aggregate concrete driveways, resulting in mechanical damage. In addition they are regularly exposed to standing water.

Recommendations: Replace non-contributing doors with replicas of the originals. Repair existing doors as follows:

- Perform a detailed survey/inspection of all doors to identify specific repair locations.
- Remove all dirt, debris and miscellaneous attachments.
- Remove finish if necessary to perform repairs.
- Repair splits and separations with waterproof glue as required.
- Consolidate deteriorated with wood epoxy or perform Dutchman repairs. Replace extensively deteriorated components in kind.
- Install weather stripping.
- Recondition extant original hardware. Install new hardware, where missing, to match original.
- Ensure the smooth operation of the doors.
- Finish doors to appropriate interpretive period.
- Inspect doors regularly for deficiencies of finish and operation.

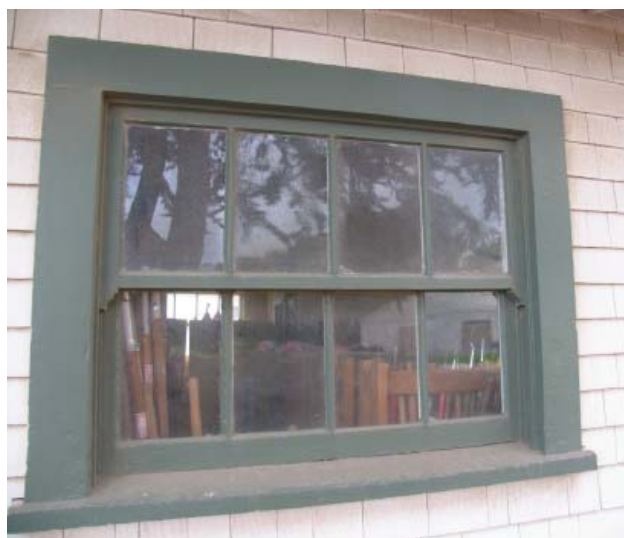
*Fig. 51: Four-over-four lite windows at the Main Boathouse.*

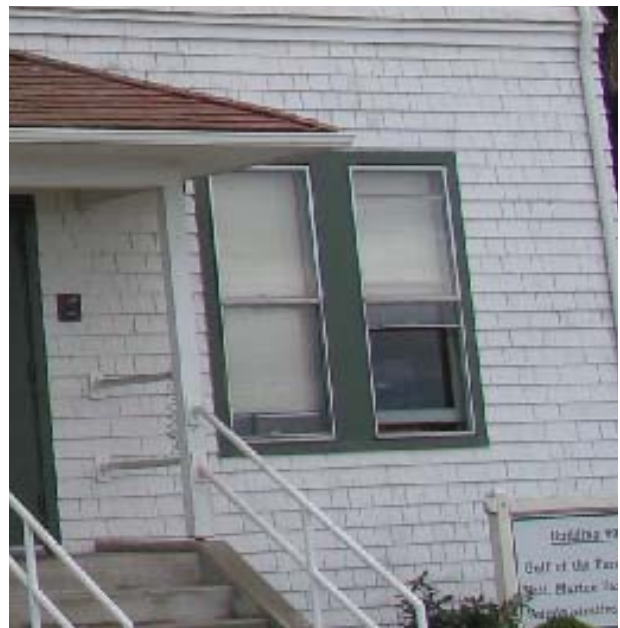
*Fig. 54: Double-hung window at the Main Boathouse*

**Condition:** The windows are in fair condition. Many have been altered over time, or have been replaced altogether with either inappropriate wood sash or with aluminum sash (see figures 22 & 33). Water intrusion was noted at south elevations, particularly where the windows have been altered or replaced. Several windows have been fixed in place, or are stuck. The exterior paint is deteriorating on many of the windows, and joint separation is occurring in some wood windows. Much of the glazing compound is dried, cracked or missing. Most hardware is intact.

**Recommendations:** Replace non-contributing windows, particular aluminum sliders, with replica wood windows to match those shown in early drawings and photographs. A number of replacement windows fall within the period of significance, therefore restoration would not necessarily warrant their removal or restoration to their pre-renovation condition. While it would be possible to restore the windows to the pre-renovation/replacement condition, it may be argued that these 60 year old replacements have acquired significance over time, and that they may help to tell the full story of the buildings. Finally, their removal may constitute intrusions to the historic fabric that would result in a net loss of historic fabric. Therefore, careful consideration of all of these factors is recommended prior to a decisions regarding the dispensation

- Survey and examine in detail the existing condition of all wood windows.
- Remove all dirt, debris and miscellaneous attachments.
- Remove paint to obtain clean surface where repairs are required.
- Remove existing glazing putty. If the existing putty contains asbestos, follow legal means for handling, removal, and disposal of contaminated material.
- Consolidate, repair or replace deteriorated wood elements in kind, where necessary.
- Restore window to proper operation.
- Install new hardware, where missing, to match original.
- Install new glazing, where cracked or missing.
- Prepare wood surfaces, prime and paint. Match historic finishes.
- Replace non-contributing wood and aluminum windows with new replica windows to match historic window types.

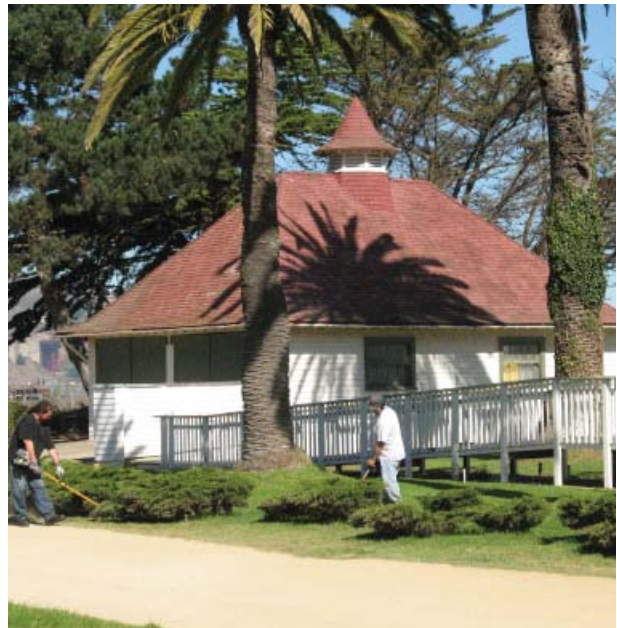
Condition: Generally, the vegetation is well-kept. The trees could potentially cause damage in the event of strong winds. The trees to the west of the 1890 Boathouse and south of the Officer in Charge Quarters are close enough to hold moisture against the buildings and support biological growth (see figure 56).

*Fig. 58: Surrounding vegetation at the 1890 Boathouse.*

Recommendations: Cut back trees and bushes in contact with the buildings. Swinging tree branches could cause impact damage. Roots can damage building foundations, underground building services and drainage systems. Additionally, vegetation can hold moisture against the buildings, providing an ideal climate for biological growth. Proposed landscape plans should use historic landscaping as a guide.

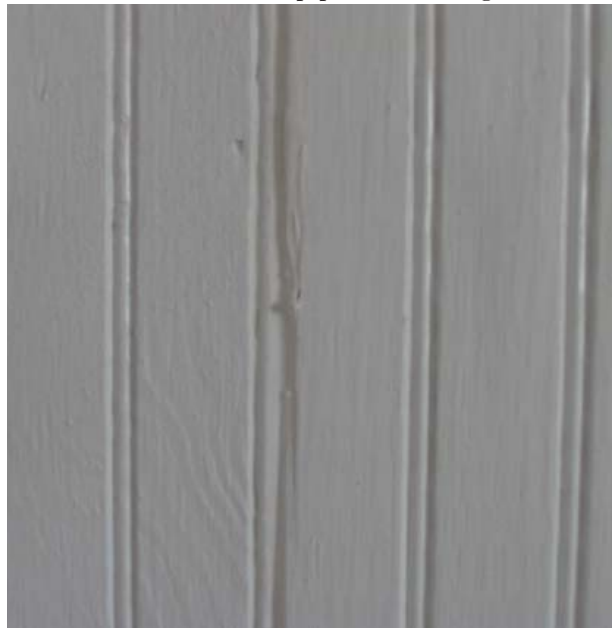
*Fig. 61 : Beadboard wall cladding in the Buoy Shack.*

**Description:** The walls of the Buoy Shack, the Tide Gauge House, and the Main Boathouse are vertical beadboard (see figure 61). The walls of the Shop & Garage, and the 1890 Boathouse are board (see figure 62). All of the walls are painted.

**Recommendations:** Repair wood wall cladding as follows:

- Conduct a detailed, wall survey to document condition of each elevation and determine, on an individual basis, required repairs.

- Remove paint and refinish to match original where necessary. Carefully remove, salvage, label and appropriately store any boards, hardware and trim that must be removed.
- Restore missing boards which have been removed during alterations. Match original with respect to profile, wood type and finish.

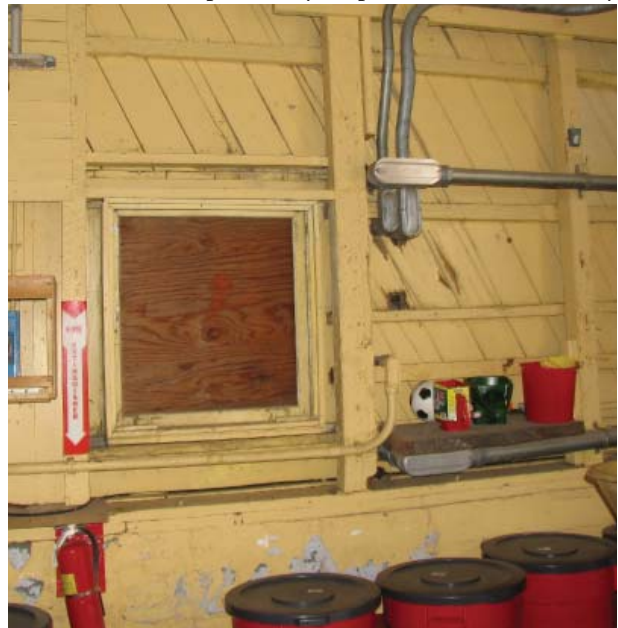
*Fig. 62 : Diagonal board walls at the Shop & Garage.*

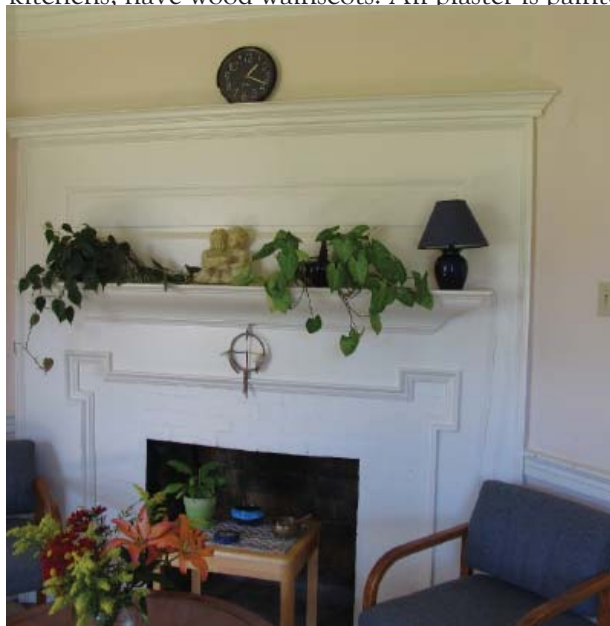
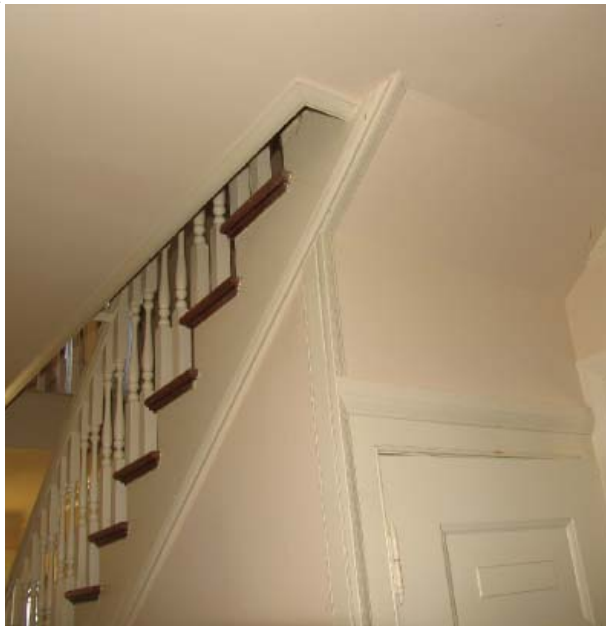
Fig. 63 :Painted wood fireplace, mantle, and wooden elements at the Officer in Charge Quarters.

Fig. 64 :Painted wood stair, balustrade, and door at the Officer in Charge Quarters.

Description: All interior plaster and woodwork is currently painted (see figures 63 & 64).

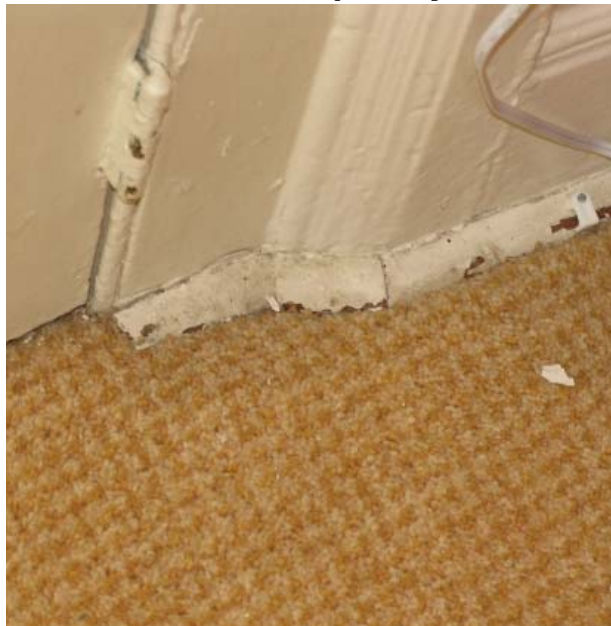
*Fig. 65 : Wood baseboard, bead molding, and carpet at the Officer in Charge Quarters.*

Description: Extant finish flooring of the Main Boathouse and Officer in Charge Quarters currently includes wall-to-wall carpet over an unknown substrate (see figure 65). The flooring in the 1890 Boathouse, Shop

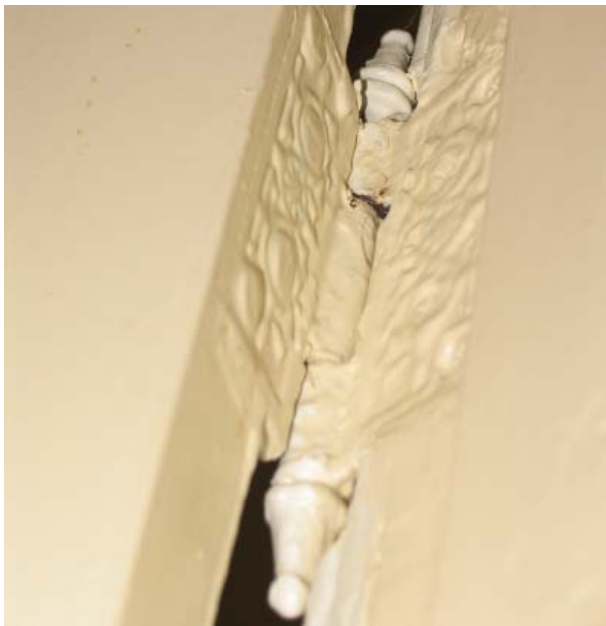
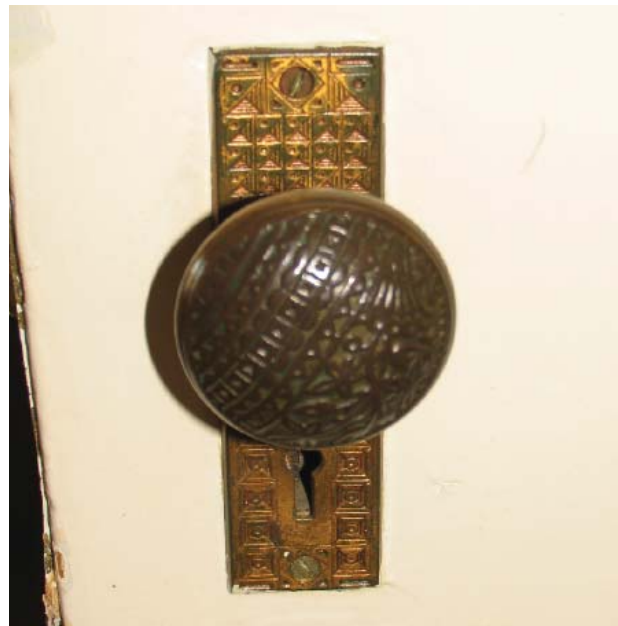
Fig. 69 : Original hardware at the Officer in Charge Quarters.

Description: The majority of the hardware is original and intact. It consists of bronze doorknobs, bronze faceplates and hinges, and bronze window catches (see figures 69 & 70). Several locks on the exterior doors have been replaced with modern dead bolt locks.

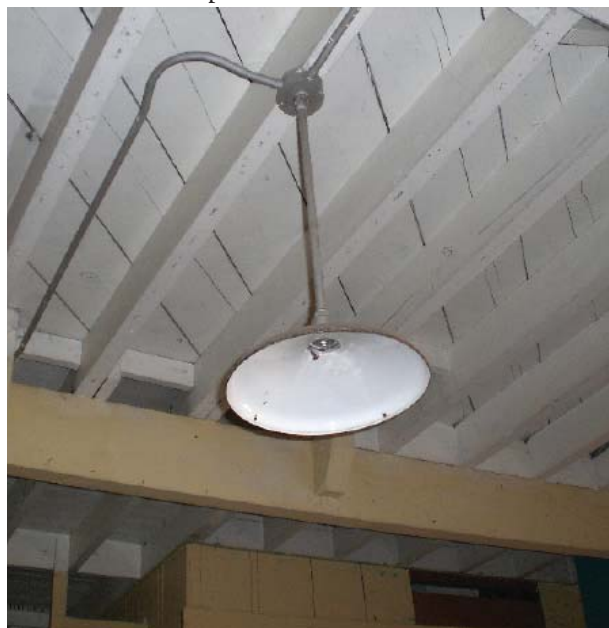
Fig. 71 : Historic pendant light fixture at the Shop & Garage.

and later, non-historic exposed single-bulb hanging pendant fixtures and ceiling-mounted fluorescent light fixtures, in the other buildings (see figure 71).

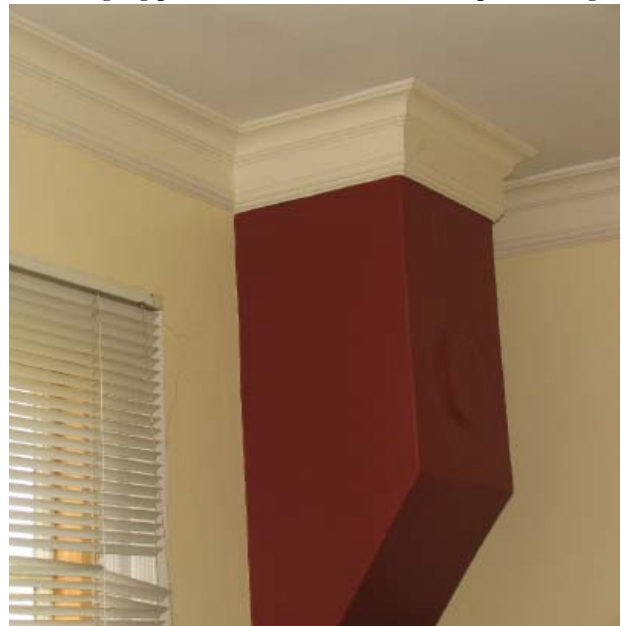
Fig. 74 : Flue and flue cover at the Officer in Charge Quarters, remnant of earlier stove heating system.

Description: The Officer in Charge Quarters was originally heated by stoves. Flue holes, covered over by plates, survive in many rooms, as do fireplaces in the parlors and dining rooms (see figure 74). A propane-fueled forced air system has been installed in the house, and grates are visible in the majority of the rooms. It is unknown whether or not any of the other structures were heated. The Officer in Charge Quarters appears to be heated by a propane-fueled forced air system.
