**Golden Gate National Recreation Area
Redwood Creek Watershed, Muir Woods
Road and Trail Re-evaluation and Assessment
Marin County, California**

Report No. 171024403
August 2017

Prepared for:
Golden Gate National Recreation Area
Building 201, Fort Mason
San Francisco, CA 94123

Prepared by:
Clay Allison, Project Geologist
Tara Zuroweste, Professional Geologist #8418
Danny Hagans, Principal Earth Scientist
Pacific Watershed Associates Inc.
PO Box 2070, Petaluma, CA 94953 / (707) 773-1385
taraz@pacificwatershed.com

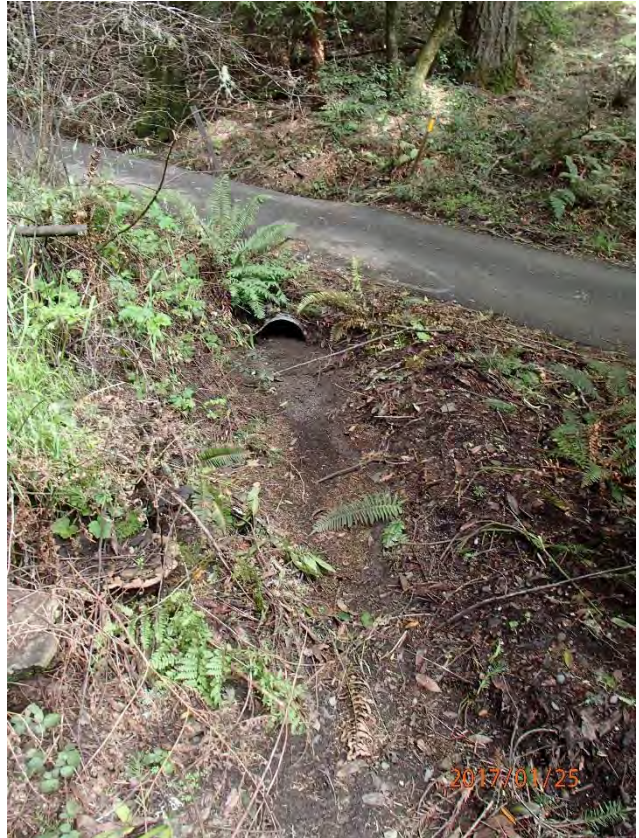
Description of Problem: Site #93 is a 12" diameter DRC receiving input from multiple areas (parking lot at park maintenance from left, plugged DRC at hairpin turn, and likely received diverted flow from Site #94 during high flows. See photos 10 and 11 below.

Photos 10 and 11. Photos taken at DRC Site #93. Photo above on left is taken from above the inlet of the 12" DRC. Photo to the right is taken below the outlet of the 12" culvert showing half plugged culvert.

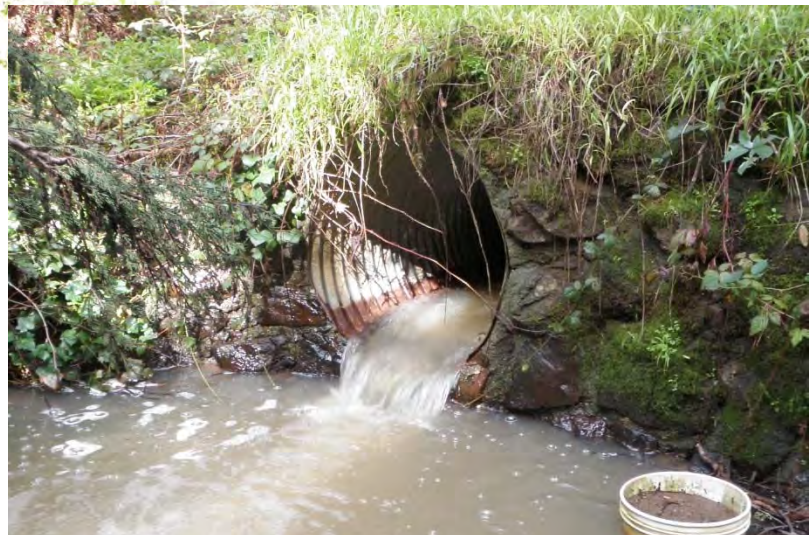
Description of Problem: Site #199 is a class 2 stream crossing conveyed through a rusted 36” diameter culvert (Photos 30, 31). There is an active overflow channel along the axis of the crossing, and the fill near the inlet is disaggregating. Also, tributary valley to the right has been completely filled in and has a very long culvert. These channels have been completely altered from their natural state all the way downstream due to road and home building activities.

Photos 30 and 31. Photos taken of stream crossing Site #199. A Class 2 stream crossing with a poorly installed 36” CMP with fill near the inlet (above, left) showing active erosion to and its’ capacity being exceeded. The outlet is placed well (right); but there is an active overflow channel along the axis of the crossing. Stream valley was filled to create building space for home to the left of the site.

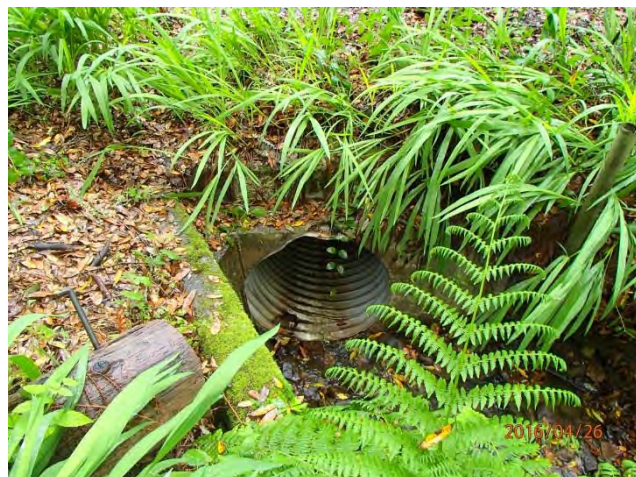
Description of Problem: Site #203 is a 6' x 2' class 2 stream flowing through a failing 36" diameter pipe that was repaired by installing a newer 30" pipe within the old culvert. Currently, flow leaks 2' before the 30" outlet through slots in the pipe. Stream flow is constricted at the inlet by the road and cement headwall on the left. Past diversion and plugging is indicated by dilapidated sand bags above inlet. The crossing was already undersized before the insert was installed further reducing capacity by 30%. In addition, the installation was too short, causing fill to collapse around the outlet. Culvert is aligned nearly perpendicular to the natural channel. The new culvert should be realigned with natural channel. This site is also receiving 150' of runoff from driveway to the right. See photos 37 and 38 below.

Photos 37 and 38. Photos taken of undersized, 30" culvert installed within failing 36" culvert at stream crossing Site #203. Photo 37 (left) is taken from the right road approach, note the blue arrow denotes the direction of flow. Photo 38 (right) shows the concrete crib wall protecting the road above the inlet at the bend in the channel.

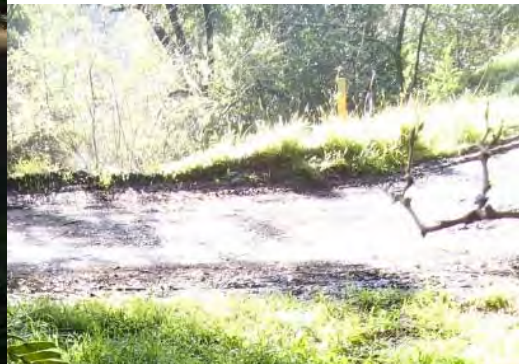
Description of Problem: Site #182 is a stream crossing with flow from a class 2 stream conveyed through a 42" diameter HDPE plastic culvert, installed after the original assessment. Culvert is set at a shallow grade, and high and short in the fill. There is a 3' drop at the culvert outlet and subsequent splash zone erosion. There is an active spring in the right IBD area that is being conveyed to the culvert inlet. See photos 45 and 46 below.

Photos 45 and 46. Photos taken of stream crossing Site #182. The culvert is set high in the fill with a 3' drop at the outlet (above, left). An active spring along the right inboard ditch is being effectively conveyed into a recently installed 42" diameter culvert.

Description of Treatment Recommendation: Install a rock grade control structure at the culvert outlet utilizing 5yd³ of mixed 1' to 2.5' diameter rip-rap to act as energy dissipation. Treat the hydrologically connected road by outsloping the road and installing a rolling dip to the right at the existing outboard drain location with a rocked outlet keyed into the road surface to prevent headward erosion into the road bed. Maintain the active IBD to drain the spring flow to the right for 20' but remove the ditch through the remaining outsloped portion.

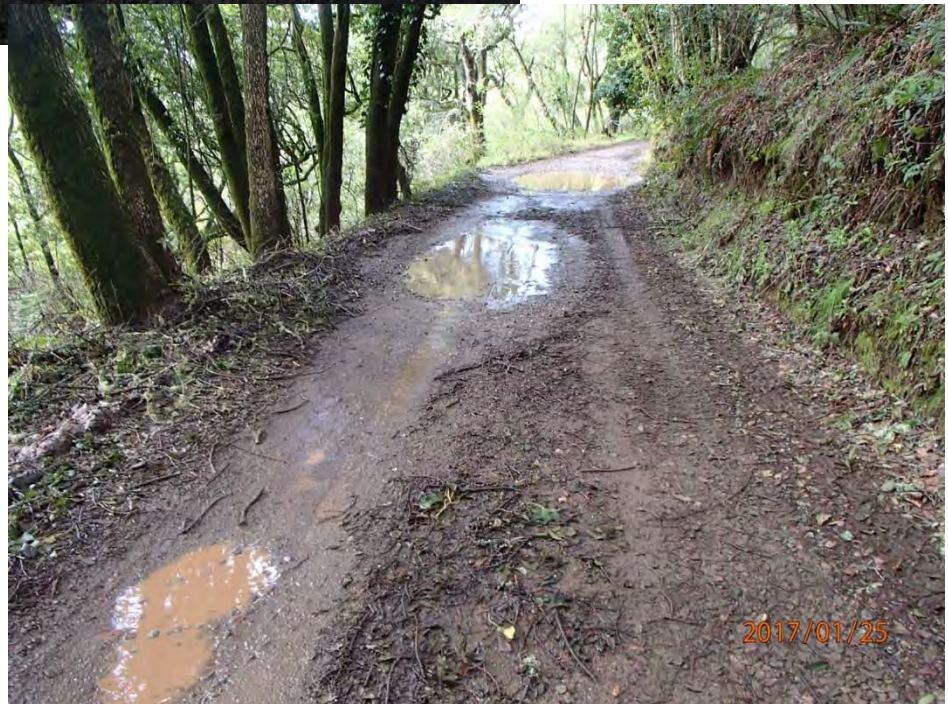
Description of Problem: Site #183 is a road surface discharge point within a section of insloped and bermed road accumulating water at 2 low spots 165' apart (Photos 47 and 48). Along this section, ponded water exits the road at OBF forming gullies along the OBF slope that deliver to class 2 streams ~45' - 200' downslope.

Photos 47 and 48. Photos taken of road surface discharge point Site #183. A section of insloped and bermed road accumulates water at 2 low spots 165' apart. At both sites ponded water exits road at OBF and is actively gullying the OBF slope.

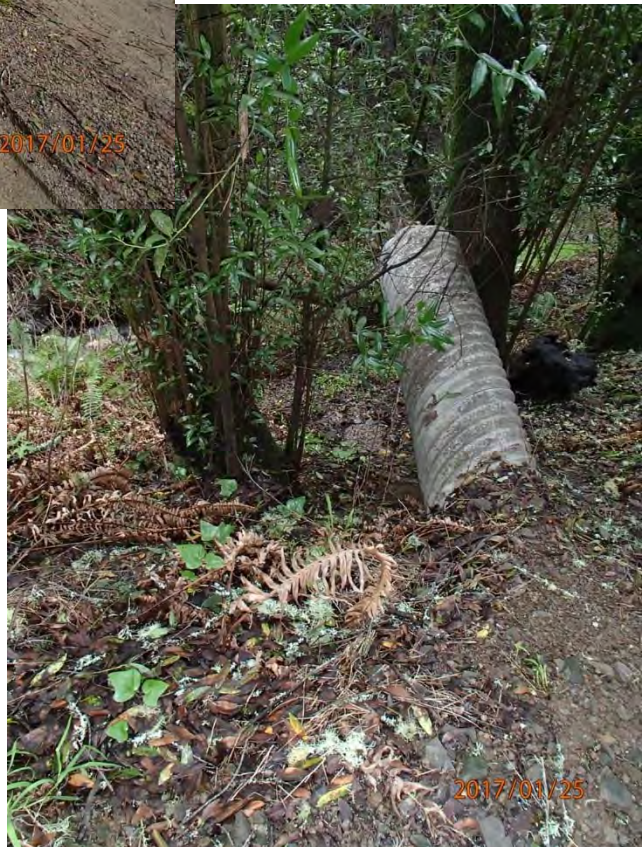
Description of Problem: Site #184 is an 18” diameter DRC that drains hydrologically connected right road and springy cutbank (Photo 49). The DRC is 30% plugged, installed at a shallow grade with the outlet shot-gunned, and a 5’ drop at the outlet (Photo 50). Additional runoff is exiting the road at the OBF, and gullying down to the class 2 stream ~150’ downslope.

Photos 49 and 50. Photos taken of DRC Site #184. An 18” diameter DRC drains the connected right road approach and springy cutbank (left). The DRC is 30% plugged and is installed at a shallow grade, and the outlet is shot-gunned with a 5’ drop at the outlet (below).

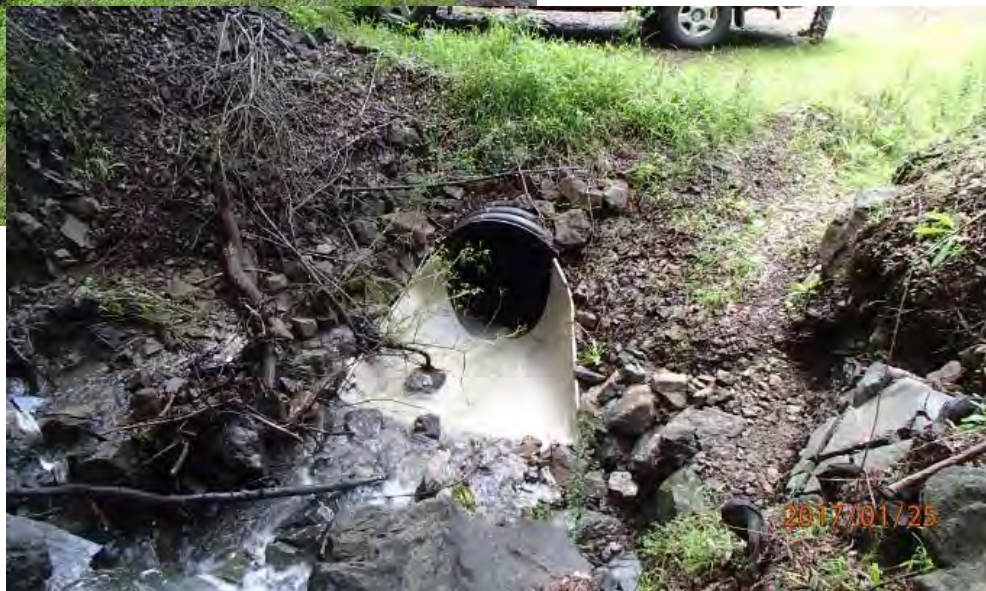
Description of Problem: Site #185 is a rowdy (rough) class 2 stream conveyed through an undersized 36" diameter HDPE plastic culvert with aluminum flared inlet set high in the fill with a shot-gunned outlet. There is also a 24" diameter CMP ~26' to the right of the stream crossing that conveys flow to site #185 from a failing network of 24" diameter plastic culverts intended to convey flow to bypass an existing gully generated by road surface runoff coming from Muir Woods Road. The culvert is separated and disconnected in several locations. The combined hillslope runoff and breached culvert flow have exacerbated the existing gully. There is a ~ 10' drop at the culvert outlets exacerbating erosion and destabilizing the outboard fillslope. See photos 51 and 52 below.

Photos 51 and 52. Photos taken of stream crossing Site #185. A rowdy Class 2 stream is conveyed through this crossing via an undersized 36" diameter HDPE plastic culvert with an aluminum flared inlet (left). There is a 24" diameter CMP ~26' to the right of the stream crossing that conveys flow from a failing downspout network upslope (right).

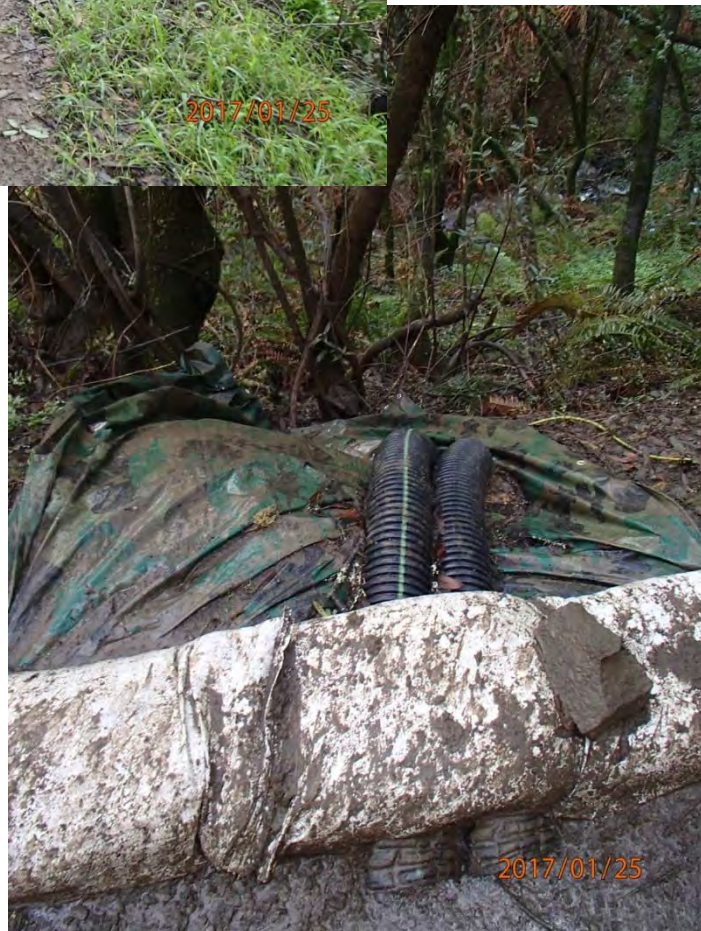
Description of Problem: Site #186 is a road surface discharge point causing a gully that delivers to a class 2 stream ~100' downslope. Accumulated runoff exits at this low point in the road from the hydrologically connected road reaches (Photos 53 and 54).

Photos 53 and 54. Photos taken of road surface discharge point Site #186. The concentrated RSDP run off is actively eroding a gully that delivers to Class 2 stream 100' downslope.

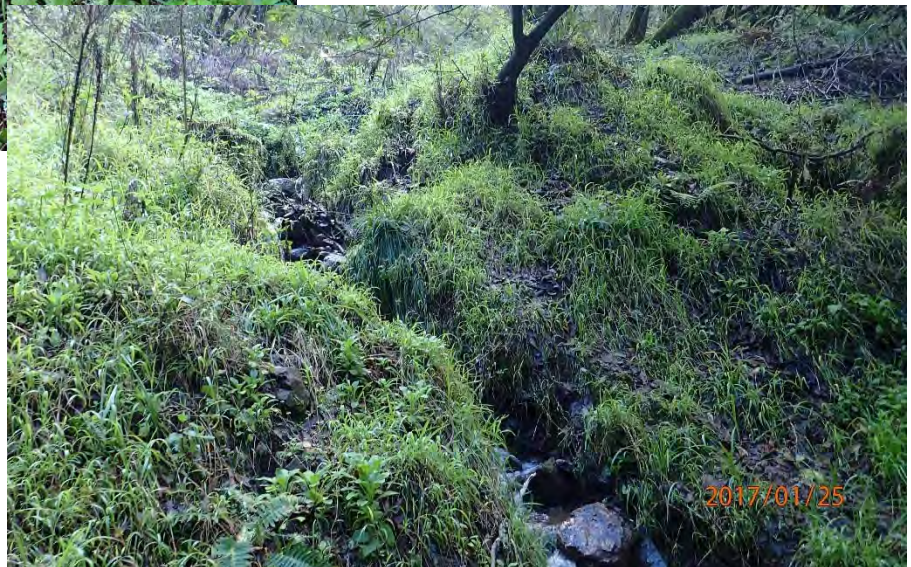
Description of Problem: Site #187.1 is a non-culverted fill crossing conveying flow from the class 2 stream (Site #187) above eroding through an abandoned road prism (Photos 57 and 58).

Photos 57 and 58. Photos taken of stream crossing Site #187.1. Stream flow from site #187 on Camino Canyon Road outlets onto this relict road prism (left). Stream flow is actively eroding through the fill and delivering sediment to the Class 2 stream downslope (below).

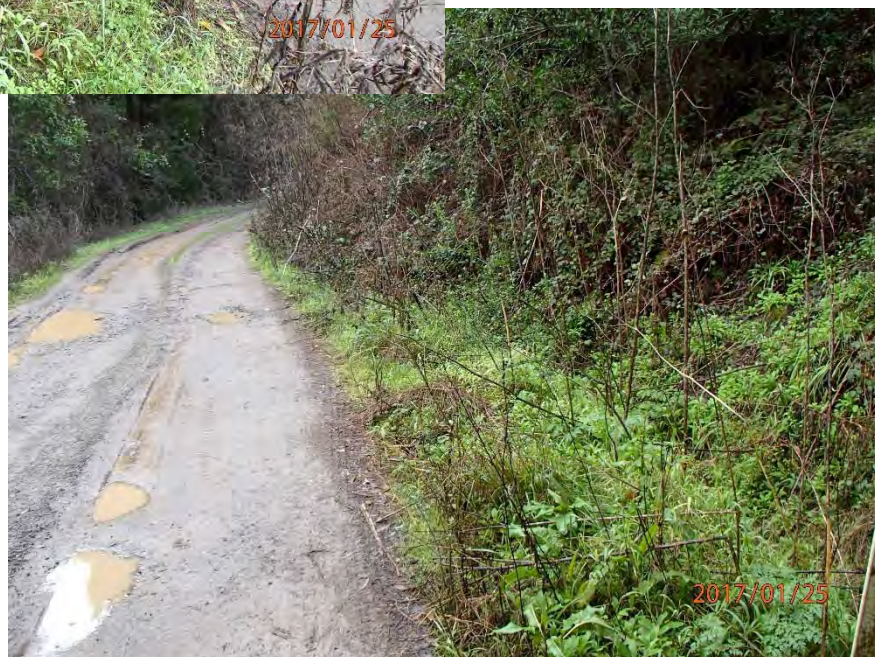
Description of Problem: Site #189 is a large debris slide that has deposited sediment into the stream channel below Site #188. Since failure, the road has been rebuilt over and through the slide deposit; therefore difficult to detect in photos 61 and 62 below. Potential future sediment delivery is still very likely towards the right side and lower to the left of the feature as well as continued road surface (*chronic*) contribution.

Photos 61 and 62. Photos taken of road beneath landslide Site #189. A large debris slide has deposited into channel below stream crossing site #188. Since failure, road has been rebuilt thru deposit with a maintained inboard ditch and DRC draining hillslope and feature seepage as well as road surface runoff.

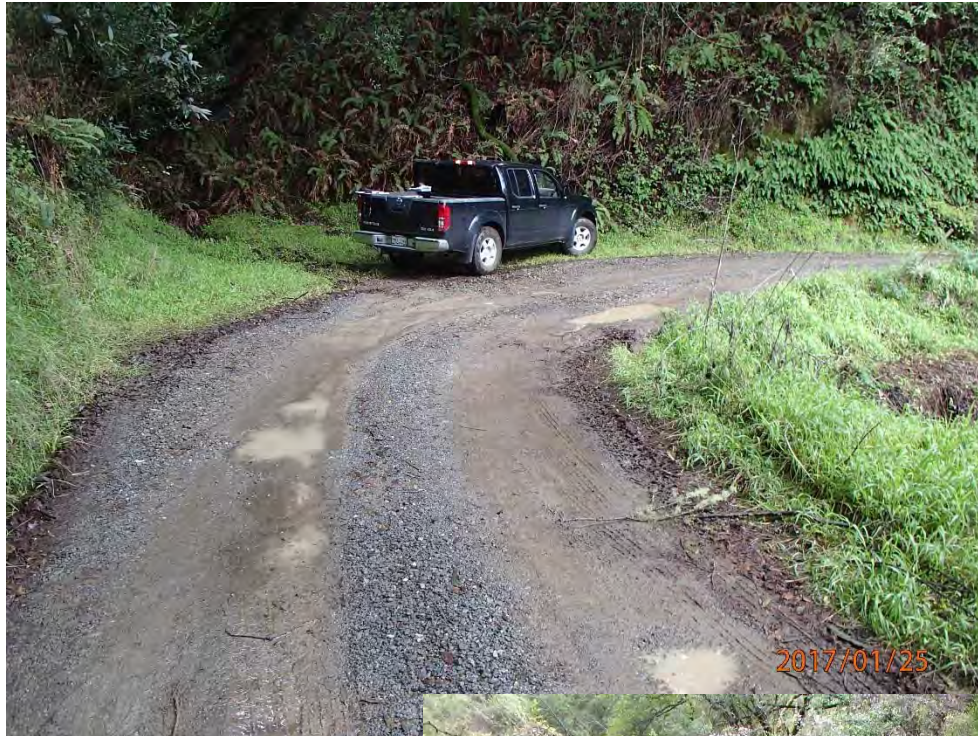
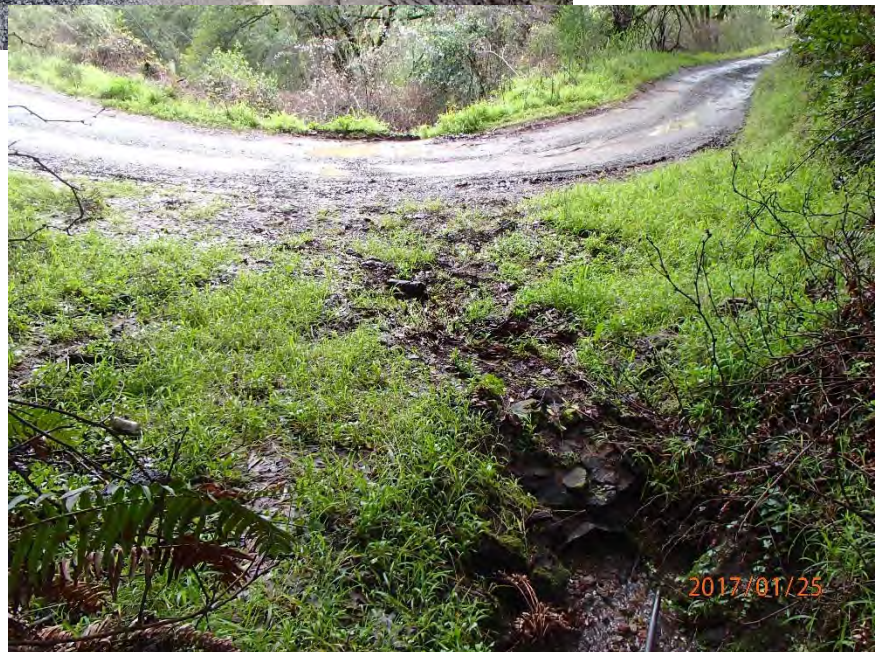
Photos 63 and 64.

Description of Problem: Site #190 is a class 3 stream crossing being conveyed through an undersized 18” aluminum culvert. The culvert is installed short and high in the fill and at a very shallow gradient. The culvert is 50% plugged with aggraded bedload, and shows evidence of recent overtopping (Photos 63 and 64).

Treatment Immediacy: High-Moderate

Photos taken of stream crossing Site #190. Flow from a Class 3 stream is conveyed through this crossing via an undersized 18” aluminum culvert. The culvert is 50% plugged with aggraded bedload, and shows evidence of recent overtopping.

Description of Treatment Recommendation: Replace the existing undersized culvert with a new 30” diameter culvert at the base of fill and install a critical dip on the left hinge to prevent diversion. Outslope hydrologically connected road reaches and install 3 rolling dips on the right road approach.

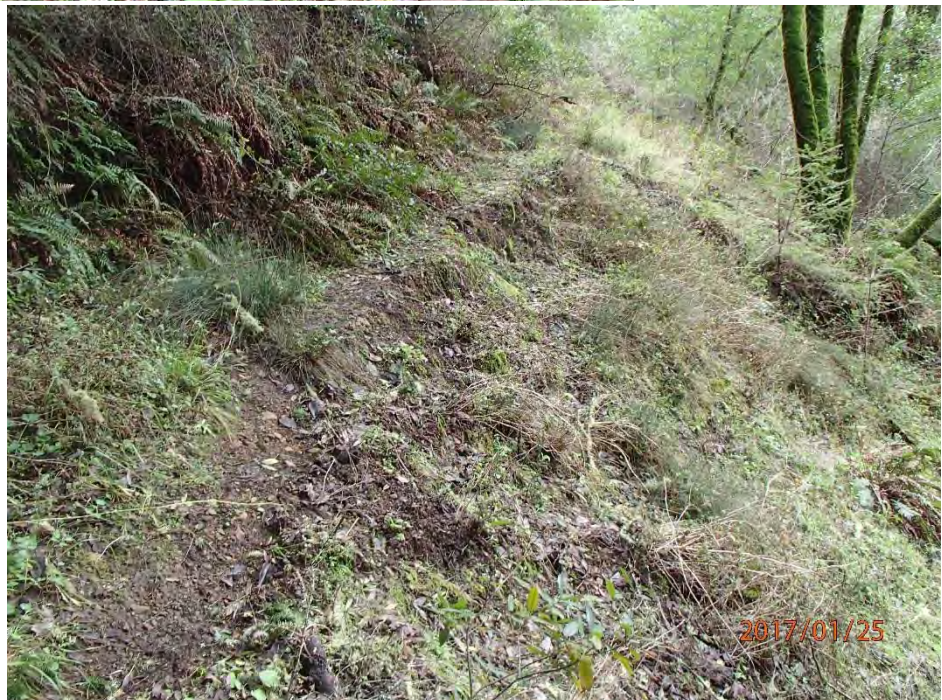
Photos 65 and 66. Photos taken of landslide Site #193. The road was decommissioned by NPS in 2003 when remaining perched fill was excavated. Currently, road and feature appear to be stable.

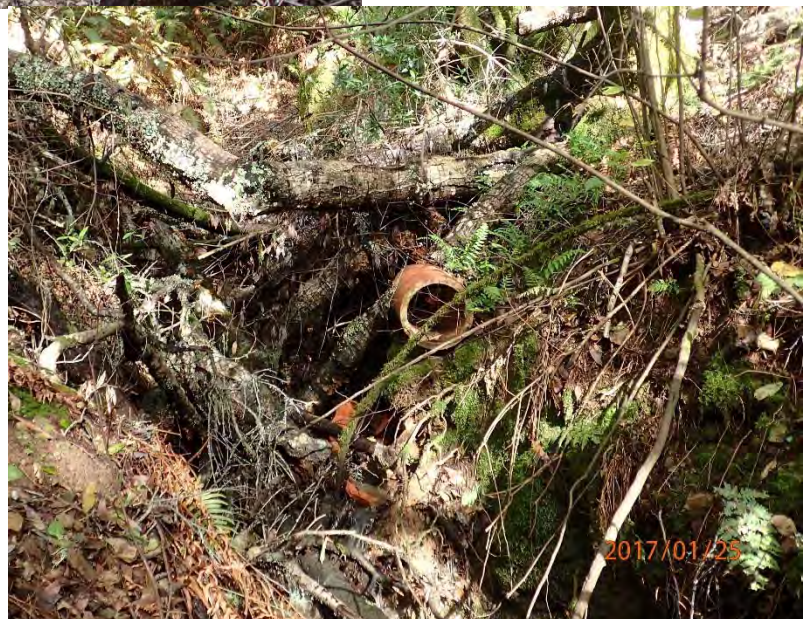
Description of Problem: Site #521.1 is a class 3 stream crossing conveyed by a 50% plugged 12" diameter culvert (Photos 70 and 71). The channel is incised. This part of the trail is an old road bed and is not needed anymore for use as a road. 1500' of steep trail contributes to this site. There are actually 2 trails (one stairs and one gullied). There is also an abandoned section of road to the left, which does not appear to have any drainage problems.

Photos 70 and 71. Photos of stream crossing Site #521.1. Culvert inlet is buried by sediment fan (left) and outlet of very undersized and poorly installed clay pipe is visible below the road (below).

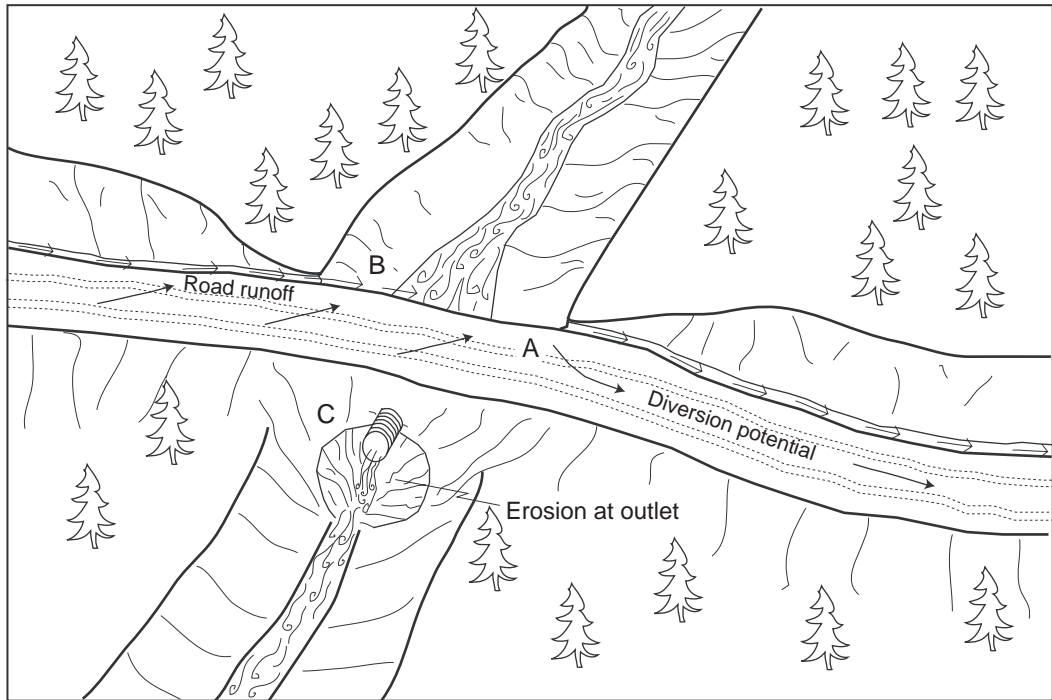
Problem condition (before)

- A - Diversion potential
- B - Road surface and ditch drain to stream
- C - Undersized culvert high in fill with outlet erosion

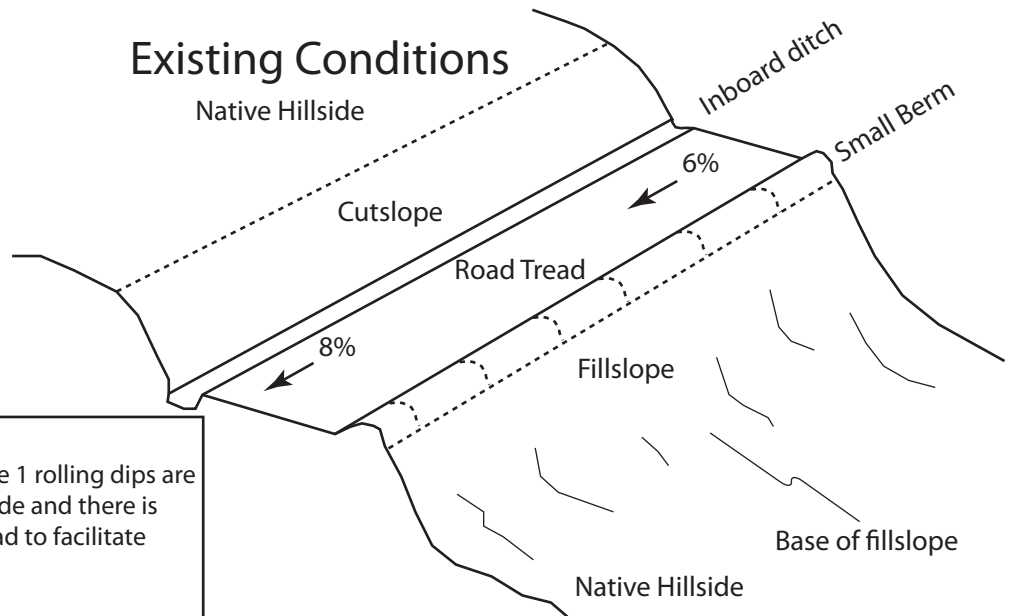
Standard (Type 1) Rolling Dip Construction

Rolling dip type 1 existing conditions: Type 1 rolling dips are utilized when roads are less than 12-14% grade and there is proximal outfall adjacent to the outboard road to facilitate road drainage.

- 1) The berm should be removed for the entire length of the dip.
- 2) The steeper the road grade the more asymmetrical the dip should be constructed, i.e. the axis of the dip should be closer to the down road side of the dip when the road gets steep. (See PWA typical drawing #11).
- 3) The dip should be outsloped at 3-4% across the road tread from start to end of each dip, and 8-10% across the outboard fill.
- 4) The dip will either connect to and drain the ditch or it will only drain the road surface, see road log for specifications.
- 5) The road tread across the dip or the outlet of the dip may be rocked depending on site specific conditions (see road log).

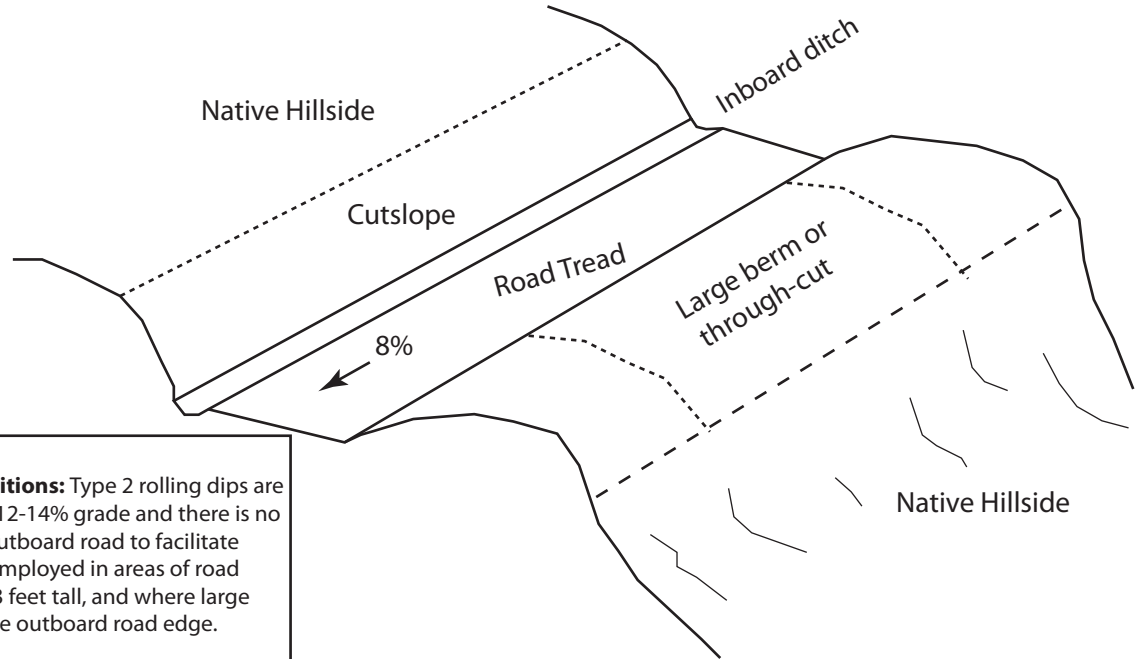
Type 2 Rolling Dip Construction

Rolling dip type 2 existing conditions: Type 2 rolling dips are utilized when roads are less than 12-14% grade and there is no proximal outfall adjacent to the outboard road to facilitate road drainage. These should be employed in areas of road through-cuts generally less than 3 feet tall, and where large wide and/or tall berms exist on the outboard road edge.

- 1) The berm or native hillside should be removed for the entire length of the excavated portion of the dip, or, at a minimum through the axis of the dip.
- 2) The steeper the road grade the more asymmetrical the dip should be constructed, i.e. the axis of the dip should be closer to the down road side of the dip when the road gets steep.
- 3) The dip should be outsloped at 3-4% across the road tread and 8-10% across the outboard berm or native hillside. (The road log will specify the length of the outlet breach throughout the large berm or native hillside).
- 4) The dip will either connect to and drain the ditch or it will only drain the road surface, see road log for specifications.
- 5) The road tread across the dip or the outlet of the dip may be rocked depending on site specific conditions (see road log).

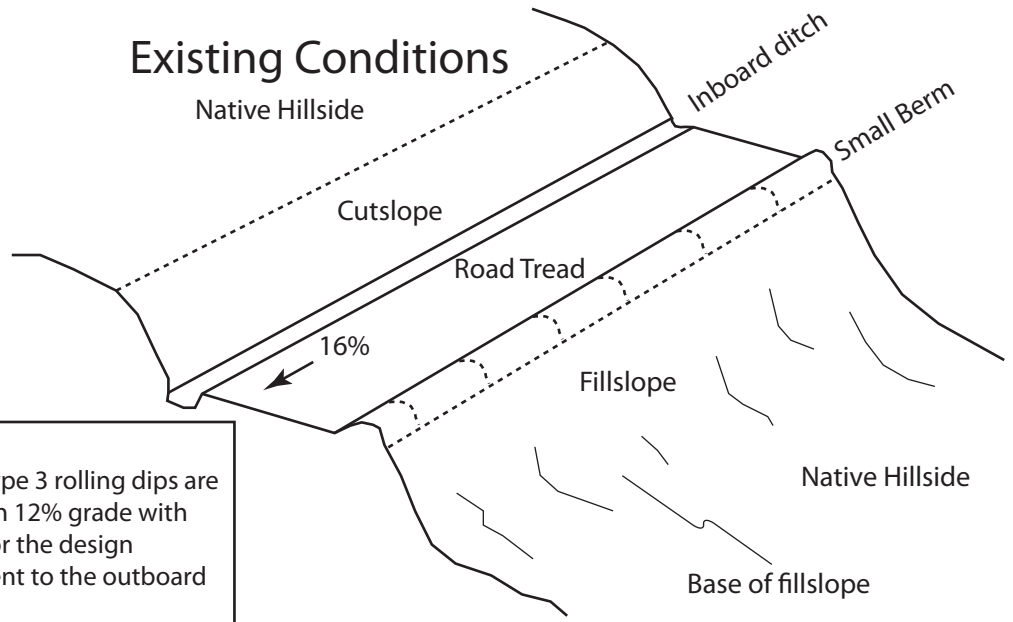
Type 3 Rolling Dip Construction (steep slope outslope)

Rolling dip type 3 existing conditions: Type 3 rolling dips are utilized when roads grades are steeper than 12% grade with little opportunity to create reverse grade for the design vehicle, and there is proximal outfall adjacent to the outboard road to facilitate road drainage.

- 1) The berm should be removed for the entire length of the outsloped section.
- 2) The dip should be outsloped at 2-4% across the road tread and 4-8% across the outboard fill. (The road log will specify the length of road to be type 3 outsloped).
- 3) The outsloping will rarely connect to and drain the ditch (see road log for specifications).
- 4) The road tread across the outsloped section or the outboard road will be rocked depending on site specific conditions (see road log).
