# Beaver Creek No. 10

## Grand Teton National Park Wyoming

### Historic Structure Report

*Prepared by*  
Colorado State University  
Architectural Preservation Institute  
Christopher Koziol, Principal Investigator

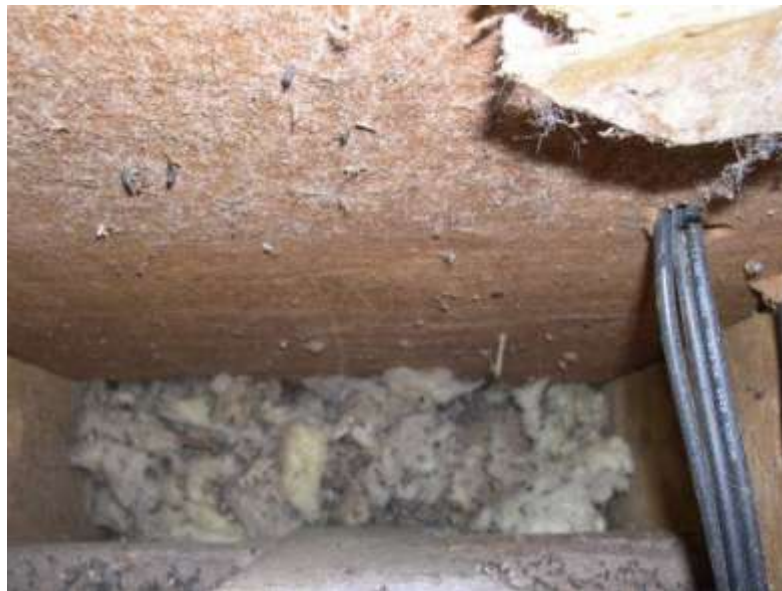
Figure 7 Void in wall in Rm. #4 where old chimney existed

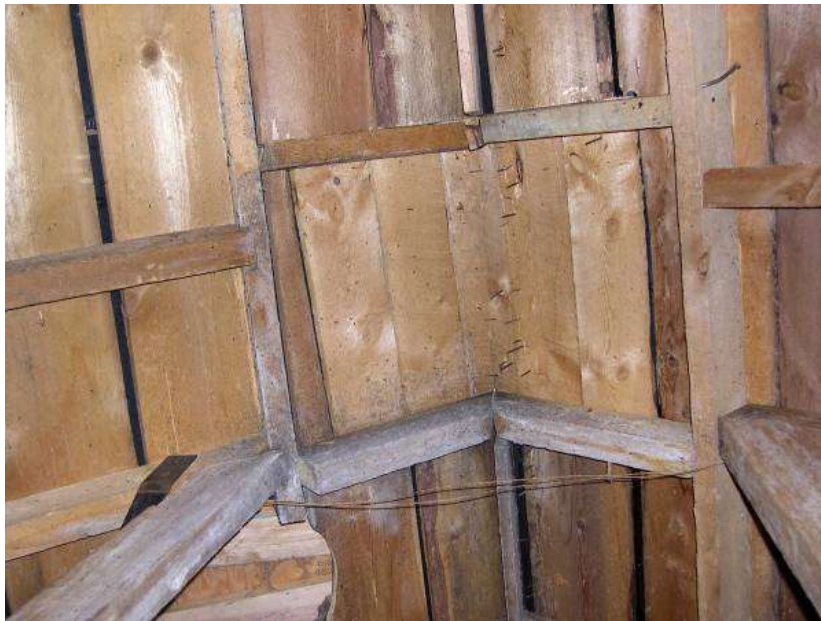
Figure 8 Rms. #3a and #4 with patch of chimney location

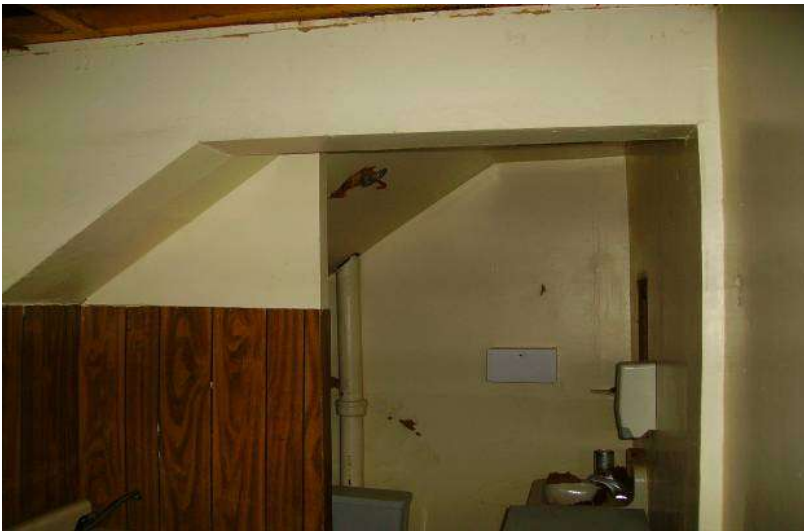
Figure 10 Rm. #8 showing evidence of lean-to roof

Sometime after the first (rear) addition was added (#13), a storage shed was added (room #8) to the inside corner of the west wall of the addition, and the north wall of the main hipped roof building. That the east wall of the subsequent addition (1939) backs up to the top of the shed roof is evidence of the sequence of construction. Remnants of the shed roof and the west shed frame wall are still present in the toilet area today. (see Figure 10)

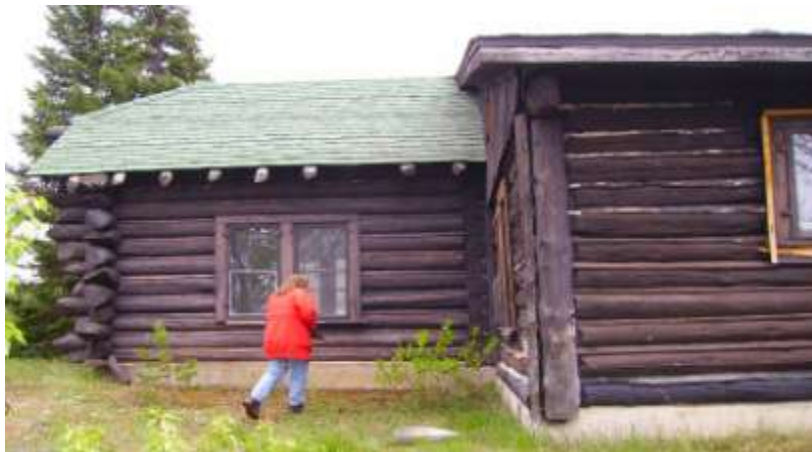
Figure 28 North elevation of Rm. #1

The north elevation pictured above is of the most eastern CCC addition of the building. There is a good example of the half-covered crawl space vent beneath the most easterly window. The two windows are undivided double-hung sash. Above the windows there are nine exposed pointed end rafters. At the intersecting corner, the point where this addition's round logs are attached to the

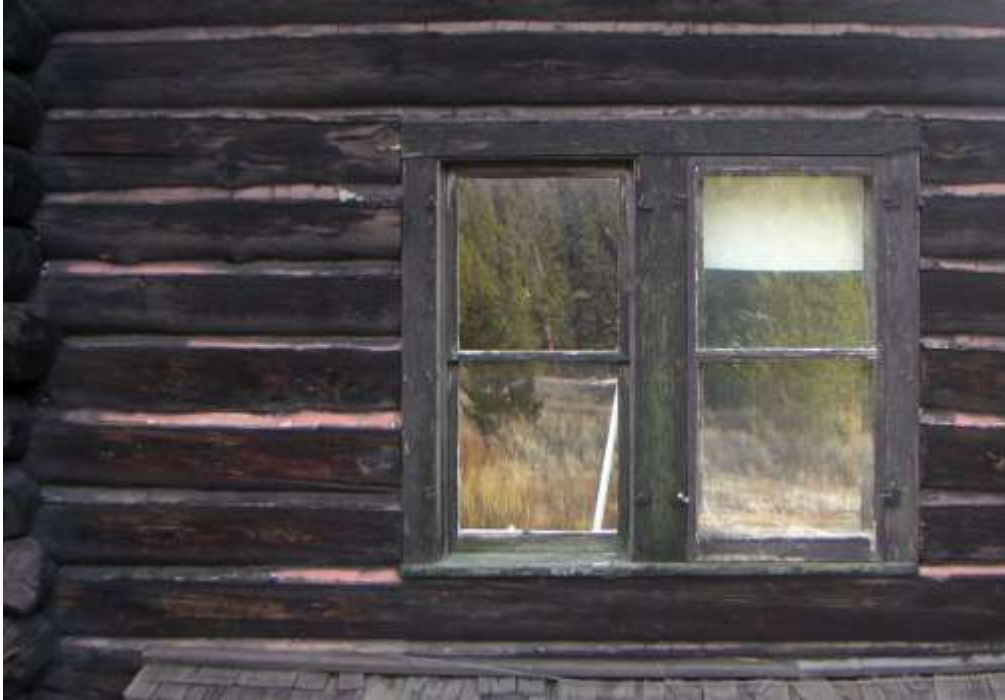
The windows are in **fair** condition. Lack of regular building maintenance has obviously adversely affected the exterior of most windows. However, no degradation appears irreversible at this time. Several windows panes are broken and some storm sashes are missing or have broken panes. All windows and trim lack paint or any other protective finish. While individual window parts may be damaged and in need of replacement or repairs, overall, the windows appear in **fair** condition. We recommend a more thorough assessment by a skilled wood preservationist.

Figure 42 West wall of Rm. #5 with double hung windows (right window has a storm sash)

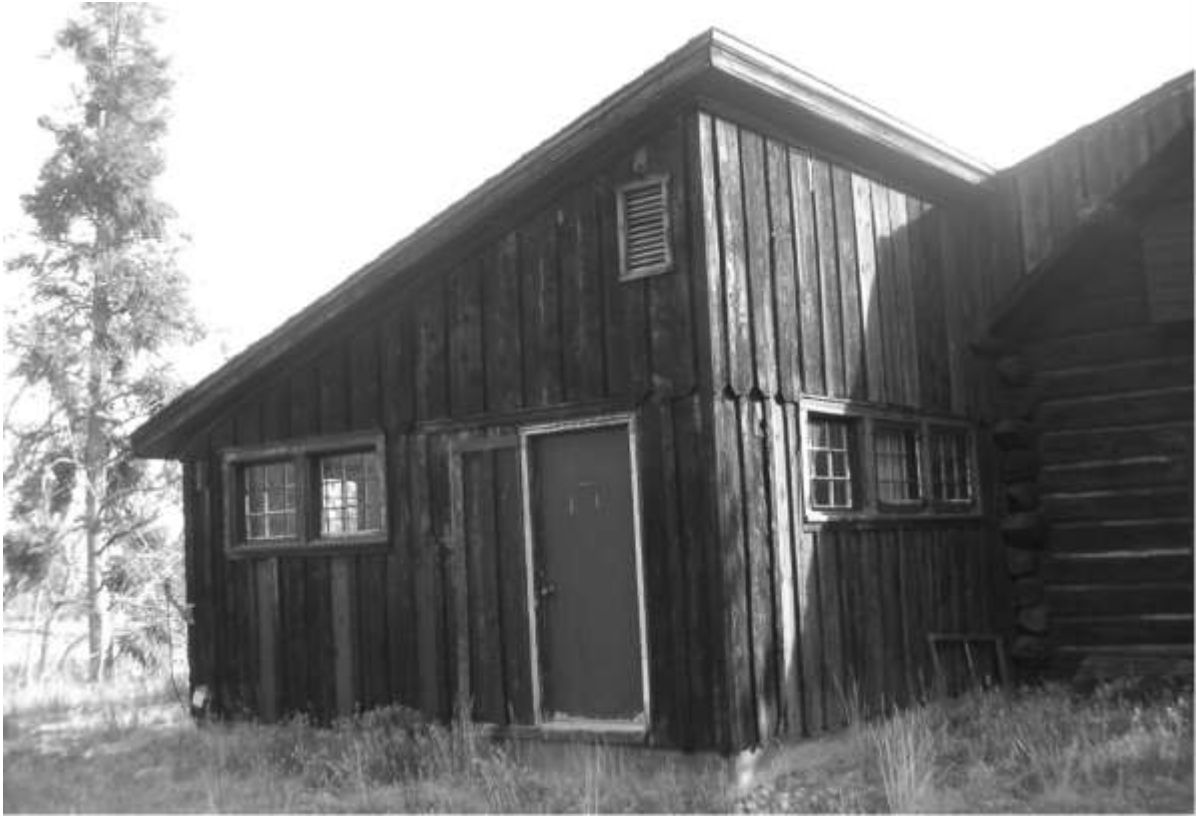
Figure 50 1956 addition from the southwest

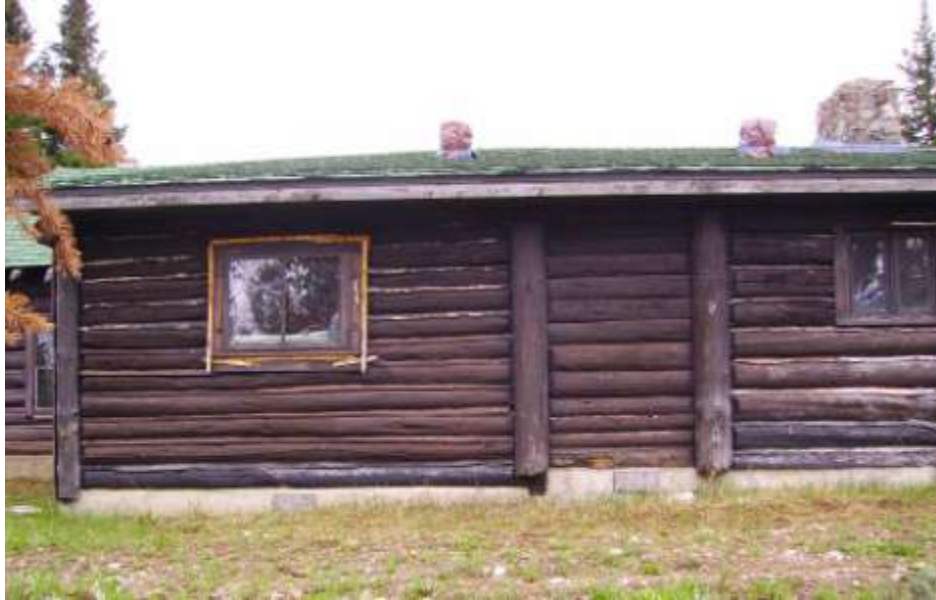
North elevation, light-colored lathe around window is left from weather film.

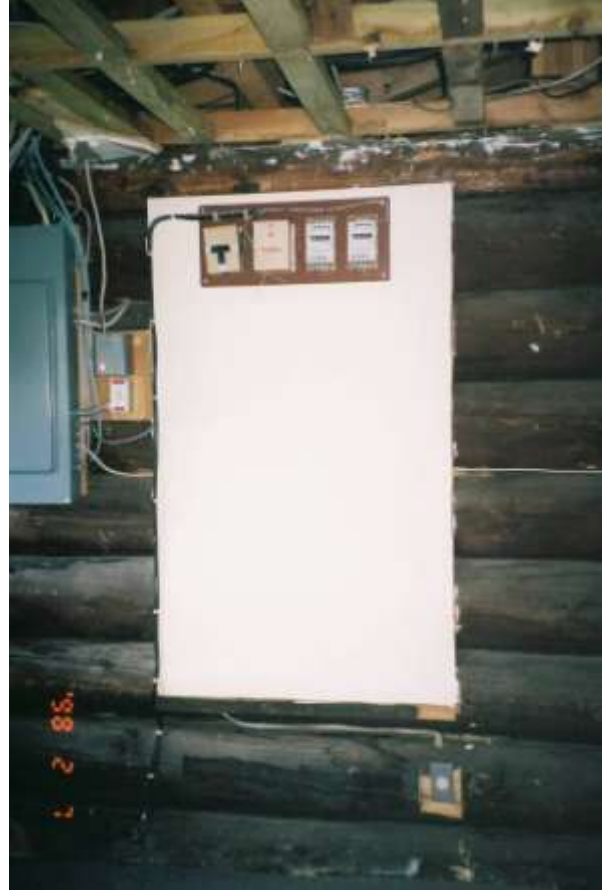
Interior room #10, electrical panel and other utilities

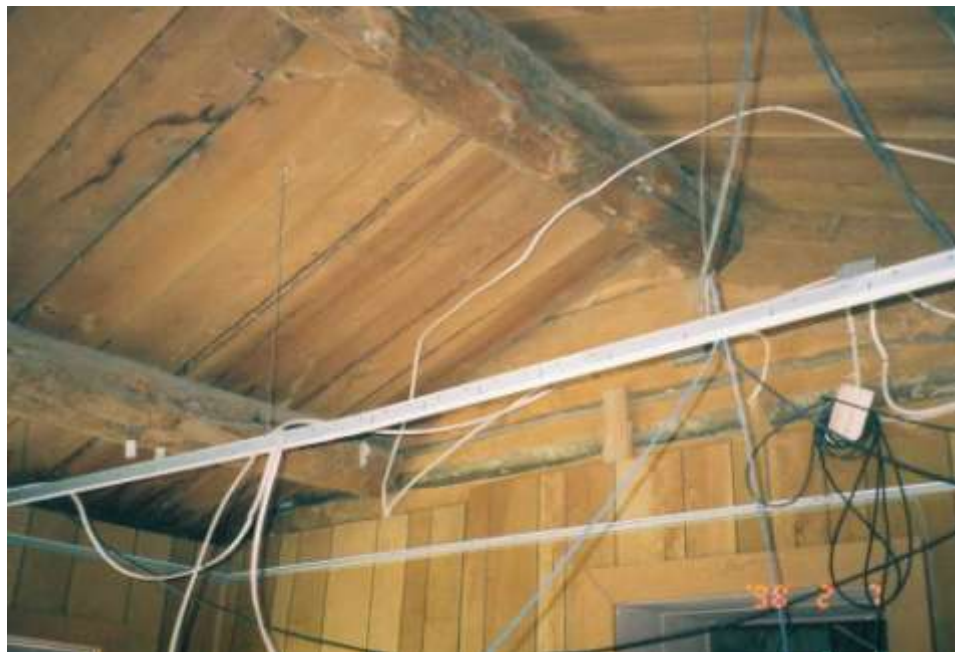
Junction of north wall of hipped roof and south wall of earliest addition

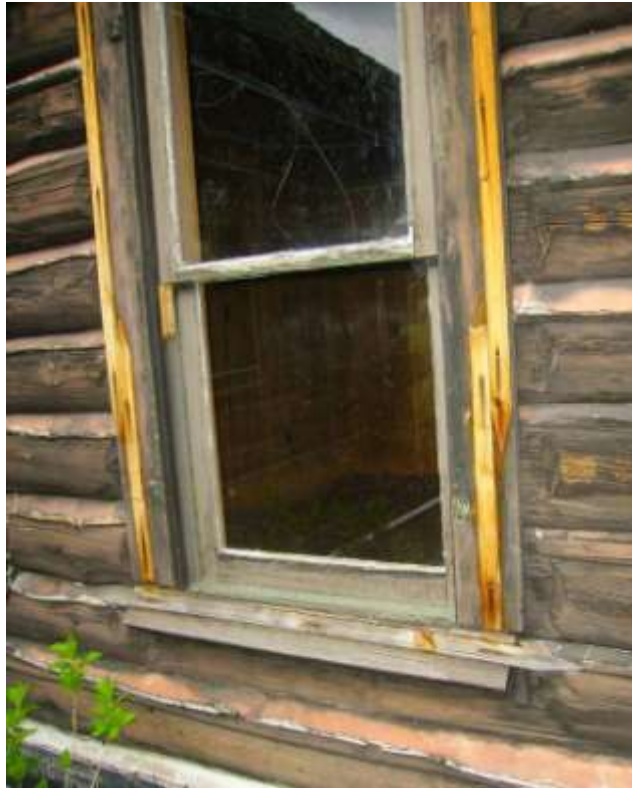
East elevation of earliest addition, showing scarring suggesting position of earlier window

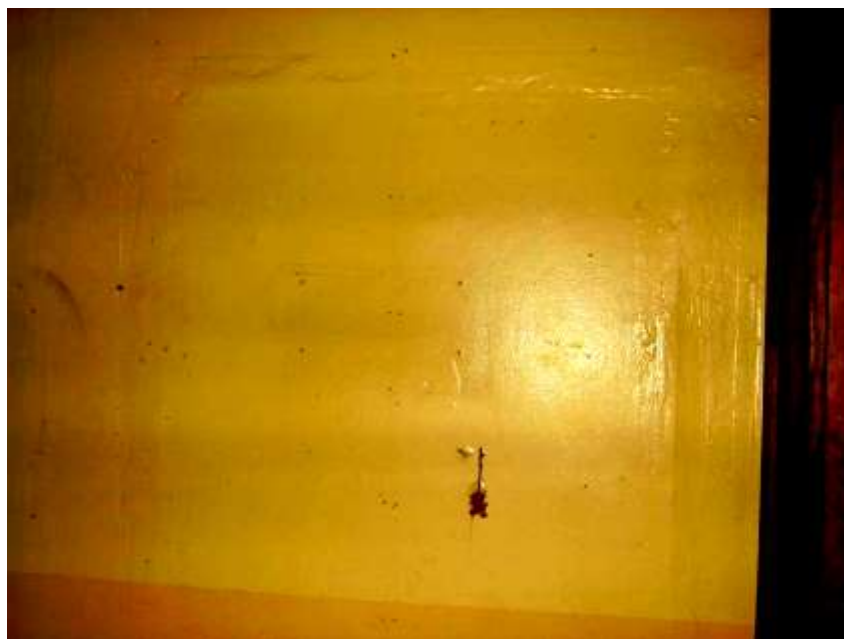
North wall of room #4, rake light showing perimeter of previous doorway to exterior wood shed (now bathroom)

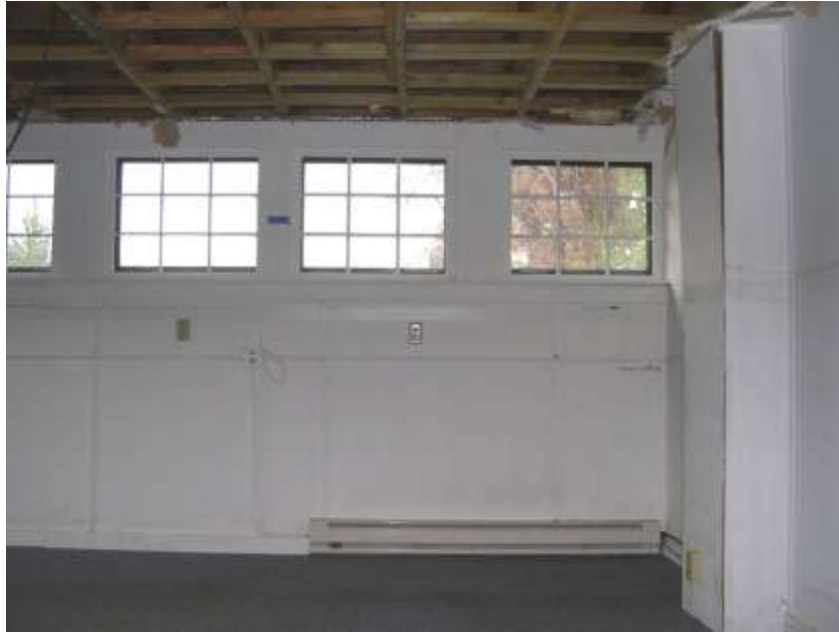
North wall of 1956 addition, windows and walls in overall good condition

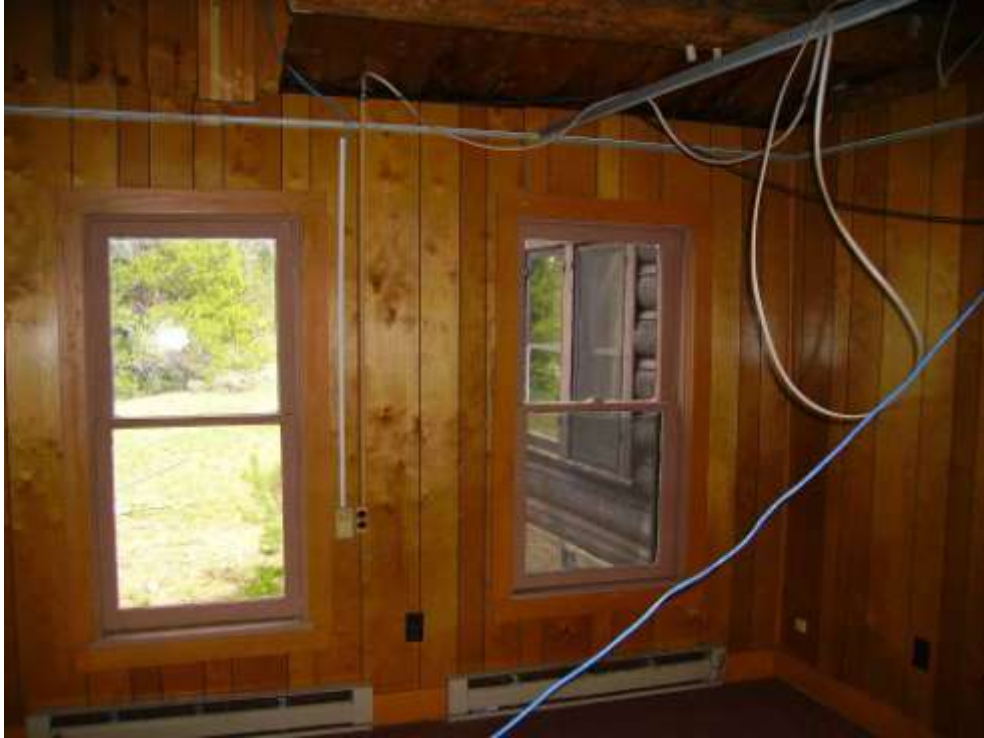
East wall of the earliest addition (room #13), windows in good condition

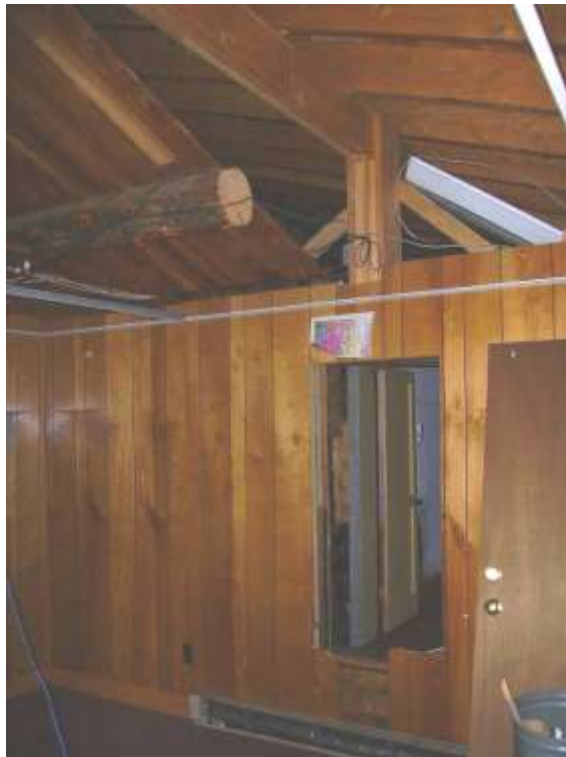
West wall of earliest addition (room #13) showing attempt to construct doorway to darkroom/storage area

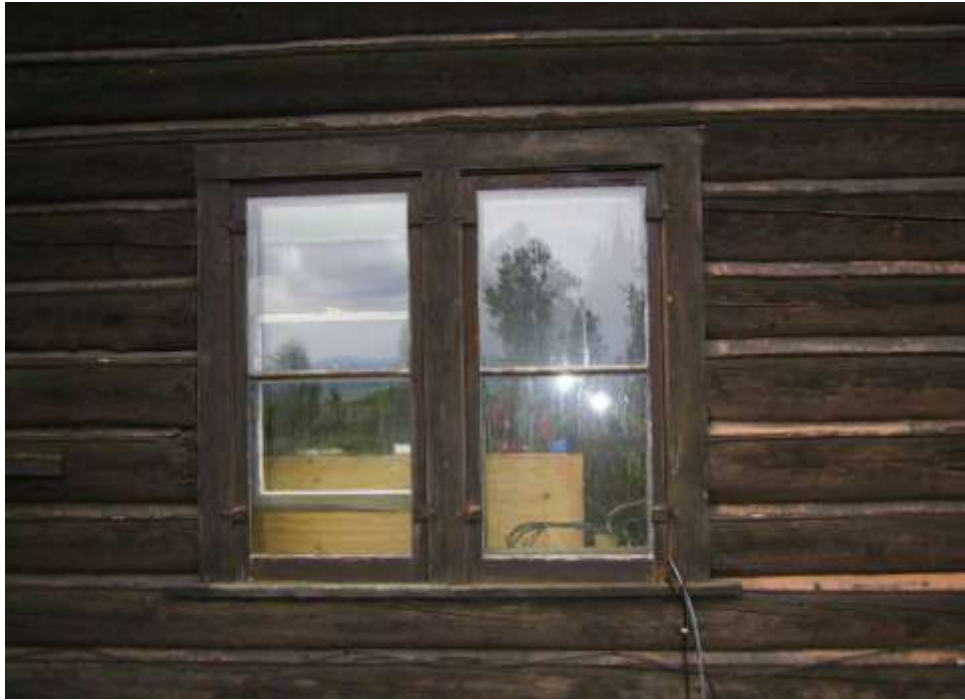
East elevation, CCC addition, windows, logs, chinking and daubing all in good condition
