East Courtroom,
Old Courthouse
Jefferson National Expansion Memorial
St. Louis Missouri

Paint & Finish Analysis
November 2011

prepared for
National Park Service
Jefferson National Expansion Memorial
St. Louis Missouri

prepared by
Richbrook Conservation
New York New York

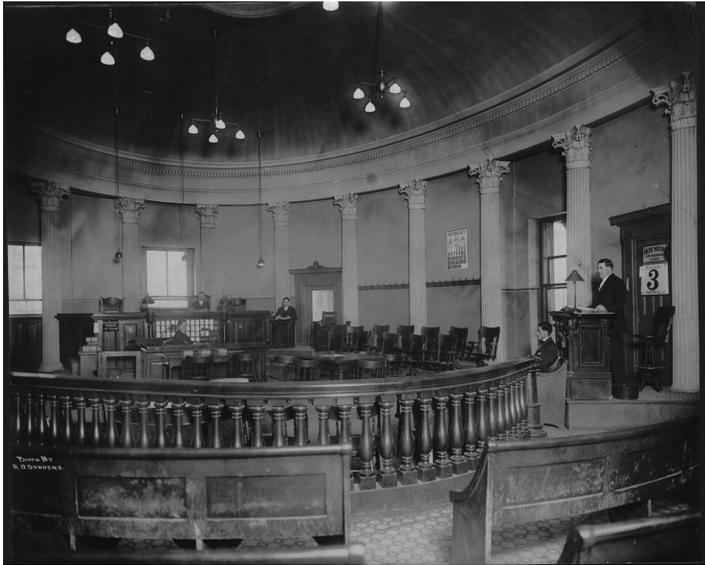
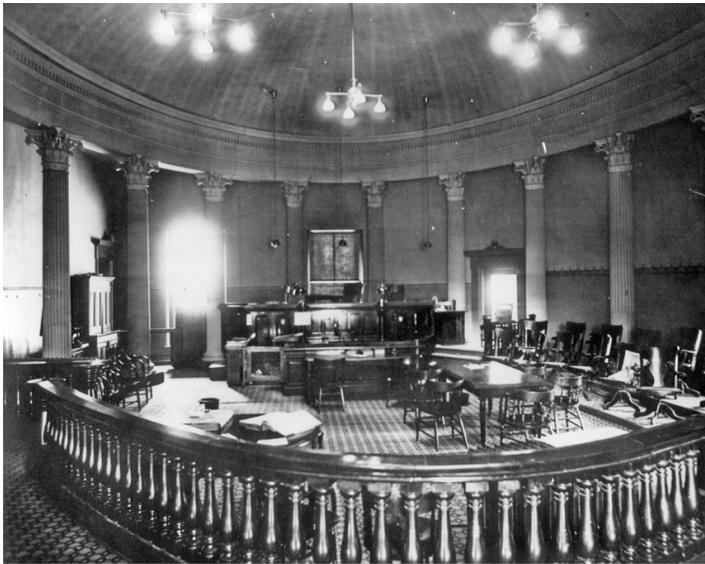
Two photographs exist of the East Courtroom, one dated 1911 but disputed to be 1914,² and the other undated, but within the same general timeframe based on the configuration and appearance of the room, and the quality of the photograph. These photographs show a hierarchy of wall treatment, with a dado area distinct from the wall field, delineated by a thin molding or painted treatment. A peg rail appears on sections of the east and west walls, at a level slightly higher than the dado treatment. The tone of the painted column capitals in the photos appears somewhat lighter than the column shafts. The window openings are devoid of surround trim. A spectator gallery was located on the south wall and wrapped around to the west wall, apparently with a riser platform and railing.

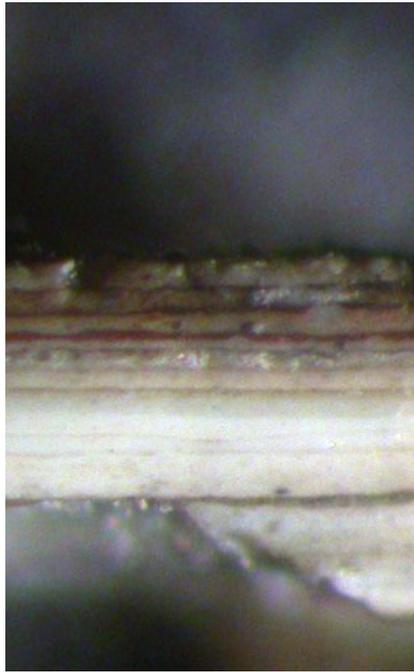
A.04 column base, typical	A.04a column base below 1903 judge's platform	
white

Three samples were taken from the cast iron column base. The cast iron was primed with a pink-grey primer with large flecks of presumably iron filings suspended in it. The sequence of finish paints on the cast iron matches that on the adjacent wood column members.

A.04a
gross sample, low magnification

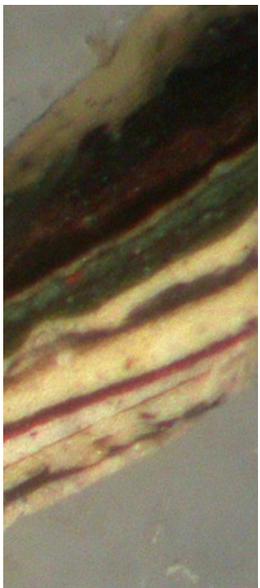
A.05 stone base, typical	A.05c column base below judge's platform	A.05d baseboard below judge's platform, at curved north wall	A.05b column plinth below gallery riser line

Five samples were taken from the stone baseboards or column plinths. The samples indicate that the stone was not painted originally, and may have matched the stone used for the floor tile.

Below the current judge's platform, the column base was apparently still an exposed part of the room at a time when the baseboard, on at least a portion of the north wall, was covered after the dark red treatment. The floorplan from 1899 shows a heater in this location, before the heating system was recorded as re-vamped in 1907 (after the platform was in place). The red would have been installed after 1870 but before 1899. The plinth sampled from a column in the southwest quadrant of the room, in an area below a paint edge-line, indicates that no paint had been applied here until the mid-20th century, suggesting that a riser had been in this location continuously. In the 1910s, the stone plinths had been painted in keeping with the wood surround trim, which would have created a continuous trim treatment.

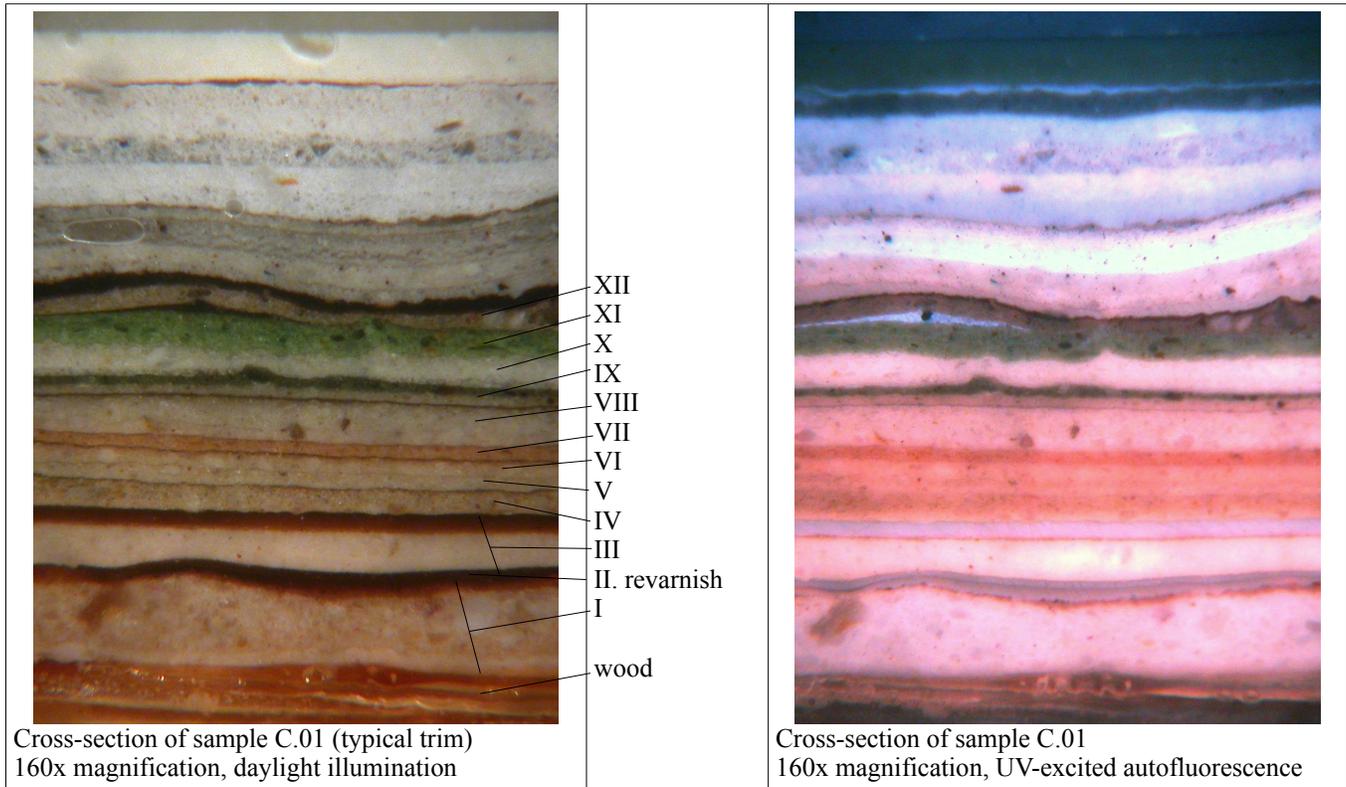
The woodwork of the door surrounds is intact, and samples retain the full sequence of approximately 19 historic finish campaigns. The earliest finishes are in cream paint with a varnish coating. Evidence of woodgraining has not been specifically observed, but the possibility has not been ruled out. The woodwork was revarnished once, then refinished using the same system of cream paint with amber varnish. In 1903 the wood trim was painted a green color, and in the subsequent campaign it was finished using a tan paint followed by a very dark varnish coating.

Cross-section of sample C.01 (typical trim)
160x magnification, daylight illumination

Cross-section of sample C.01
160x magnification, UV-excited autofluorescence

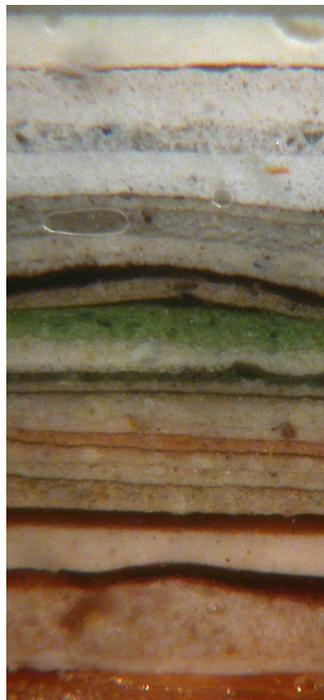
C.01 trim (typical)	C.01a trim at bailiff's door

This cross-section of typical wood surround trim shows the earliest cream paint followed by a warm amber varnish. The fluorescence response shows one later re-varnish before the finish system was recreated.

The trim comparison shows that the surround moldings at the bailiff's door are not original to construction, but were installed during a later generation finish.

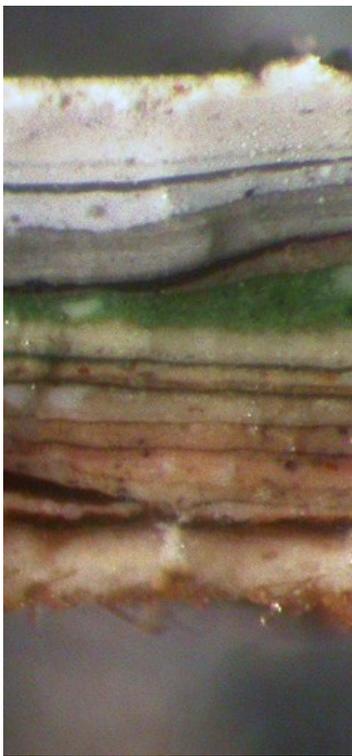
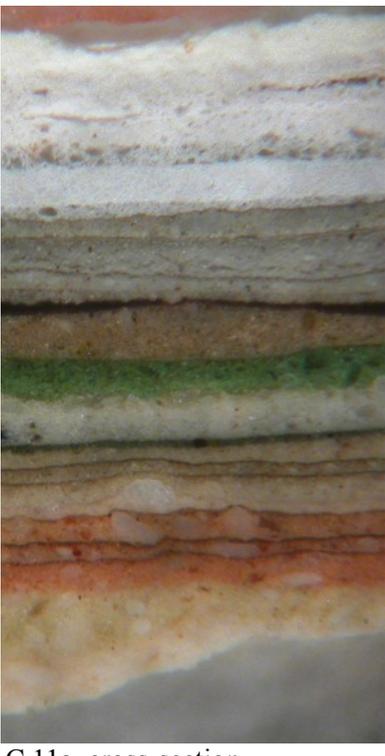
C.11, door to witness room (typical)	C.11a door at bailiff's stand

Comparison of paint on a typical door, and that on the bailiff's door, show that this was a later addition.

The paint samples from the bailiff's door indicate that this was a later replacement or installation. There was a door opening shown in that location on the 1899 floorplan, so it may have been added after 1870 to serve the judge when the bench was located on the east wall. Based on stratigraphy comparison with known or suspected 1870 finishes, it can be concluded that the bailiff's door was not an 1870 addition, but was added sometime after 1870, but before 1903. While the judge's bench was relocated to this East wall area in 1870, this door was not added until a later period. Because one wallpaper was observed in place behind the door trim, a location to which it would have been impossible to evenly apply wallpaper, the door opening was created at the time of, or shortly after, the first use of wallpaper in the room (potentially 1870s or 1880s).

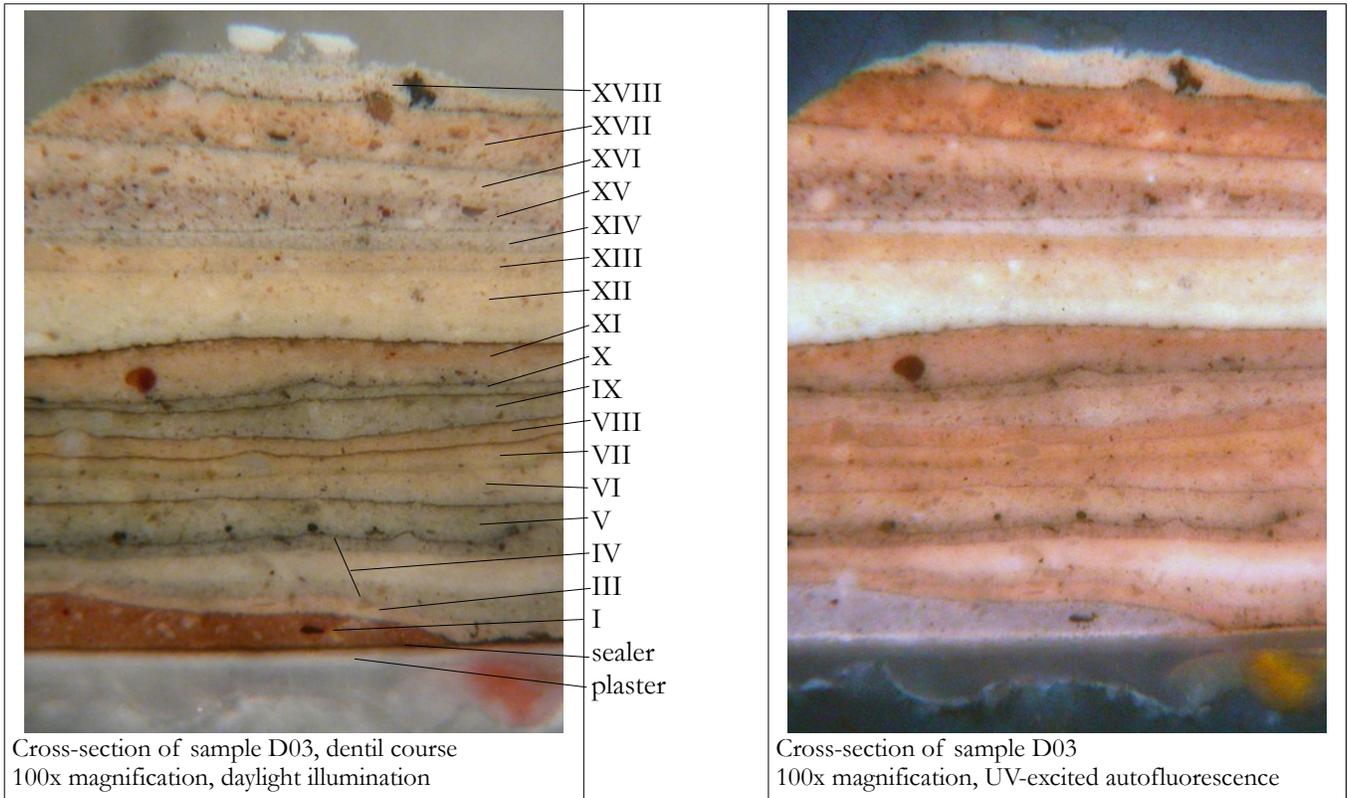
Cross-section of sample D03, dentil course
100x magnification, daylight illumination

Four paint samples were taken from the dentil molding elements, and retain the full sequence of historic paint layers. The surface of the plaster exhibits a fine dirt accumulation, sealed in by the later applied preparation sealer coat. That the plaster was exposed in-situ for a short period of time is consistent with the findings on the wall surfaces as well, which were prepared and base coated, but not decorated immediately. The earliest finish observed on these few samples from a limited area of the entablature is visually consistent with the paint first applied to the walls, characterized historically as "fresco." Limited composition testing confirms that it is not oil-based, has no protein component, and is not lead-bearing. The original color on the dentil is cream, while the recess and the top edge of molding below the dentil course were both painted a burnt-sienna color. As suspected for the walls, the 'frescoed' plasterwork may not have been overpainted until the III generation, potentially 1870. In 1903 (XI), it was finished in ochre with a varnish, and in the subsequent period (XII) this area of the molding was uniformly light yellow.

This sample exhibits the full finishes history as it survives on the dentil molding. The earliest, “fresco” coating is in a burnt-sienna color. The fluorescence response of this layer is not consistent with a traditional oil, oil-casein, or distemper type paint, suggesting it may be an alternative paint medium.

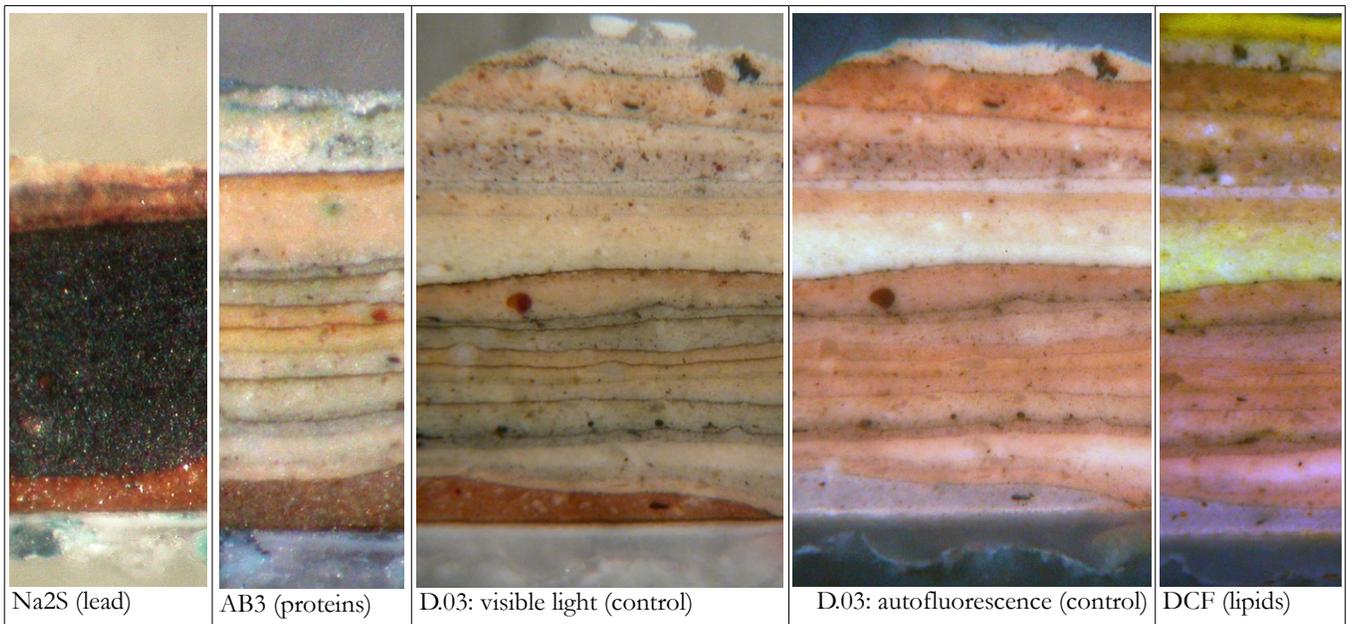
Supplementary staining tests for typical binding media confirm that this initial decorative treatment was not executed in a lead-white/oil nor in a protein binder, but an alternative medium. The test for lipids using 2,7 dichlorofluorescein (DCF) registers negative in that layer, compared with the control image. The AB3 test in normal light, to detect proteins, is likewise negative, and the test for lead in the form of lead-based pigments (typical for oil paints) is also negative for that first paint layer, although the series of layers which follow all turned black as a positive response.

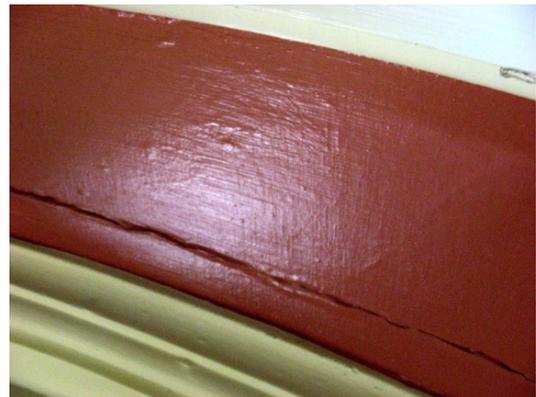
The current decorative painted pattern in the dome has been executed on canvas, applied over the historic painted plaster. Raking light inspection shows the extent of damage to the underlying paint layers.

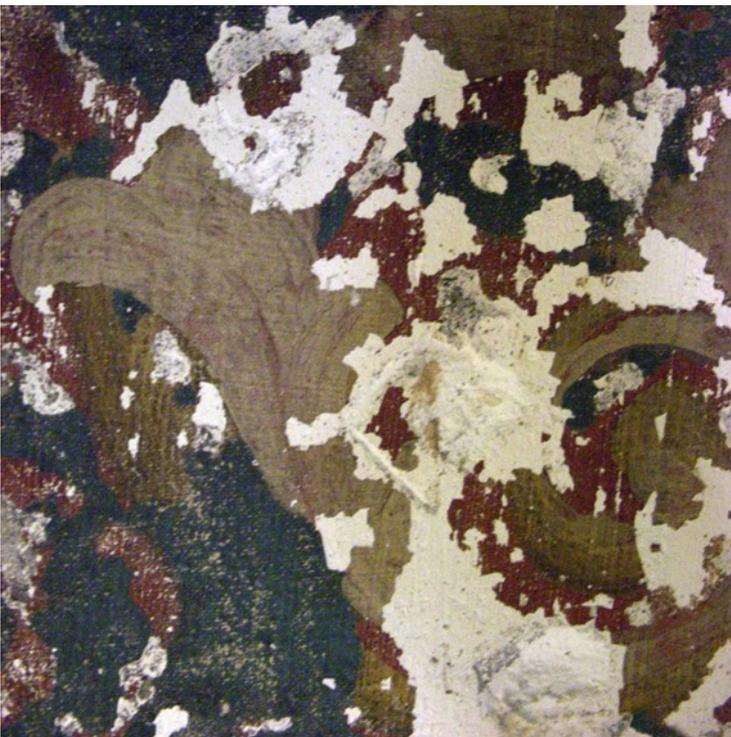
Detail of the historic painted decoration

The historic design and color scheme differ from the interpretation installed in the 1950s. The ground is a very dark green (approximate Munsell 2.5GY 4/3) with a design executed primarily in shades of ochre (approximate Munsell 2.5Y 6.5/4) and dark red (approximate Munsell 2.5YR 3.5/8).⁴

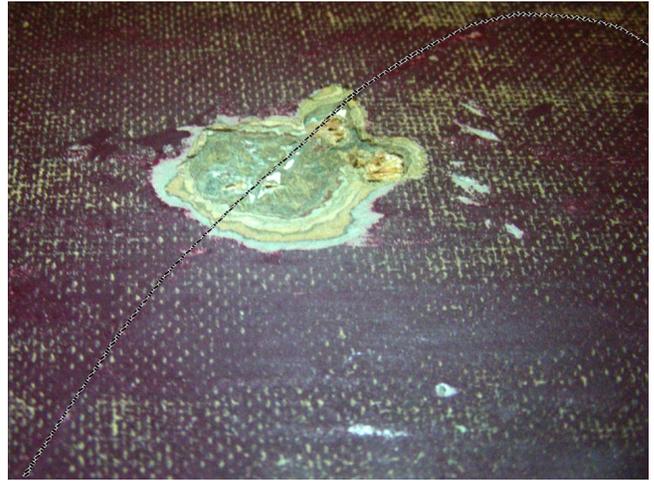
To investigate the wave pattern telegraphing through the canvas on the wood frieze, the canvas in this area was partially pulled back and a small investigative scraping done to determine the nature and location in the sequence of this decorative feature. Each layer in the sequence was scraped down one at a time to look for evidence of a decorative treatment. In a very early layer close to the wood substrate, evidence was found of a built-up white line, outlining the wave pattern, possibly a gesso or “stucco” technique, or the edge of a previous applique.

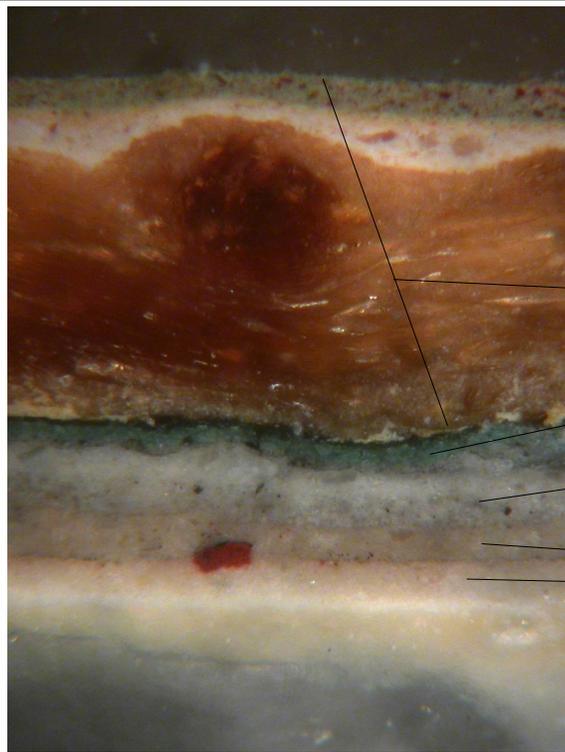
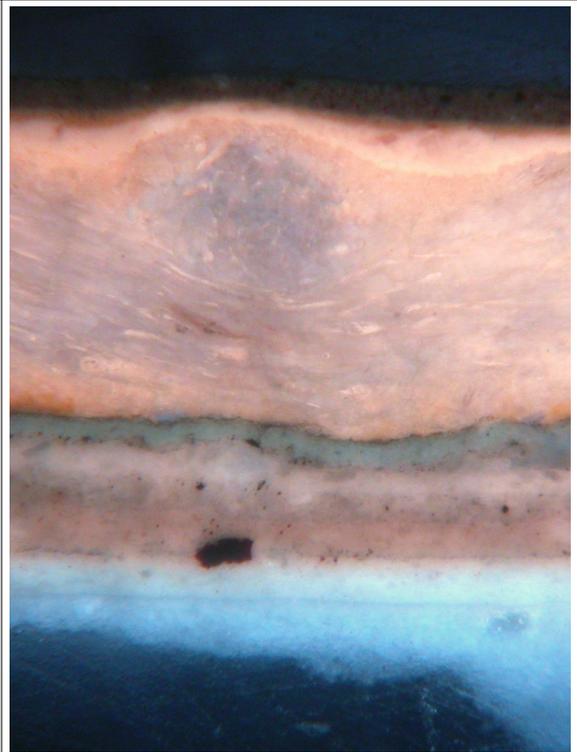
Cross-section of sample E.01, plaster dome
160x magnification, daylight illumination

This cross-section shows a limited sequence of applied paint on the plaster dome prior to the canvas treatment. The deep green paint visible below the canvas represents the ground color of the decoratively painted trompe l'oeil panels.

This wider view of cross-section E.01 illustrates the mechanical stress and disruption that the early paint layers suffered through the action of removing Lincrusta, which may have been applied with a high-strength adhesive.

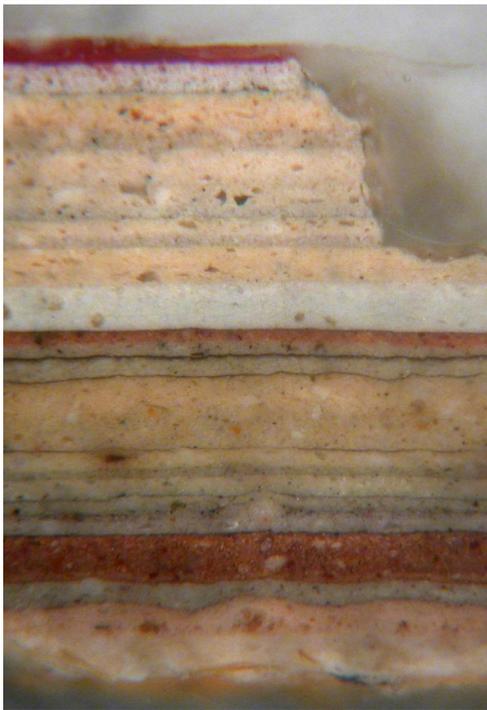
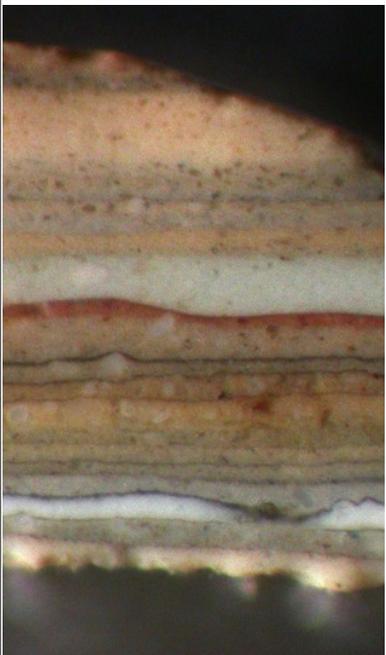
<p>Cross-section of sample E.02, frieze 100x magnification, daylight illumination</p>	E.02 typical	E.02a at 'wave'

This comparison of frieze samples shows that the third finish after that from 1870 involved a decorative application of a relief “wave” pattern executed using a thick, gesso-like layer, with a dark surface treatment. The representative sample on the left shows that other areas of this frieze were painted a corresponding deep red-brown.

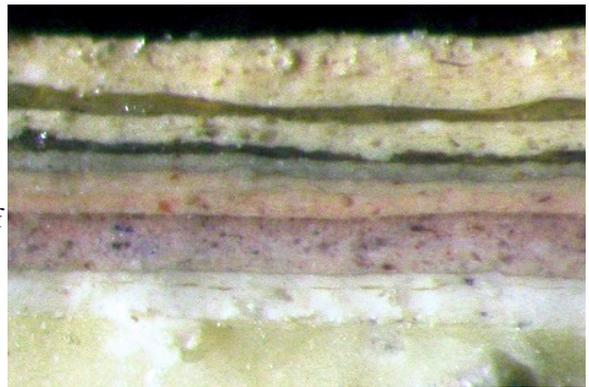
Gross sample at 40x magnification

One fragment of painted plaster was recovered from this gap. The paint sequence is consistent with a wall surface, beginning with the white base coat, pink decorative layer, and later light ochre and buff paint. After the buff paint there is a layer of residual wallpaper glue, followed by a cream paint, another layer of glue residue and a final cream paint.

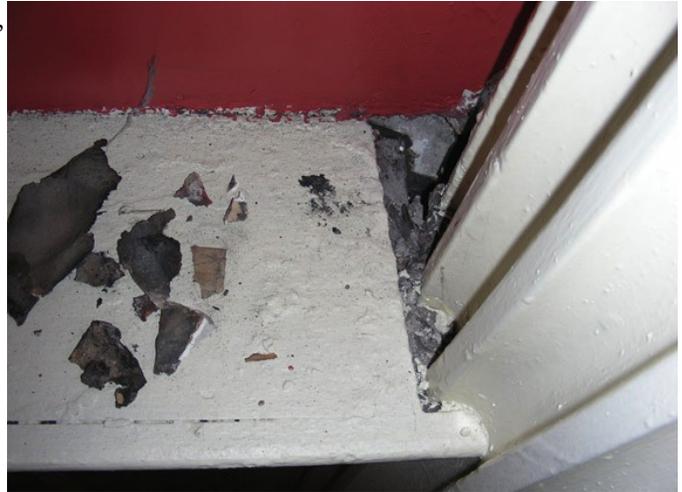
Site X2 is the gap behind the door header on the East wall, historically the Bailiff's door. Scraps of wallpaper, including 2 papers adhered together in sequence (WP-05/05a), were recovered, in addition to painted plaster fragments.

Fragments of painted plaster recovered from this gap match the sequence found on paint sample P11 taken from the wall in this location, with four early paint layers before remnants of an applied wallpaper, one with a blonde paper base.

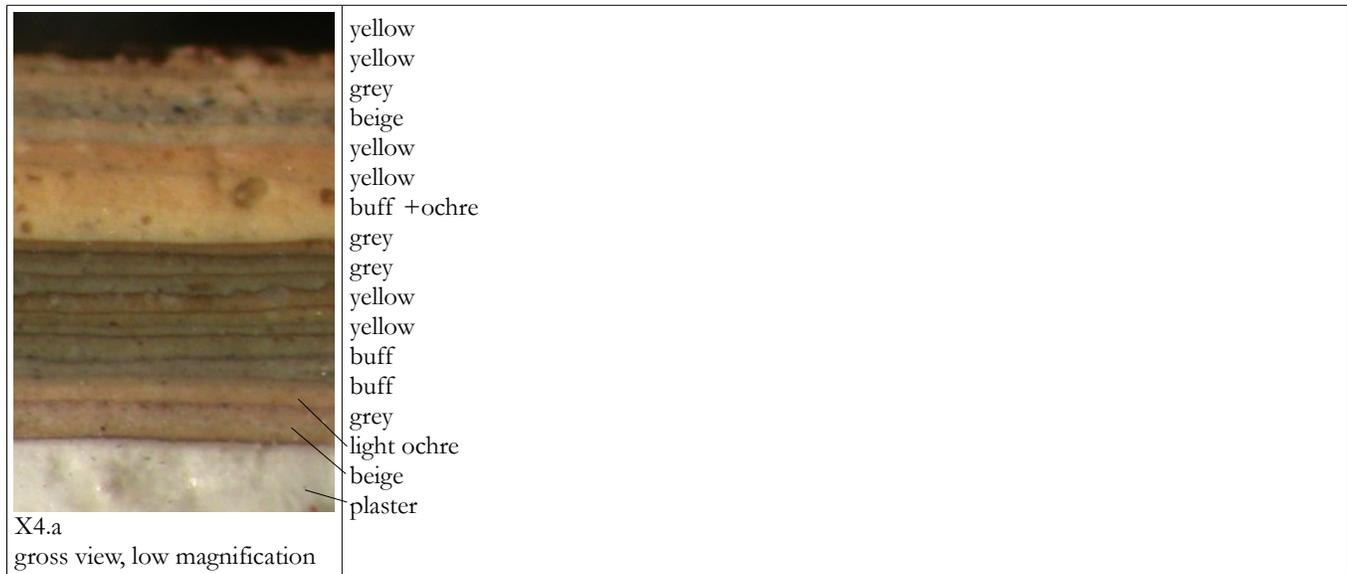
Site X4 is likewise the hollow of a column capital, one located in the southwest area of the room. One plaster fragment was recovered from this site. This sample is similar to, but reveals a subtle variation in paint treatment from the other two fragments shown above. The earliest paint sequence begins with a beige “fresco” type paint with a subtle pink surface application. This plaster was not base-coated prior to the “fresco” coating, and reveals no evidence of historic wallpaper use, ruling out the wall as the original location. Subsequent to the cream with pink, this element was painted light ochre, then grey. This fragment may likewise have come from an entablature element.

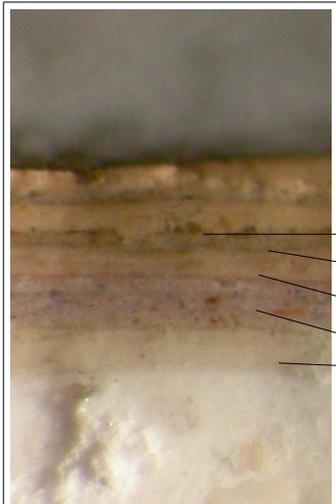
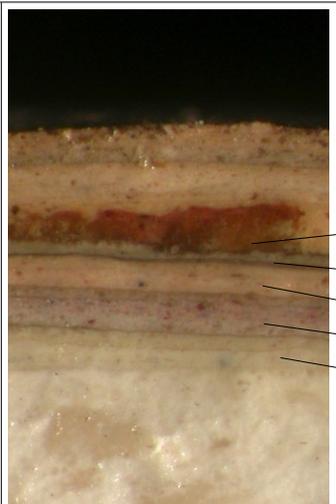
Based on the base-coating of the plaster in these samples prior to the decorative pink layer, these chips may be interpreted as originating from the wall rather than from an entablature molding. These chips show that some point in the early to mid 20th century the accumulated wallpapers were substantially removed and the wall plaster (at least above dado level) was painted three times in shades of cream or yellow before being removed in the 1950s.

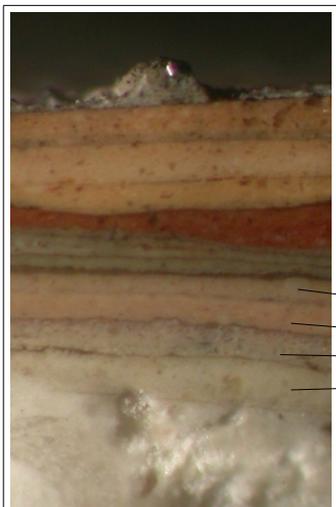
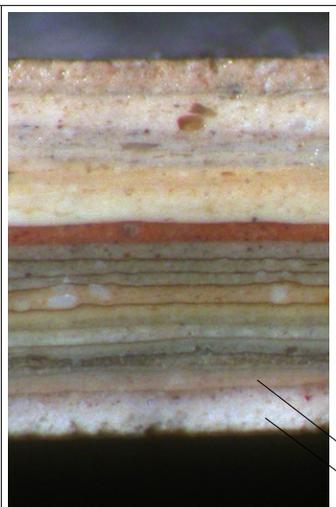
Sample a3 on the left exhibits the white base coat on the plaster, with a decorative layer executed in cream with a purple surface application. The white base coat suggests wall, but the decorative color does not match that used for the wall. The subsequent paint layers are likewise not consistent with wall treatments. It is suspected that this chip may have originated in the soffit, and therefore would have been initially finished per the walls, but in a lighter, more purple hue, and was not wallpapered, but painted more in keeping with the adjacent entablature. The chip on the right, a4, appears consistent with chips recovered from suspected entablature moldings, with an original cream decorative layer and subtle pink surface treatment.

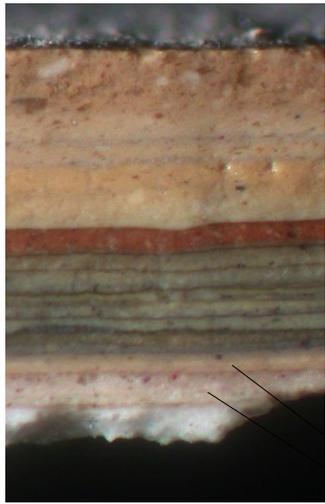
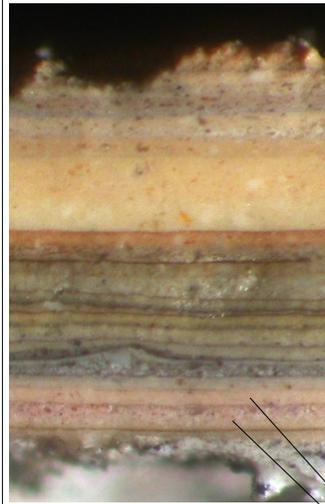
These two chips from this site exhibit a similar paint sequence, but with a possible subtle difference in the pink of the first decoration. Likewise at the time of the 1903 redecoration, one element was painted in the sienna color, the other in ochre.

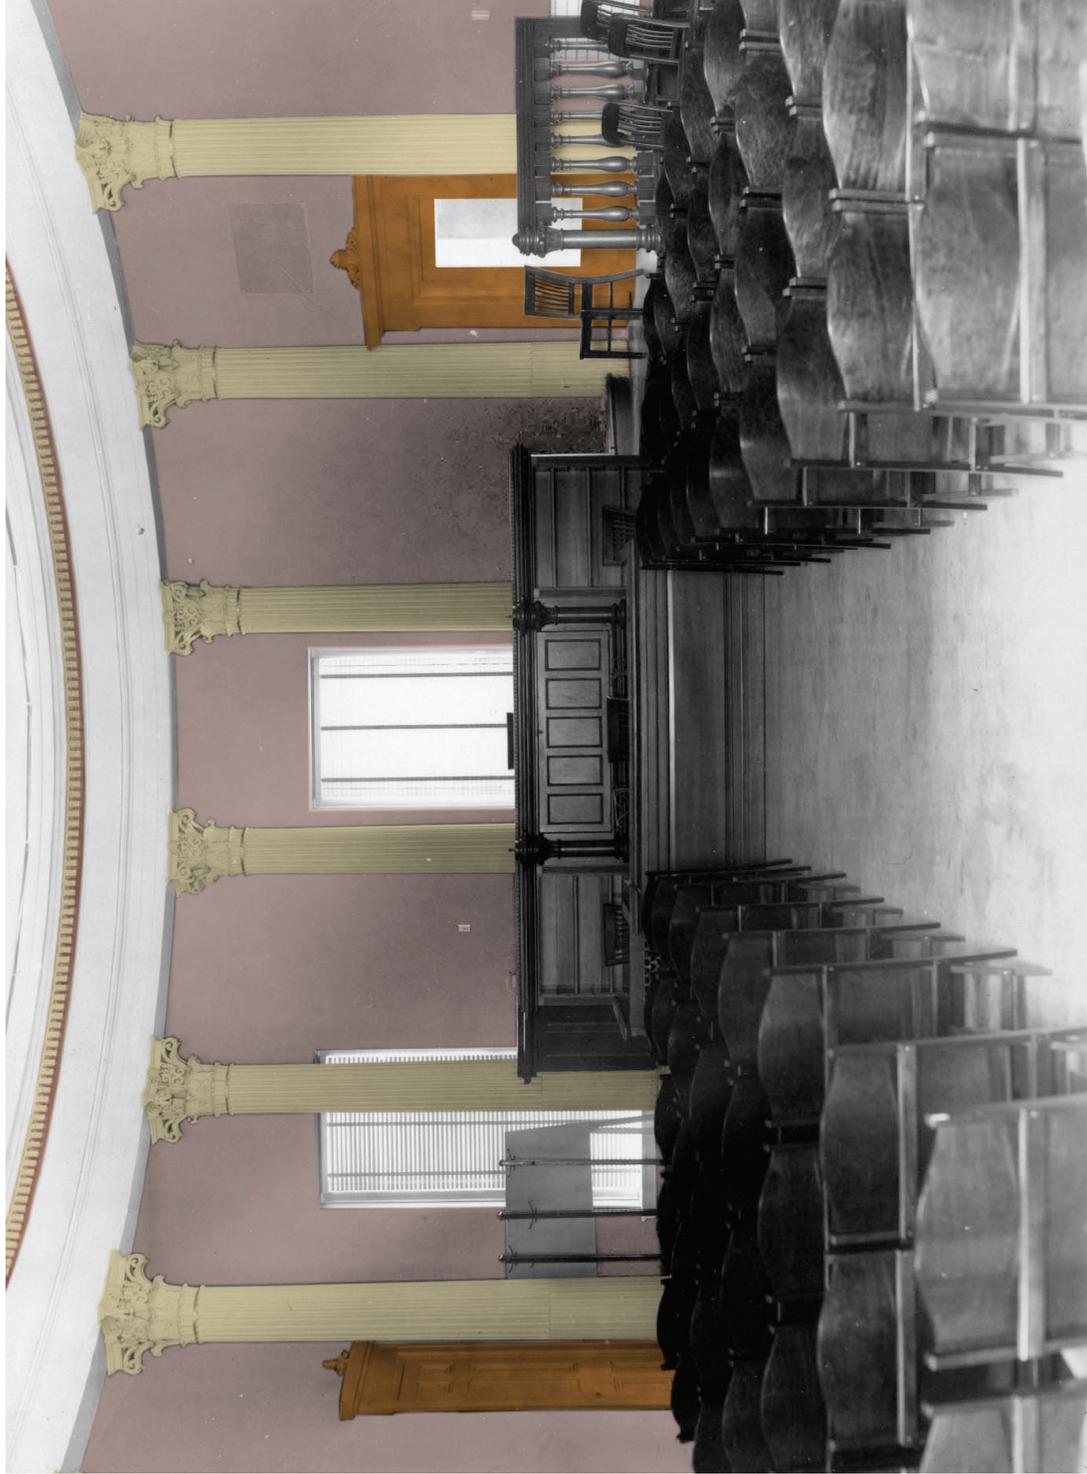
Interpretation of the room finishes installed circa 1856 based on paint analysis by Richbrook Conservation (contract #P11PC61853) November 2011

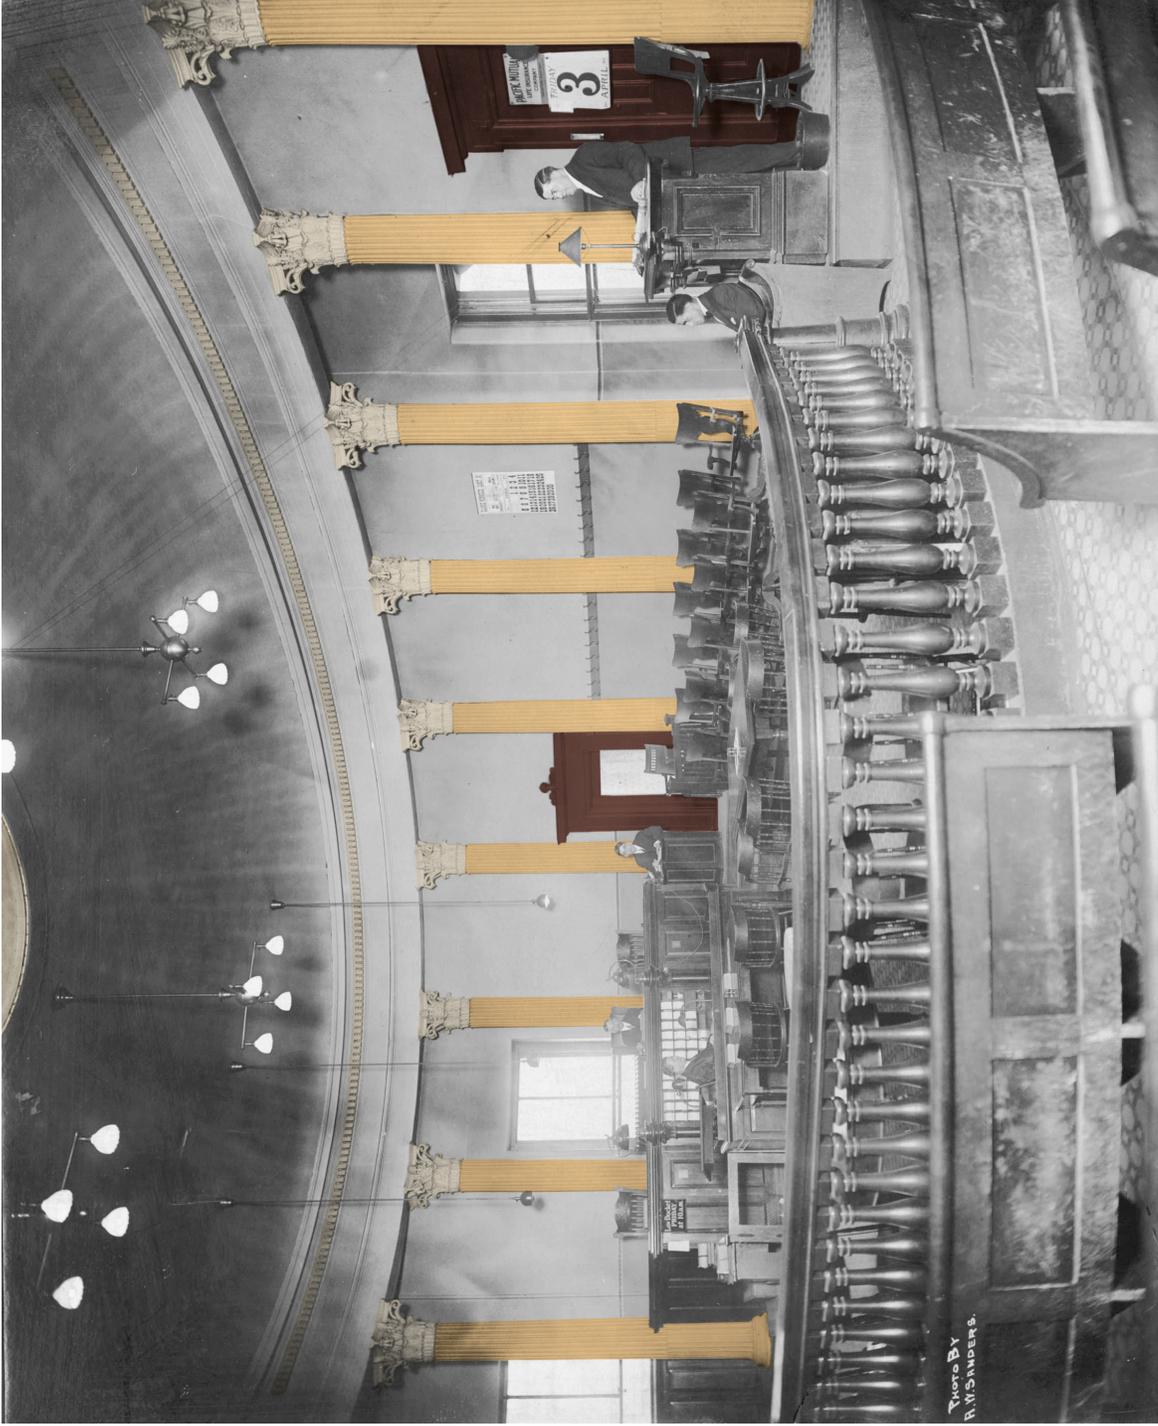
Interpretation of the room finishes
installed during the period after 1903
up until circa 1914
(estimated 1909)
based on paint analysis by
Richbrook Conservation
(contract #P11PC61853)
November 2011

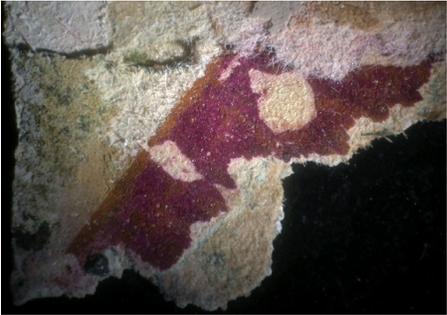
Catalog number	Location found	Visual characterization of paper base	Visual characterization of decoration	Notes/photo
WP-01	In-situ, on North wall below judge's bench (sample P-15); Above painted finishes; below WP-02	white	Fuchsia, rust and mustard colors

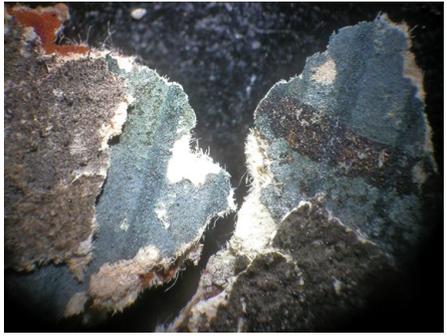
WP-02	In-situ, on North wall below judge's bench (sample P-15); Above WP-01, below WP-03	white	Teal blue, possible stripes with bronze-powder feature

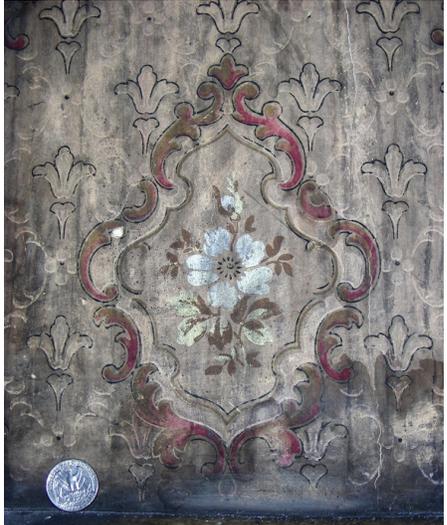
WP-03	In-situ, on North wall below judge's bench (sample P-15); Above WP-02, below WP-04	white	Subtle pattern in cream or white, with pale blue, mica	
WP-04	In-situ, on North wall below judge's bench	Brown, brittle	pattern with white rose motif, red flourish, repeating fleur-di-lis with "silver" metallic ink

18" wide from vertical seam to seam

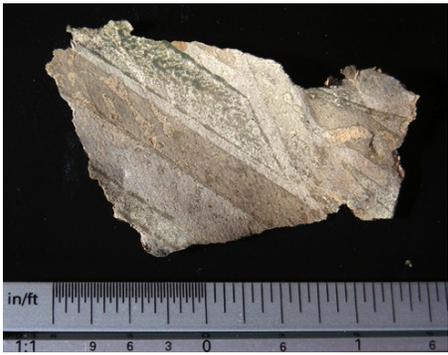
WP-05a	Loose, from East wall gap behind bailiff's door header; found adhered below WP-05	brown	Structured, graphic pattern in cream, white, dark olive

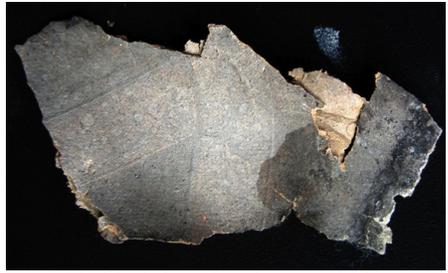
<p>Found behind door header- would have come from upper wall.</p>
WP-05	Loose, from East wall gap behind bailiff's door header	brown	Subtle pattern with ribbons, in white, cream, mica particles
