Lincoln Memorial circle and radial roads

Map 14
RADIAL ROADS - VEGETATION
LINCOLN MEMORIAL CIRCLE &
RADIAL ROADS
 CULTURAL LANDSCAPE REPORT
 LINCOLN MEMORIAL GROUNDS
 PREPARED BY: M. JOSEPH DATE: OCTOBER 1996 FEB. 1997

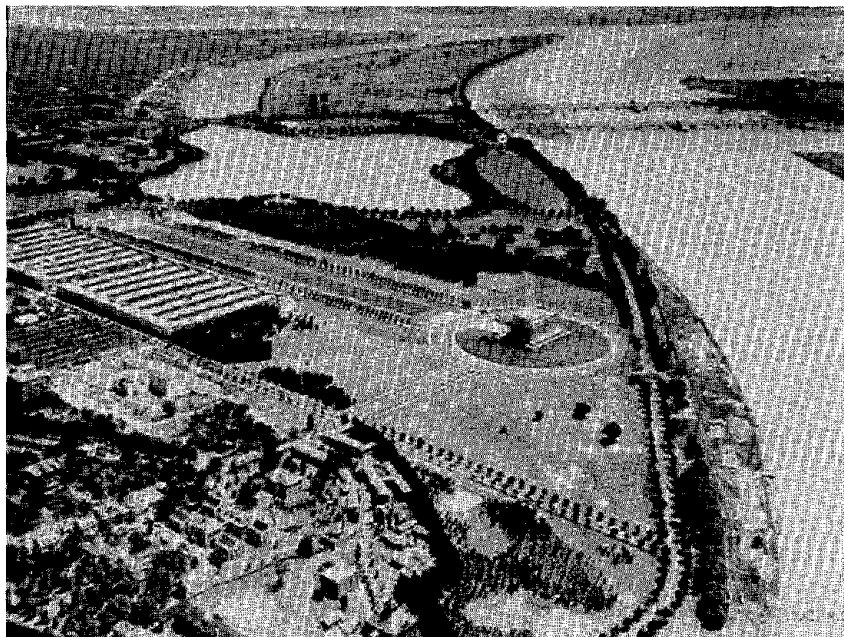
Figure 59 - Aerial view of first phase of planting American elms along the radial and eastern side of Lincoln Circle, 1927. MRC 1-54.

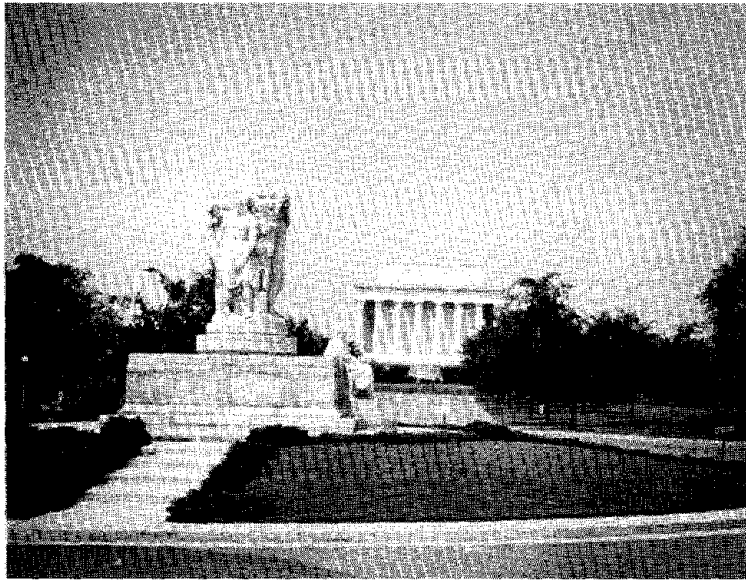
Figure 60 - Ericsson Memorial and newly planted junipers around base, c. 1932. MRC 1-136.

Around the Ericsson Memorial, the planting plan was changed substantially. Japanese holly replaced the original junipers, which once encircled the granite platform. Four walks, which radiated from the granite platform, also were lined with junipers, but these shrubs were also removed and now the walks are surrounded by grass. These changes have further downplayed the connection of the Ericsson Memorial to the Lincoln Memorial landscape.

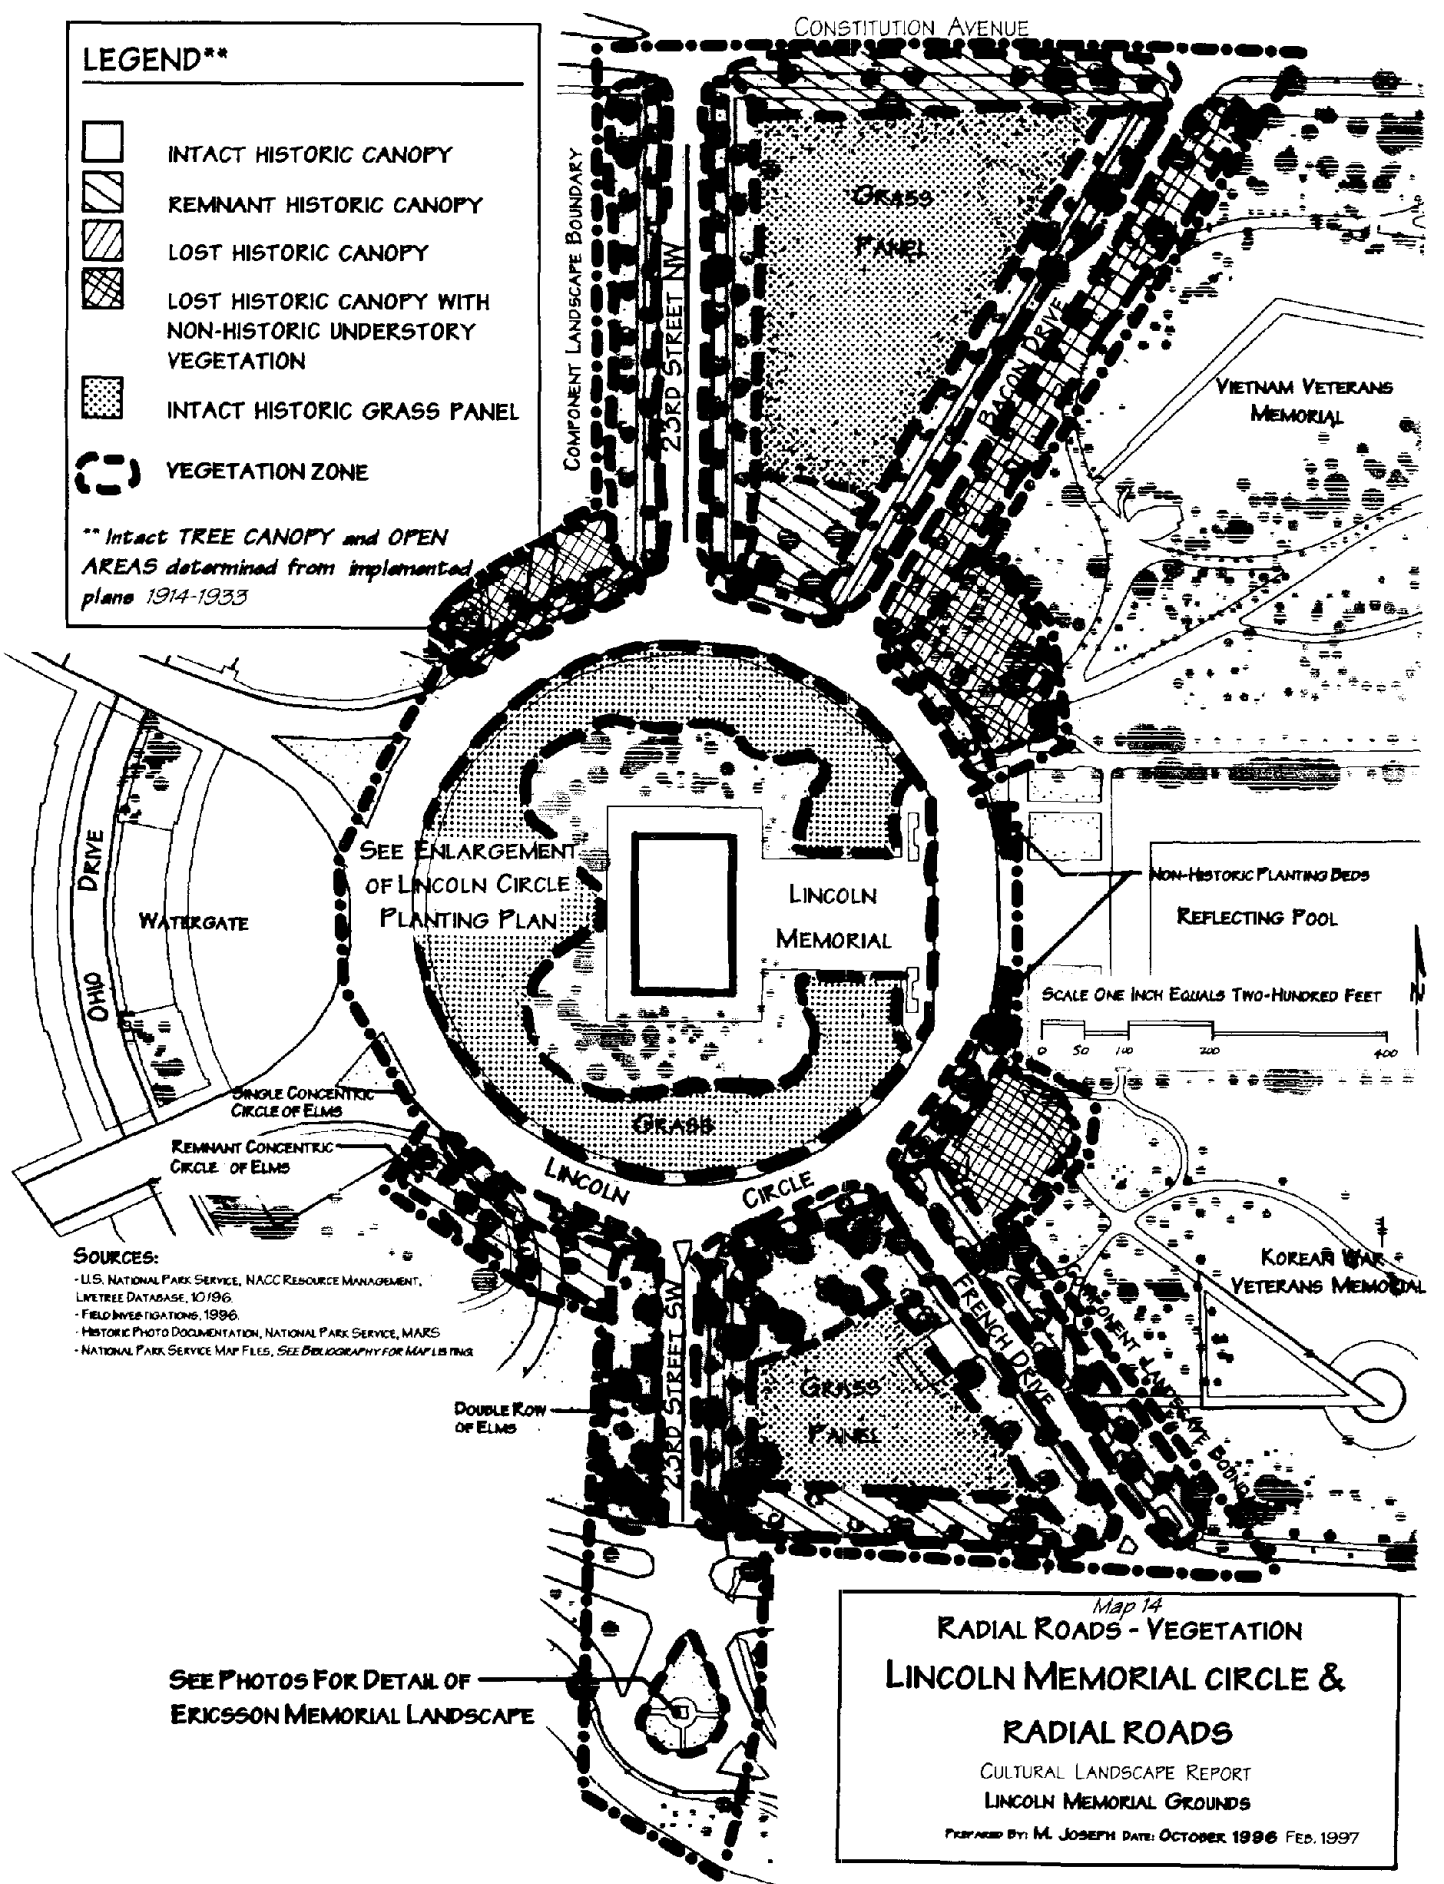
Unlike the radial roads, the original planting pattern around the outer circle is almost entirely lost. Only a few remnant elms remain to suggest the old design. While the quadruple band on the eastern part of the circle is evident between 23rd Street NW and Bacon Drive and 23rd Street SW and French Drive, the areas between the two drives and the Reflecting Pool no longer show any evidence of the old tree pattern. In these two areas, the distinctive landscape plans for Constitution Gardens and Korean War Veterans Memorial have encroached upon the old concentric design for the elms. Here newer plantings of native understory trees are clustered beneath a mixed

canopy of oaks, zelkovas, and maples (*Quercus* sp., *Zelkova serrata*, *Acer* sp.). The development of these other sites with such different plant selections has significantly altered the character of the overall design for the Lincoln Memorial grounds and has compromised the integrity of the original plan. West of 23rd Street, only a remnant of the old double band of elms is in place. The single circular band of elms between the 23rd Street NW west to the Watergate area is entirely lost because of the realignment of the outer circle curb for the 1940s on-ramp road. However, the single circular band of trees between the roadway and the sidewalk is mostly intact for the southwestern portion of the outer circle.

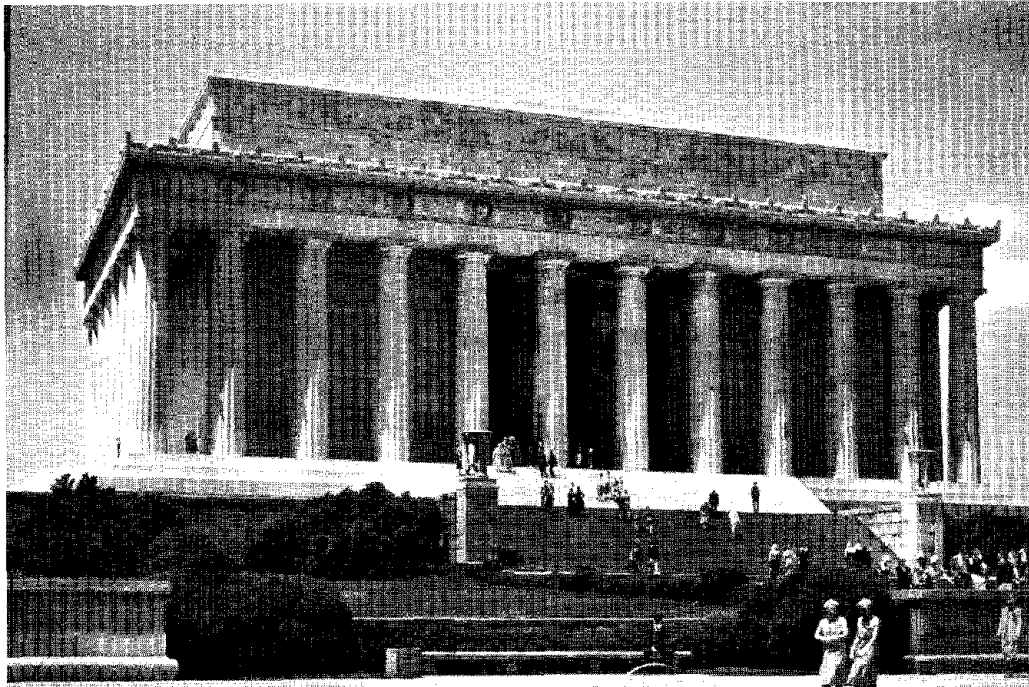
Figure 65 - East side of Lincoln Memorial showing mature boxwood and yew shrubs, 1935, by Orren R. Loudon. Used by permission from the National Geographic Society.

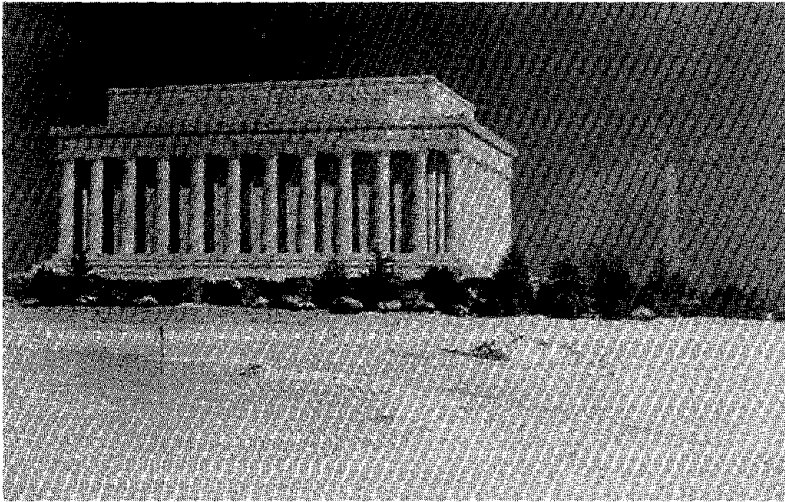
Figure 66 - West side or rear of Lincoln Memorial showing newly planted foundation plantings, c. 1932. MRC 2-20.

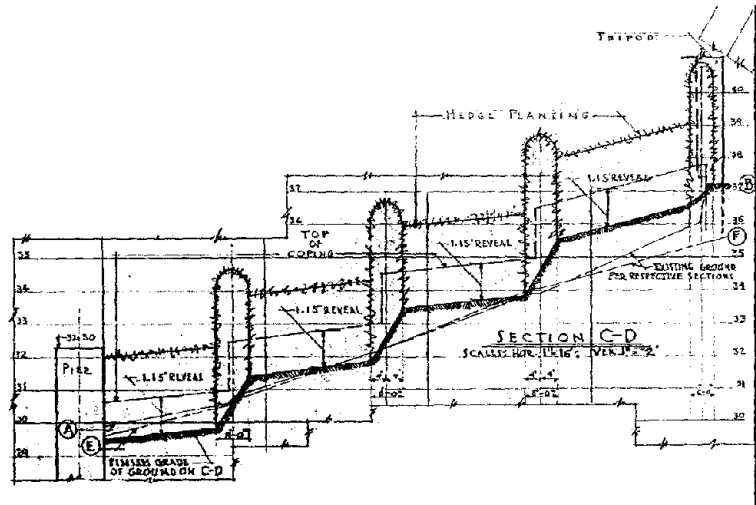
Figure 67 - Section showing desired character of replacement hedge along approachway, 1944. NPS Map 801/80347.

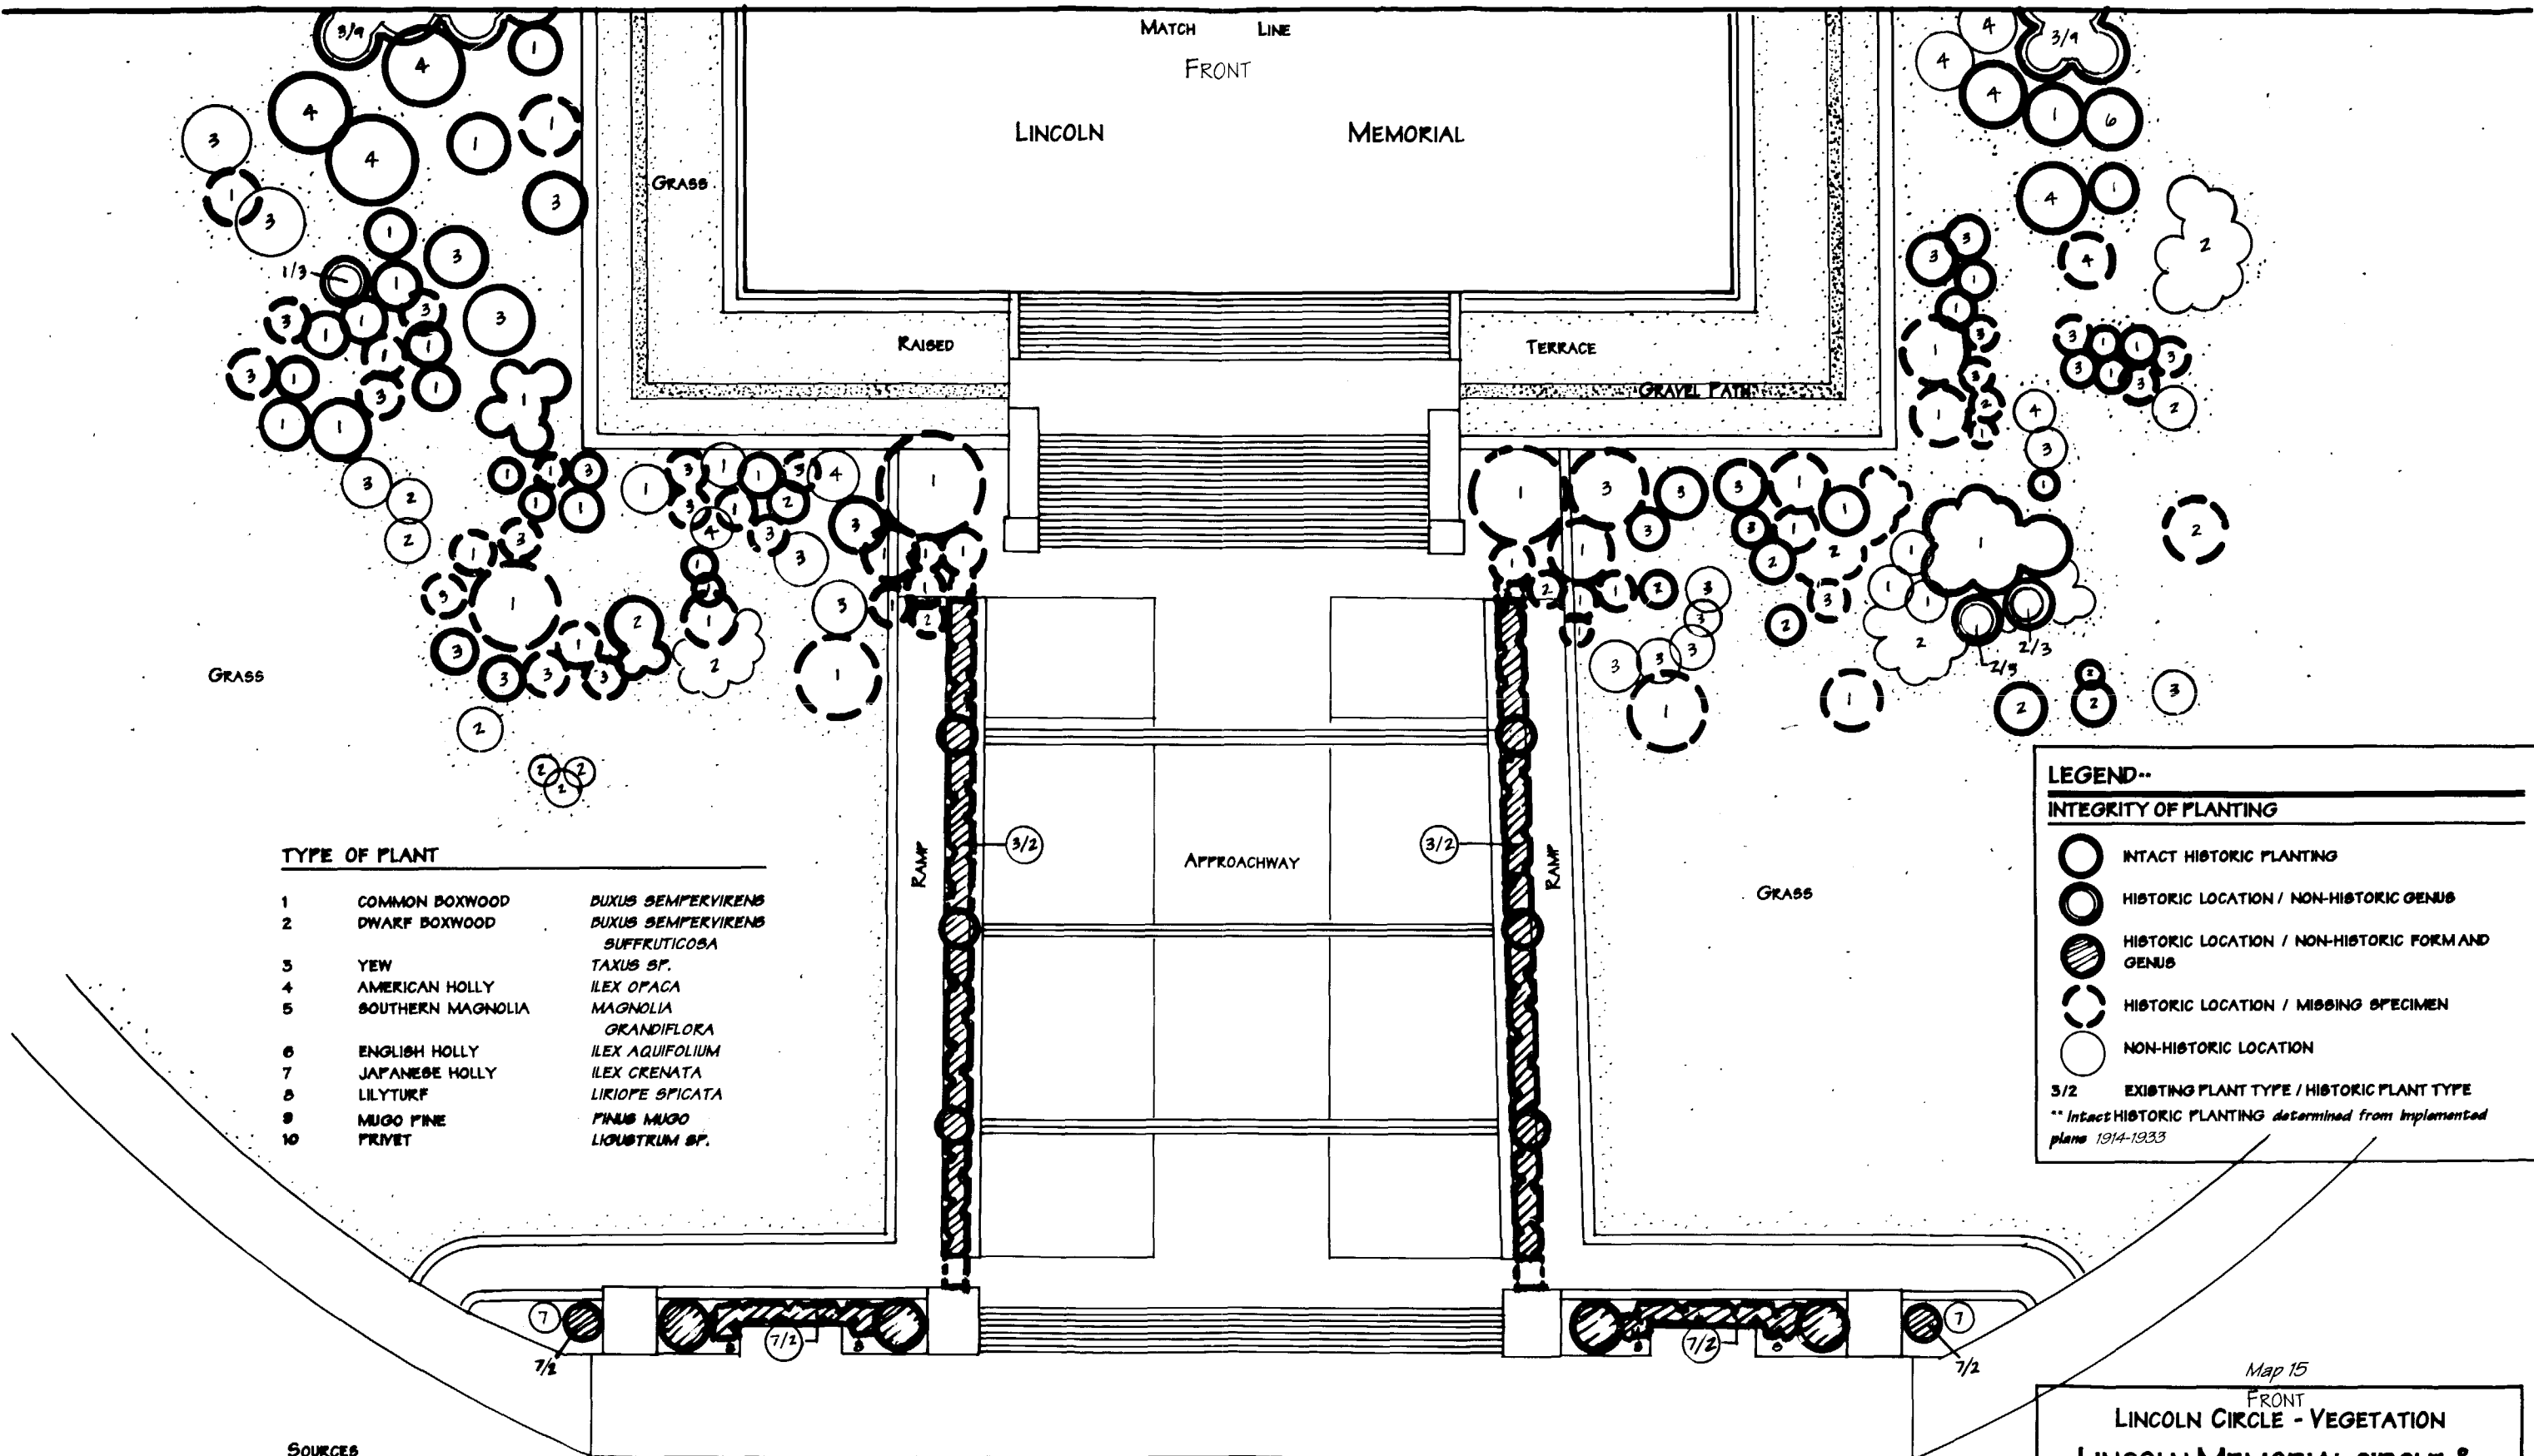
Map 15
 FRONT
LINCOLN CIRCLE - VEGETATION
LINCOLN MEMORIAL CIRCLE & RADIAL ROADS
 CULTURAL LANDSCAPE REPORT
 LINCOLN MEMORIAL GROUNDS
 PREPARED BY: M. JOSEPH DATE: OCTOBER 1996 FEB. 1997

The trees and shrubs surrounding the memorial currently exhibit different degrees of health and reflect a range of growing conditions. Along the front or east side, the plantings have suffered greatly from the effects of repeated construction activity and preparation for large-scale public events that have occurred in this area over time. The 1995-96 construction on the approachway has caused further damage to the foundation plantings. The lack of routine maintenance and regular pruning has also caused some of the plantings to appear ragged or

overgrown. When the park revised the original plans by replacing the boxwood hedges with yews in 1945, they altered the character of the entry planting, yet retained some of the historic integrity by keeping a band of green hedge growing on both sides of the approachway. However, the addition of an American holly and the Japanese hollies to the front side and massings of yews to screen floodlights have further compromised the character of the planting design. Because replacement plantings have deviated from the original design, the landscape on the front side retains a lower degree of integrity. On the sides and rear of the memorial, the integrity of the plantings is mostly intact, although some boxwood planted near the magnolias and close to the raised terrace have been shaded out and are unhealthy, or have died. At the midpoint of the north and south sides, two thick masses of *Taxus cuspidata* 'Nana' provide the horticultural transition between the character of the two different planting areas. Even though these yews were planted to replace the original mugo pines, the design intent of keeping a lower growing conifer mass in this area is still evident. In other areas overgrown plant material, like some American hollies that were planted on either side of the horizontal-growing yew mass on the north face of the memorial, are encroaching upon the designed opening above the raised terrace. See Map 15 and Map 16 *Lincoln Circle - Vegetation* for the graphic representation of the front and back plantings.

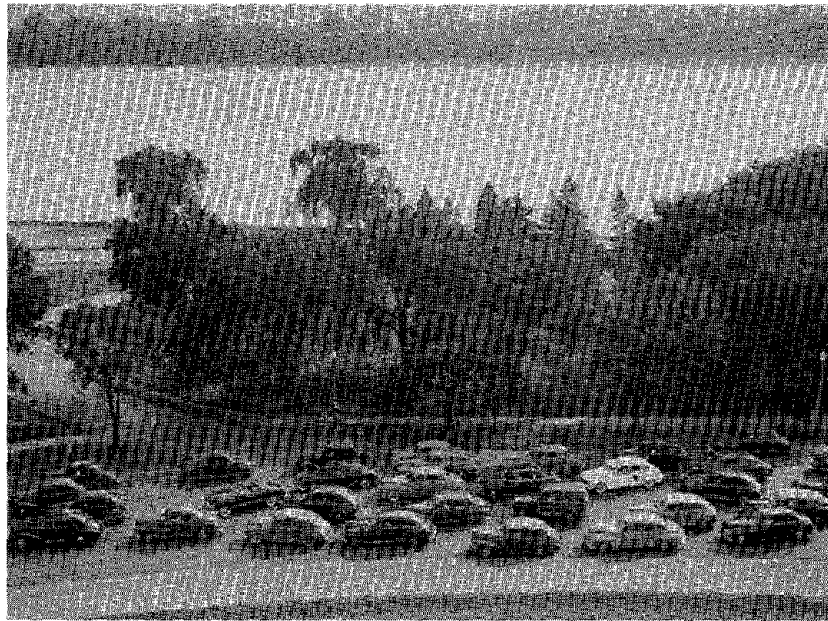
Figure 70 - Rush hour traffic around Lincoln Circle, c. 1944. MRC 2-4.

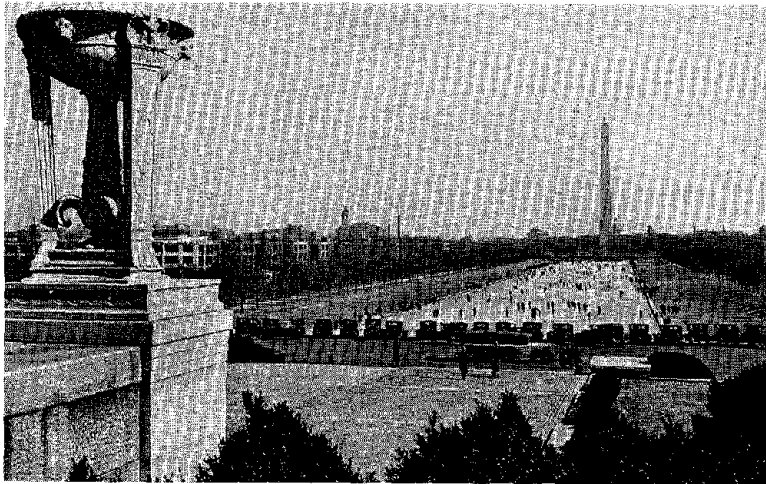
Figure 72 - Unofficial parking area at top of Reflecting Pool steps and Lincoln Circle, 1929. Used by permission from the National Geographic Society.

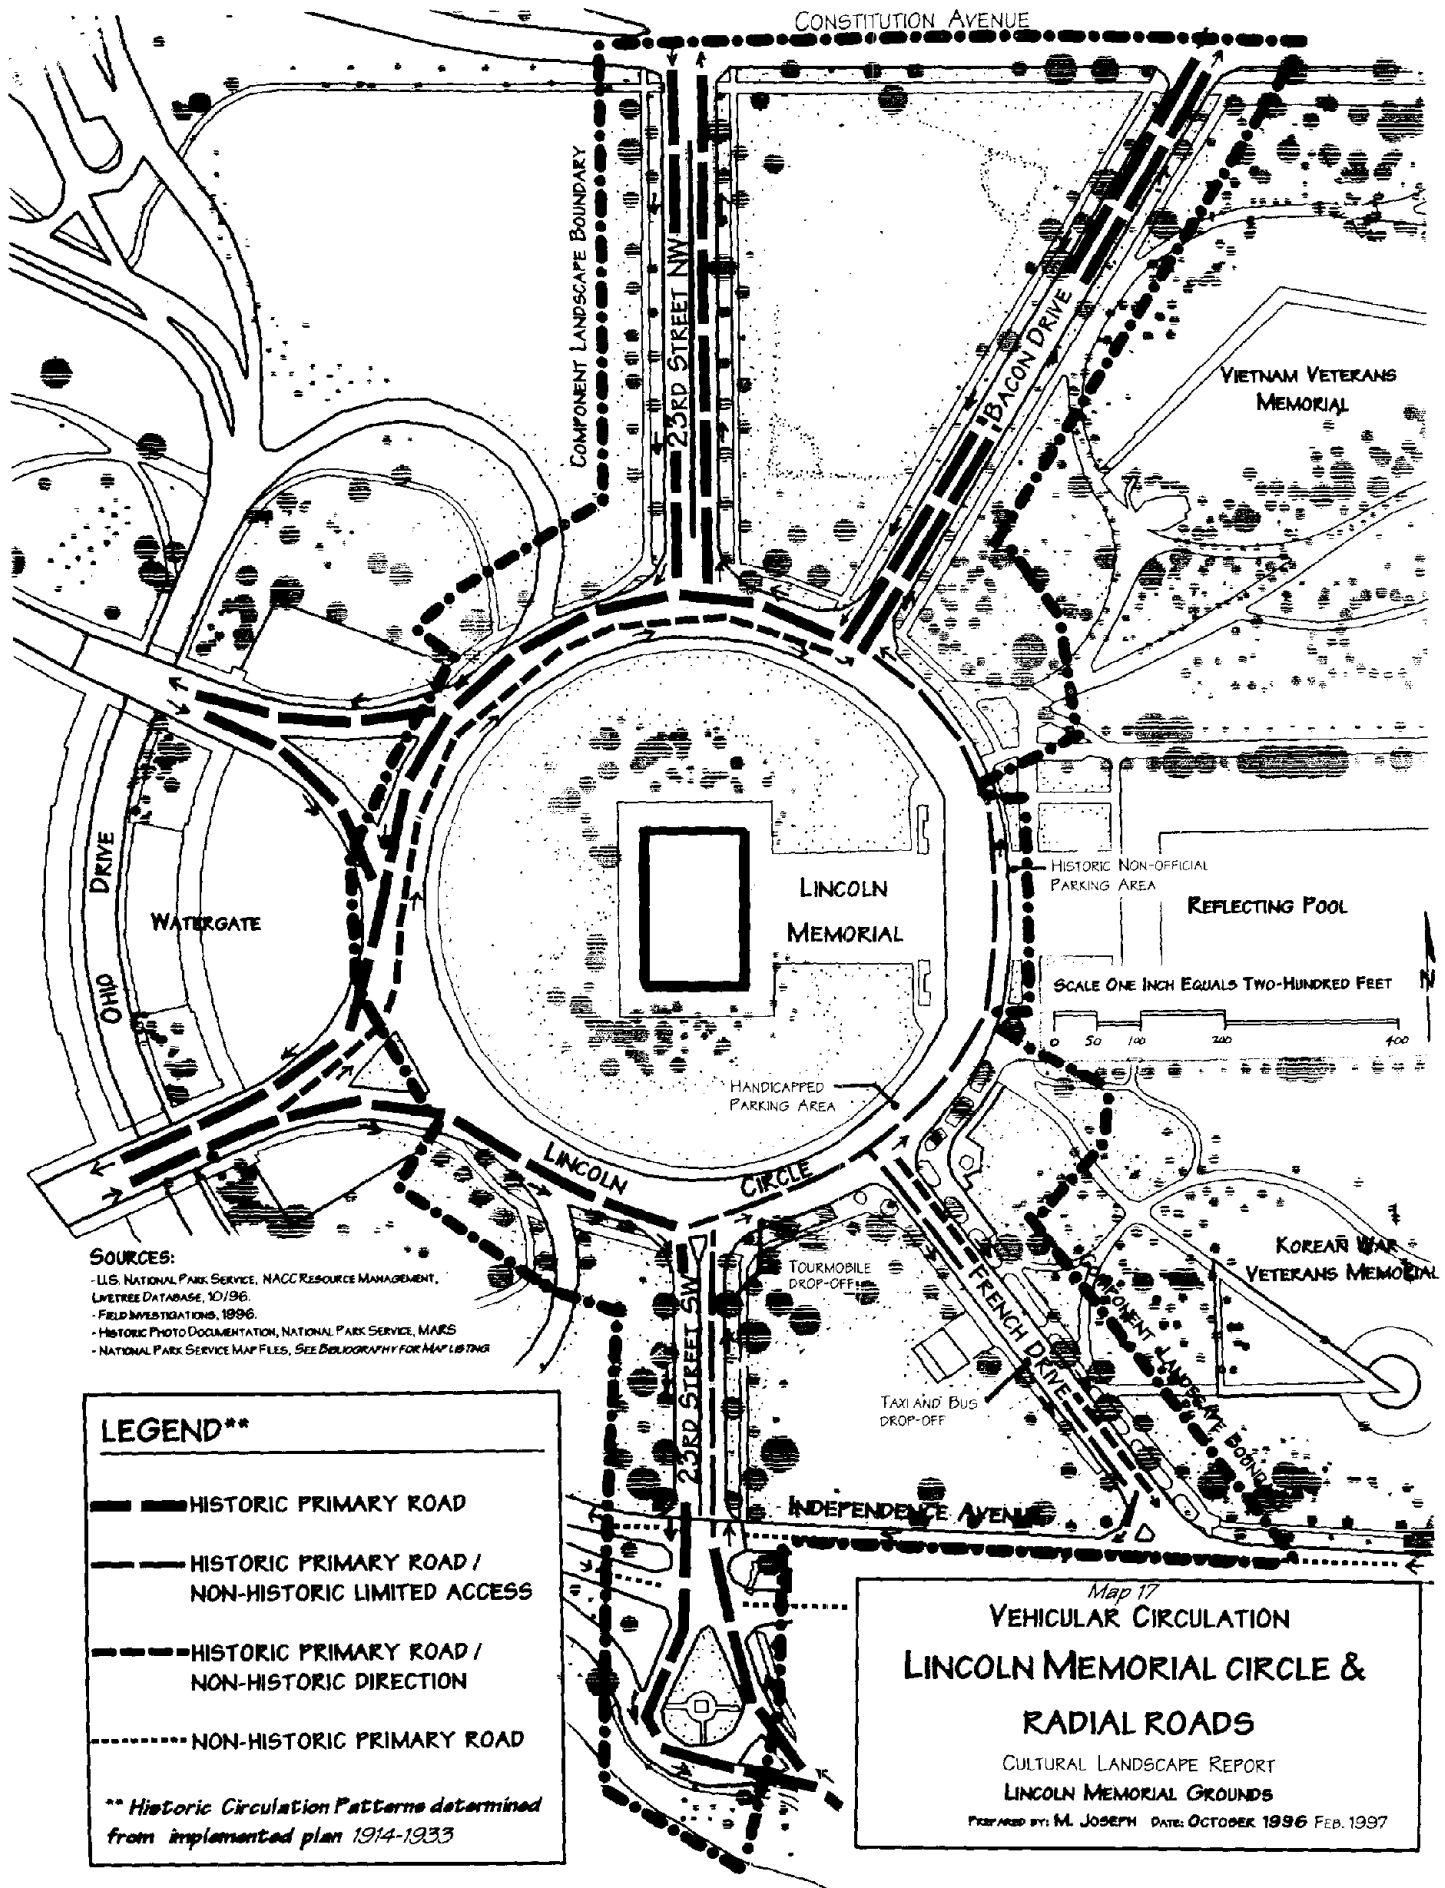
Map 17
VEHICULAR CIRCULATION
LINCOLN MEMORIAL CIRCLE & RADIAL ROADS
 CULTURAL LANDSCAPE REPORT
 LINCOLN MEMORIAL GROUNDS
 PREPARED BY: M. JOSEPH DATE: OCTOBER 1996 FEB. 1997

and French Drive and along the eastern side of 23rd Street SW. Other tour buses and taxis are directed to French Drive for all dropoffs and pickups, making this area very congested. See Map 17 *Lincoln Memorial circle and radial roads - Vehicular Circulation* for location of parking areas.

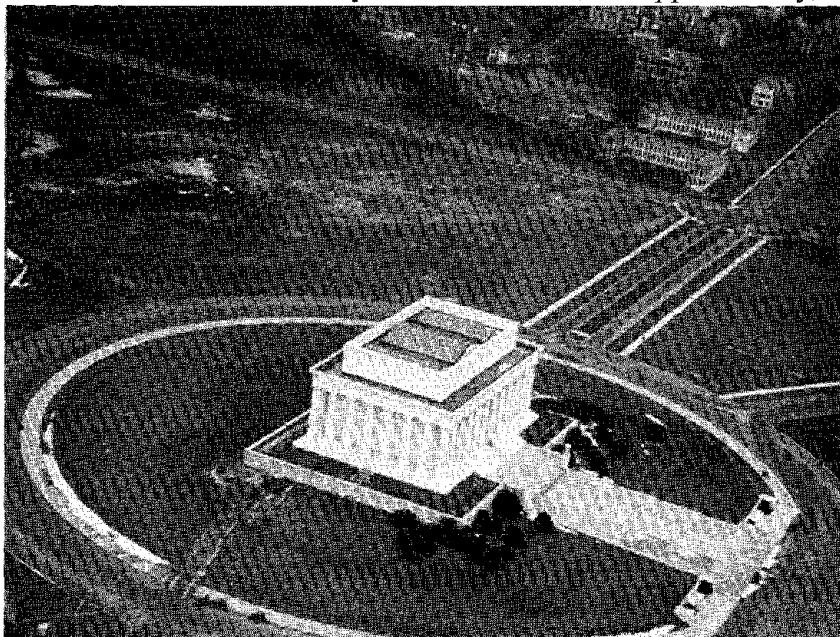
Figure 74 - Initial sidewalk installation, February 13, 1922. U.S. Navy photo. MRC I-61.

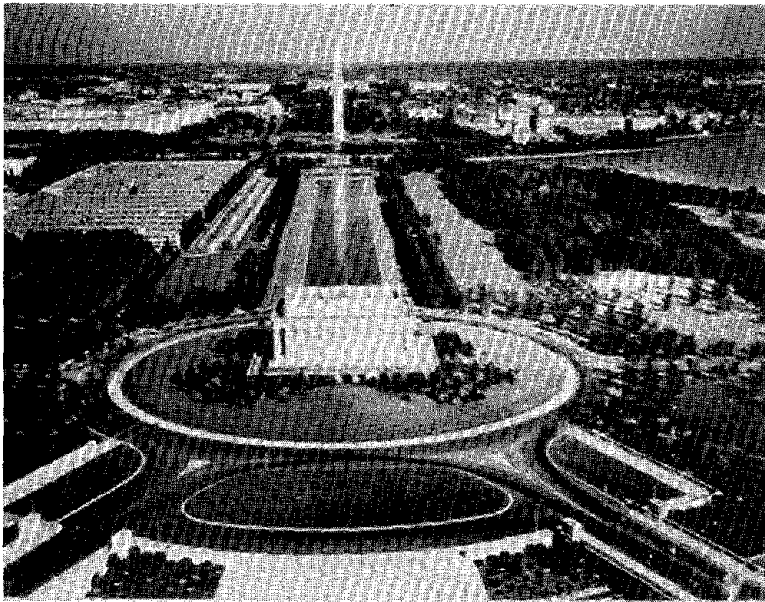
Figure 75 - Painted crosswalks from Lincoln Circle to the sidewalks along the radial roads and approaches, 1934. MRC 1-67.

At Lincoln Circle, pedestrian crosswalks were painted at all intersections with the radial roads and the approachway (1932 photo documentation). However, from that time forward, pedestrians crossing from any point on the circle encountered hazardous traffic conditions, especially on the east side of the memorial. To provide a safe, unimpeded place for crossing, the National Park Service began limiting vehicular traffic to the eastern segment, between French and Bacon Drives, during the 1972 tourist season.

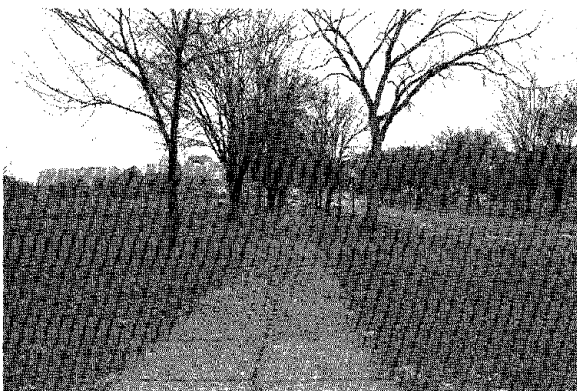
Figure 76 - Eight-foot wide sidewalk along 23rd Street NW, January 3, 1997. LINC 16-13.

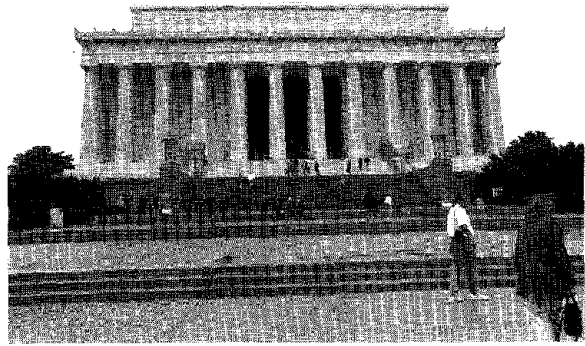
Figure 78 - Approachway and Lincoln Memorial, January 3, 1997. LINC 16-20.

Through the years the cobblestone panels have deteriorated, mostly due to freeze-thaw cycle. Park maintenance has responded by patching the deteriorated areas with a variety treatments. The unsightly appearance of this repair work for the cobblestone and safety concerns for visitors walking on the irregular surface, in addition to the structural problems, poor drainage, and lack of expansion joints, prompted the National Park Service to restore the entire approachway structure in 1995-1996. A few additions and alterations were made to the approachway area during this project. The cobblestone panels were removed and constructed in the same fashion as the original, with the exception that the stones were set to a greater depth in mortar to deter the

stones from dislodging. Also the ramps were redesigned to meet current accessibility standards according to the Americans with Disabilities Act (ADA) and provide a wider path for visitors. The new ramps have a more gentle slope (5%) and are 9 feet wide, 3 feet wider than the old ramps. As a result of the reduced slope of the ramps, the coping on the planting bed retaining walls needed to be raised 11 inches. Another course of granite and new granite coping (due to the deteriorated state of the original coping) were placed on top of the existing walls. The last change to the structure was the realignment of the ramps where they met the inner circle sidewalk. The previous ramps had a blind curve where the ramp and sidewalk came together. This situation was corrected to give visitors a clearer view when descending the ramp. Although the ramps are not historic, the National Park Service treated this area with the same respect for the historic fabric as they did for the main entrance steps by integrating the redesign of the ramp into the original approachway design. By using granite paving instead of exposed aggregate for the ramp surface, and by defining the edge of the ramps with granite coping, the ramps appear to be a part of the approachway.

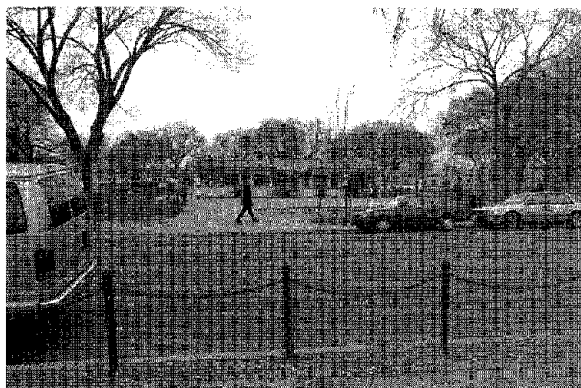
Figure 80 - Refreshment stand along French Drive, December 5, 1996. LINC 13-18.
